# Memorandum

**Re: First Quarter 2024 Semi-Annual Inspection and Progress Report; Harriman Inactive Waste Disposal Site No. 336006**

## Spring 2024 Semi-Annual Well Inspection Report

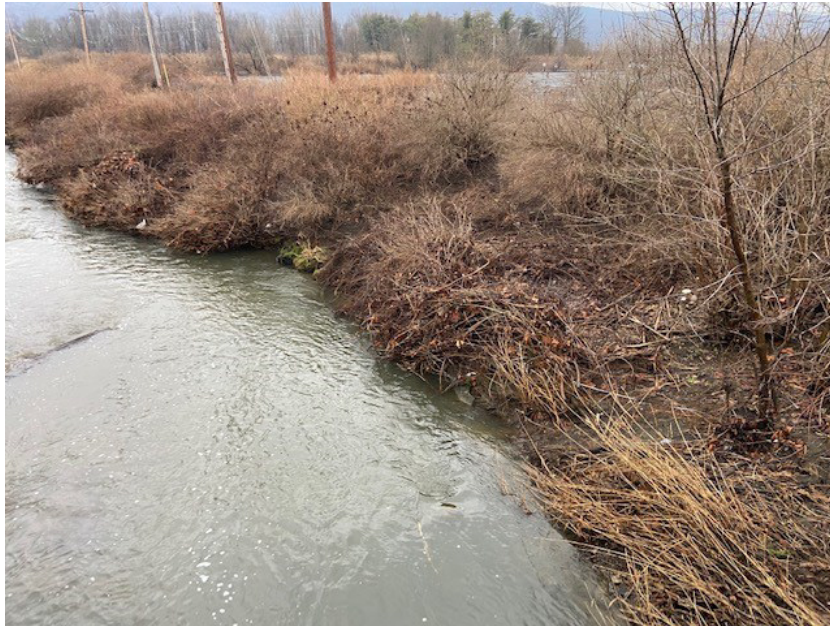
**Photograph 1**  
**Representative Streambank Photograph**

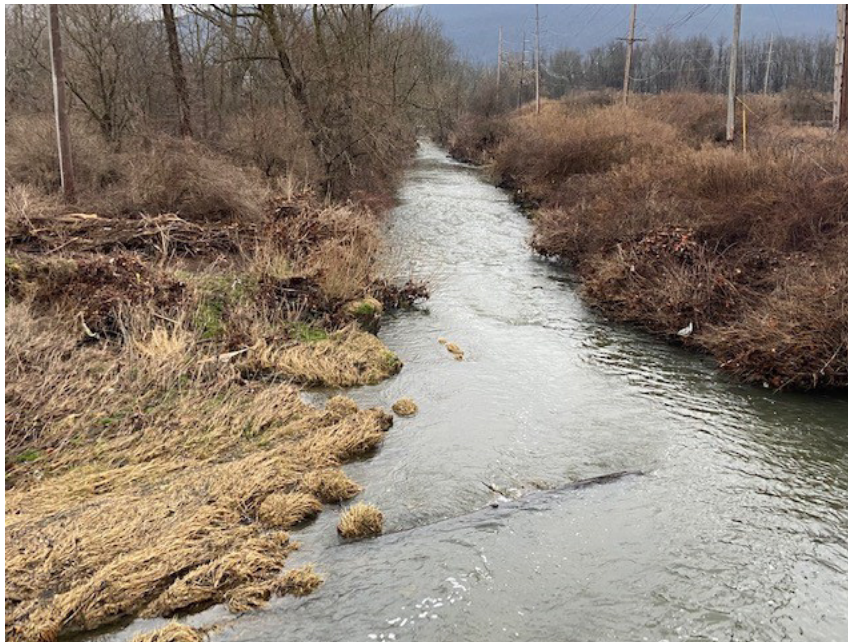
**Photograph 2**  
**Representative Streambank Photograph**

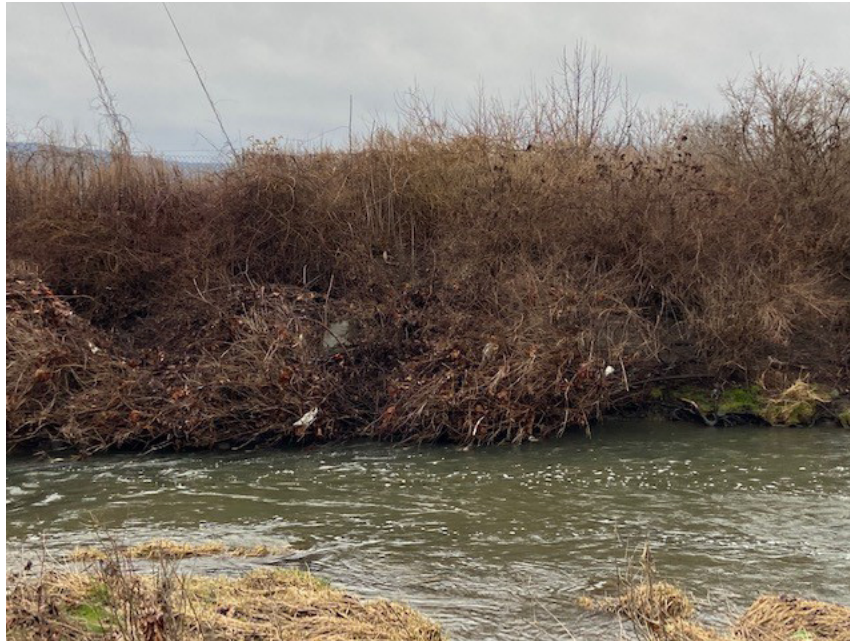
**Photograph 3**  
**Representative Streambank Photograph**

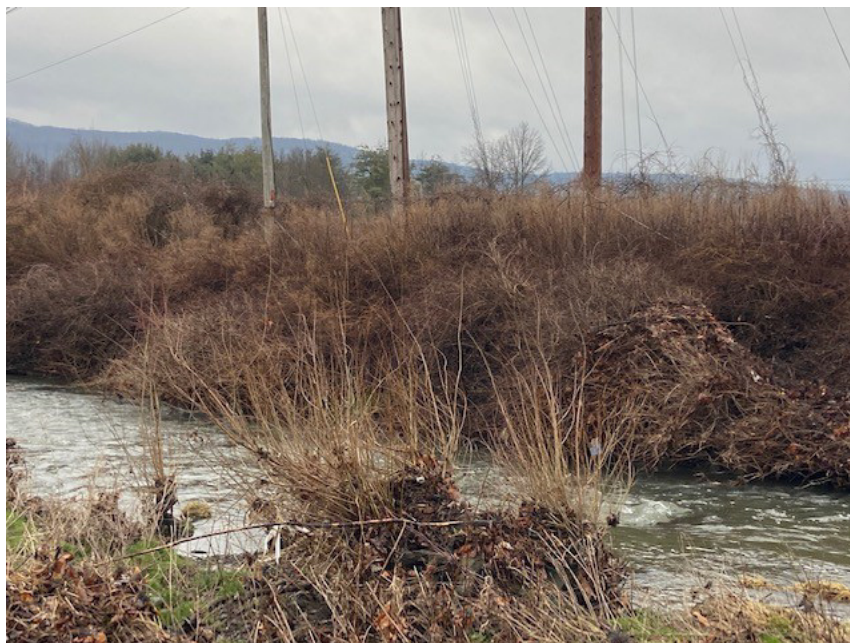
The interim riverbank turf reinforcement mat and vegetative cover system along the West Branch of the Ramapo River was inspected. Representative photographs of the area are provided along with the inspection form in Attachment 2. Observations of the cover system showed vegetation with no significant signs of erosion, and the system is functioning as designed.

**Photograph 4**  
**Representative Streambank Photograph**

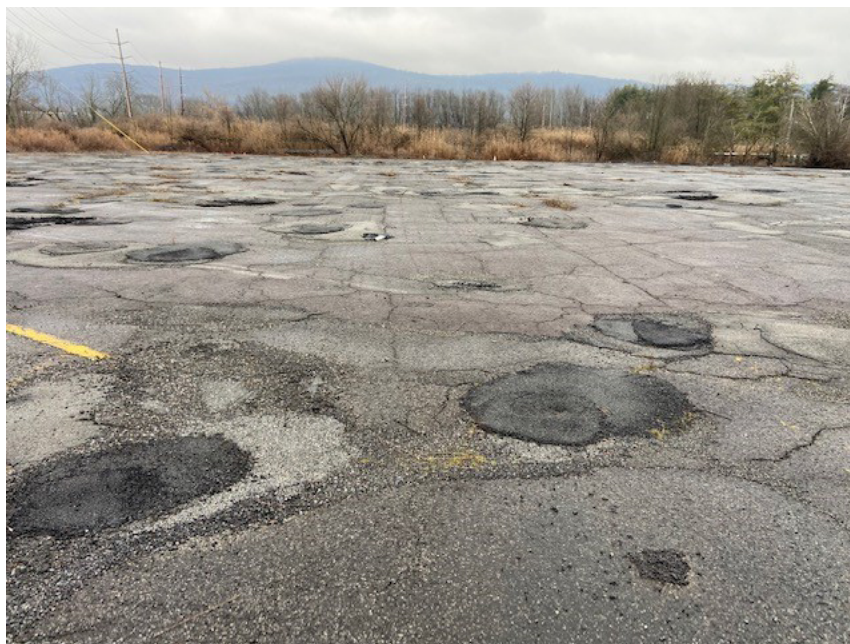
**Photograph 5**  
**Representative Parking Lot Photograph Facing North**

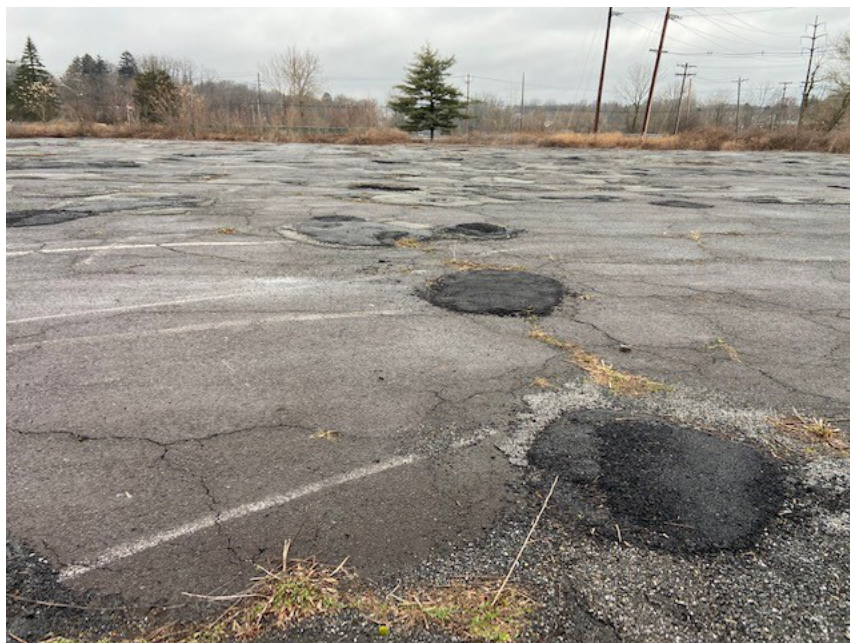
**Photograph 6**  
**Representative Parking Lot Photograph Facing South**

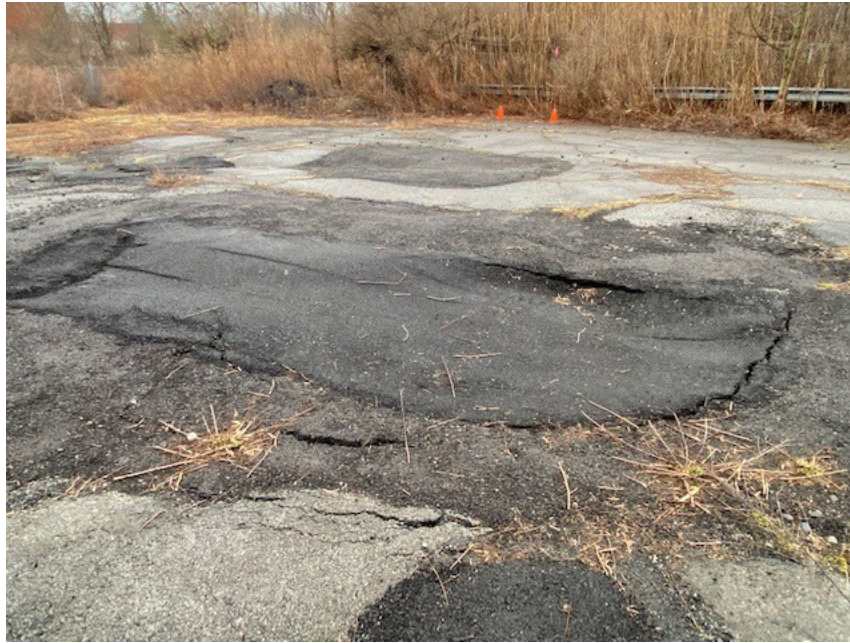
Section 3.4.1 of the ISMP addresses the interim control and integrity of the parking lot asphalt cover. Following the fourth quarter 2023 inspection, identified deficiencies were patched and repaired on December 4 and 5, 2024. Although the first quarter 2024 inspection identified the beginning of asphalt subsidence, the asphalt continues to provide erosion protection to the area. Representative photographs of the parking lot conditions are included in Attachment 2.

| | STATUS | COMMENTS |
|---|---|---|
| D. Settlement of parking lot cover | <u>Beginning</u> | <u>Some settlement observed to repairs made.<br/>Re-inspect next quarter.</u> |

**Photograph 7**  
**Representative Parking Lot Photograph Showing Signs of Settlement**

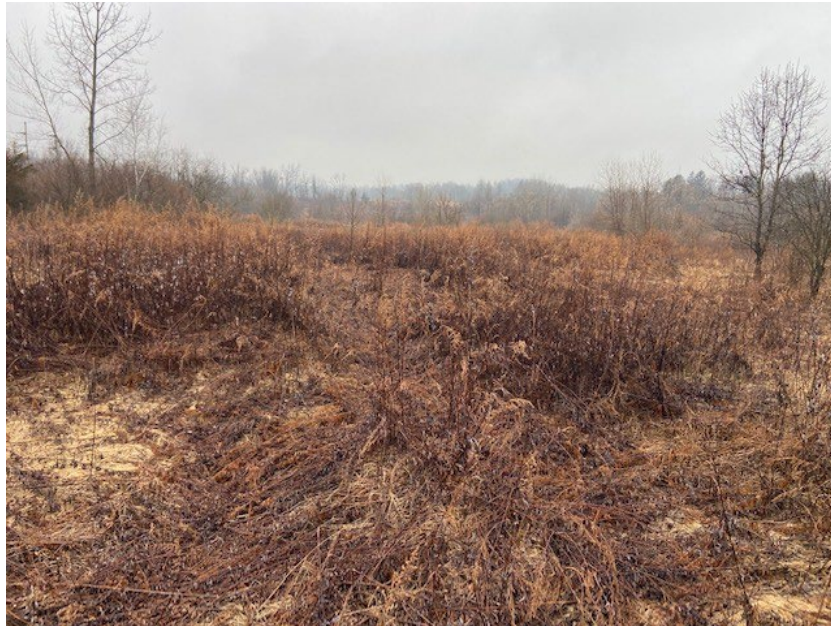
| | STATUS | COMMENTS |
|---|---|---|
| A. AREA F | <u>OK</u> | <u>No disturbance - natural vegetation</u> |

**Photograph 1**  
**Former Drum Excavation Area Facing Southwest**

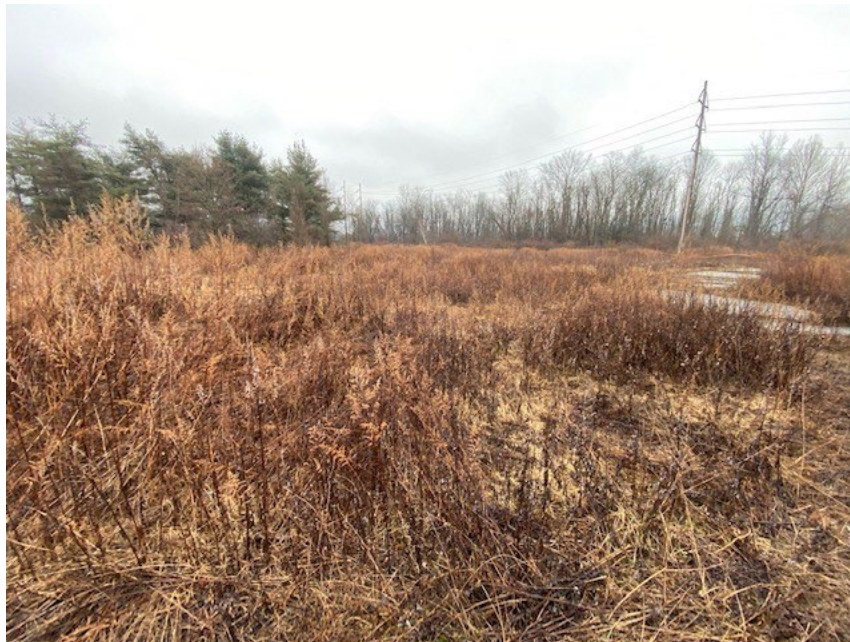
| | STATUS | COMMENTS |
|---|---|---|
| B. BUILDING 53 AREA | <u>OK</u> | <u>No disturbance - natural vegetation</u> |

**Photograph 2**  
**Former Drum Excavation Area Facing East**

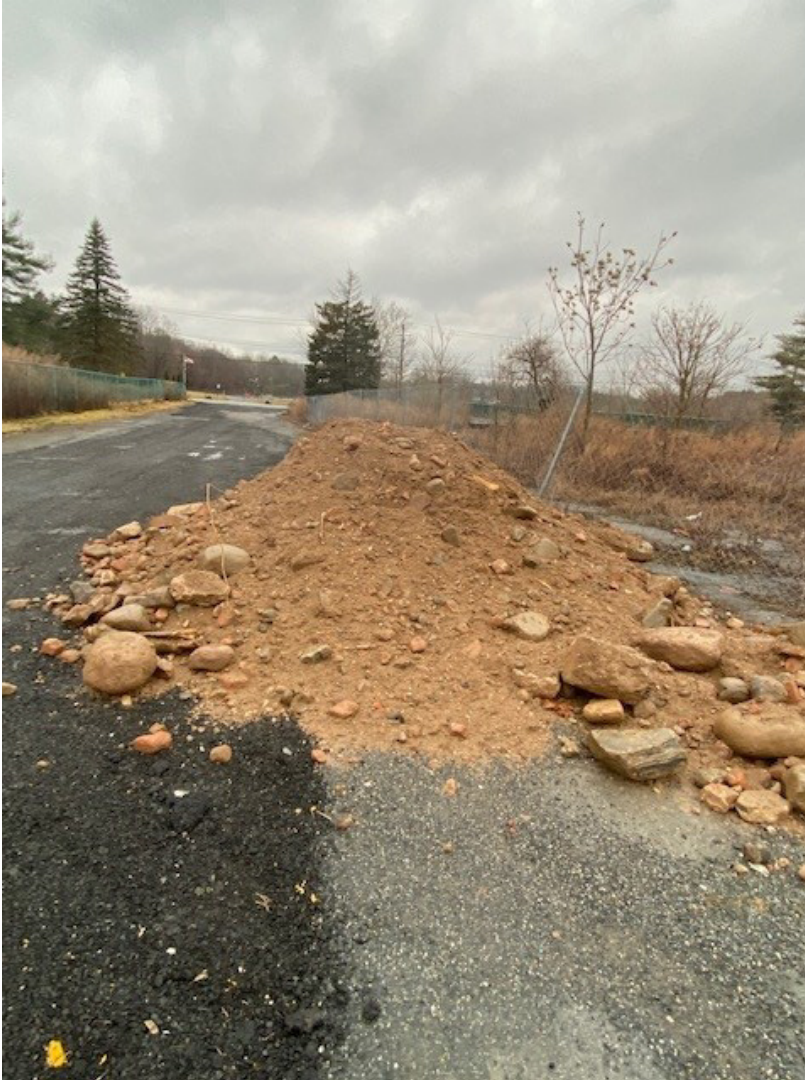
On February 23, 2024, ELT was informed by the Harriman Police Department that a load of soil and building debris had been illegally dumped on the property, at the edge of Arden House Road and the perimeter of the parking lot, and a portion of the fence adjacent to the dump site had been knocked down. During the site inspection, Anchor QEA staff securely covered the soil pile with a polyethylene tarp to prevent runoff. NYSDEC was then informed on March 25, 2024, that ELT had moved the soil pile to a former building slab on the plant site area to prevent interaction with site groundwater or surface runoff. ELT also plans to collect a composite sample of the soil pile and have it analyzed for volatile organic compounds (VOCs), semivolatile organic compounds (SVOCs), polychlorinated biphenyls (PCBs), metals, PFAS, and Resource Conservation and Recovery Act (RCRA) waste characteristics. Additional updates on the disposal plans will be provided to NYSDEC once characterization is complete.

South side of parking lot along Arden House Road damaged due to vandalism.

**Photograph 1**  
**Illegal Dumping and Fence Damage Facing Northwest**

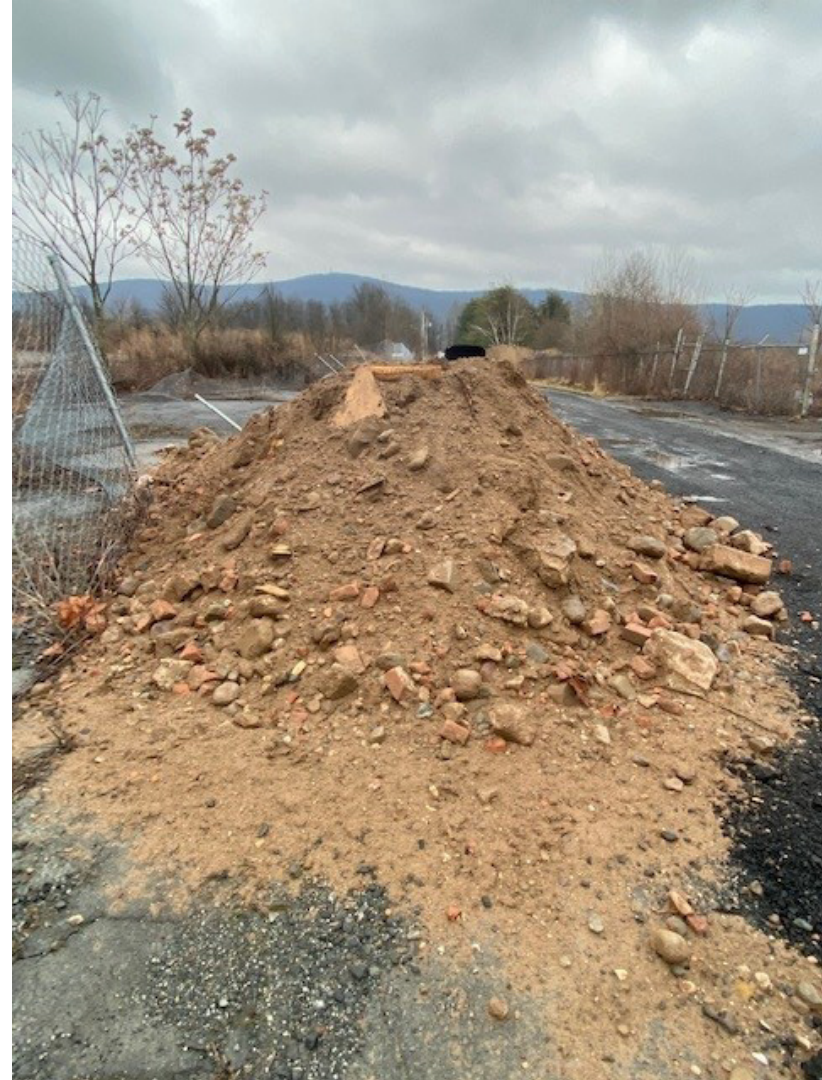
**Photograph 2**  
**Illegal Dumping and Fence Damage Facing Southeast**
