# Memorandum

July 17, 2025

**Re: First Quarter 2025 Semi-Annual Inspection and Progress Report; Harriman Inactive Waste Disposal Site No. 336006**

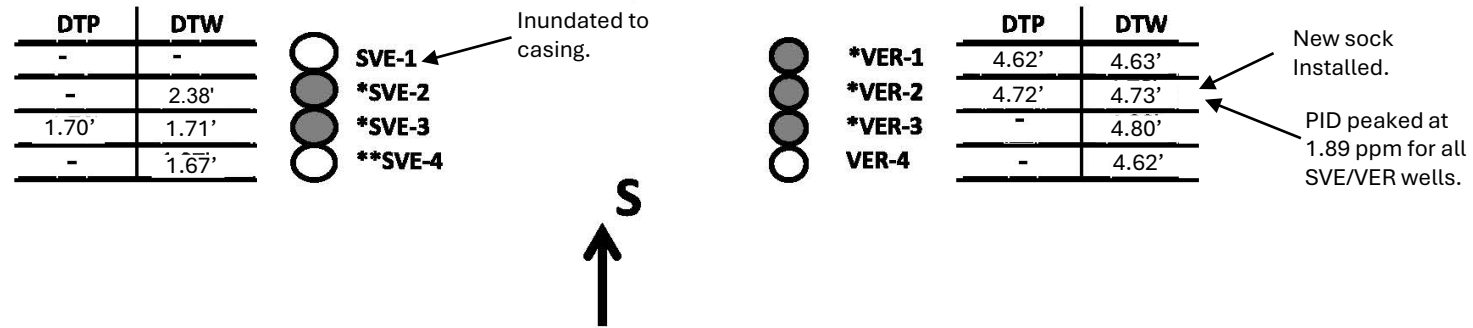
**SVE/VER PRODUCT MEASUREMENT CHECKLIST**

As outlined in Section 3.3.4 of the ISMP, product has historically been observed in soil vapor extraction (SVE) well VER-2. An absorbent sock was placed in that well, and the sock was monitored during subsequent site inspections. The absorbent sock was last replaced on December 14, 2023, during the Phase III Emerging Contaminant Investigation program. The sock was at 100% capacity when VER-2 was inspected on March 24, 2025, and was replaced

Absorbent socks were placed in four other wells (SVE-2, SVE-3, VER-1, and VER-3) on March 1, 2024, after a thin layer of product was detected by the interface probe. During the March 24, 2025, inspection, three of the absorbent socks in the four wells had slight discoloration, although product was detected in only two of the wells (0.01 inch each in wells SVE-3 and VER-1). The discoloration on the sock in VER-1 was a dark orange, in contrast to the brown or light-yellow discoloration of socks historically present in other soil vapor extraction wells. The photoionization detector (PID) readings in the vicinity of the sock were non-detect, further indicating that the dark orange substance was likely not the product found in other wells. Because only approximately 20% of the sock was discolored, the sock was not replaced. Monitoring well SVE-1 was inundated, and a depth-to-water reading could not be collected. No sheen was observed on the pooled water at this location. No product was observed in wells SVE-2, SVE-4, VER-3, or VER-4.

**Comments:**  
Graphic represents orientation of wells when facing south.  
Check wells for depth to water (DTW) and depth to product (DTP) after absorbent sock is removed.  
\*Absorbent sock present in VER-1 through VER-2, SVE-2, and SVE-3 and prior observations of product have been noted in this well.  
\*\*Bottom of SVE-4 partially filled in during prior demolition work (Bottom at 2.65 ft).

Future inspections will continue to monitor the socks in these five wells. The semi-annual SVE/VER well inspection form is provided for reference in Attachment 1.

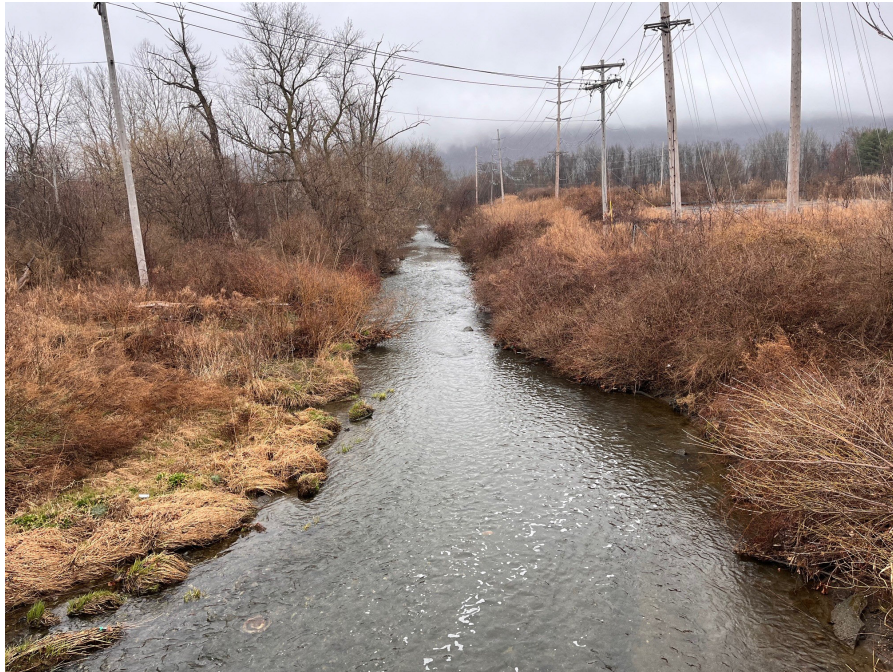
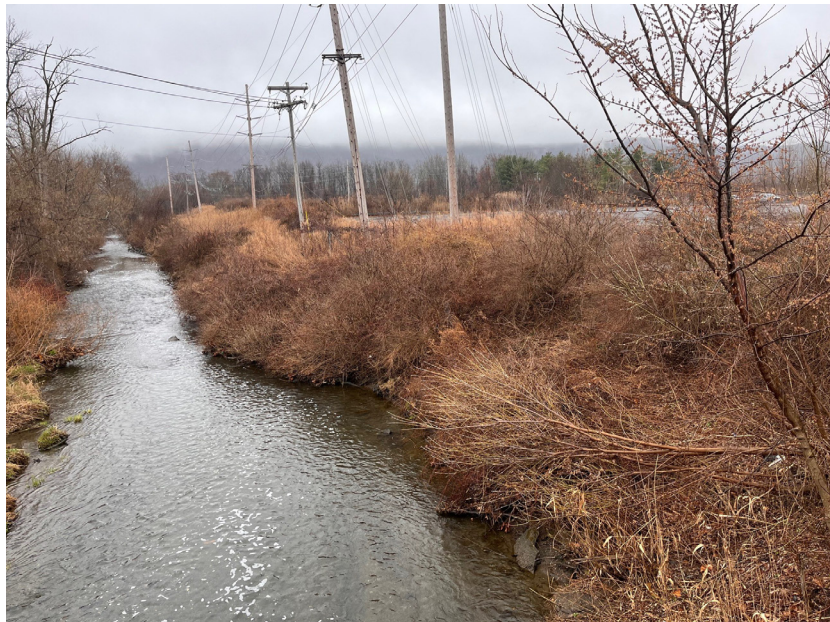
The interim riverbank turf reinforcement mat and vegetative cover system along the West Branch of the Ramapo River was inspected. Representative photographs of the area and the inspection form are provided in Attachment 2. Observations of the cover system showed vegetation with no significant signs of erosion and the system functioning as designed.

| | STATUS | COMMENTS |
|---|---|---|
| A. General condition of riverbank cover material | <u>OK</u> | <u>Stable</u> |
| B. Settlement of riverbank cover | <u>OK</u> | <u>None observed</u> |

**Photograph 1**  
**Representative Streambank Photograph**

**Photograph 2**  
**Representative Streambank Photograph**

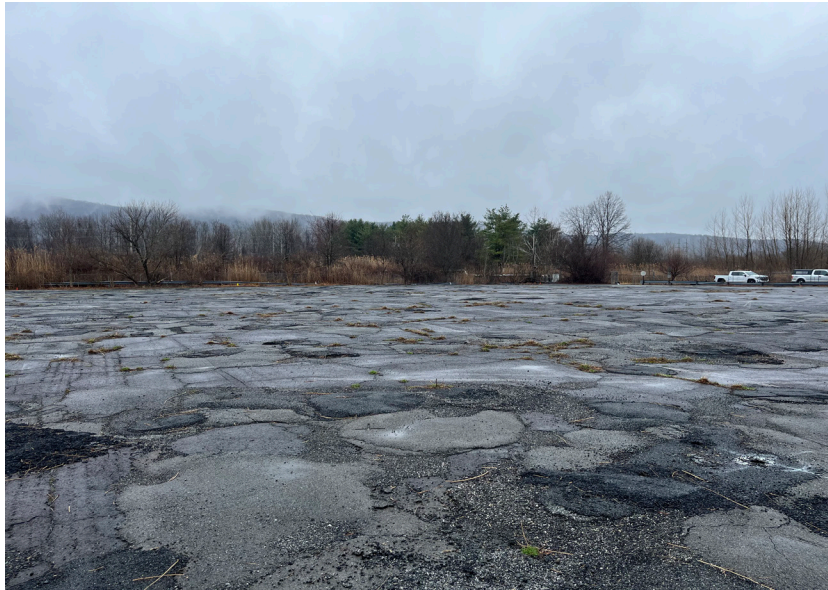
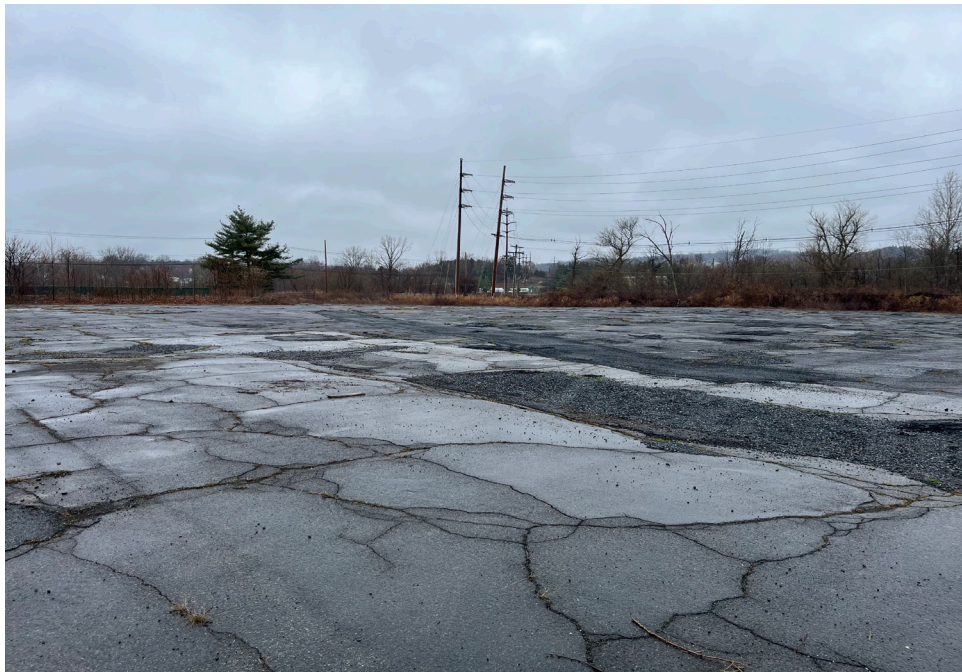
Section 3.4.1 of the ISMP addresses the interim control and integrity of the parking lot asphalt cover. Deficiencies identified during the fourth quarter 2023 inspection were patched and repaired on December 4 and 5, 2023. As with the fourth quarter 2024 inspection, there were some small, localized areas with limited subsidence of the asphalt; however, the asphalt remains intact and continues to provide erosion protection for materials beneath the parking lot area. Representative photographs of the parking lot conditions are provided in Attachment 2.

| | STATUS | COMMENTS |
|---|---|---|
| C. General condition of parking lot cover material | <u>OK</u> | <u>10-15 small holes observed across the parking lot</u> |

**Photograph 3**  
**Representative Parking Lot Photograph Facing Southeast**

**Photograph 4**  
**Representative Parking Lot Photograph Facing Northwest**

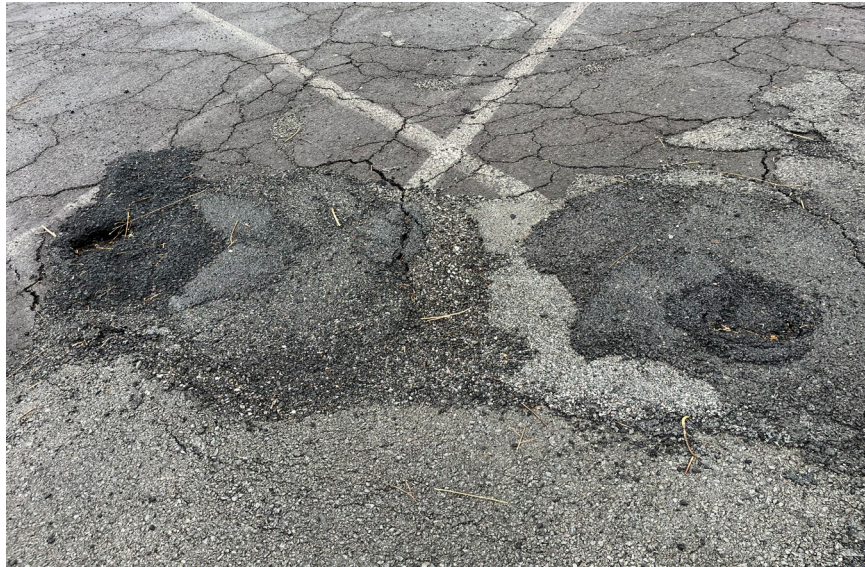
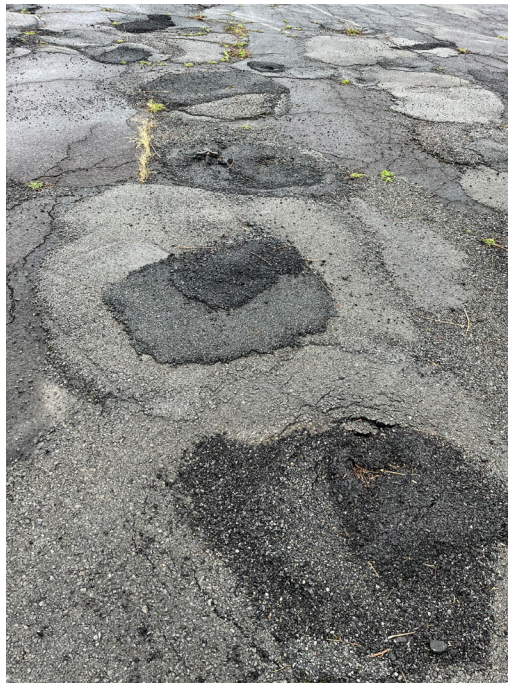
| | STATUS | COMMENTS |
|---|---|---|
| D. Settlement of parking lot cover | <u>OK</u> | <u>Recent repairs have settled</u> |

**Photograph 5**  
**Representative Parking Lot Photograph Showing Areas of Repair**

**Photograph 6**  
**Representative Parking Lot Photograph Showing Areas of Repair**

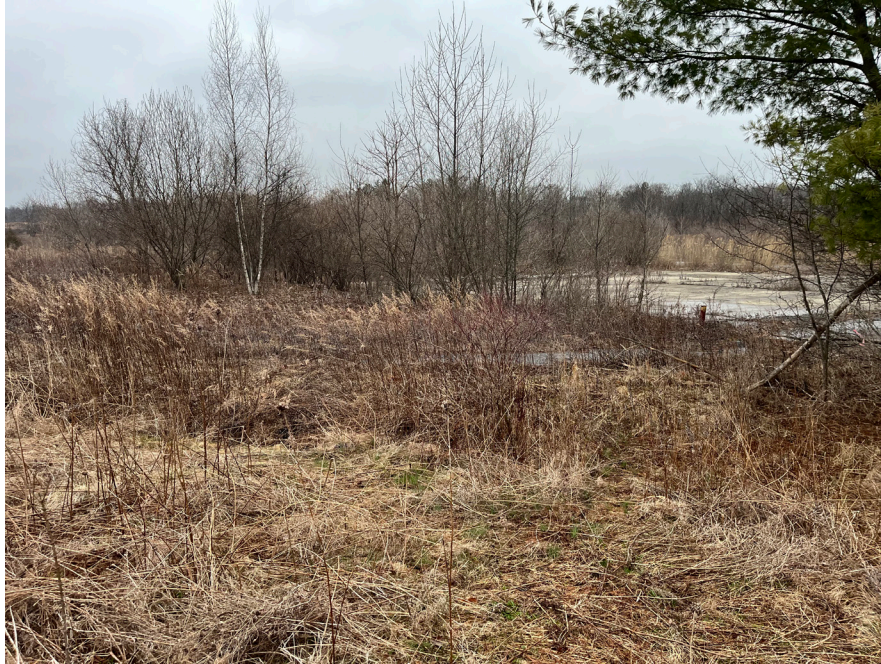
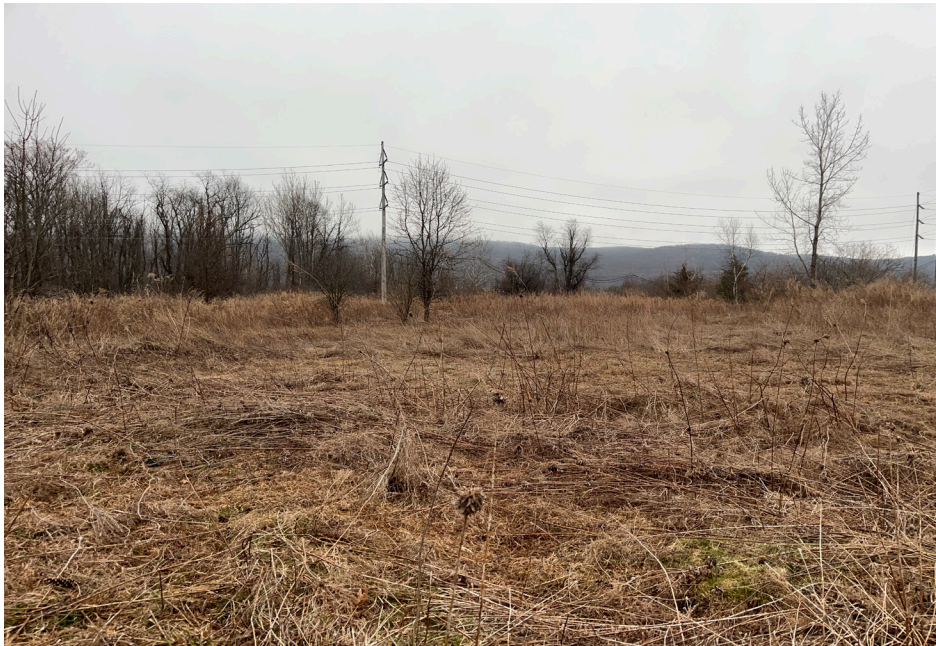
contain vegetation with no visual evidence of disturbance or erosion. The inspection form and photographs for these areas are provided in Attachment 3.

| | STATUS | COMMENTS |
|---|---|---|
| A. AREA F | <u>OK</u> | <u>No disturbance. Natural vegetation.</u> |
| B. BUILDING 53 AREA | <u>OK</u> | <u>No disturbance. Natural vegetation.</u> |

**Photograph 1**  
**Former Drum Excavation Area Facing Southwest**

**Photograph 2**  
**Former Drum Excavation Area Facing East**

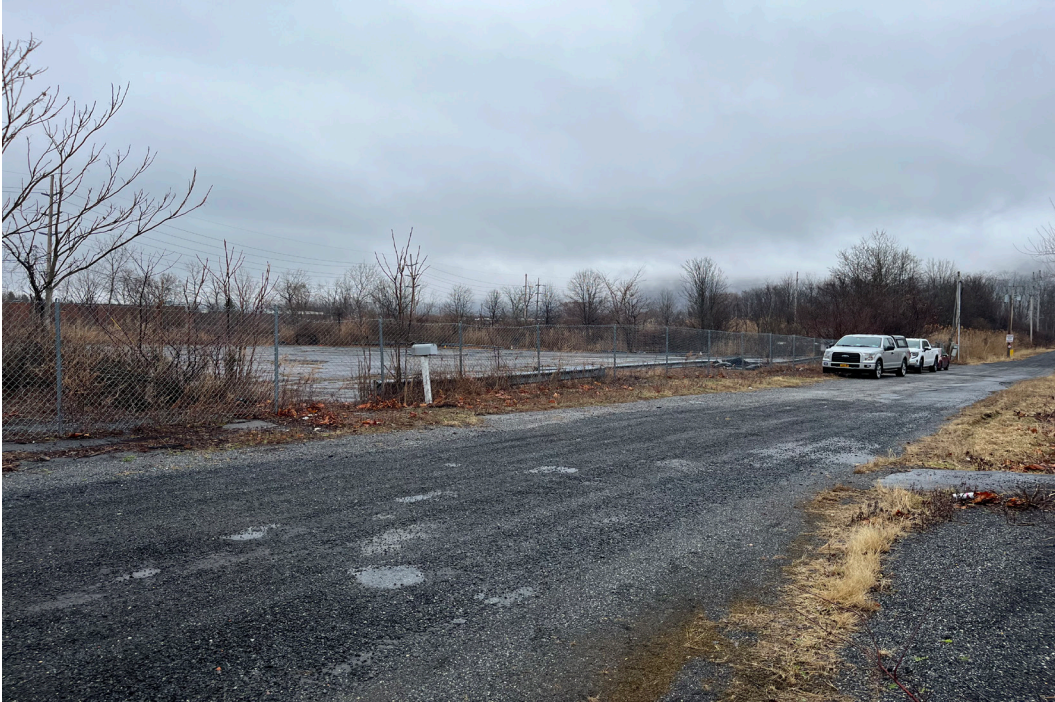
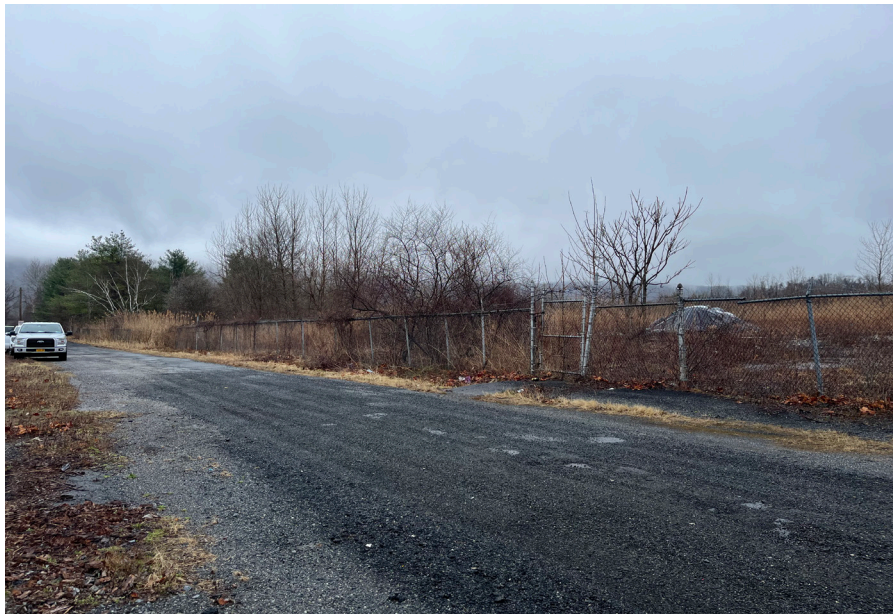
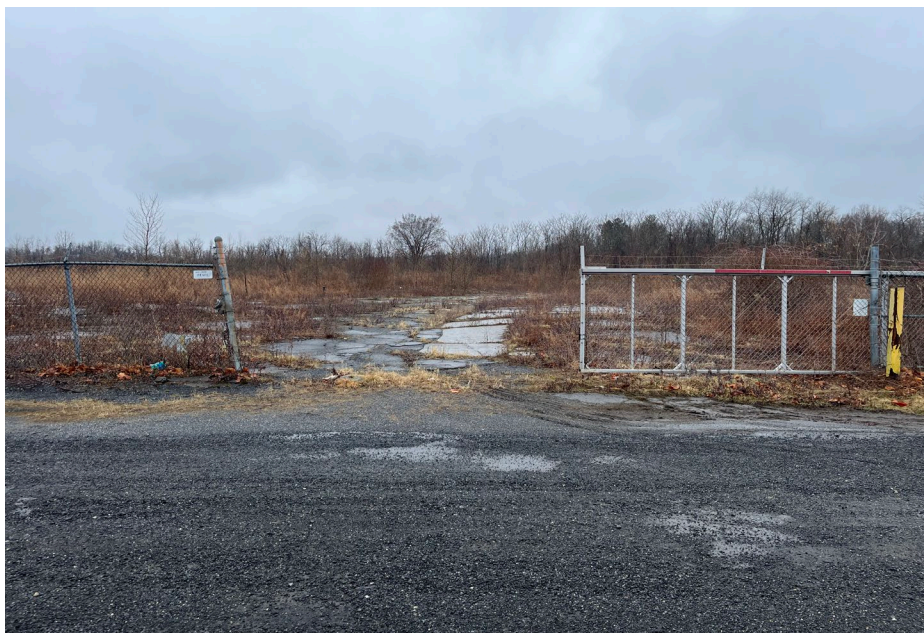
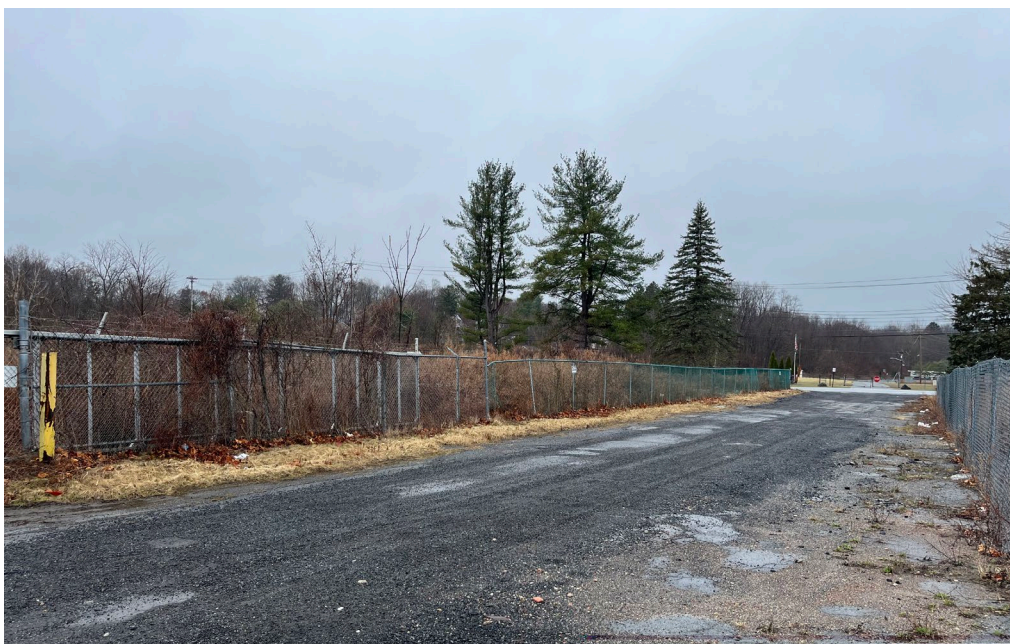
**Photograph 1**  
**Parking Lot Fence Facing Southwest**

**Photograph 2**  
**Lot Fence facing Southeast**

**Photograph 3**  
**Fence Facing South**

**Photograph 4**  
**Fence Gate Facing North**

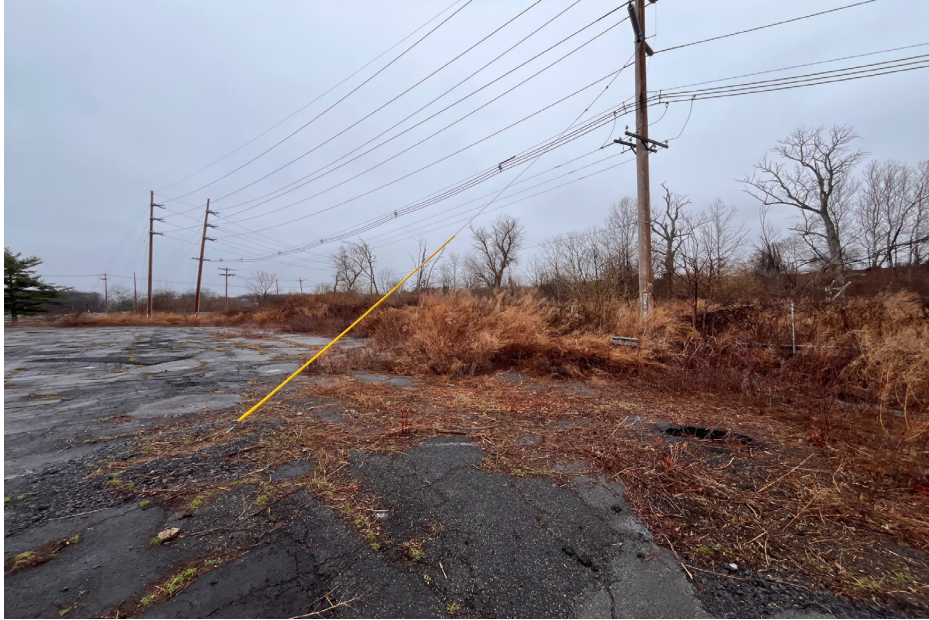
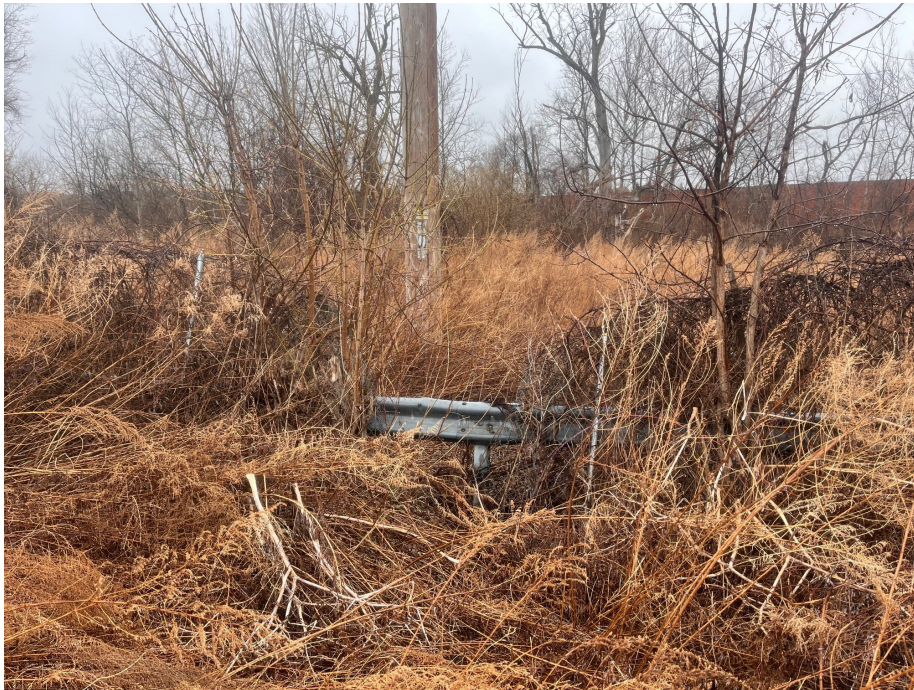
Section 3.4.6 of the ISMP requires visual inspections of the fence and gates to restrict unauthorized access to the Site. During the site inspection, the fence perimeter was visually inspected and it was observed that the fencing on the north side of the parking lot, adjacent to the river, was damaged. Access is likely restricted due to the location and extent of vegetation present, but repairs can be made as appropriate. The section of the fence adjacent to the parking lot that was repaired on March 26, 2024, was observed to be in good condition. Additional photographs and inspection forms are provided in Attachment 4.

| <b>B. Perimeter fence around NEPERA Parking Lot</b> | Damaged |

Five foot gap in fencing on N side of parking lot. Dense vegetation throughout

**Photograph 5**  
**Fence Damage on North side of Parking Log**

**Photograph 6**  
**Fence Damage on North side of Parking Log**
