# Memorandum

**Re: Third Quarter 2025 Semi-Annual Inspection and Progress Report; Harriman Inactive Waste Disposal Site No. 336006**

### Third Quarter 2025 Semi-Annual Well Inspection Report

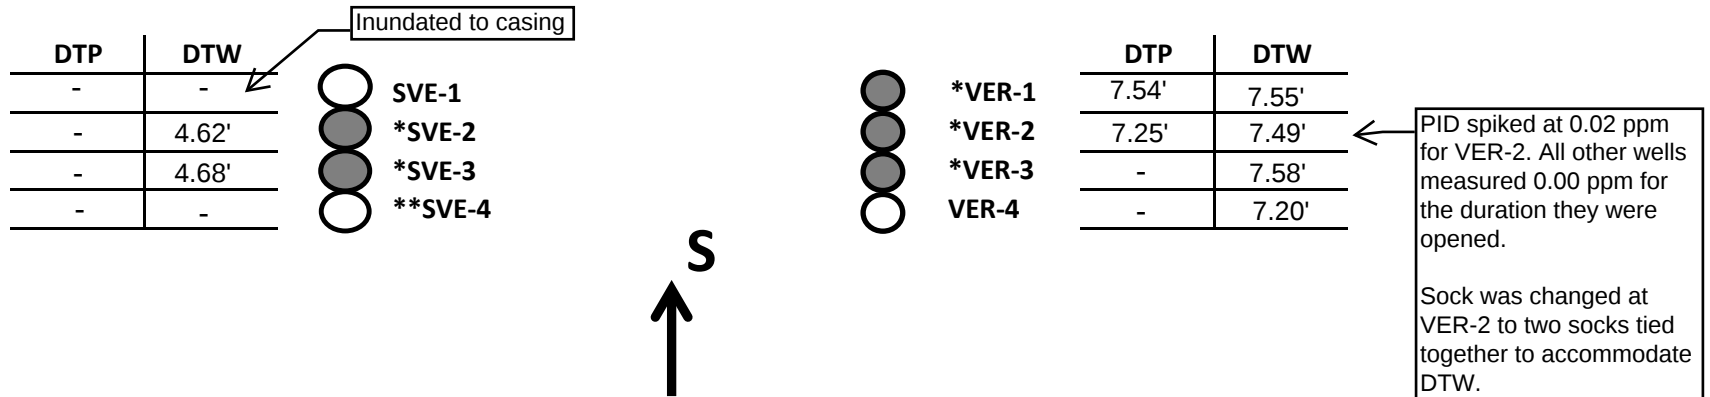
# SVE/VER PRODUCT MEASUREMENT CHECKLIST

The absorbent sock in soil vapor extraction (SVE) well VER-2 was observed to be at 30% capacity when inspected on September 18, 2025, and was replaced with two socks tied together to accommodate variation in water level. This absorbent sock was last replaced on March 24, 2025.

The absorbent socks present in four other wells (SVE-2, SVE-3, VER-1, and VER-3) were also inspected on September 18, 2025. Three of these absorbent socks had slight discoloration, although product was detected in only one of the wells (0.01 inch in VER-1). Because only approximately 30% of each of these socks was discolored, none were replaced. Monitoring well SVE-1 was inundated, and a depth-to-water reading could not be collected. No sheen was observed on the pooled water at this location. No product was observed in wells SVE-2, SVE-3, SVE-4, VER-3, or VER-4.

\*Absorbent sock present in VER-1 through VER-3, SVE-2, and SVE-3 and prior observations of product have been noted in these wells.

\*\*Bottom of SVE-4 partially filled in during prior demolition work (Bottom at 2.65 ft).

Future inspections will continue to monitor the socks in these five wells. The semi-annual SVE/VER well inspection form is provided for reference in Attachment 1.

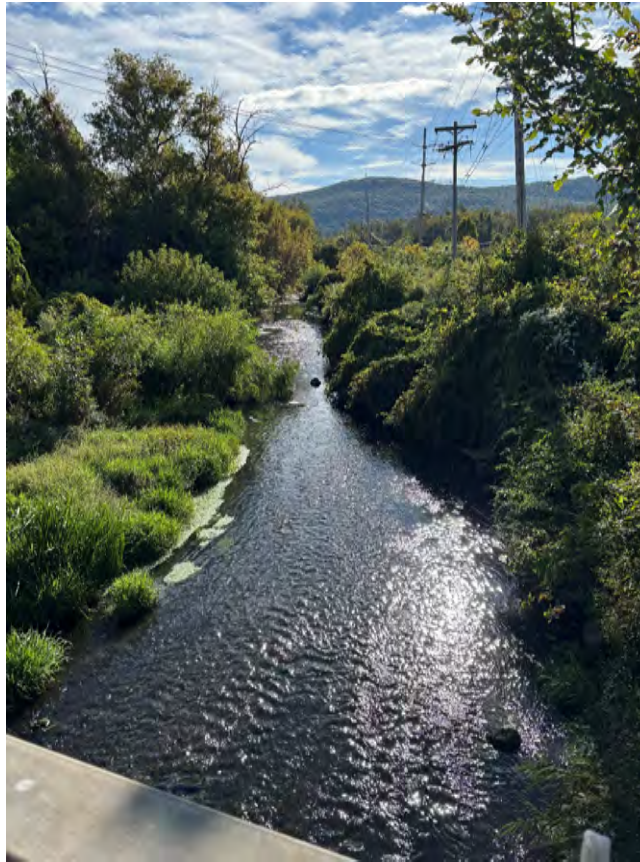
**Photograph 1**  
**Representative Streambank Photograph**

The interim riverbank turf reinforcement mat and vegetative cover system along the West Branch of the Ramapo River was inspected. Representative photographs of the area and the inspection form are provided in Attachment 2. Observations of the cover system showed vegetation with no significant signs of erosion and the system functioning as designed.

| | STATUS | COMMENTS |
|---|---|---|
| A. General condition of riverbank cover material | <u>OK</u> | <u>Stable, dense vegetation</u> |
| B. Settlement of riverbank cover | <u>OK</u> | <u>None observed</u> |

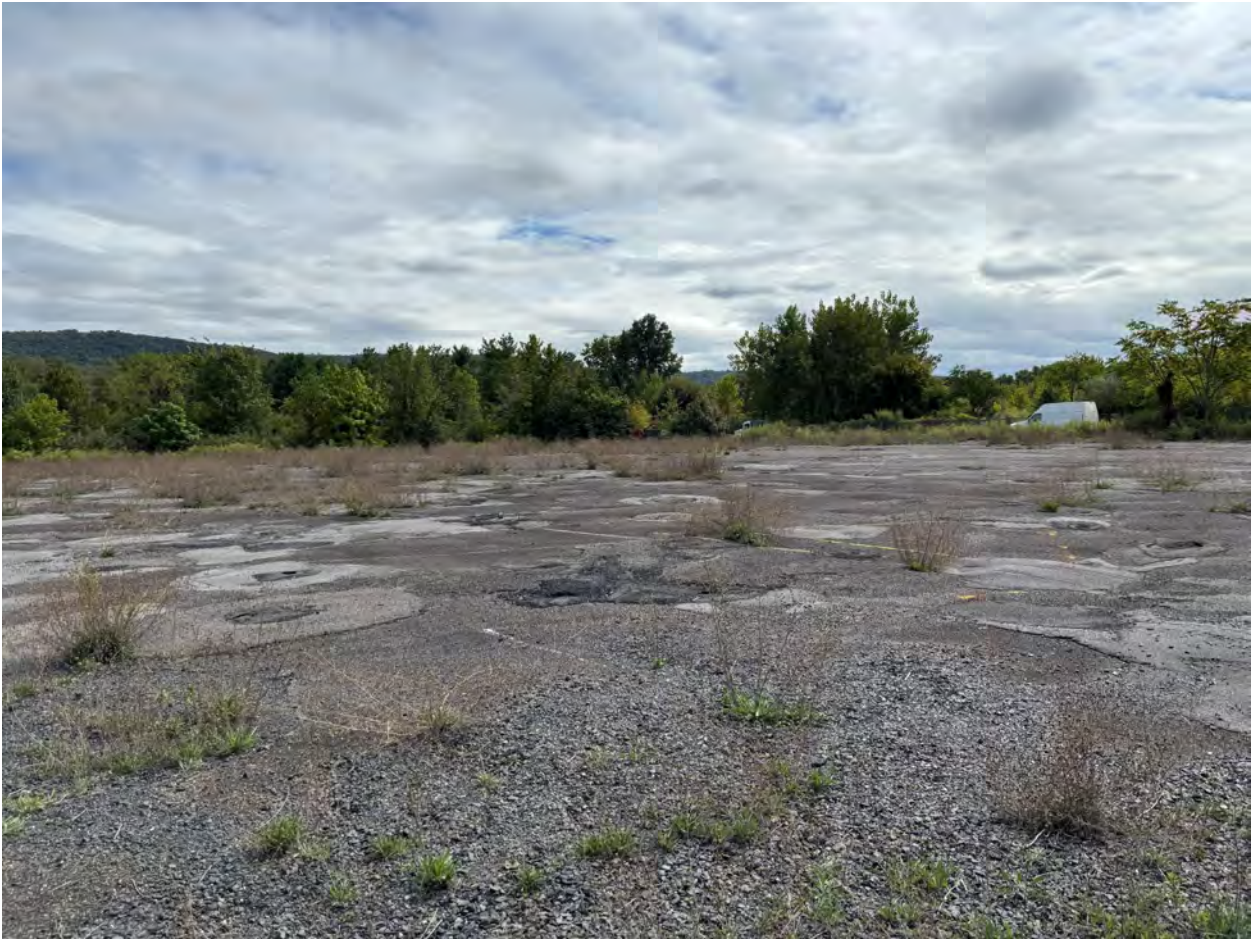
**Photograph 3**  
**Representative Parking Lot Photograph Facing Southeast**

Section 3.4.1 of the ISMP addresses the interim control and integrity of the parking lot asphalt cover. Deficiencies identified during the fourth quarter 2024 inspection were patched and repaired in January 2025. There were many small, localized areas with limited subsidence of the asphalt; however, larger holes were also observed which would benefit from focused repairs to provide erosion protection for materials beneath the parking lot area. As done in the past, patching and repair of the areas in the parking lot requiring attention will be completed in the upcoming quarter pending weather conditions. Representative photographs of the parking lot conditions are provided in Attachment 2.

| | STATUS | COMMENTS |
|---|---|---|
| C. General condition of parking lot cover material | <u>Poor</u> | <u>Three large holes (&gt;12"), 17 medium holes (6-12"), 36 small holes (&lt;6")</u> |

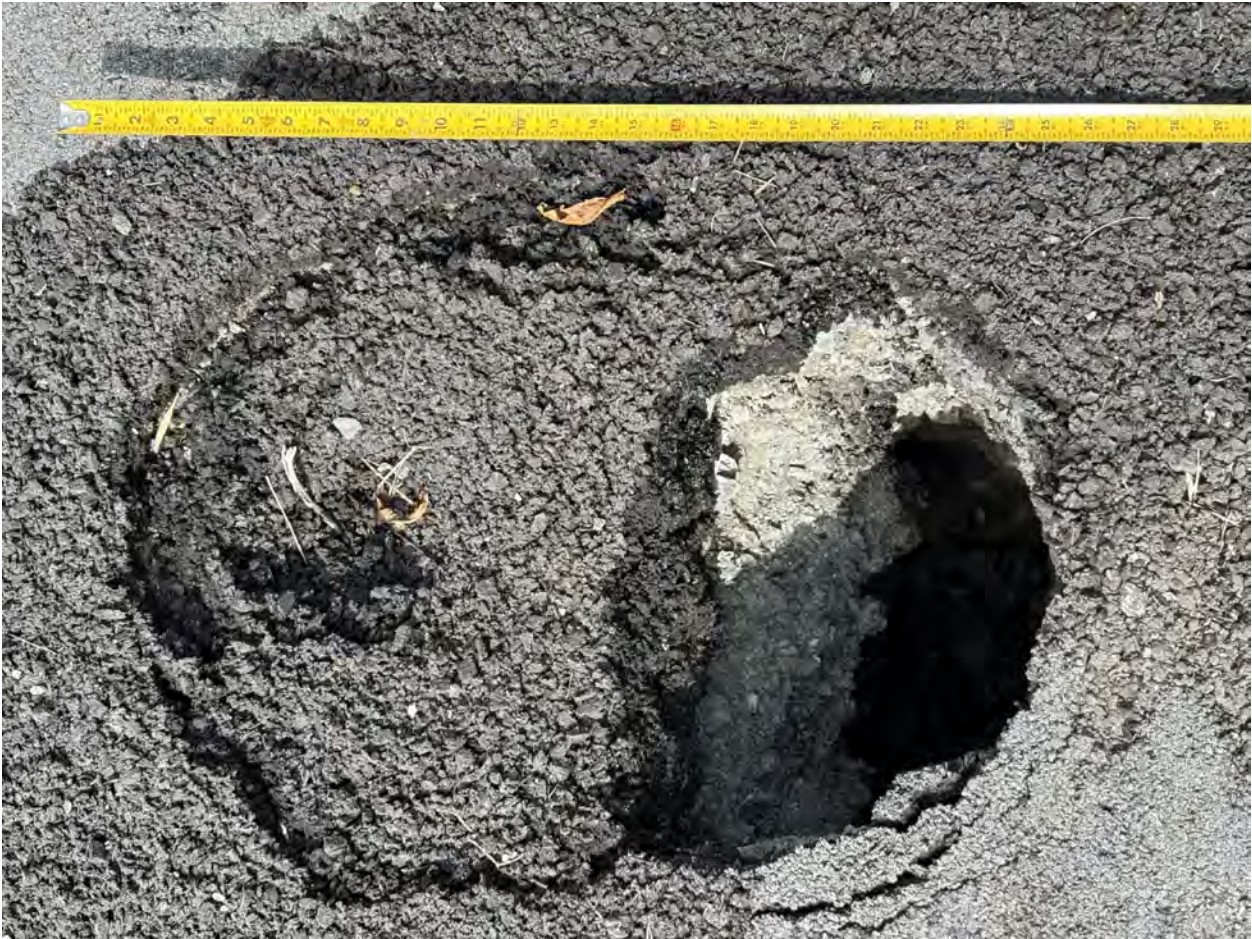
**Photograph 5**  
**Representative Parking Lot Photograph Showing Areas of Repair**

| | STATUS | COMMENTS |
|---|---|---|
| D. Settlement of parking lot cover | <u>OK</u> | <u>Recent repairs have settled</u> |

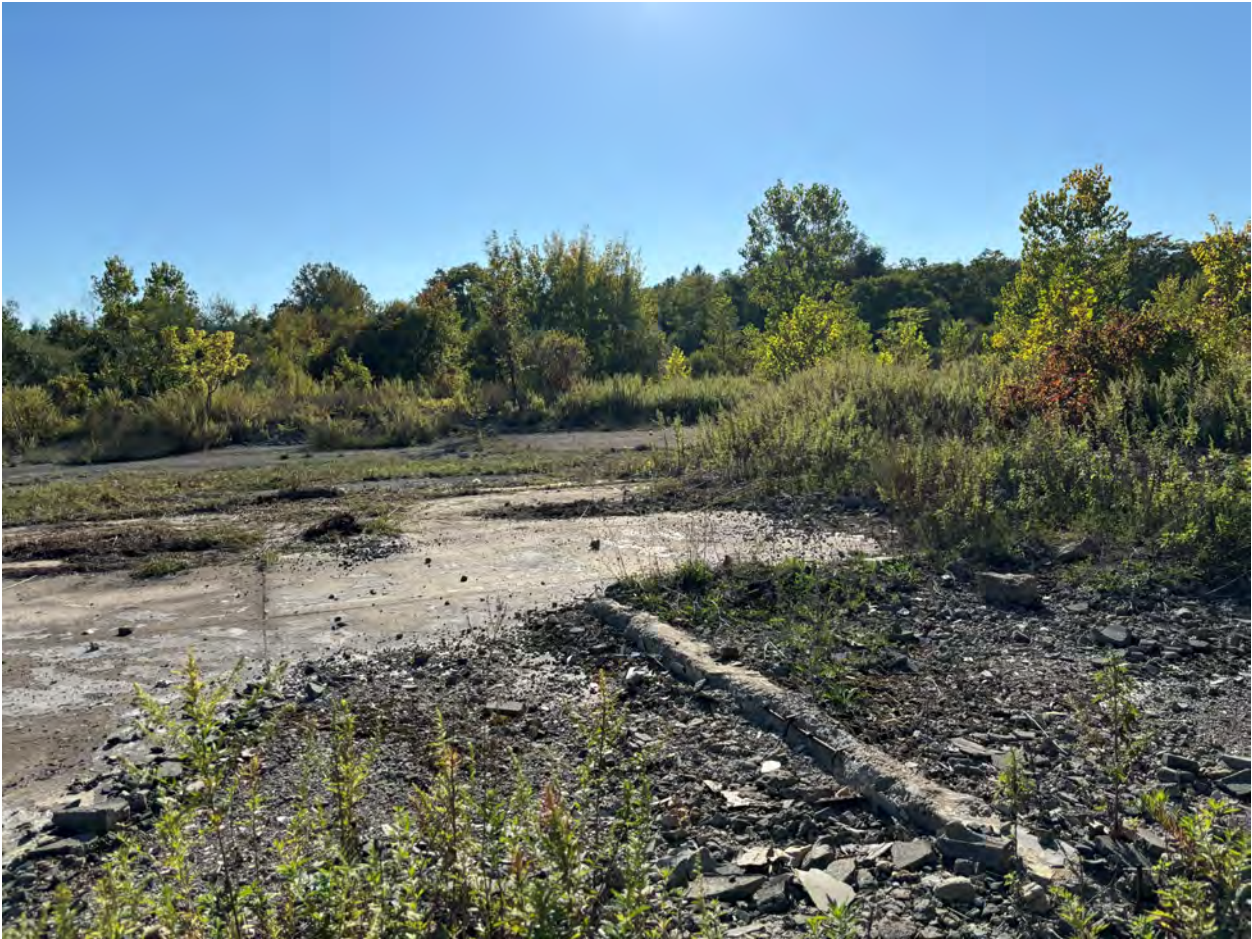
**Photograph 1**  
**Former Drum Excavation Area Facing Southwest**

Section 3.4.2 of the ISMP requires the inspection of former excavation and backfill areas to evaluate them for signs of significant erosion or vandalism. Areas of Building 53 and Area F were observed to contain vegetation with no visual evidence of disturbance or erosion. The inspection form and photographs for these areas are provided in Attachment 3.

No disturbance. Natural vegetation. Recently cleared.

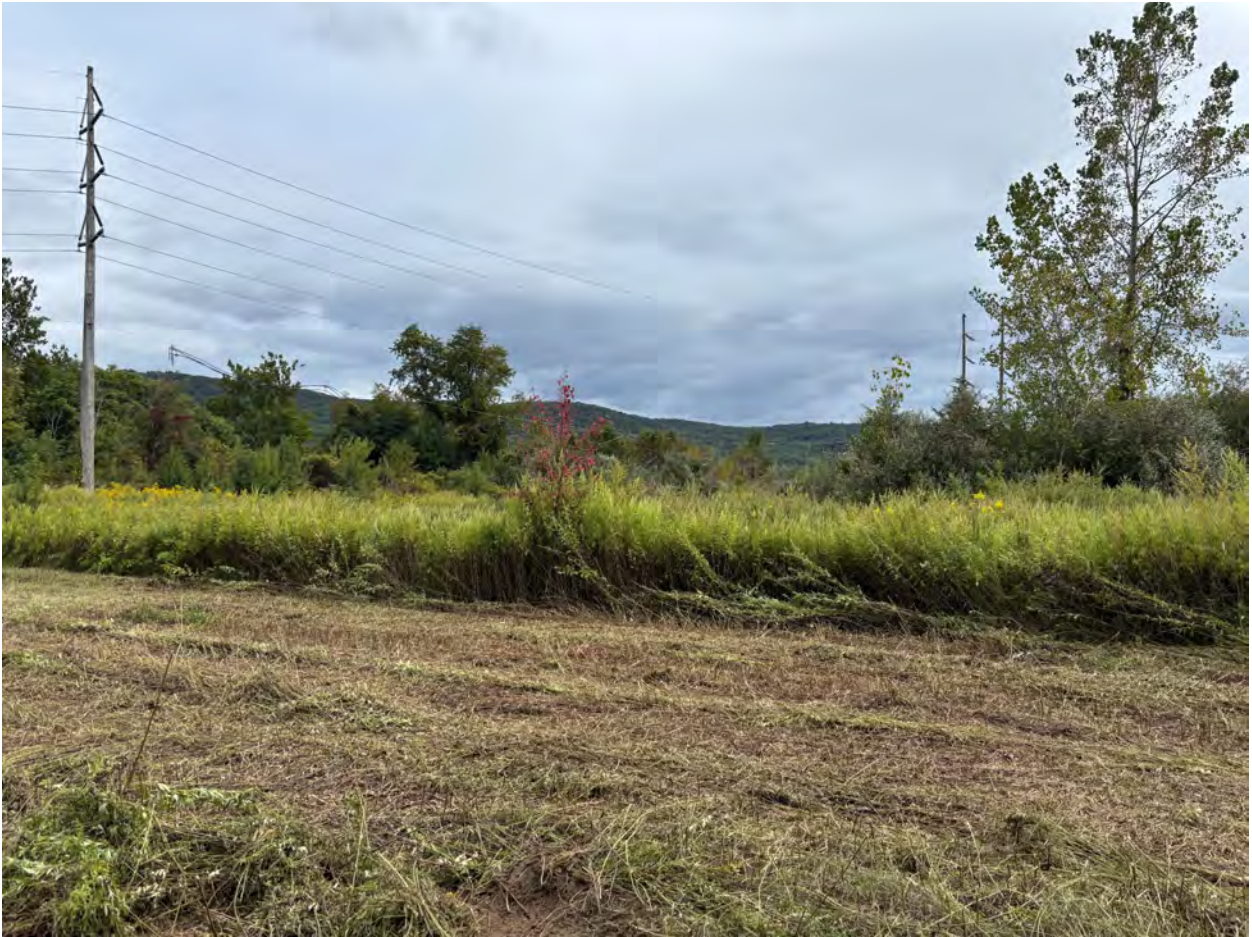
**Photograph 2**  
**Former Drum Excavation Area Facing East**

No disturbance. Natural vegetation. Recently cleared.

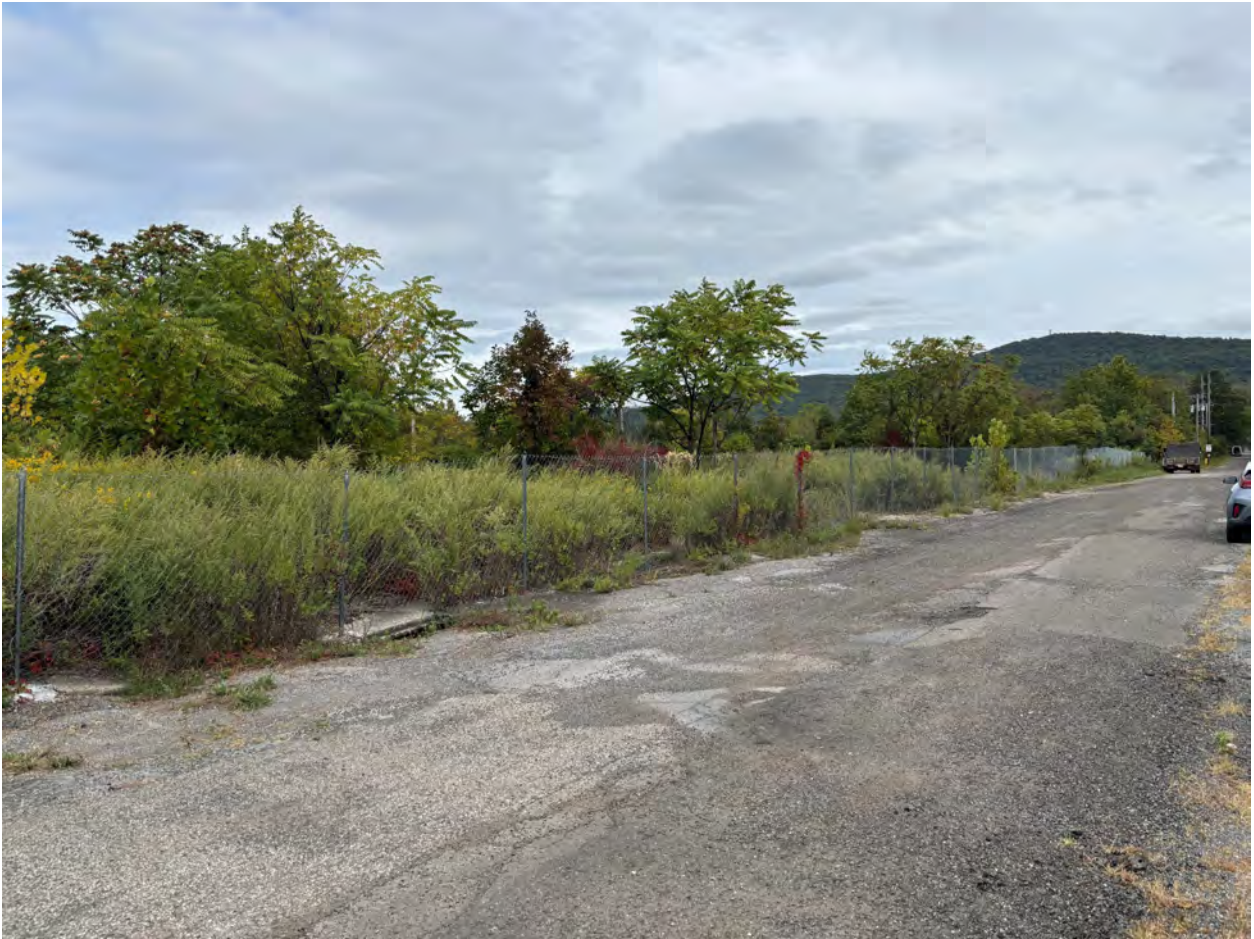
**Photograph 1**  
**Parking Lot Fence Facing Southwest**

| <b>B. Perimeter fence around NEPERA Parking Lot</b> | <u>Damaged</u> |

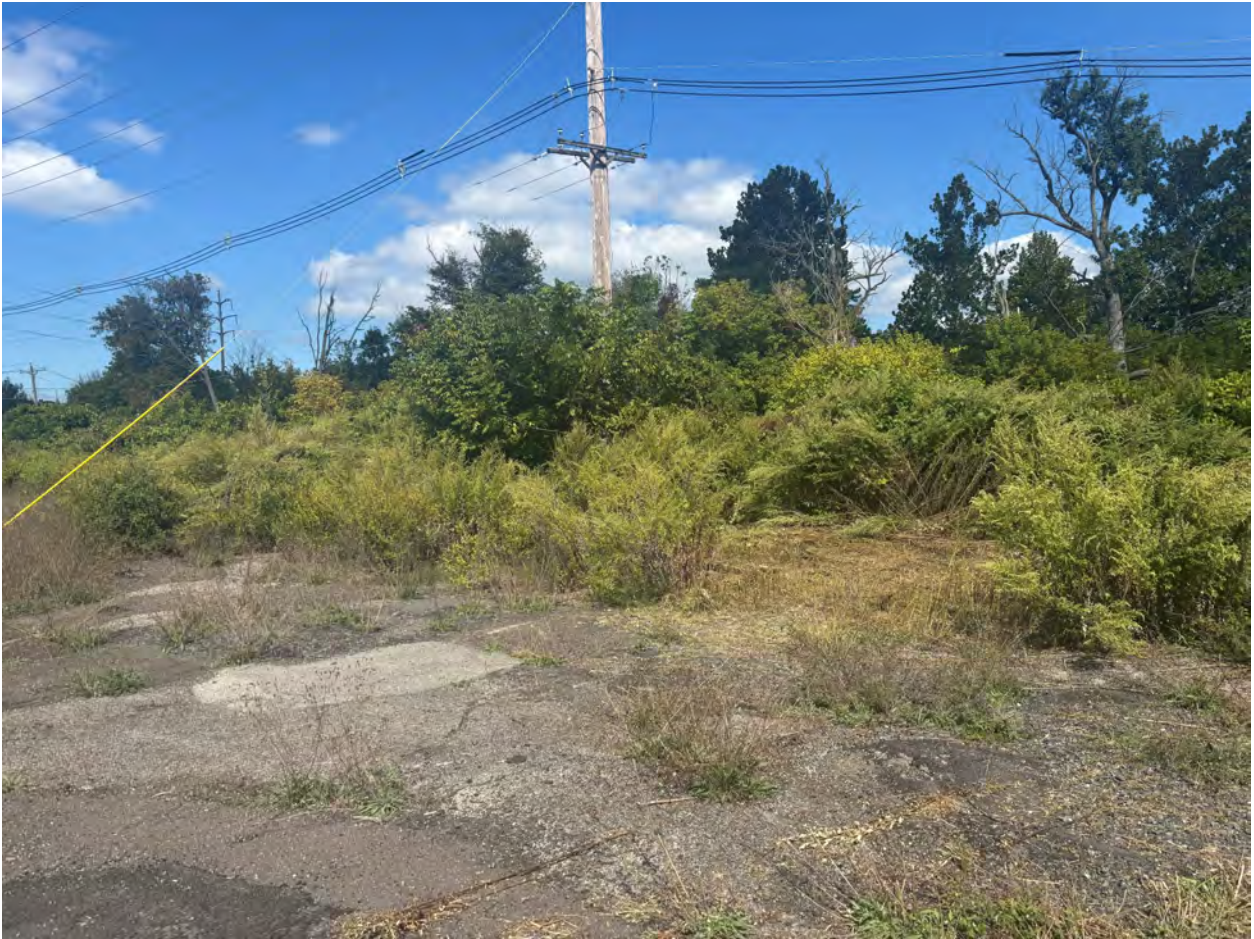
**Photograph 5**  
**Fence Damage on North side of Parking Log**

Section 3.4.6 of the ISMP requires visual inspections of the fence and gates to restrict unauthorized access to the Site. During the site inspection, the fencing on the north side of the parking lot, adjacent to the river, could not be observed due to dense vegetation. This portion of the fence was previously noted as damaged during the March 2025 inspection. Access is likely restricted due to the location and extent of vegetation present, but the site owner has been made aware and repairs can be made as appropriate. The section of the fence adjacent to the parking lot that was repaired on March 26, 2024, was observed to be in good condition. Additional photographs and inspection forms are provided in Attachment 4.

Five foot gap in fenceing on N side of parking lot. Unable to view due to dense vegetation.
