# Memorandum

**Re: First Quarter 2026 Semi-Annual Inspection and Progress Report; Harriman Inactive Waste Disposal Site No. 336006**

First Quarter 2026 Semi-Annual Well  
Inspection Report

## RIVERBANK AND PARKING LOT INSPECTION FORM

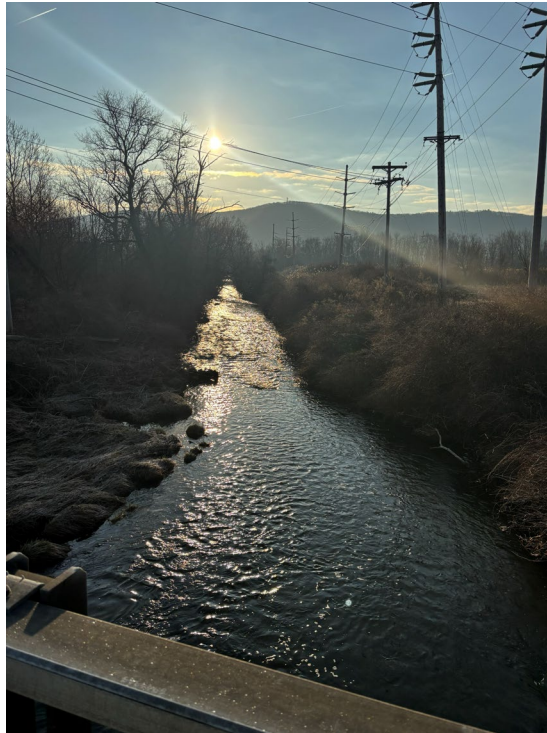
The interim riverbank turf reinforcement mat and vegetative cover system along the West Branch of the Ramapo River was inspected. Representative photographs of the area and the inspection form are provided in Attachment 2. Observations of the cover system showed vegetation with no significant signs of erosion and the system functioning as designed.

| | STATUS | COMMENTS |
|---|---|---|
| A. General condition of riverbank cover material | <u>OK</u> | <u>Stable, dense vegetation</u> |
| B. Settlement of riverbank cover | <u>OK</u> | <u>None observed</u> |

**Photograph 1**  
**Representative Streambank Photograph**

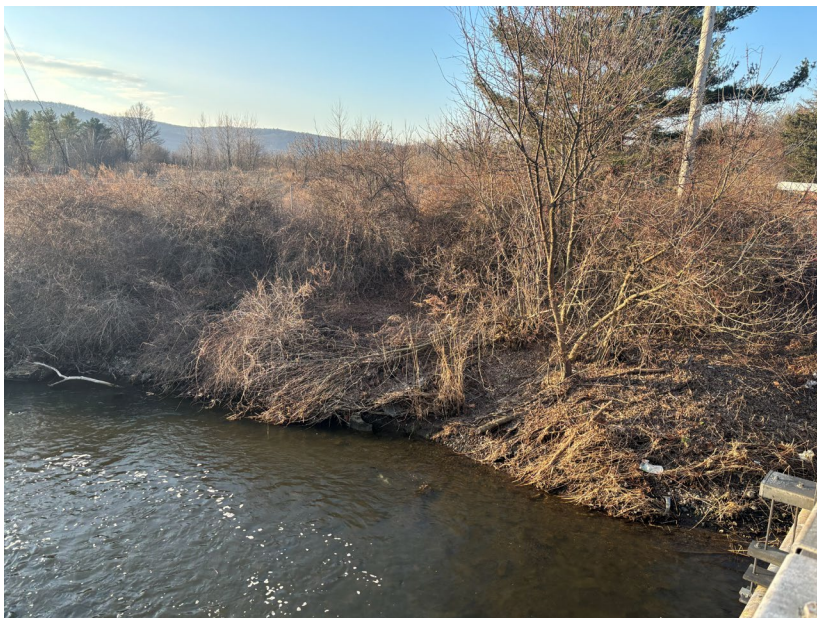
**Photograph 2**  
**Representative Streambank Photograph**

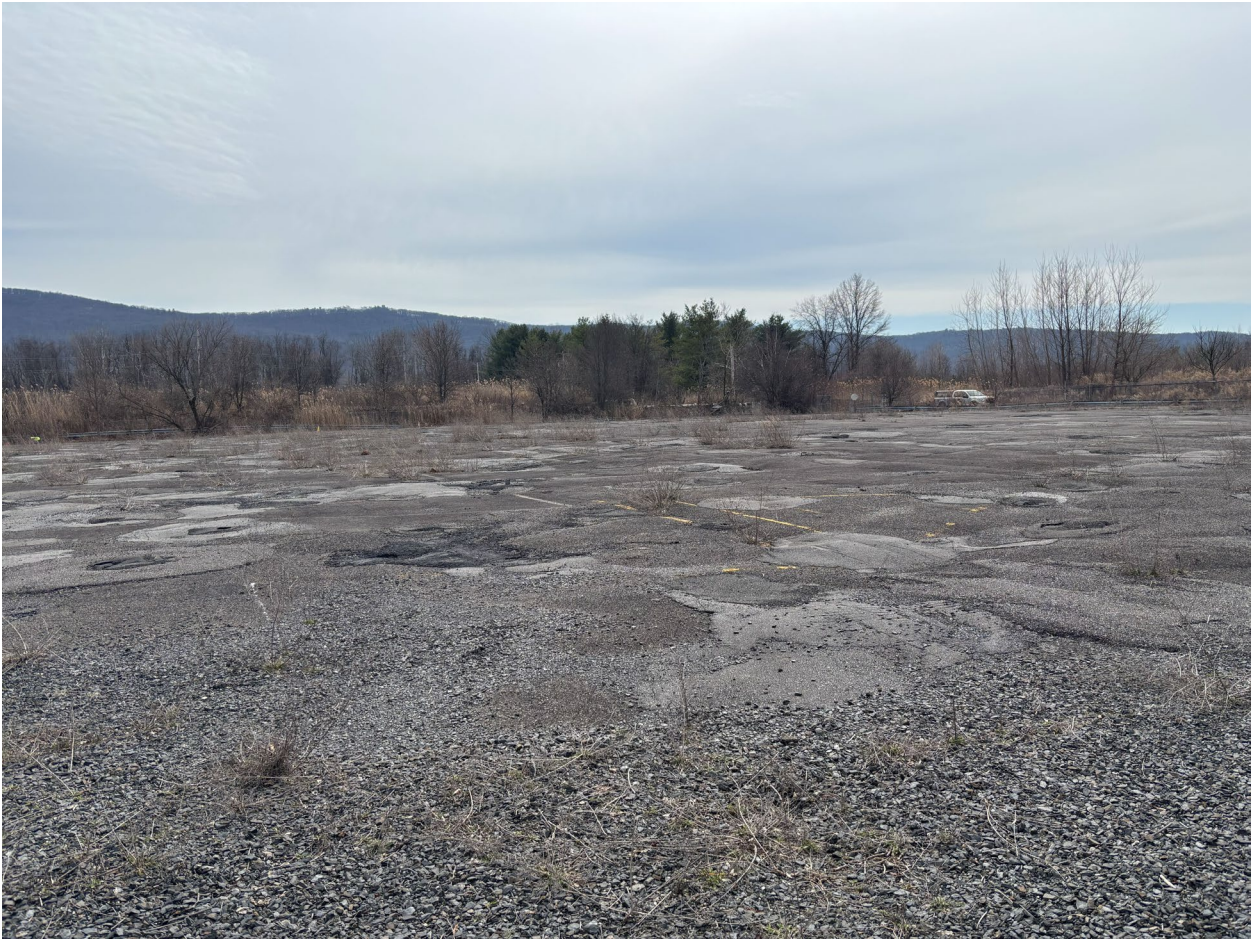
Section 3.4.1 of the ISMP addresses the interim control and integrity of the parking lot asphalt cover. Deficiencies identified during the fourth quarter 2025 inspection were patched and repaired in December 2025. While there are small, localized areas with limited subsidence, immediate repair is not necessary at this time. Representative photographs of the parking lot conditions are provided in Attachment 2.

| | STATUS | COMMENTS |
|---|---|---|
| C. General condition of parking lot cover material | <u>OK</u> | <u>Some limited settling from recent repairs</u> |
| D. Settlement of parking lot cover | <u>OK</u> | <u>Some settling</u> |

**Photograph 3**  
**Representative Parking Lot Photograph Facing Southeast**

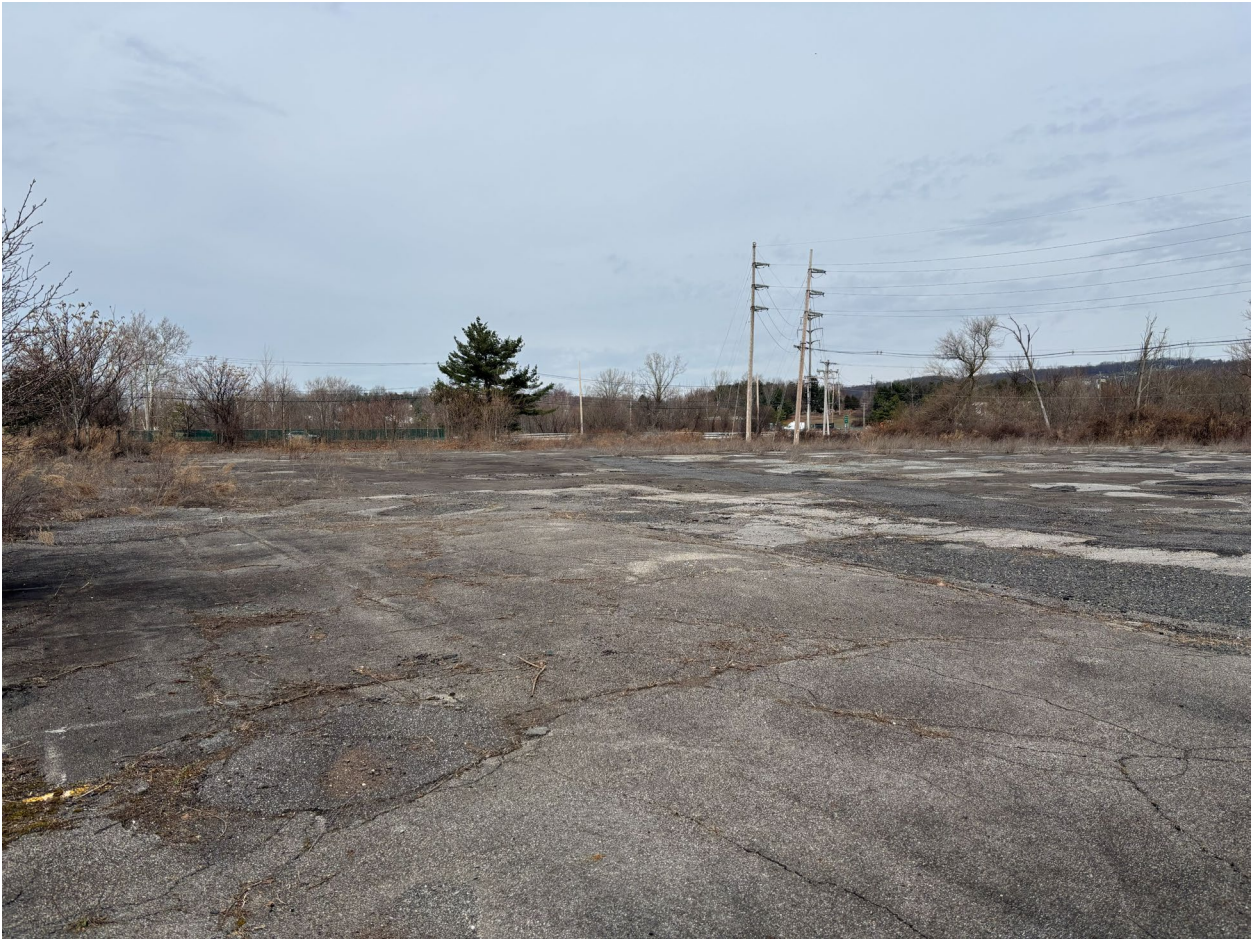
**Photograph 4**  
**Representative Parking Lot Photograph Facing Northwest**

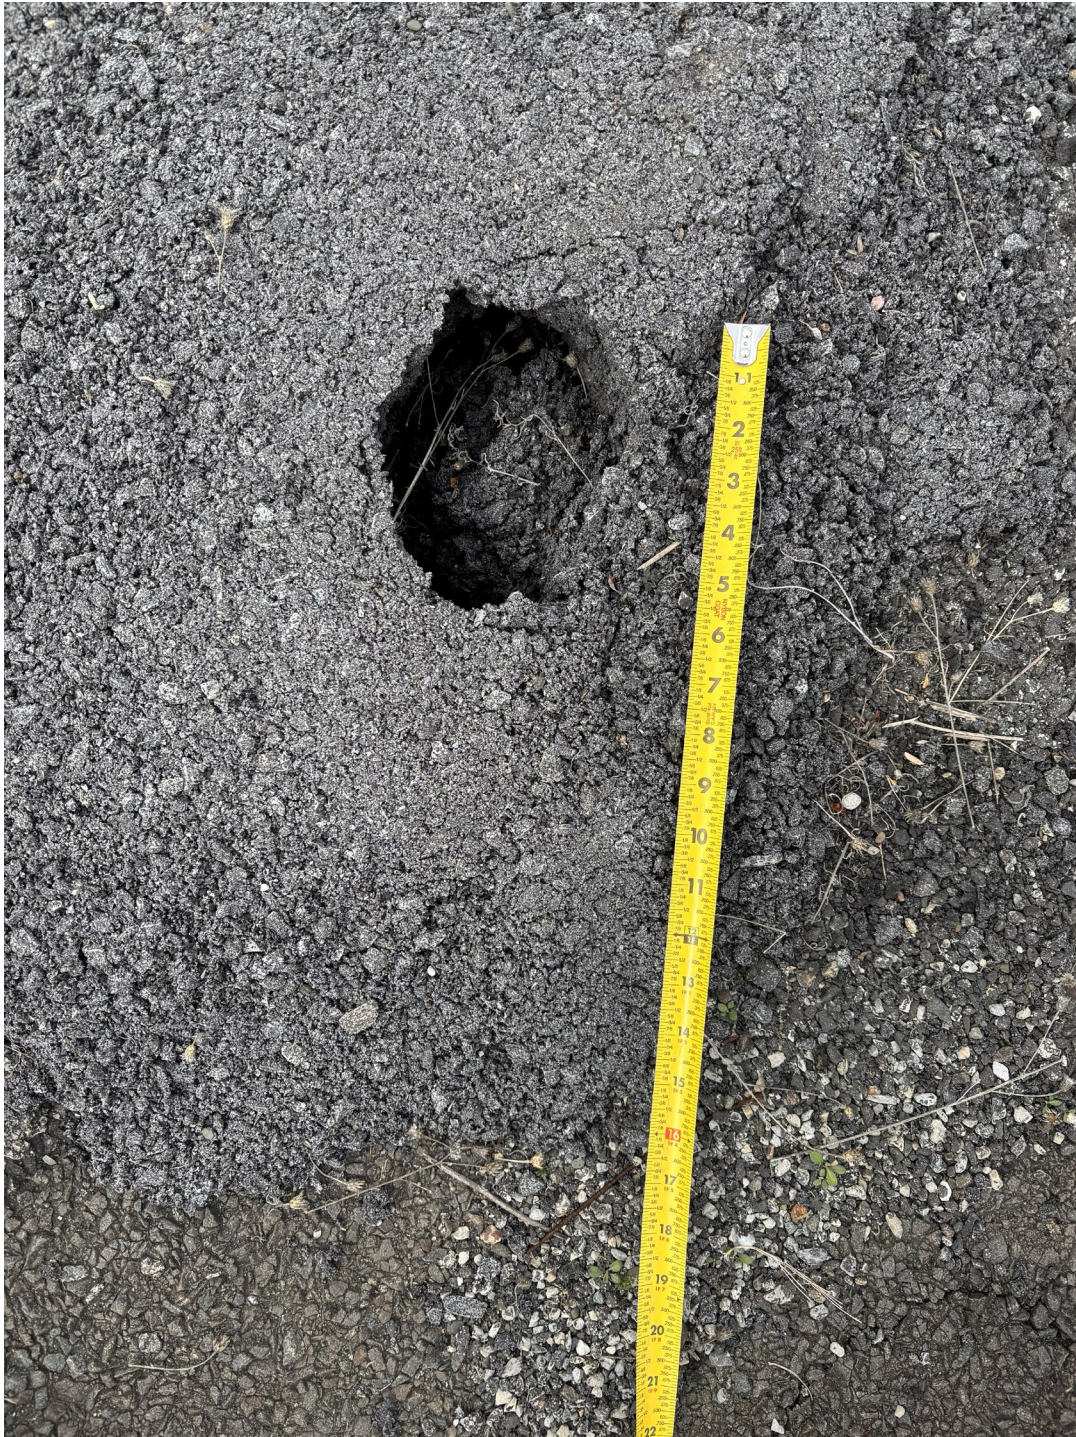
**Photograph 5**  
**Representative Parking Lot Photograph Showing Small Hole**

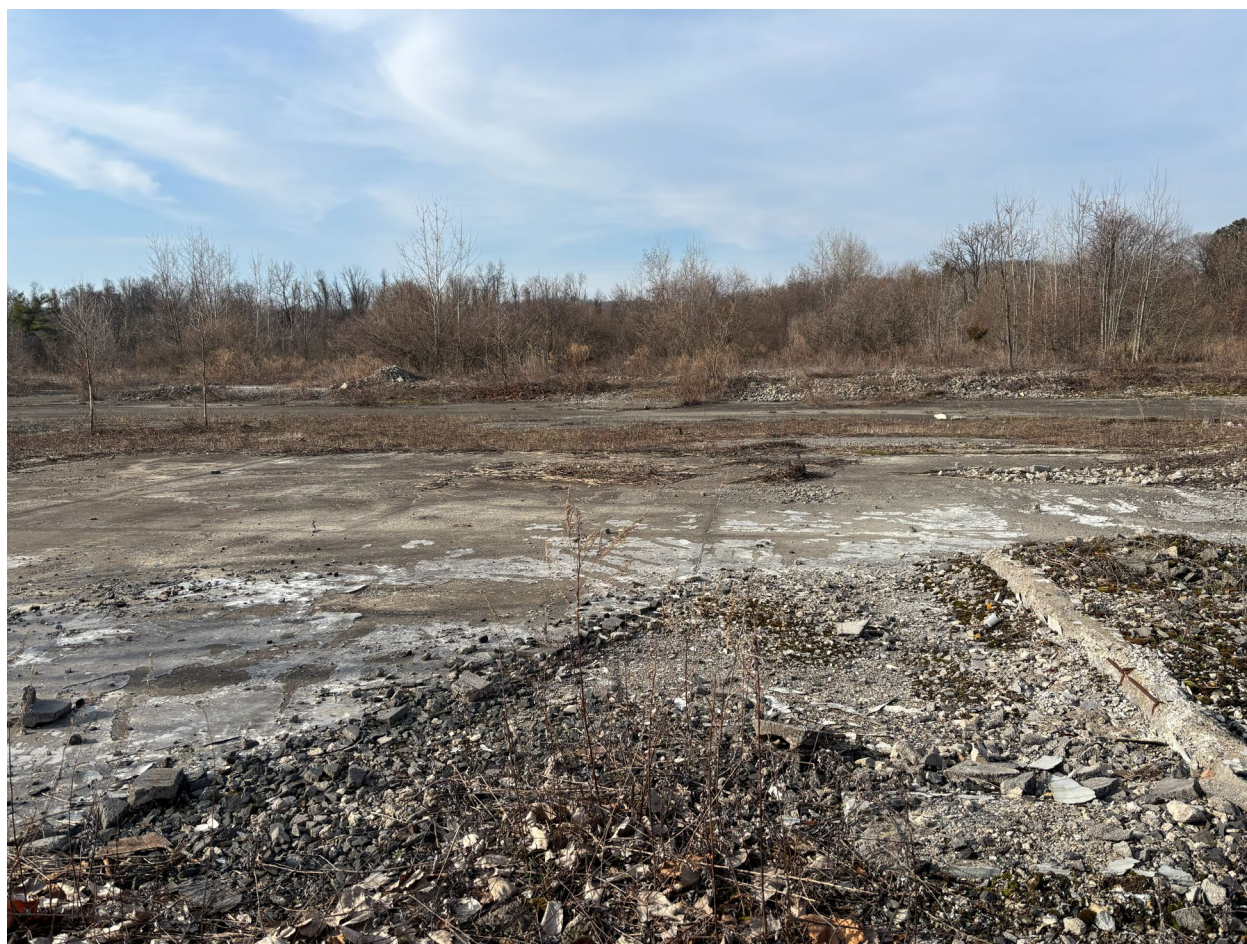
Section 3.4.2 of the ISMP requires the inspection of former excavation and backfill areas to evaluate them for signs of significant erosion or vandalism. Areas of Building 53 and Area F were observed to contain vegetation with no visual evidence of disturbance or erosion. The inspection form and photographs for these areas are provided in Attachment 3.

No disturbance, natural vegetation

**Photograph 1**  
**Former Drum Excavation Area Facing Southwest**

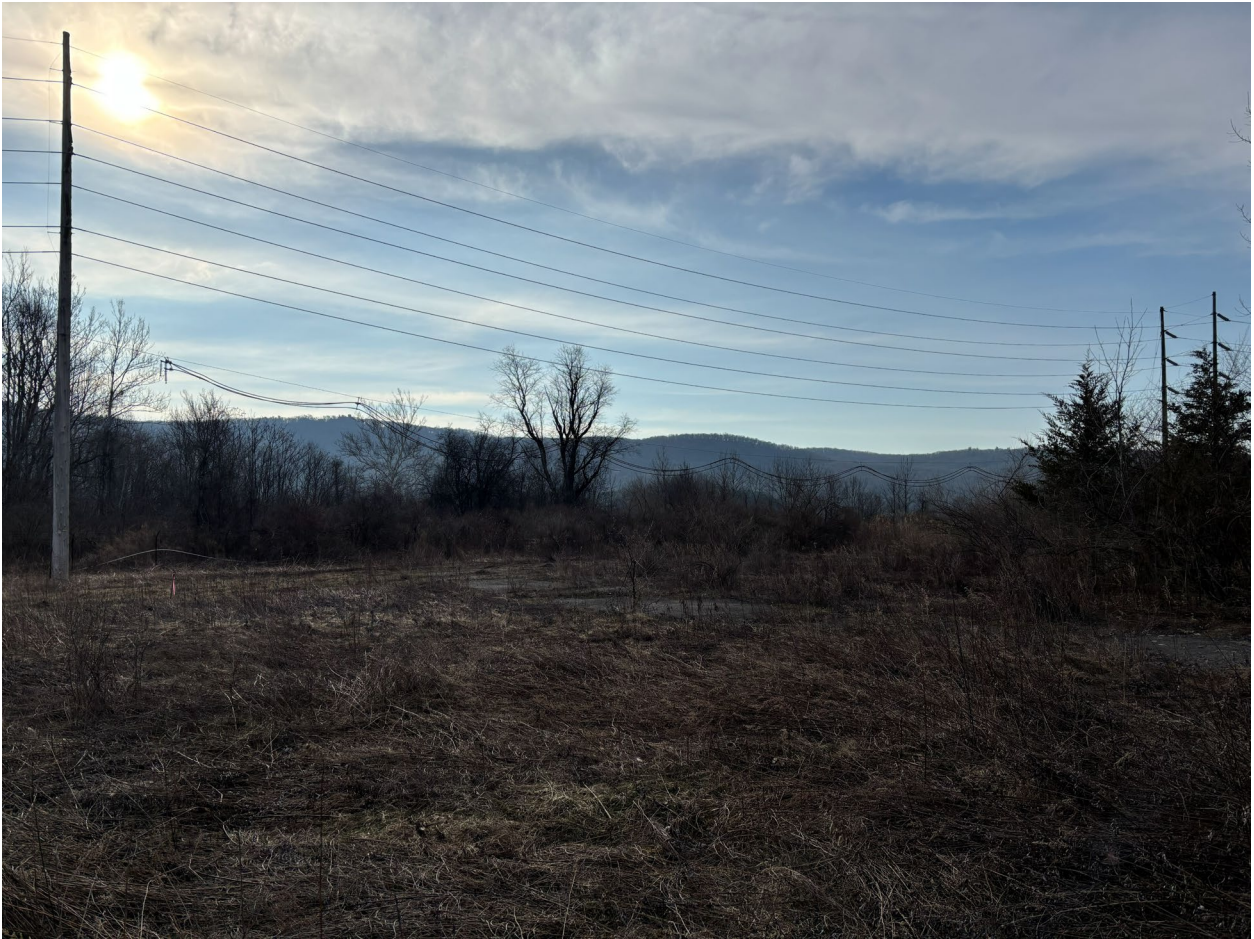
No disturbance, natural vegetation

**Photograph 2**  
**Former Drum Excavation Area Facing East**

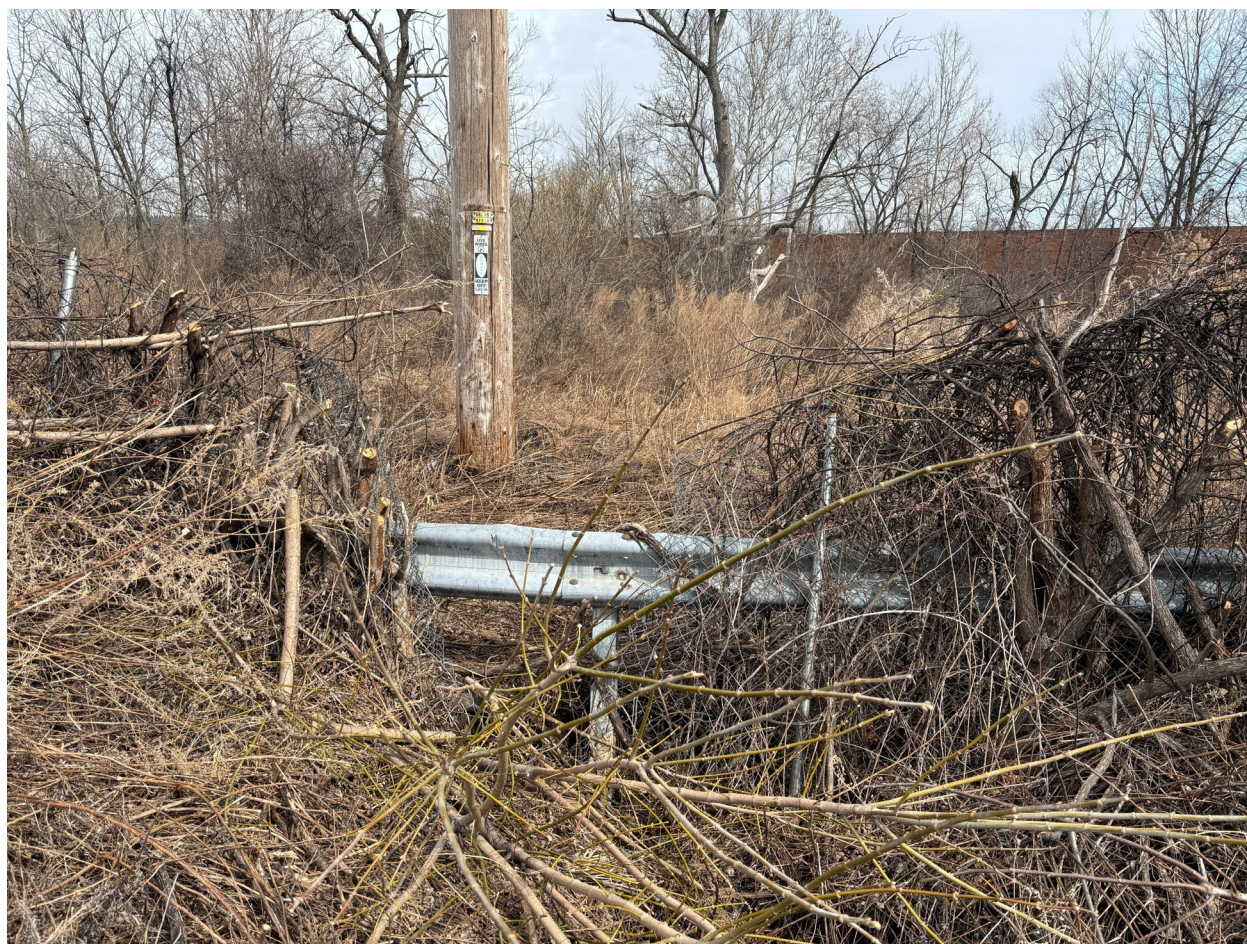
Section 3.4.6 of the ISMP requires visual inspections of the fence and gates to restrict unauthorized access to the Site. During previous site inspections, the fencing on the north side of the parking lot, adjacent to the river, indicated one area with some damage (See Attachment 4). The site owner

| | STATUS | COMMENTS |
|---|---|---|
| | Partially<br>Damaged | Five foot gap in fencing on N side of parking lot near telephone pole |

**Photograph 5**  
**Fence Damage on North side of Parking Log**

has been made aware and repairs can be made if necessary given the limited access to this area and presence of the guard rail. The section of the fence adjacent to the parking lot with the previous truck damage repaired on March 26, 2024 was observed to be in good condition. Additional photographs and inspection forms are provided in Attachment 4.
