# PERIODIC REVIEW REPORT JUNE 2017 – JUNE 2022

**TUXEDO WASTE DISPOSAL SITE  
TUXEDO, NEW YORK 10987**

**NYSDEC Site No. 336035**

**Work Assignment No. D009812-25**

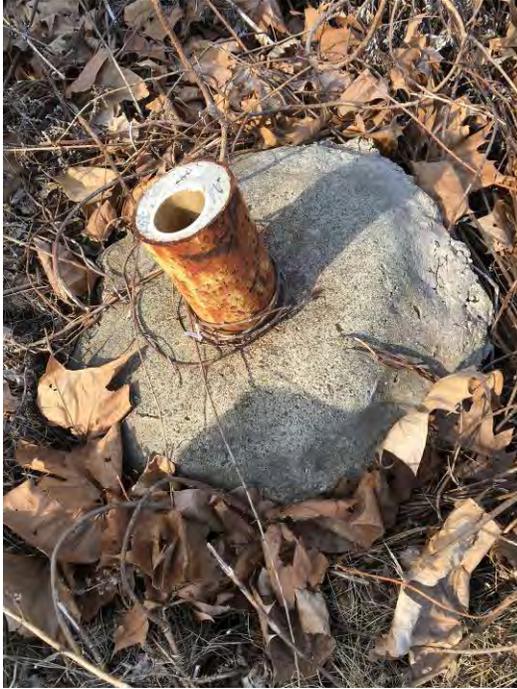
Monitoring Well Network	Monitoring wells were found to be in good condition, except for MW-7 which has been destroyed, and RI-3 and RI-5A which are partially obstructed. Monitoring well caps that were damaged were replaced during the first inspection event conducted by TRC in March 2019.	Based on a review of the monitoring well network and sampling results, RI-5A can be removed from the well network and decommissioned. RI-3 should be further assessed to dislodge the obstruction or decommissioned and replaced.
Monitoring Well Gauging	Monitoring well MW-7 was not gauged during the March 2019 and July 2020 gauging events. Monitoring wells RI-3 and RI-5A were gauged during the July 2020 event but documented to be partially obstructed. Sample the tubing would not lower past the obstructions. Monitoring well MW-1 was not located during the visit, as it is in an area of dense vegetation during the summer months.	Vegetation in the area of MW-1 should be addressed prior to groundwater sampling to ensure accessibility to the well.

**Photo 9:** View of MW-7, well is obstructed.

- Based on the review of MW-7 and RI-5A, TRC recommends that these wells be removed from the monitoring well network. RI-5A may be decommissioned when time permits.
- Monitoring well RI-3 should be assessed in order to dislodge the obstruction from the well. If the obstruction cannot be dislodged, the monitoring well should be replaced, and the existing RI-3 should be decommissioned during replacement activities.
- Water level measurements should be collected at the 10 monitoring wells included in the monitoring well network during the biennial groundwater monitoring events to evaluate the groundwater flow direction.
- The monitoring well network should include the sampling of 10 existing monitoring wells including: MW-1, MW-2, MW-3, MW-4, MW-5, MW-6, RI-1, RI-2, RI-3, and RI-4.

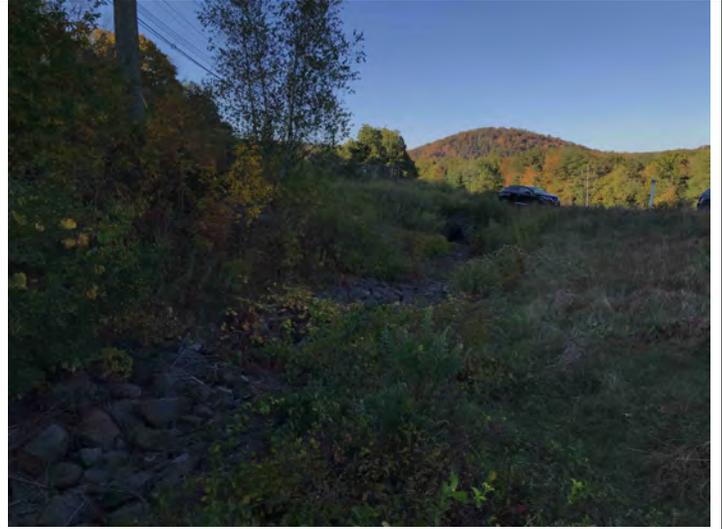
**Photo 2:** Looking north. View of vegetation in swale at the northern end of the site.

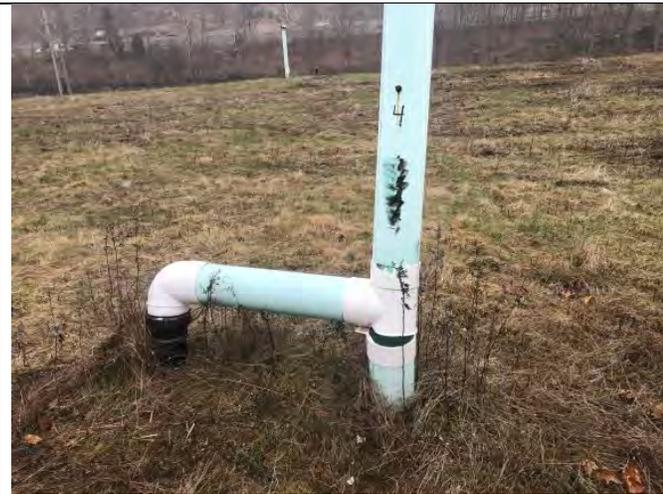
**Photo 3:** View looking east. Looking at damaged gas vent GVS-4

Site Access Roads and Gates	Site access gates were operable and locked. The entrance gate is locked with a Master Lock® with code #2537. TRC noted during the May 2022 site inspection that the perimeter fence was damaged at the northern and southern ends.	The perimeter fence will be repaired during the next site inspection event.
Landfill Gas Monitoring	All twelve of the gas vent stations and twelve of the thirteen monitoring points were screened for combustible gases and VOCs quarterly. During the Q4 2020 site visit the TRC field staff observed that gas vents GVS-4, GVS-6, and GVS-11 were damaged. During the May 2022 site visit, the turbine vents on GVS-4 and GVS-6 were found not rotating freely.	TRC repaired the GVS-4, GVS-6, and GVS-11 and replaced the damaged during the Q2 2021 site visit. The vents were restored to their prior, functioning state. The turbine vents at GVS-4 and GVS-6 will be replaced during the Q3 2022 site visit.

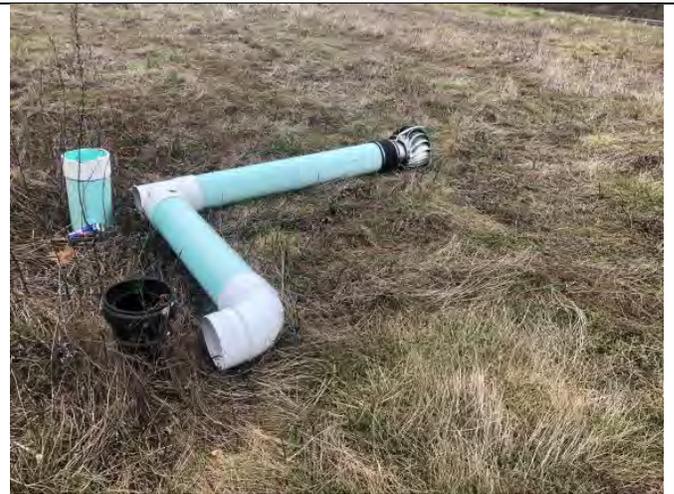
**Photo 4:** Looking downward at damaged gas vent GSV-6

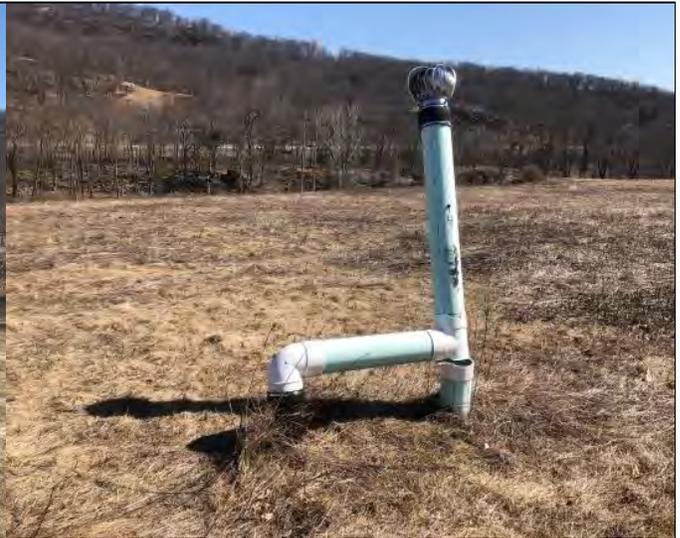
**Photo 2:** Looking southeast. View of damaged GVS-4.

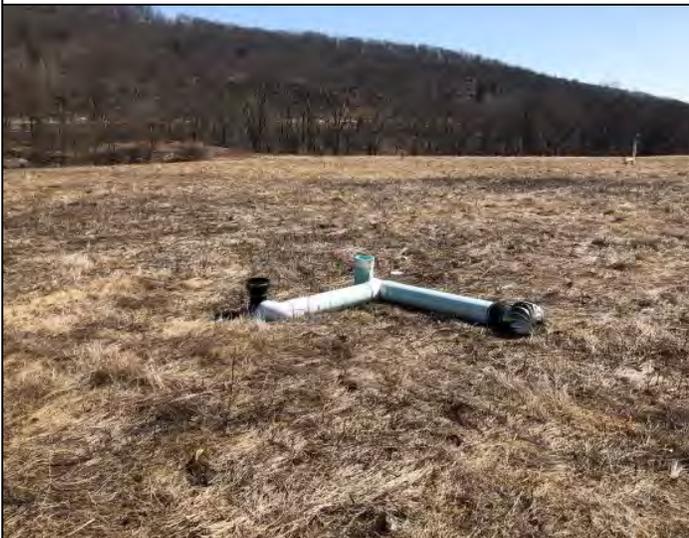
**Photo 3:** View looking southeast at damaged GVS-6 that has completely detached from the base.

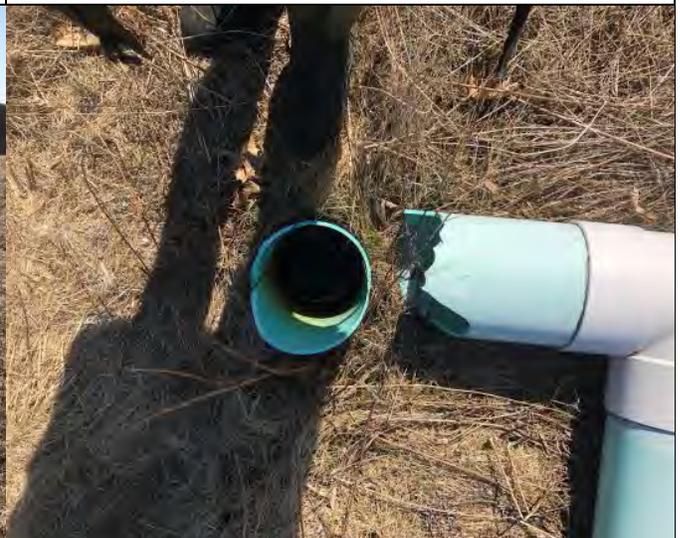
**Photo 4:** View looking downward at damaged GVS-6 at a close up of the broken PVC base.

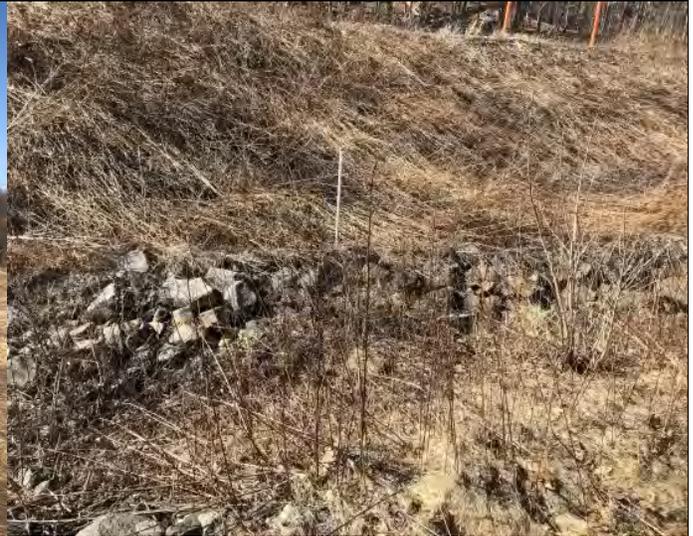
**Photo 6:** View of the dense debris and dead vegetation located in the drainage swales.

Recommendations	<ol style="list-style-type: none"> <li>Vegetation within the drainage swales and basins should be removed to ensure proper flow of water.</li> <li>The gas vents with damaged turbine vents should be repaired.</li> <li>The damaged fence should be repaired.</li> <li>Perimeter gas monitoring point PMP-3 should be repaired.</li> </ol>
Cost Evaluations	TRC's cost for site management activities this reporting period (beginning October 2018 when TRC began managing the Site and ending in June 2022 upon completion of the reporting period) was \$75,985.00. This cost includes labor and expenses incurred by TRC. It should be noted this cost does not include any costs incurred directly by the NYSDEC.

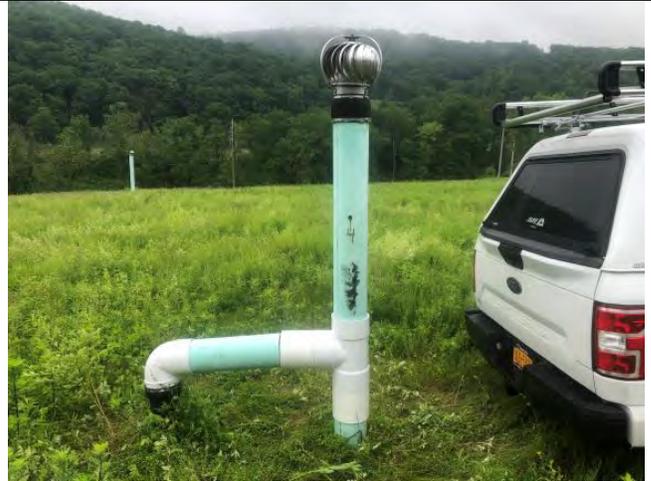
**Photo 4:** View looking east at the repaired gas vent, GVS-4.

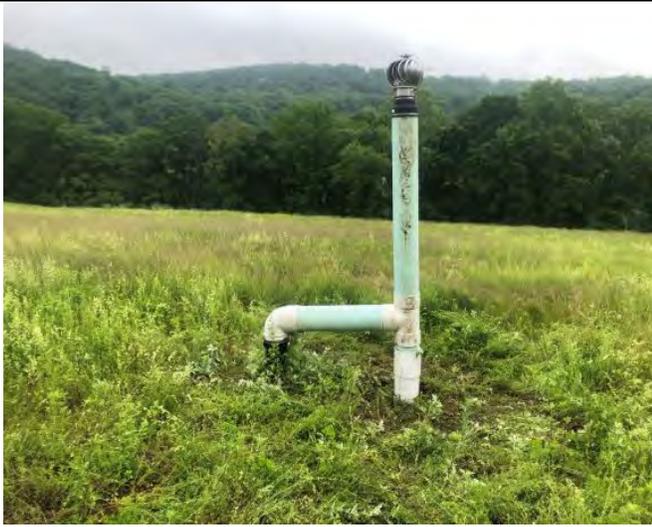
**Photo 5:** Looking east at the repaired gas vent, GVS-11.

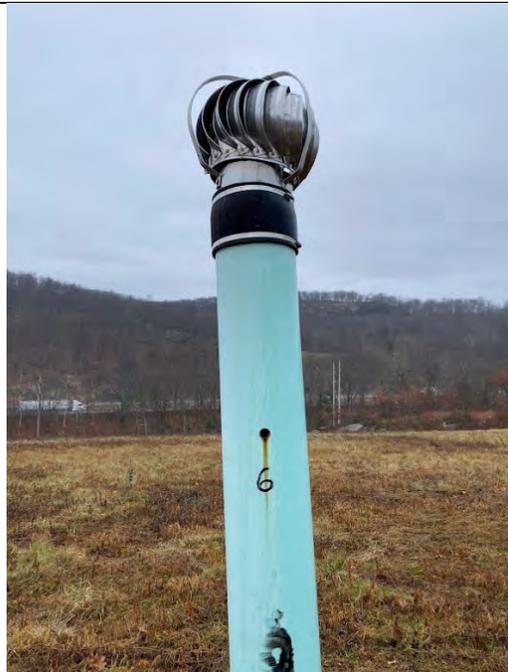
**Photo 4:** View of damaged wind turbine ventilator on GVS-6, looking east.

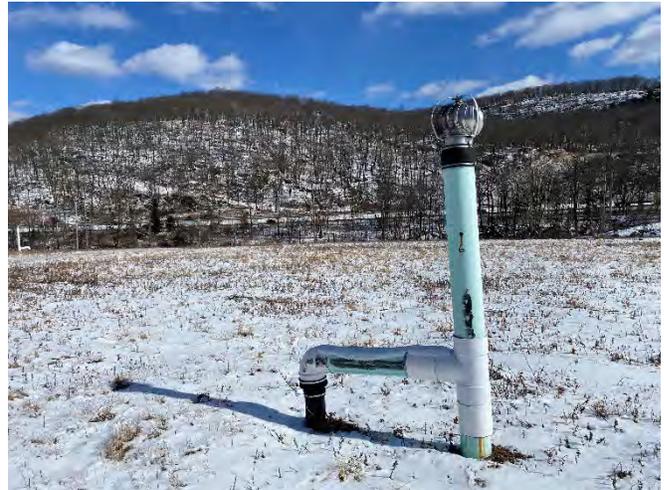
**Photo 4:** View of damaged wind turbine ventilator on GVS-6, looking east.

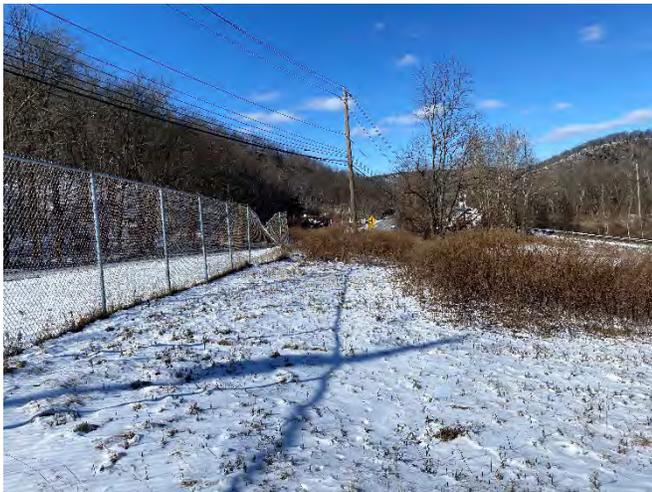
**Photo 7:** View of damaged portion of fence in northern portion of Site, looking north.

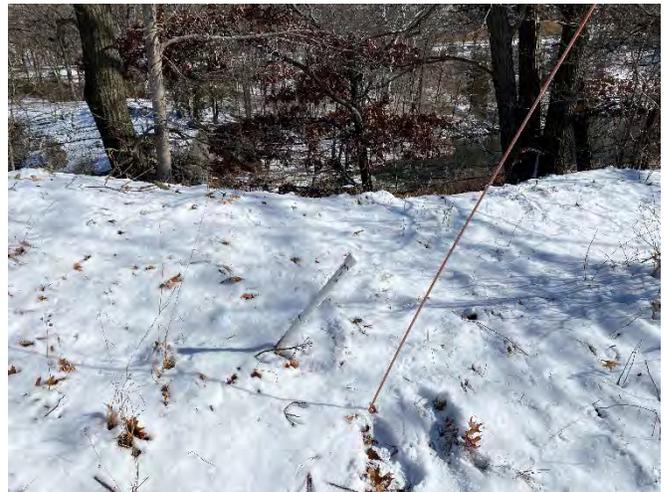
**Photo 8:** View of lopsided PMP-8, looking east.

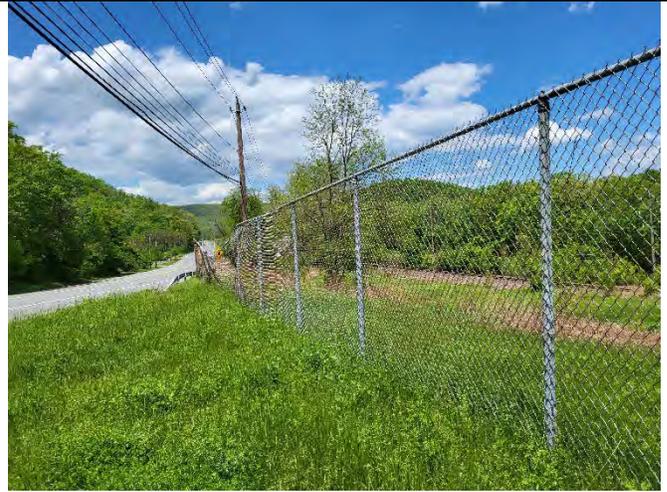
**Photo 2:** View of fence damage to be repaired at northern end of fence, looking north.

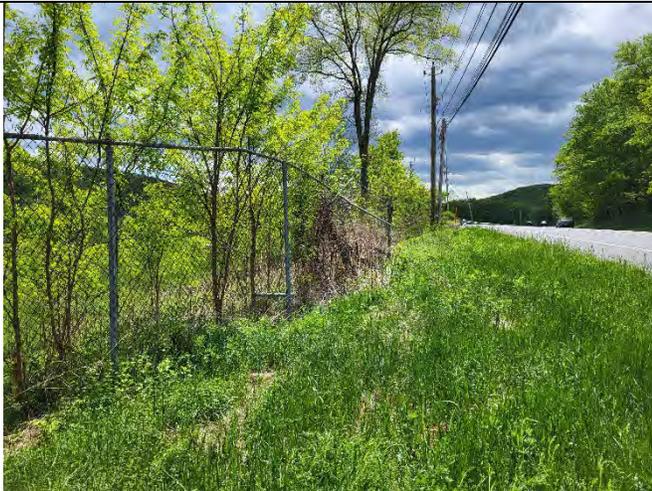
**Photo 3:** View of fence damage to be repaired at southern end of fence, looking south.

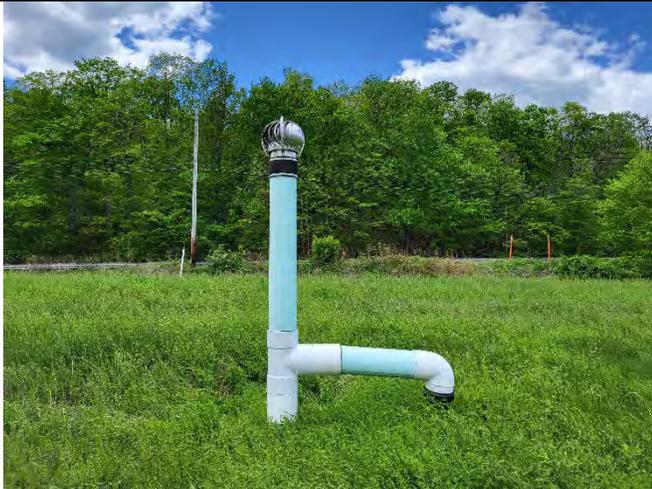
**Photo 9:** View of GVS-6 with damaged wind turbine ventilator, looking west.
