APPENDIX I

PHOTOGRAPHS

OPERABLE UNIT 1 REMEDIAL CONSTRUCTION PHOTOGRAPHS

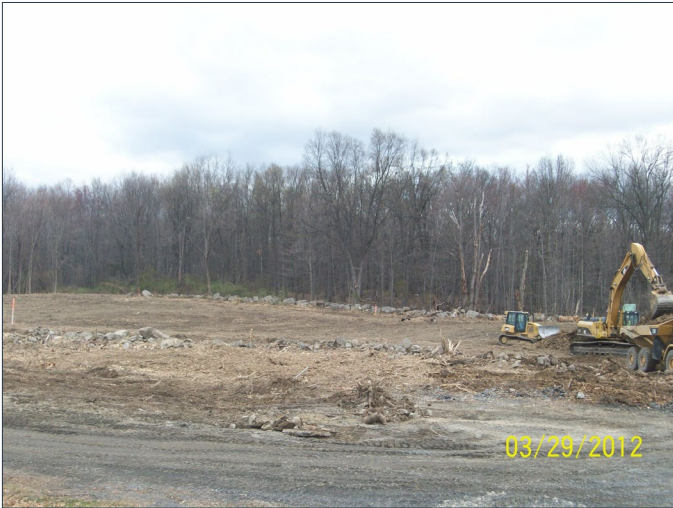
Photo No. 1: View of clearing and grading of Containment Cell footprint

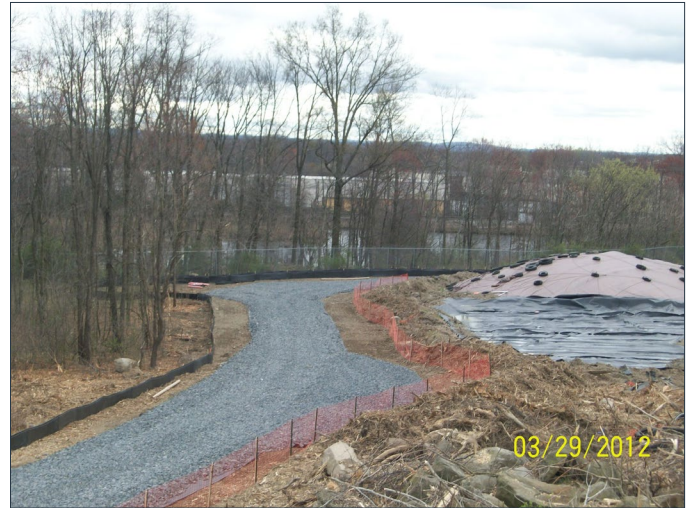
Photo No. 2: View of haul road construction in the Eastern Fill Area

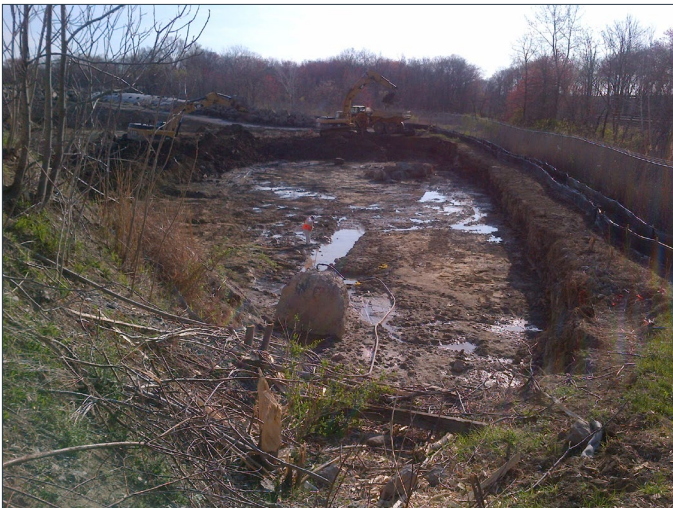
Photo No. 3: View of excavation of water-filled excavation in Eastern Fill Area

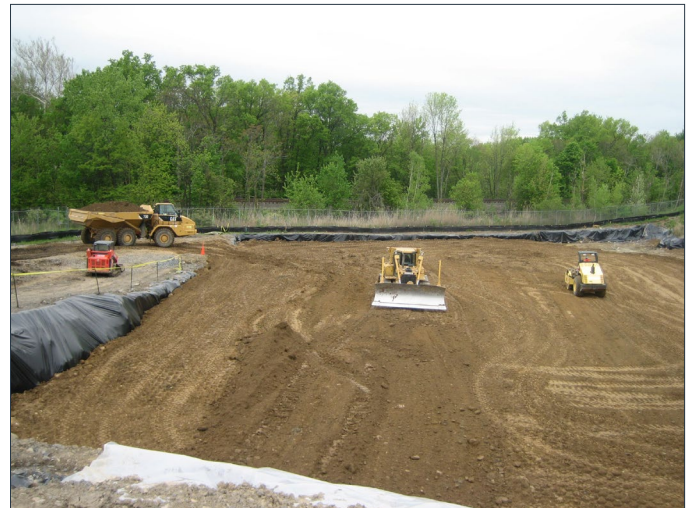
Photo No. 4: View of backfilling of water-filled excavation in Eastern Fill Area

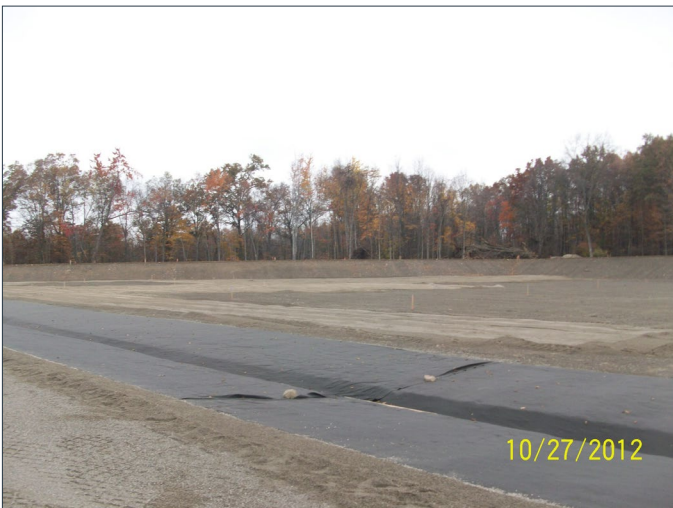
Photo No. 5: View of installation of bedding layer and groundwater underdrain for Containment Cell

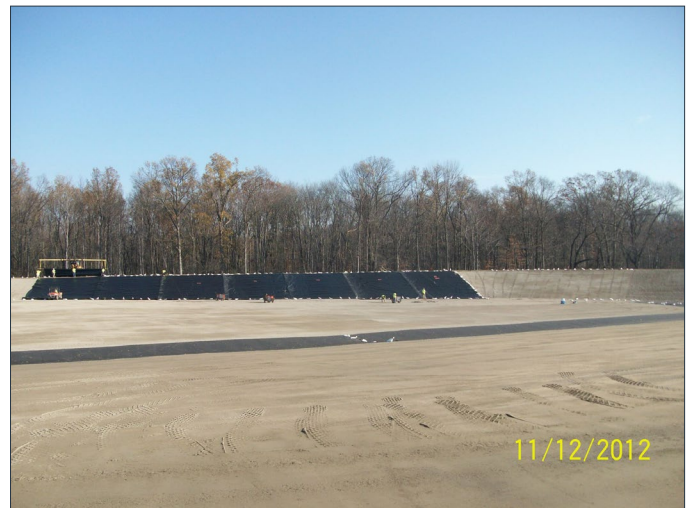
Photo No. 6: View of installation of HDPE geomembrane for bottom liner of Containment Cell

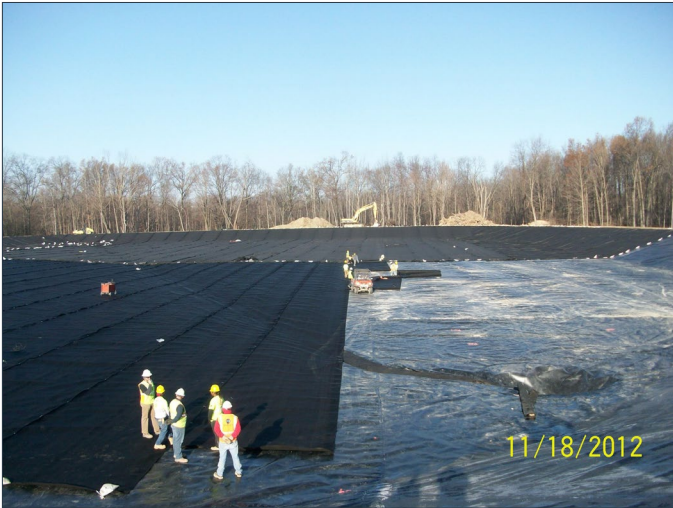
Photo No. 7: View of installation of composite drainage layer for bottom liner of Containment Cell

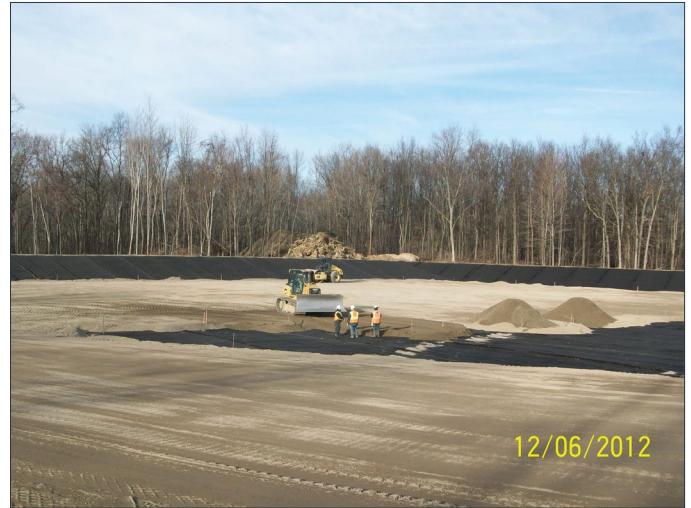
Photo No. 8: View of placement of protective soil layer on bottom liner of Containment Cell

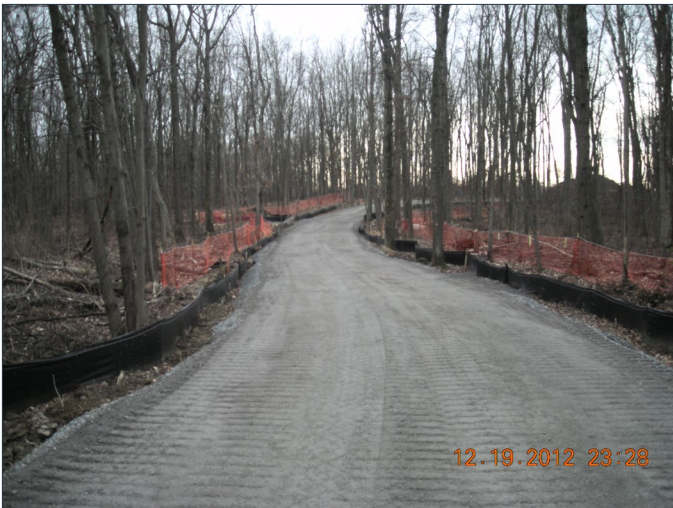
Photo No. 9: View of constructed temporary construction road

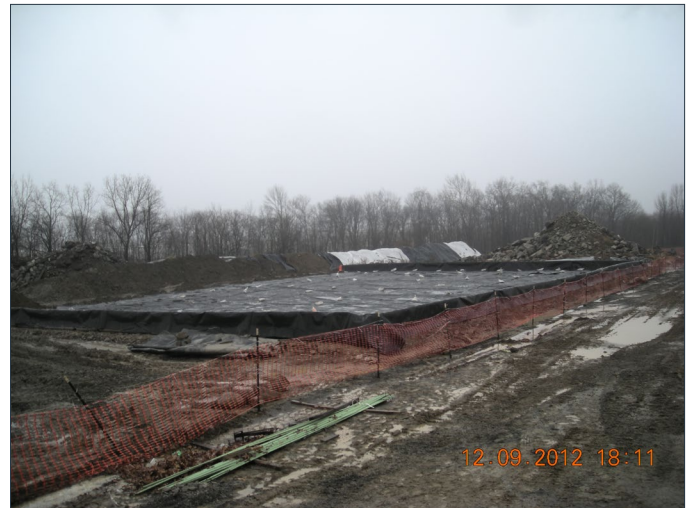
Photo No. 10: View of constructed batch treatment area at CAMUs in Eastern Fill Area

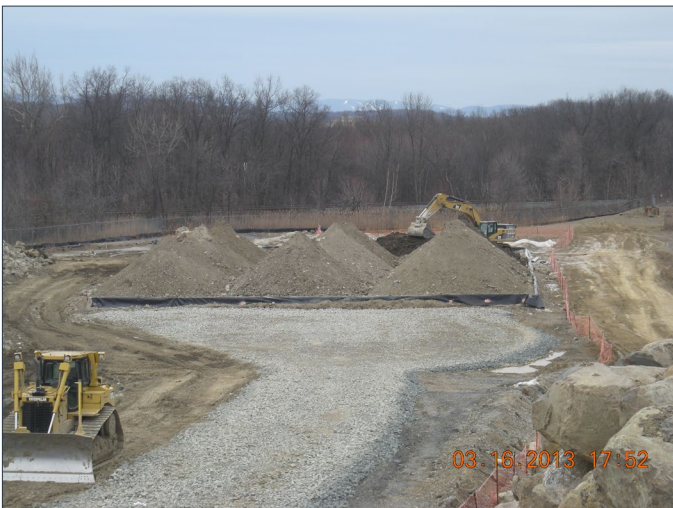
Photo No. 11: View of soil stabilization in batch treatment area

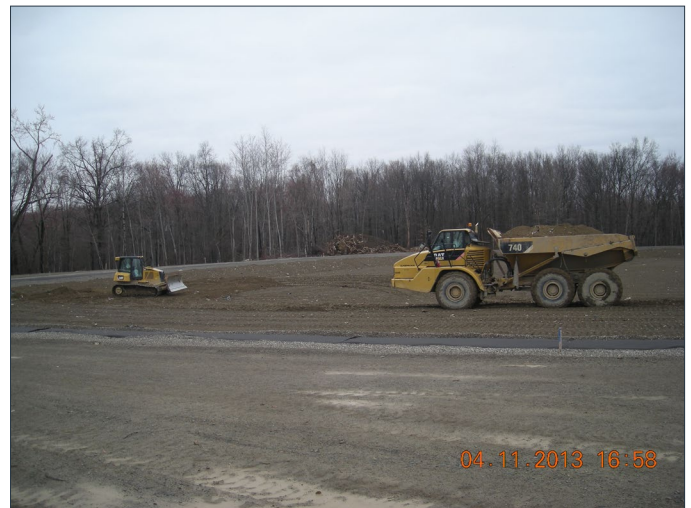
Photo No. 12: View of placement of stabilized soil in Containment Cell

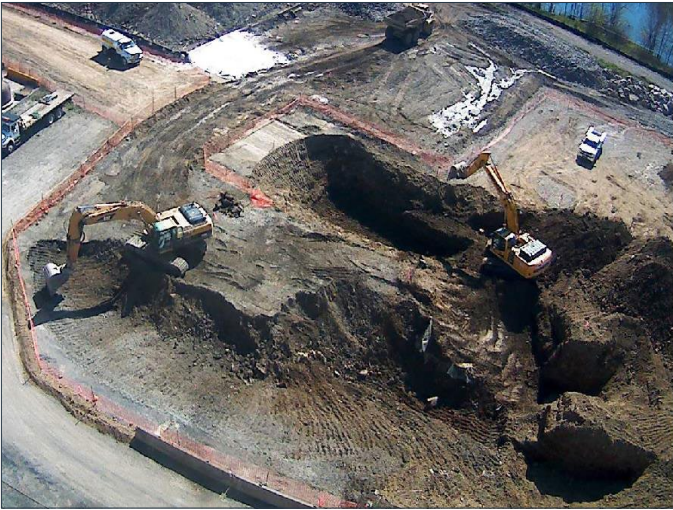
Photo No. 13: View of excavation of WESP footprint in Eastern Fill Area

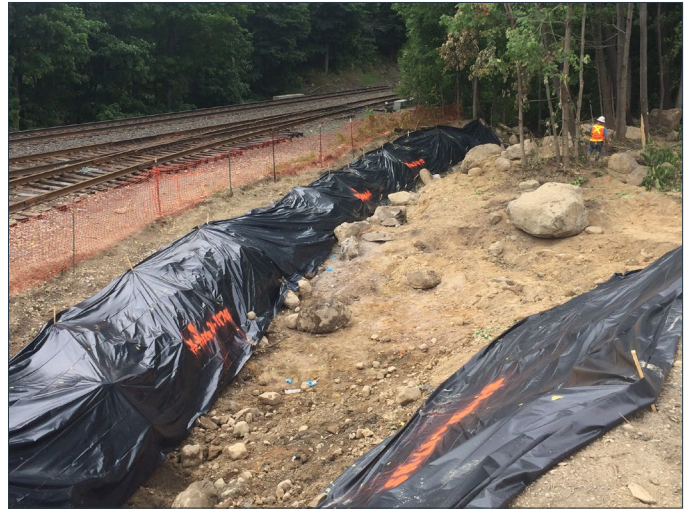
Photo No. 14: View of placement of demarcation liner in excavated Area 20

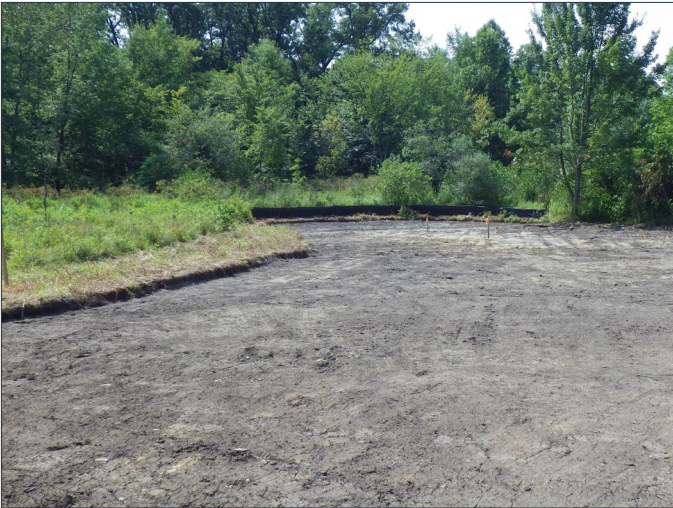
Photo No. 15: View of excavated surface of Area 11

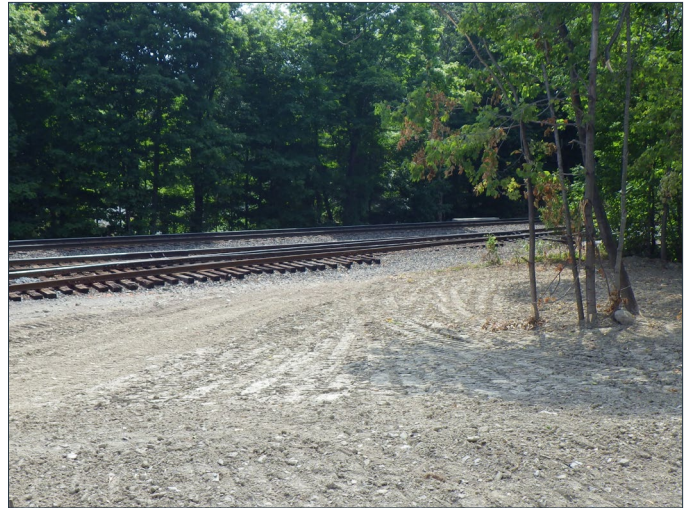
Photo No. 16: View of backfilled surface of Area 20

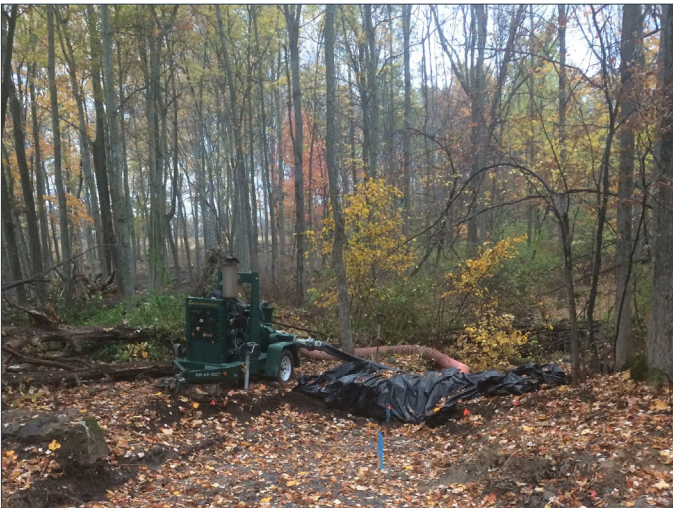
Photo No. 17: View of surface water bypass system at Eastern Stream

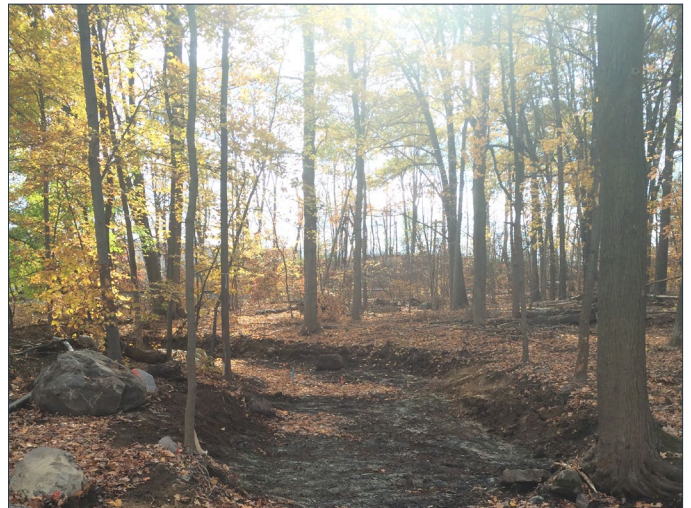
Photo No. 18: View of excavated section of Eastern Stream

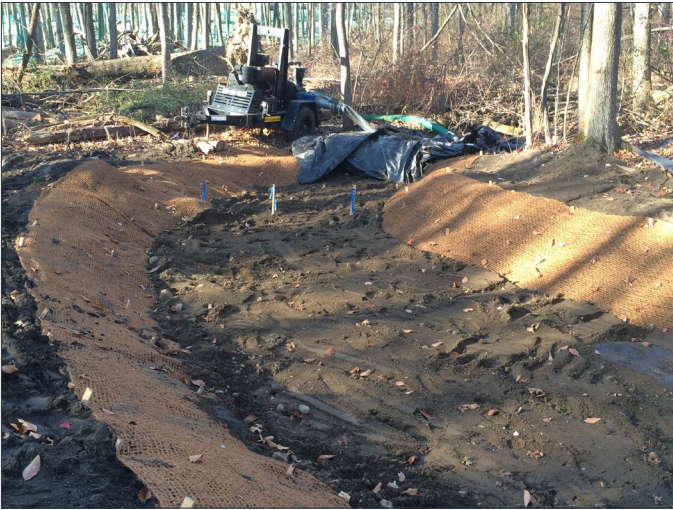
Photo No. 19: View of restored section of Eastern Stream

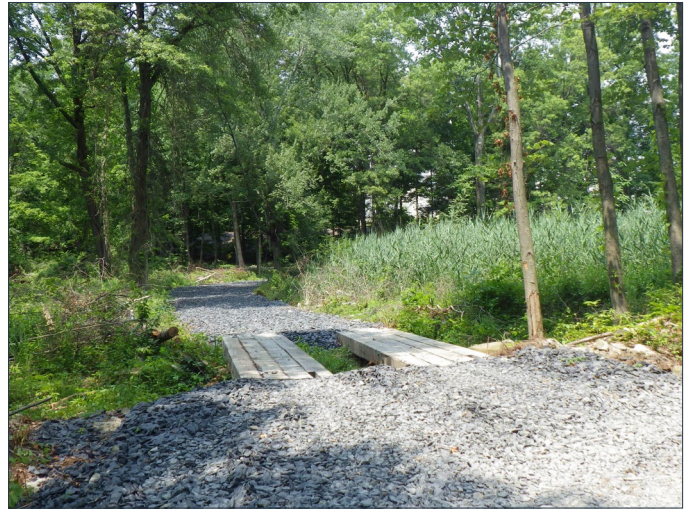
Photo No. 20: View of constructed haul road and stream crossing in Ecological Area

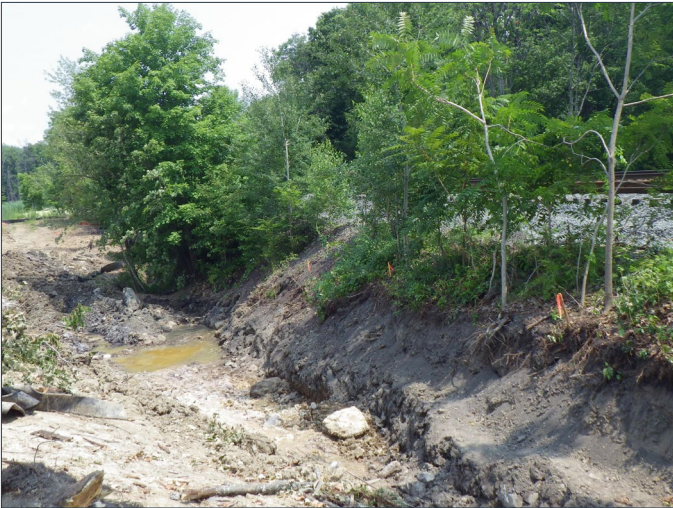
Photo No. 21: View of excavation of Railroad Pond Stream

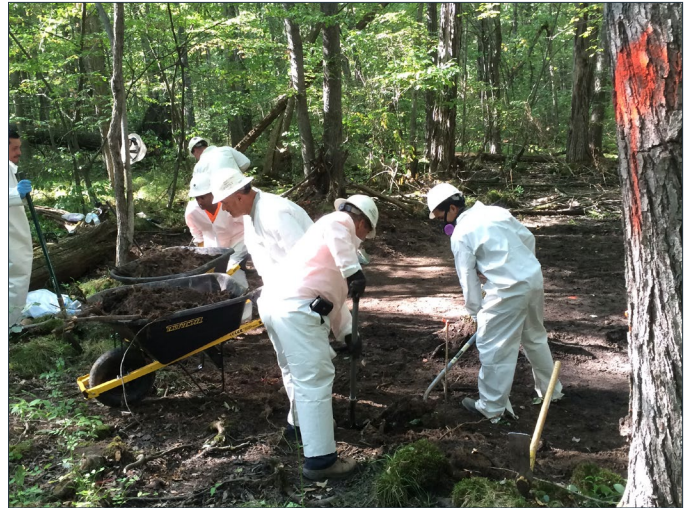
Photo No. 22: View of excavation of hot spot AZ5 in Ecological Area

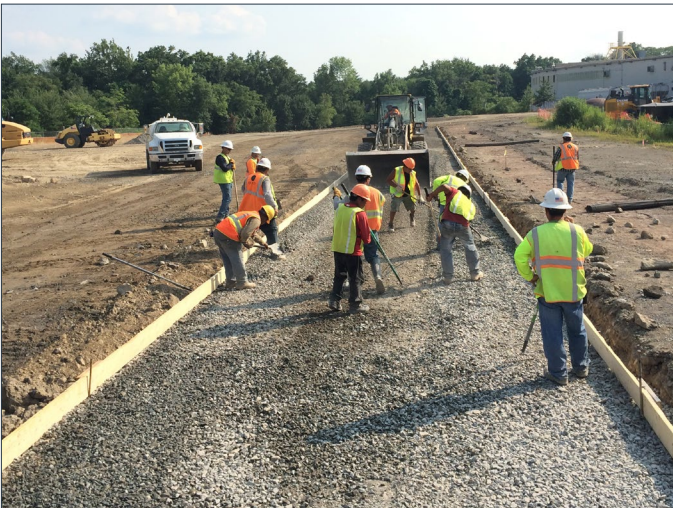
Photo No. 23: View of grading and installation of concrete road in Eastern Fill Area

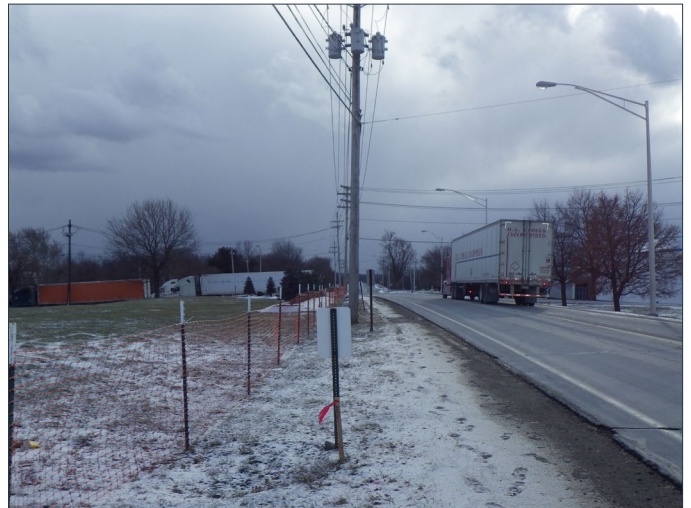
Photo No. 24: View of marked Ballard Road right-of-way along Front Lawn Area

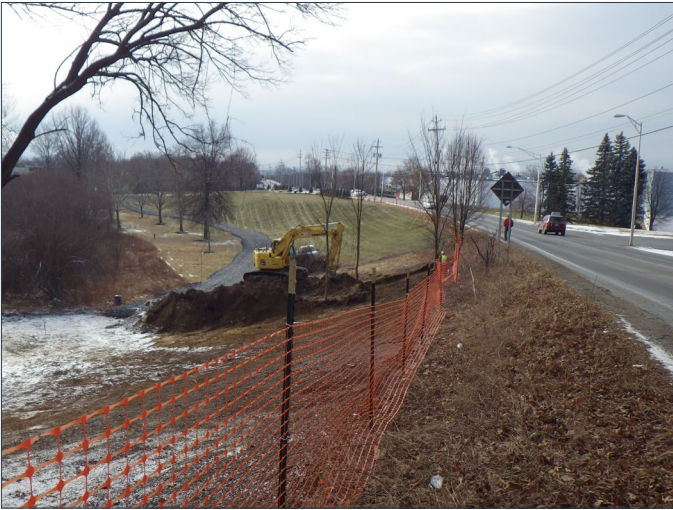
Photo No. 25: View of excavation of Area 15

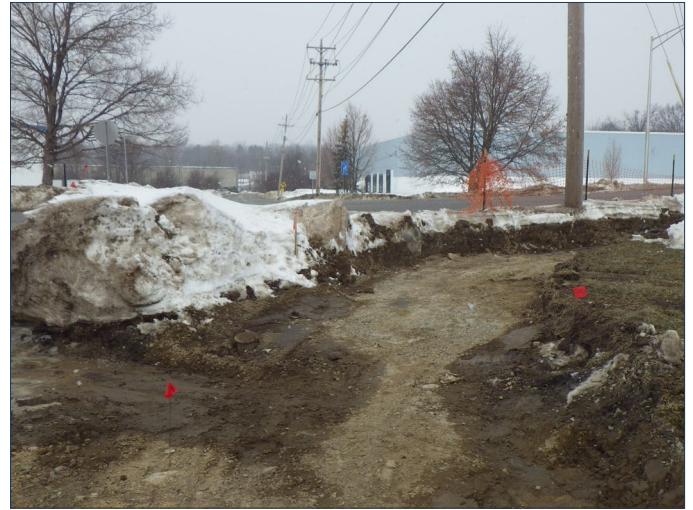
Photo No. 26: View of excavation of Front Lawn Area at Ballard Road and facility driveway

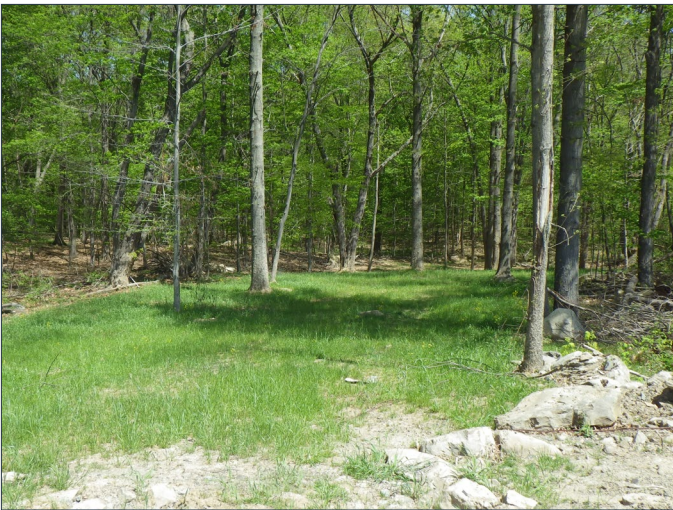
Photo No. 27: View of revegetated section of Area 5

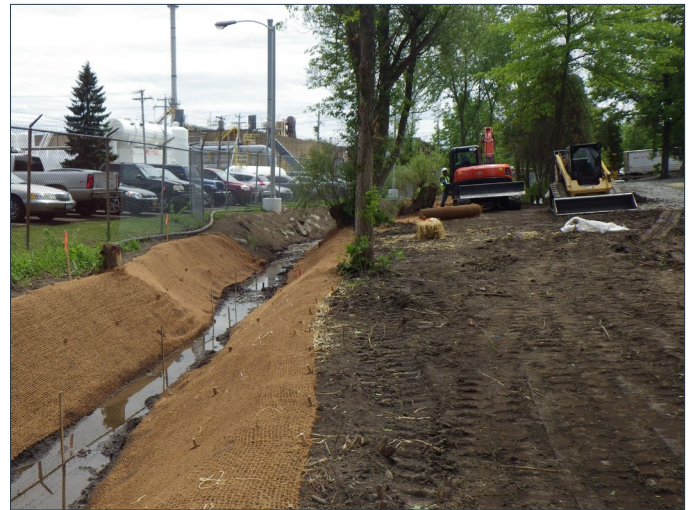
Photo No. 28: View of restored section of Western Stream north of facility driveway (Area 16A)

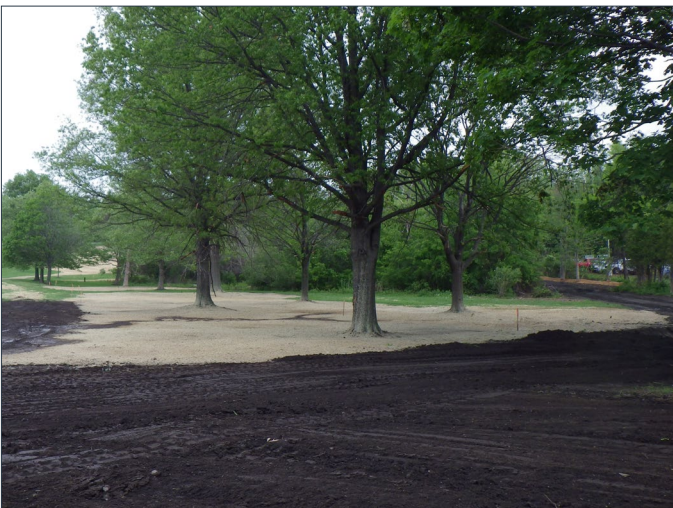
Photo No. 29: View of topsoil placement on excavated surface of Front Lawn Area

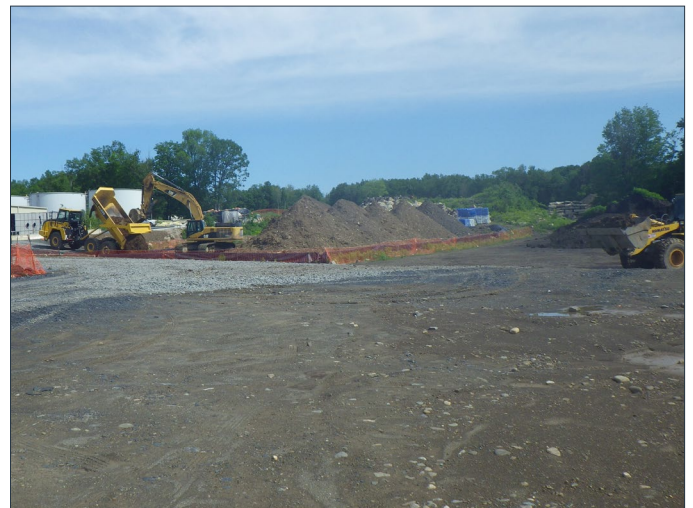
Photo No. 30: View of soil stabilization at relocated batch treatment area at north end of Eastern Fill Area

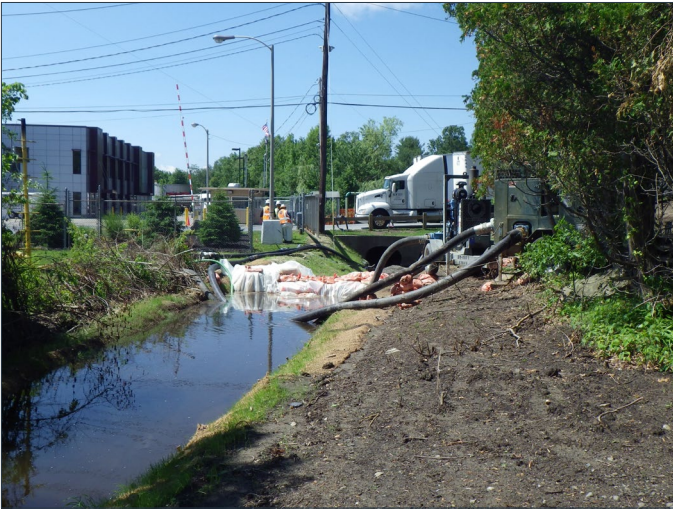
Photo No. 31: View of surface water bypass system for Western Stream south of facility driveway (Area 16B)

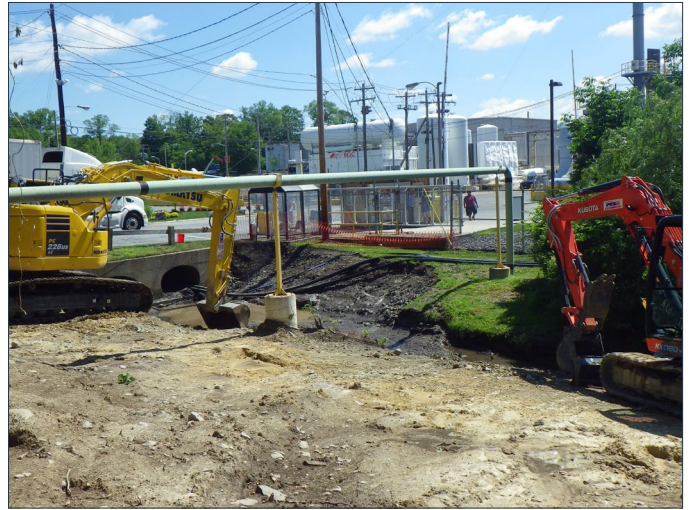
Photo No. 32: View of excavation of Western Stream south of facility driveway (Area 16B) and Area 19

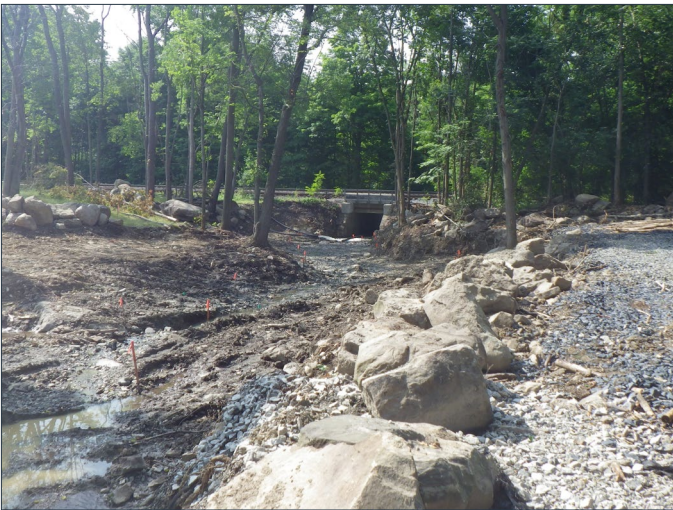
Photo No. 33: View of excavation of Western Stream north of railroad tracks (Area 16B)

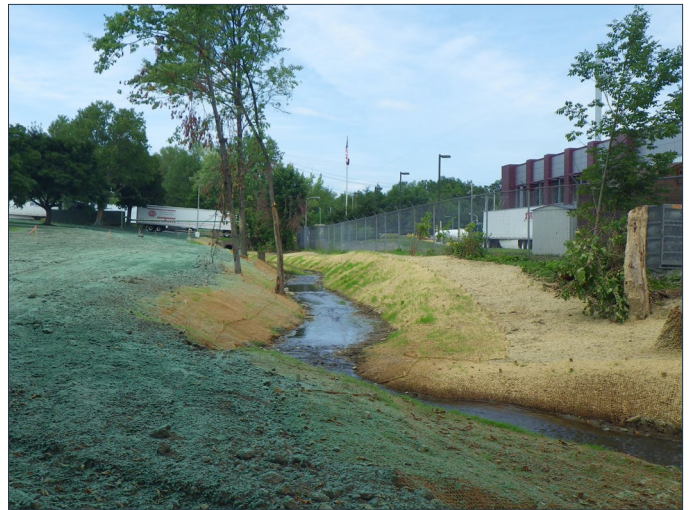
Photo No. 34: View of restored surface of Area 19 and Western Stream (Area 16B)

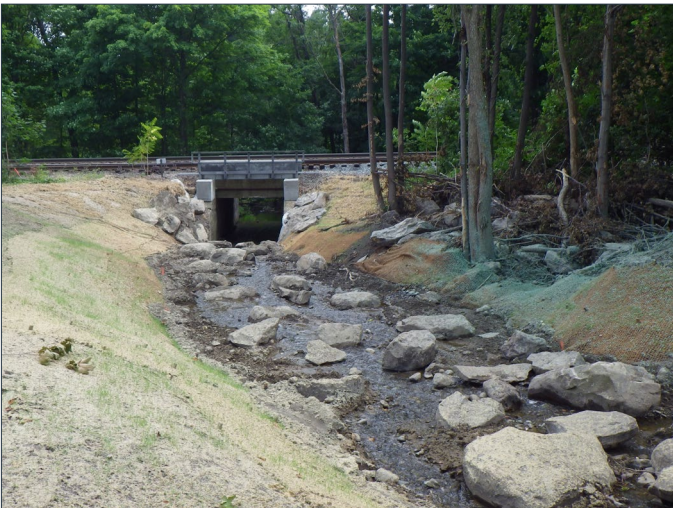
Photo No. 35: View of restored section of Western Stream north of railroad tracks (Area 16B)

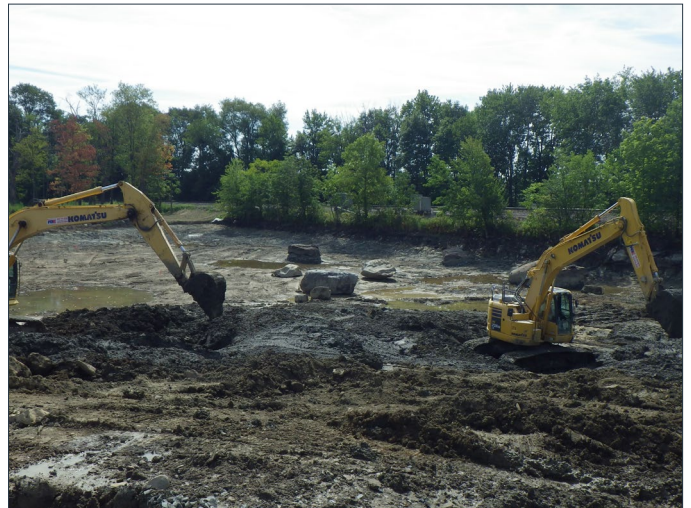
Photo No. 36: View of excavation of Railroad Pond (Area 22)

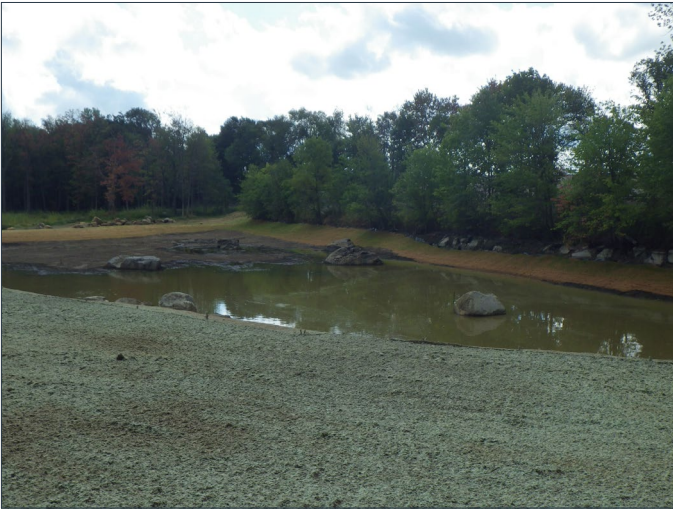
Photo No. 37: View of restored surface of Railroad Pond (Area 22)

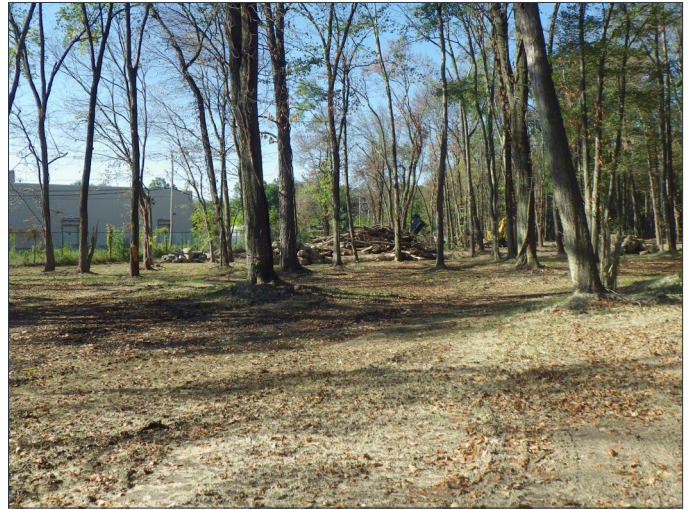
Photo No. 38: View of backfilled surface of Area 28

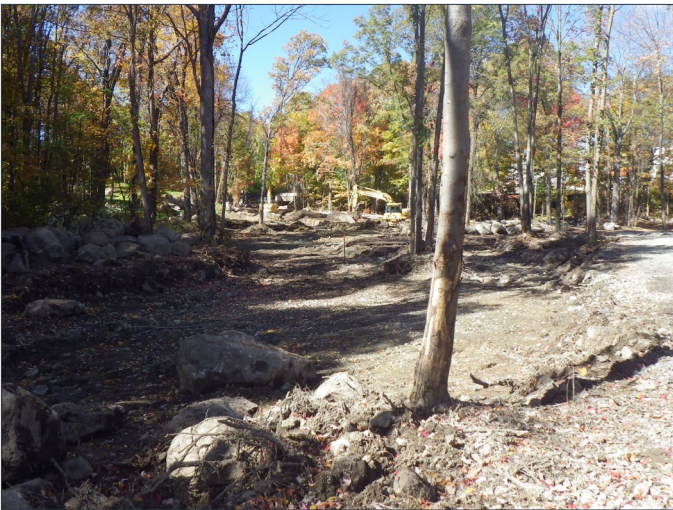
Photo No. 39: View of excavated section of Western Stream (Area 38B)

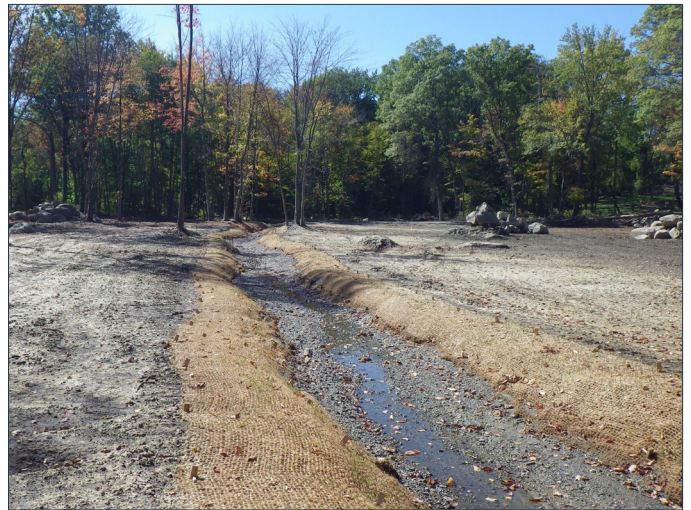
Photo No. 40: View of restored section of Railroad Pond Stream south of railroad tracks (Area 38A)

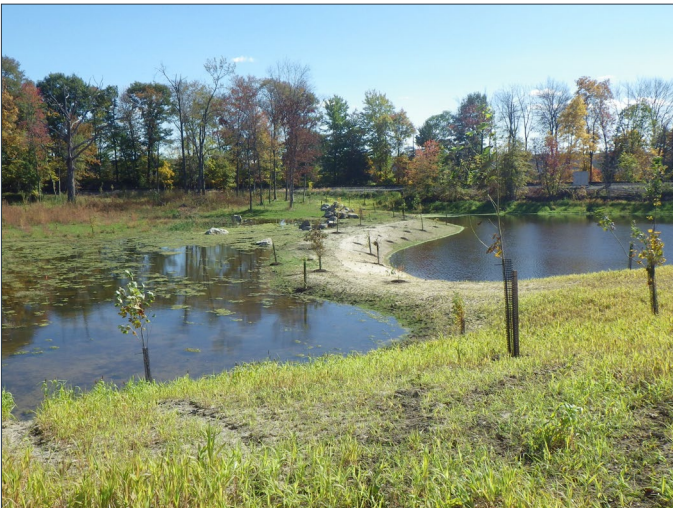
Photo No. 41: View of tree plantings at Areas 2 and 22

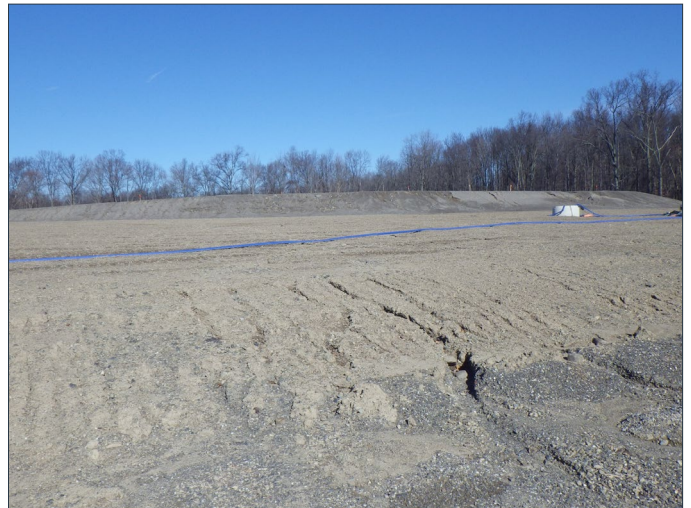
Photo No. 42: View of graded surface of temporary and permanent sections of Containment Cell

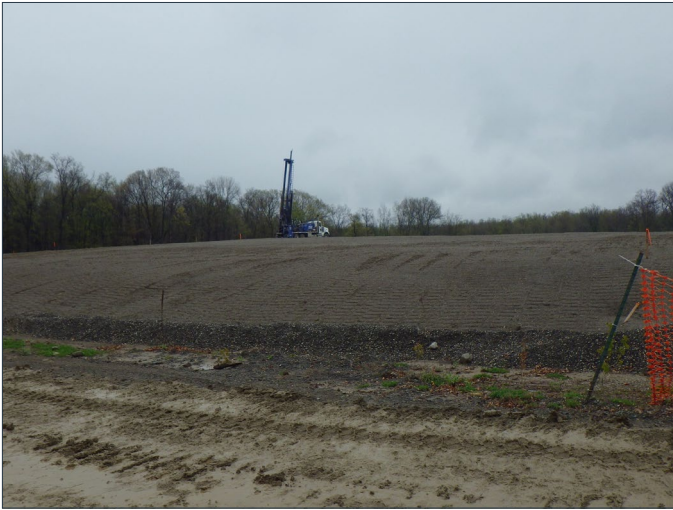
Photo No. 43: View of installation of gas vents in Containment Cell

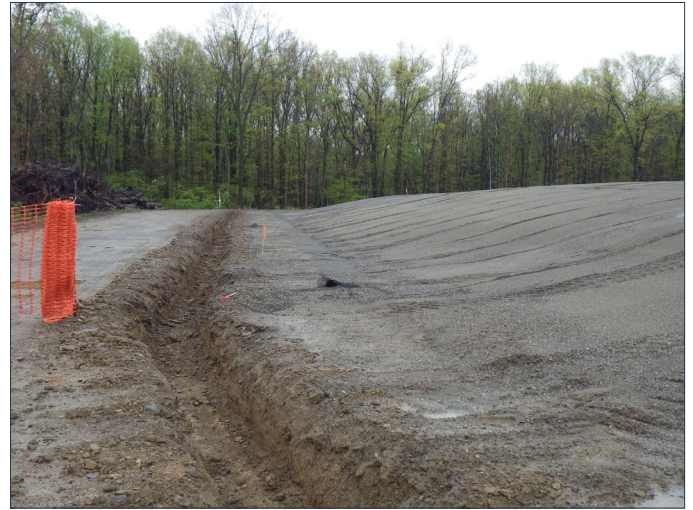
Photo No. 44: View of excavated anchor trench for top liner at Containment Cell

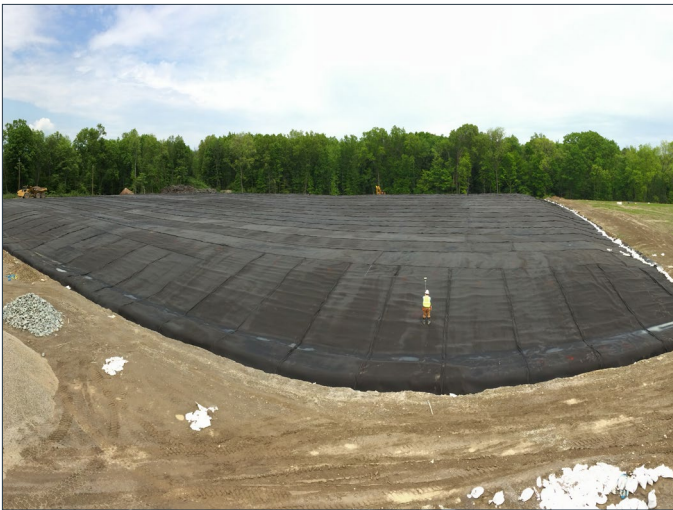
Photo No. 45: View of installed top liner of Containment Cell cap permanent section

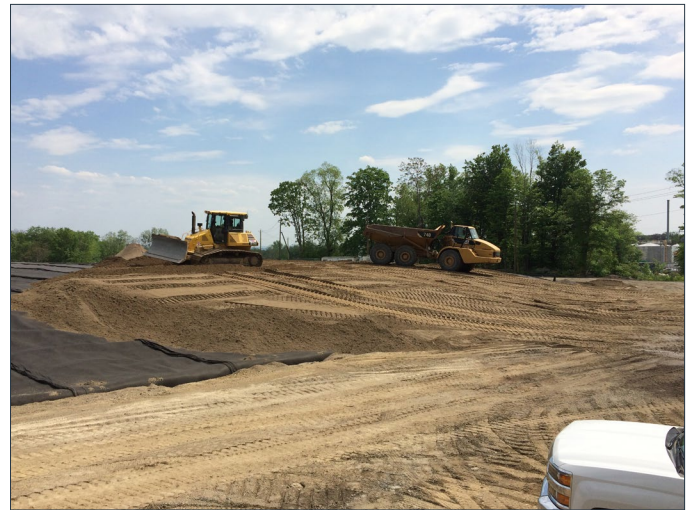
Photo No. 46: View of placement of protective cover soil on Containment Cell cap permanent section

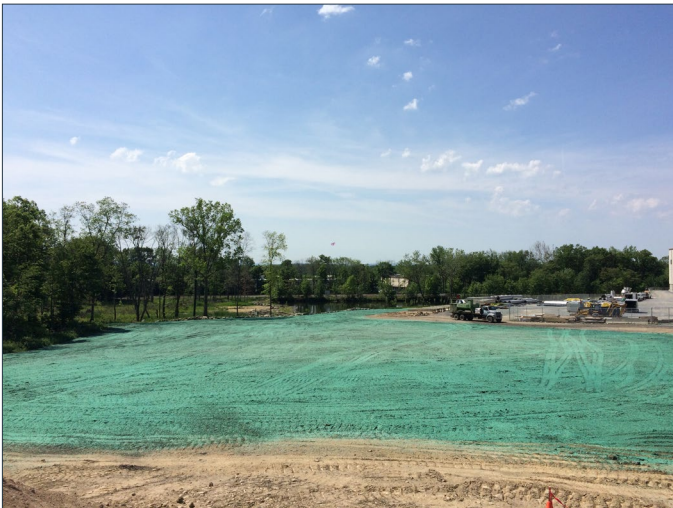
Photo No. 47: View of hydroseeded surface of Eastern Fill Area surface drainage area south of Containment Cell

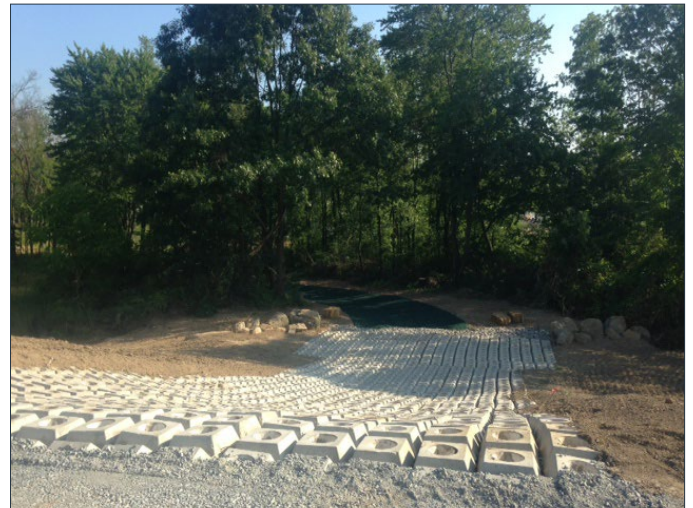
Photo No. 48: View of installed concrete block and vegetated swale spillway from Containment Cell

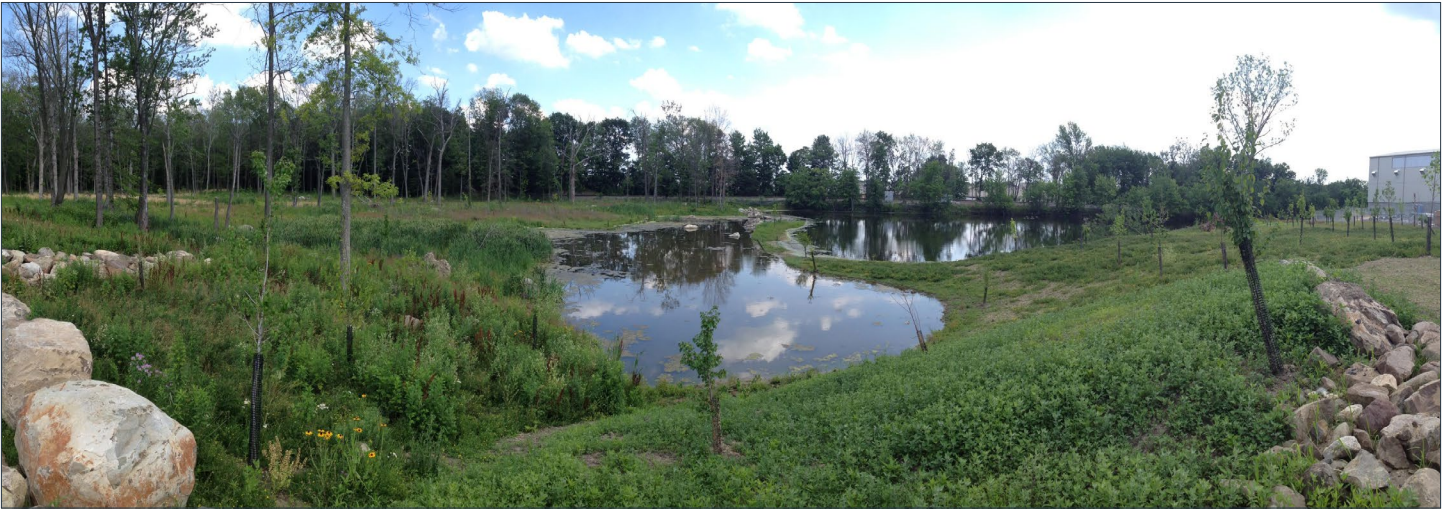
Photo No. 49: View of restored Railroad Pond

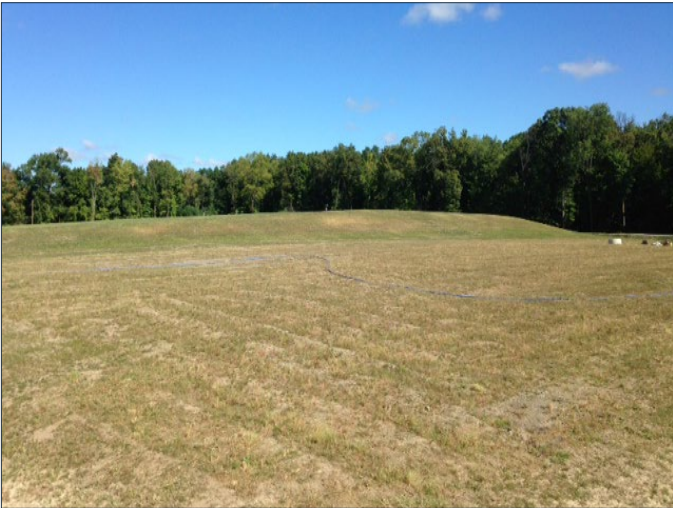
Photo No. 50: View of restored temporary cap at Containment Cell

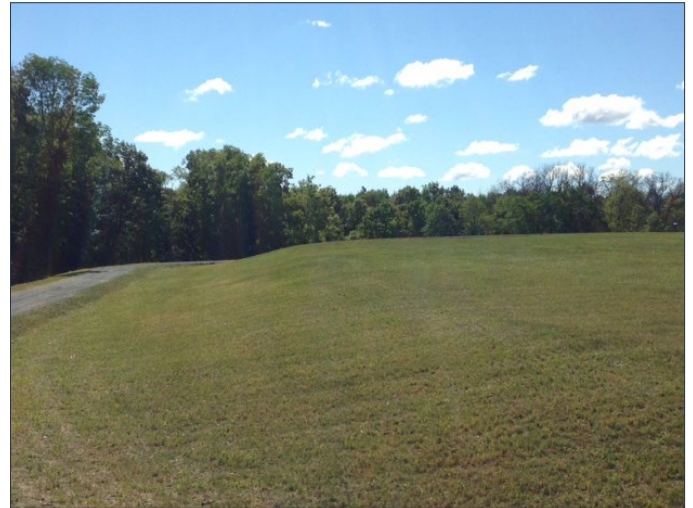
Photo No. 51: View of restored permanent cap at Containment Cell

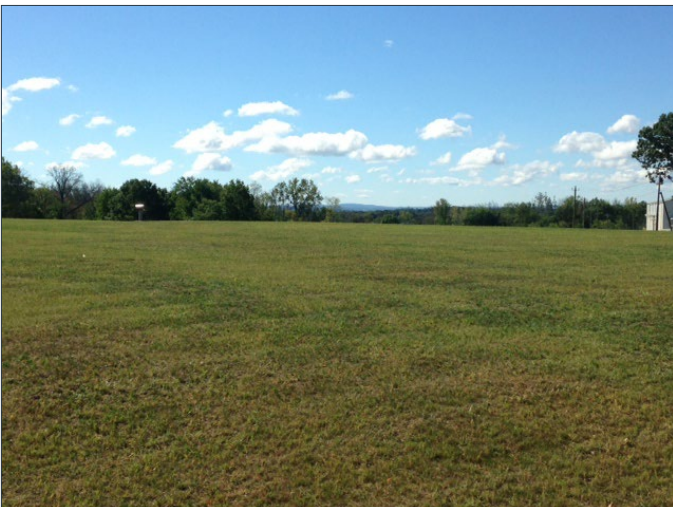
Photo No. 52: View of restored permanent cap at Containment Cell

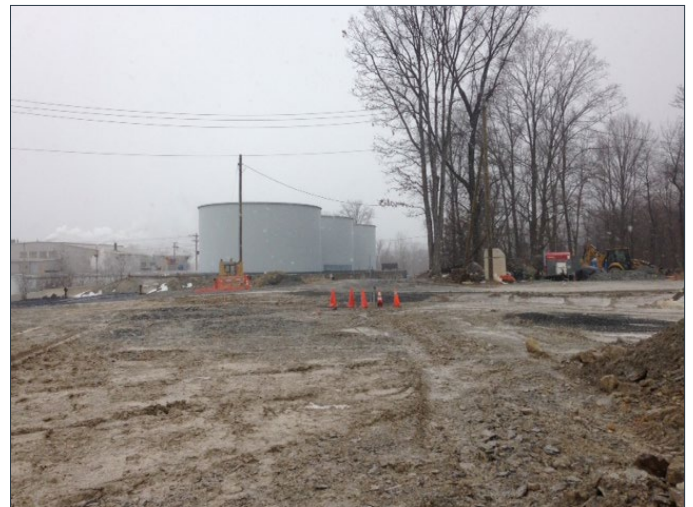
Photo No. 53: View of backfilled surface of permanent leachate conveyance pipe between vaults

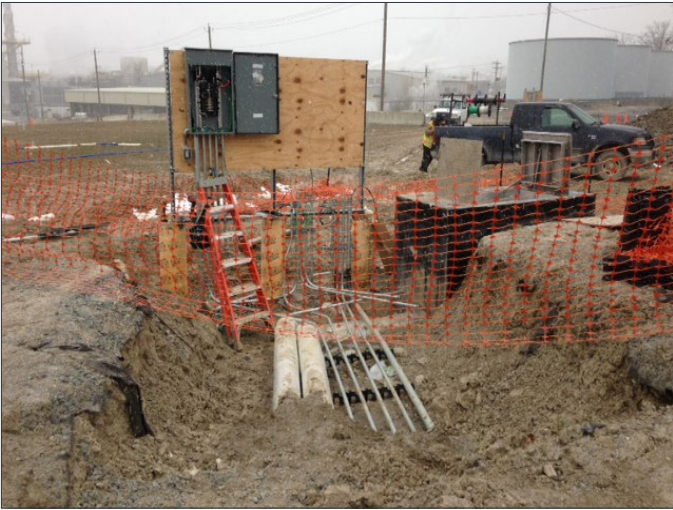
Photo No. 54: View of installation of permanent leachate conveyance system plumbing and electrical components at vault

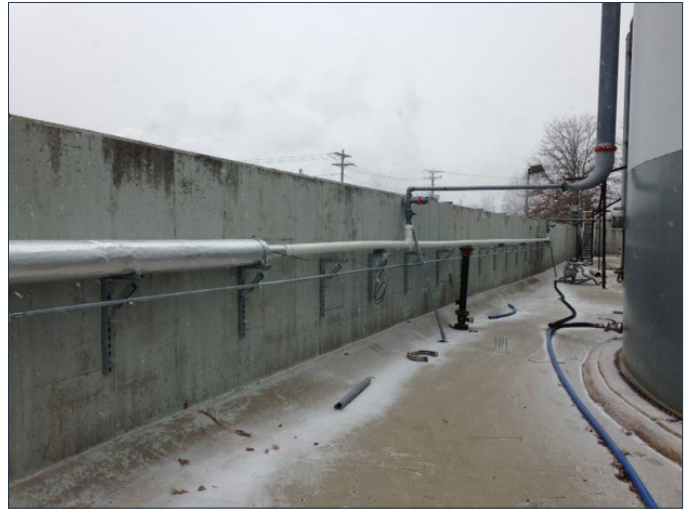
Photo No. 55: View of installation of permanent leachate conveyance piping at tanks
