October 19, 2011
File No. 147-104414

Re: Progress Letter for September 2011
Former tesa tape, Inc., Middletown Facility
NYSDEC Site #3-36-56
Order of Consent (Index # W3-0906-02-07)

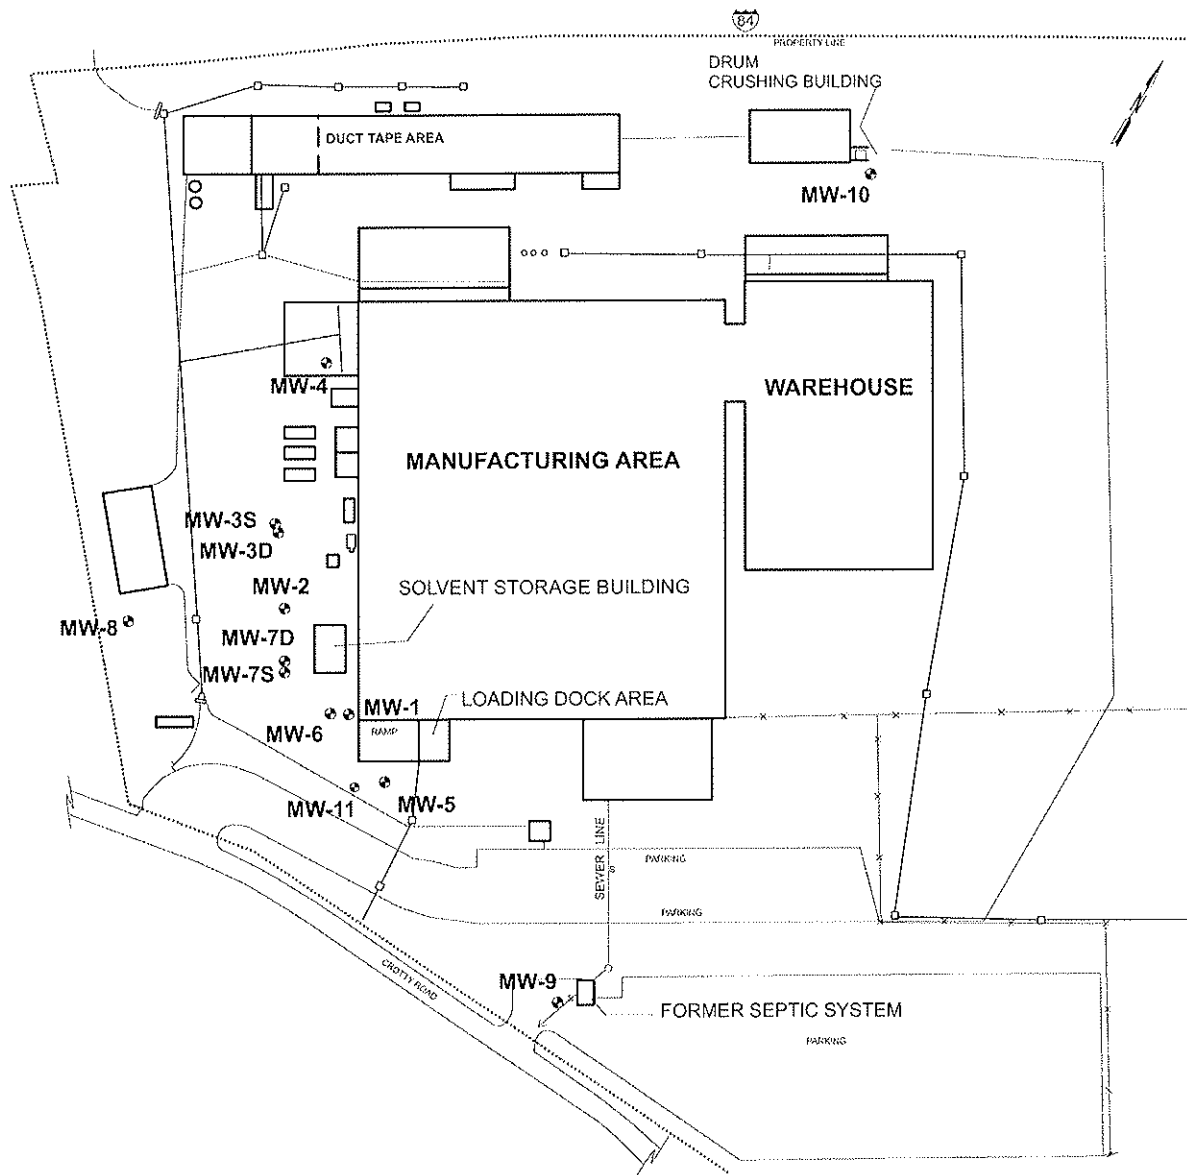
Figure
2

At mid morning HDR met with drillers from Parratt Wolff Inc. (Parratt Wolff) at the Site. Parratt Wolff was contracted by HDR to abandon the thirteen monitoring wells located across the site (Figure 2). All of the wells on site consisted of 2 inch schedule 40 PVC with flush mount curb boxes. The wells were abandoned by either pulling the casing or grouting in place after breaking the bottom well cap (Table 1). The abandonment procedure followed guidance found in CP-43 Groundwater Monitoring Well Decommissioning Policy, NYSDEC, , August 2009.

Prior to abandoning the wells the concrete well pads and steel curb boxes were removed. The concrete and curb boxes were disposed of as solid waste. Each well was grouted in place by pumping grout into the well from the bottom up using a "tremie" pipe. The tremie pipe was lifted up as the well was filled with grout. In some cases the PVC casing was loose and was removed prior to pumping grout into the well. Grout was

pumped into the well until it appeared at the surface. Displaced groundwater flowed into the cavity left behind by the former curb box and was allowed to percolated back into the surrounding soil. After approximately ten minutes the grout had settled approximately six to ten inches in each well (or approximately 18 inches below grade). After the well was grouted and allowed to set the curb box area was filled with asphalt patch to match the area surrounding the well. The asphalt was tamped into place by hand. The only exception is MW-8 which is located in a grassy lot. The former curb box in this area was filled with a mixture of sand and native soil to match the surrounding area.
