Hurricane Project Status Report

Inspection performed by A. Caniano of Dvirka and Bartilucci on November 9, 2012. Conditions were sunny and the temperature approximately 50 degrees Fahrenheit.

Site Name: [Glenmere Lake Property, Site No. 336071](#)

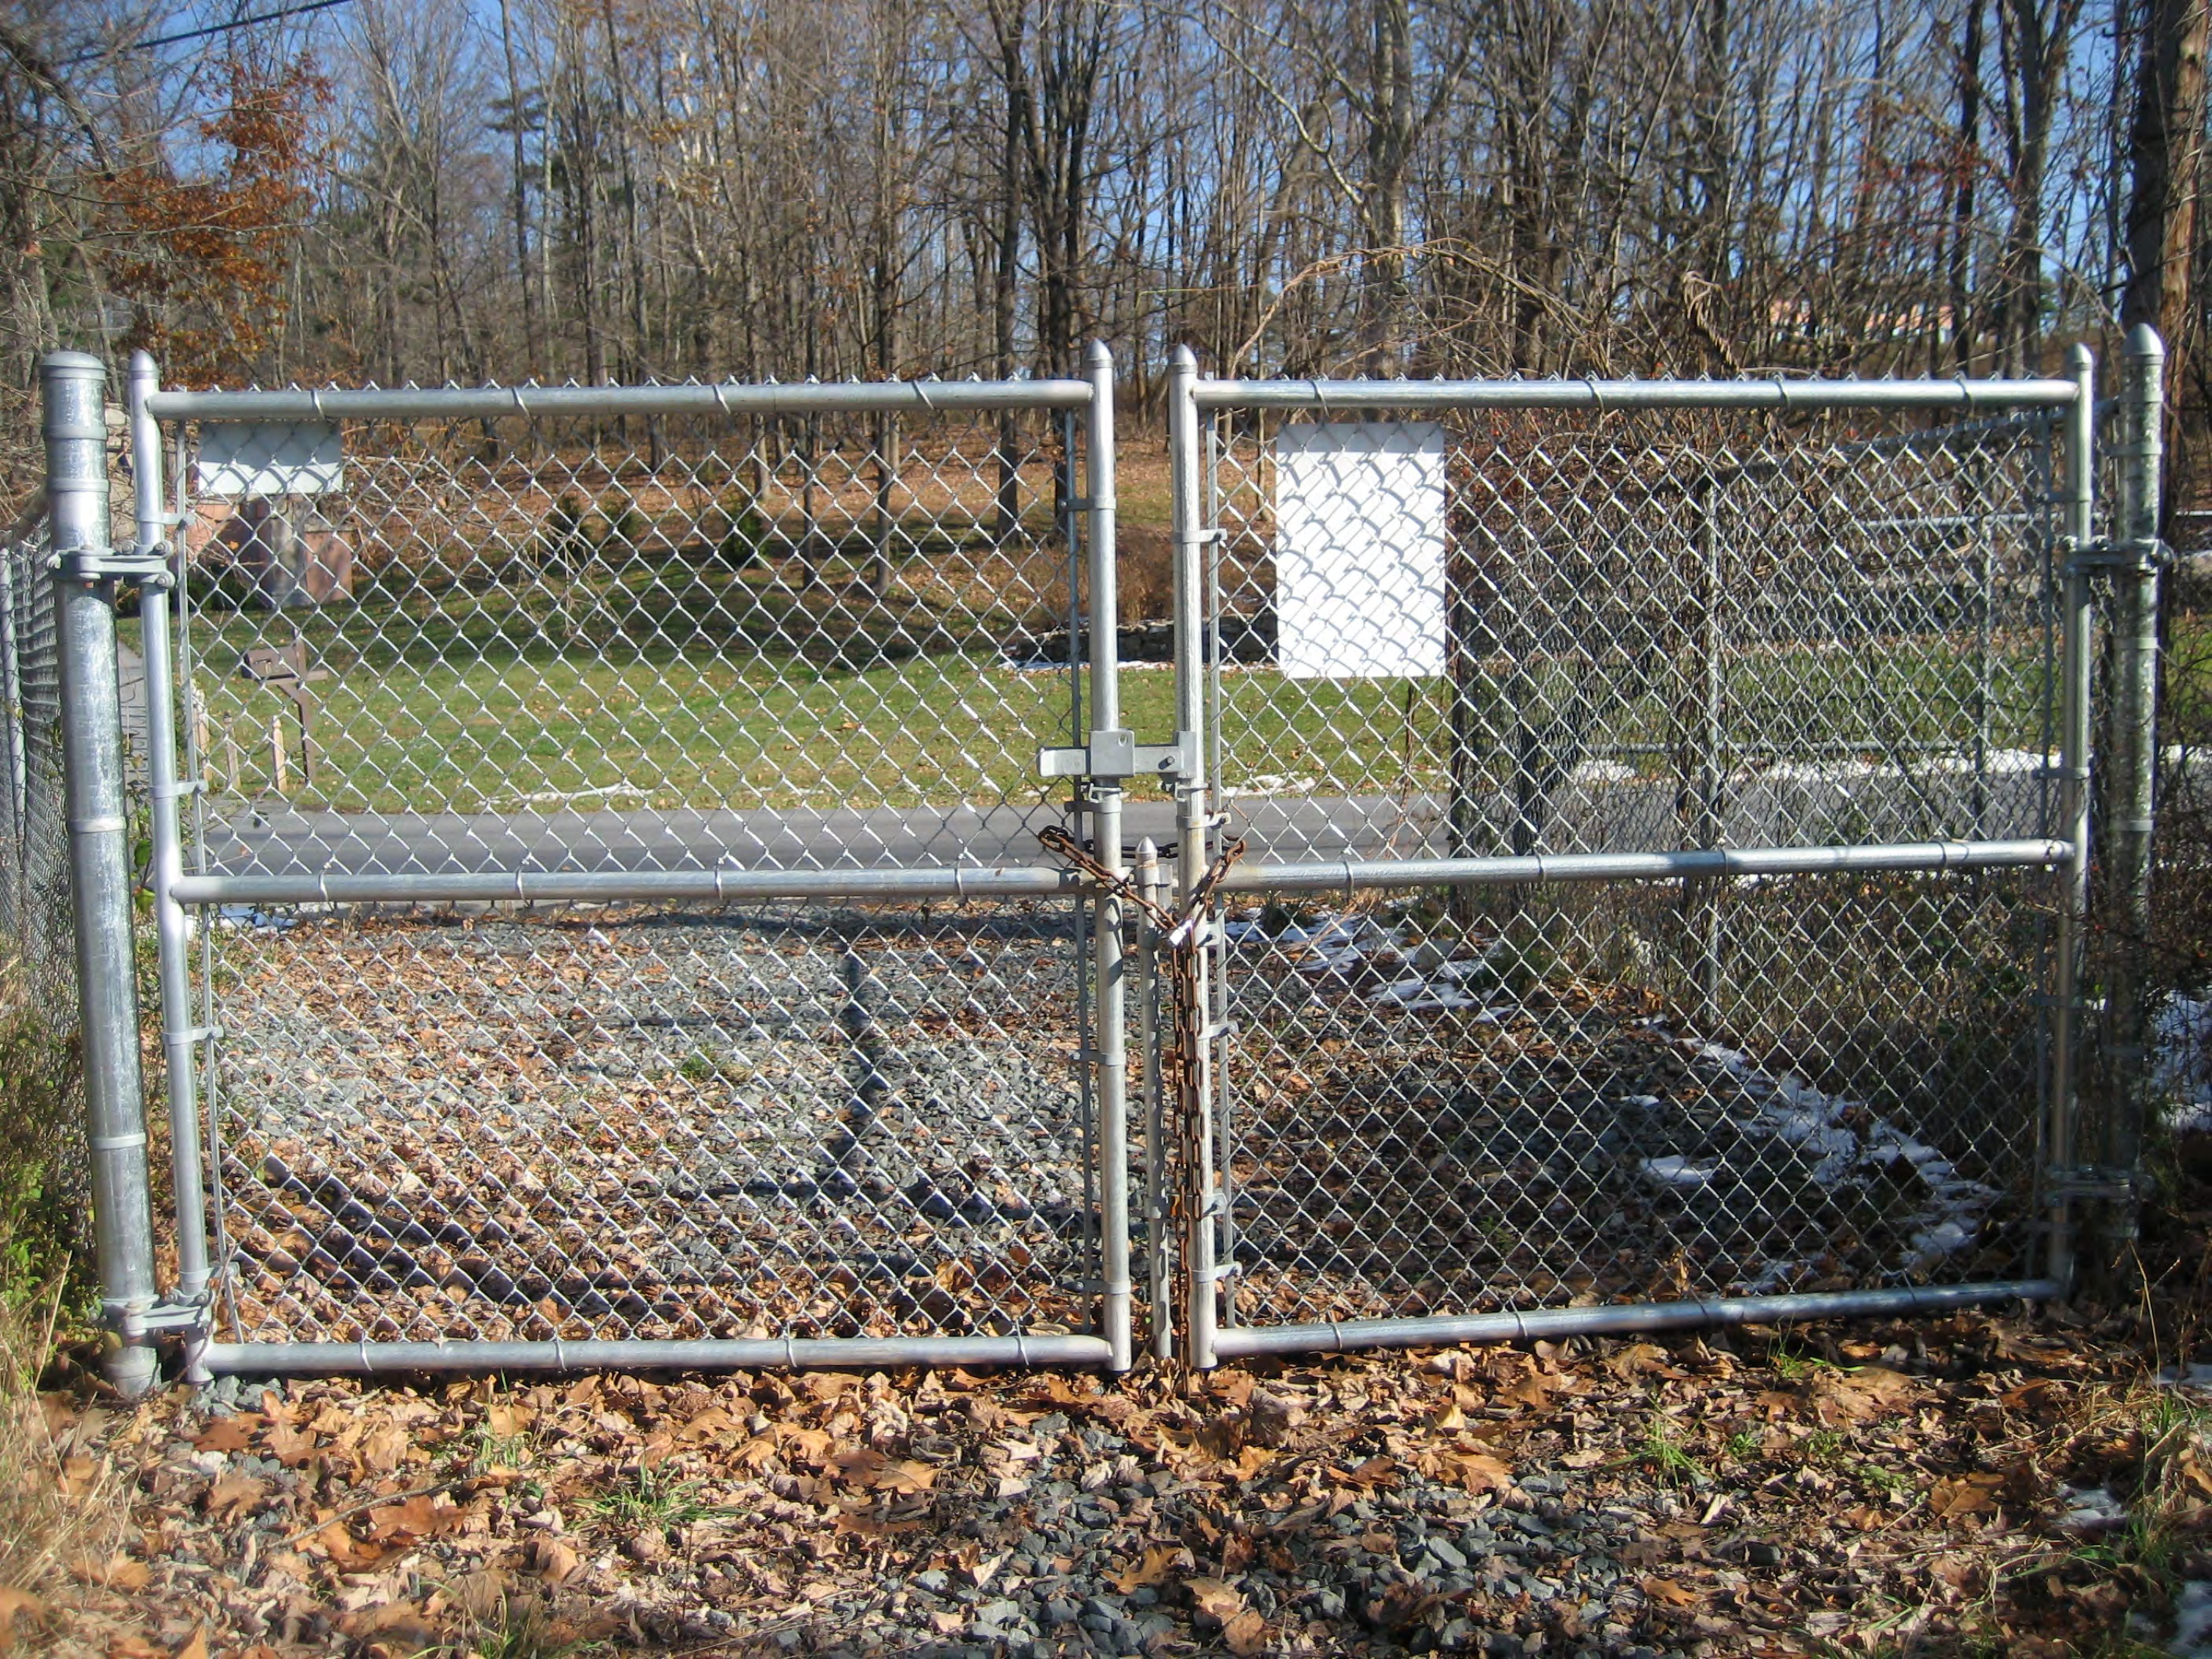
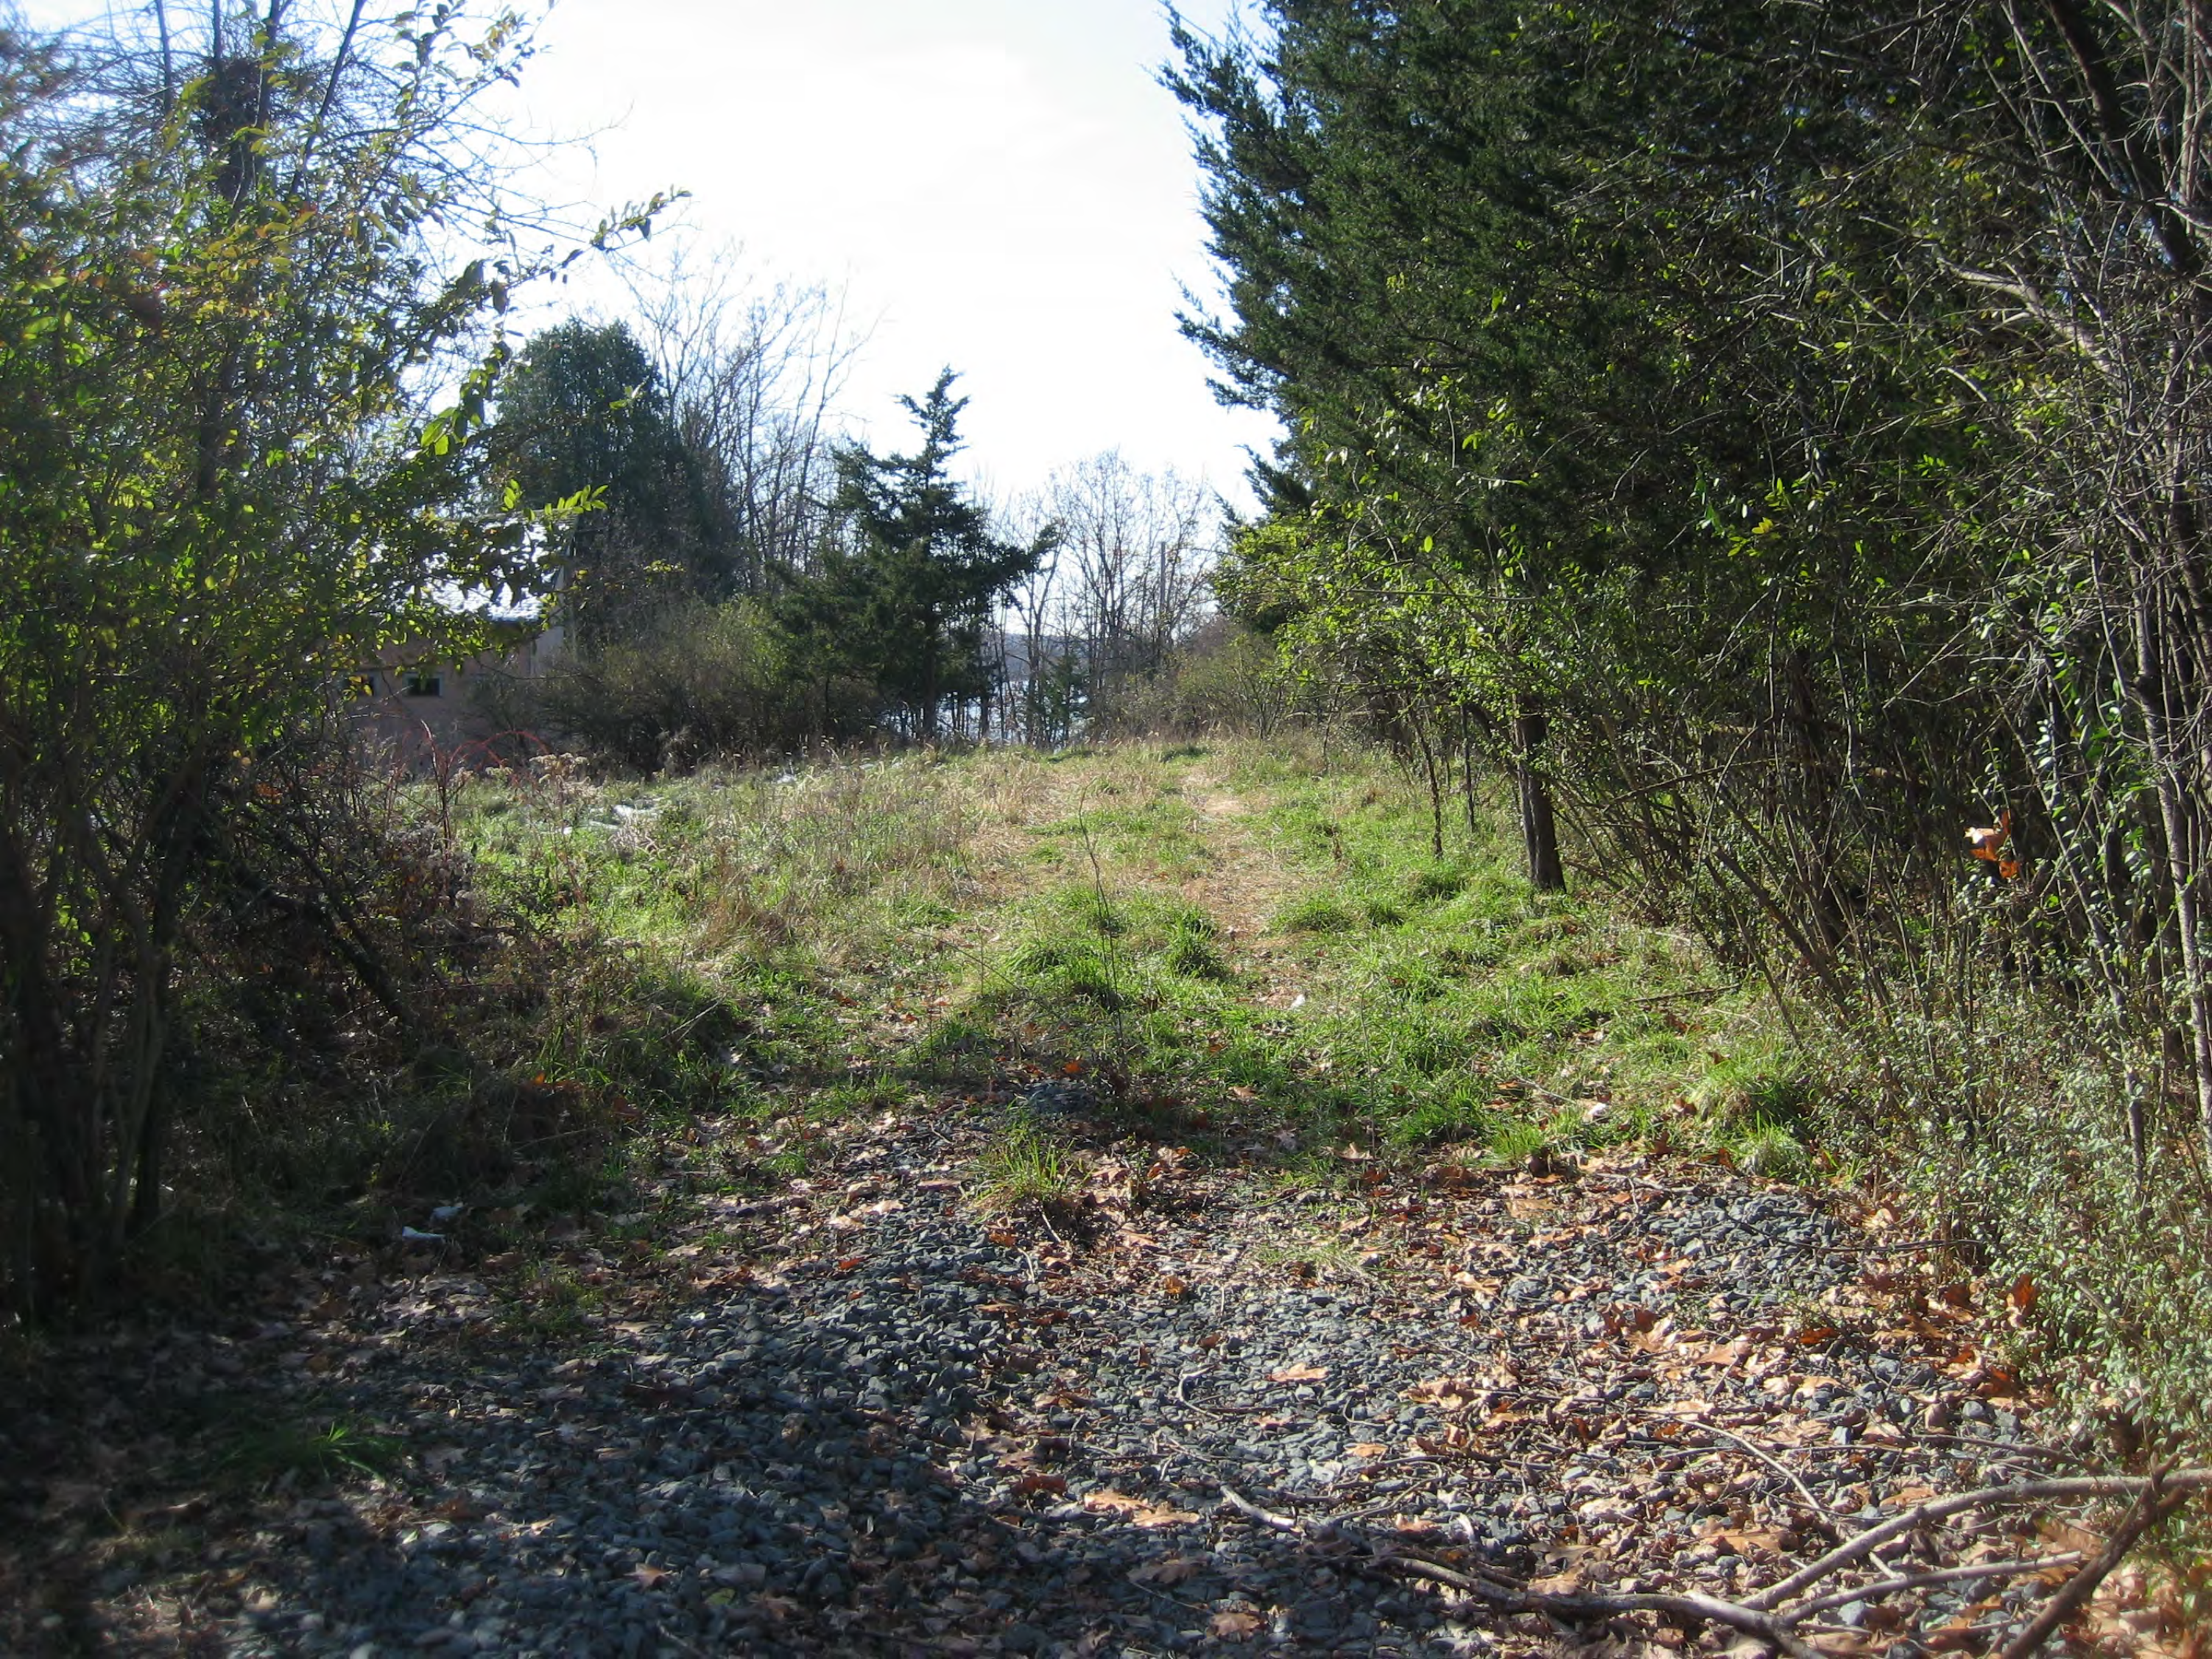
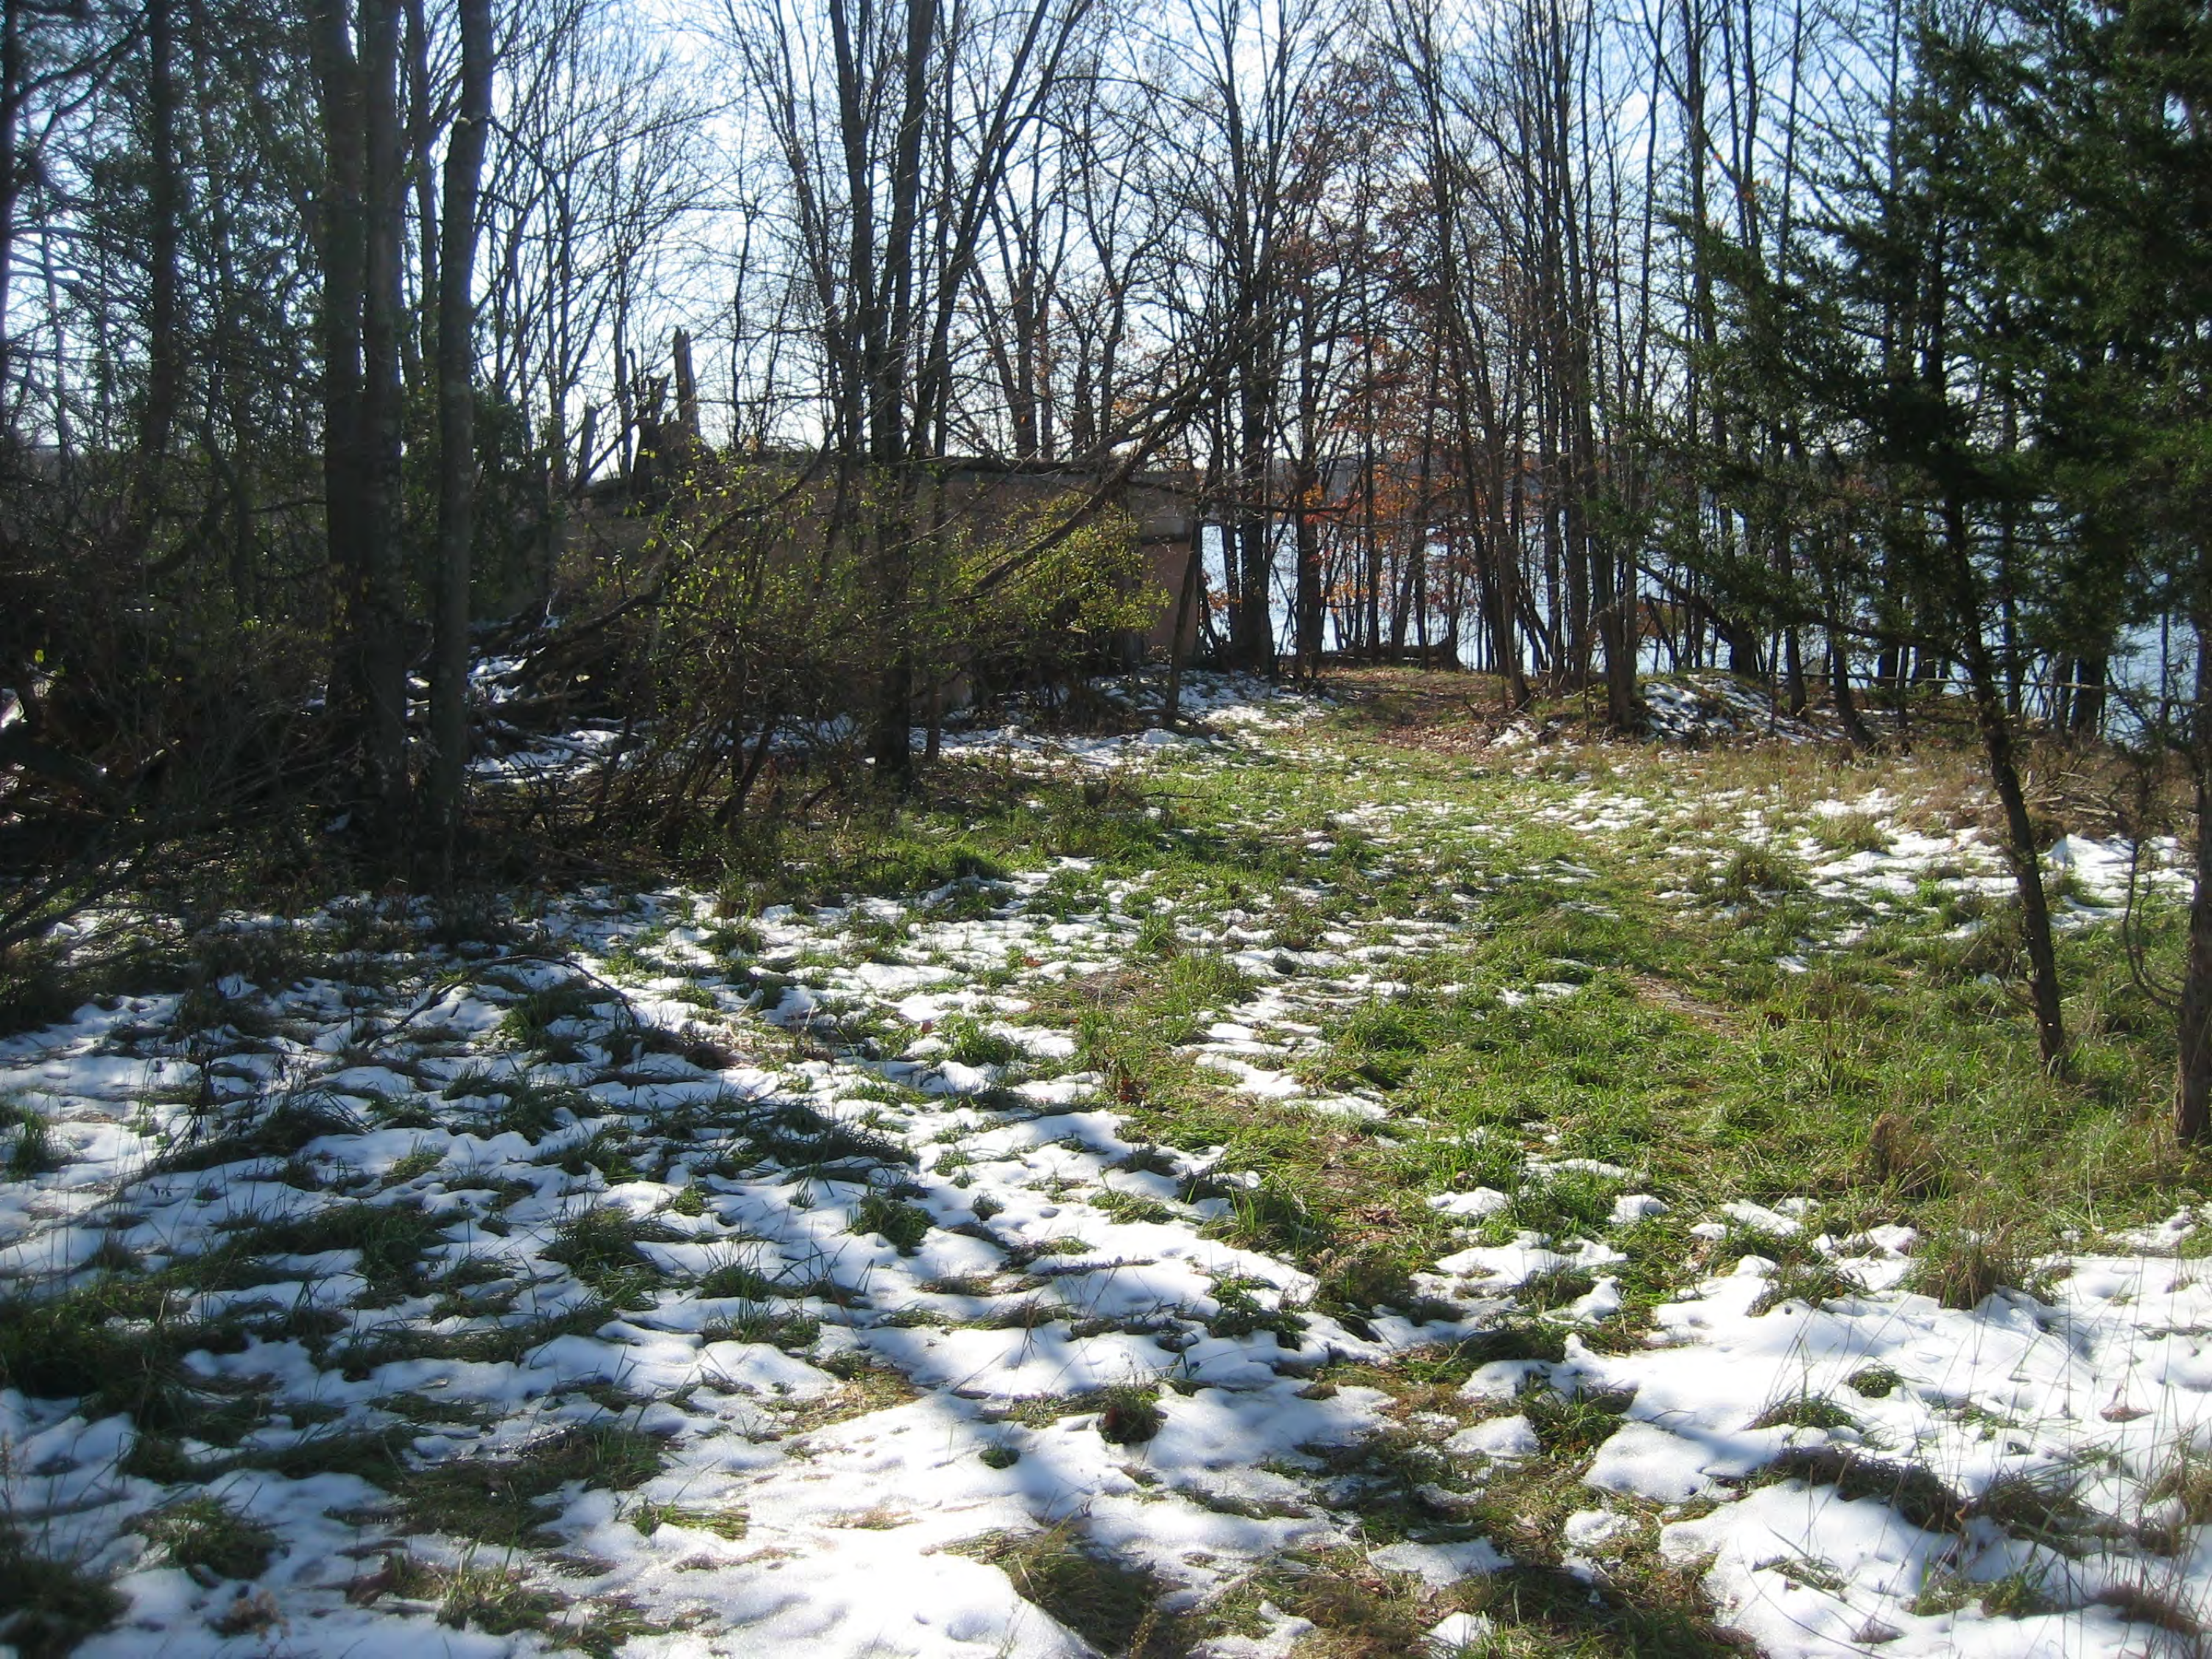
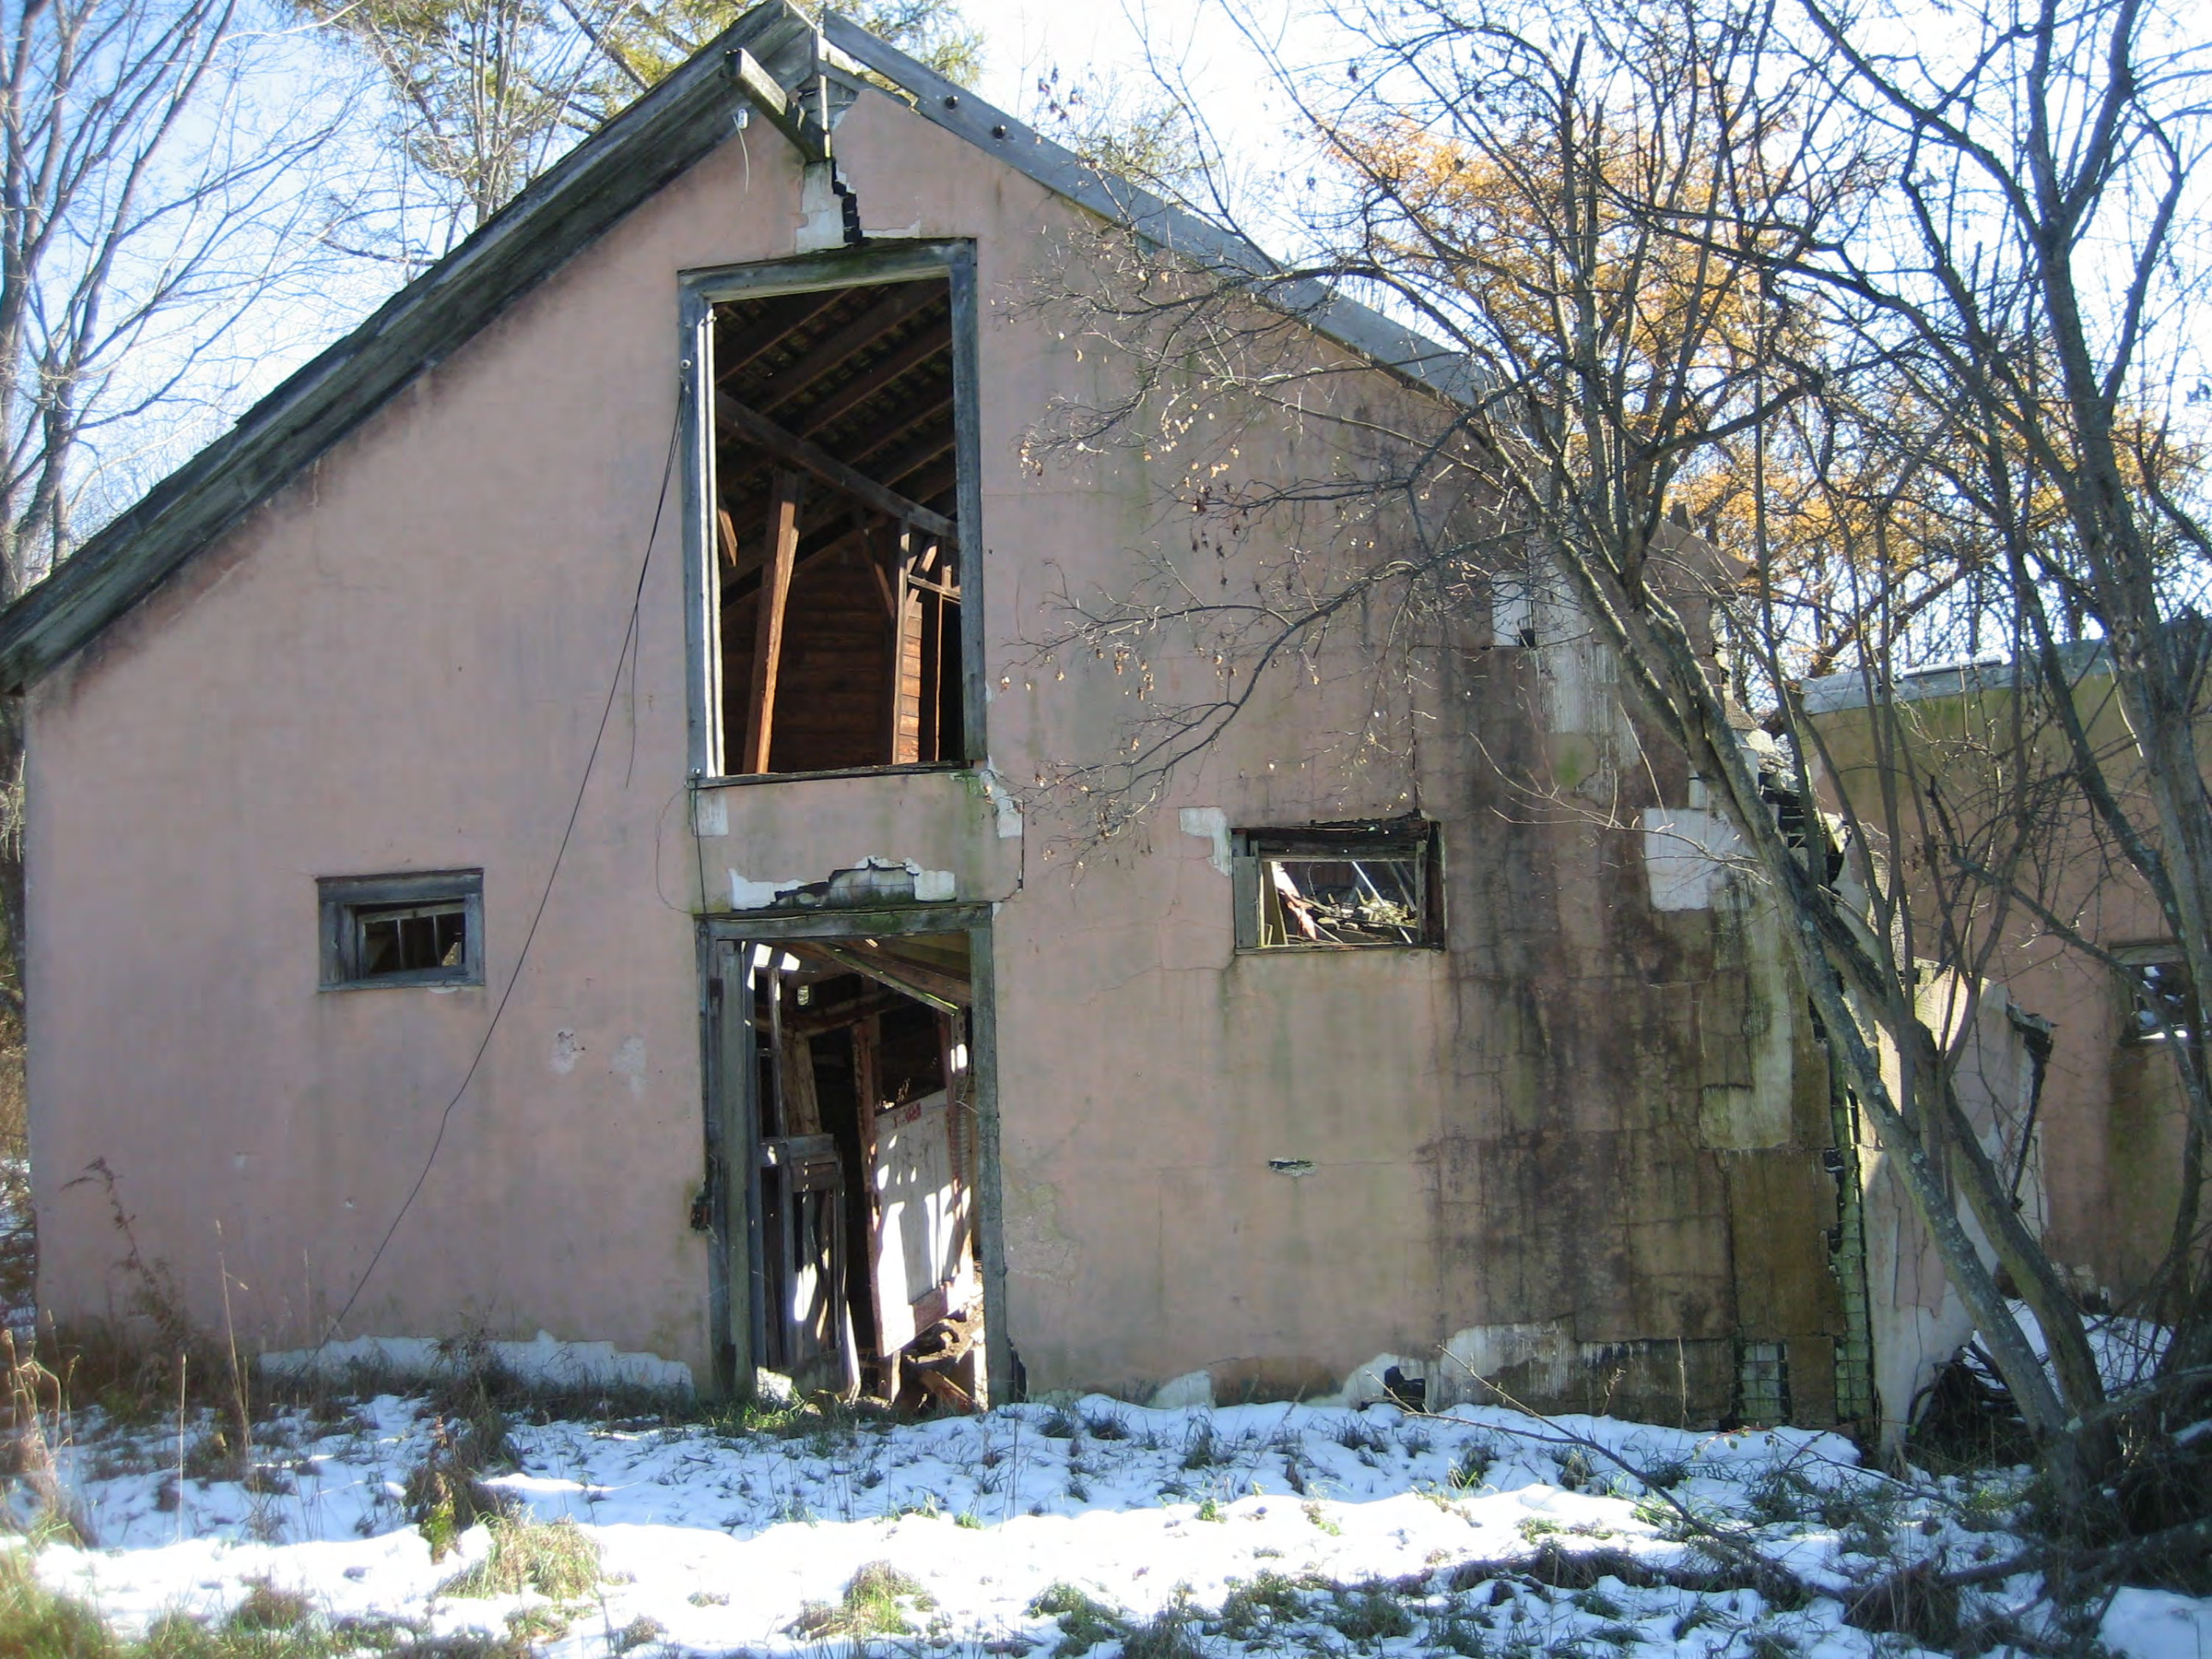
No damage was observed due to Hurricane Sandy, and only a few newly downed trees were noted on-site. None of the downed trees further damaged the dilapidated buildings or blocked the main access road on the site. There was no evidence of any new discharges or erosion of soil into Glenmere Lake. There was no new apparent damage to the dilapidated buildings – they remain in an advanced state of collapse. Attached pictures show that the entrance to the site remains secure, the access road clear and the building walls still standing.
