**PERFLUORINATED COMPOUNDS PRELIMINARY ASSESSMENT
SITE VISIT REPORT**

**NEW YORK AIR NATIONAL GUARD
STEWART AIR NATIONAL GUARD BASE
NEWBURGH, NEW YORK**

February 2016

**BB&E, Inc.
February 2016**

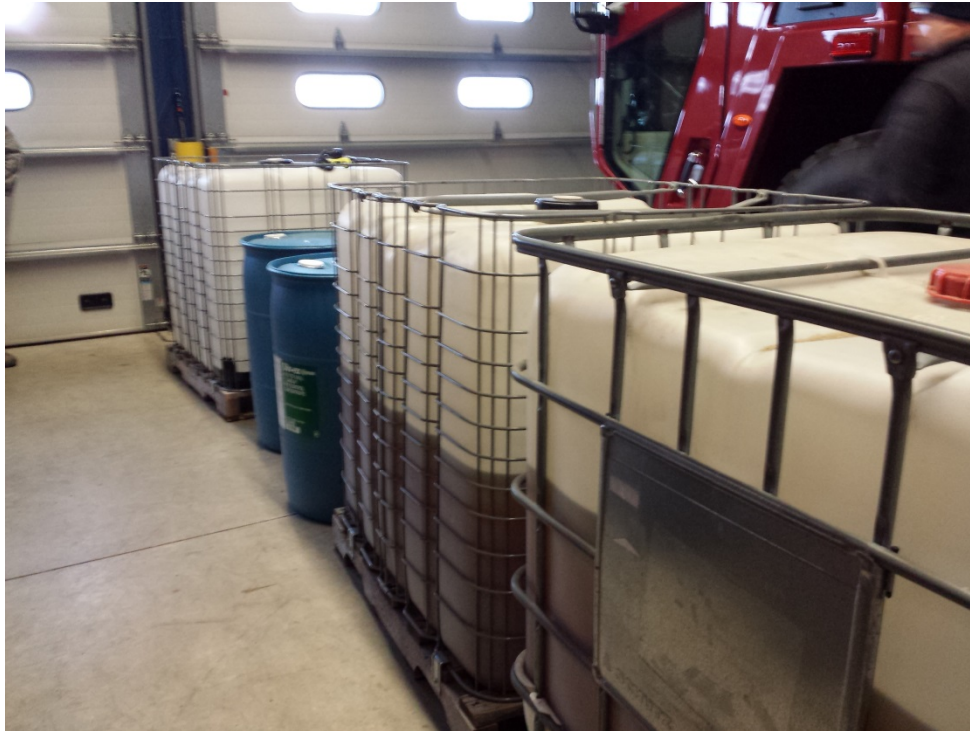
Photo 1: Current AFFF tote and drum storage in Building 104 (Current Fire Station).

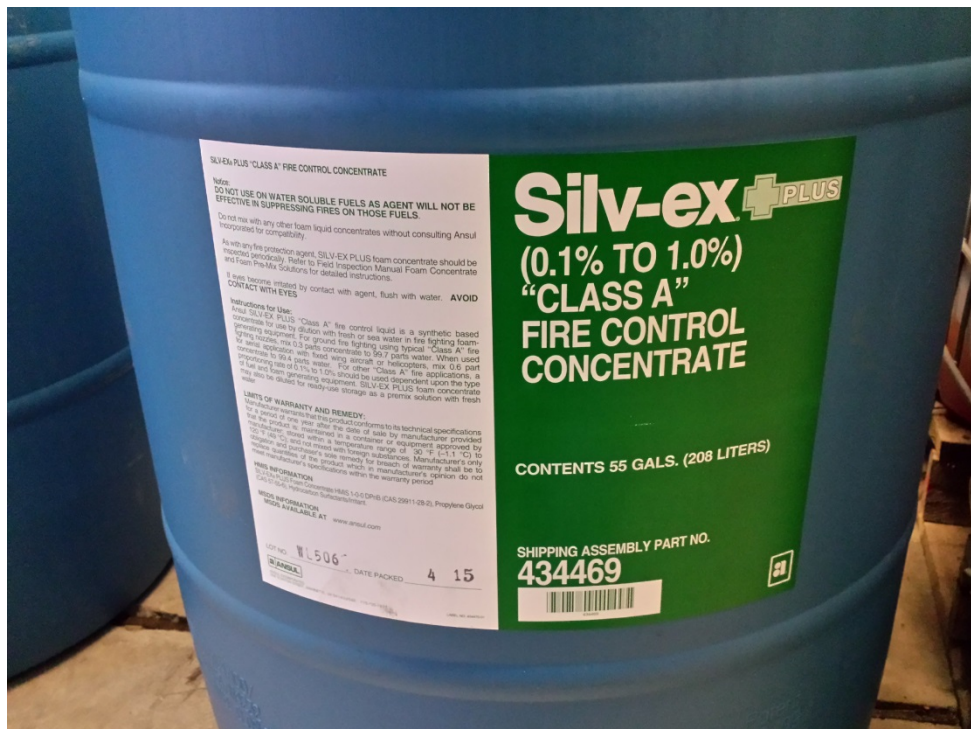
Photo 2: Current AFFF drum storage in Building 104 (Current Fire Station).

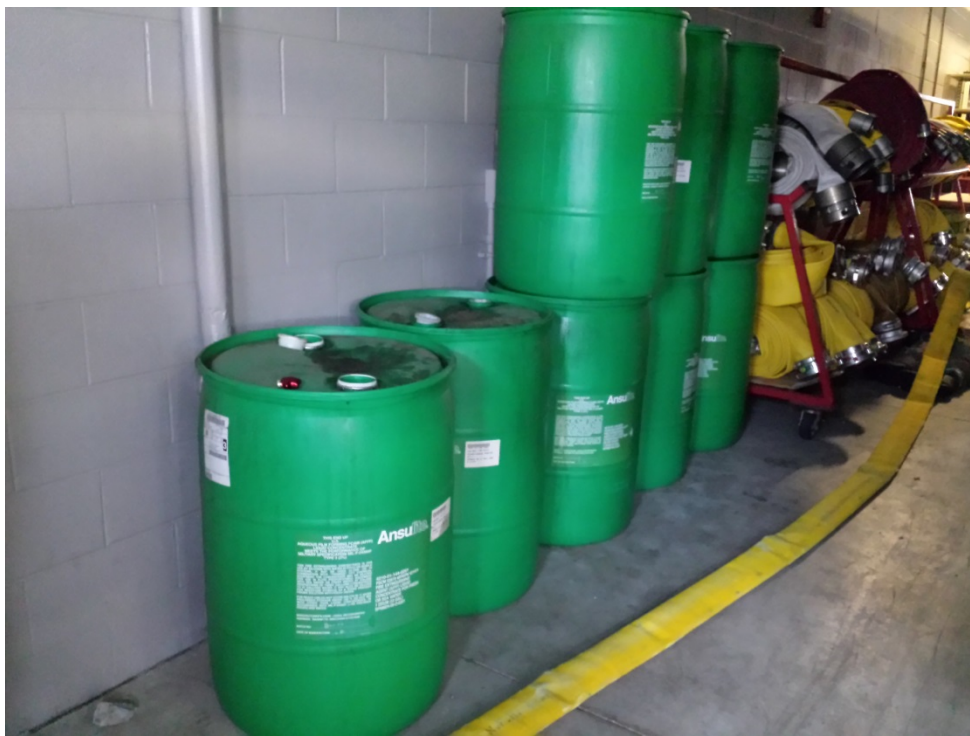
Photo 3: Empty drums in Building 104 (Current Fire Station) used for transfer of AFFF from vehicles.

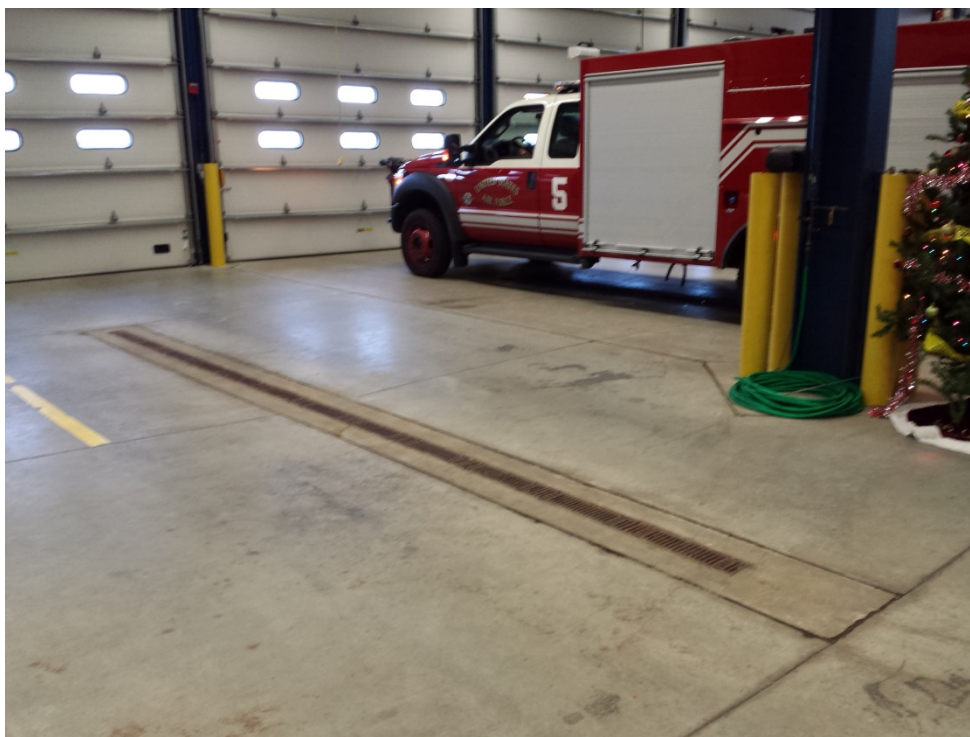
Building 104 was built in 2007. Bulk AFFF is stored in totes and drums and is also present in the fire department (FD) vehicles. Current FD vehicle AFFF inventory amounts are included as Appendix C-1. Additionally, the foam trailer currently carries 1,000 gallons (gal) of AFFF. AFFF is transferred to vehicles within the Fire Station via a pony pump on the foam trailer. If AFFF is removed from the trucks for maintenance, it is transferred to empty 55-gal drums within the Fire Station. Any AFFF releases are typically captured by the trench drains which discharge into the storm sewer system, ultimately flowing through an oil/water separator (OWS) at Building 111. Discharges from the OWS (Building 111) are typically routed to Recreation Pond (off-site) through Outfall 002, but can be diverted to the Retention Basin through the Diversion Chamber (see further discussion in Section 3.1.15). A project is currently being investigated by the Base to re-route the Building 104 trench drains from the storm sewer system (ANG, 2015).

Photo 4: Trench drains were present in Building 104 (Current Fire Station).

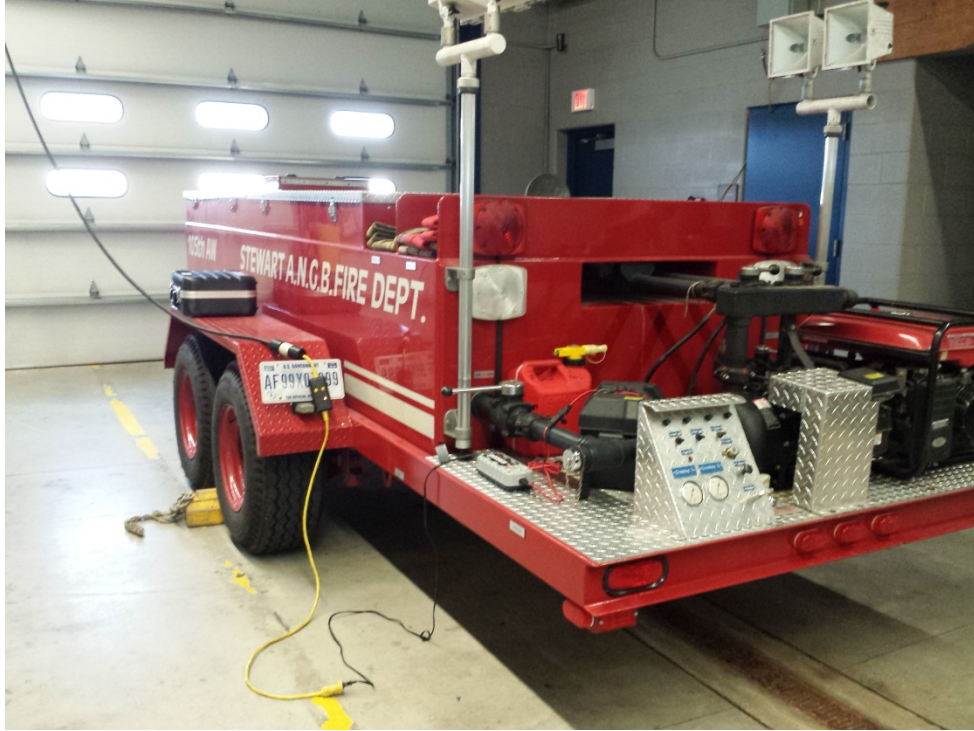
Photo 5: The current AFFF inventory includes a 1,000 gallon trailer, located at Building 104 (Current Fire Station).

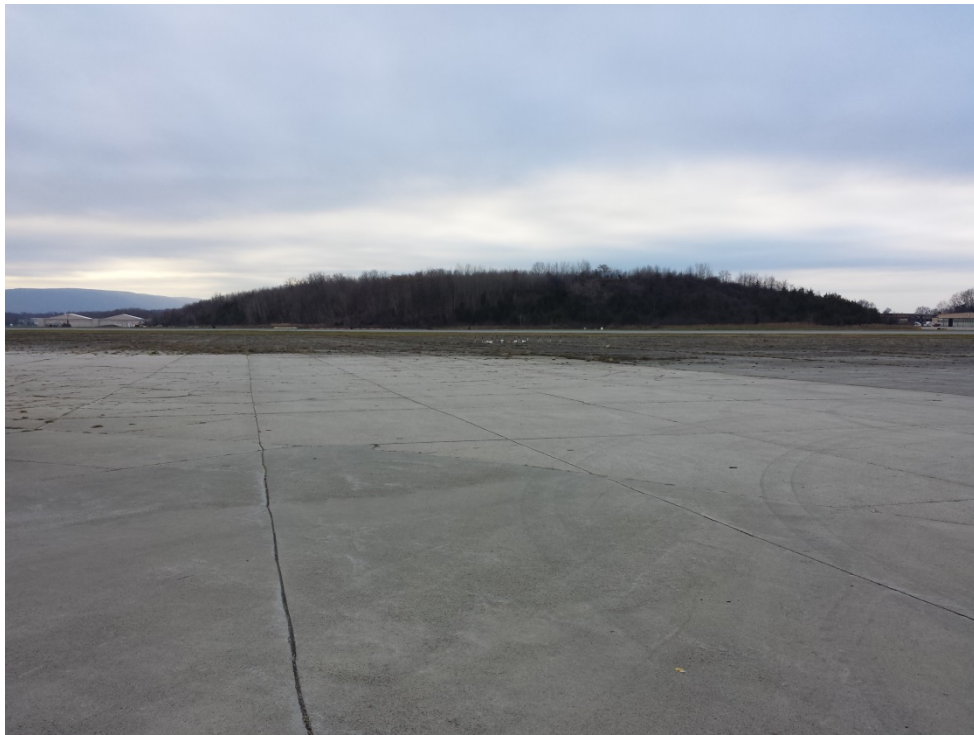
According to Base personnel, the concrete area west of Building 104 has been used for annual FD vehicle nozzle testing since 2007 and is the only known location of nozzle testing. No records of nozzle testing were available. Cracks in the concrete were observed during the site visit.

Photo 6: Looking west from Building 104 (Current Fire Station) toward the Nozzle Testing Area.

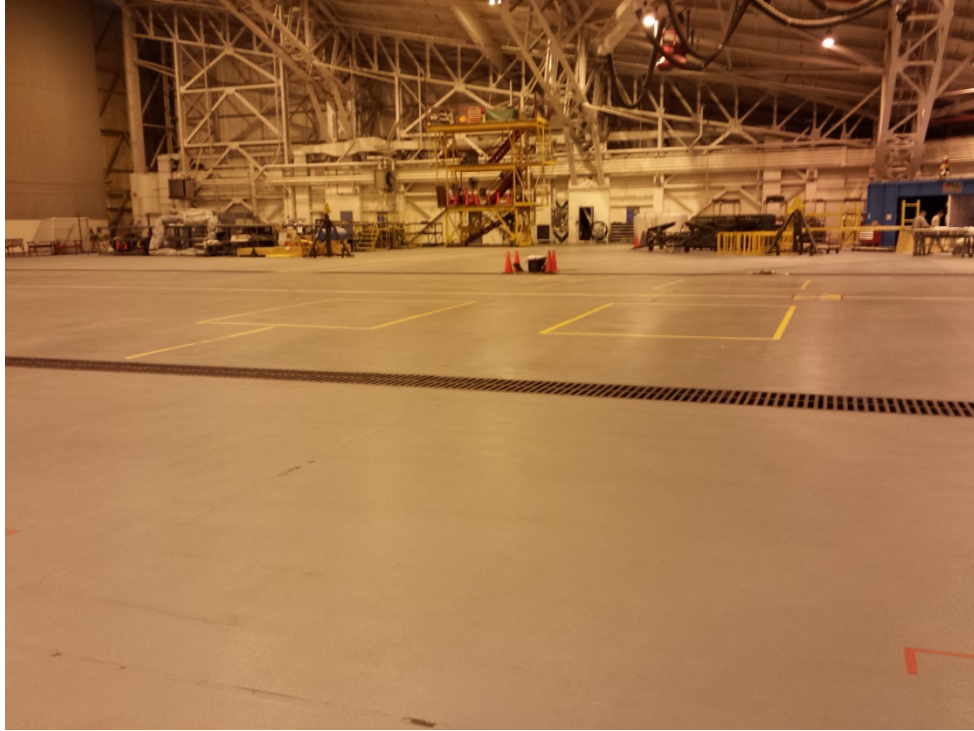
Operation of the AFFF fire suppression system at Hangar 101 started in 1987 and continued until 2009, when the system was retrofitted for use of HEF. The AFFF FSS included underwing and overhead foam generators. The existing overhead foam generators were retained for reuse with HEF. Historically, AFFF storage tanks were kept on the floor of the main hangar. It is not known if, or how often, fire suppression systems were tested. No records of accidental AFFF releases exist. According to Base personnel, several accidental AFFF FSS activations occurred at

Hangar 101 but never resulted in a full-system release. Trench drains in this hangar discharge to an OWS through the industrial waste system to the Retention Basin (ANG, 2015) (see further discussion in Section 3.1.15). Hangar 101 construction drawings of the FSS conversion from AFFF to HEF are included in Appendix C-3.

Photo 7: Floor drains are present at Hangar 101.

5	Hangar 101	41.499191°	-74.085677°	AFFF FSS from 1987 to 2009. Several accidental AFFF releases occurred during FSS activation. Trench drains discharge to the industrial waste system and ultimately the Retention Basin.	Proceed to SI; focus on soil and groundwater.
6	Hangar 102	41.498436°	-74.087234°	AFFF FSS from 1988 to 2006. Several accidental AFFF releases occurred during FSS activation. Trench drains discharge to the industrial waste system and ultimately the Retention Basin.	Proceed to SI; focus on soil and groundwater.

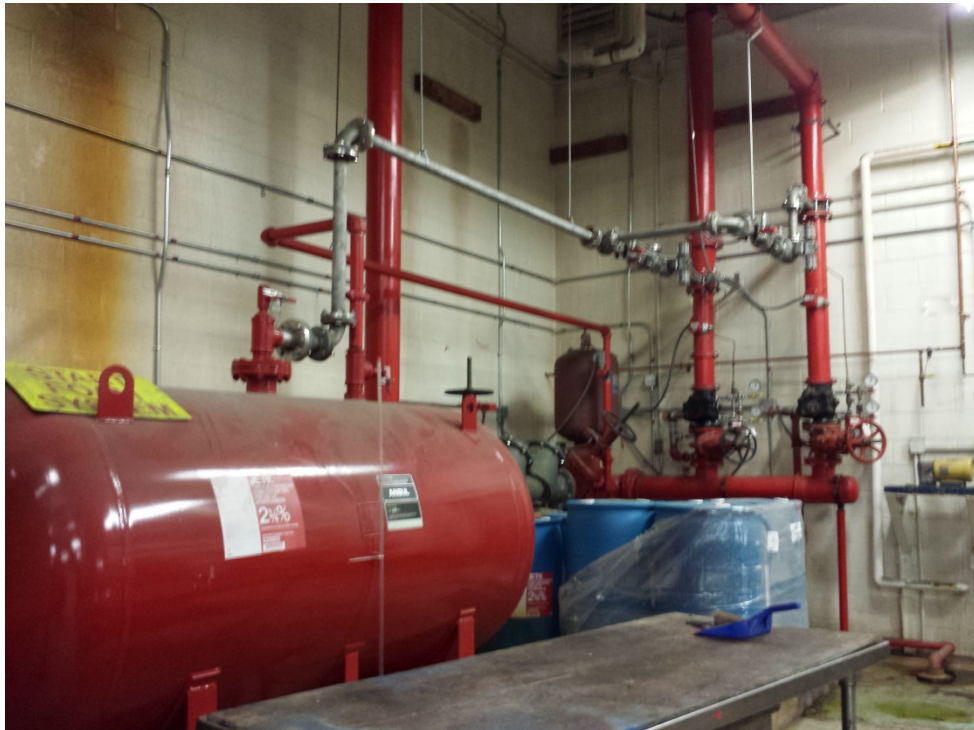
Photo 8: Boiler Room at Hangar 100, which currently is equipped with a HEF bladder tank (formerly equipped with AFFF bladder tanks).

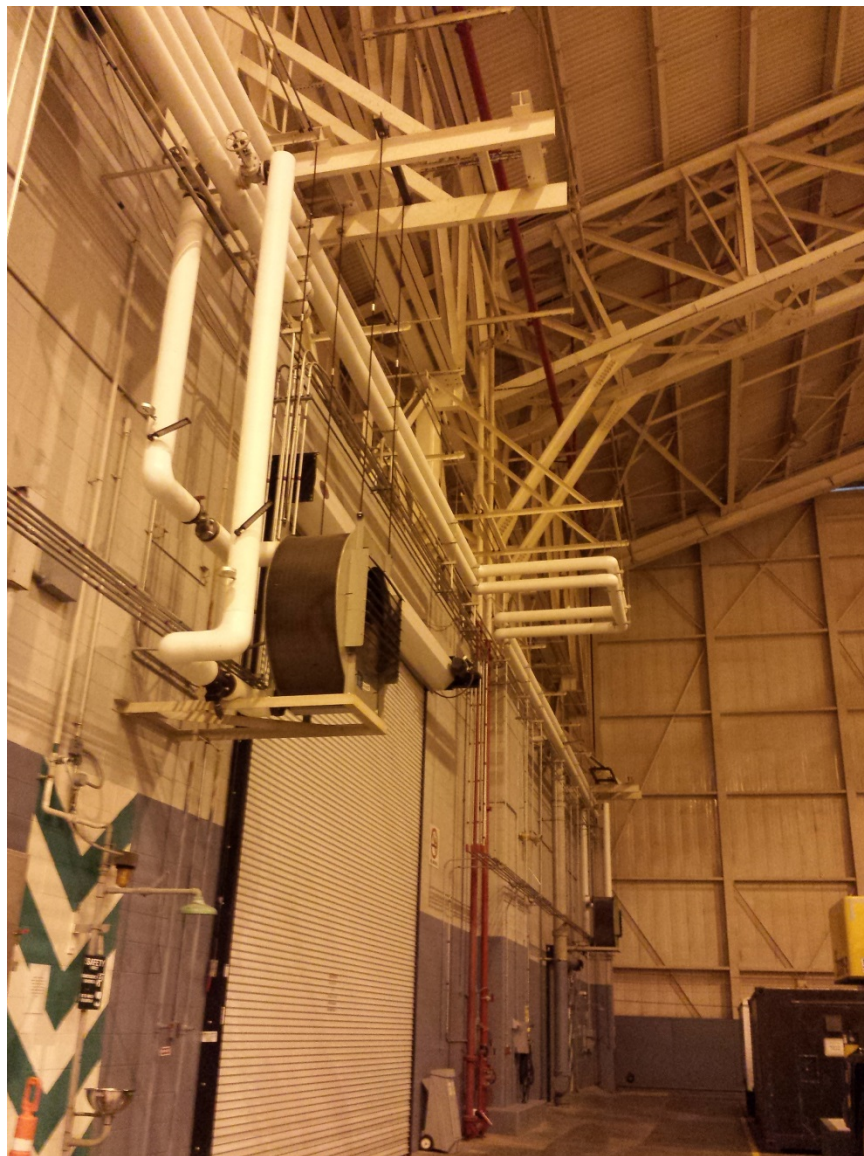
Photo 9: AFFF generators were formerly installed on the high beams in Hangar 100.

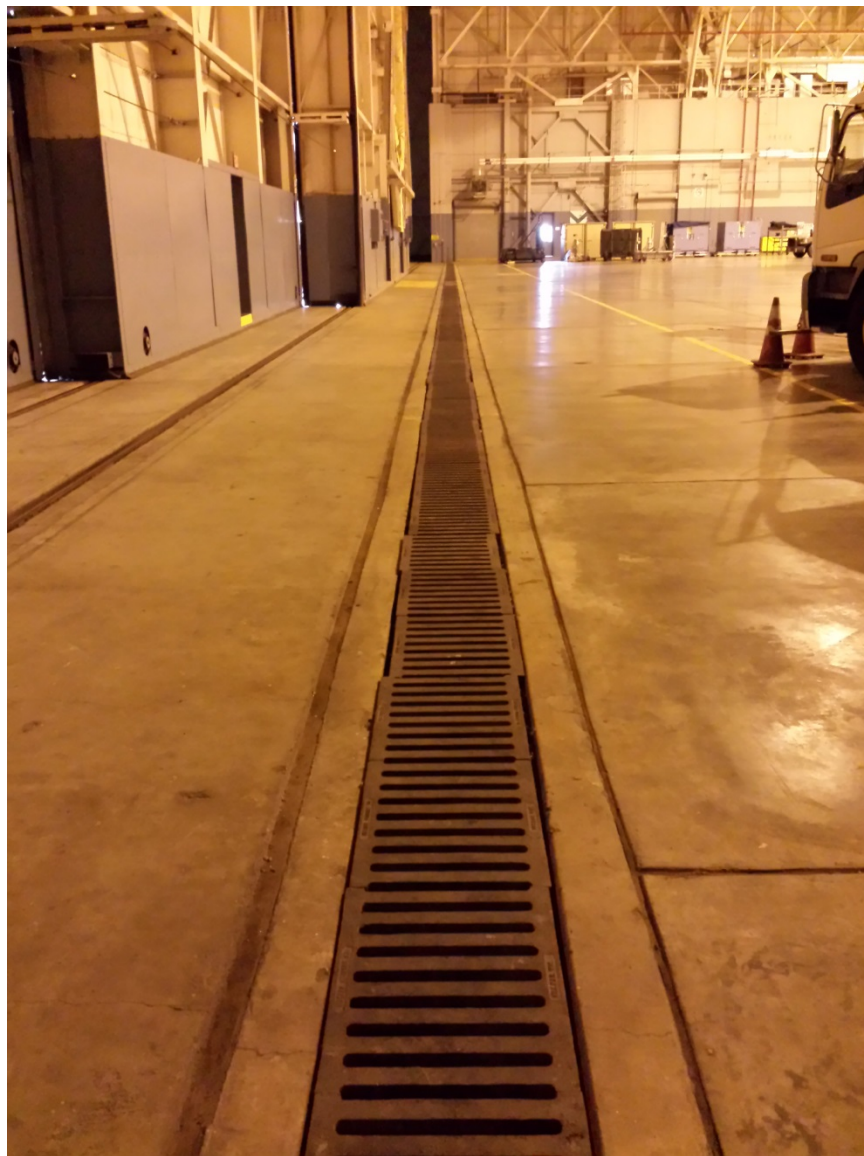
Operation of the AFFF fire suppression system (FSS) at Hangar 100 started in 1987 and continued until 2006, when the system was retrofitted for use of high expansion foam (HEF). Prior to removal, three AFFF supply tanks (unknown capacity) for the fire suppression system were located in the boiler room. It is not known if, or how often, fire suppression systems were tested. No records of accidental AFFF releases exist, but according to Base personnel, at least one accidental release occurred at Hangar 100. A 1990 article from The Sentinel (Appendix C-2) describes an AFFF spill from Hangar 100 that discharged directly into New Windsor's sanitary sewer system, generating plans to construct a second lagoon within the Retention Basin system. Any AFFF releases at Hangar 100 typically would enter the trench drain and building OWS through the industrial waste system and discharge to the Retention Basin (ANG, 2015) (see further discussion in Section 3.1.15). Hangar 100 construction drawings of the FSS conversion from AFFF to HEF are included in Appendix C-3.

Photo 10: Floor drains were present in Hangar 100.

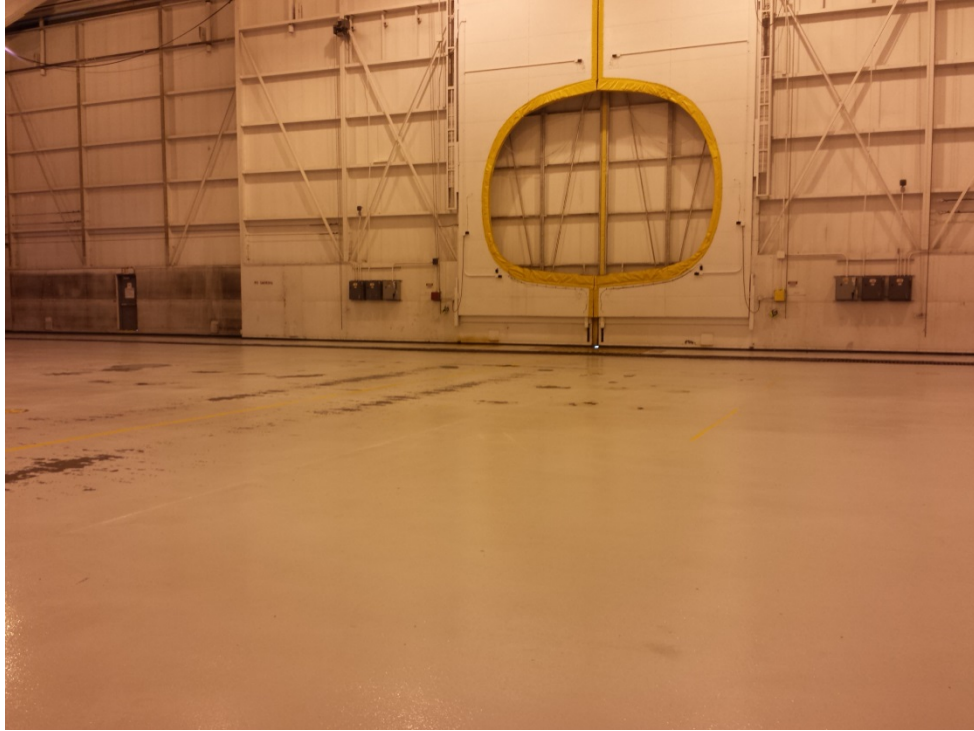
Photo 11: Floor drains were present at Hangar 102.

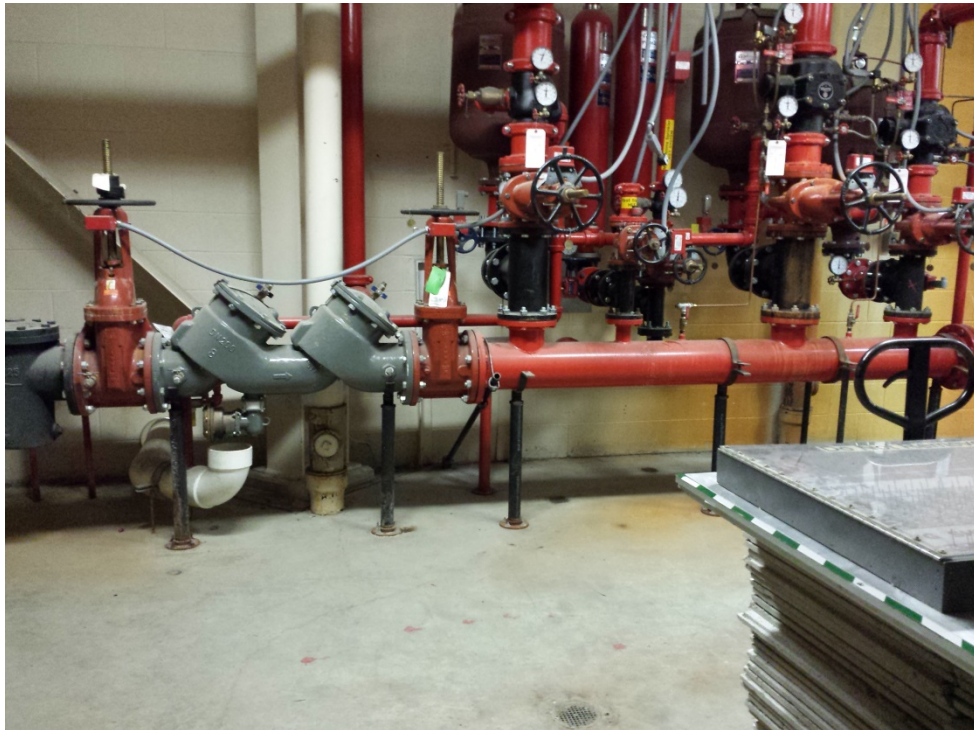
Operation of the AFFF fire suppression system at Hangar 102 started in 1988 and continued until 2006, when the system was retrofitted for use of HEF. The existing overhead foam generators were retained for reuse with HEF. Two AFFF supply tanks (1,800 gallons [gal] and 700 gal) for the FSS were located in the Electrical and Fire Protection Equipment Room (Room 115). Staining on the floor and walls was observed in Room 115 during the site visit, potentially due to an AFFF or HEF release (Appendix A, Photo 12). There are no floor drains in Room 115, but an overhead door is located near the FSS which may facilitate an outdoor release of foam if opened during FSS activation. No records of accidental AFFF releases exist. According to Base personnel, several accidental AFFF FSS activations occurred at Hangar 102 but never resulted in a full-system release. It is not known if, or how often, fire suppression systems were tested. Trench drains, located in the hangar bay, discharge to an OWS through the industrial waste system to the Retention Basin (ANG, 2015) (see further discussion in Section 3.1.15). Hangar 102 construction drawings of the FSS conversion from AFFF to HEF are included in Appendix C-3.

Photo 12: Staining on the walls and floor of the Electrical and Fire Protection Equipment Room in Hangar 102 was observed.

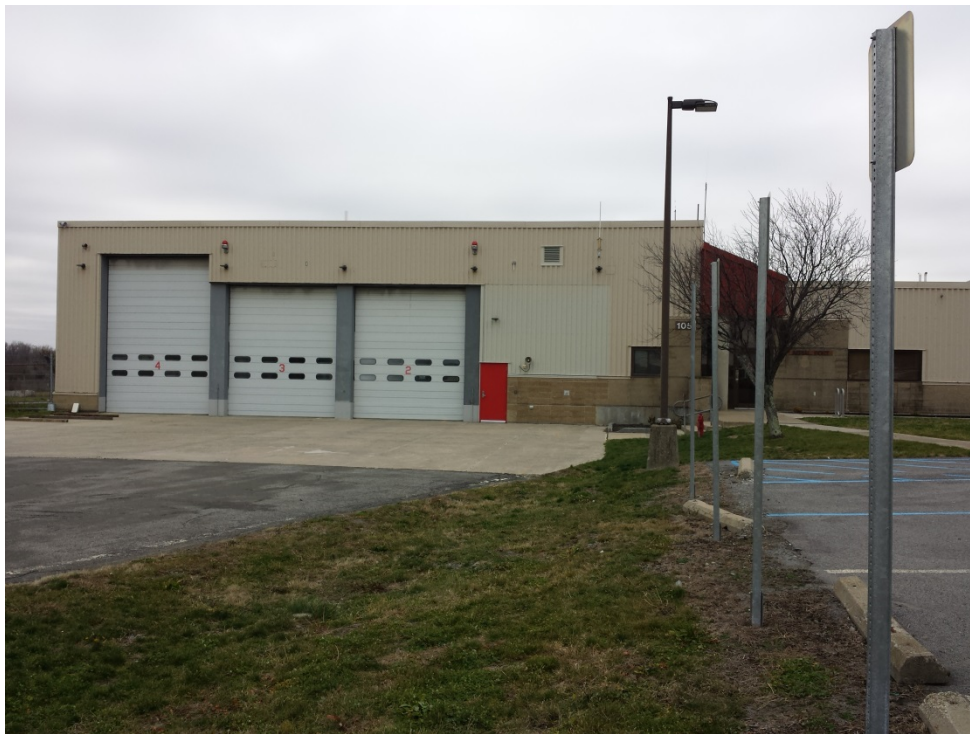
Photo 13: Looking west toward Building 105 (Former Fire Station).

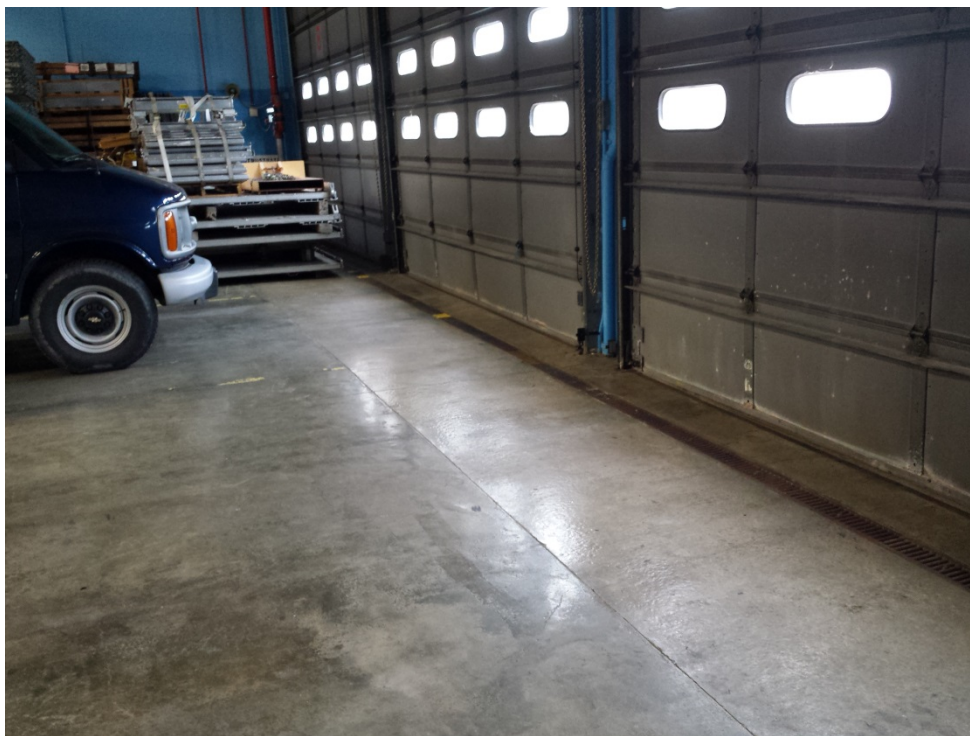
Prior to relocation to Building 104 in 2007, the FD was stationed in Building 105 (built in 1988). No known Base personnel were identified during the site visit that would have a recollection of AFFF handling and usage within Building 105, but practices are presumed to be similar to those of Building 104. Trench drains were located on either end of the truck bays, near the overhead doors. There are no known records or personnel knowledge of AFFF releases at Building 105. Any releases within Building 105 would have been captured by the trench drains, which discharge into the industrial waste line. It is not known if vehicle nozzle testing was conducted outside of Building 105 during FD occupancy.

Photo 14: Floor drains were present at Building 105 (Former Fire Station).

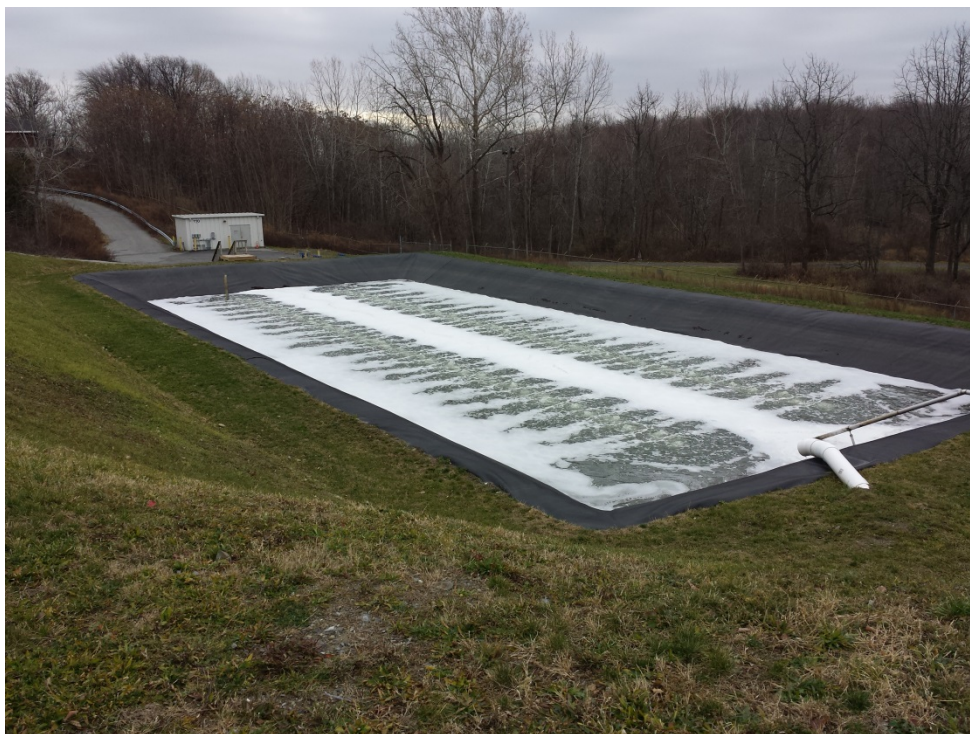
The Retention Basin is composed of two lined depressions, known as lagoons to Base personnel. The eastern lagoon was built in 1986 and the western lagoon was built in 1992. Both were relined in 2011. As discussed in Section 3.1.11, if a spill occurs or the storm water system is threatened with contaminants, drainage from the aircraft parking apron is redirected at the Diversion Valve Chamber and diverted to the Retention Basin. Additionally, all releases from Base buildings enter their respective OWSs prior to discharge into the Retention Basin via the industrial waste system. According to Base personnel, AFFF releases on the Apron may have been directed to Recreation Pond or to the Retention Basin; AFFF releases in the hangars were redirected to the Retention Basin and were either disposed off-site or trickled into the sanitary sewer system, as referenced by a 1990 news article (Appendix C-2).

Photo 15: Looking east toward the eastern lagoon (Retention Basin).

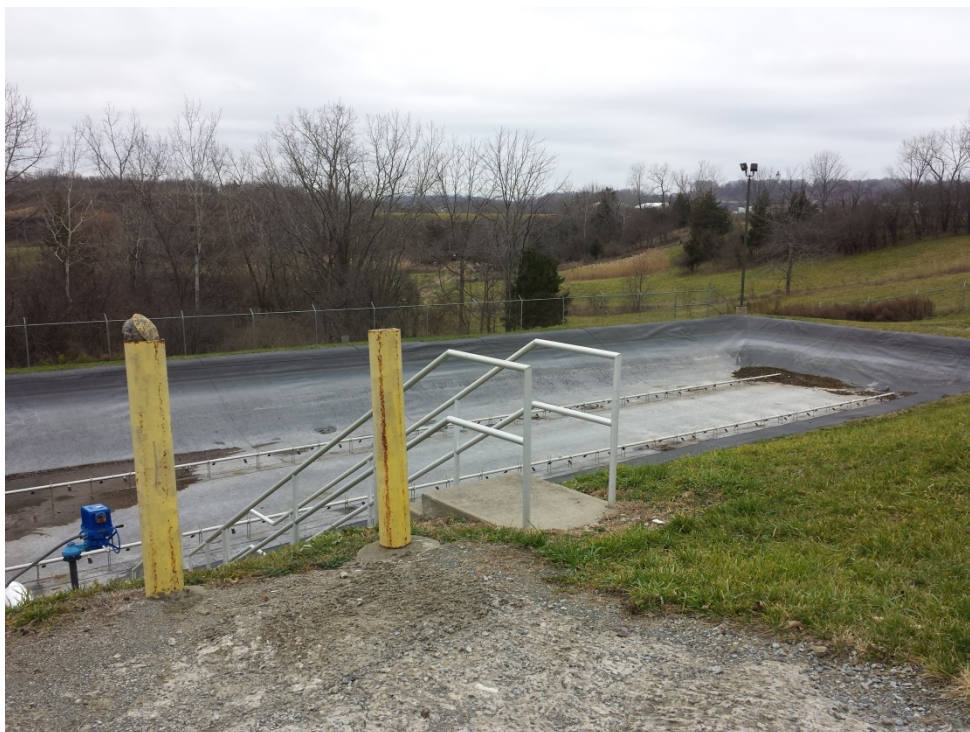
Photo 16: Looking south toward the western lagoon (Retention Basin).

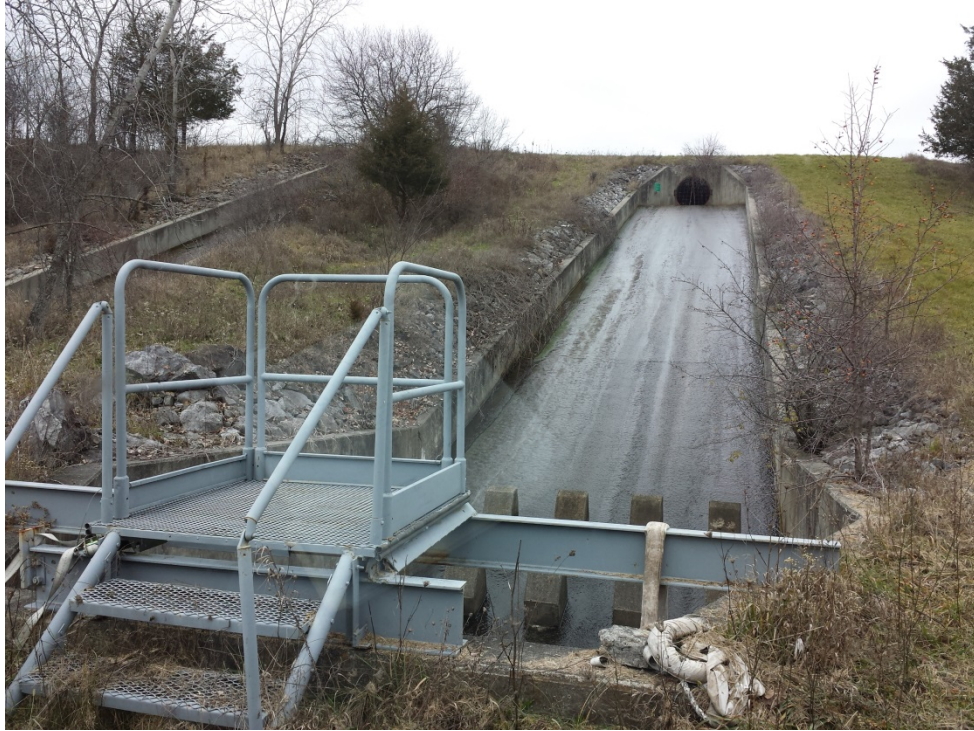
The drainage basins of the Base discharge through a network of in-ground conveyances and grass-lined ditches to the Recreation Pond or through several points along the eastern border of the Base. There are ten drainage basins that contain the industrial activities of the Base. These basins generally slope from northwest to southeast and are summarized below (ANG, 2015). Each drainage basin has an associated outfall. Drainage Basin 002 includes a portion of Building 101, Buildings 100,104, 200, 301, 302, 400 and Apron which drain through Outfall 002 (ANG, 2015).

Photo 17: Looking north toward Outfall 002.

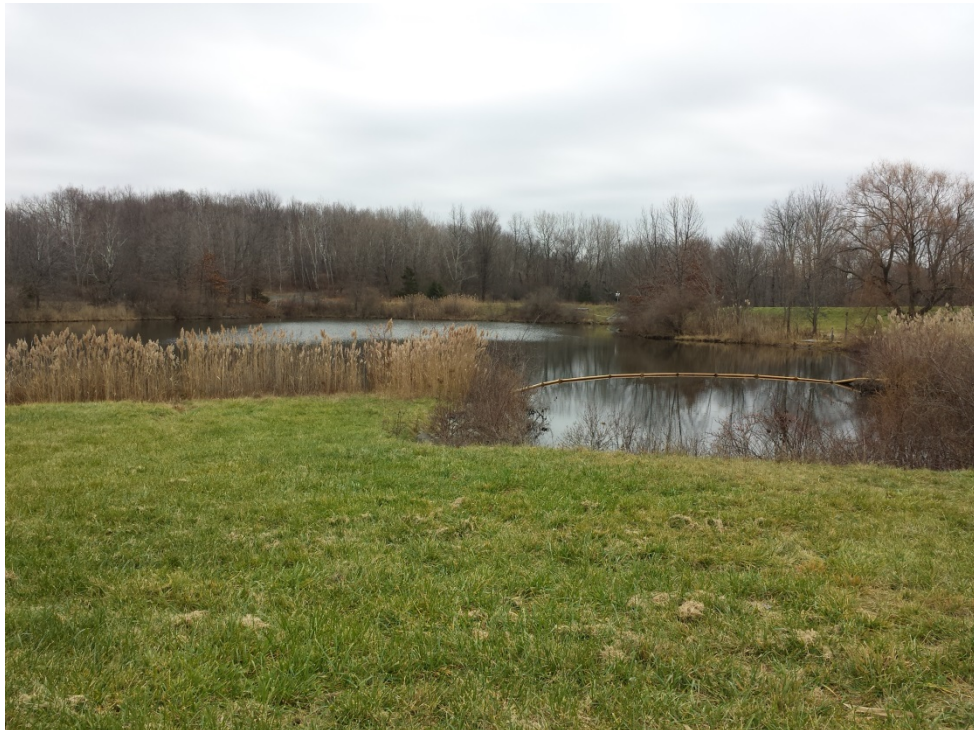
Photo 18: Looking south toward Recreation Pond, located south of the Base property boundary.

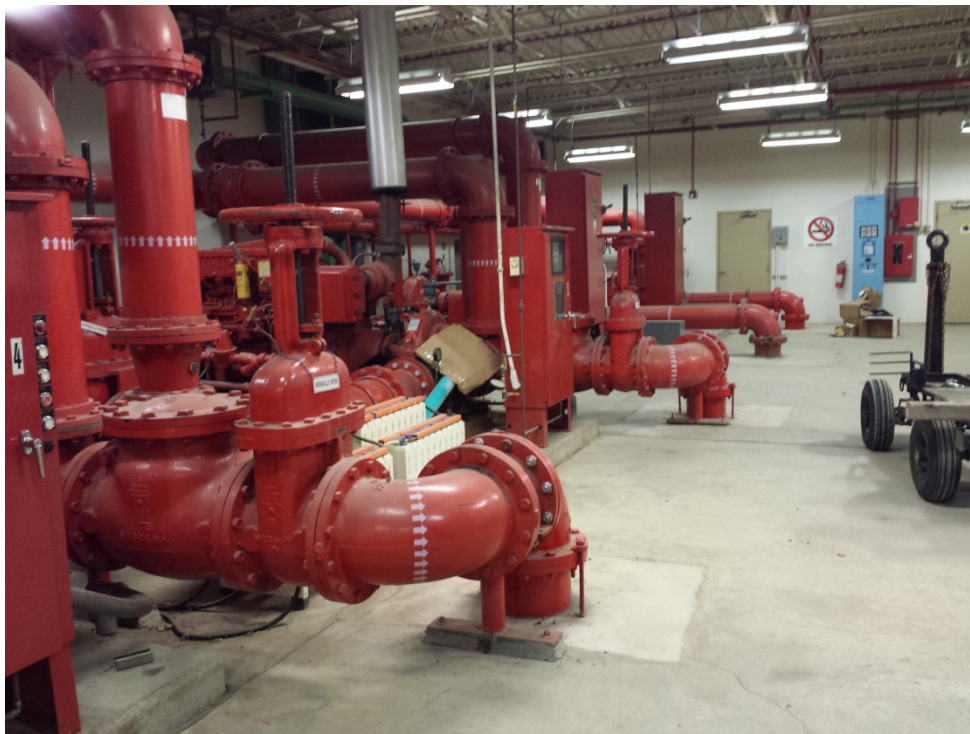
Building 108, built in 1988, was a historical AFFF storage location according to Base personnel. The dates and amounts of AFFF stored are unknown. No records of accidental AFFF releases exist. According to base personnel, there were no known spills. Building 108 floor drains discharge via the storm sewer system to Outfall 006.

Photo 19: Building 108 (Pump House). Floor drains were present.

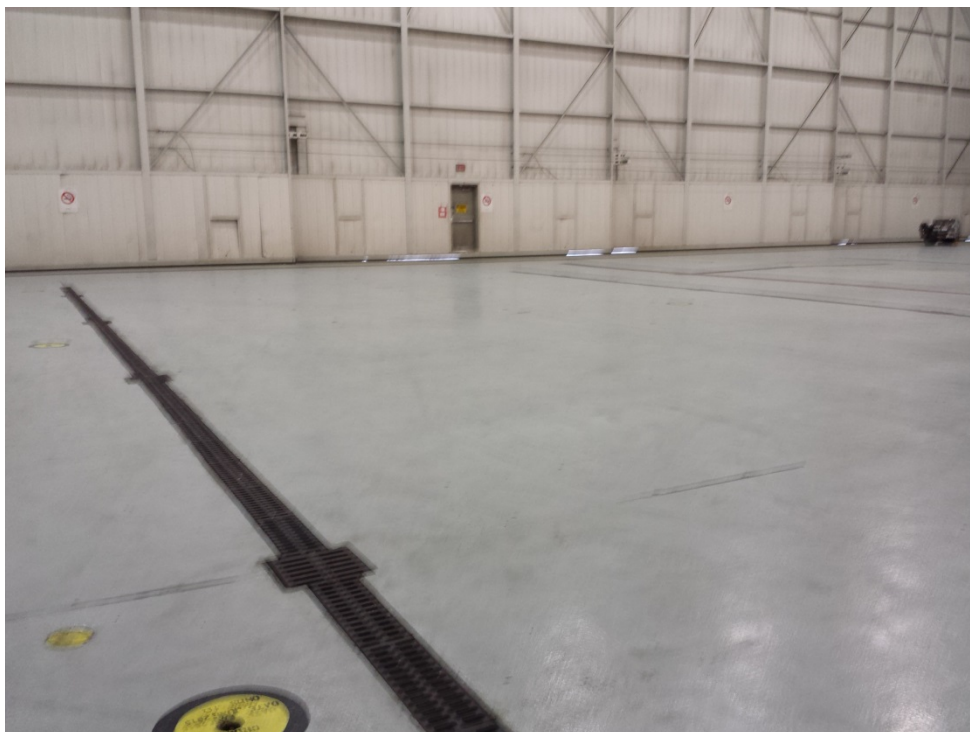
Operation of the AFFF fire suppression system at Hangar 301 started in 1992 and continued until 2004, when the system was retrofitted for use of HEF. Two 1,300-gal AFFF supply tanks were located in the Mechanical Room. It is not known if, or how often, fire suppression systems were tested. No records of accidental AFFF releases exist, but according to Base personnel, at least one accidental release occurred at Hangar 301. This maintenance facility is on the flight line and is used by the USMC MAG 49, Det B for maintenance of aircraft fuel cells and for the washing and corrosion control of aircraft. Trench drains in this hangar discharge to an OWS through the industrial waste system to the Retention Basin (ANG, 2015) (see further discussion in Section 3.1.15). Hangar 301 construction drawings of the FSS conversion from AFFF to HEF are included in Appendix C-3.

Photo 20: Floor drains were present in Hangar 301.

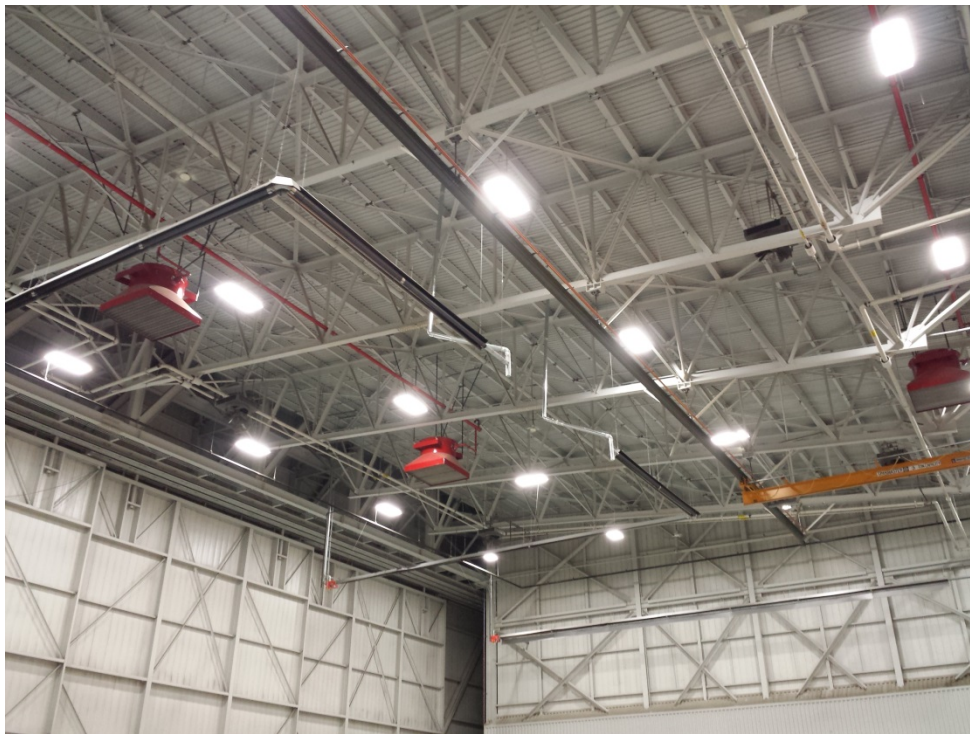
Photo 21: Current HEF FSS at Hangar 301.

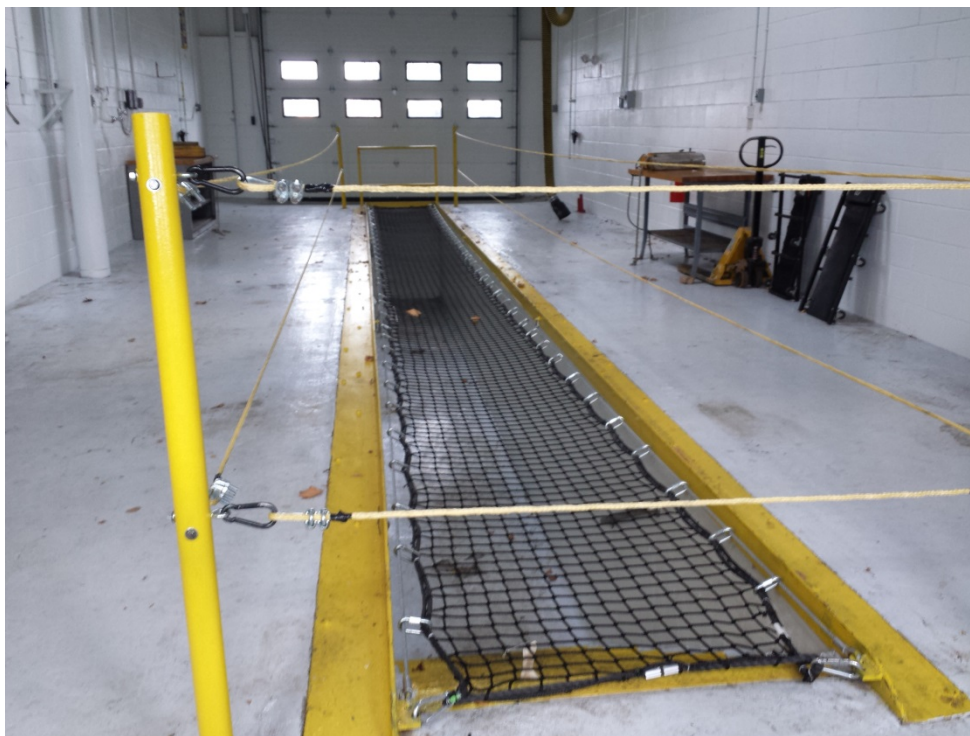
Building 200, built in 1988, consists of vehicle maintenance bays and a washrack. Maintenance bay floor drains lead to an OWS prior to discharge to the sanitary sewer system. During equipment washing at the washrack, a valve-operated trench grate system is opened and discharges flow to the sanitary sewer system via an OWS. Although there are no records or knowledge of known AFFF spills at Building 200, Base personnel indicated that spills may have occurred due to residual foam in the lines of FD vehicles.

Photo 22: Fire department vehicle maintenance is conducted in the pit bay within Building 200 (AGE Maintenance).
