Operation and Maintenance Report

Clarkstown Sanitary Landfill

January-December 2016

TITLE: Operation and Maintenance Report
Clarkstown Sanitary Landfill; January-December 2016

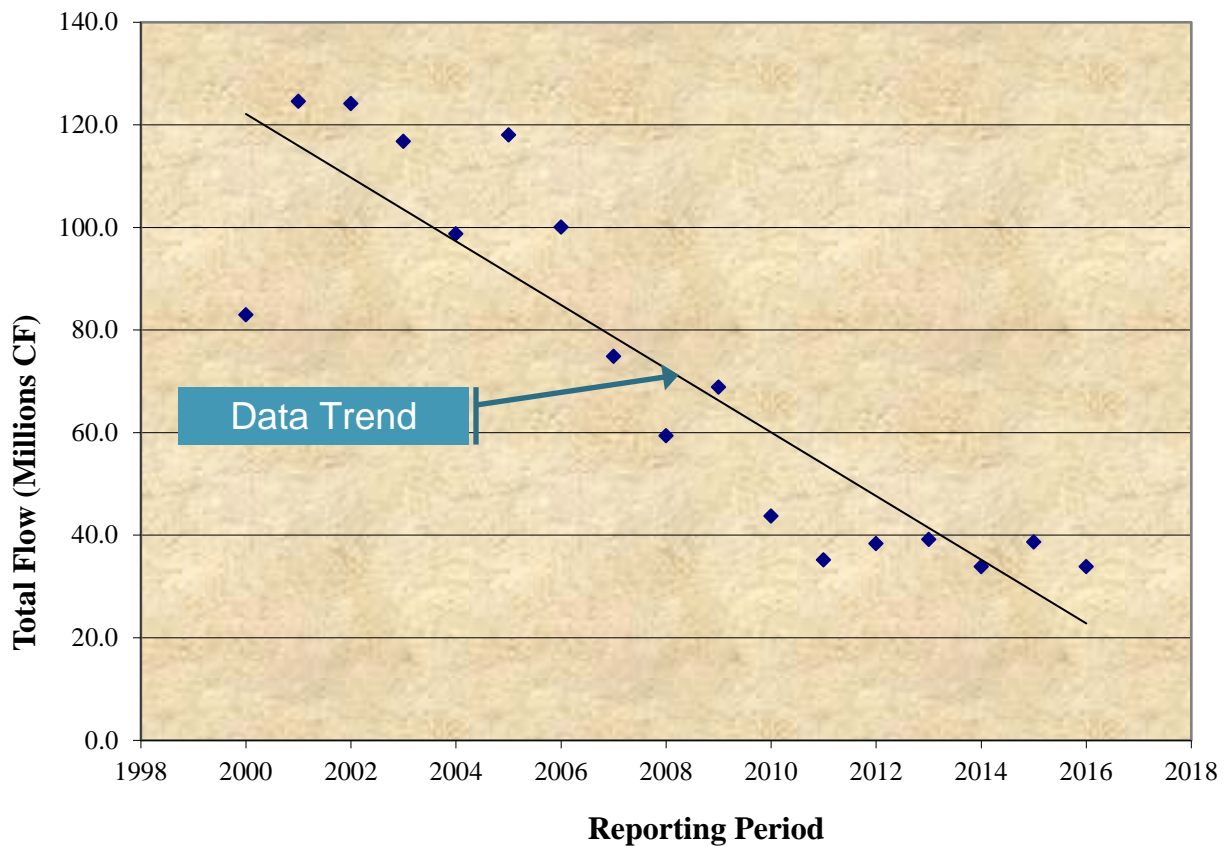
Graph 4-1: Gas Volume Extraction Trends

Graph 4-1 illustrates the volume of landfill gas removed on an annual basis. The graph illustrates the decreasing trend in the volume of gas removed from the Landfill over the past 17 years. The graph shows landfill gas removal has become asymptotic over the past six years. This is the typical and expected result of continued landfill gas removal.

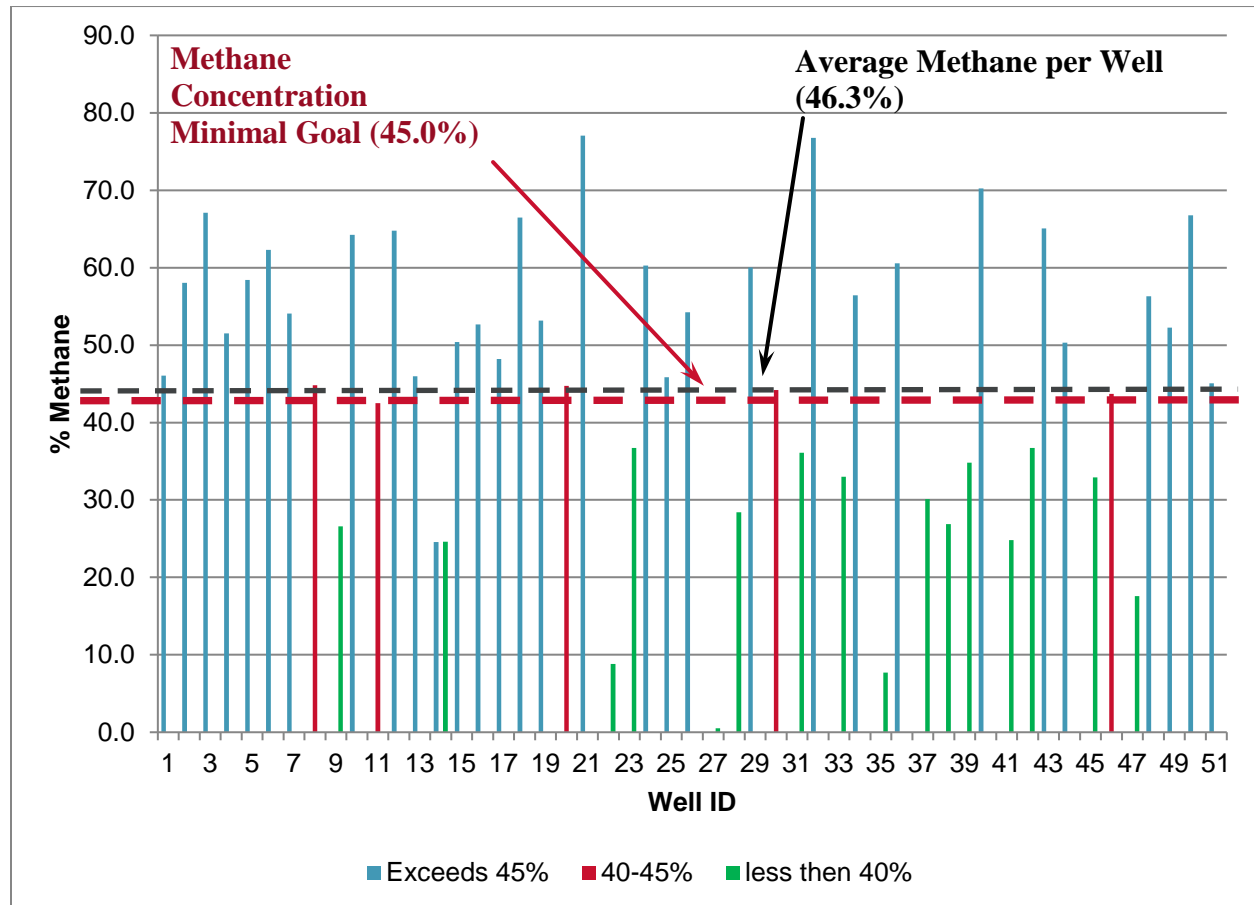
Graph 4-2 Average Methane Concentrations per Extraction Well

The average methane composition during this period was 46.3% (down from 47.1 the previous year) and the median was 47.2%. Twenty-one wells had an average methane concentration below the 45% methane goal. Five of the twenty-three wells were within 5% of the goal (>40%). The remaining eighteen wells had average methane concentrations less than 40%. Thirteen of the eighteen wells are located along the perimeter of the Landfill or low lying areas and diminishing methane is expected to be greater in these areas over time.

Over the past 15 years, the data suggest that the methane production along the perimeter of the Landfill is diminishing at a consistent rate. Despite limited flows (valve settings), methane production and accumulation along the Landfill perimeter remains low in concentration.

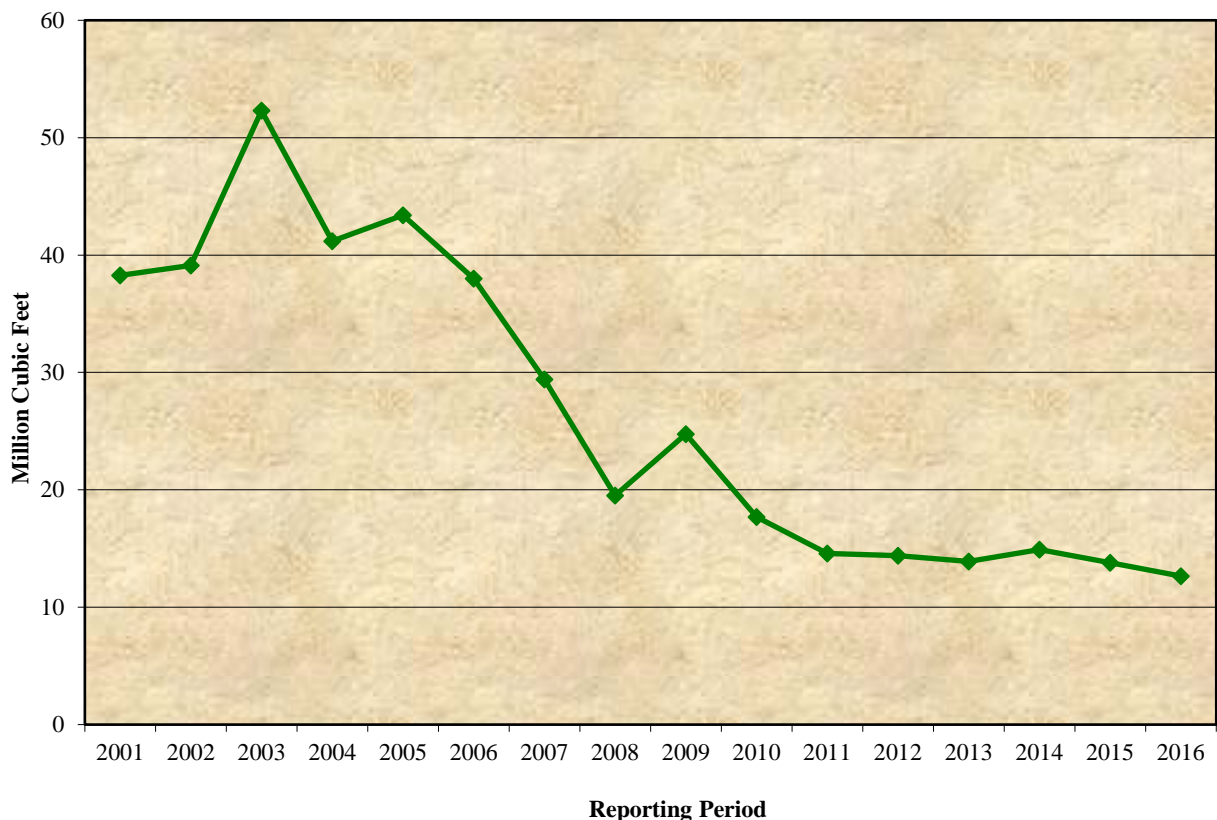
Graph 4-3 Annual Methane Removal over Time

The following graph (Graph 4-3) illustrates methane removal at the Landfill; it is an approximation based on field measurements. During the 2016 monitoring period, HDR estimates 13.8 million cubic feet of methane were removed. The graphs illustrate the decreasing rate of methane removal from the Landfill over the past 16 reporting periods. The graph also show the trends is approaching asymptotic conditions over the past six years.
