**From:** [Montroy, Brian](#)  
**To:** [Spellman, John \(DEC\)](#)  
**Cc:** [Christopher Wagner](#)  
**Subject:** 2021 Operation and Maintenance Report, Clarkstown Sanitary Landfill  
**Date:** Monday, March 7, 2022 10:49:31 PM  
**Attachments:** [Transmittal.pdf](#)  
[Operation and Maintenance Report 2021 DRAFT final.pdf](#)

Subject: 2021 Annual Landfill Gas Report

**PROJECT:**     **Clarkstown Sanitary Landfill; Landfill Gas Management**  
                  **Town of Clarkstown, Department of Engineering & Facilities Management**  
                  **West Nyack, New York**  
                  **NYSDEC Inactive Hazardous Waste Site No. 344001**

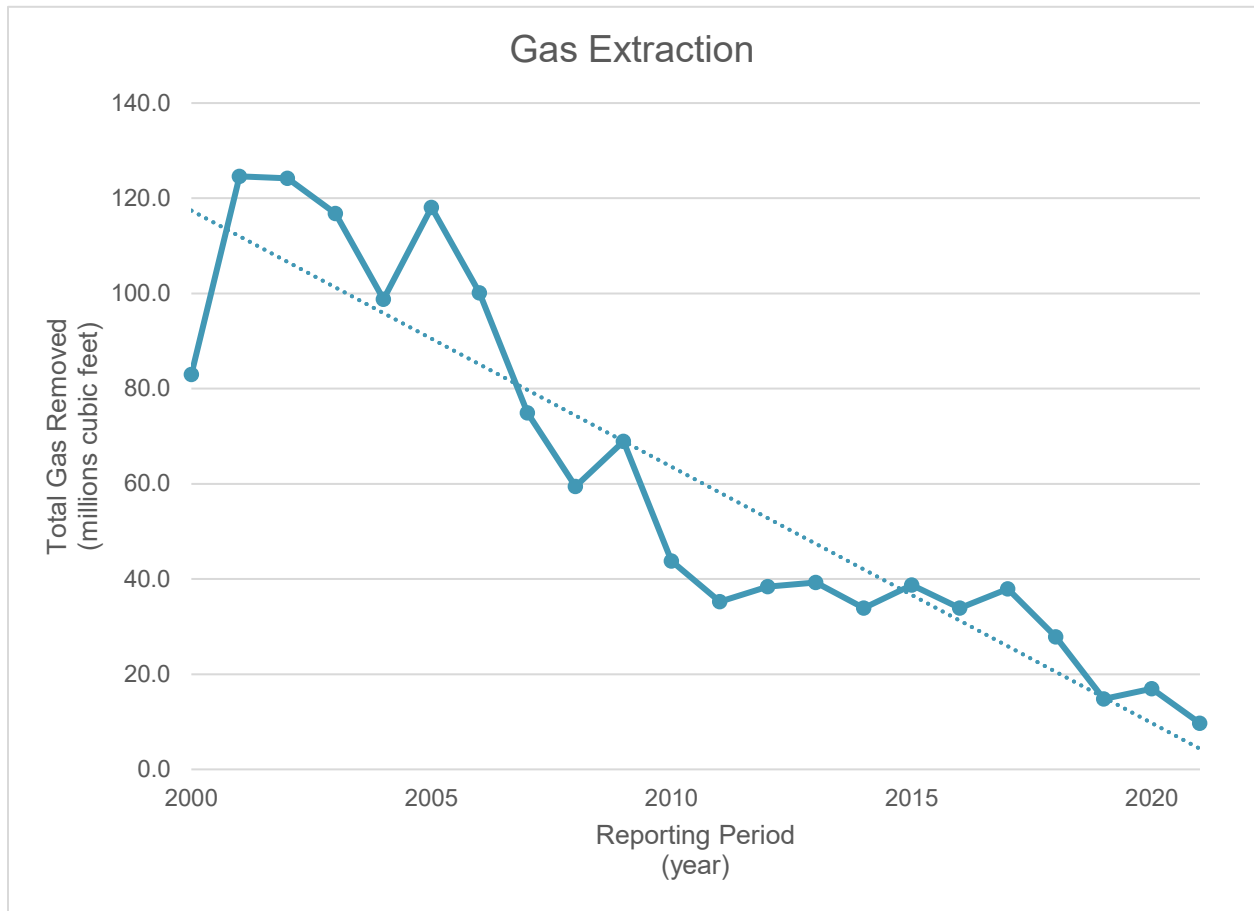
**Graph 4-1: Gas Volume Extraction Trends**

Graph 4-1 illustrates the volume of landfill gas removed on an annual basis. The graph illustrates a decreasing trend in the volume of gas removed from the Landfill over the past 19 years. This is the typical and expected result of continued landfill gas removal. 4-1: Volume of Condensate Removed from Drip Legs

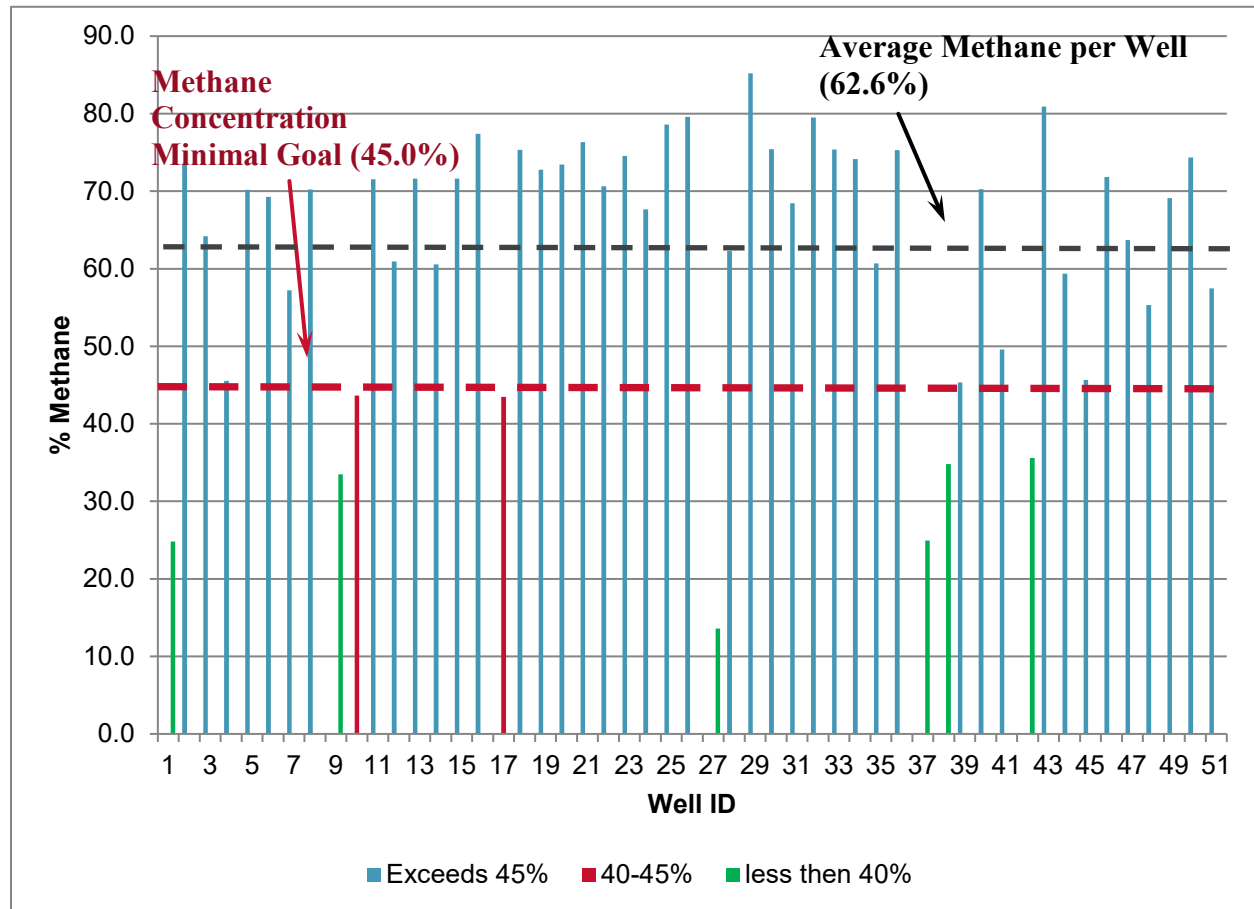
**Graph 4-2 Average Methane Concentrations per Extraction Well**

The average methane composition during this period was 62.6% (up from 53.09% the previous year). Forty-Four wells had an average methane concentration above the 45% methane goal. two of the fifty-two wells were below the goal (>45%) but within 5% of it. The remaining six wells had average methane concentrations less than 40%. five of the six wells are located along the perimeter of the Landfill or in low lying areas. Diminishing methane levels are expected in these areas and data from the last 20 years, which show a reduction in methane production along the perimeter, confirms this. Methane production and accumulation along the Landfill perimeter remains low despite limiting the flow using valve settings.

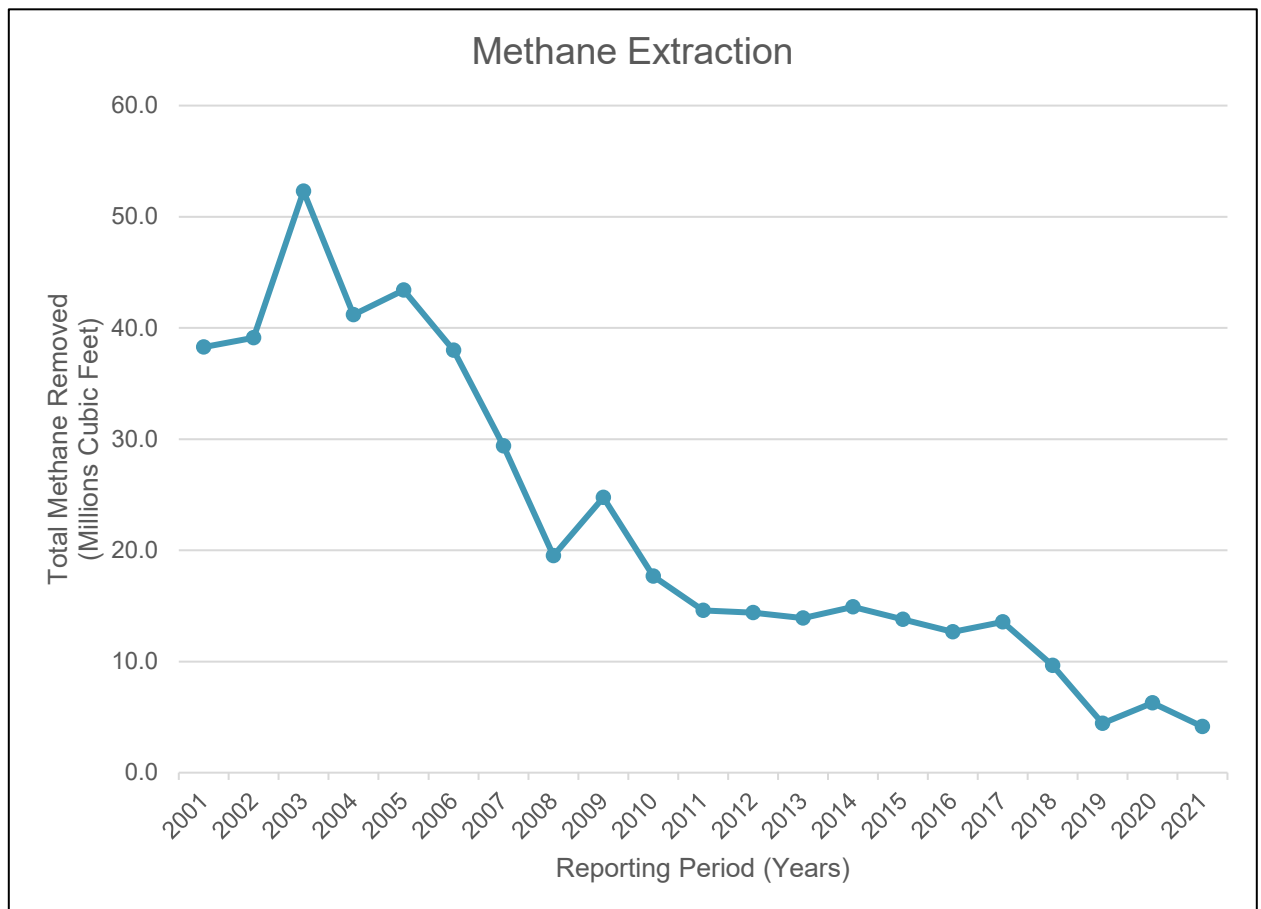
**Graph 4-3 Annual Methane Removal over Time**

Graph 4-3 illustrates annual methane removal at the Landfill as an approximation based on field measurements recorded during monthly O&M events. An estimated 4.1 million cubic feet of methane were removed during the 2021 reporting period. The graph illustrates the decreasing rate of methane removal from the Landfill over the past 20 reporting periods.

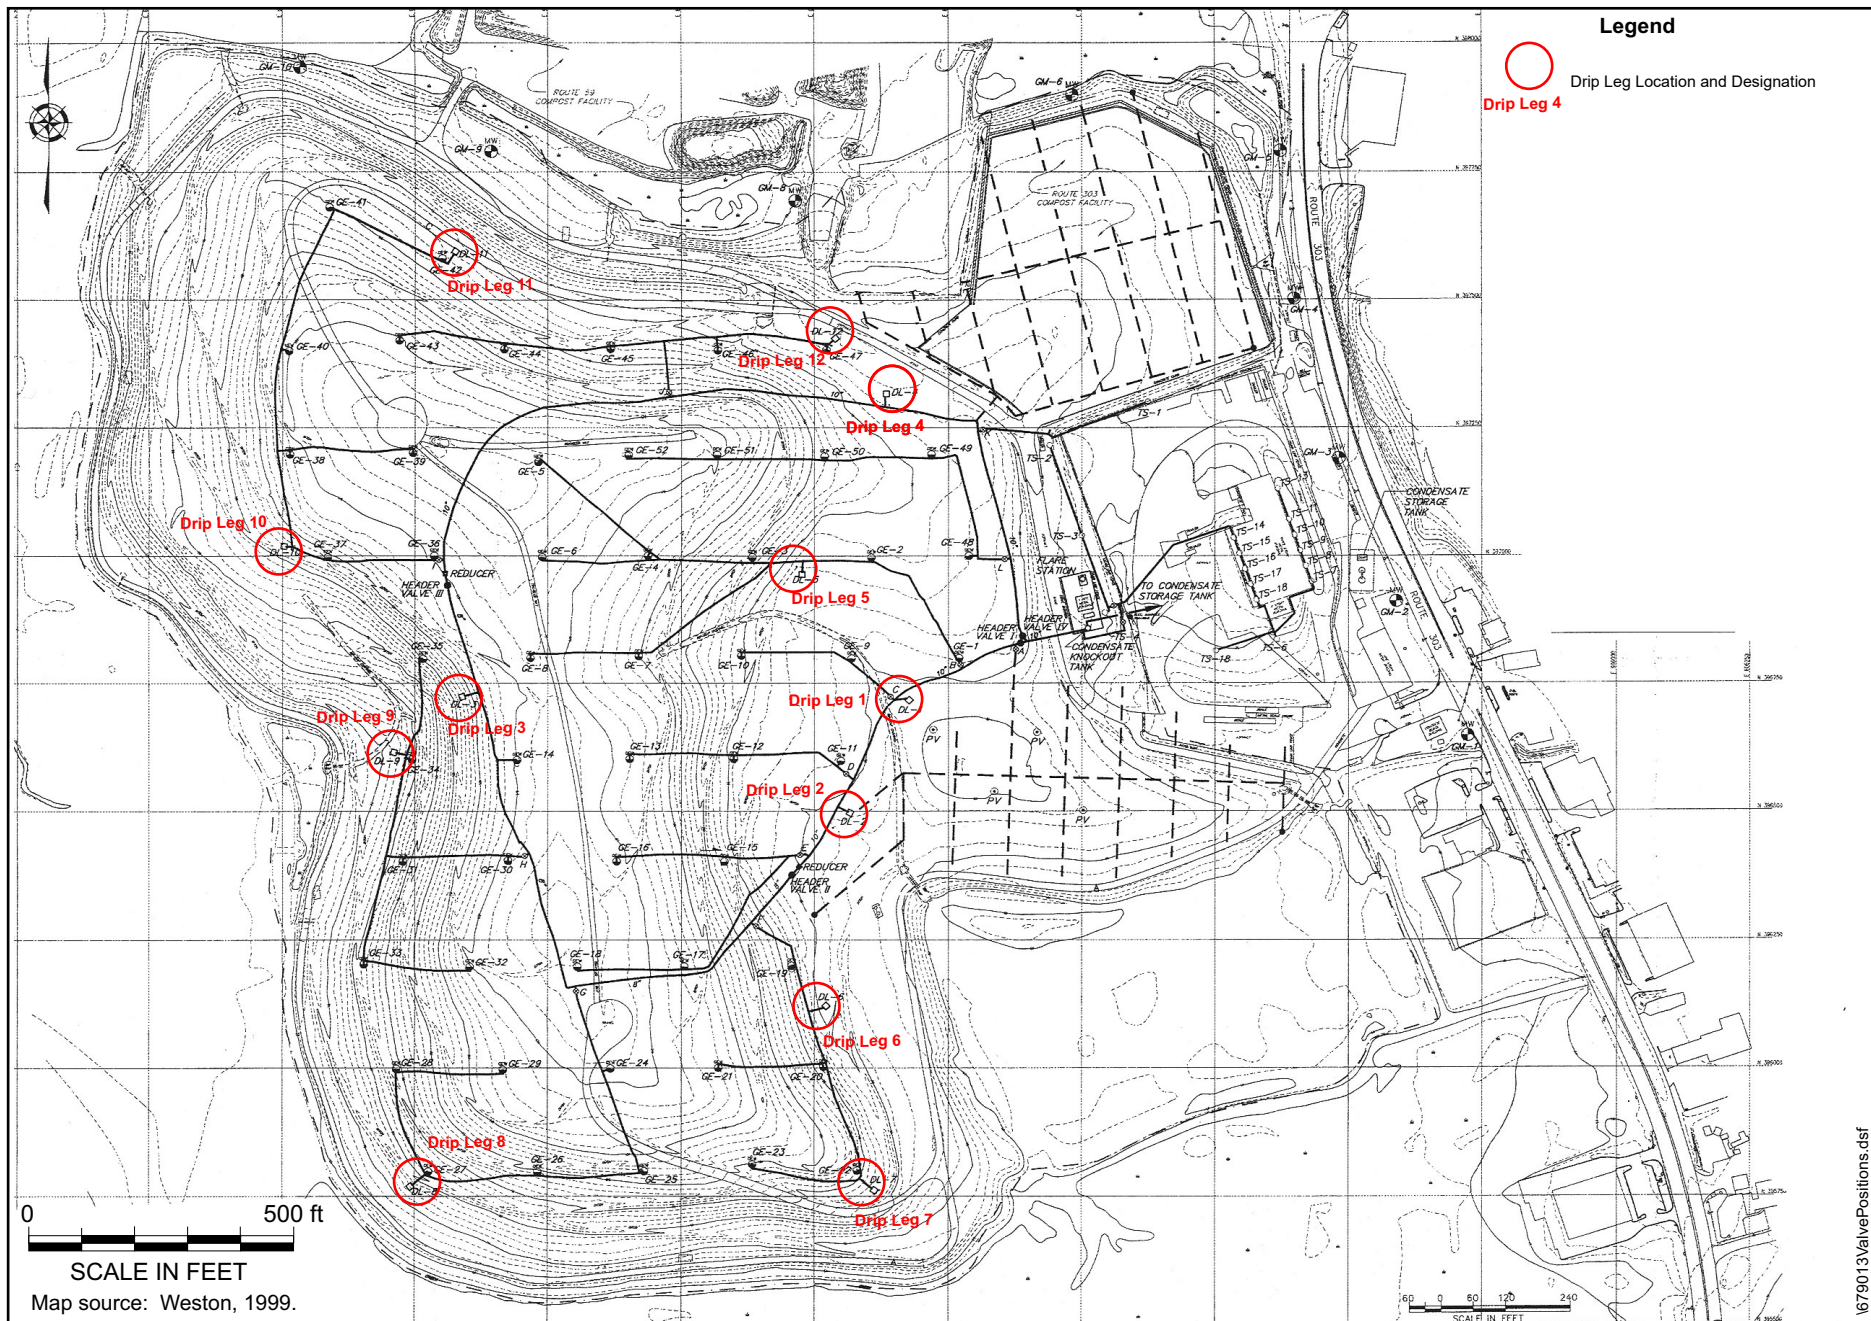
**Figure 5**

There are 12 drip leg assemblies (Figure 5) located at the Landfill. Some areas along the gas collection piping experience restrictions in air flow caused by the accumulation of condensate in low lying areas of the gas collecting piping. These locations are near Drip Leg (DL) 1 and DL-5 and to a lesser extent DL-10. Starting during the 28 June 2021 O&M event a 2" PVC drip leg located adjacent to GE-09 was also checked. These areas are inspected/monitored, and condensate is removed during monthly site visits. It should be noted that it is common for condensate to accumulate and landfill gas lines and these issues are not unique to this landfill.

At each restricted location, the collection leg was tapped and fitted with a pipe-sleeve and tee. A PVC riser pipe and valve were connected to this sleeve/tee. The modification to the Landfill collection pipe is used exclusively to remove condensate. During each monthly site visit, each location was inspected for the presence of condensate (positive vs. negative pressure). If positive pressure or minimal negative pressure is noted, condensate is removed by utilizing a submersible or peristaltic pump which has proven to be highly effective in removing the condensate plugs in the collection pipe.

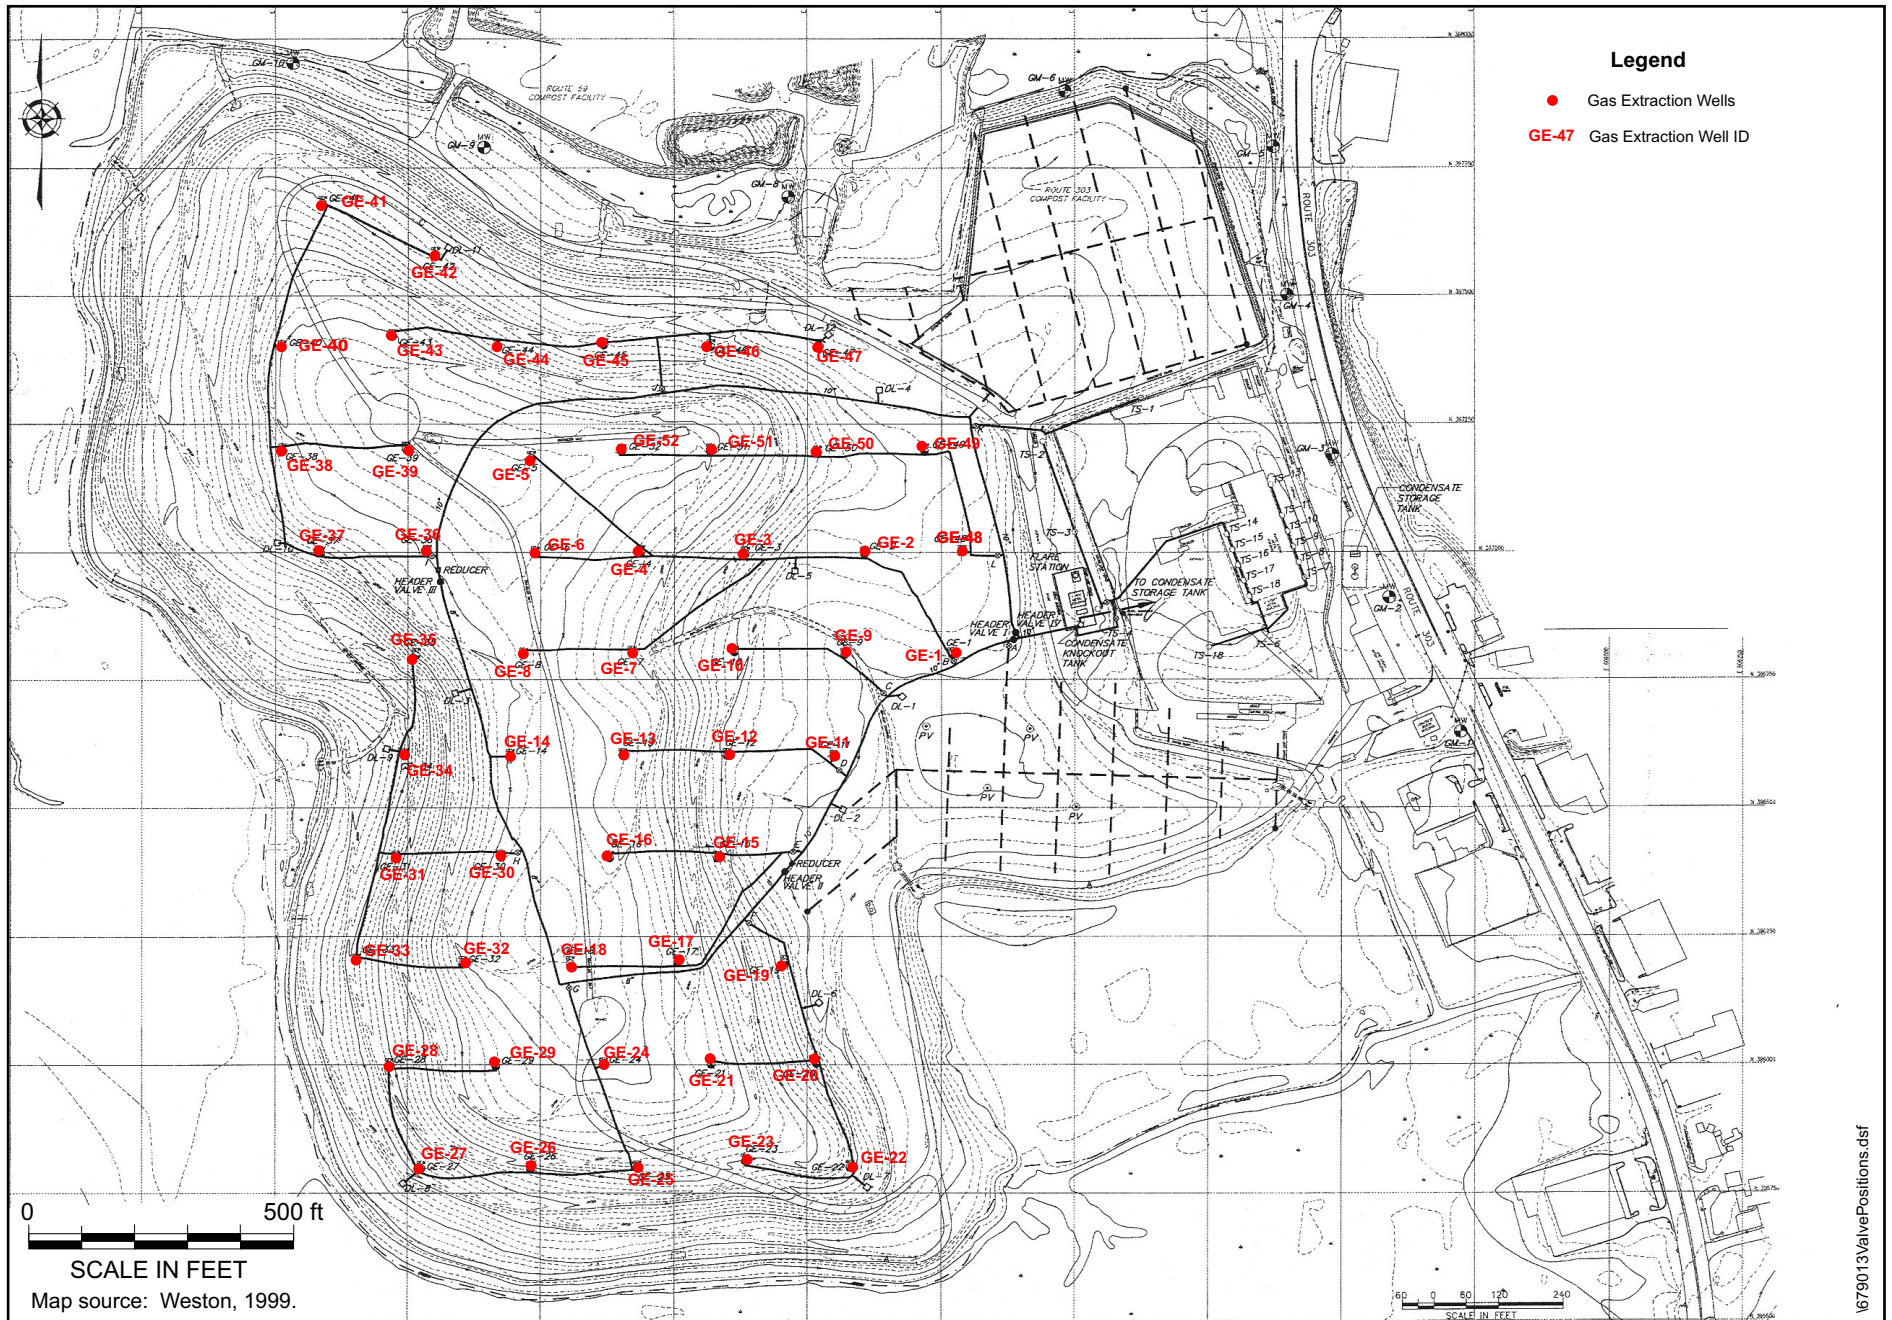
Figure 6

The 52 LFG extraction wells (Figure 6) were inspected during monthly site visits. Gas extraction well monitoring, and inspections of each well were conducted to identify potential leakage, liquid pooling, and hazardous methane conditions in the surrounding area. Deficiencies noted during the monthly inspections were reported on Form DP-1, which are included as Appendix B.

Settlement of the well head vaults is an ongoing issue at the Landfill. The Town, in conjunction with HDR has evaluated the well head construction and design and has retrofitted LFG extraction wells and vaults at 35 locations with new QED® Accu-Flo well heads, located above grade. This new design eliminates the slip/trip/fall hazard which was associated with settlement of the old vault system. Additionally, the new well heads are clearly visible and easily accessible. The new well head design also allows differential pressures to be measured. These measurements allow HDR to calculate the flow rate at the wells that have been retrofitted.

Seventeen LFG extraction wells and associated valves have not yet been retrofitted. These vaults are constructed of heavy-duty fiberglass. Over the years, some of the vaults exhibit minimal to moderate amounts of damage around the lip of the vault and/or the vault covers. This damage is cosmetic and does not affect the performance or operation of the LFG collection piping or wells.

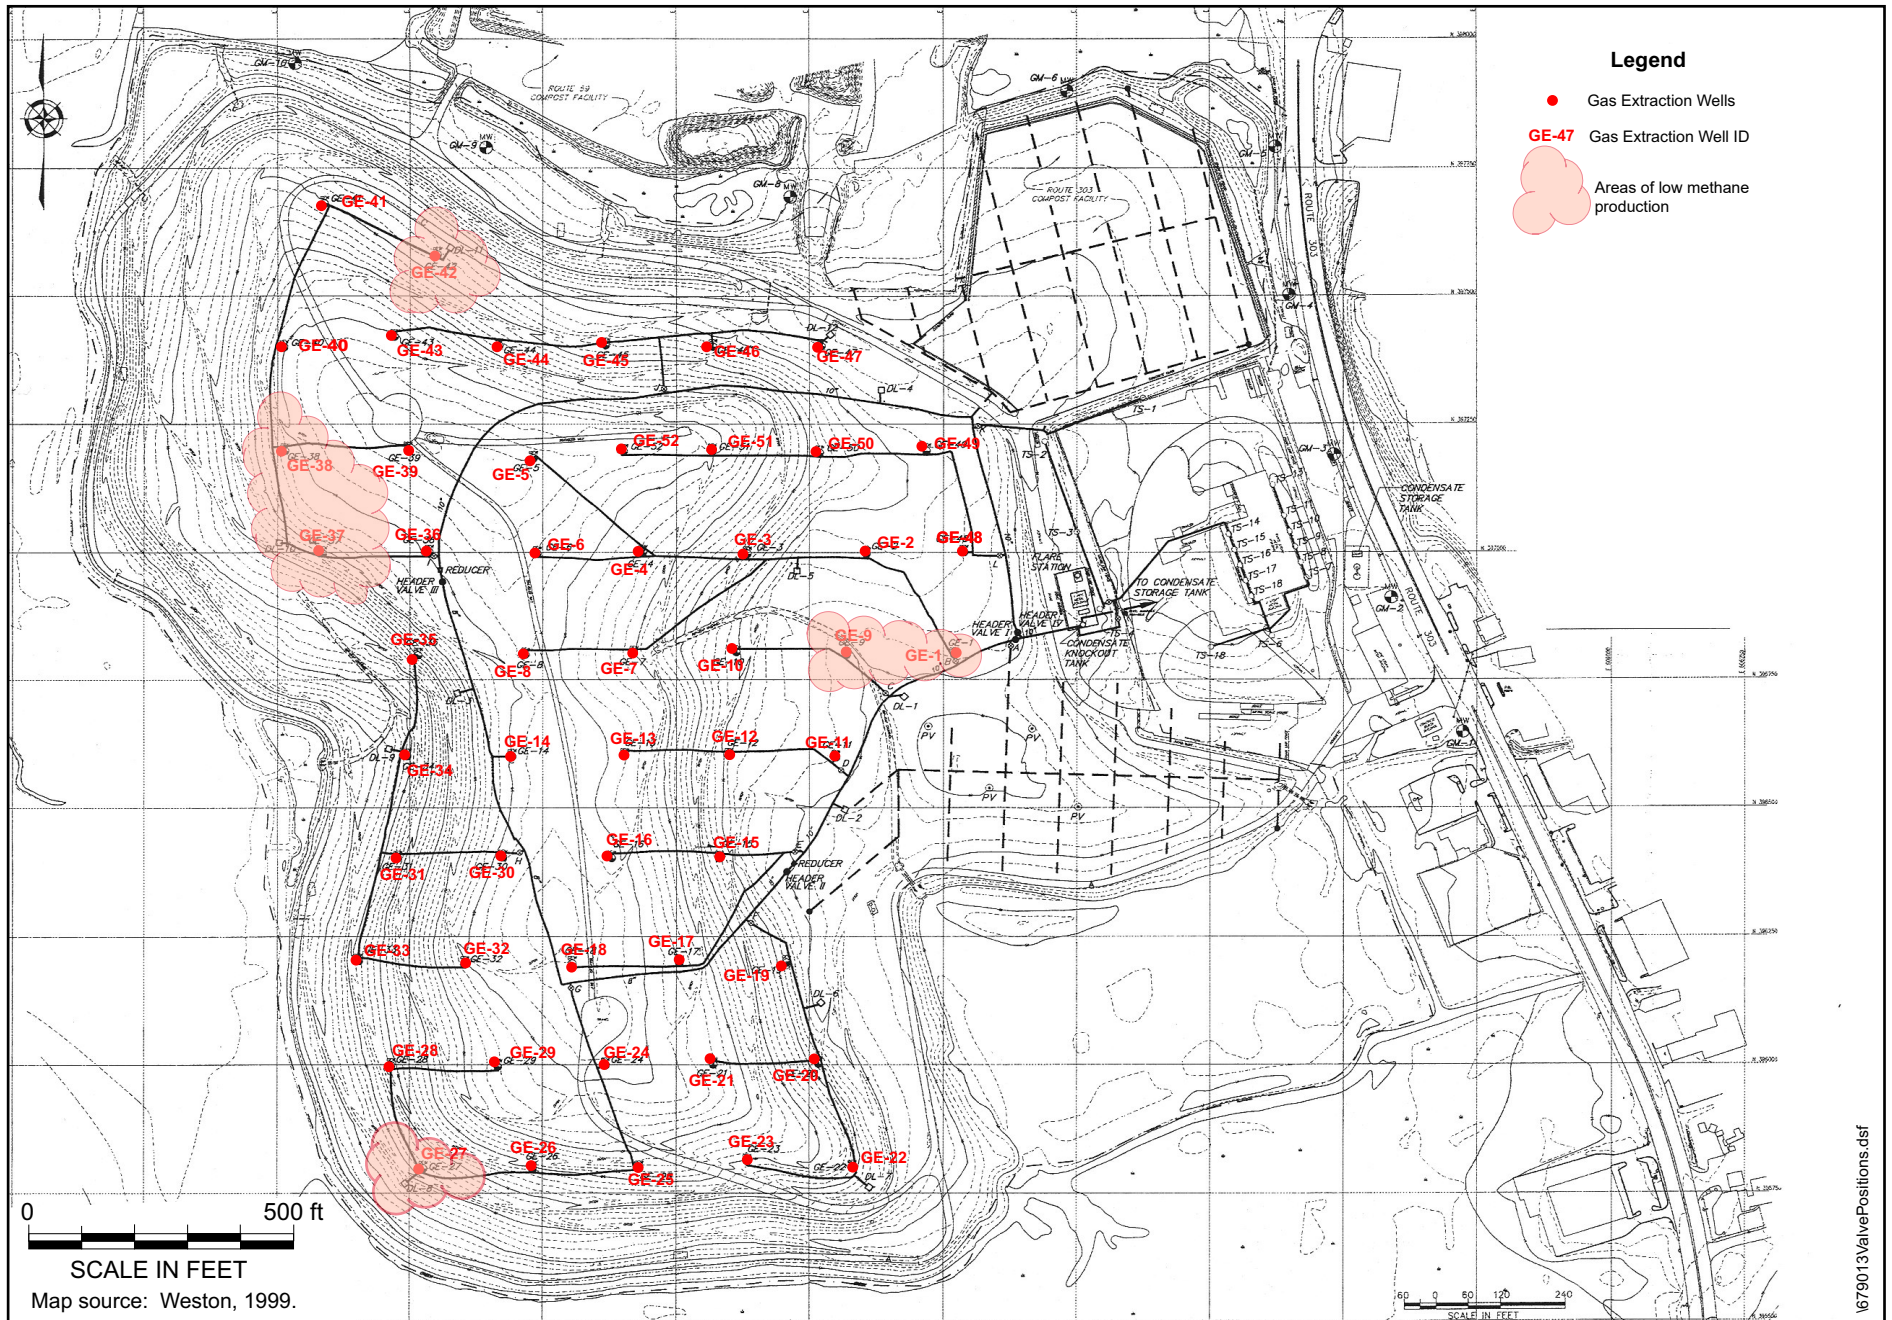
Figure 8

It was also observed during the reporting period that the historic area of low methane production located on the northwest side of the landfill (Figure 8) has now split forming two areas of low methane production. It was also reported that a small area along the east side and the southwest corner of the landfill also showed low methane production during the reporting period. It is not clear why methane production in this area have changed in 2021 operational year but monthly well balancing will continually be adjusted as necessary to account for these fluctuations.
