Operation and Maintenance Report

Clarkstown Sanitary Landfill
Period - January-December 2023

West Nyack NY

PROJECT: Clarkstown Sanitary Landfill; Landfill Gas Management

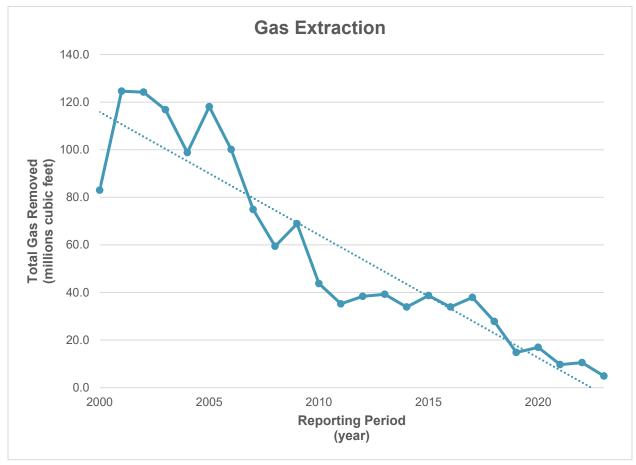
Graph 4-1 illustrates the volume of landfill gas removed on an annual basis. A decreasing trend in the volume of gas removed from the Landfill over the past 22 years is observed. This is the expected result of continued landfill gas removal.

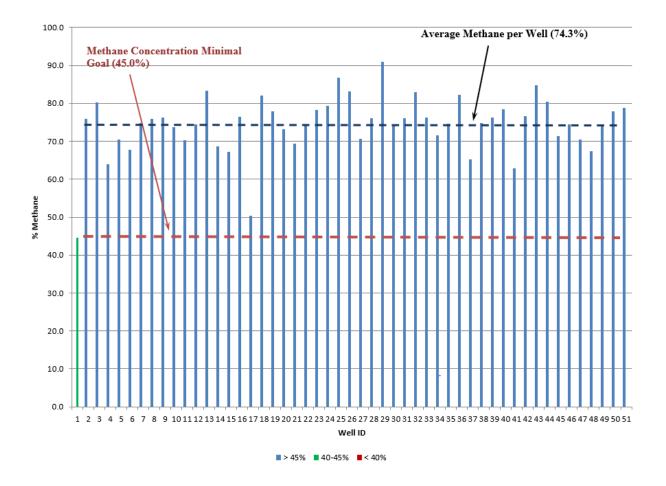
Graph 4-2 Average Methane Concentrations per Extraction Well

The average methane composition during this period was 74.3% (up from 67.5% the previous year). 51 wells had an average methane concentration above the 45% methane goal. One of the fifty-two wells were below the goal (>45%) but within 5% of it. Diminishing methane levels are expected in these areas and data from the last 20 years, which show a reduction in methane production along the perimeter, confirms this. Methane production and accumulation along the Landfill perimeter remains low despite limiting the flow using valve settings.
