NEW YORK STATE DEPARTMENT OF ENVIRONMENTAL CONSERVATION  
DIVISION OF HAZARDOUS WASTE REMEDIATION  
INSPECTOR'S DAILY REPORT

| Site Code No. <u>344004</u> | Date <u>6-4-01</u> | I.R. No. <u>13</u> | |
| Site Name: <u>Ramapo L.F.</u> | Sheet <u>1</u> of <u>2</u> | AM | PM |

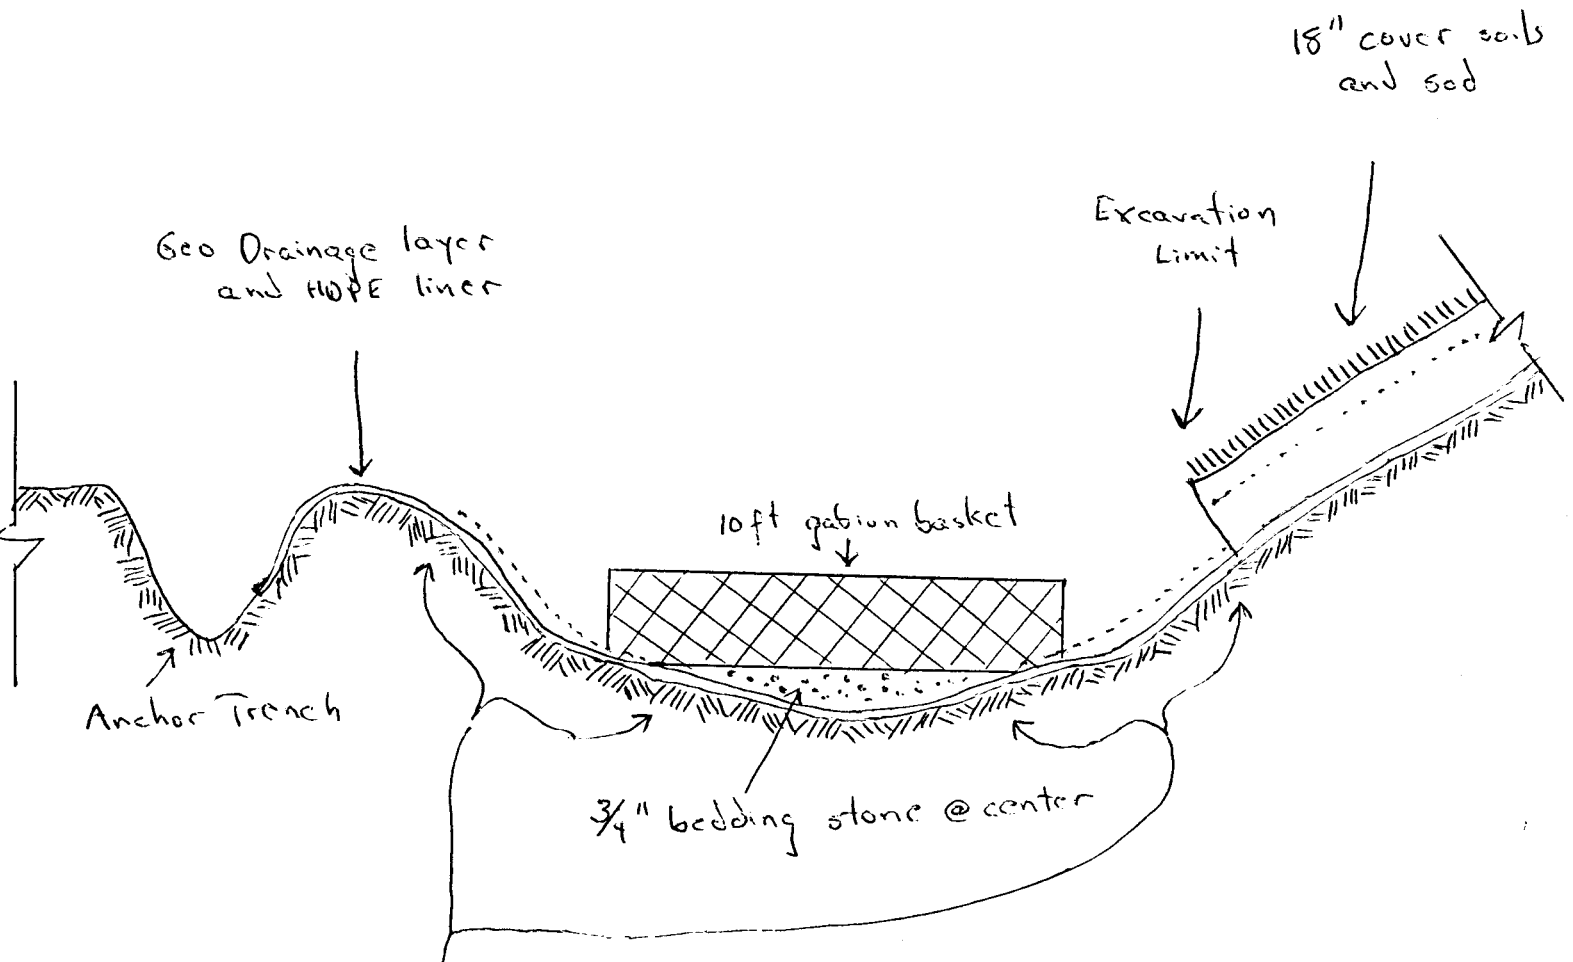
Drwg #7 Typical Revised Channel #1 Detail

→ ① Installation of gabion baskets without 1ft bedding material shown on approved drawings. One layer of 16 oz fabric has been substituted. May result in damage to liner at channel #1.

Areas where fabric substituted for 12\" 3/4 stone bedding

(Gabion basket "wings" to be installed)  
in these areas too
