Subject: Town of Ramapo Landfill
USEPA 3rd 5-Year Review Report (December 2009)
STERLING File #20010 – Task 402 Monitoring Well Survey

MONITORING WELL SURVEY
JULY 1 & 2, 2010
TOWN OF RAMAPO
RAMAPO LANDFILL

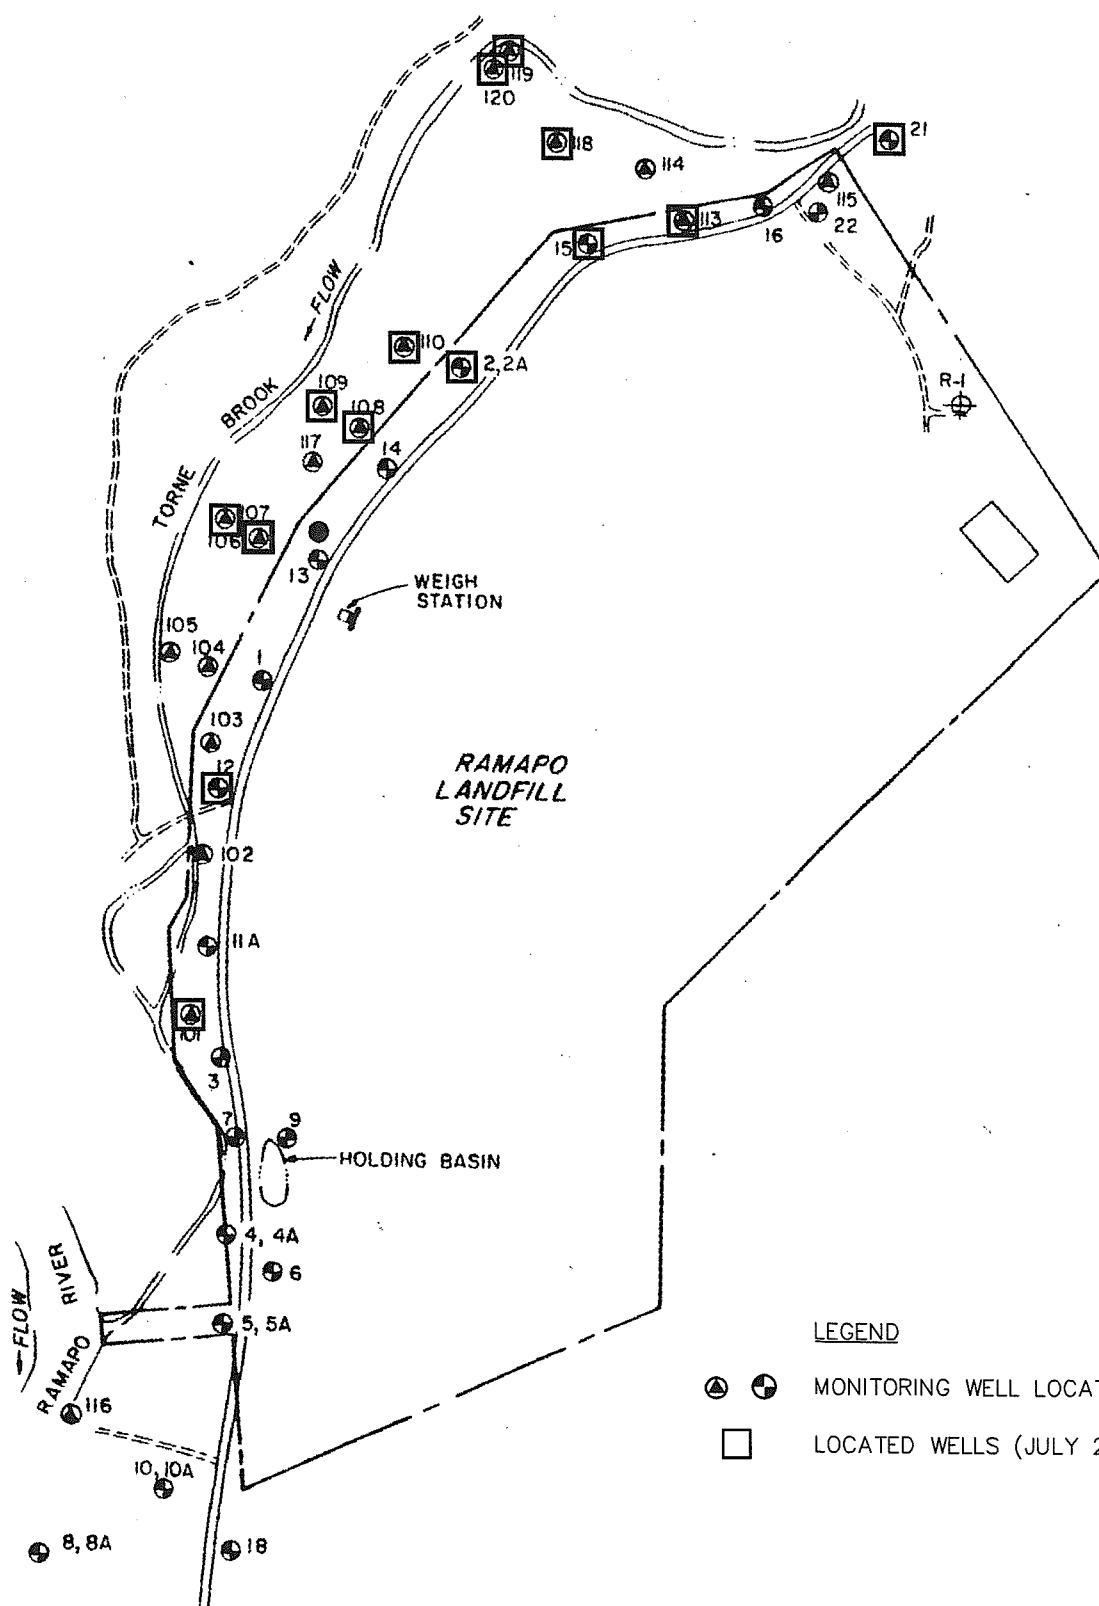
FIGURE 1

STERLING located and inspected fourteen (14) monitoring wells. The located monitoring wells are identified on Figure 1. Located wells (listed from north to south) are 21, 113, 118, 119, 120, 15, 2/2A, 108, 109, 110, 107, 106, 12 and 101. Monitoring well 21 was not inspected because a bee nest in the well casing prevented entry. The monitoring well locations were surveyed using a Geographic Positioning System (GPS). The accuracy of the GPS location is provided on the attached Checklist for each well. Well depths and depths to water were measured and recorded and the condition of the protective casings, riser pipes, well caps and locks for each well were assessed and documented. GPS data and an assessment of the condition of each monitoring well are summarized on the attached USEPA Region 2 Superfund Well Assessment Checklists.

Some areas surrounding the Landfill are currently under construction. Monitoring wells 4/4A, 6, 5/5A, 8/8A, 10/10A and 18 may have been destroyed as a result of construction activities. In general, the fourteen (14) monitoring wells are in good condition and can be considered for future groundwater monitoring events if needed. Some wells need replacement of the concrete pad and/or protective casings. All wells should be redeveloped by surging and pumping, prior to sampling, to ensure groundwater can enter the well.
