**Periodic Review Report August 2023**  
**NYSDEC Site No. 344014**  
**West Nyack Operating Center**

766 West Nyack Road, West Nyack, NY  
(Formerly 180 West Nyack Road)

August 2023  
Project 2101712

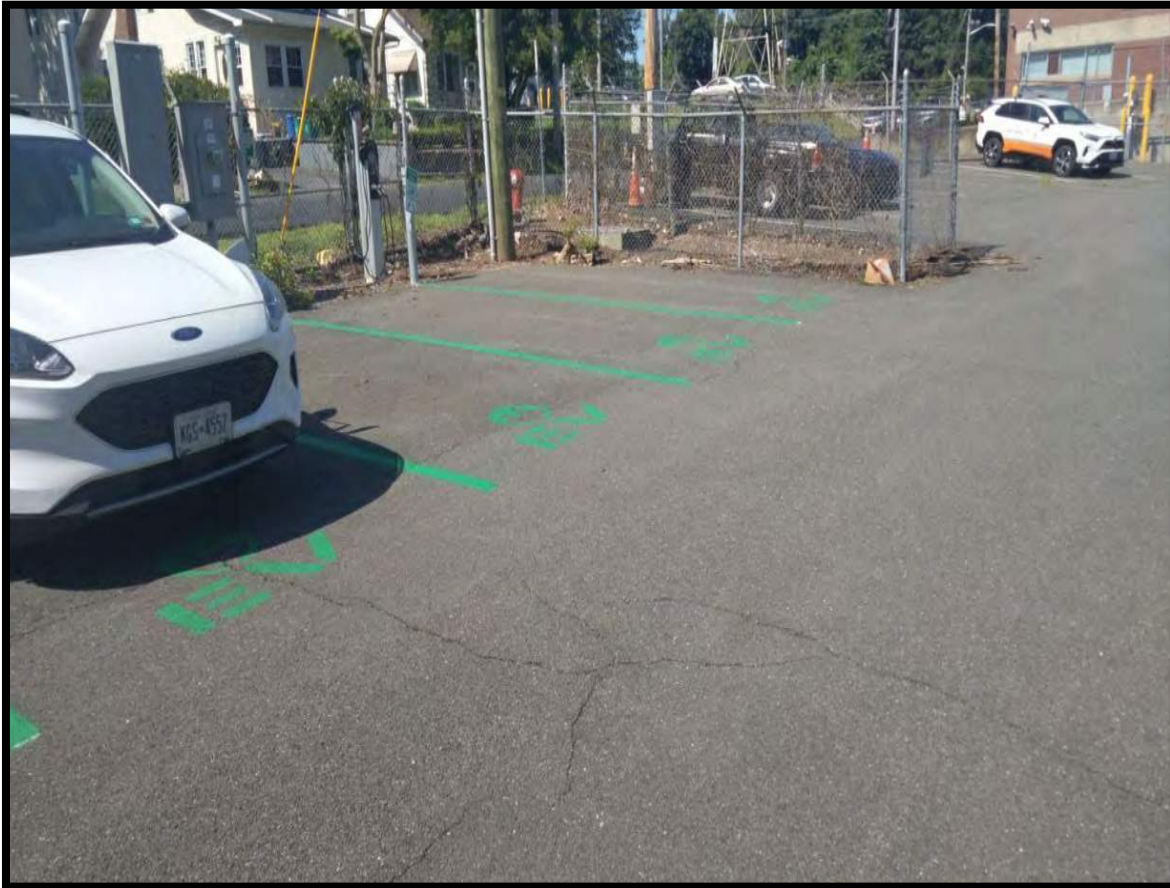
**PHOTOGRAPH 1**

- The asphalt cover in the facility parking and driveway areas is in overall good condition. Some settlement cracks were identified within the asphalt during the 2020 inspection and remain present as of the 2023 inspection. However, the cracks remain surficial and there is no exposure to the sub-base or subsurface material. (Photographs 1-8, Photograph 16).

- The concrete floor of the facility building is in good condition (Photograph 14).
- The perimeter fence is in good condition (Photograph 1, 12, 16).
- There was no evidence of unauthorized use (i.e., no evidence of excavation, construction, groundwater use, or farming in the Site soil, etc.).

Pavement and fence in front parking area, fencing – View looking southwest

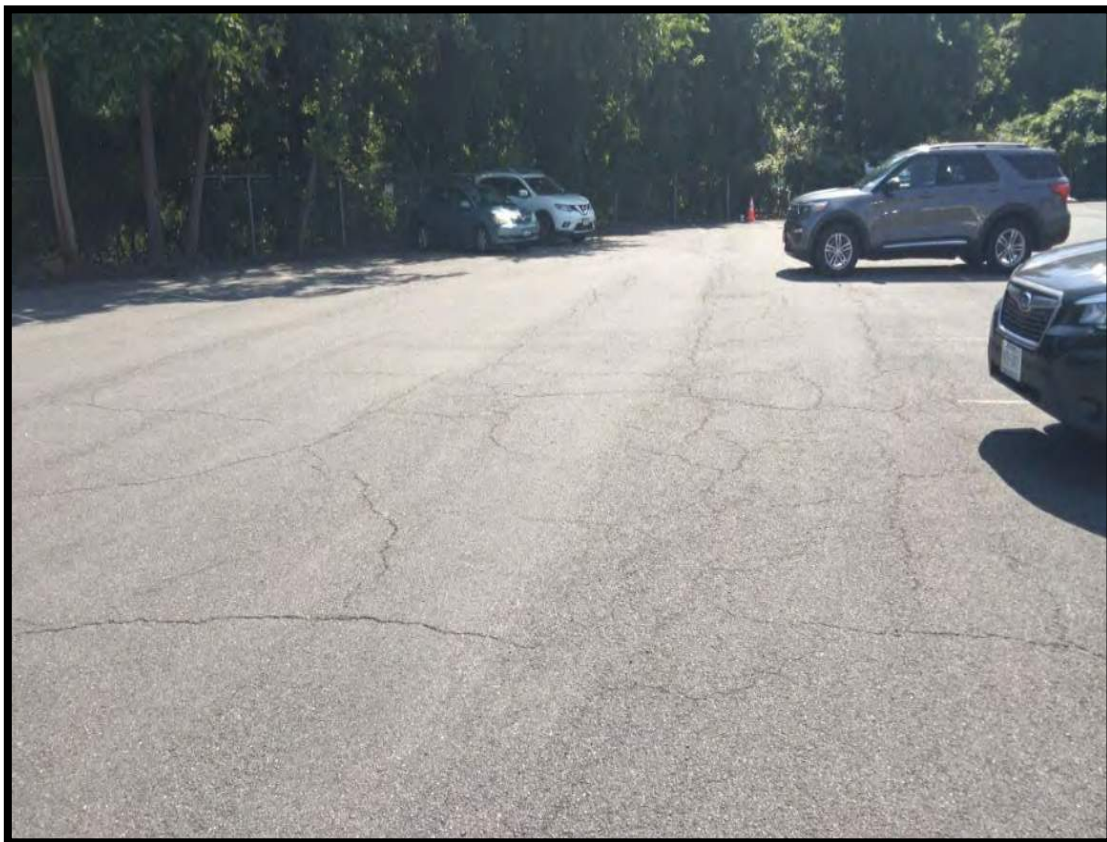
**PHOTOGRAPH 2**

Pavement in parking area – View looking northeast

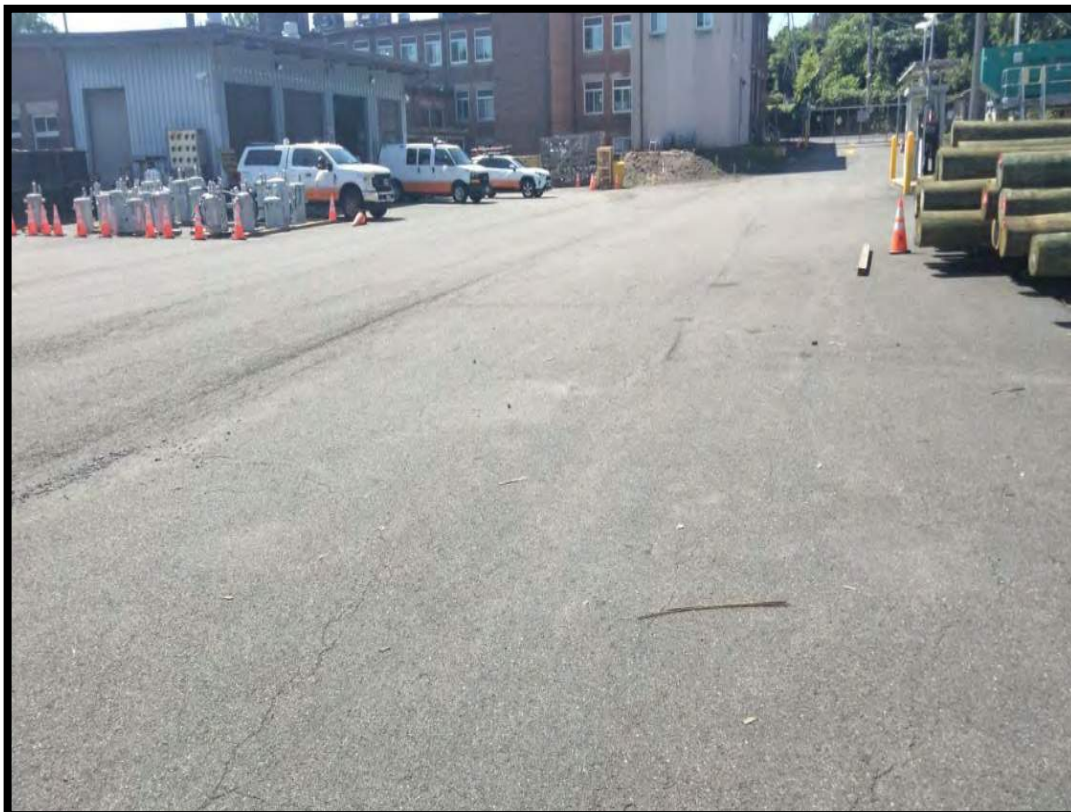
**PHOTOGRAPH 4**

Pavement in rear of facility – View looking south from behind west side of buildings

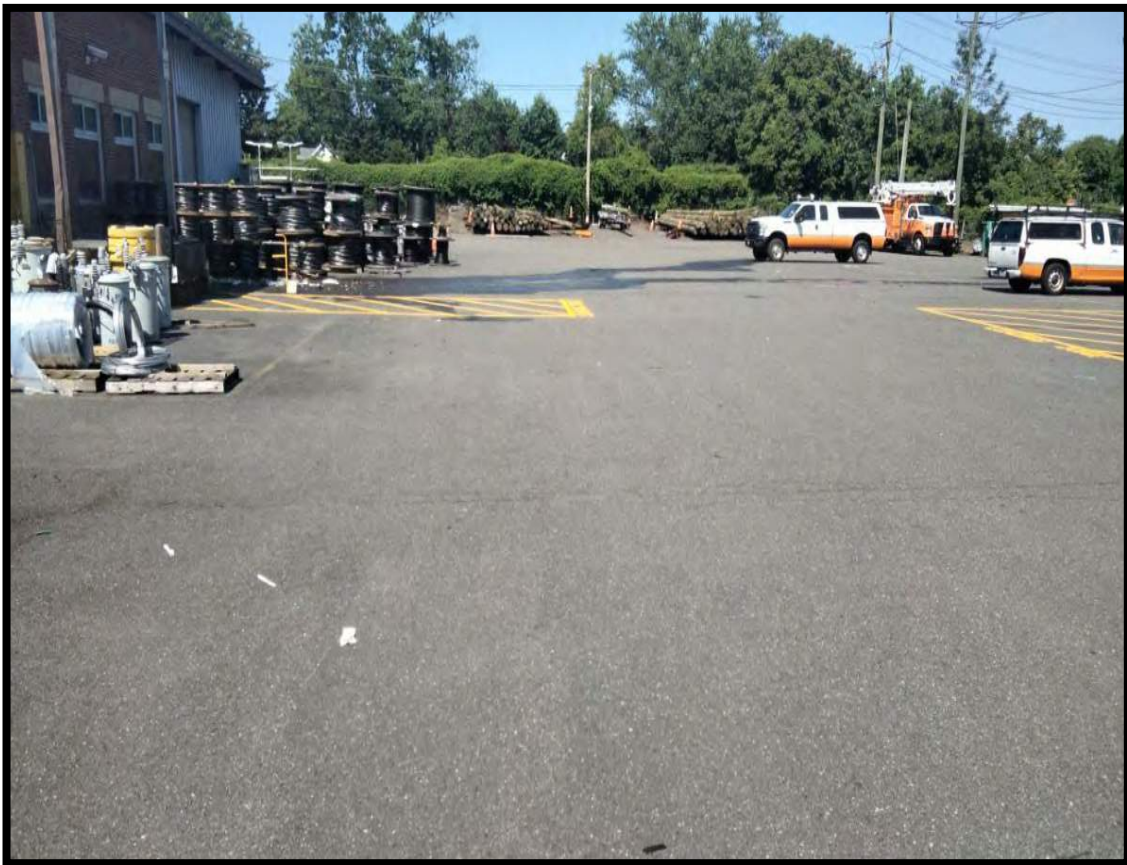
**PHOTOGRAPH 5**

Pavement behind facility buildings – View looking southwest

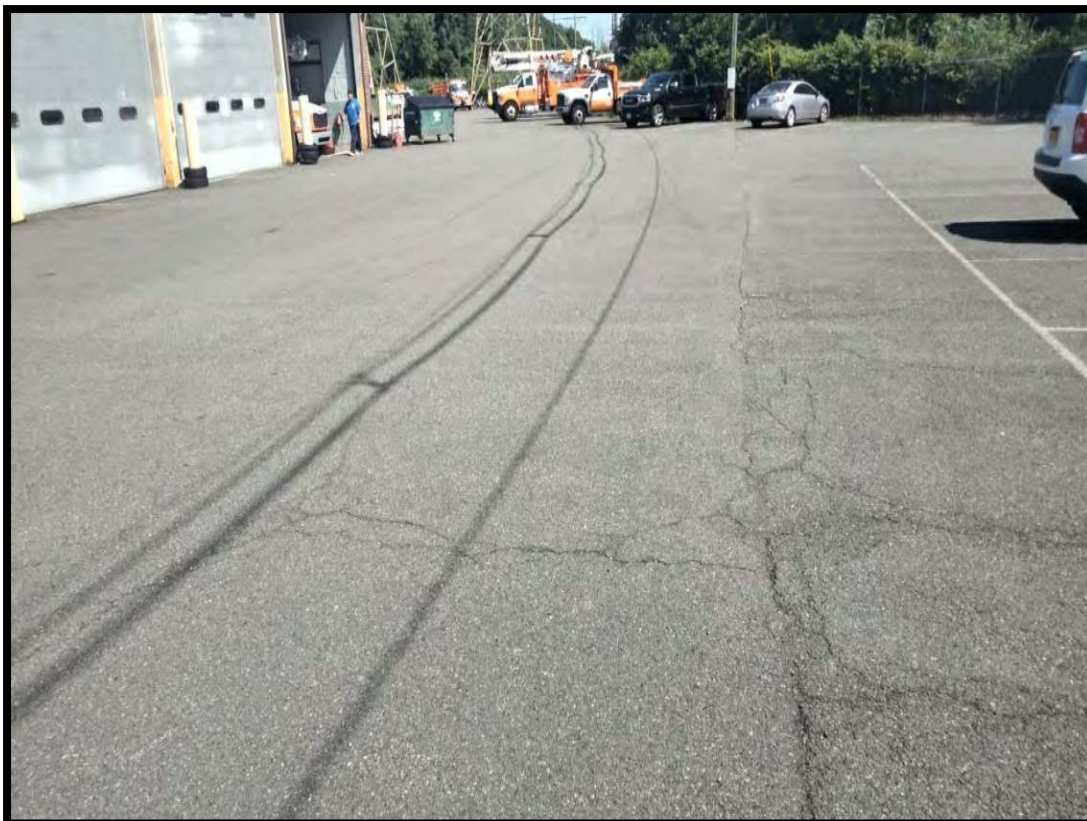
**PHOTOGRAPH 6**

Pavement on east side of facility buildings – View looking north

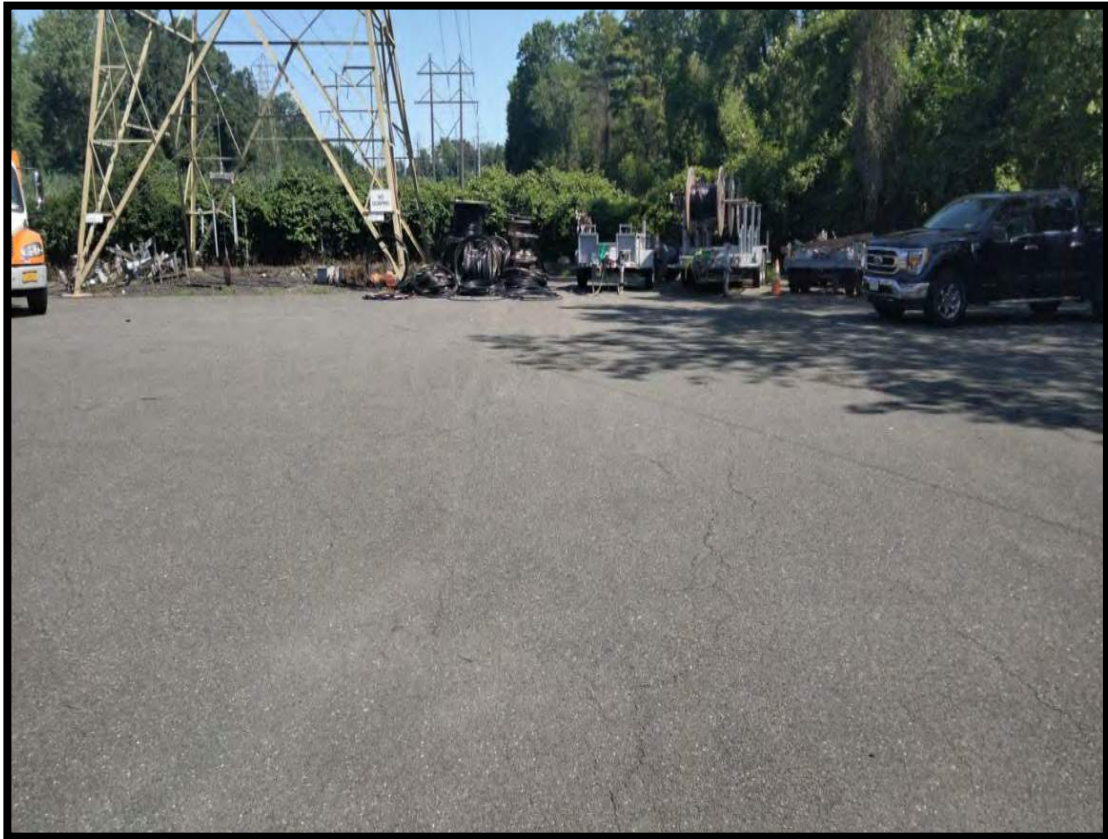
**PHOTOGRAPH 7**

Pavement behind facility buildings– View looking northeast, transmission towers in background

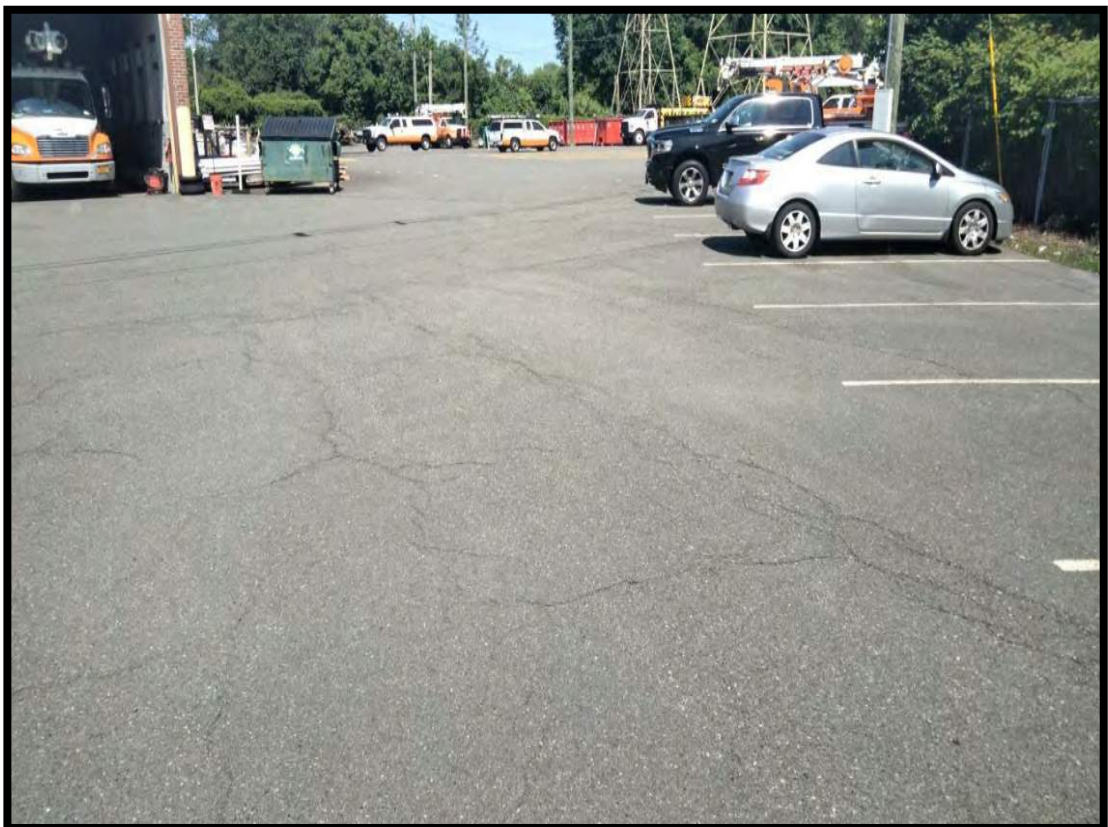
**PHOTOGRAPH 8**

Pavement to east of buildings – View looking northeast, fence at right

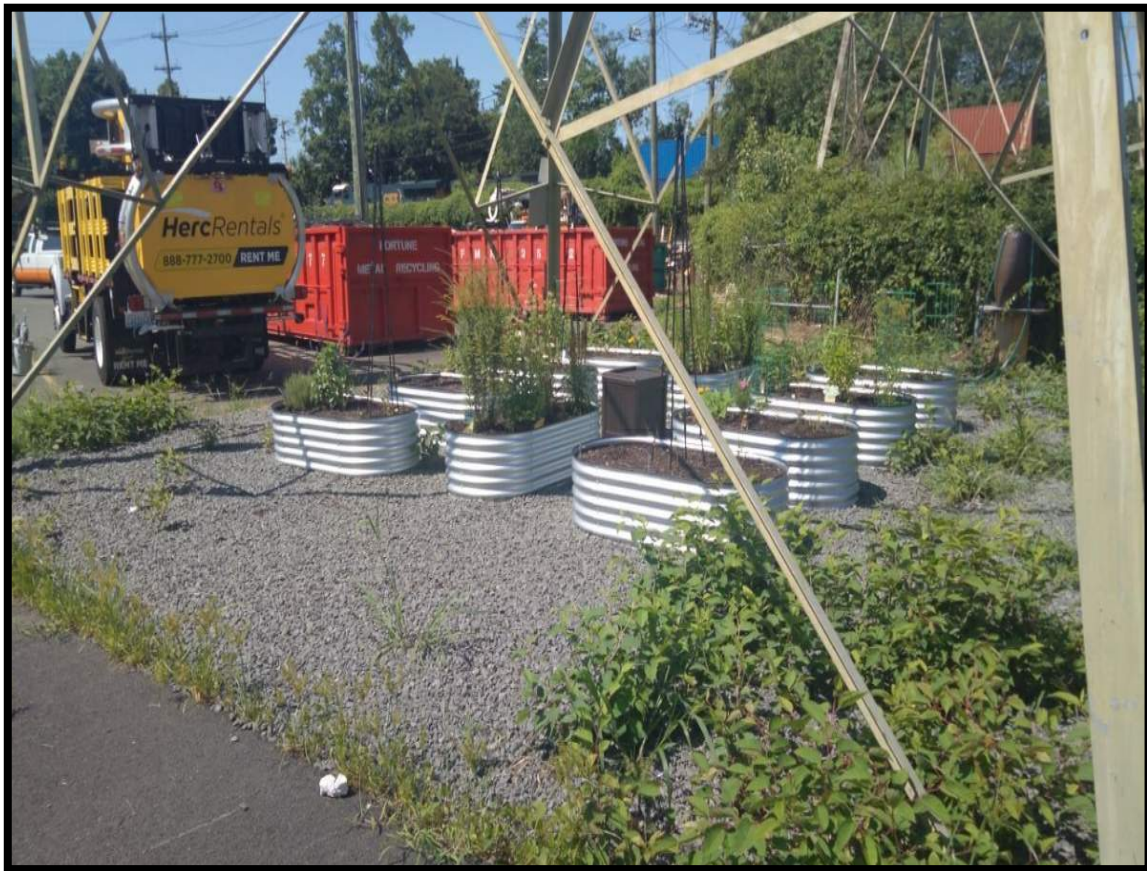
**PHOTOGRAPH 9**

- The oil stone chips are present beneath the transmission towers. The oil stone cover preventing exposure to subsurface soil at these locations appears to be intact. It appears that the oil stone chips have been replenished under the northwestern tower, but not the northeastern tower. Replacement of oil stone chips under the northeastern tower should be considered to prevent exposure of soil in the future (Photograph 10). Raised-bed gardens have been added under the northwestern transmission tower (Photograph 9); however, these gardens are wholly contained within planters (i.e., galvanized steel water trough/stock tanks) and are not filled with or in contact with on-Site soil.

Base of northwestern transmission tower – Oil & stone chips present

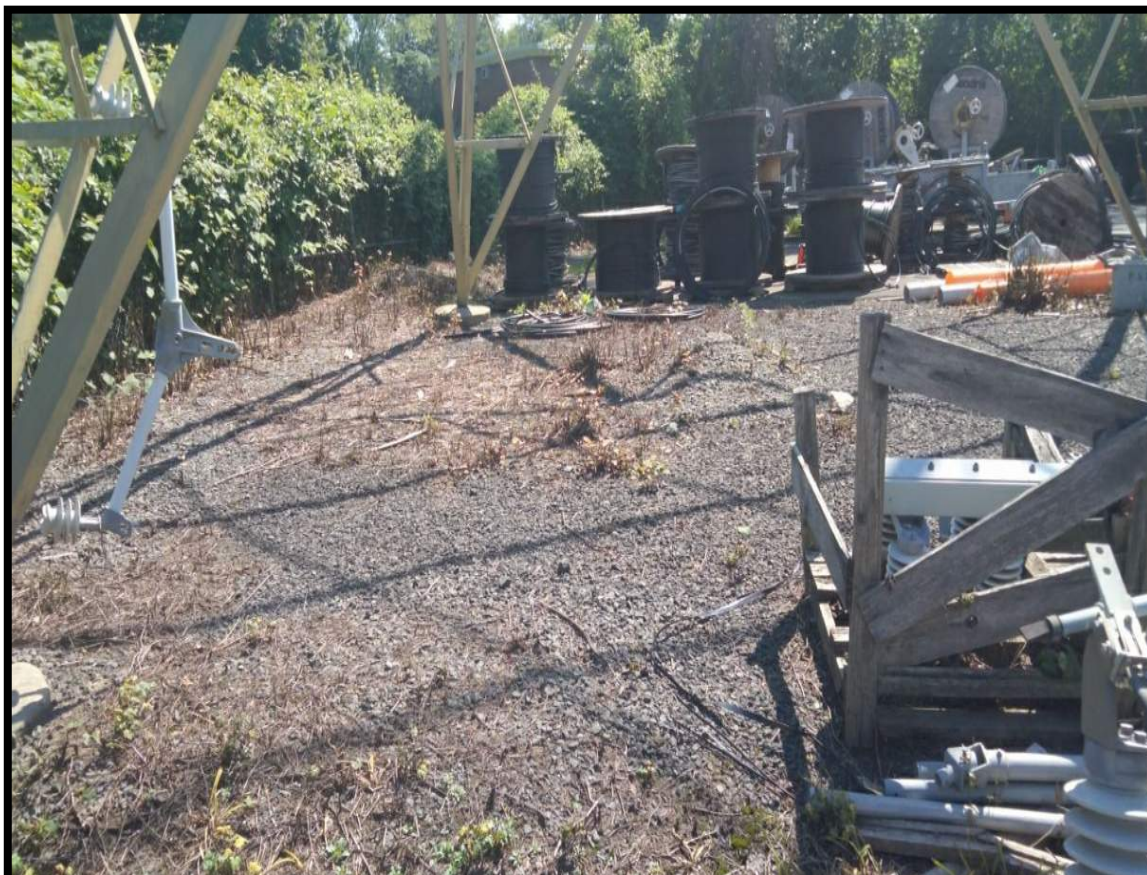
**PHOTOGRAPH 10**

Base of northeastern transmission tower – Oil & stone chips present, minimal erosion and vegetation

- Continued control of vegetation in all oil stone chip areas to prevent it from compromising the integrity of the cover material; and
- Replacement or future maintenance of the oil chips on the sloped areas adjacent to the southwestern side of the building and beneath the northeastern transmission tower to prevent further erosion.

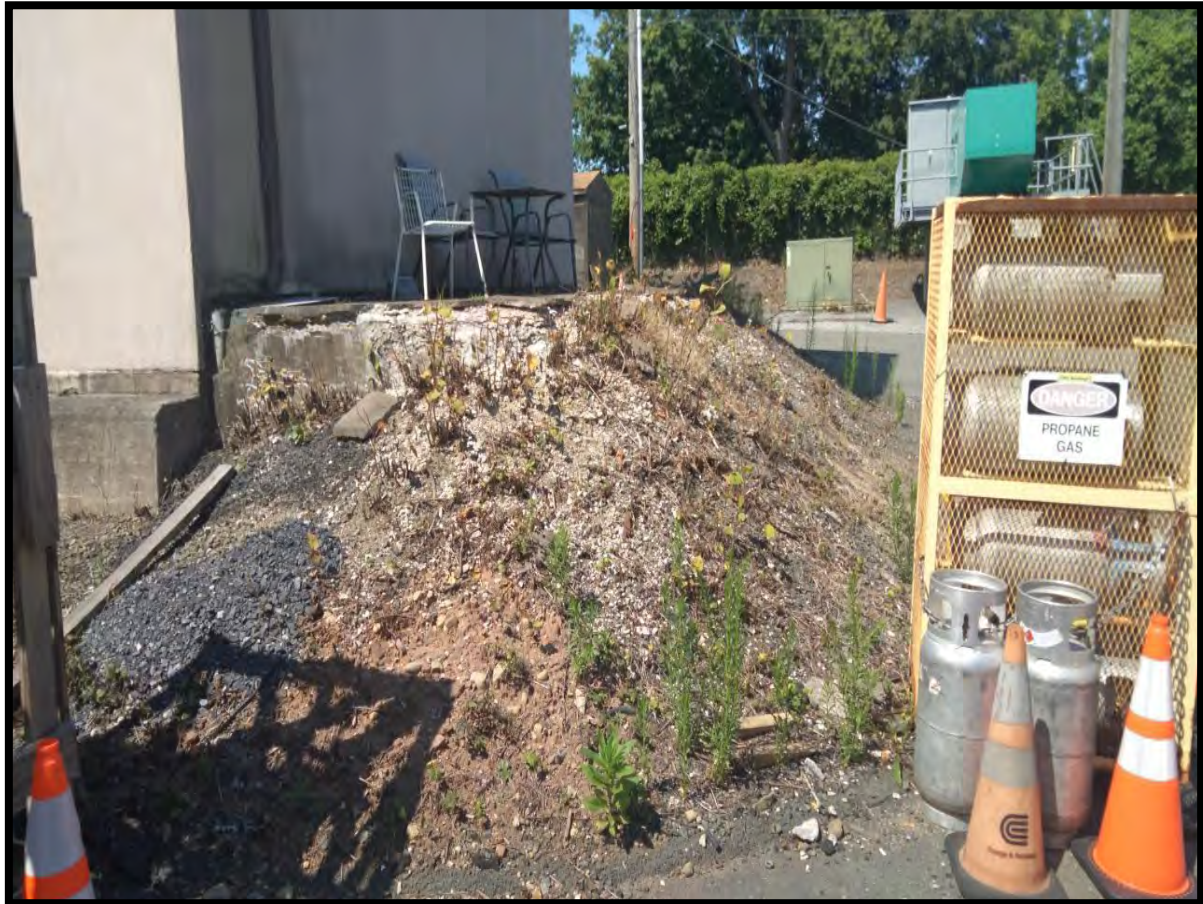
**PHOTOGRAPH 11**

Southwest side of building, eastern corner – – Oil & stone chips present, minimal erosion and vegetation

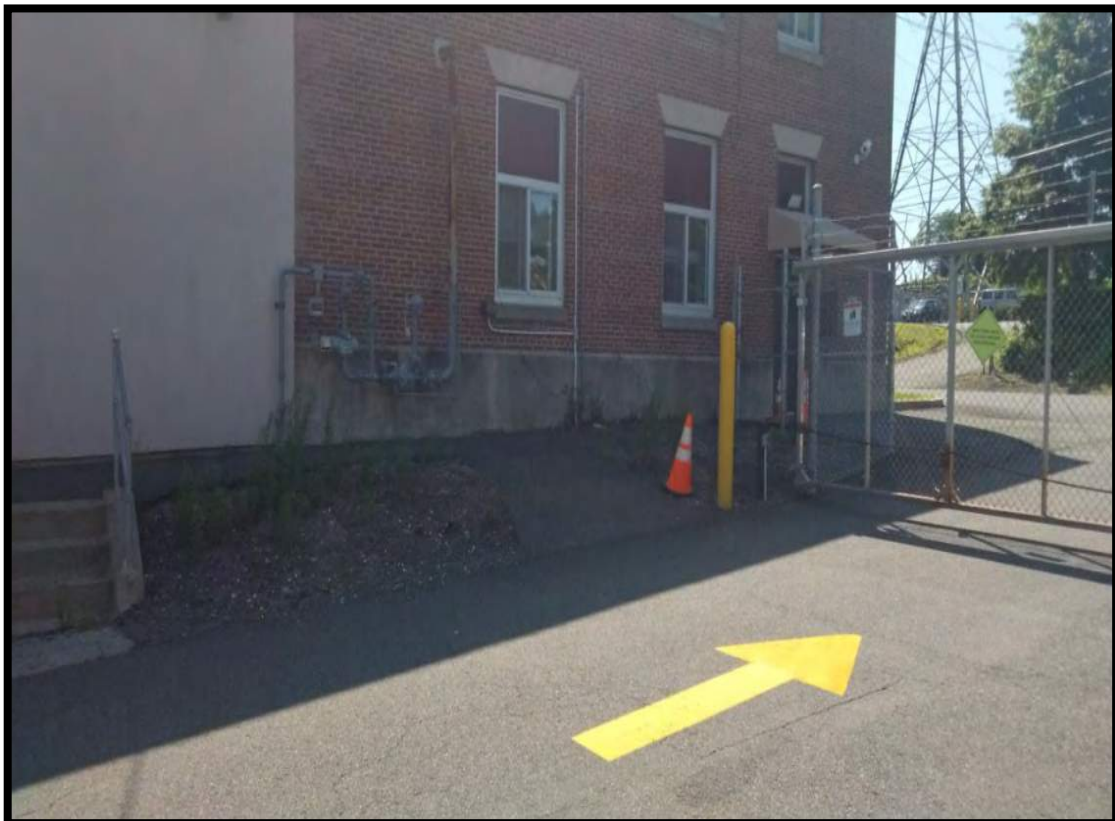
**PHOTOGRAPH 12**

Western side of building, fencing – Oil & stone chips present, minimal vegetation

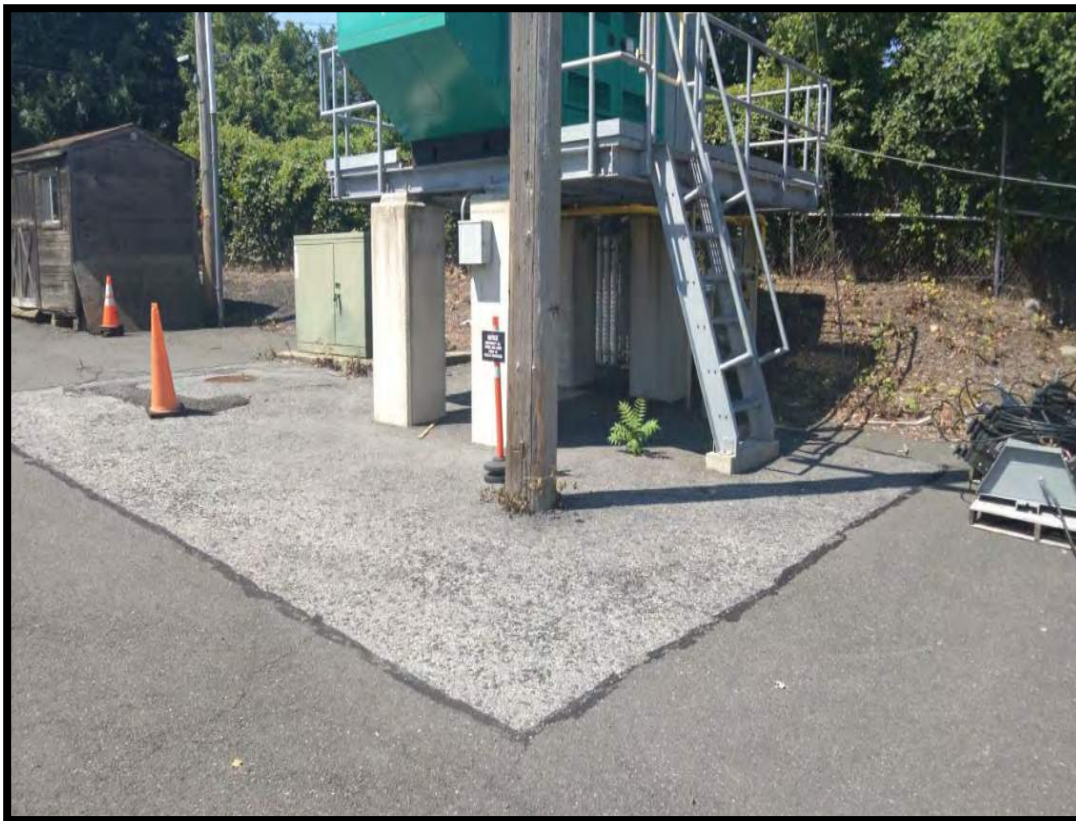
**PHOTOGRAPH 13**  
Maintained pavement patch for emergency generator

- The pavement patch for the emergency generator installed in 2017 continues to be maintained in good condition (Photograph 13).
- The pavement on Lot 48 west of the fence-line and east of the railroad is in overall good condition. Minor cracks were observed consistent with observations during recent annual inspections. However, the cracks remain surficial and there is no exposure to the subsurface soil.

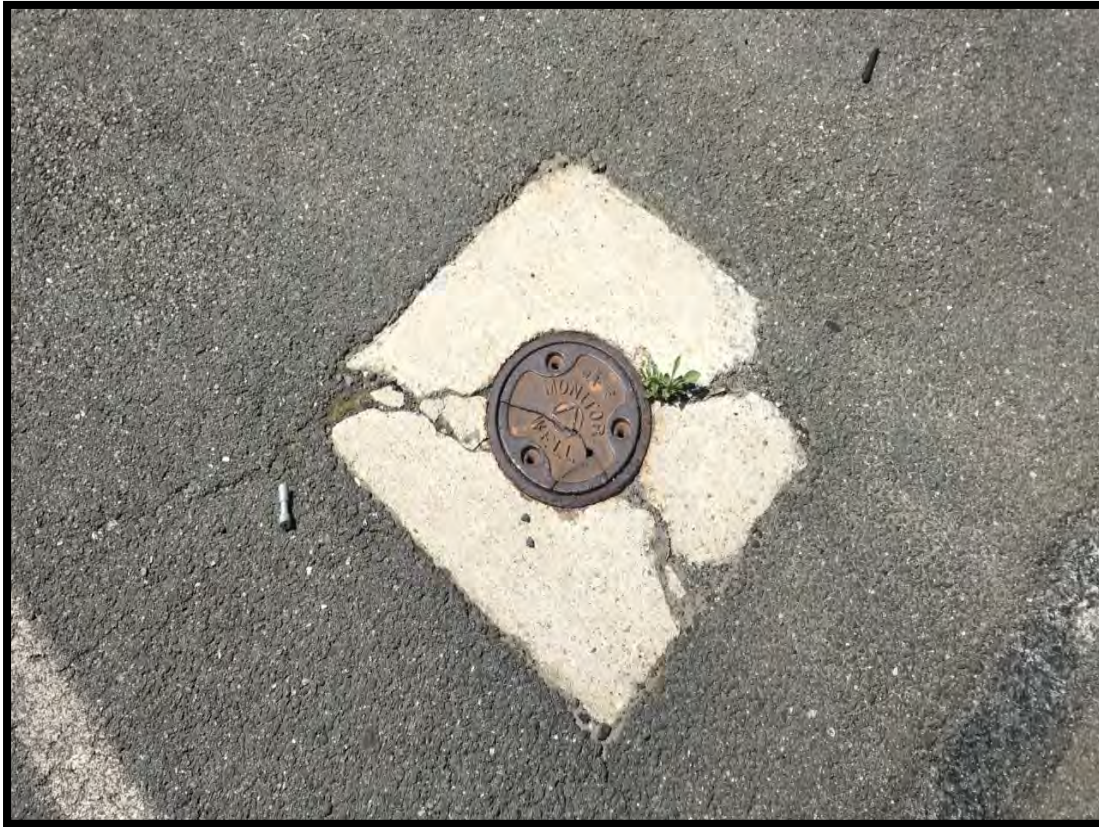
**PHOTOGRAPH 15**  
MW-10S – Crack in concrete pad and cover

- Although not a part of the surface cover inspection, the on-Site monitoring wells were also observed. The concrete pad and well cap at MW-10S are cracked (Photograph 15) such that the well's surface completion components should be replaced. The concrete pad for monitoring well MW-5B is also cracked but remains competent. MW-8S, MW-8B, and MW-11S were uncovered from under accumulated soil/debris, but competent. Monitoring well EXW5 could not be found in 2023.

In the meantime, the surface conditions of the on-Site monitoring wells are assessed during Site inspection and cover monitoring events. Most recently in 2023, a damaged protective casing for groundwater monitoring well MW-10S (**Figure 2**) was identified and will be repaired. The remainder of the on-Site monitoring wells were observed in functional condition.

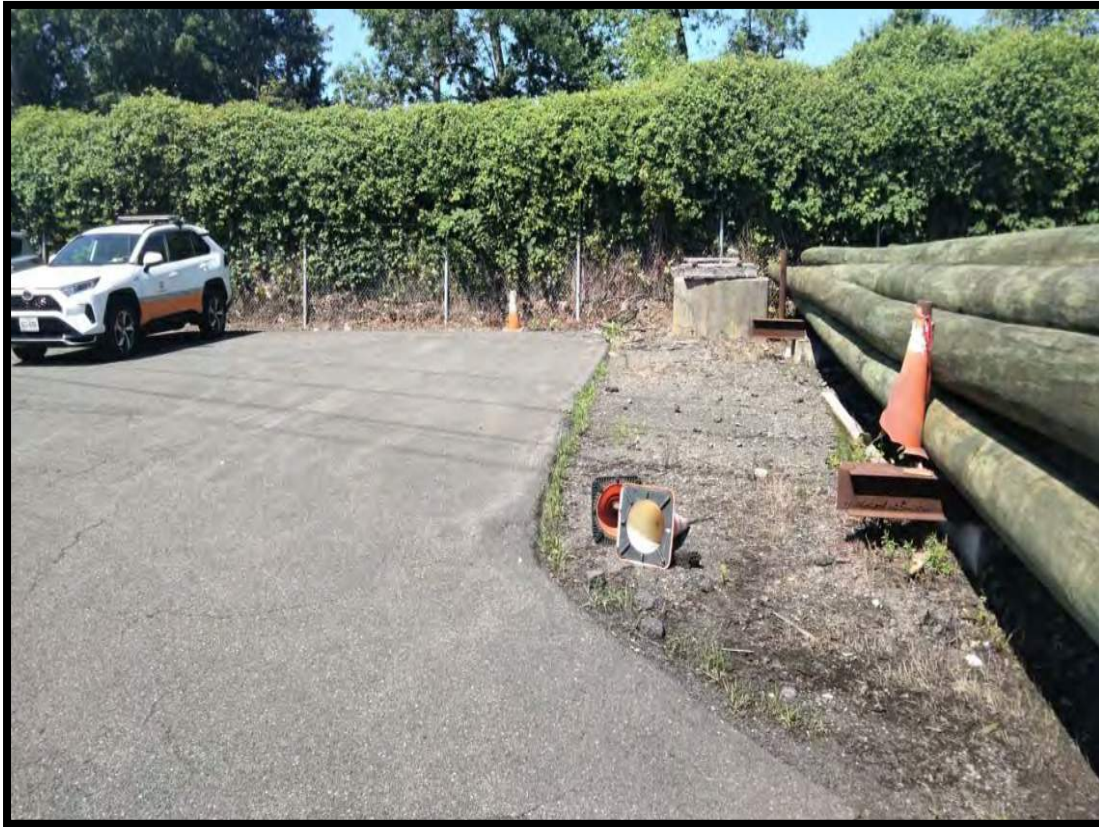
**PHOTOGRAPH 17**

- The pole rack along the northwestern fence line was covered with equipment and the oil stone chips in area beneath were minimally visible. The condition of the oil stone chips, and possible vegetation growth was assessed to the extent possible and found to be competent based on visual observations (Photograph 17).

South side of pole rack – View looking east, oil & stone chips present - minimal visibility

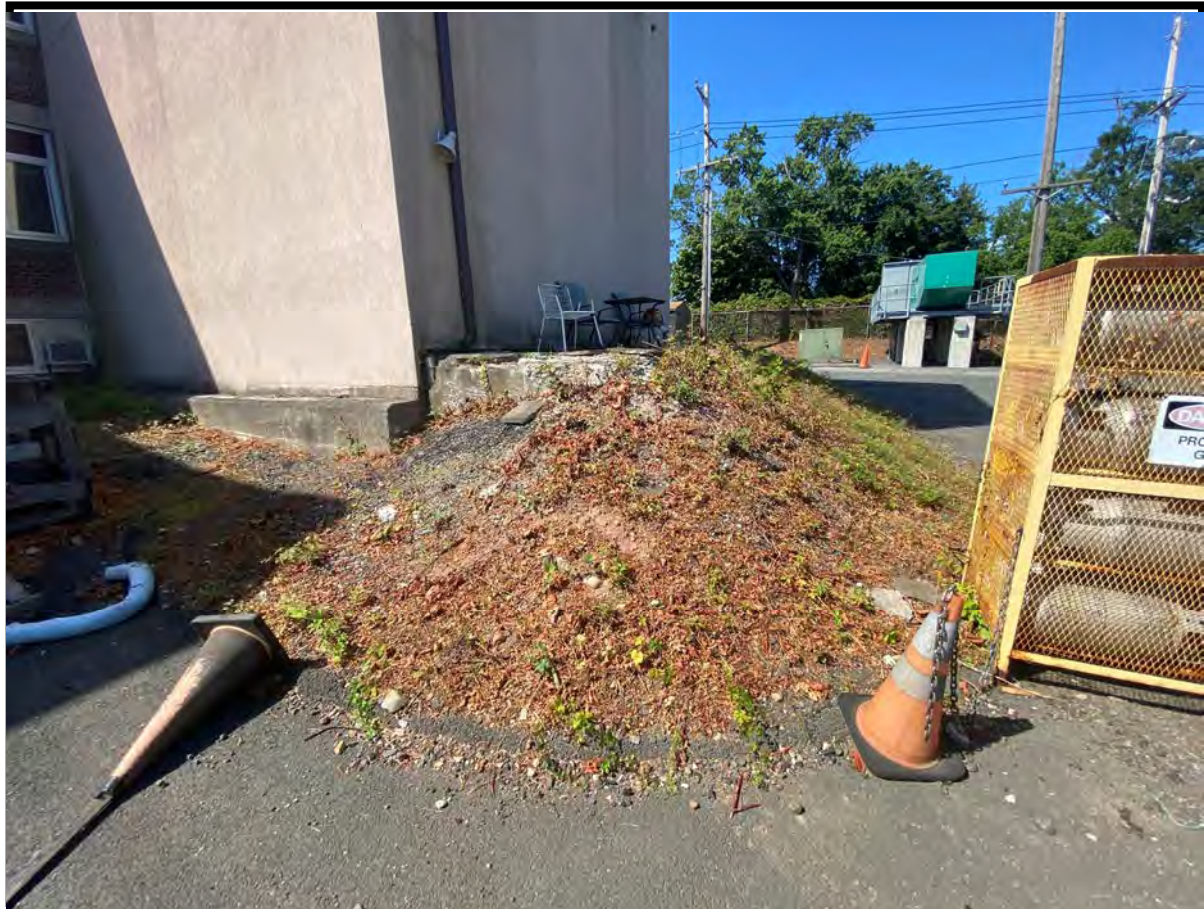
**PHOTOGRAPH 11**

Southwest Side of Building-Eastern Corner - Erosion of Oil Stone Chips and Vegetation

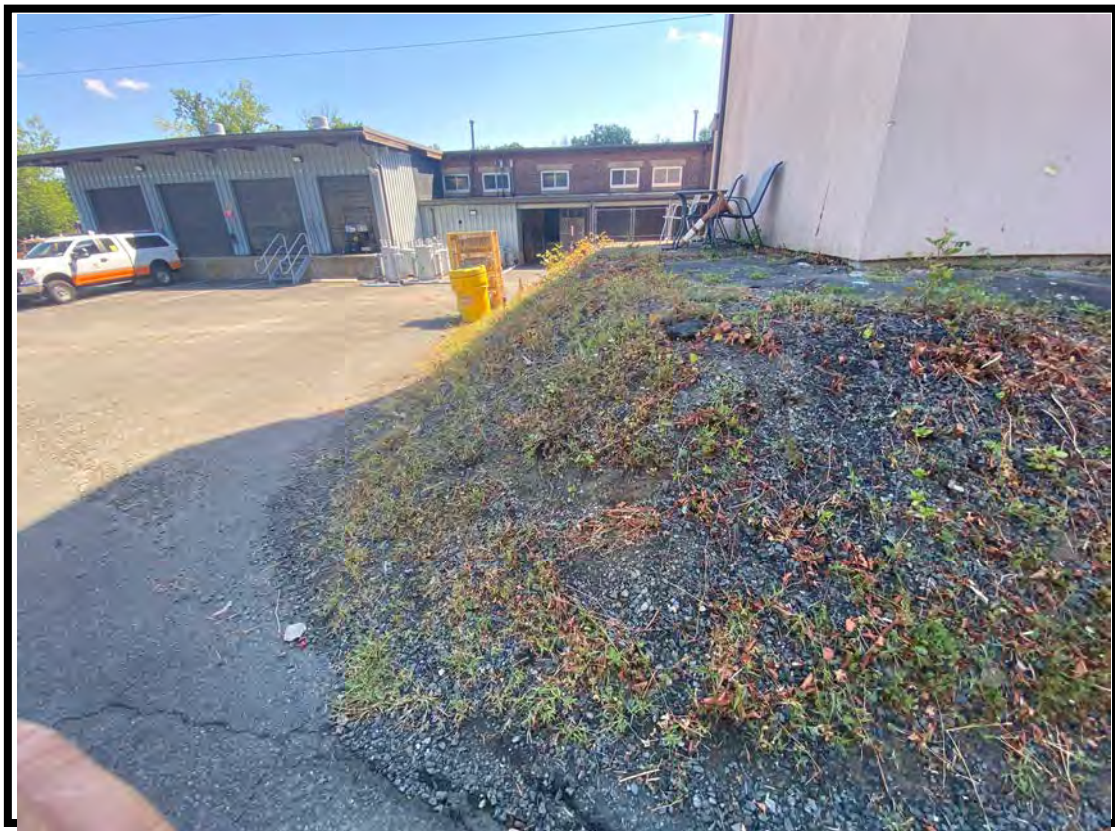
**PHOTOGRAPH 12**

Southwestern Side of Building – Oil Stone Chips Adjacent to Building with Vegetation

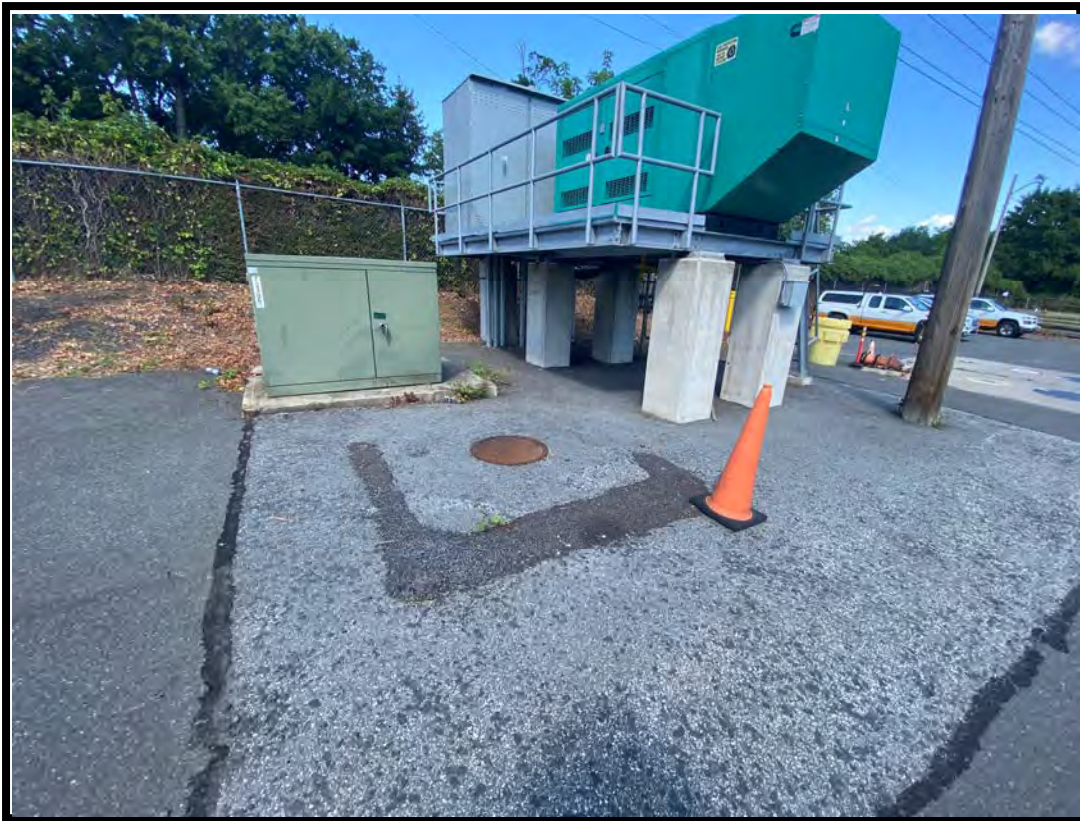
**PHOTOGRAPH 13**

Fixed Depression/Crack in Pavement Patch for Emergency Generator

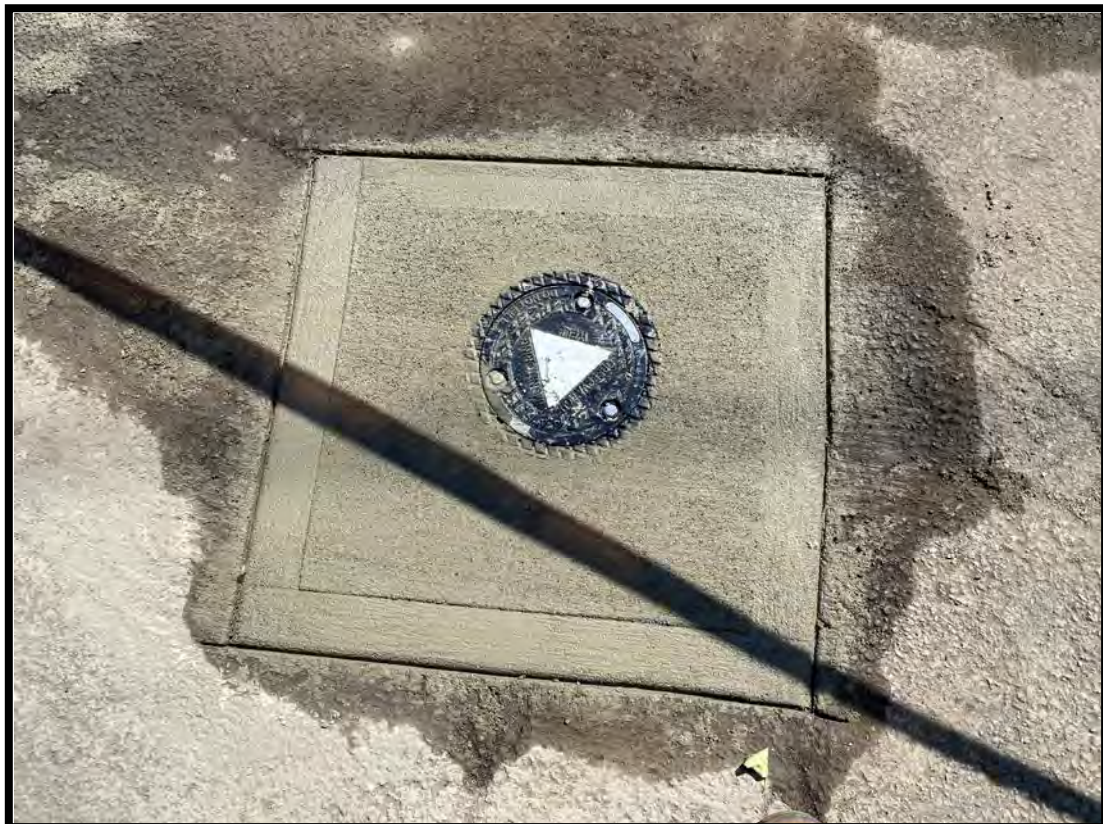
**PHOTOGRAPH 16**  
MW-5B Repaired Road box

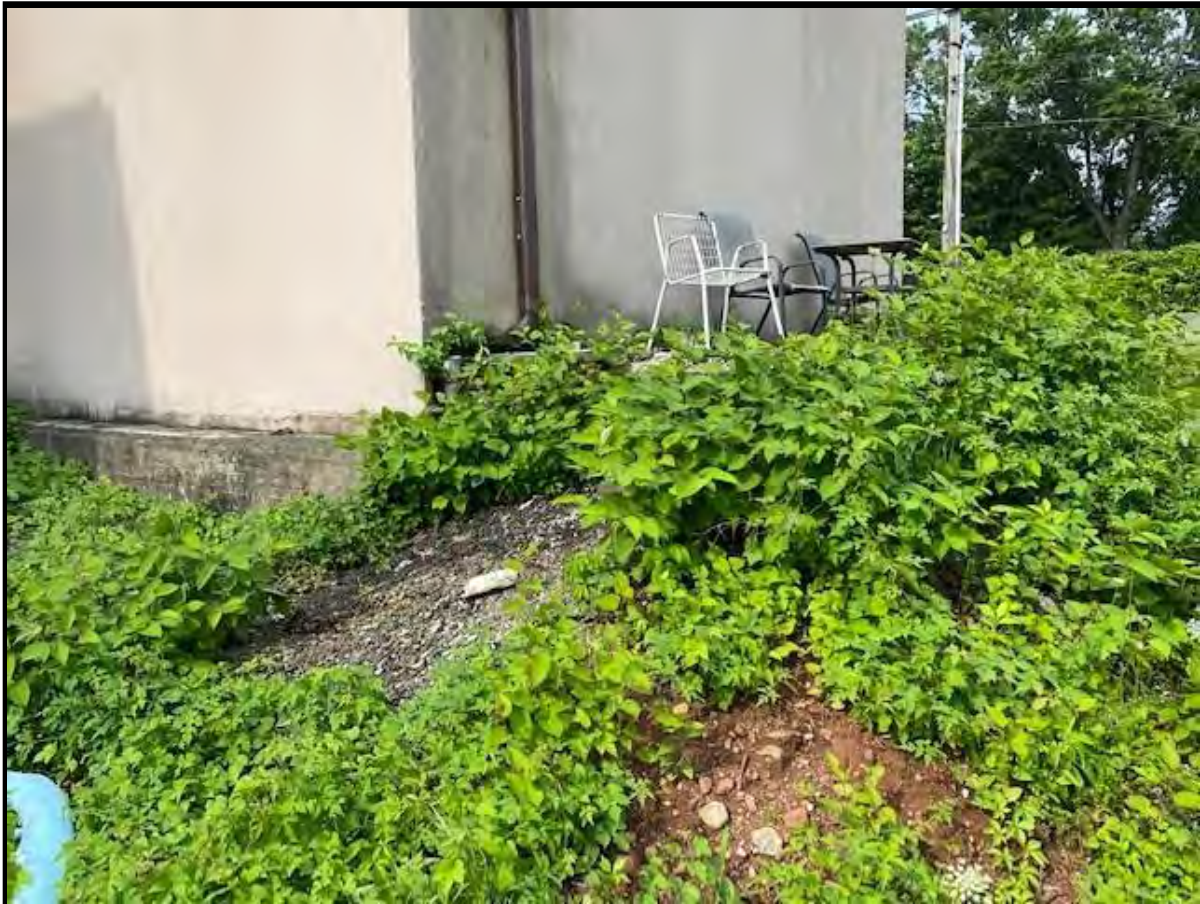
**PHOTOGRAPH 13**

Southwest Side of Building-Eastern Corner - Erosion of Oil Stone Chips and Vegetation

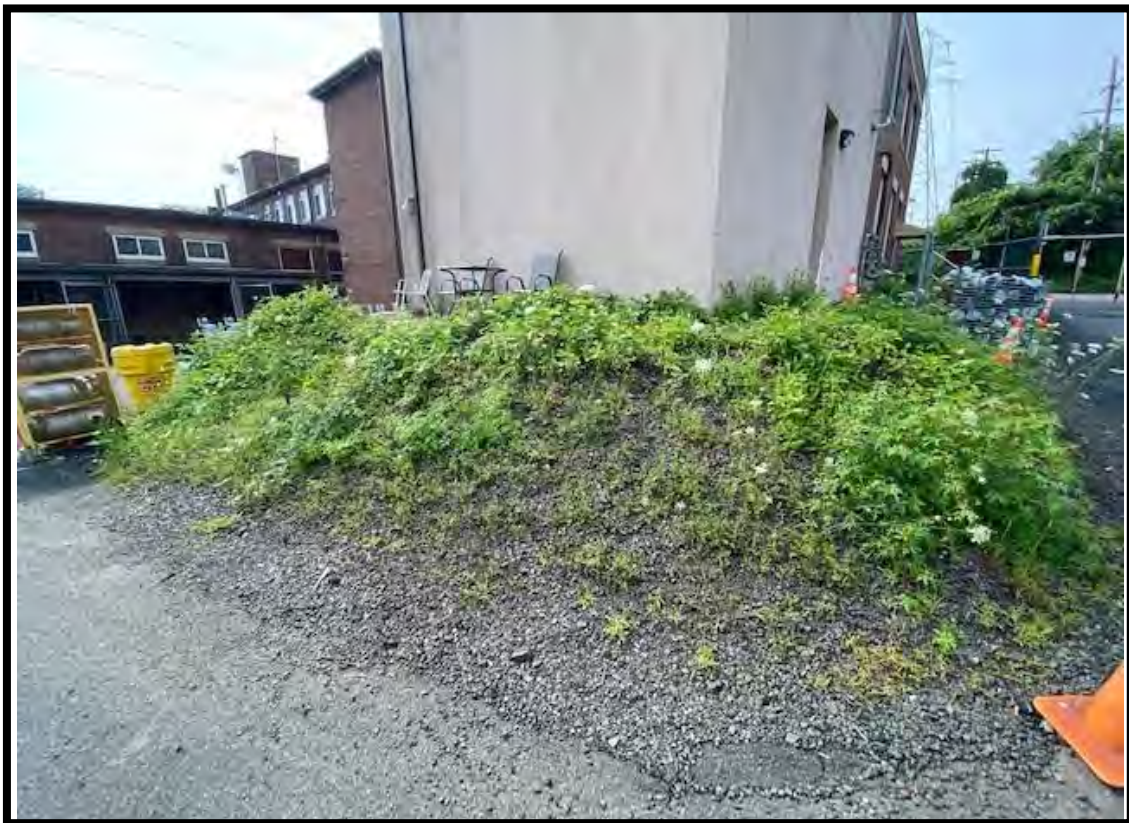
**PHOTOGRAPH 14**

Southwestern Side of Building – Oil Stone Chips Adjacent to Building with Vegetation

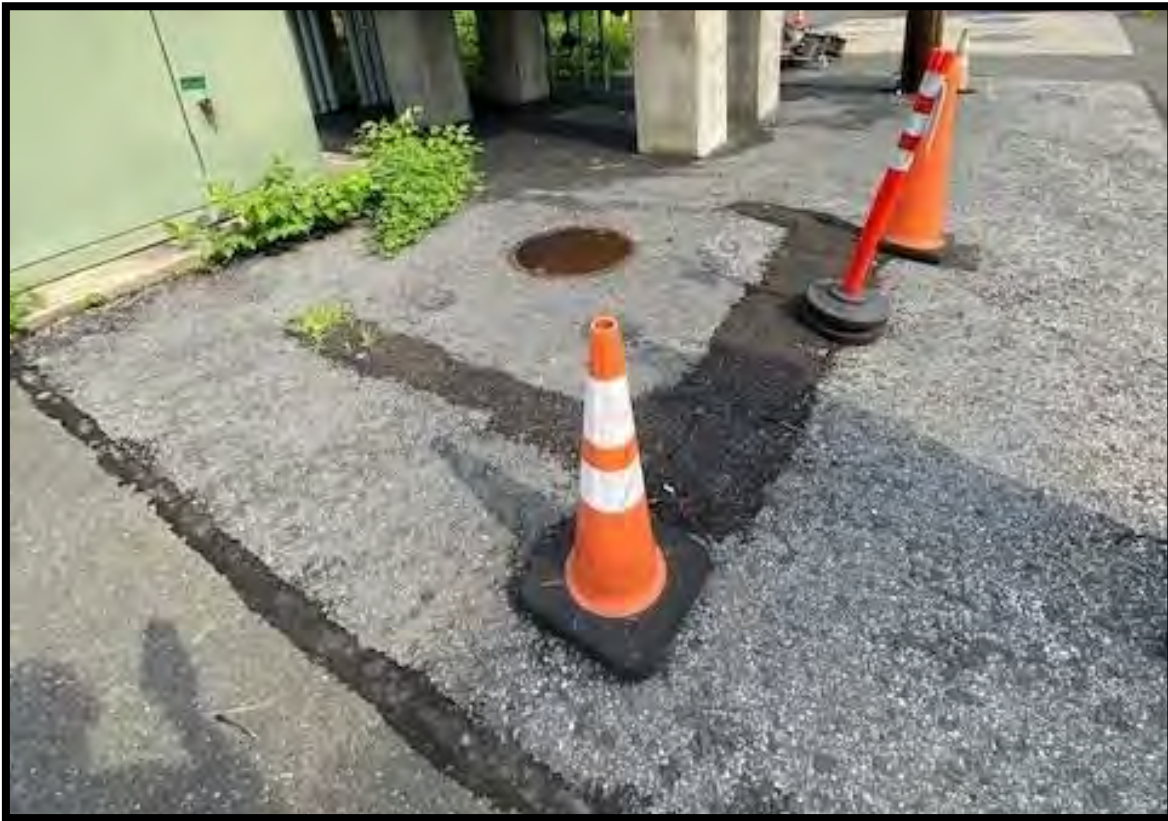
**PHOTOGRAPH 15**  
Fixed Depression/Crack in Pavement Patch for Emergency Generator

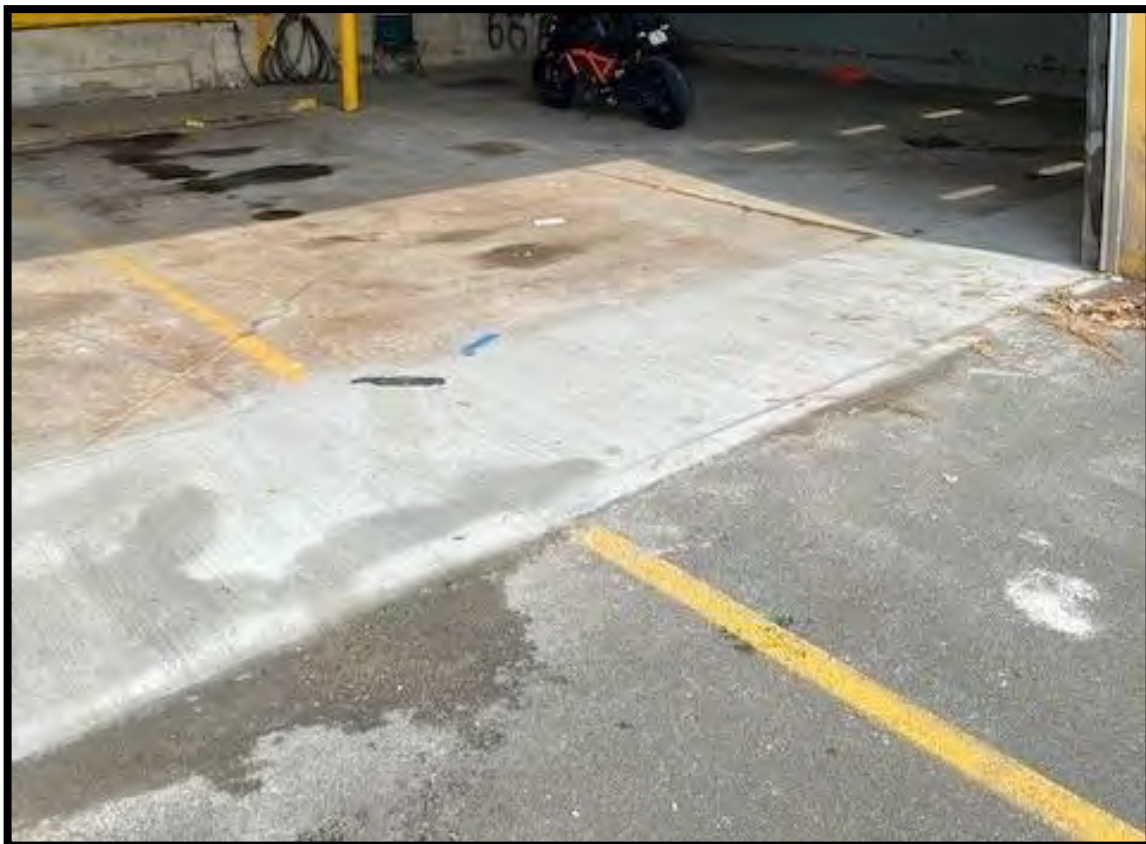
**PHOTOGRAPH 16**  
Cracks in Concrete Floor Fixed of Garage on East Side of Building
