**Periodic Review Report August 2023**  
**NYSDEC Site No. 344014**  
**West Nyack Operating Center**

766 West Nyack Road, West Nyack, NY  
(Formerly 180 West Nyack Road)

August 2023  
Project 2101712

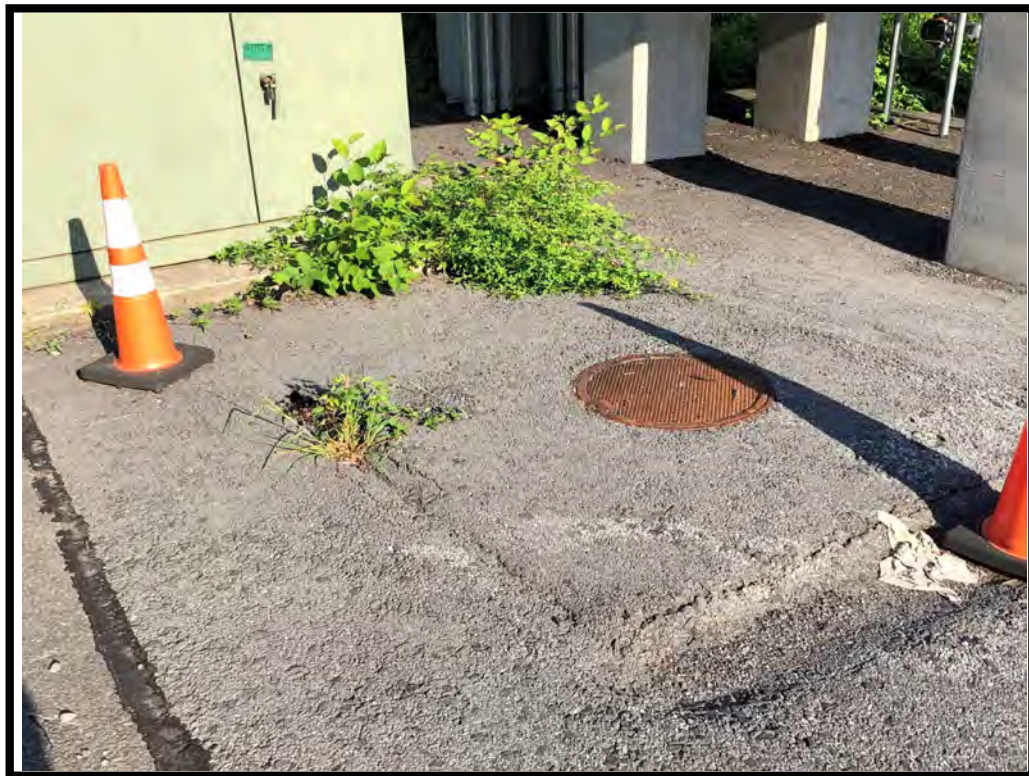
**PHOTOGRAPH 8**

Depression/Crack in Pavement Patch for Emergency Generator

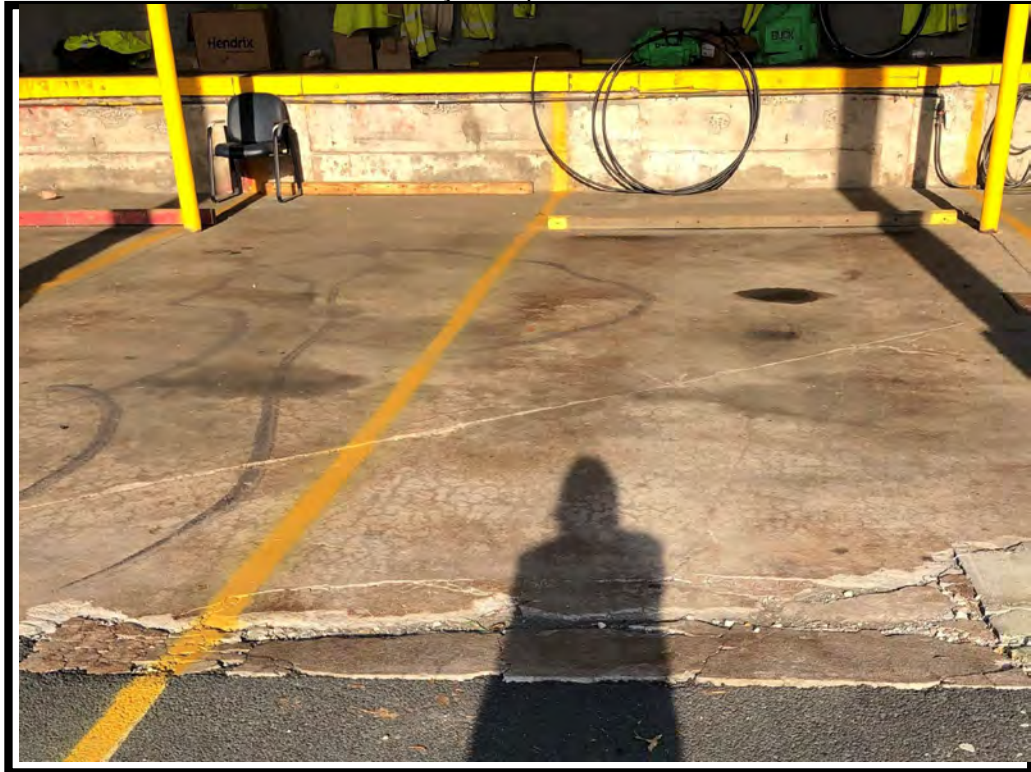
**PHOTOGRAPH 9**  
Cracks in Concrete Floor of Garage on East Side of Building

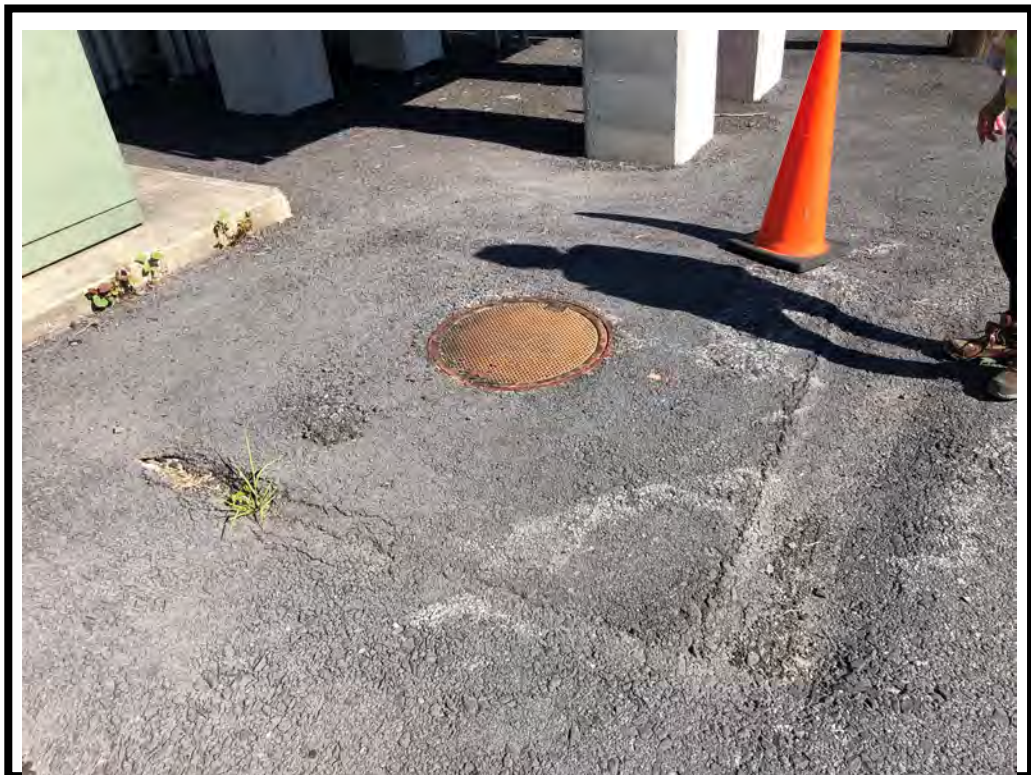
**PHOTOGRAPH 8**  
Depression/Crack in Pavement Patch for Emergency Generator

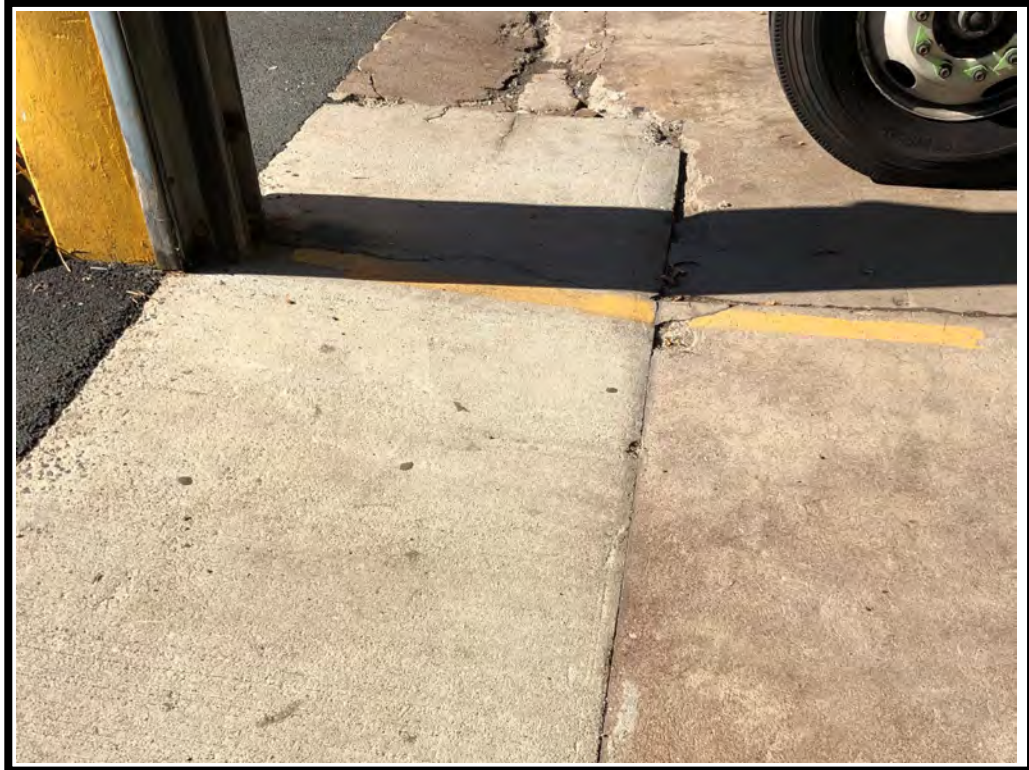
**PHOTOGRAPH 9**  
Cracks in Concrete Floor of Garage on East Side of Building
