HAVERSTRAW 93B MAPLE AVENUE FORMER MGP SITE, OPERABLE UNIT 2 PERIODIC REVIEW REPORT NYSDEC AOC INDEX NO. D3-0001-99-01 SITE NO: 3-44-044

ORANGE & ROCKLAND UTILITIES, INC. 390 WEST ROUTE 59 SPRING VALLEY, NY 10977

GEI Consultants, Inc., P.C. 5586 Post Road, Suite 1 East Greenwich, RI 02818

August 2022

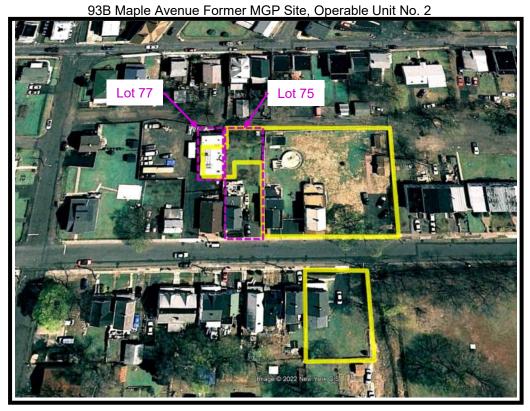
PHOTOGRAPH 1

April 2007 OU-2 Site Conditions Following IRM Completion.

SMP Applies to Lots 75 and 77 Within OU-2.

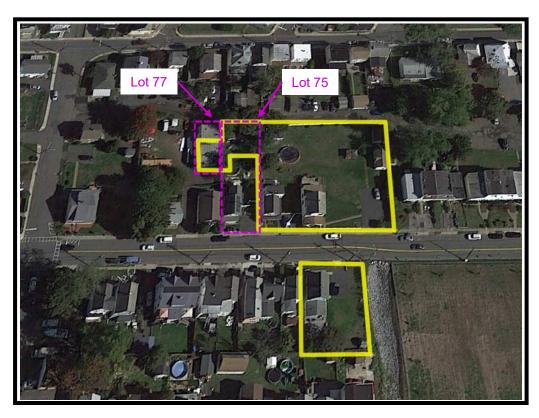
PHOTOGRAPH 2

October 2020 OU-2 Site Conditions. SMP Applies to Lots 75 and 77 Within OU-2.

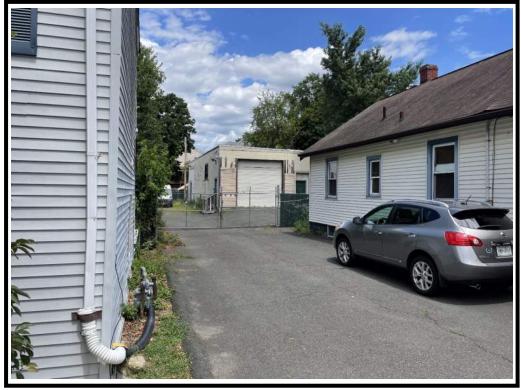
PHOTOGRAPH 3

July 2022 93B Maple Avenue Vacant Lot and 93A Maple Avenue Concrete Block Building (Lot 77) From Driveway of 93 Maple Avenue

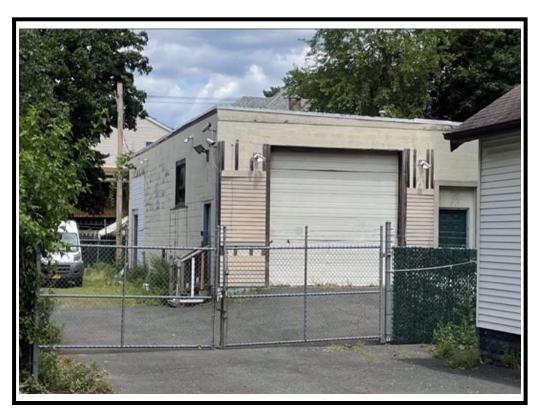
PHOTOGRAPH 4

July 2022 93A Maple Avenue Concrete Block Building (Lot 77) from Driveway of 95 Maple Avenue

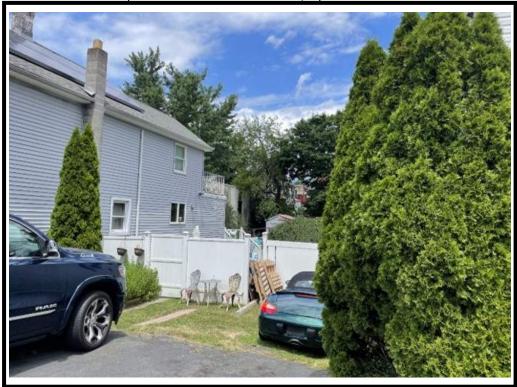
PHOTOGRAPH 5

July 2022 93A Maple Avenue Concrete Block Building (Lot 77) and Rear of 95 Maple Avenue Property (Lot 75) from Driveway of 95 Maple Avenue

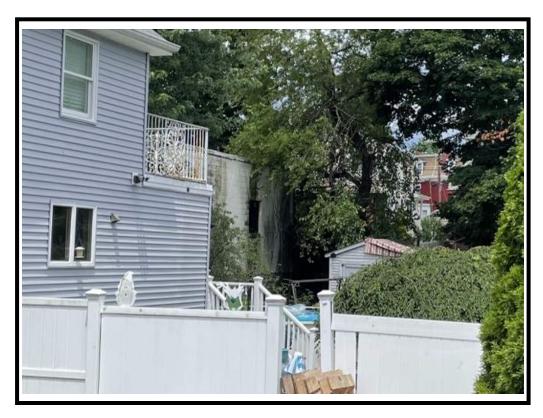
PHOTOGRAPH 6

July 2022 93A Maple Avenue Concrete Block Building (Lot 77) and Rear of 95 Maple Avenue Property (Lot 75) from Driveway of 95 Maple Avenue

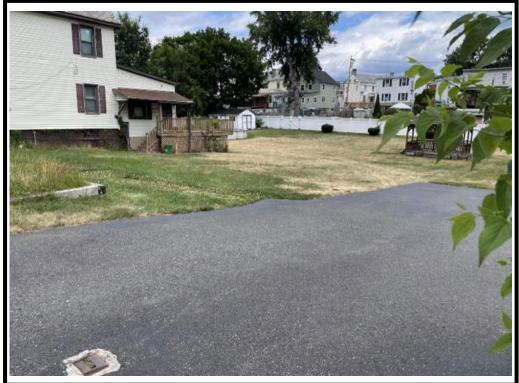
PHOTOGRAPH 7

July 2022 Rear of 99 Maple Avenue and 103 Maple Avenue Properties (Lots 74 and 73) from Driveway of 103 Maple Avenue. Lots 74 and 73 Are Not Included in OU-2 SMP Area.

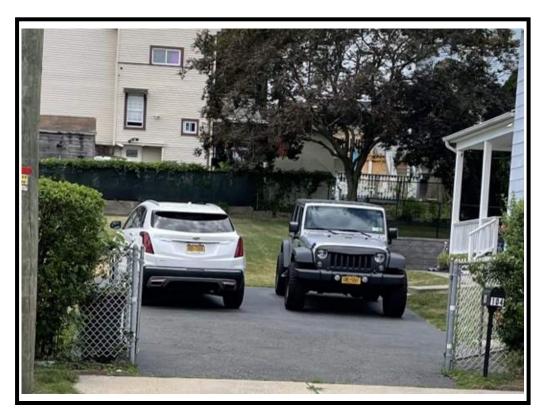
PHOTOGRAPH 8

July 2022 104 Maple Avenue Properties (Lot 8) from Maple Avenue Sidewalk. Lot 8 Is Not Included in OU-2 SMP Area
