**HAVERSTRAW 93B MAPLE AVENUE FORMER MGP SITE
OPERABLE UNIT 2
PERIODIC REVIEW REPORT
NYSDEC AOC INDEX NO. D3-0001-99-01
SITE NO: 3-44-044**

**ORANGE & ROCKLAND UTILITIES, INC.
390 WEST ROUTE 59
SPRING VALLEY, NY 10977**

**GEI Consultants, Inc., P.C.
530 7th Avenue, Ste. 2007
New York, NY 10018**

August 25, 2023

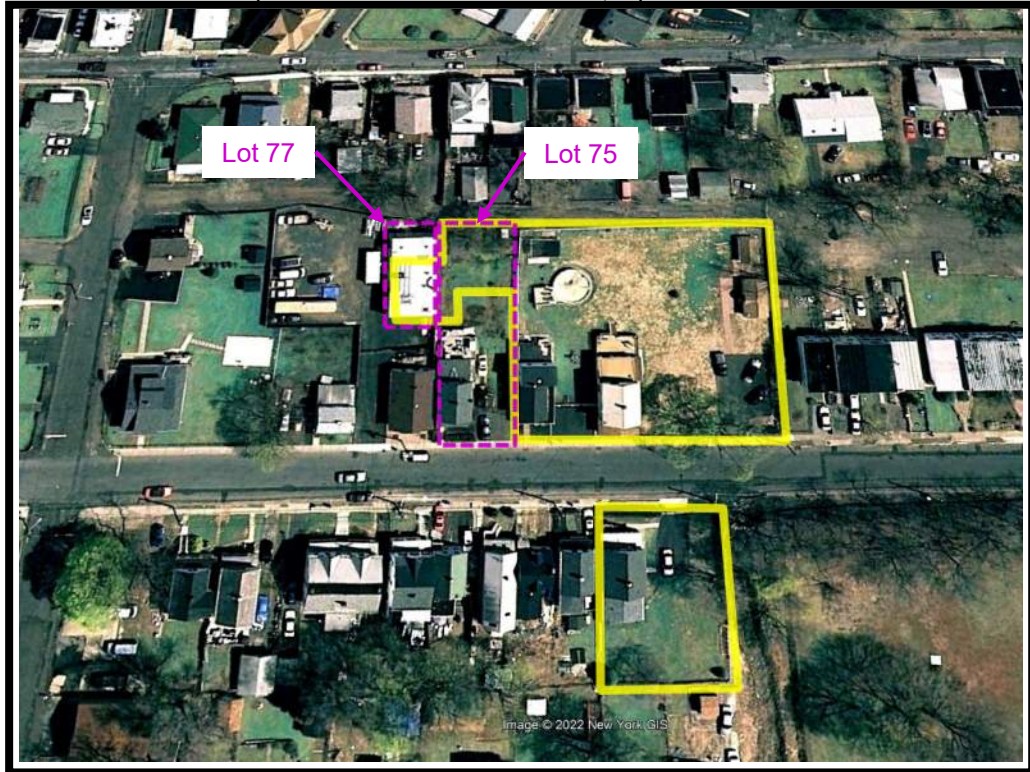
PHOTOGRAPH 1

April 2007 OU-2 Site Conditions Following IRM Completion.
SMP Applies to Lots 75 and 77 Within OU-2.

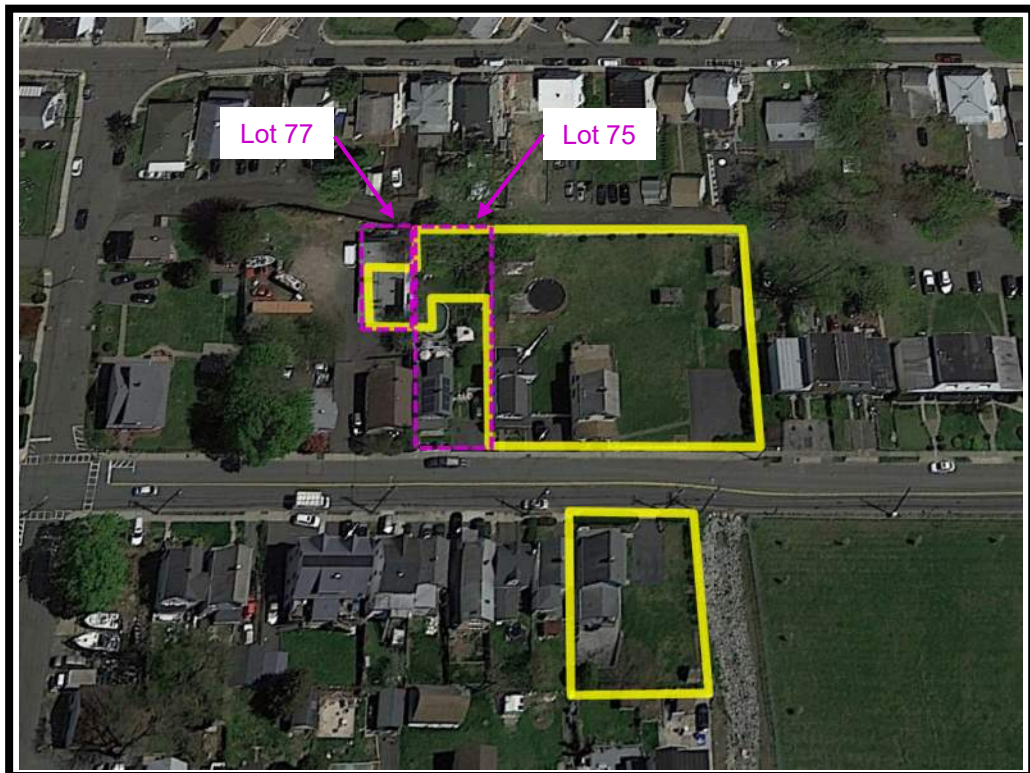
PHOTOGRAPH 2

April 2022 OU-2 Site Conditions. SMP Applies to Lots 75 and 77 Within OU-2.

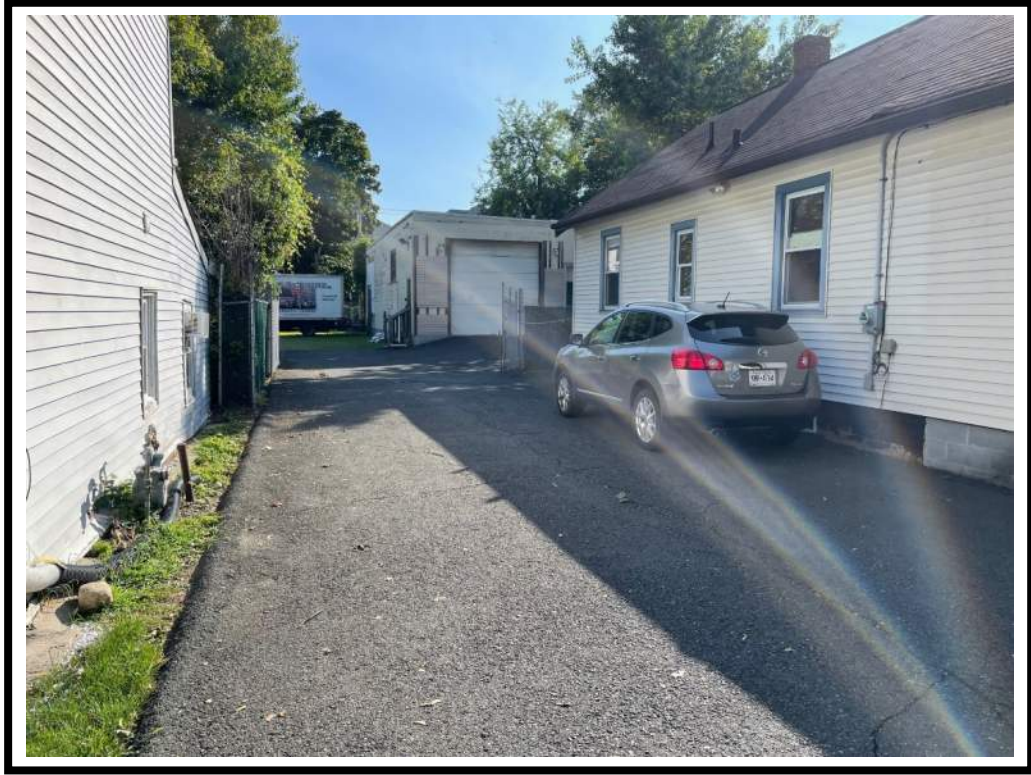
PHOTOGRAPH 3

August 2023 93B Maple Avenue Vacant Lot and 93A Maple Avenue Concrete Block Building (Lot 77)
From Driveway of 93 Maple Avenue

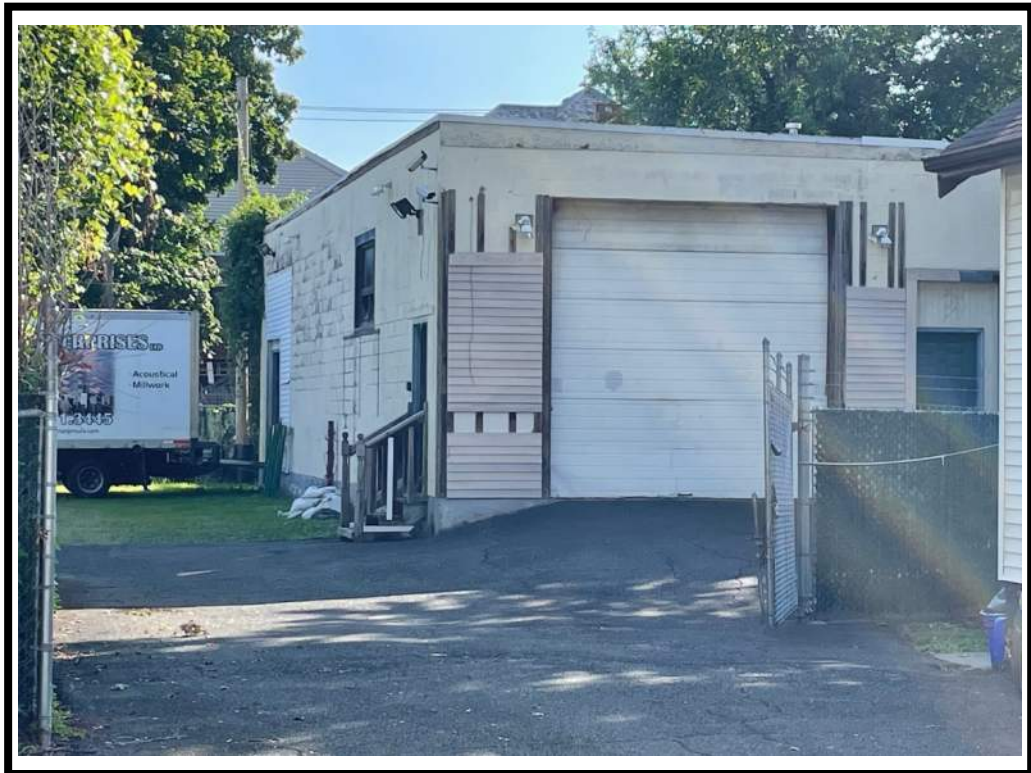
PHOTOGRAPH 4

August 2023 93A Maple Avenue Concrete Block Building (Lot 77)
from Driveway of 95 Maple Avenue

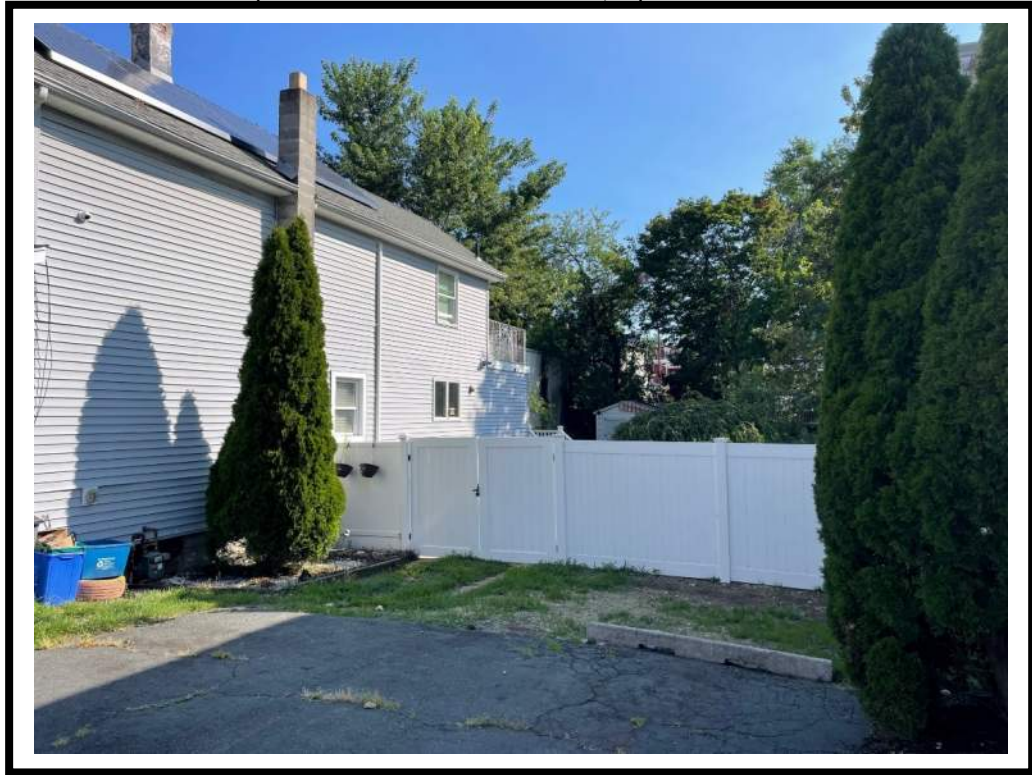
PHOTOGRAPH 5

August 2023 93A Maple Avenue Concrete Block Building (Lot 77) and Rear of 95 Maple Avenue Property (Lot 75) from Driveway of 95 Maple Avenue

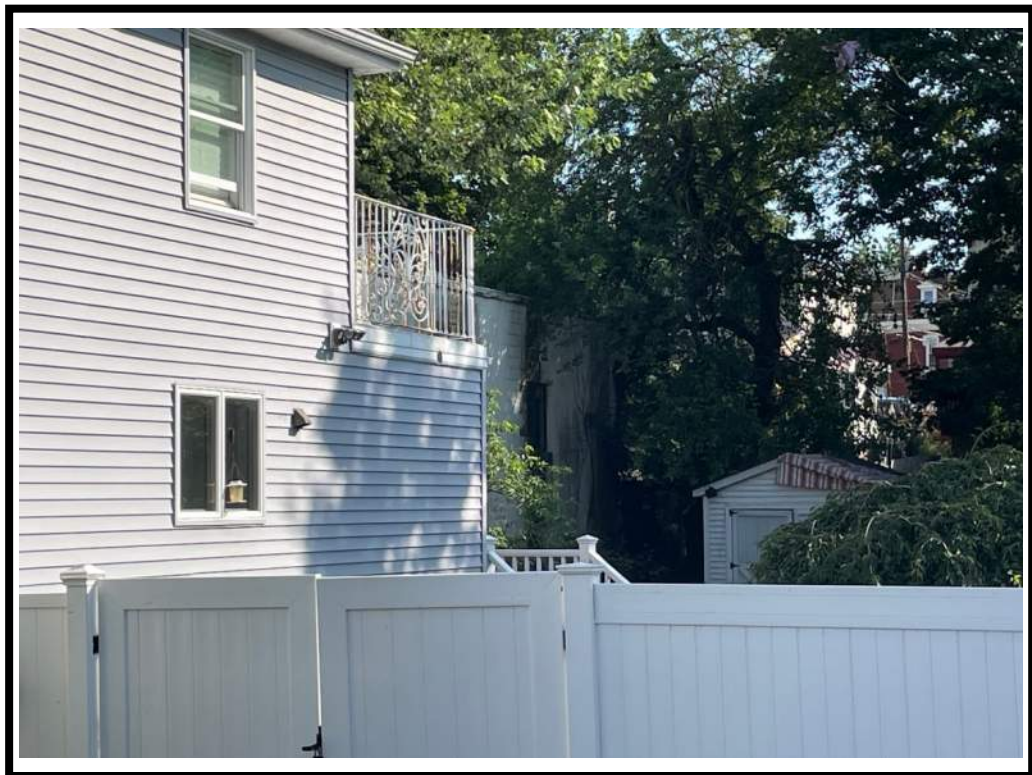
PHOTOGRAPH 6

August 2023 93A Maple Avenue Concrete Block Building (Lot 77) and Rear of 95 Maple Avenue Property (Lot 75) from Driveway of 95 Maple Avenue

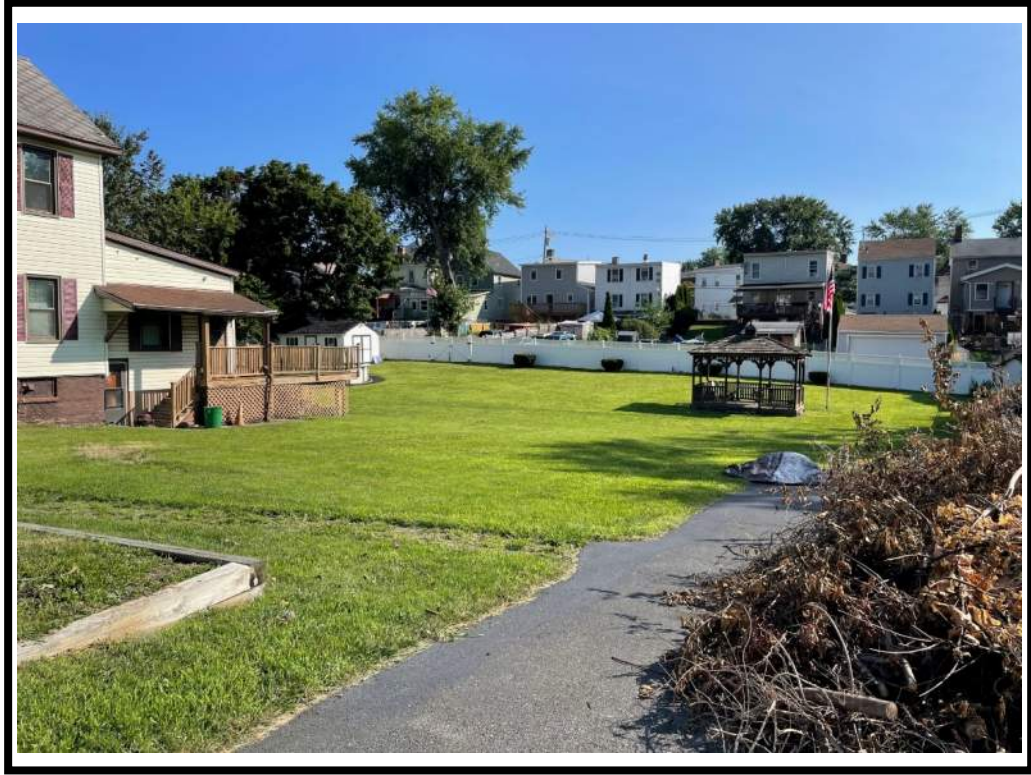
PHOTOGRAPH 7

August 2023 Rear of 99 Maple Avenue and 103 Maple Avenue Properties (Lots 74 and 73) from Driveway of 103 Maple Avenue. Lots 74 and 73 Are Not Included in OU-2 SMP Area.

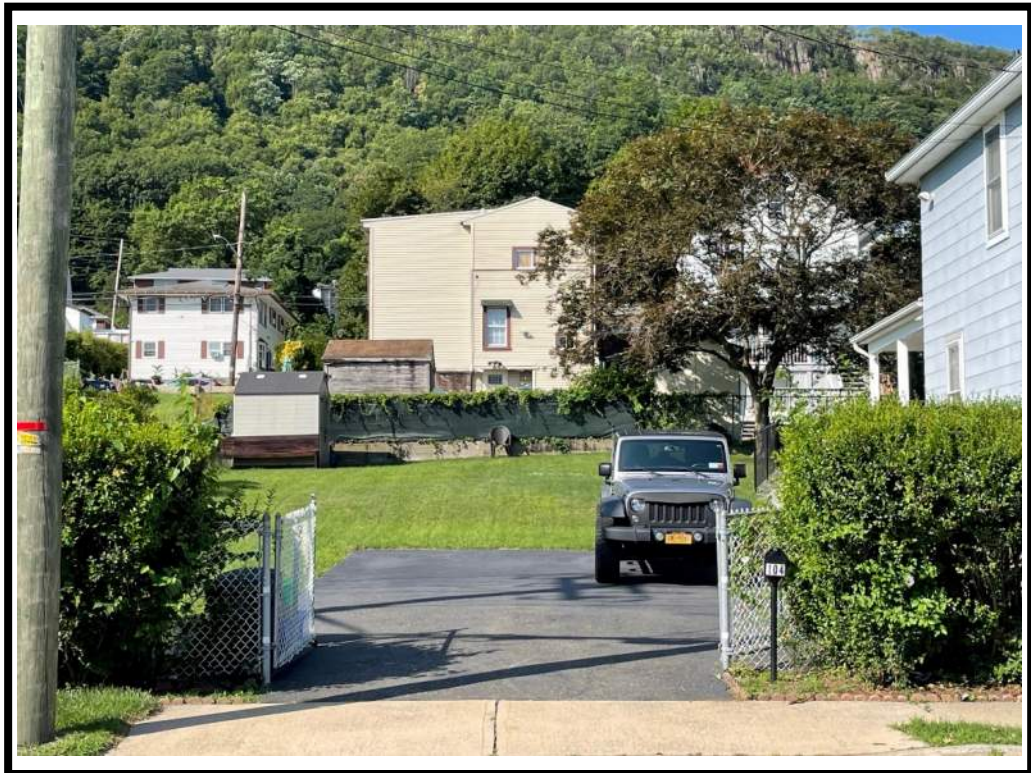
PHOTOGRAPH 8

August 2023 104 Maple Avenue Properties (Lot 8) from Maple Avenue Sidewalk. Lot 8 Is Not Included in OU-2 SMP Area
