Hurricane Project Status Report

Site Name: **Nyack MGP**

Address: **Gedney St. Nyack, NY**

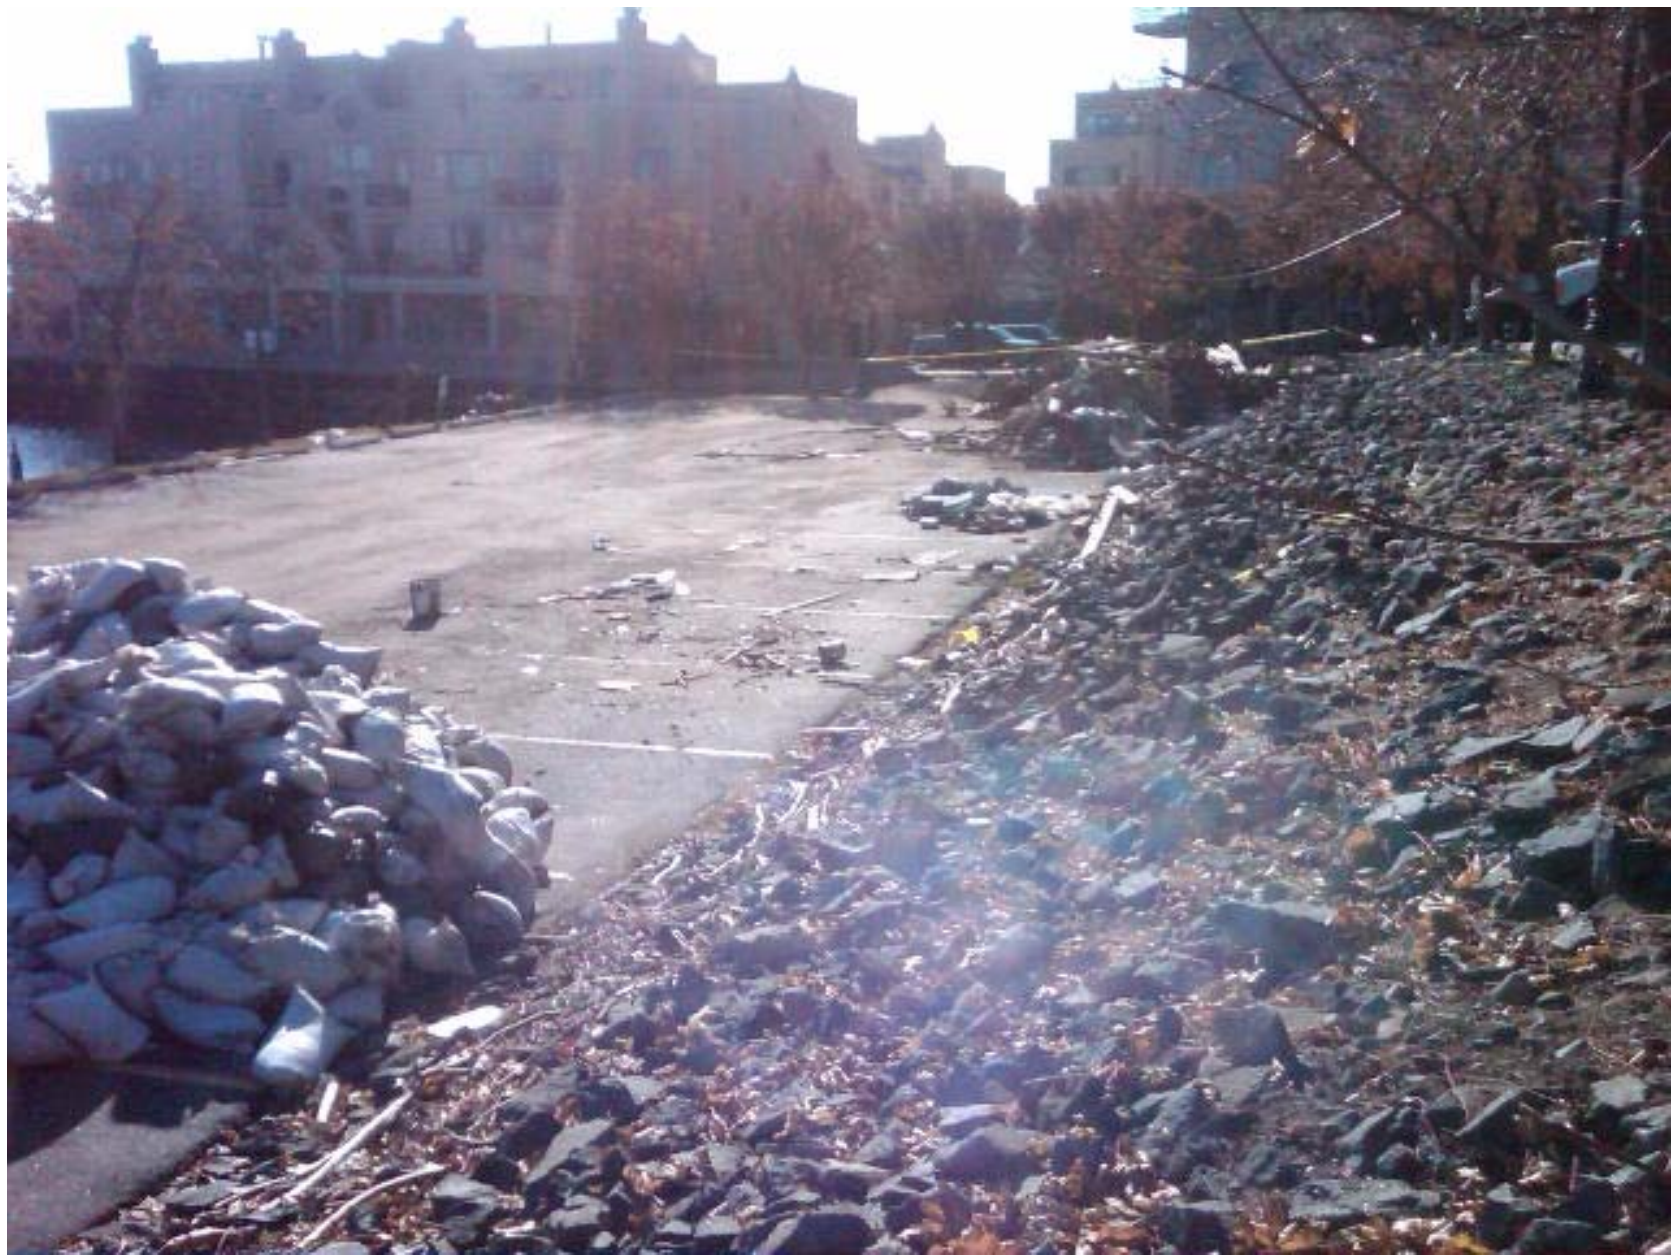
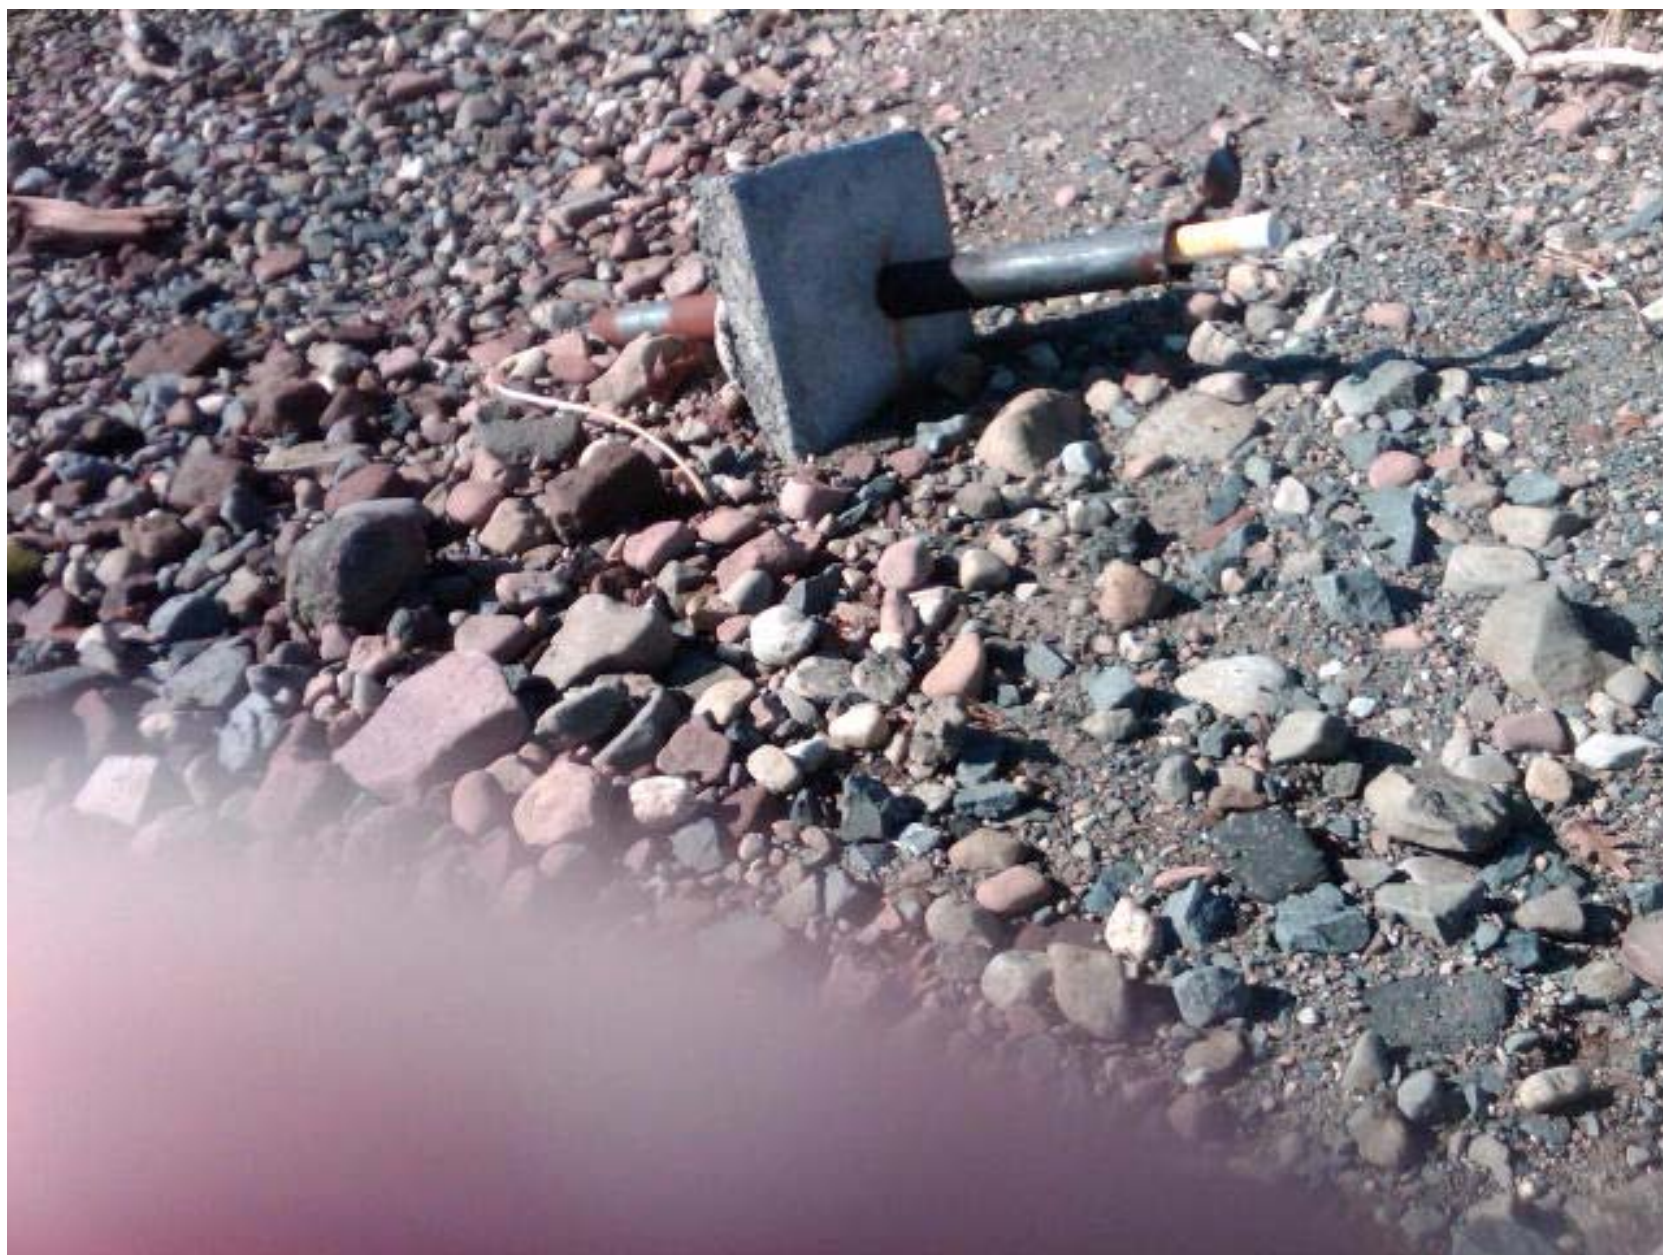
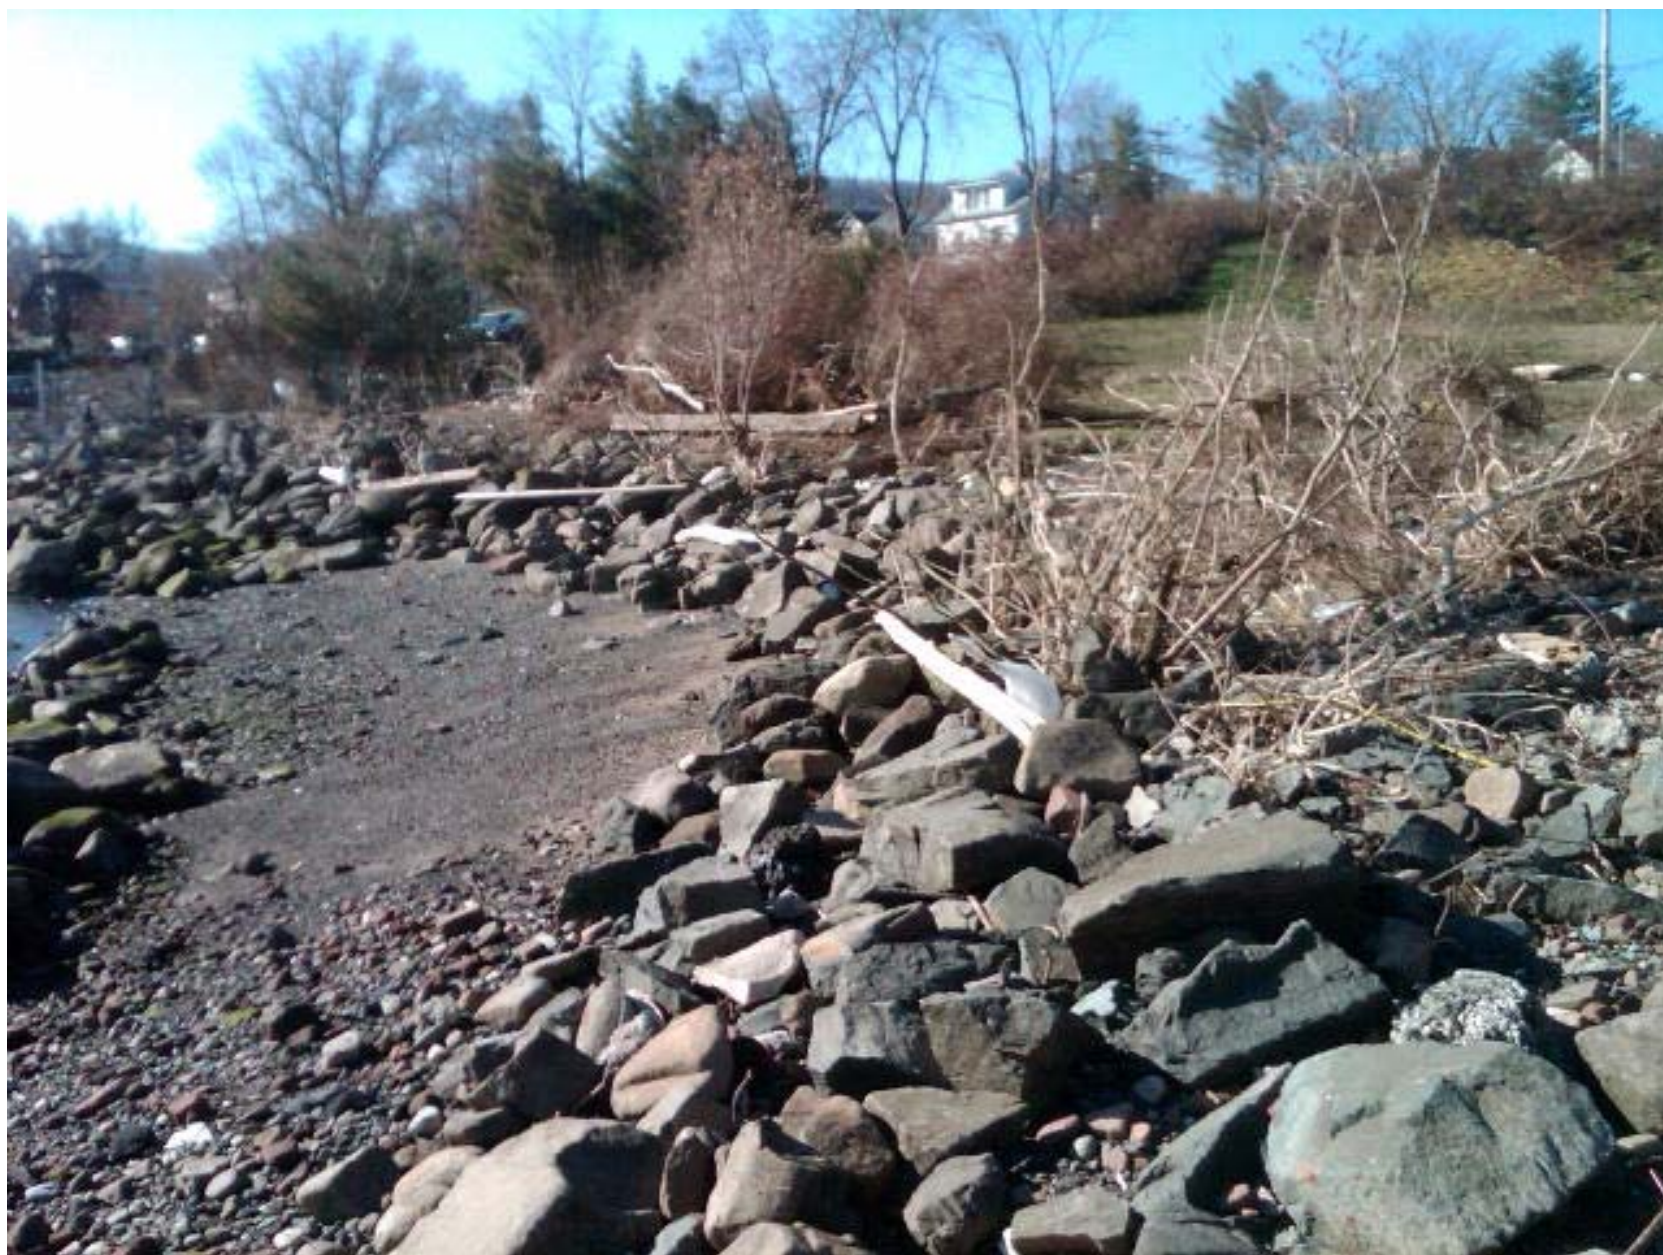
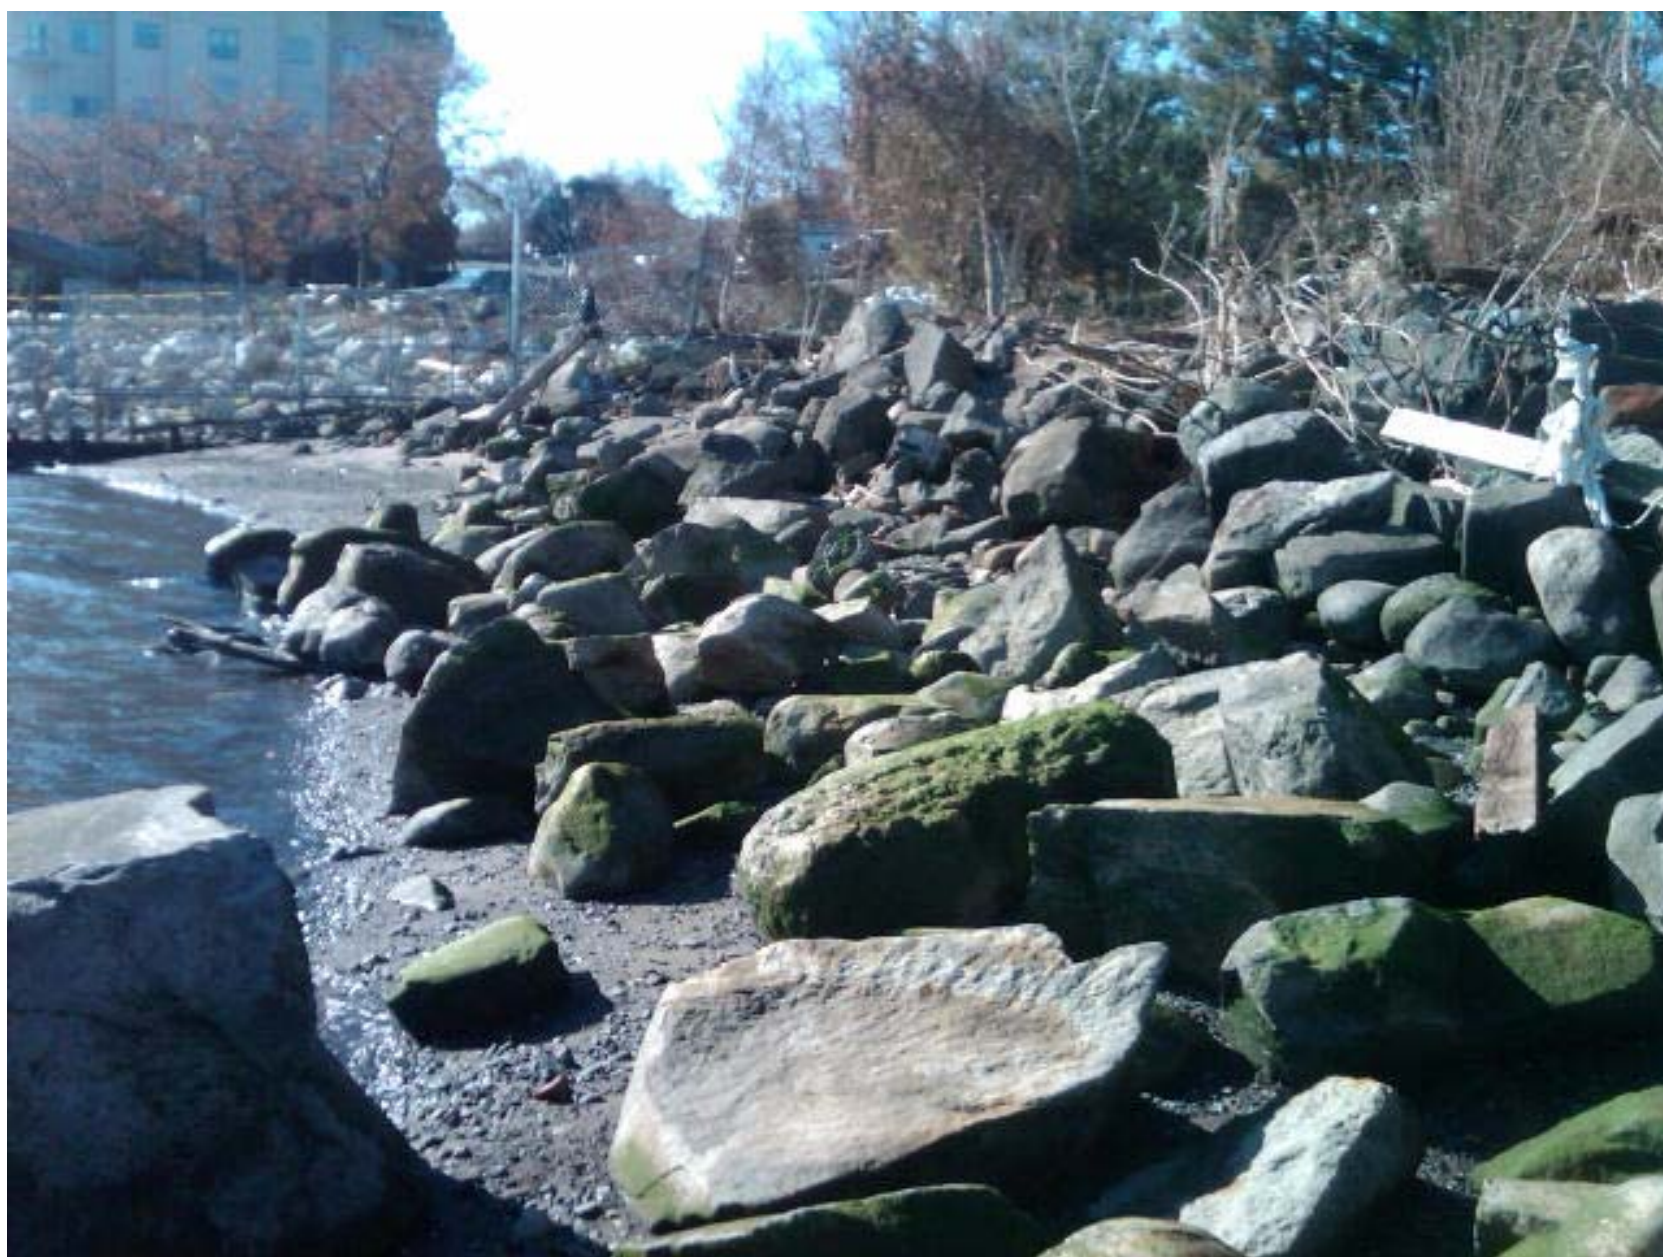
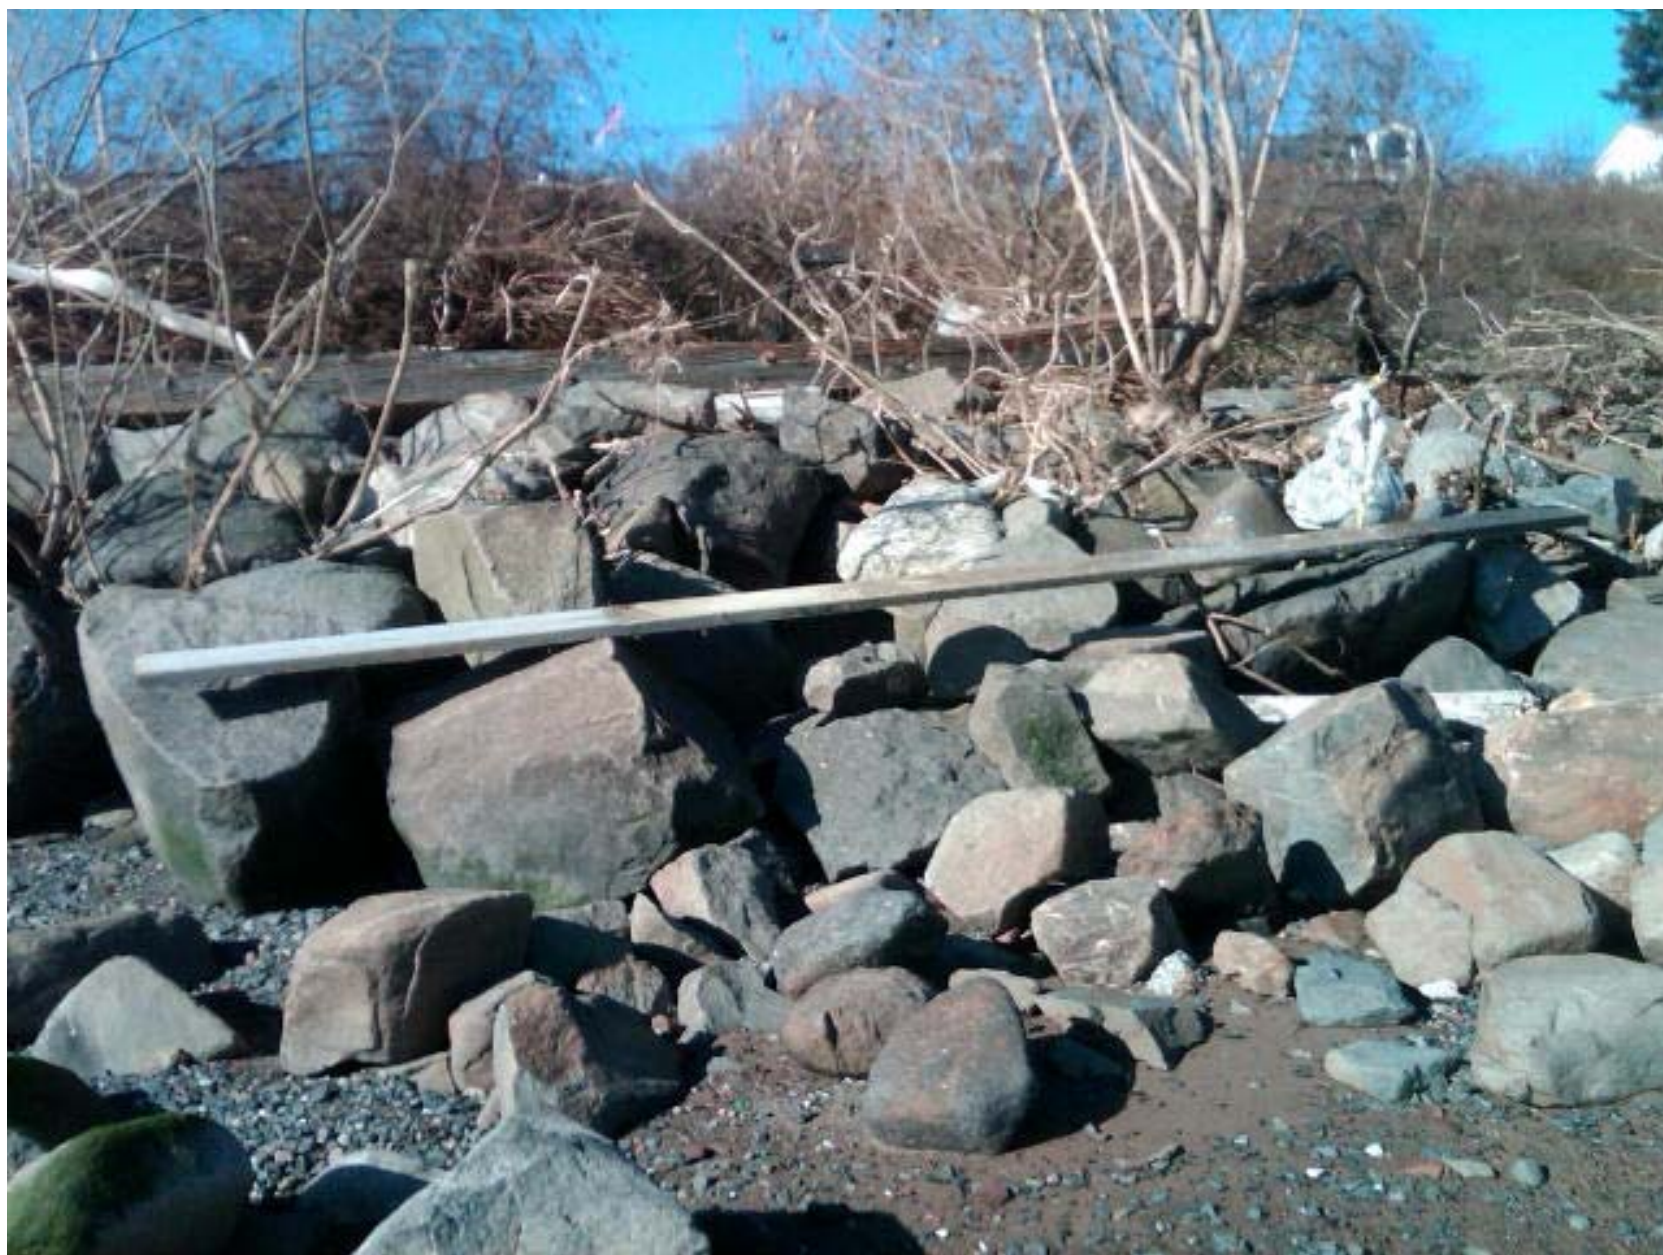
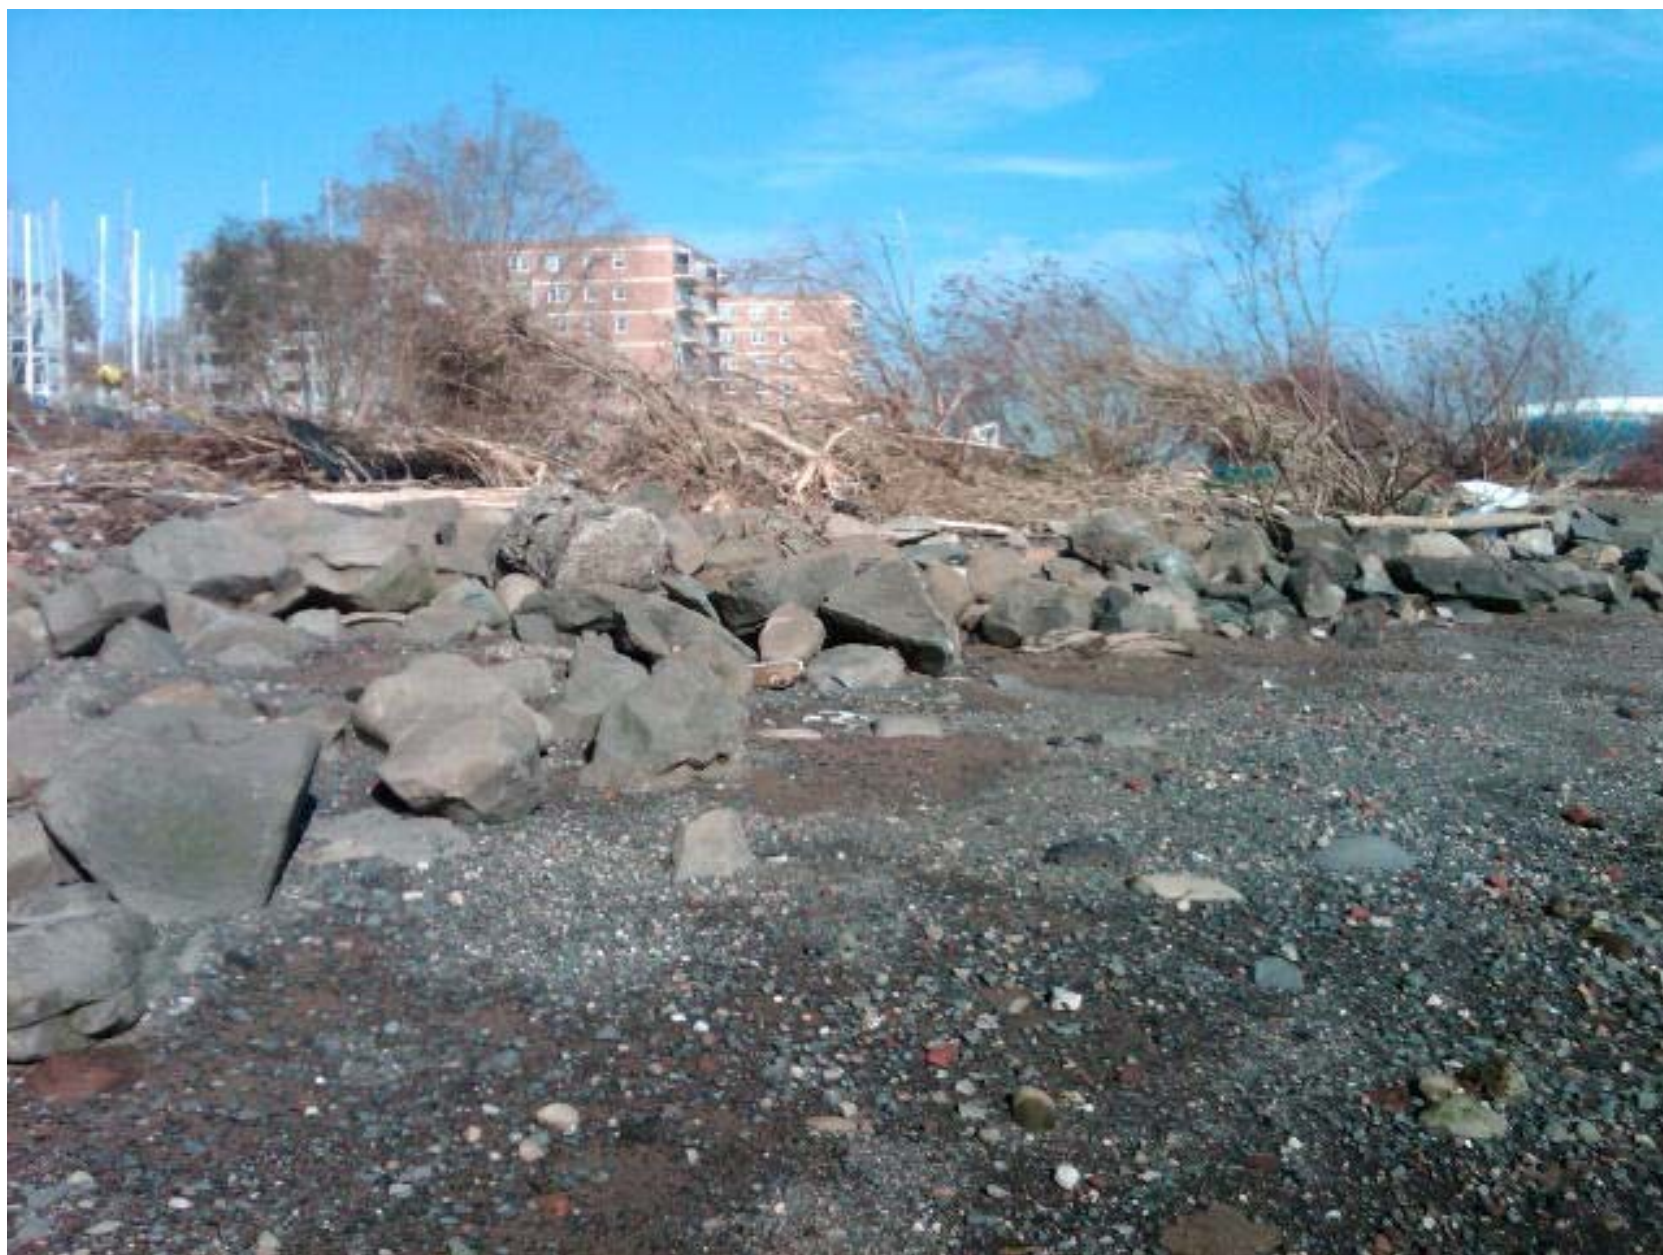
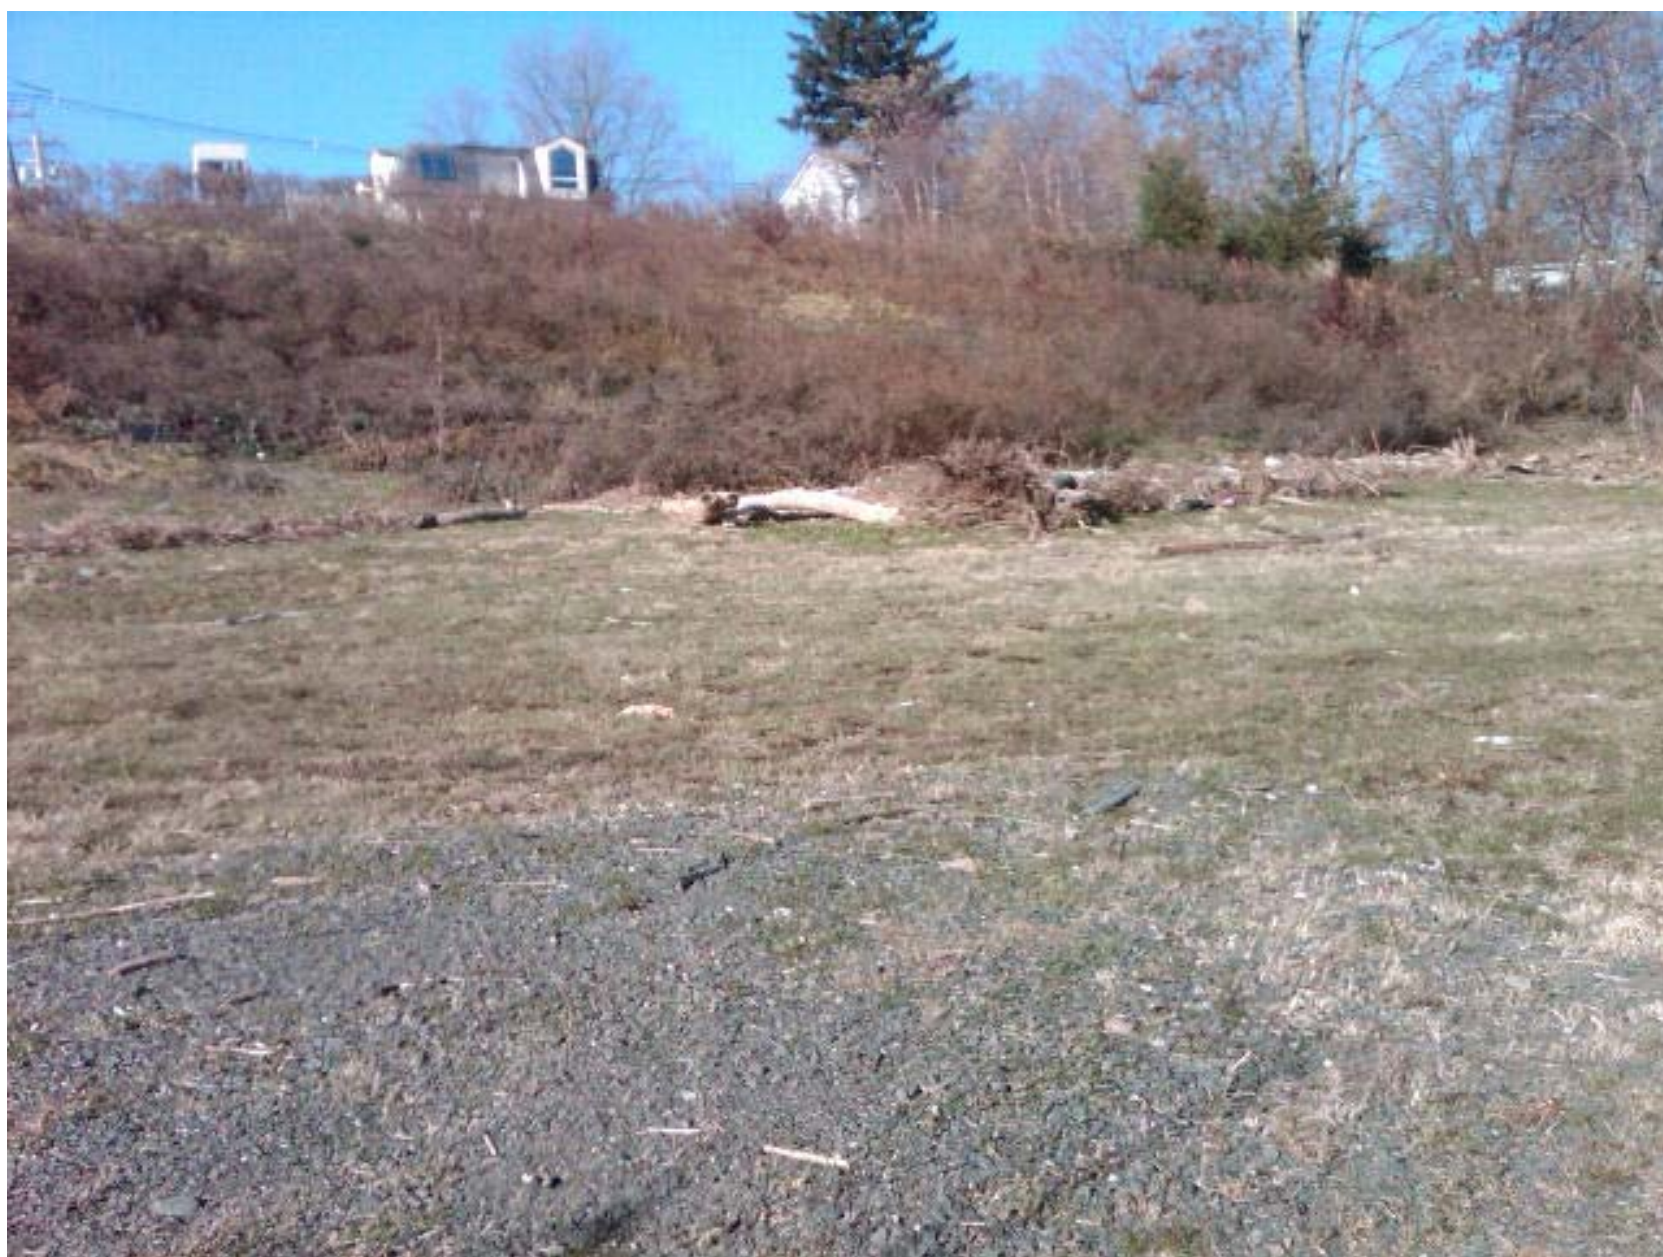
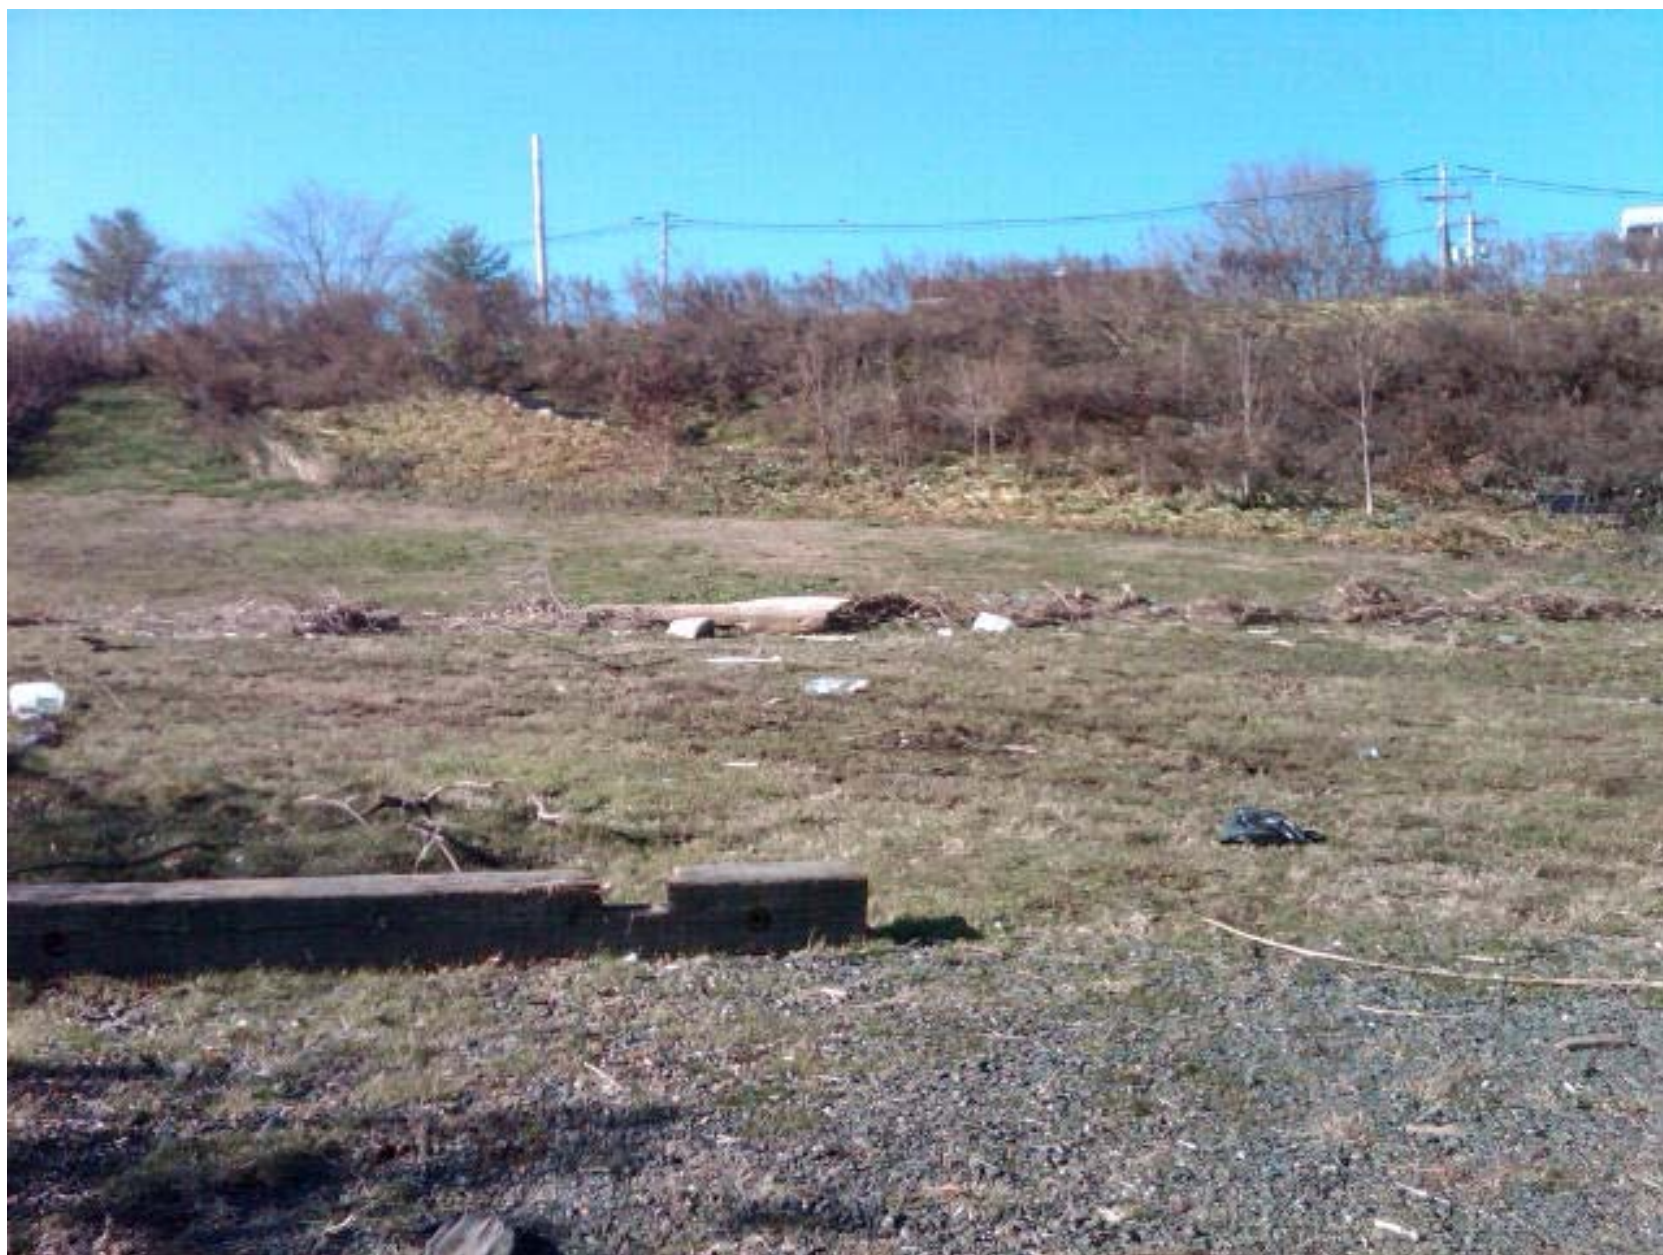
If yes, please describe the approximate volume, nature of impact and area of impact (mud in roads, etc.). Also provide photograph. **Photos attached showing shoreline and debris line on lower terrace.** _____

Was there any erosion damage? **Rip rap along shoreline appears intact. Shoreline vegetation was damaged by storm surge.** _____

Have all active remedial systems (GW pump and treatment, SVE/AS, SSDS) been checked and verified to be operating properly? MW- 42 was found to be damaged (Photo attached)

been removed from site. The second boat was on site on 11/23 but had an insurance inspection sticker on it so O&R expects that boat will be removed from site shortly. IDW on site was on the upper terrace. Drums are secure and undamaged. Photos attached.

What corrective actions are planned? O&R will coordinate with GEI to either repair or decommission MW-42
