2020 Annual Report Site Management Plan

**Nyack Manufactured Gas Plant Site
Village of Nyack, Rockland County, New York**

**NYSDEC Site Number: 344046
Index # D3-001-98-08**

December 2020

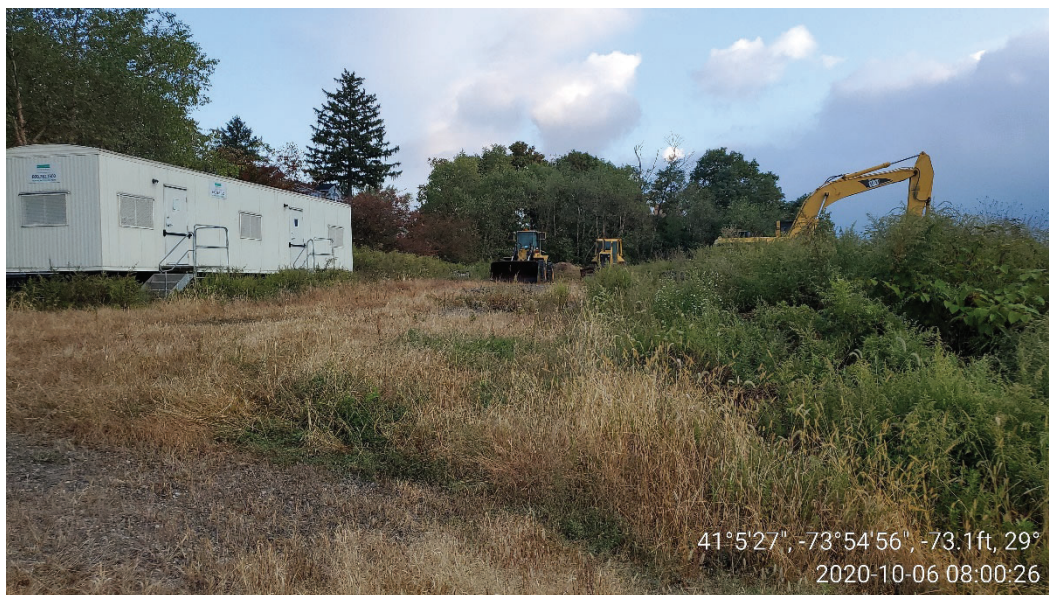
Photo No.: 1
Photographer: S. DiBartolo
Date: 10/6/2020
Direction: North

Comments:
Upper Terrace

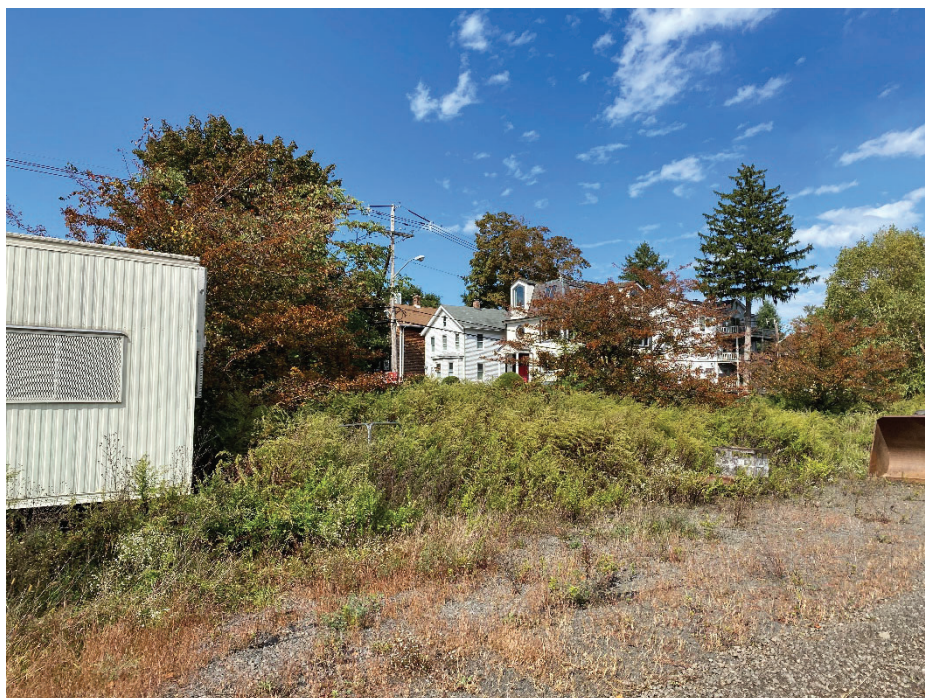
Photo No.: 2
Photographer: E. Christian
Date: 10/2/2020
Direction: Northwest

Comments:
Upper Terrace

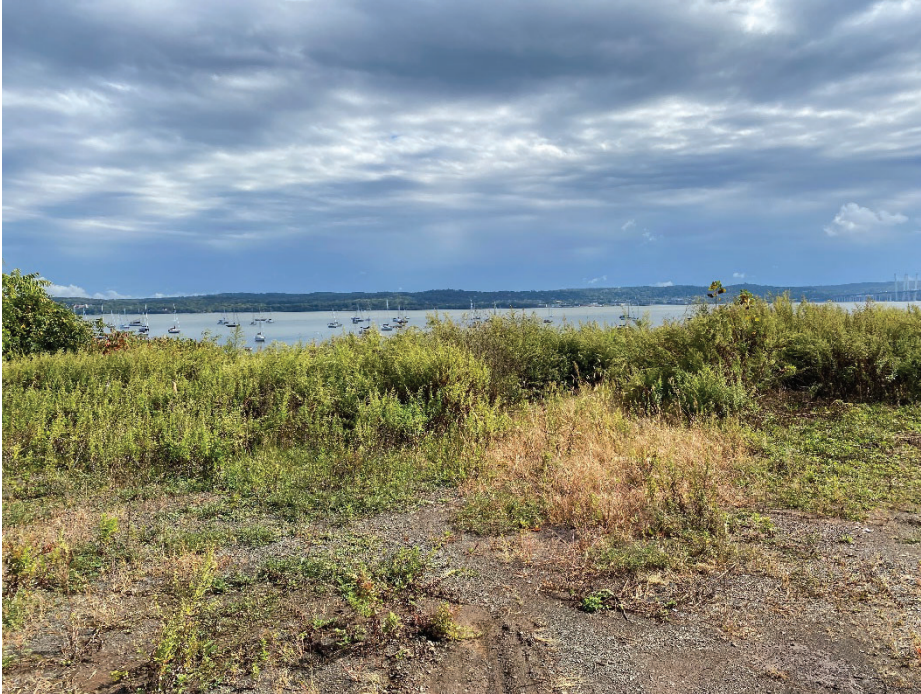
Photo No.: 3
Photographer: E. Christian
Date: 10/2/2020
Direction: East

Comments:
Upper Terrace

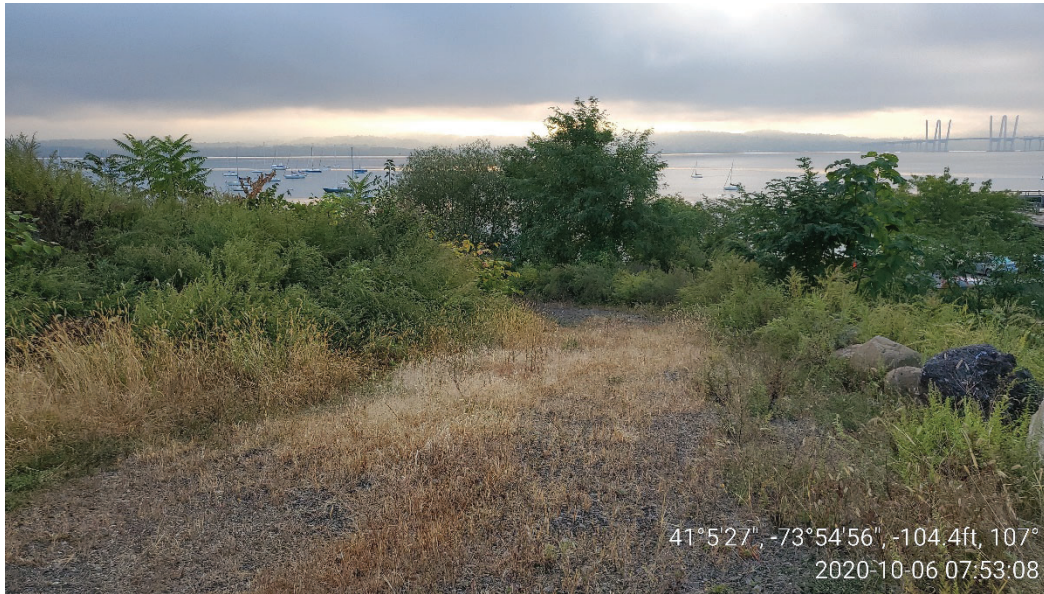
Photo No.: 4
Photographer: S. DiBartolo
Date: 10/6/2020
Direction: East

Comments:
Lower Terrace and Hudson
River Area

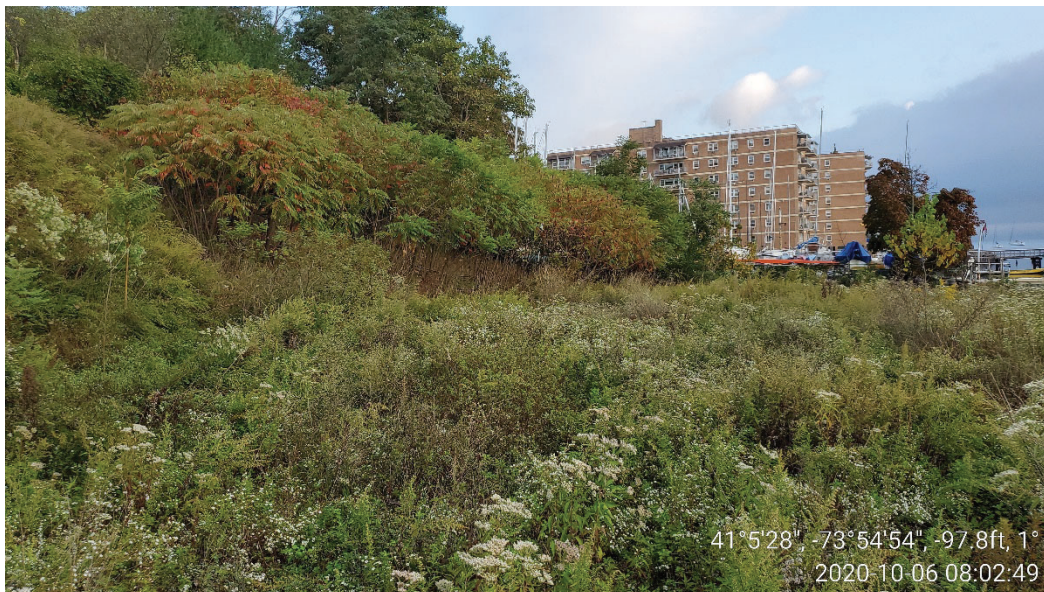
Photo No.: 5
Photographer: S. DiBartolo
Date: 10/6/2020
Direction: North

Comments:
Lower Terrace

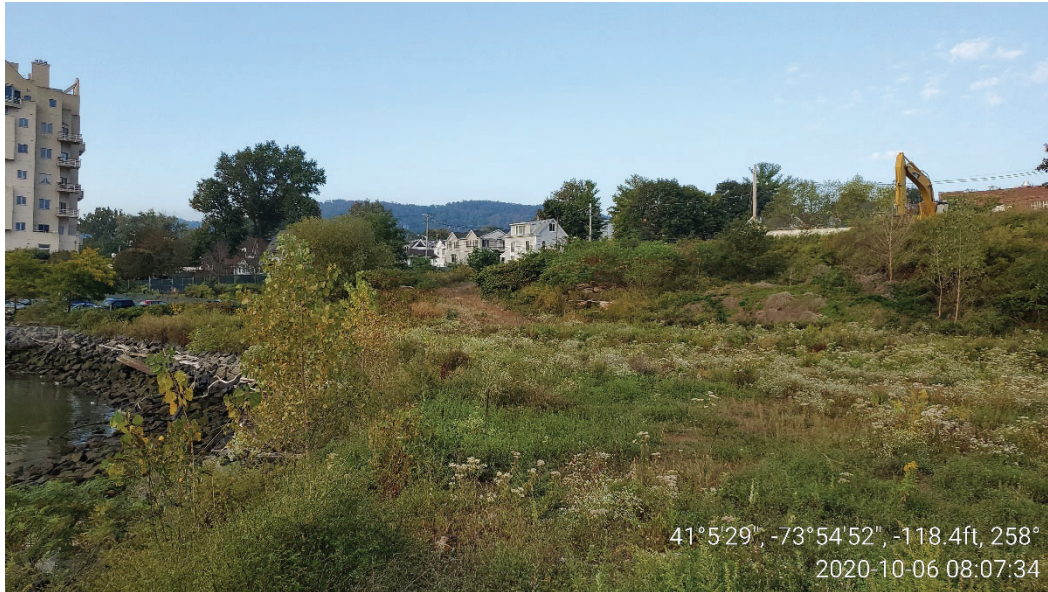
Photo No.: 6
Photographer: S. DiBartolo
Date: 10/6/2020
Direction: Southwest

Comments:
Lower Terrace

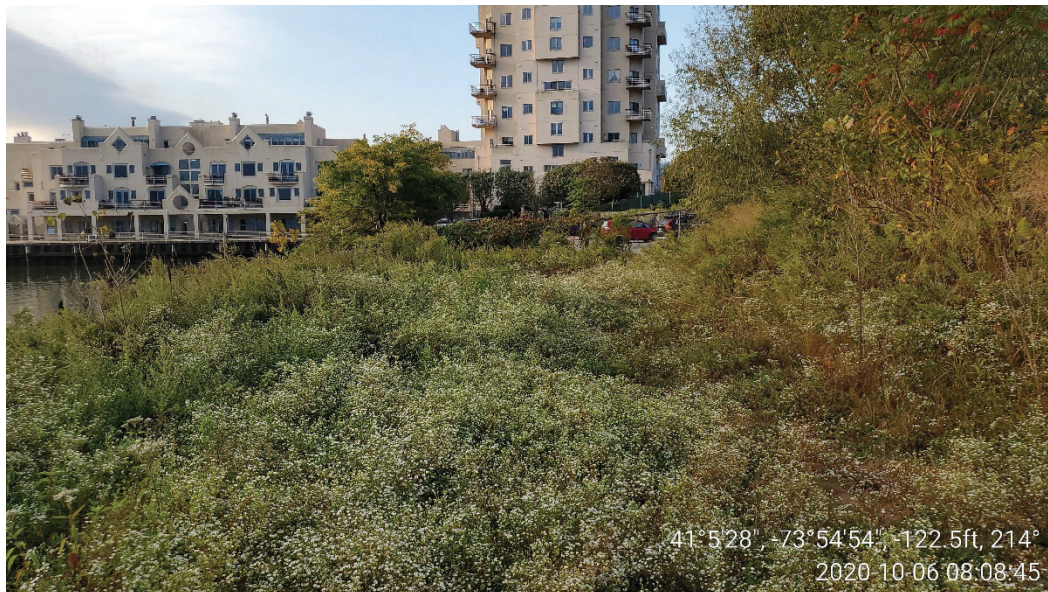
Photo No.: 7
Photographer: S. DiBartolo
Date: 10/6/2020
Direction: South

Comments:
Lower Terrace towards
Hudson Vista Parking Lot

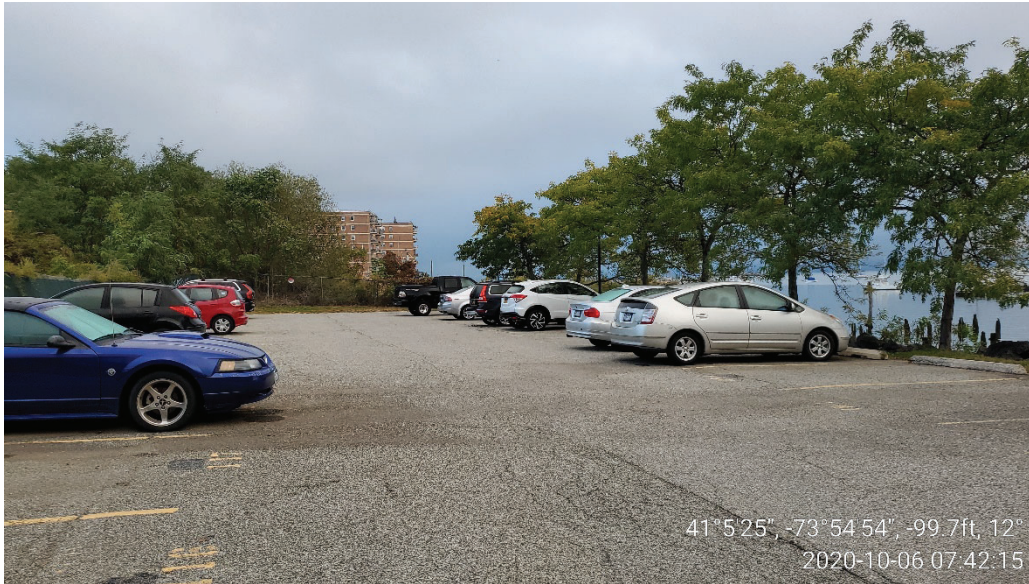
Photo No.: 8
Photographer: S. DiBartolo
Date: 10/6/2020
Direction: North

Comments:
Hudson Vista Associates
Parcel lower parking lot
portion of surface cover

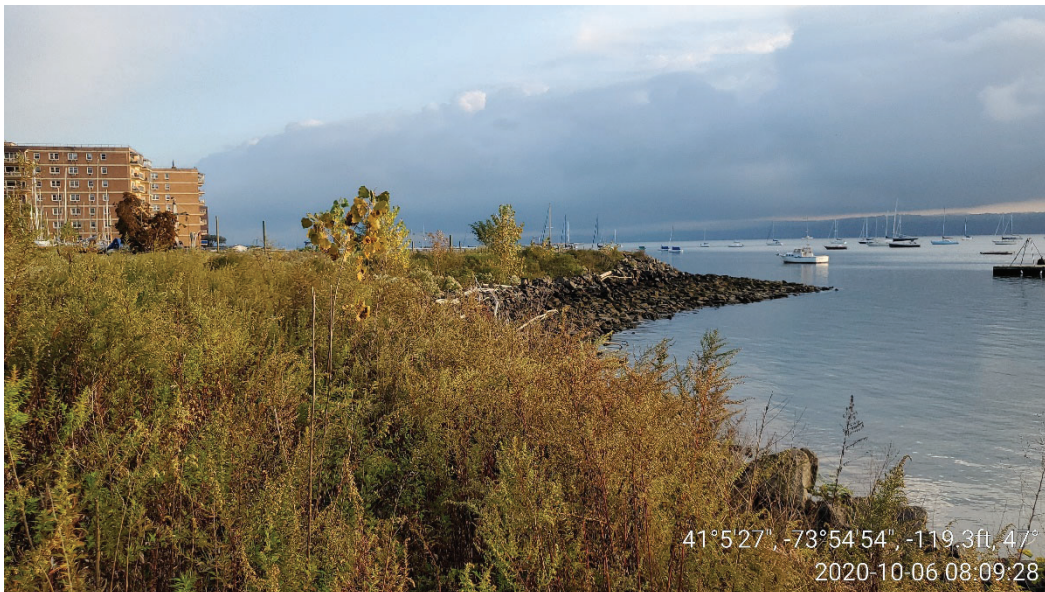
Photo No.: 9
Photographer: S. DiBartolo
Date: 10/6/2020
Direction: Northeast

Comments:
Lower Terrace and Riprap
Slope

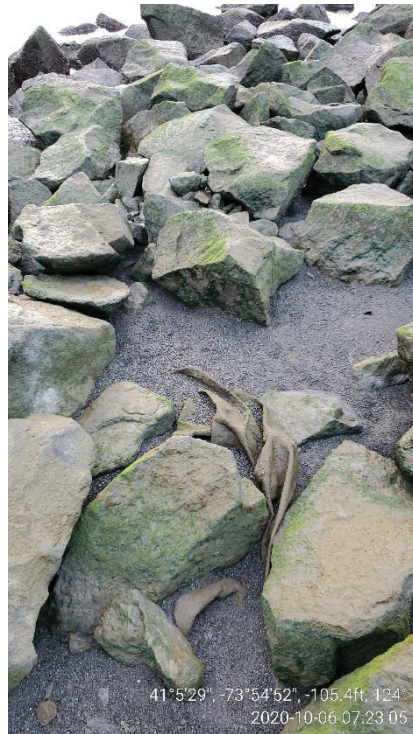
Photo No.: 10
Photographer: S. DiBartolo
Date: 10/6/2020
Direction: Southeast

Comments:
Riprap Slope at Hudson River
at Low Tide

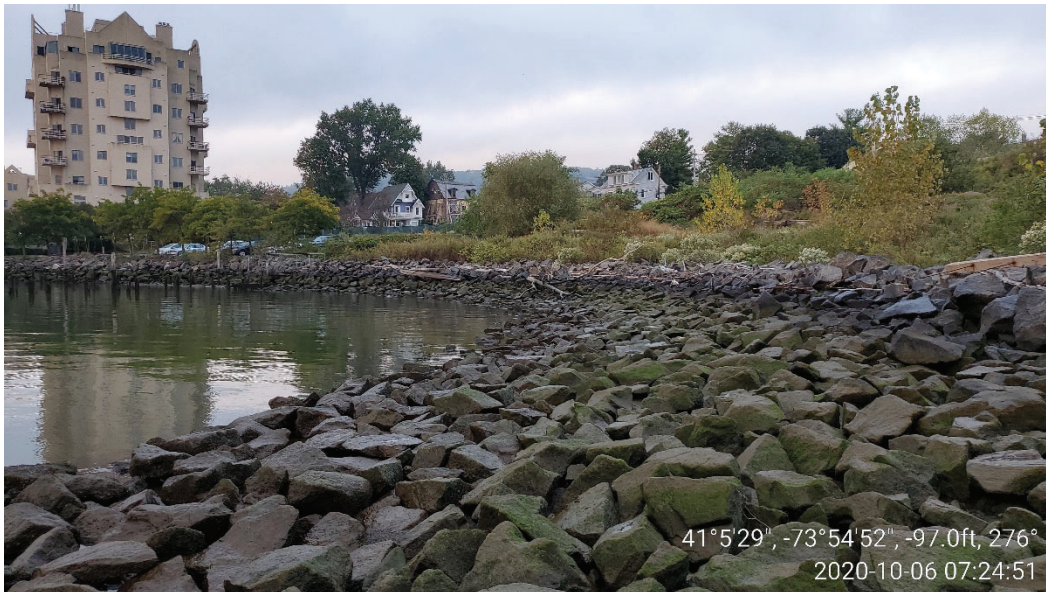
Photo No.: 11
Photographer: S. DiBartolo
Date: 10/6/2020
Direction: Southwest

Comments:
Riprap Slope at Hudson River
at Low Tide

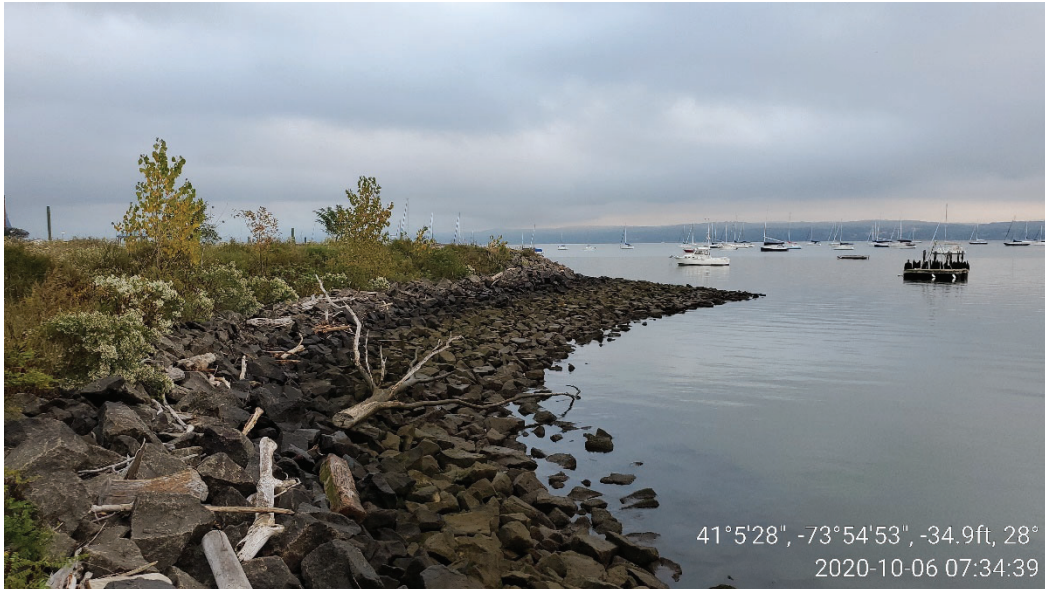
Photo No.: 12
Photographer: S. DiBartolo
Date: 10/6/2020
Direction: Northeast

Comments:
Riprap Slope at Hudson River
at Low Tide

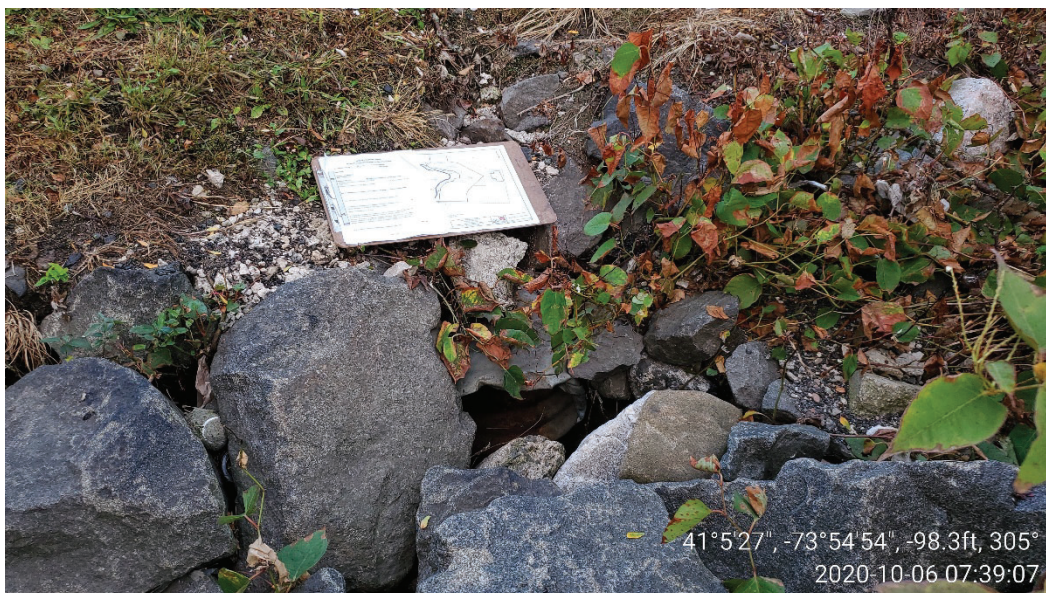
Photo No.: 13
Photographer: S. DiBartolo
Date: 10/6/2020
Direction: Northwest

These features were observed to be present, and not disturbed at the time of the October 6, 2020 site inspection. A photograph of the storm sewer outlet is included in Photographic Record in Appendix B.

There does not appear to have been any construction activities although equipment remains onsite (as shown in the attached photos). It appears that mowing of the site has not been performed in 2020. Minor erosion was observed at the drain outfall pipe at the southeast corner of the site at the north end of the Hudson Vista parking lot (photo is included in attached photo log).

Comments:
Stormwater CMP Outfall at
North end of Hudson Vista
Parking Lot

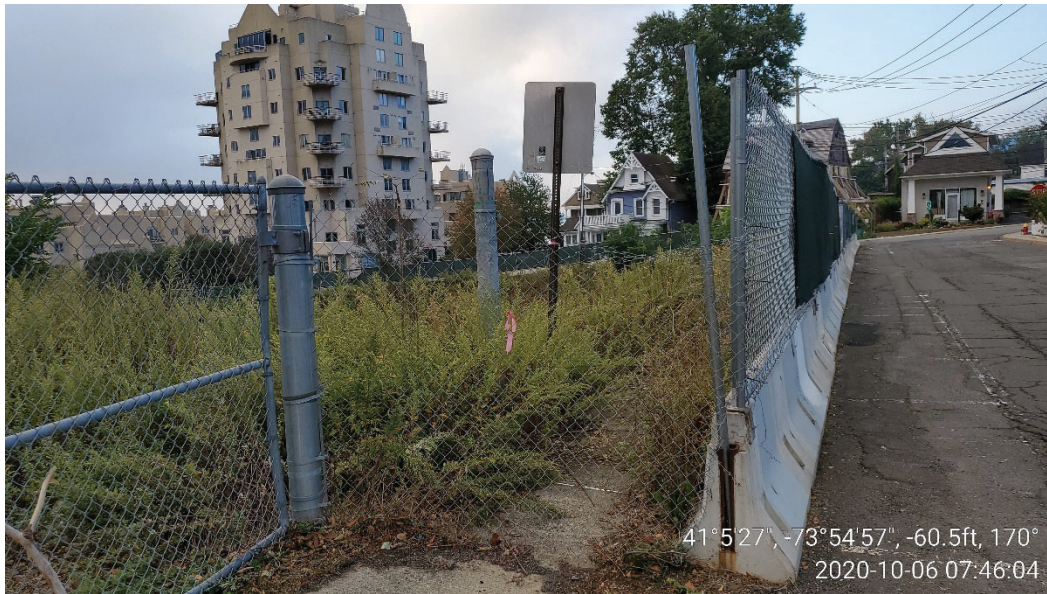
Photo No.: 14
Photographer: S. DiBartolo
Date: 10/6/2020
Direction: South

Comments:
Perimeter fence at Gedney Street

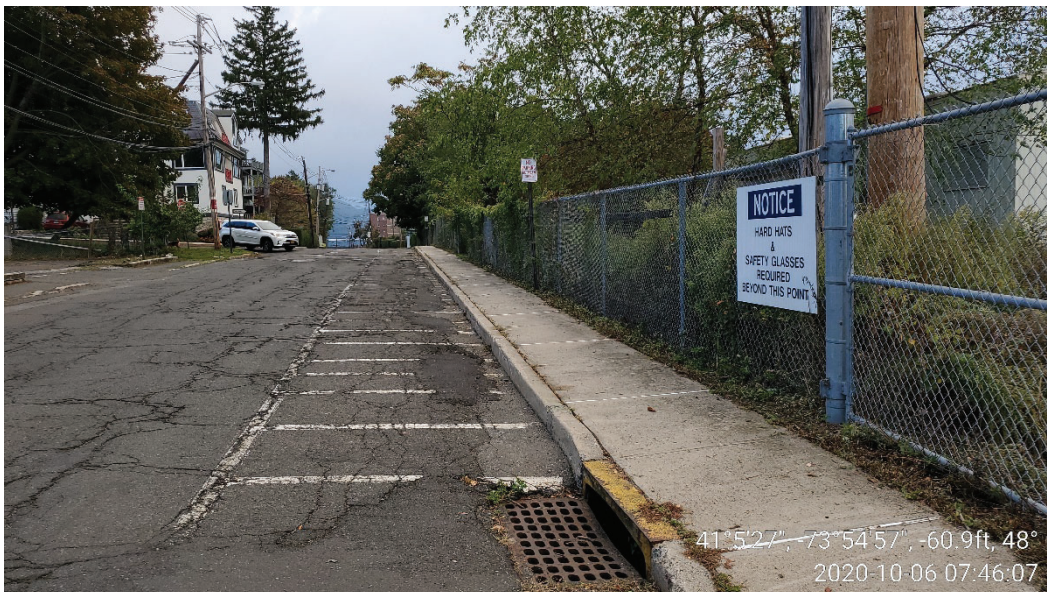
Photo No.: 15
Photographer: S. DiBartolo
Date: 10/6/2020
Direction: Northeast

Comments:
Perimeter fence at Gedney Street

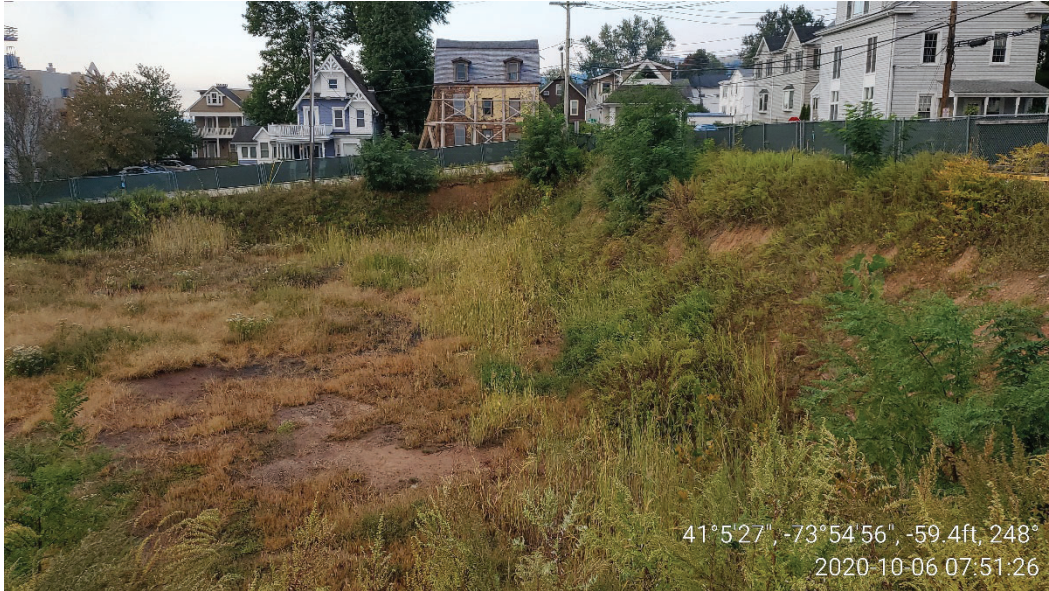
Photo No.: 16
Photographer: S. DiBartolo
Date: 10/6/2020
Direction: Southwest

Comments:
Perimeter fence at Main Street
(upper left side of photo) and
Gedney Street (upper right
side of photo)
