2021 Periodic Review Report

Nyack Manufactured Gas Plant Site Village of Nyack, Rockland County, New York

NYSDEC Site Number: 344046 Index # D3-001-98-08

December 2021 Project 2101497

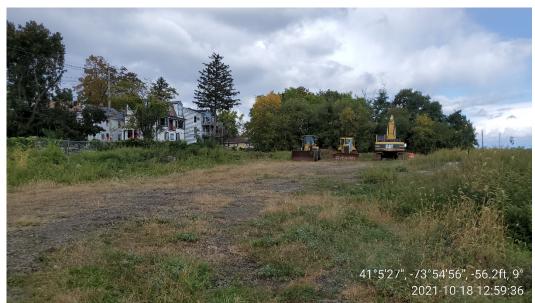
Photo No.: 1

Comments:
Upper Terrace

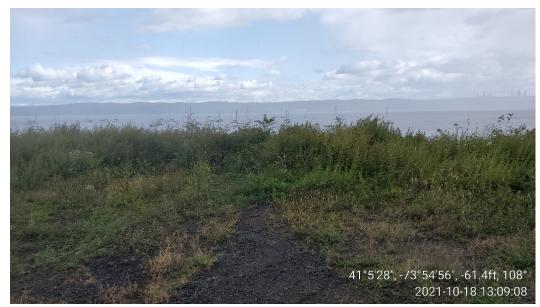
Photo No.: 3

Comments:
Upper Terrace

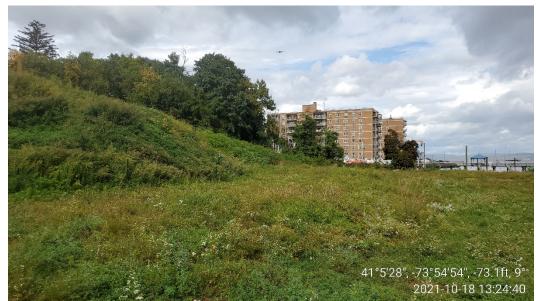
Photo No.: 5

Comments: Lower Terrace

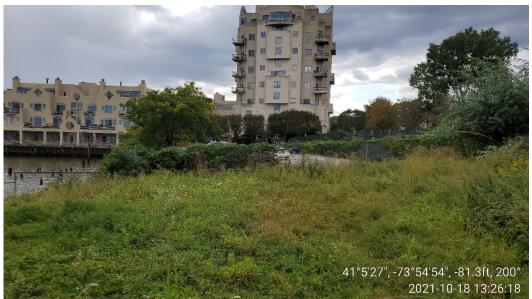
Lower Terrace towards Hudson Vista Parking Lot

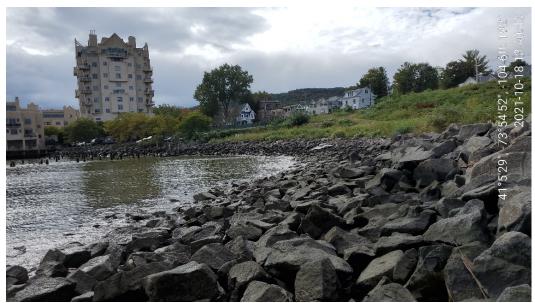
Photo No.: 11

Riprap Slope at Hudson River

at Low Tide

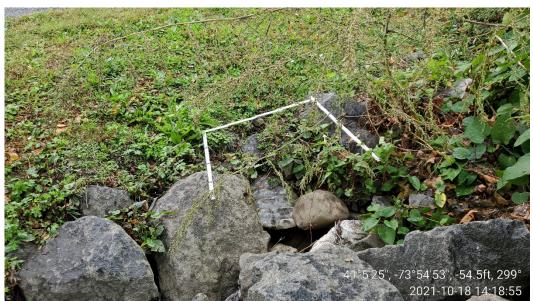
Photo No.: 13

These features were observed to be present, and not disturbed at the time of the October 18, 2021 site inspection. While some minor erosion exists at the storm sewer outlet, it is localized and has not changed from that which was observed during prior events. A photograph of the storm sewer outlet is included in the Photographic Record in Appendix B.

Stormwater CMP Outfall at North end of Hudson Vista

Parking Lot

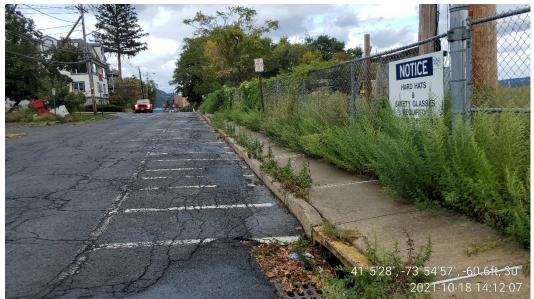
Photo No.: 15

Perimeter fence at Gedney

Street

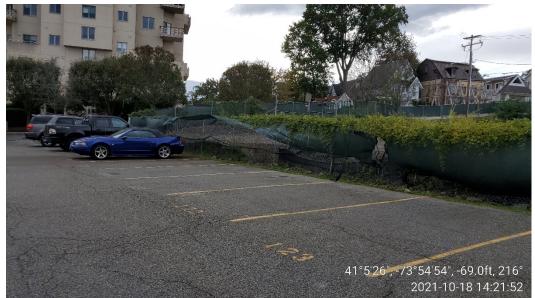
Photo No.: 17

Perimeter fence at Hudson Vista Associates Parcel lower parking lot. Fence in disrepair
