2022 Periodic Review Report

Nyack Manufactured Gas Plant Site Village of Nyack, Rockland County, New York

NYSDEC Site Number: 344046
Index # D3-001-98-08

December 2022
Project 2202333

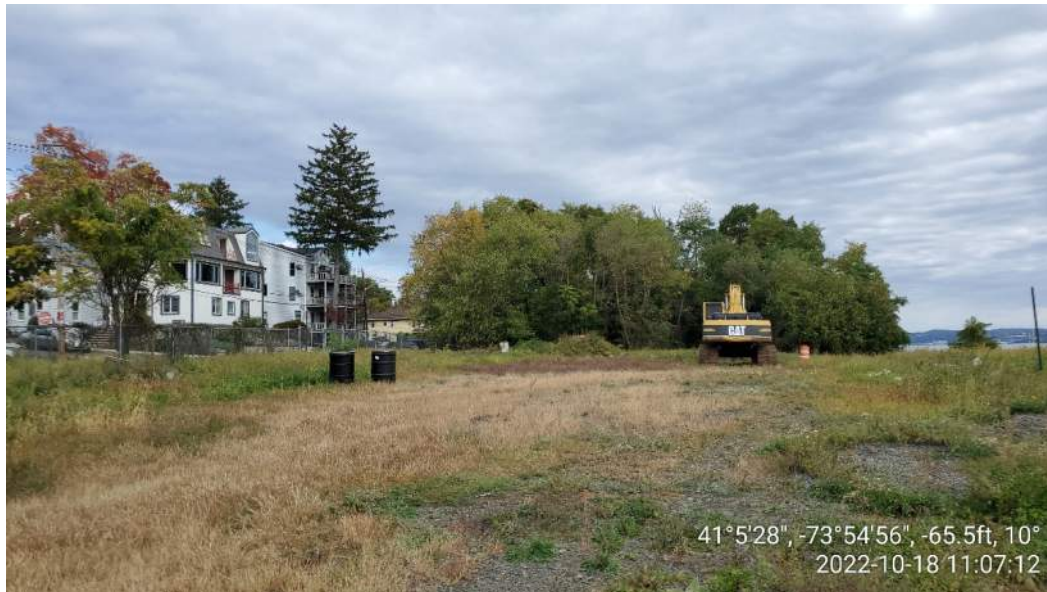
Photo No.: 1
Photographer: S. DiBartolo
Date: 10/18/2022
Direction: North
Comments:
Upper Terrace

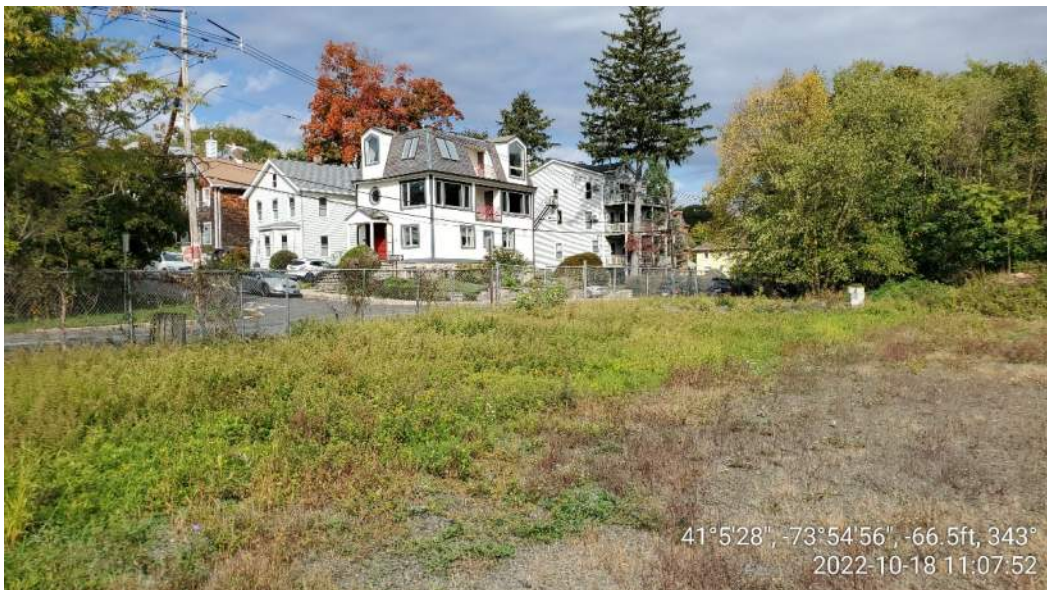
Photo No.: 2
Photographer: S. DiBartolo
Date: 10/18/2022
Direction: Northwest
Comments:
Upper Terrace

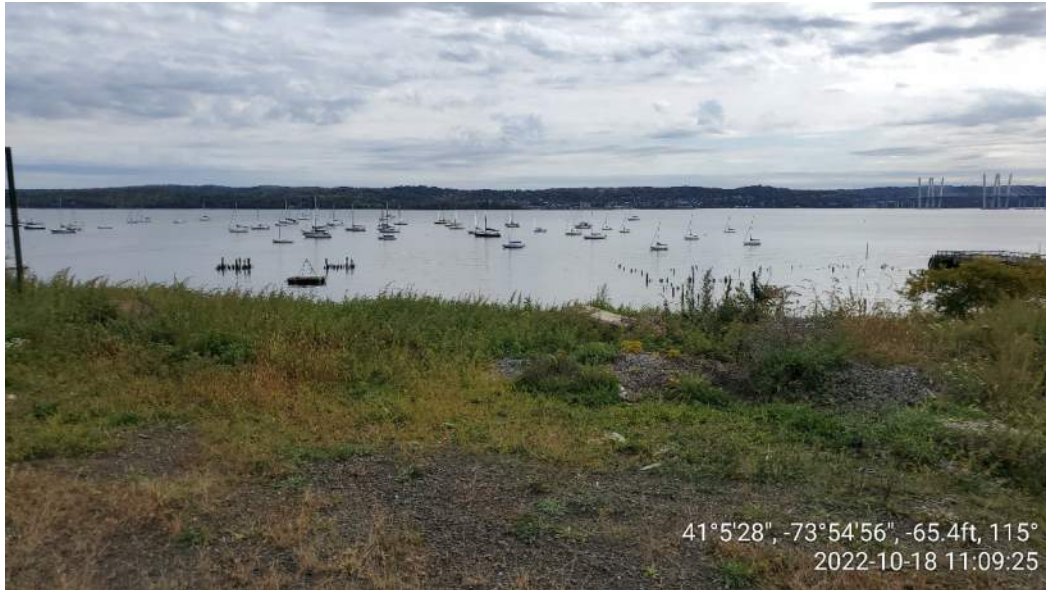
Photo No.: 3
Photographer: S. DiBartolo
Date: 10/18/2022
Direction: East
Comments:
Upper Terrace

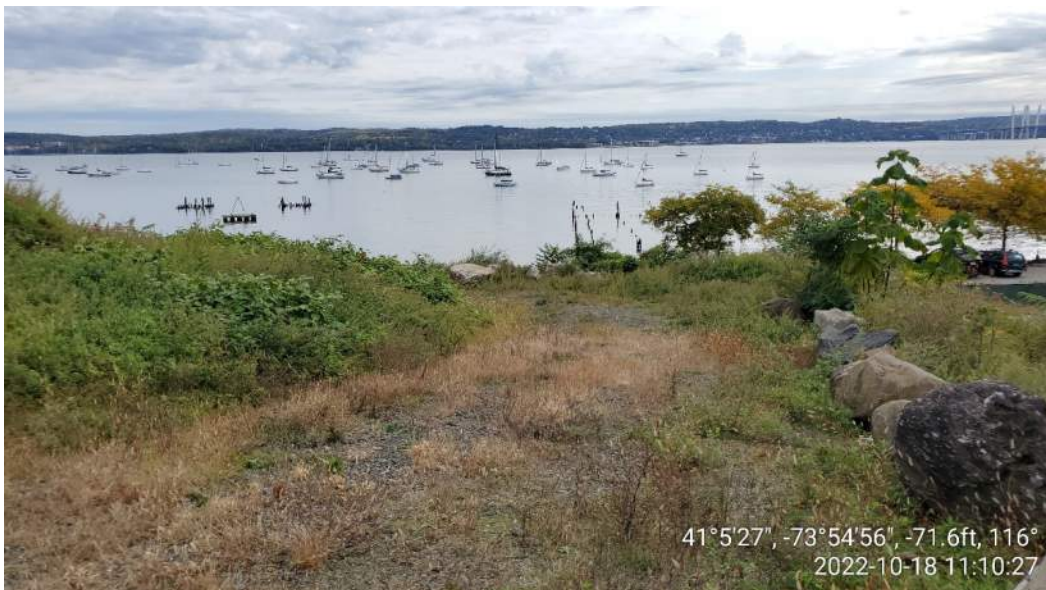
Photo No.: 4
Photographer: S. DiBartolo
Date: 10/18/2022
Direction: East
Comments:
Lower Terrace and Hudson
River Area

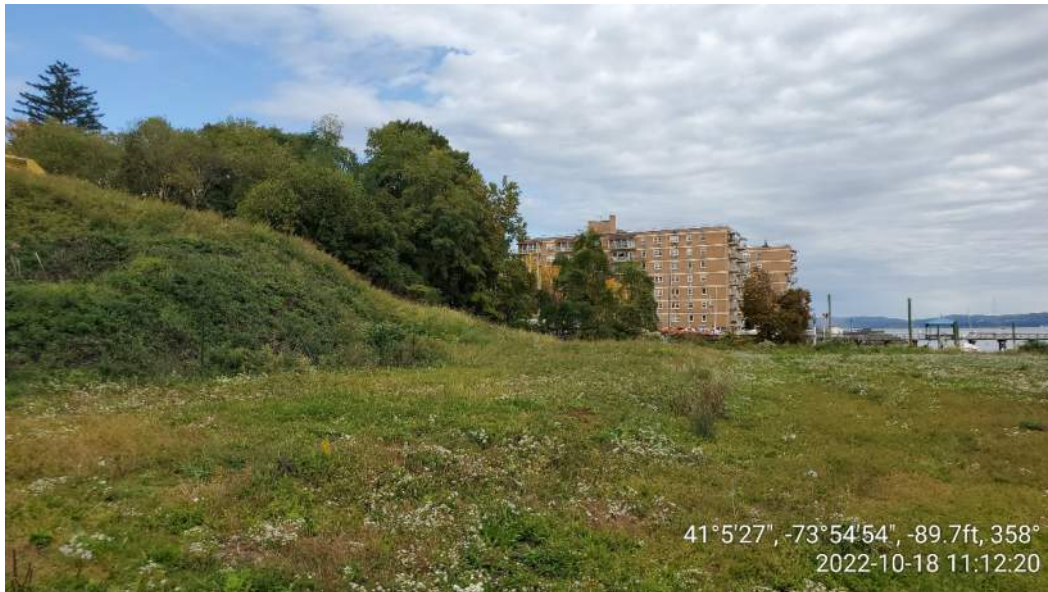
Photo No.: 5
Photographer: S. DiBartolo
Date: 10/18/2022
Direction: North

Comments:
Lower Terrace

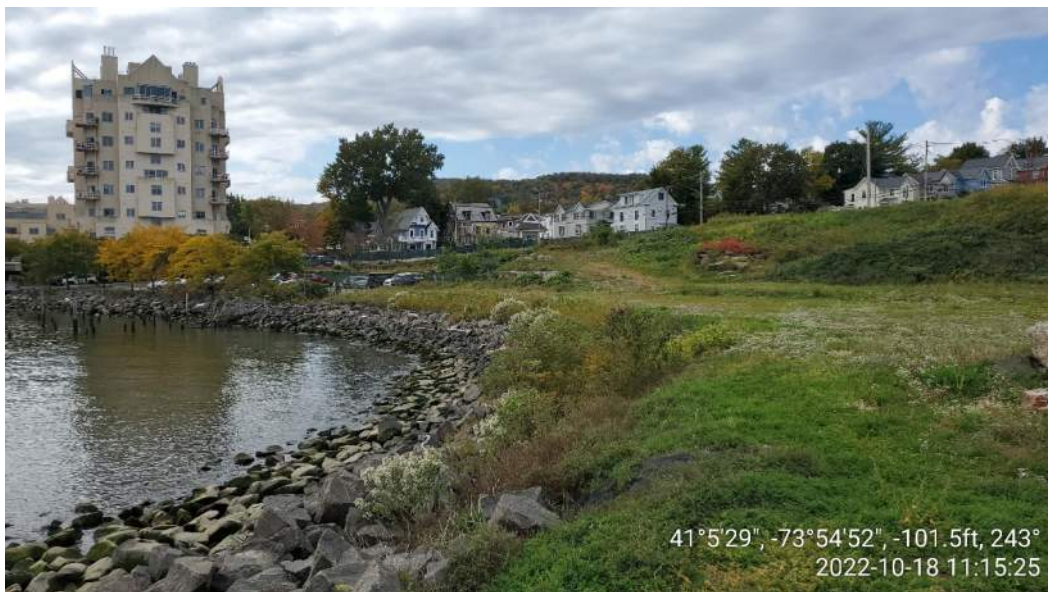
Photo No.: 6
Photographer: S. DiBartolo
Date: 10/18/2022
Direction: Southwest

Comments:
Lower Terrace

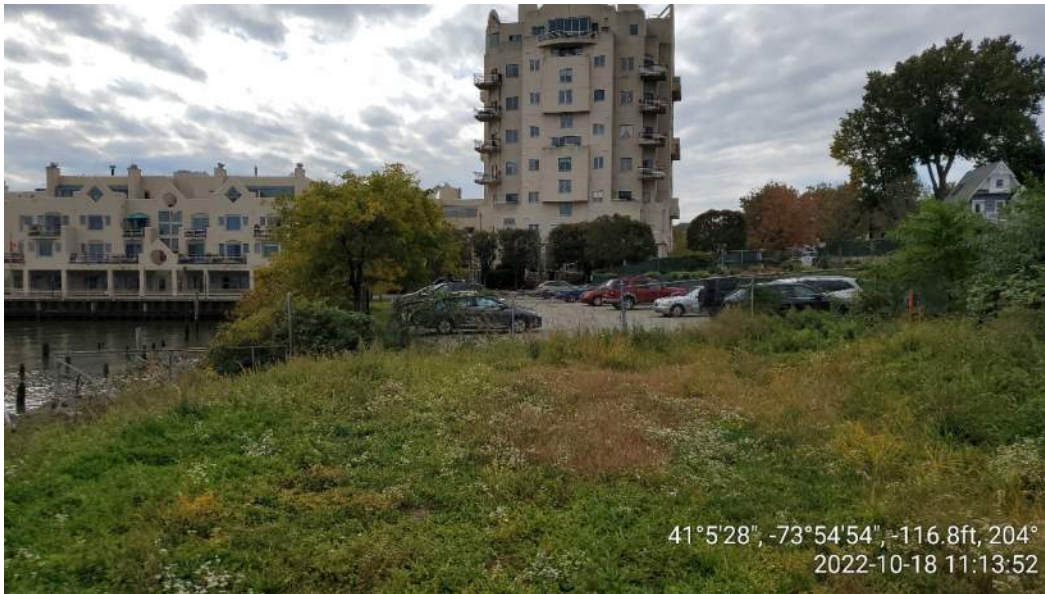
Photo No.: 7
Photographer: S. DiBartolo
Date: 10/18/2022
Direction: South

Comments:
Lower Terrace towards
Hudson Vista Parking Lot

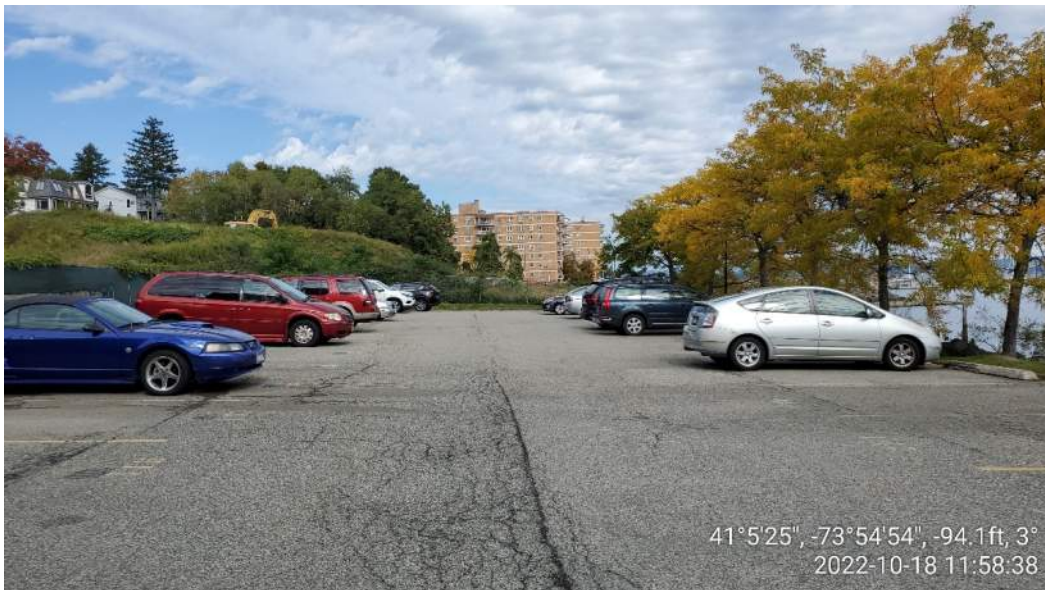
Photo No.: 8
Photographer: S. DiBartolo
Date: 10/18/2022
Direction: North

Comments:
Hudson Vista Associates
Parcel lower parking lot
portion of surface cover

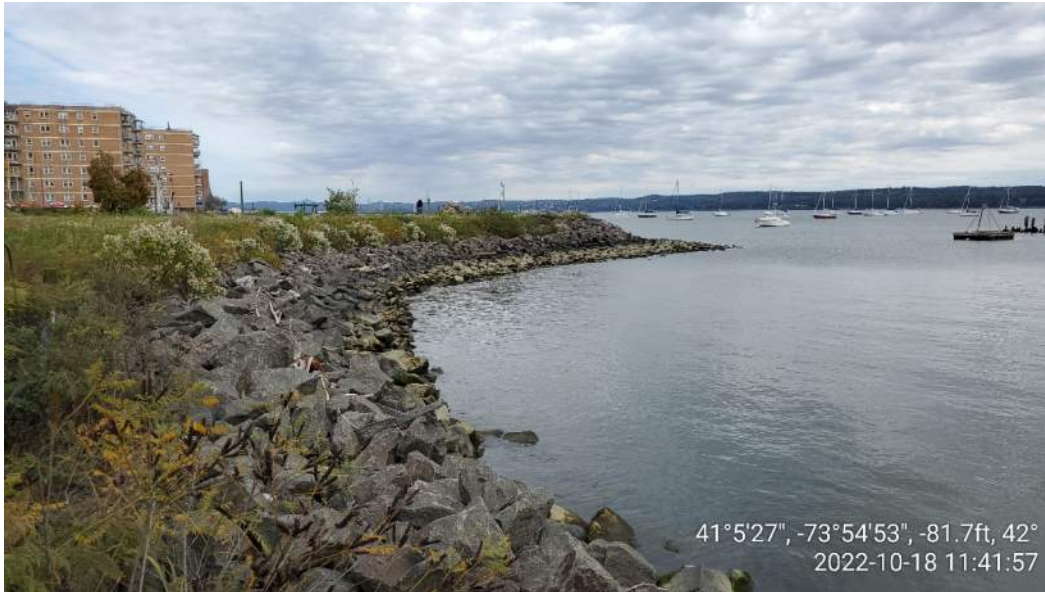
Photo No.: 9
Photographer: S. DiBartolo
Date: 10/18/2022
Direction: Northeast

Along the Lower Terrace shoreline, the ISS materials are protected from contact by site users and erosion by the installation of riprap during the remedial action, and by the placement of additional riprap at the shoreline by the Site Owner. Riprap areas were observed by GEI to be in good condition. Sediment has partially covered small portions of the riprap area, but evidence of movement or undermining was not observed anywhere in the riprap areas. Photographs of the shoreline are included in the Photographic Record in Appendix B.

Comments:
Lower Terrace and Riprap Slope

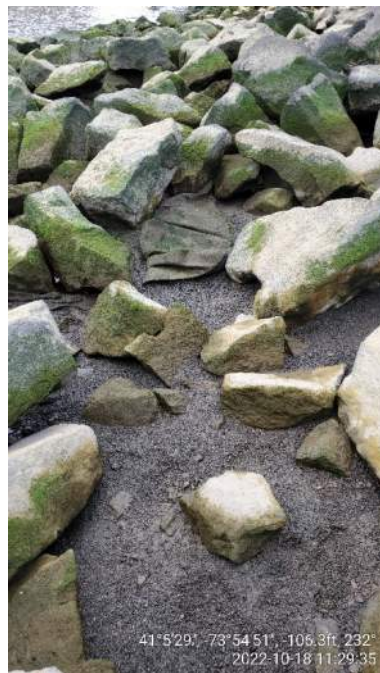
Photo No.: 10
Photographer: S. DiBartolo
Date: 10/18/2022
Direction: Southeast

Comments:
Riprap Slope at Hudson River
at Low Tide

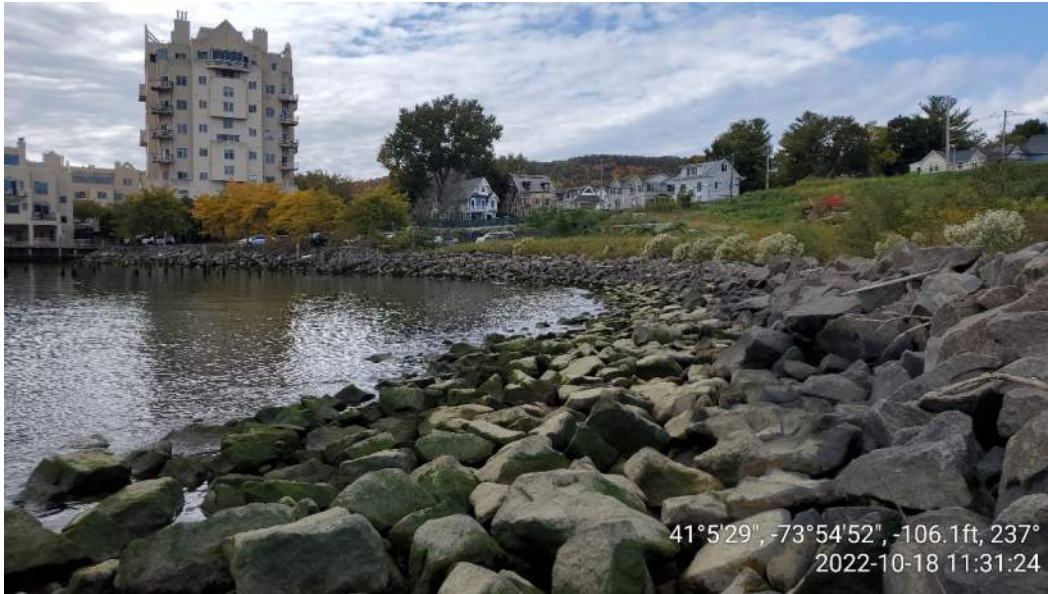
Photo No.: 11
Photographer: S. DiBartolo
Date: 10/18/2022
Direction: Southwest

Comments:
Riprap Slope at Hudson River
at Low Tide

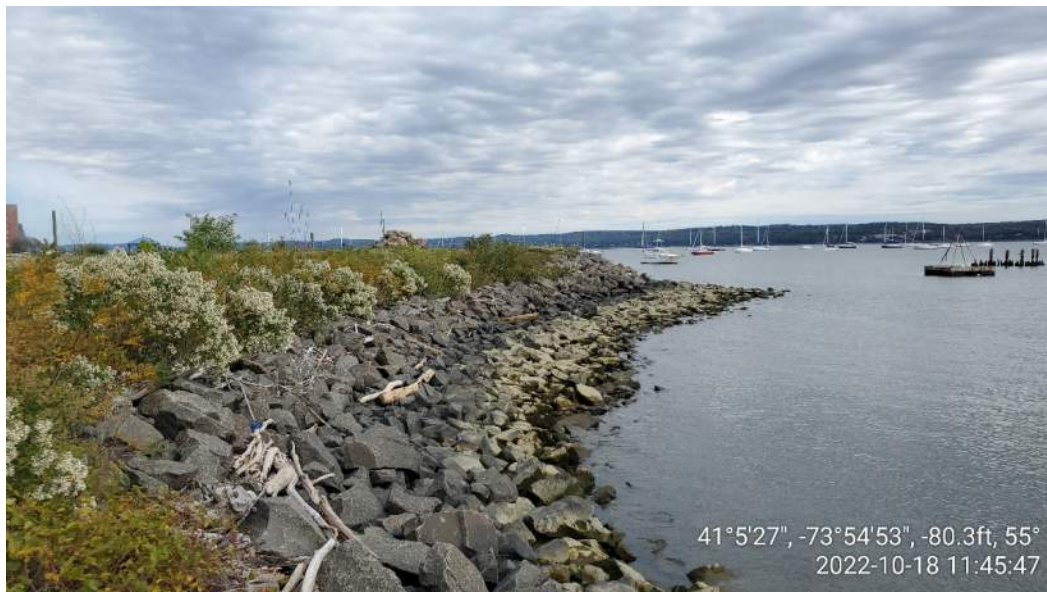
Photo No.: 12
Photographer: S. DiBartolo
Date: 10/18/2022
Direction: Northeast

Comments:
Riprap Slope at Hudson River
at Low Tide

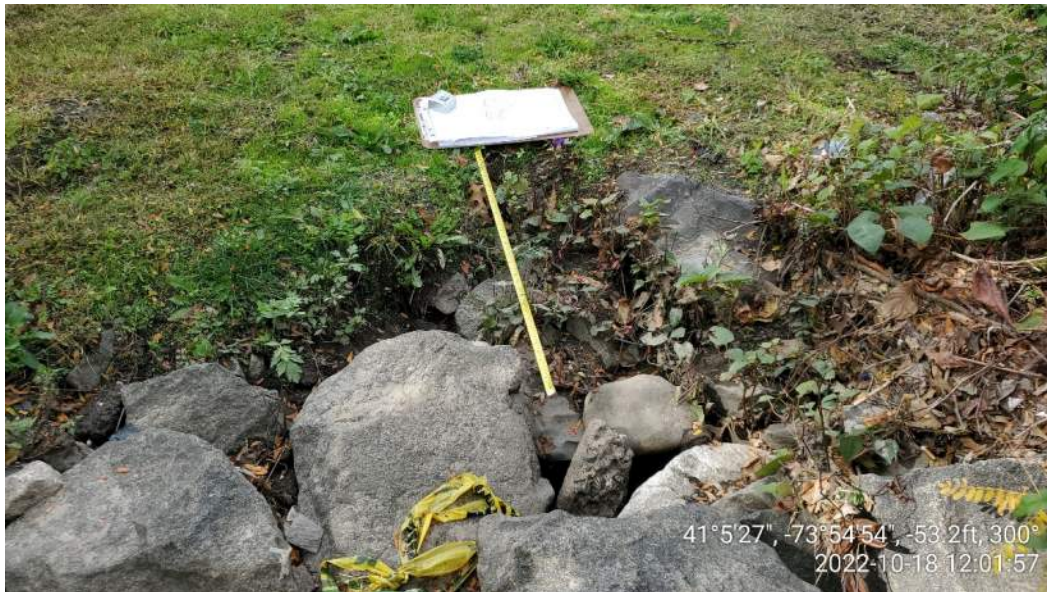
Photo No.: 13
Photographer: S. DiBartolo
Date: 10/18/2022
Direction: Northwest

These features were observed to be present, and not disturbed at the time of the October 18, 2022, site inspection. While some minor erosion continues to exist at the storm sewer outlet, it is localized and has not changed from that which was observed during prior events. A photograph of the storm sewer outlet is included in the Photographic Record in Appendix B.

There does not appear to have been any construction activities since last inspection. However, equipment remains onsite (as shown in the attached photos). Minor erosion was observed at the drain outfall pipe at the southeast corner of the site at the north end of the Hudson Vista parking lot (photo is included in attached photo log; additional erosion (minor) noted from 2021 inspection). Additionally, there appears to be storage of boating equipment onsite from the adjacent boat club to the north just on the other side of the property fence line. However, this does not appear to be affecting the environmental controls for the site.

Comments:
Stormwater CMP Outfall at
North end of Hudson Vista
Parking Lot

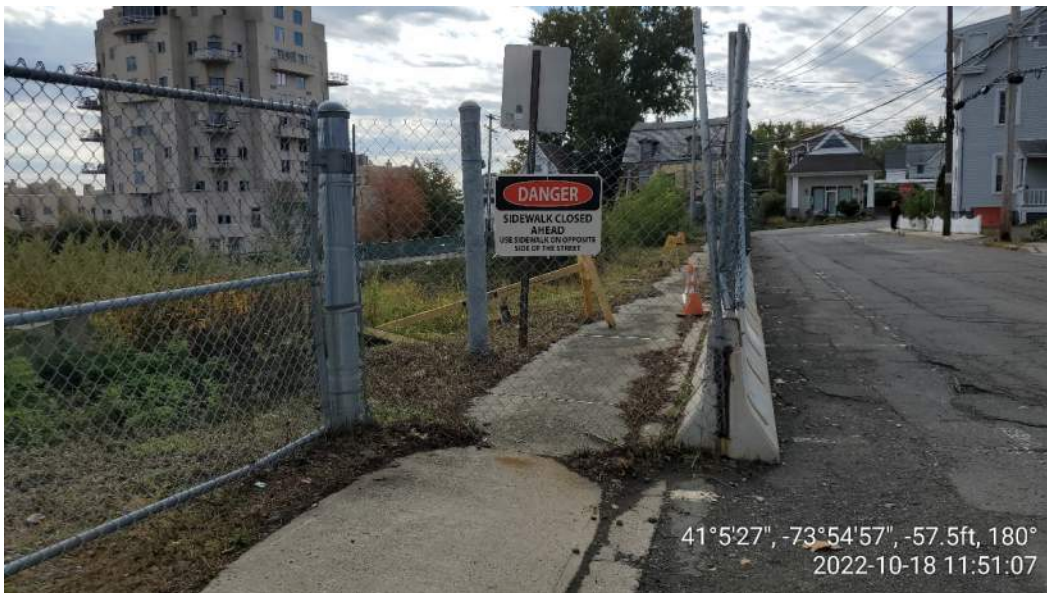
Photo No.: 14
Photographer: S. DiBartolo
Date: 10/18/2022
Direction: South

Comments:
Perimeter fence at Gedney
Street

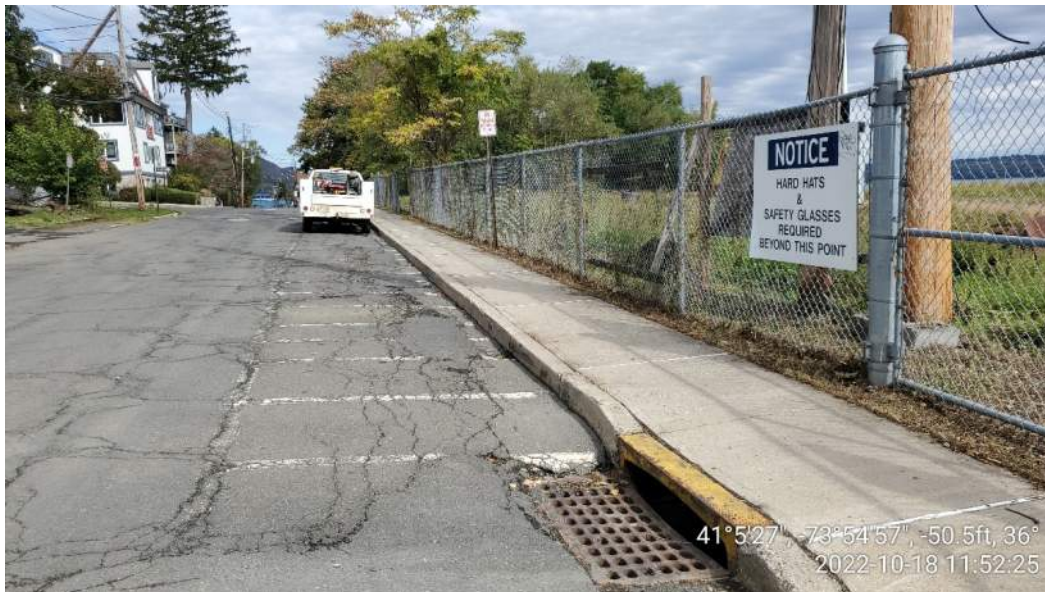
Photo No.: 15
Photographer: S. DiBartolo
Date: 10/18/2022
Direction: Northeast

Comments:
Perimeter fence at Gedney Street

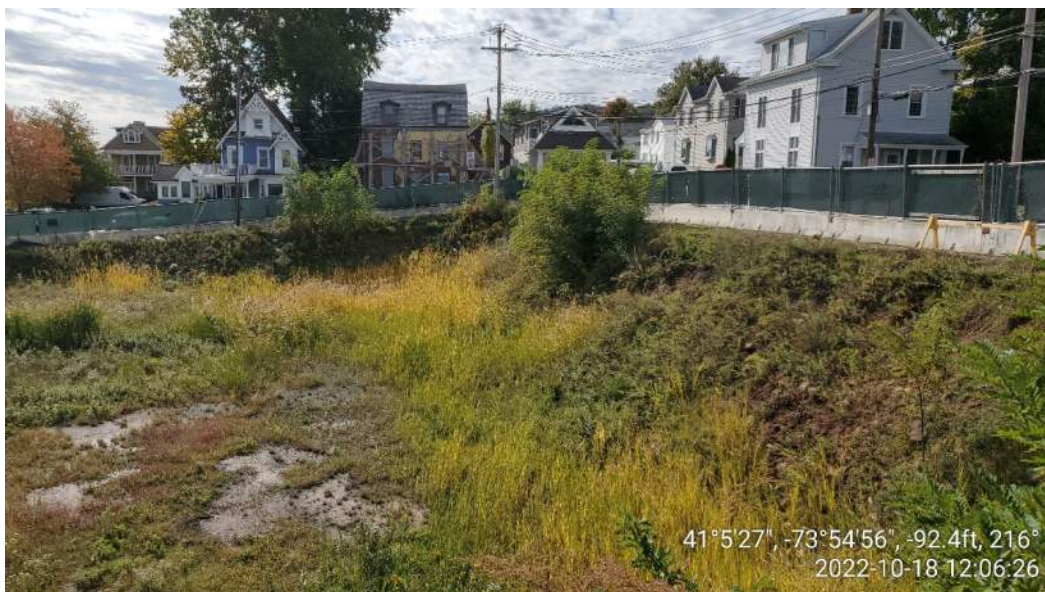
Photo No.: 16
Photographer: S. DiBartolo
Date: 10/18/2022
Direction: Southwest

Comments:
Perimeter fence at Main Street (upper left side of photo) and Gedney Street (upper right side of photo)

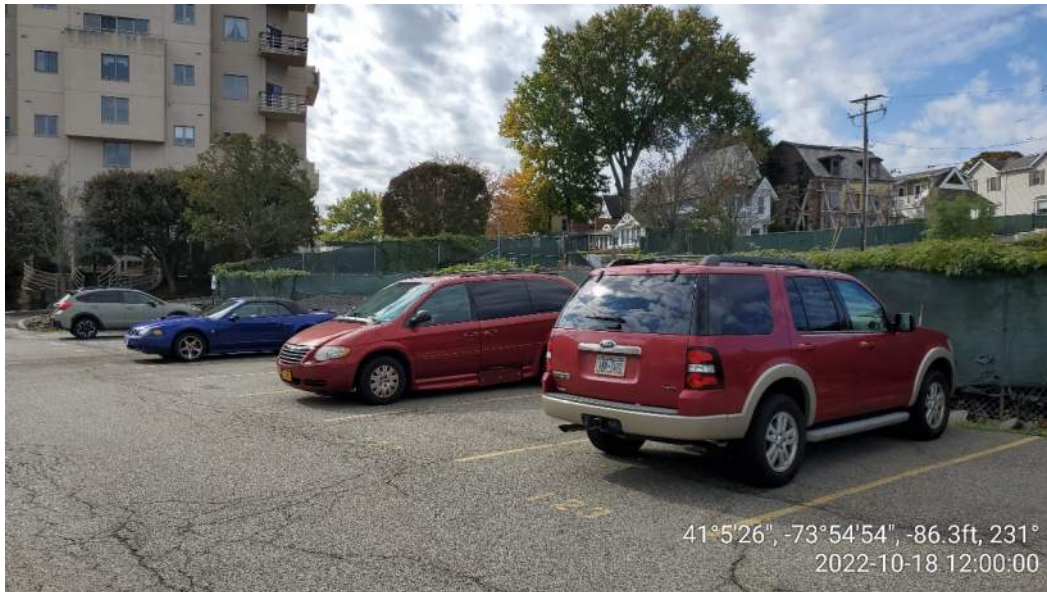
Photo No.: 17
Photographer: S. DiBartolo
Date: 10/18/2022
Direction: Southwest

Comments:
Perimeter fence at Hudson Vista Associates Parcel lower parking lot.

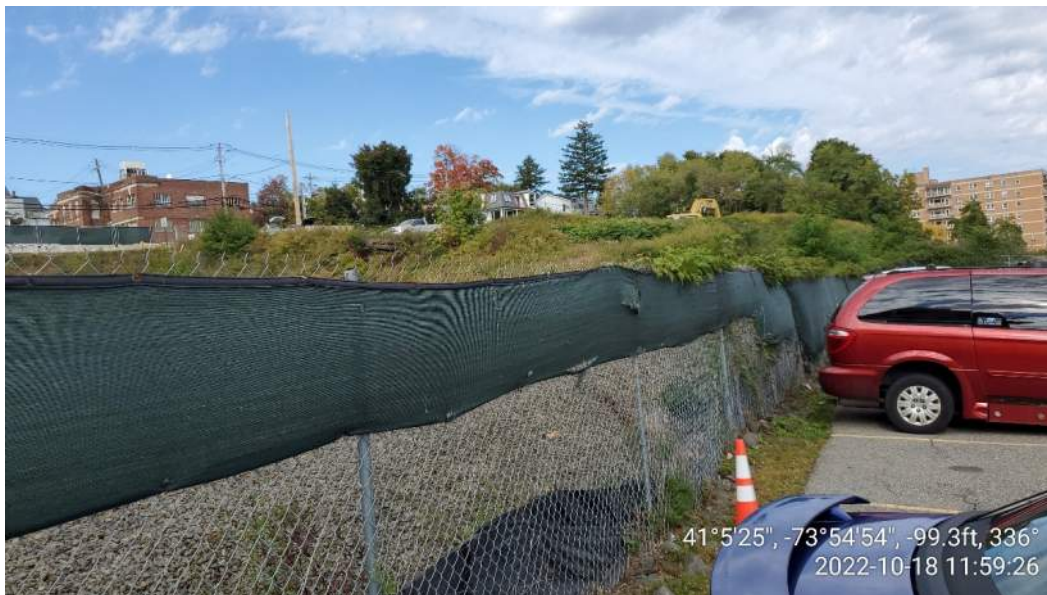
Photo No.: 18
Photographer: S. DiBartolo
Date: 10/18/2022
Direction: North

Comments:
Perimeter fence at Hudson Vista Associates Parcel lower parking lot.

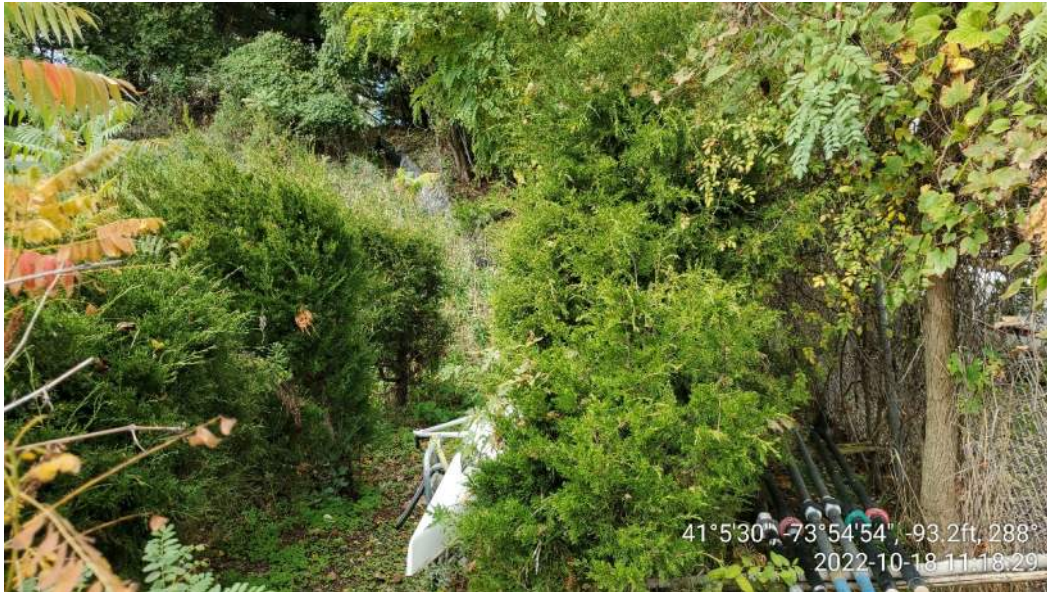
Photo No.: 19
Photographer: S. DiBartolo
Date: 10/18/2022
Direction: West

Comments:
Storage of boating equipment on Property. North perimeter fence does not extend onto the riprap slope and the site can be accessed from adjacent boat club to the north.
