**2017 ANNUAL  
RESTORATION MONITORING REPORT**

**Ford Motor Company Site: Operable Unit 2 Remediation Project  
Ramapo, Rockland County, New York, Site No. 3-44-065**

**December 2017**

AMY S. GREENE ENVIRONMENTAL  
CONSULTANTS, INC.  
4 Walter E. Foran Blvd., Suite 209  
Flemington, NJ 08822

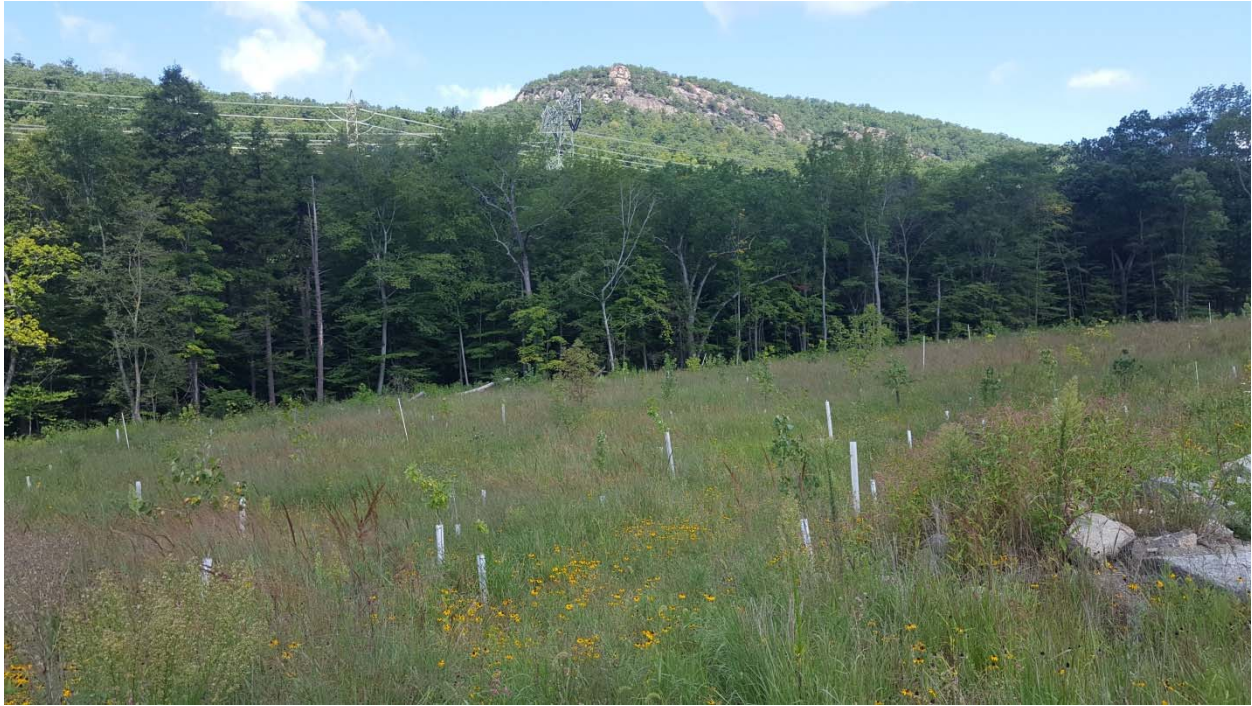
View of restored areas in the southern portions of OU-2 showing variable herbaceous coverage in August 2017.

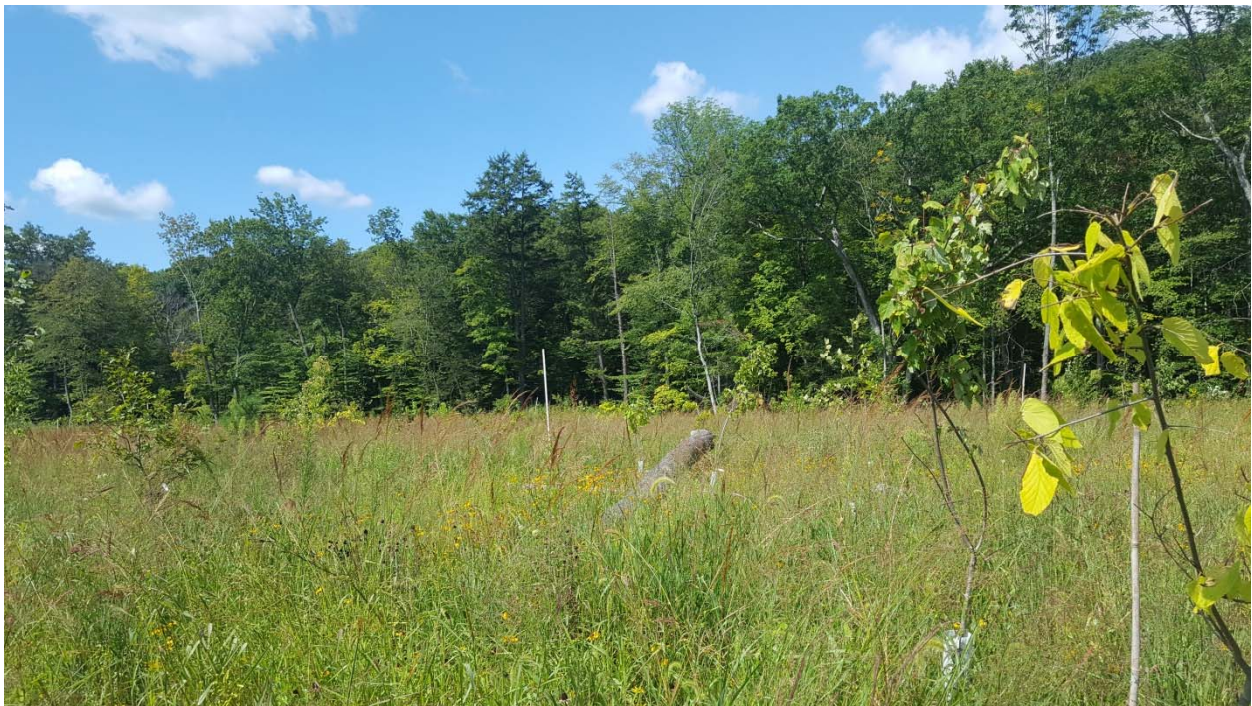
View south of the southern areas of OU-2 showing average cover within monitoring plot 2 (MP-2).

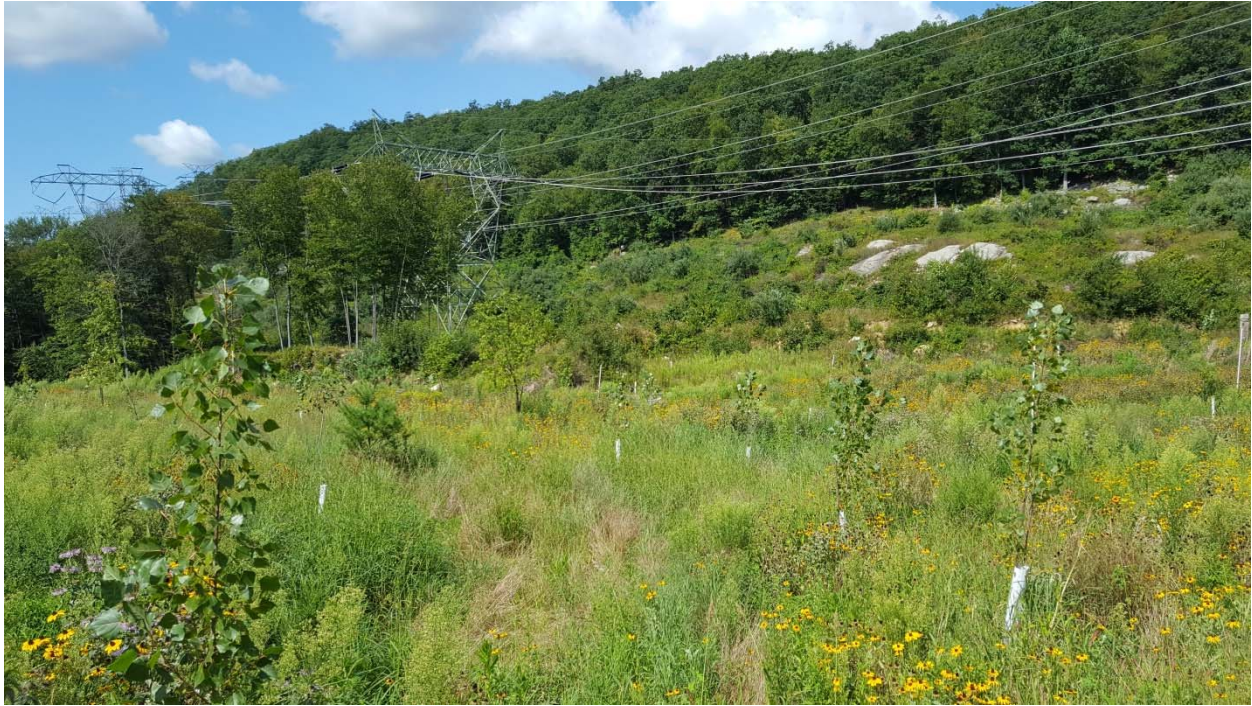
View south of the northern portion of OU-2 showing an overview of a large portion of the site having canopy trees established.

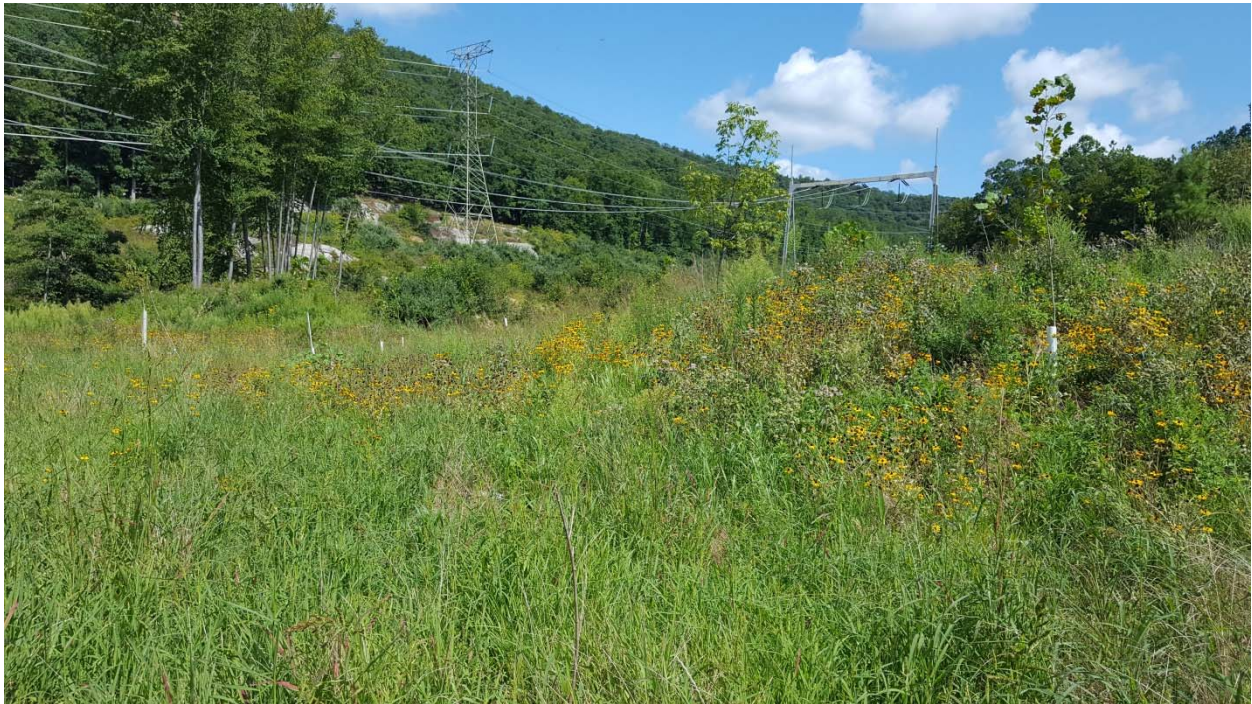
View north of the northern portions of OU2 established wildflowers and warm season grasses.

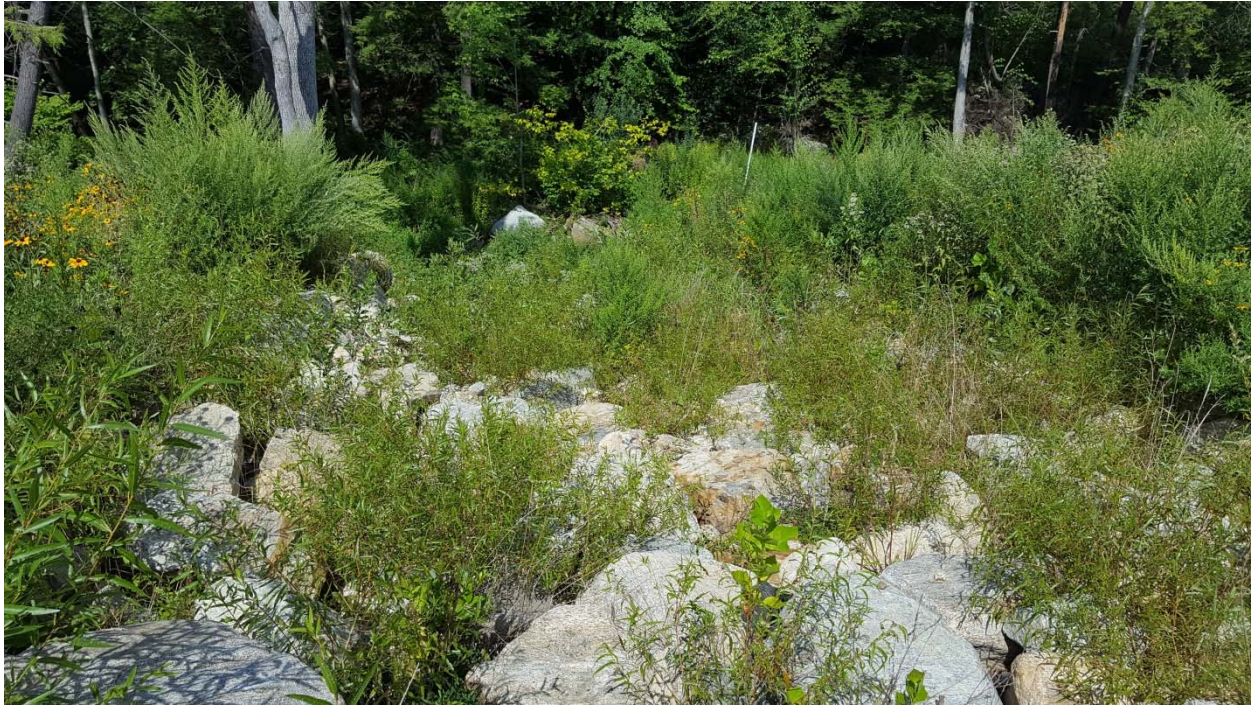
View of the rip rap spillway that flows to Torne Brook showing the establishment of willow live stakes throughout.

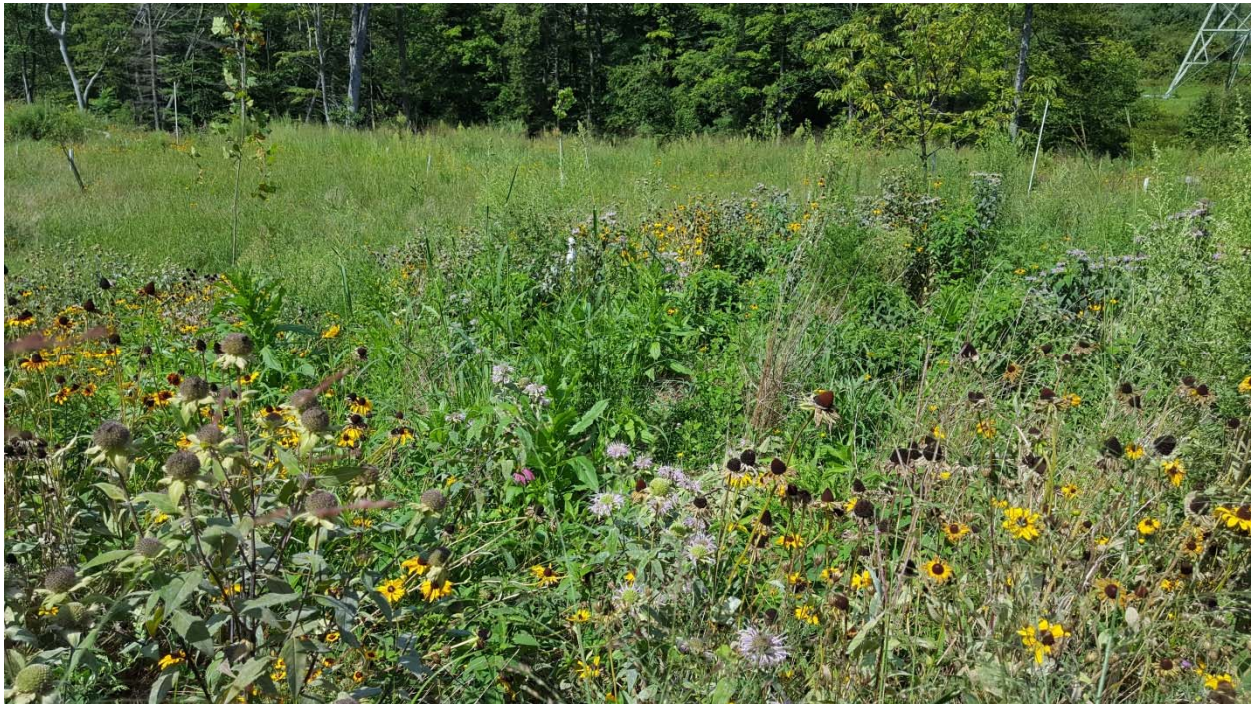
View of typical patches of grasses and wildflowers dominated by black-eyed susans and wild bergamot.

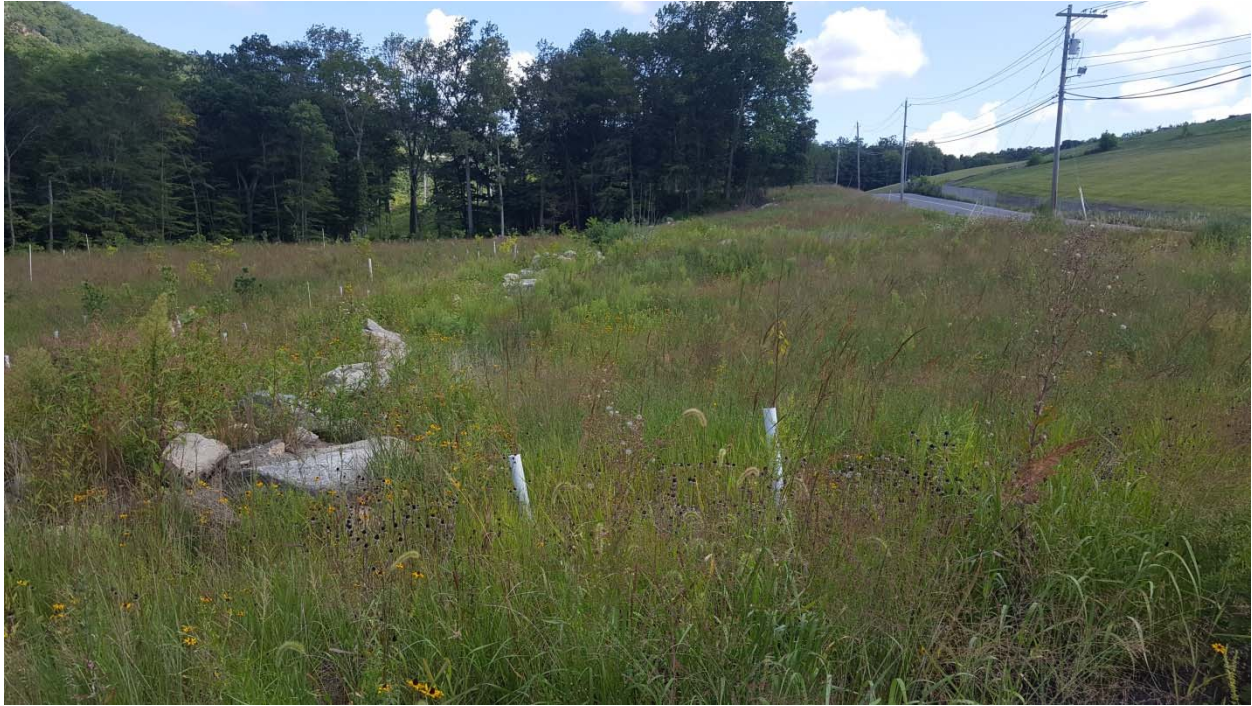
View north of the roadside easement showing black eyed susan and warm season grass establishment.

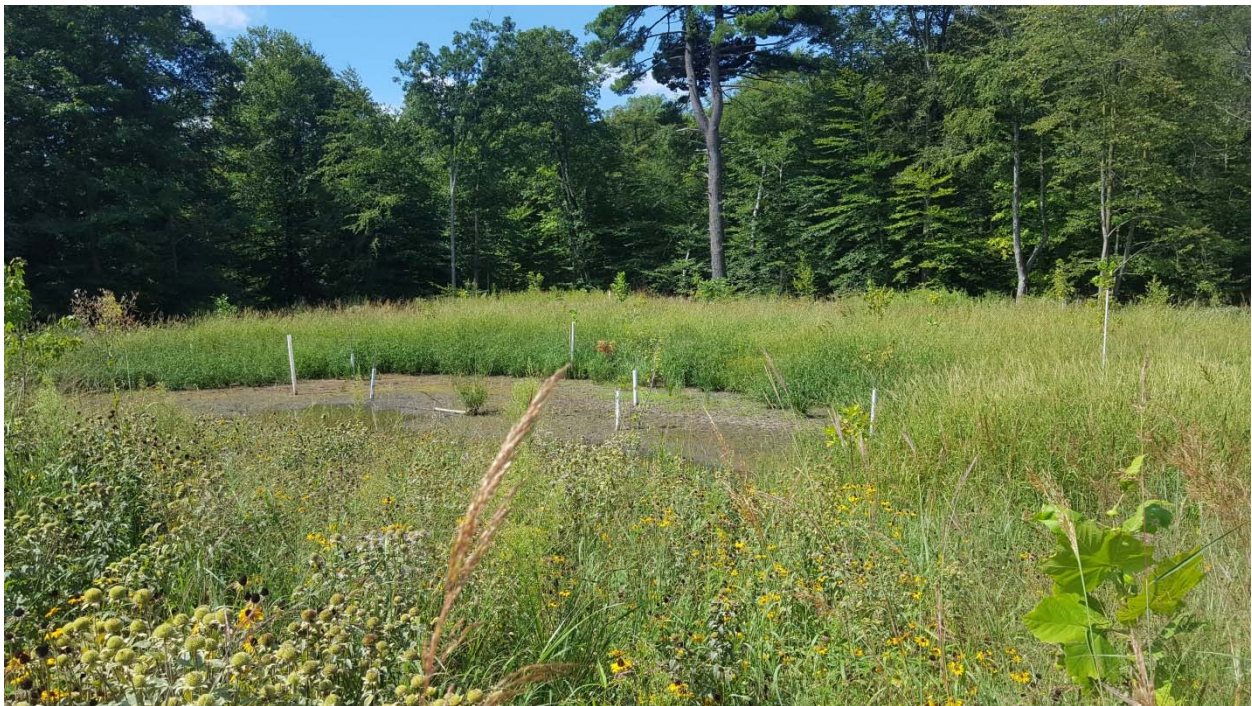
View south within the southern portions of OU-2 showing a vernal pool established from surface runoff. The vernal pool creates great habitat for aquatic species such as frogs, salamanders, and dragonflies.
