Annual Site Restoration Monitoring Summary – 2018  
Ramapo Paint Sludge Site – Operable Unit 2 (OU-2)  
Ramapo, Rockland County, New York  
Site No. 344065

**2018 ANNUAL  
RESTORATION MONITORING REPORT**

**Ford Motor Company Site: Operable Unit 2 Remediation Project  
Ramapo, Rockland County, New York, Site No. 3-44-065**

**December 2018**

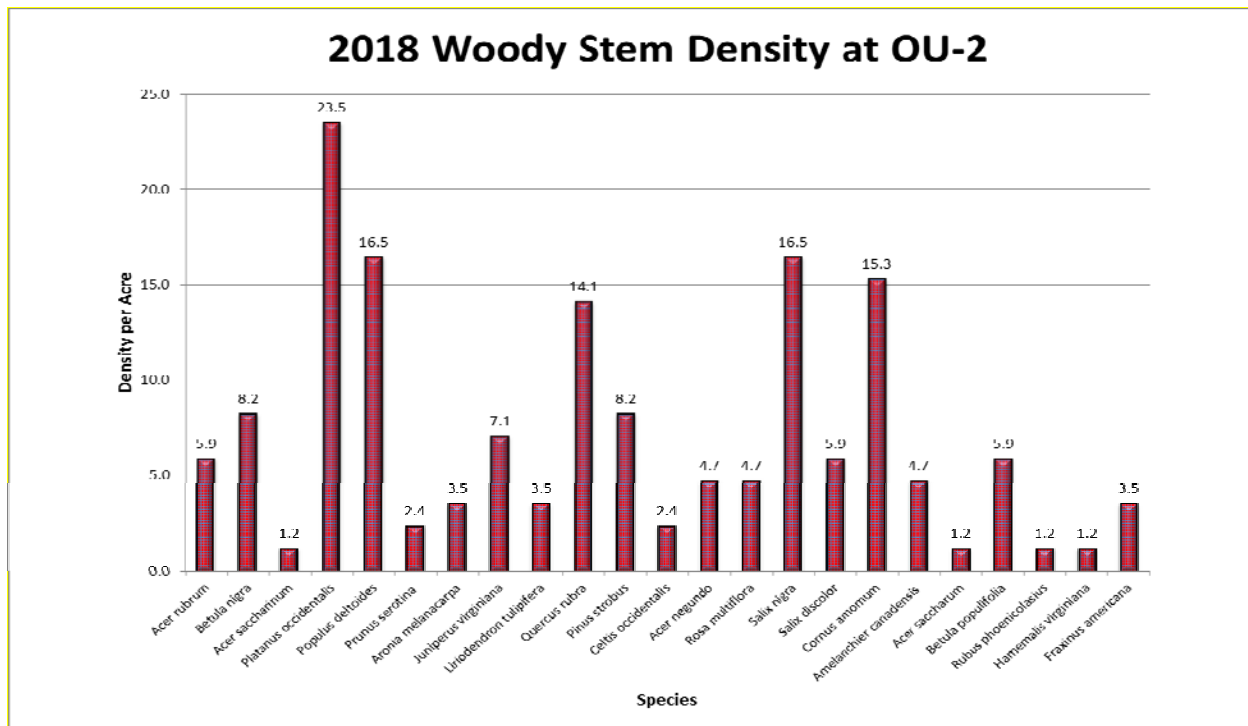
**FIGURE 3:** Average woody stem density for all species recorded within monitoring plots at the OU-2 Restoration following the 2017 growing season.

Planted tree and shrub density for individual species ranged from approximately 1 to 24 stems per acre (see Table 1 and Figure 3 above). Shrub establishment and growth is minimal, except for the stream embankment area where black willow (*Salix nigra*), pussy willow (*Salix discolor*) and silky dogwood (*Cornus amomum*) are present from the establishment of live stakes. Shrub establishment has been undoubtedly hindered by the presence of deer.

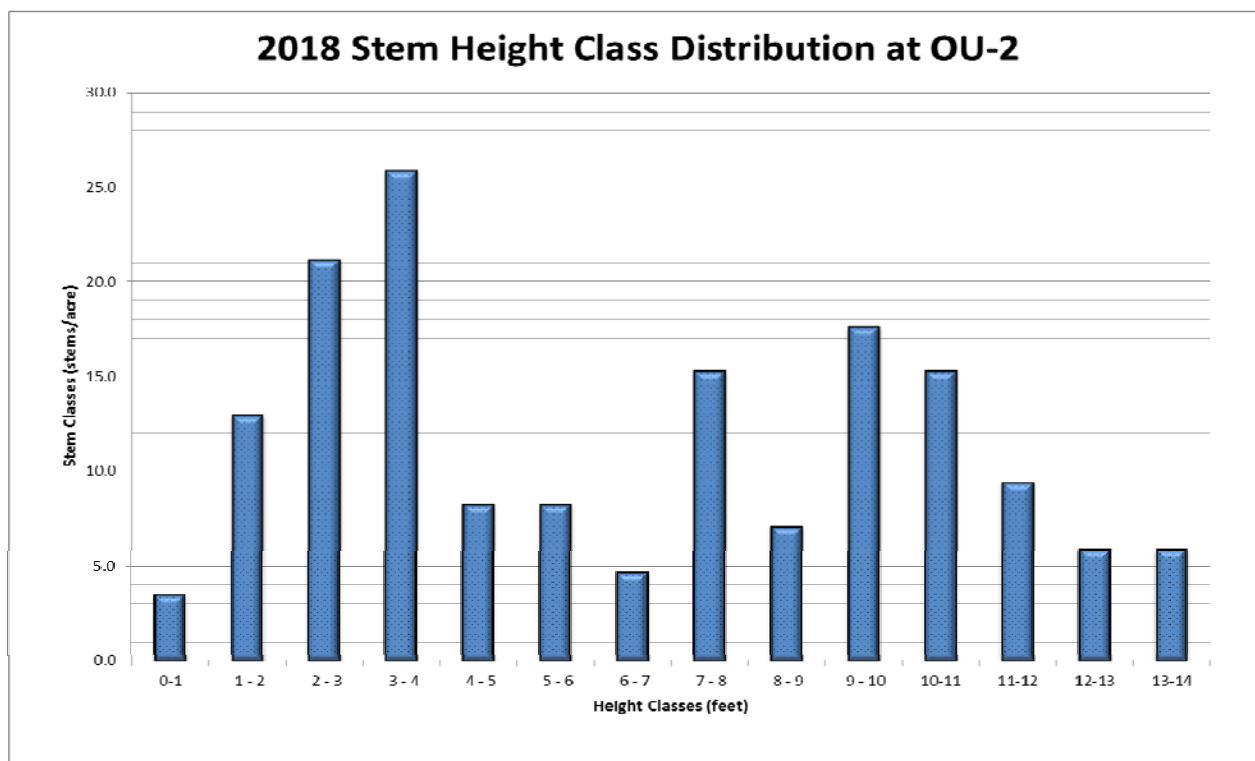
**FIGURE 4:** Woody stem height class distribution for planted species within the OU-2 restoration area following the 2017 growing season.

Average height class of planted species sampled within the monitoring plots during 2018 was estimated at 6.8 feet, increasing slightly from the previous monitoring event. Individual species ranged from 2 foot saplings to trees over 14 feet tall. The most abundant stem class was in the 3-4 foot range due to the presence of live stakes. Putting those live stakes aside, the highest number of trees and shrubs fell within the 9 to 10 feet average height classes. A majority of the planted species have average heights greater than 6 feet. Comparing the collected data from previous years, it is evident that the trees throughout the Site are thriving and growing.

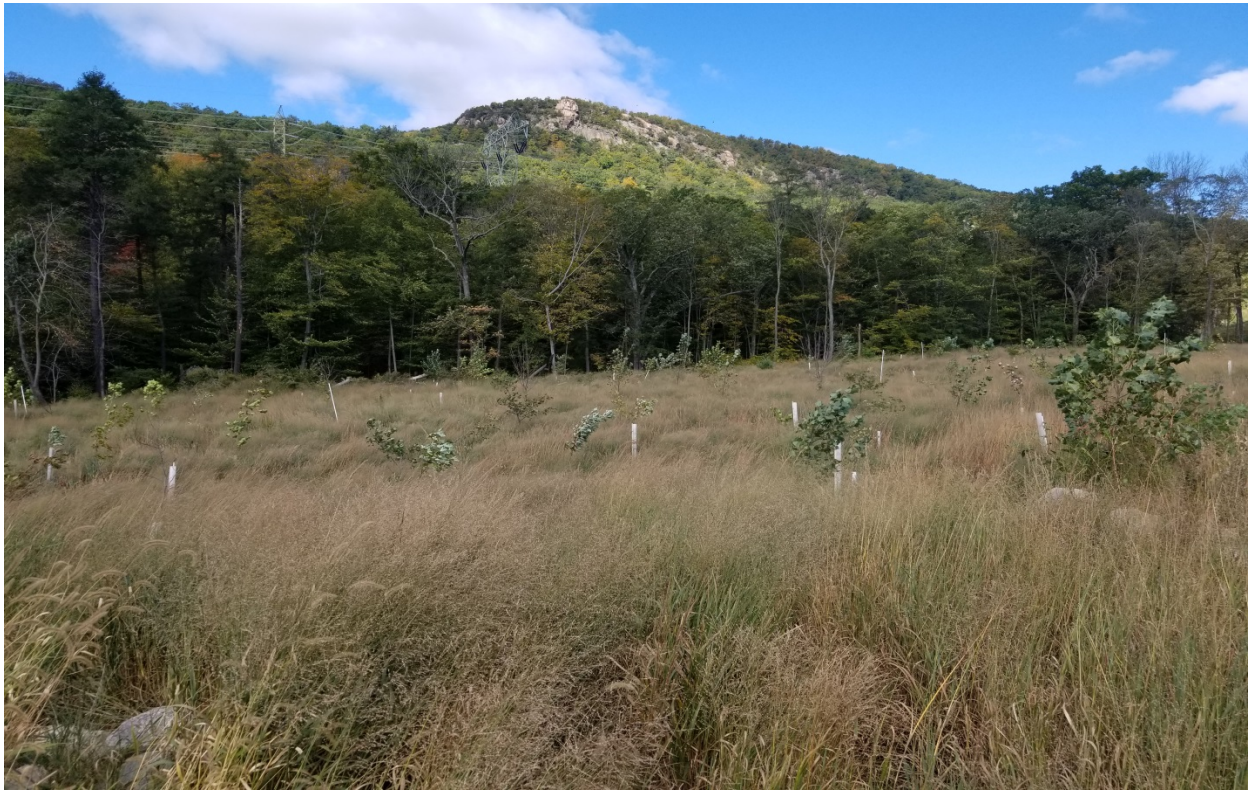
View of restored areas in the southern portions of OU-2 showing thick warm season grass coverage with large trees in October 2018.

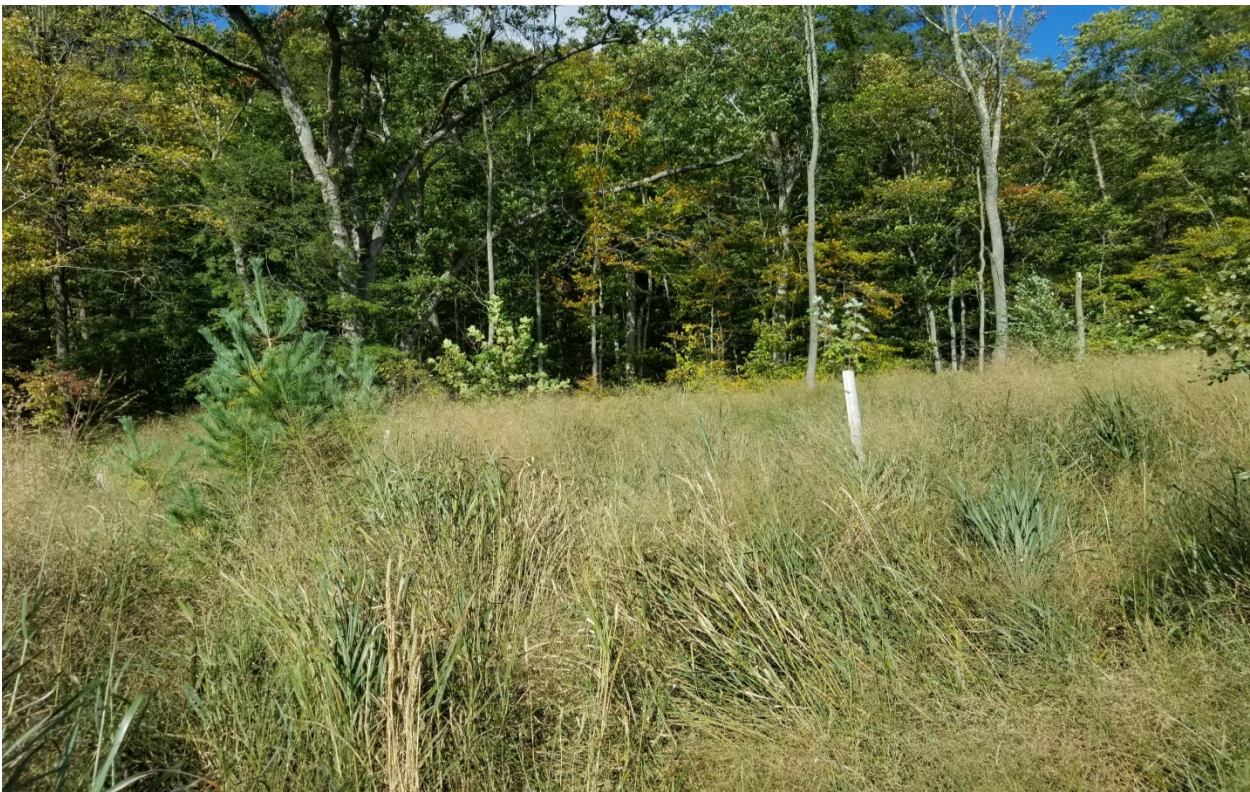
View north of the southern areas of OU-2 showing average cover within monitoring plot 2 (MP-2).

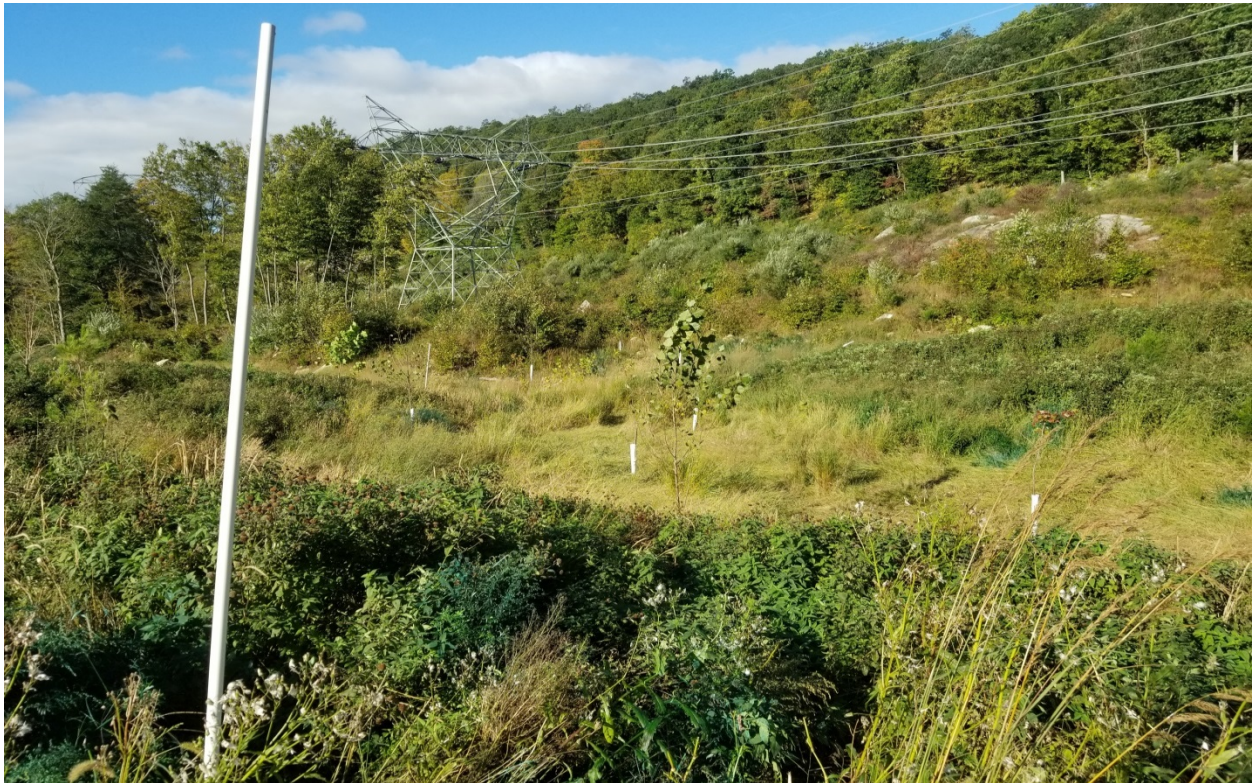
View south of the northern portion of OU-2 showing an overview of a large portion of the site from Plot MP-6.

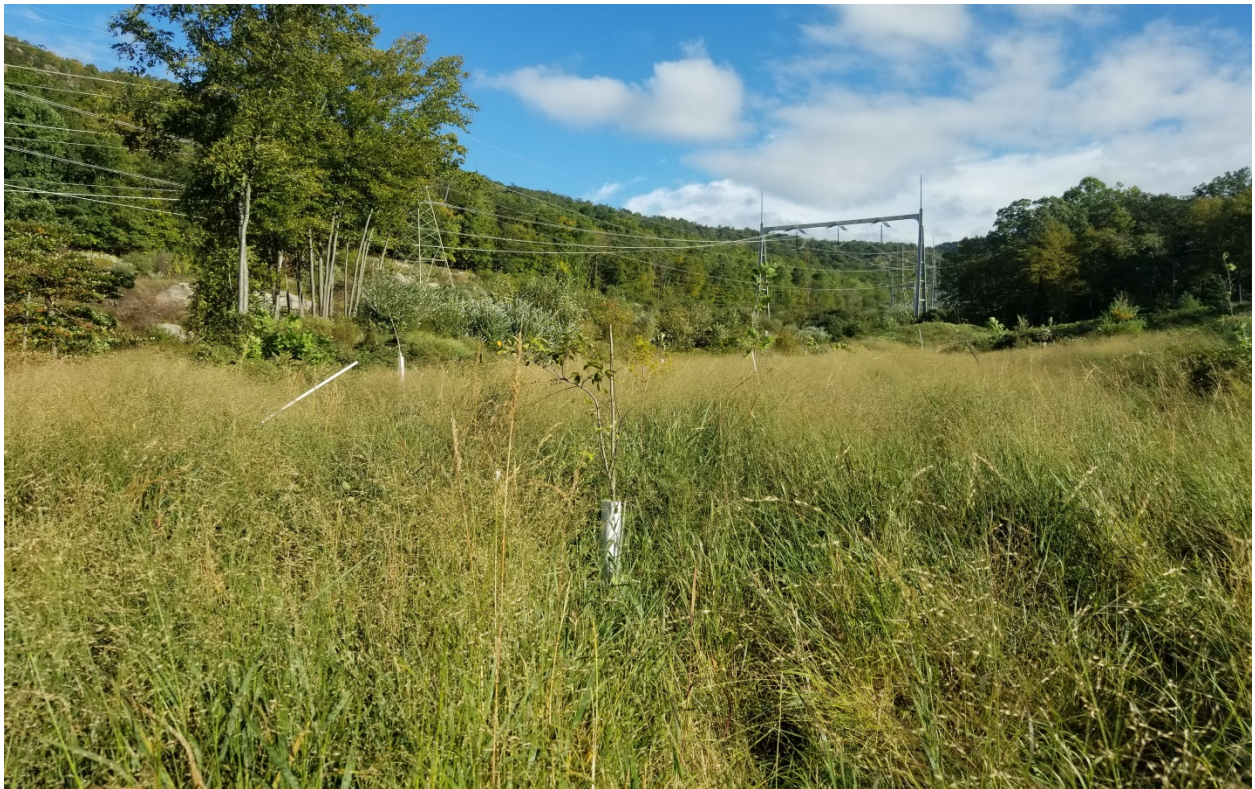
View north of the northern portions of OU2 established warm season grasses near Plot MP-4.

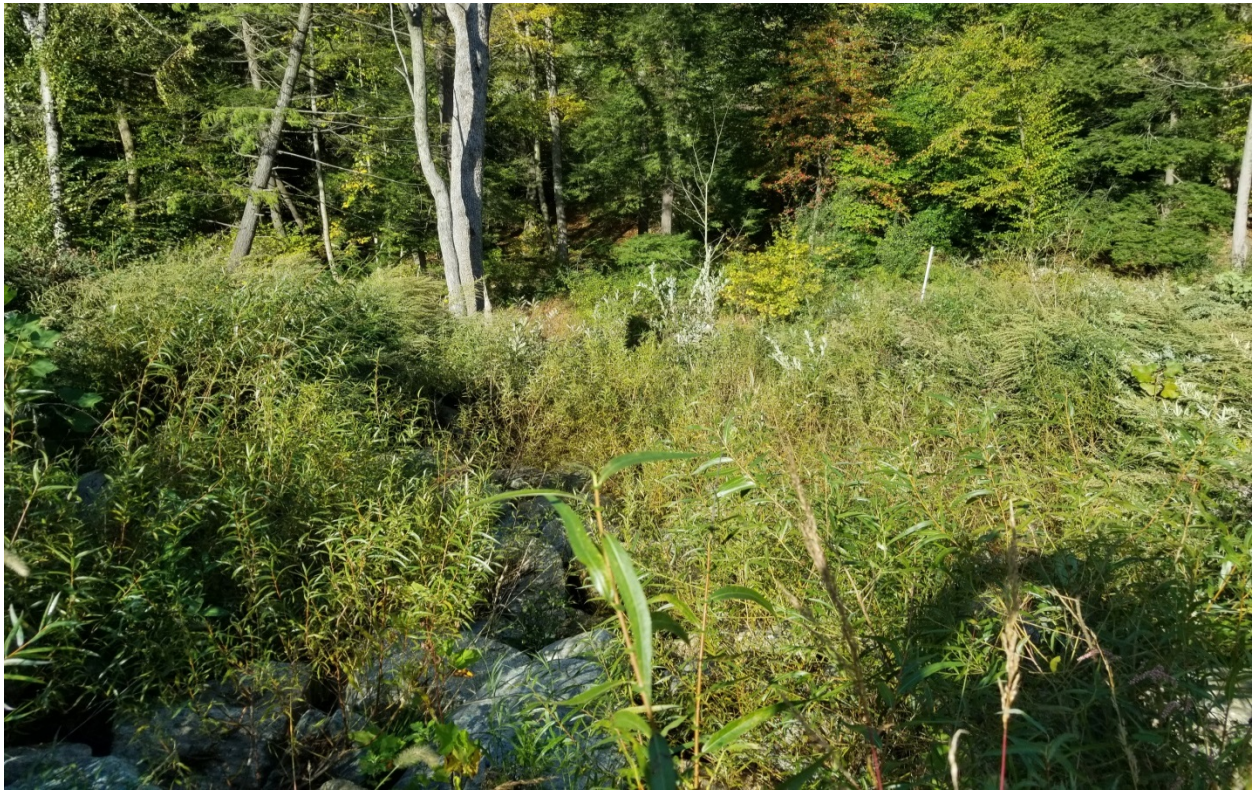
View of the rip rap spillway that flows to Torne Brook showing the establishment of willow live stakes near MP-3.

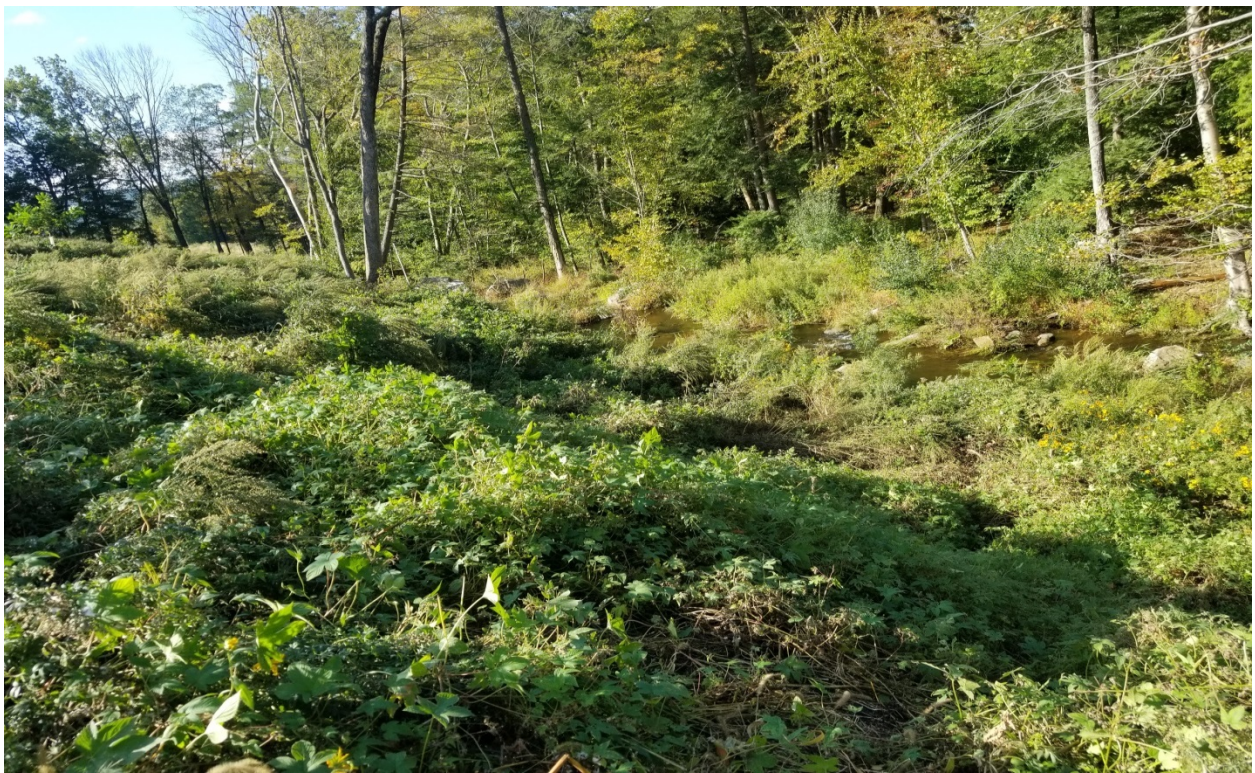
View of invasive species Japanese hops and mugwort along the Torne River embankment.

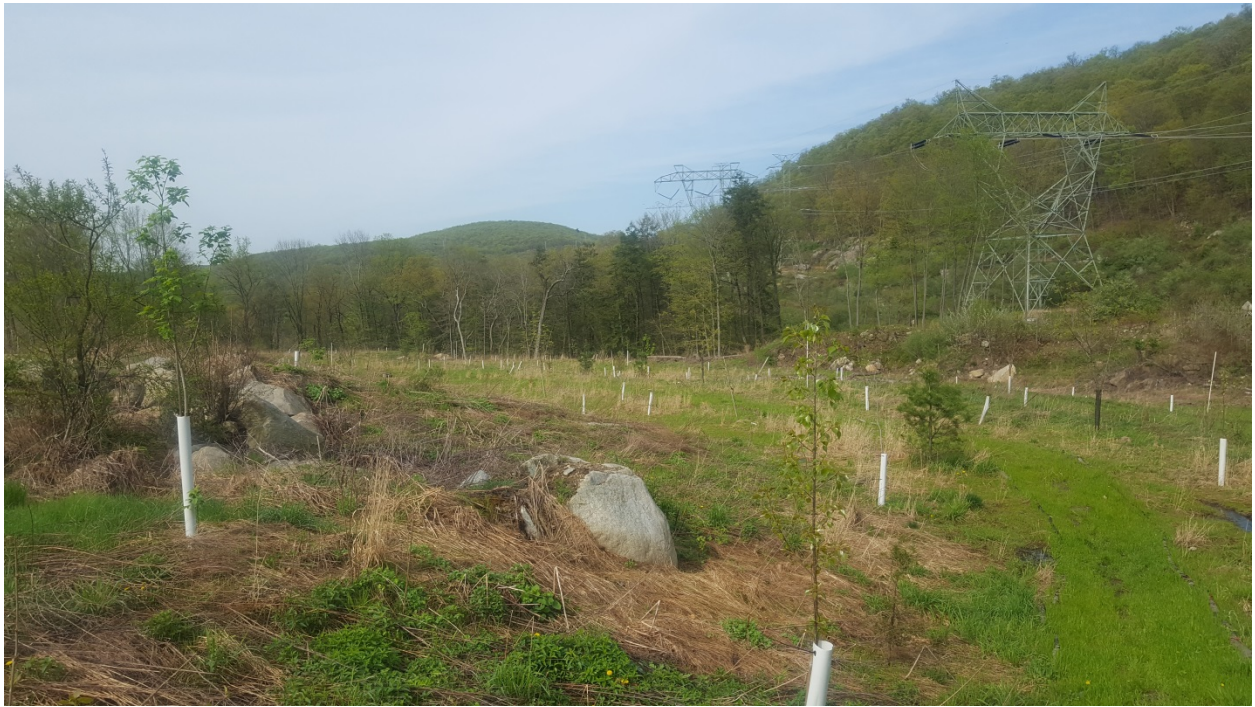
View south showing an overview of the northern portions of OU-2 during May 2018.

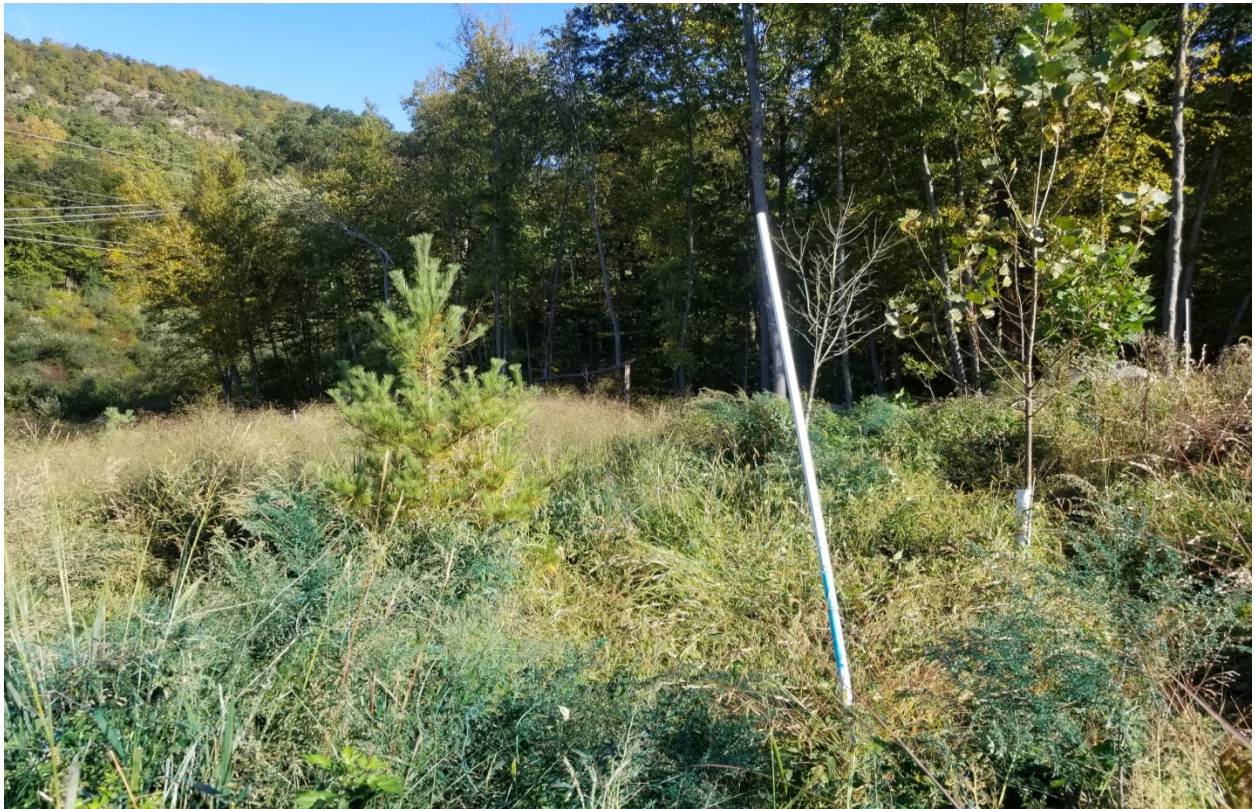
View of the treatment of mugwort throughout the site in October 2018.
