2019 ANNUAL RESTORATION MONITORING REPORT

**Ford Motor Company Site: Operable Unit 2 Remediation Project
Ramapo, Rockland County, New York, Site No. 3-44-065**

February 7, 2022

Davey Tree Expert Company
4 Walter E. Foran Blvd., Suite 209
Flemington, NJ 08822

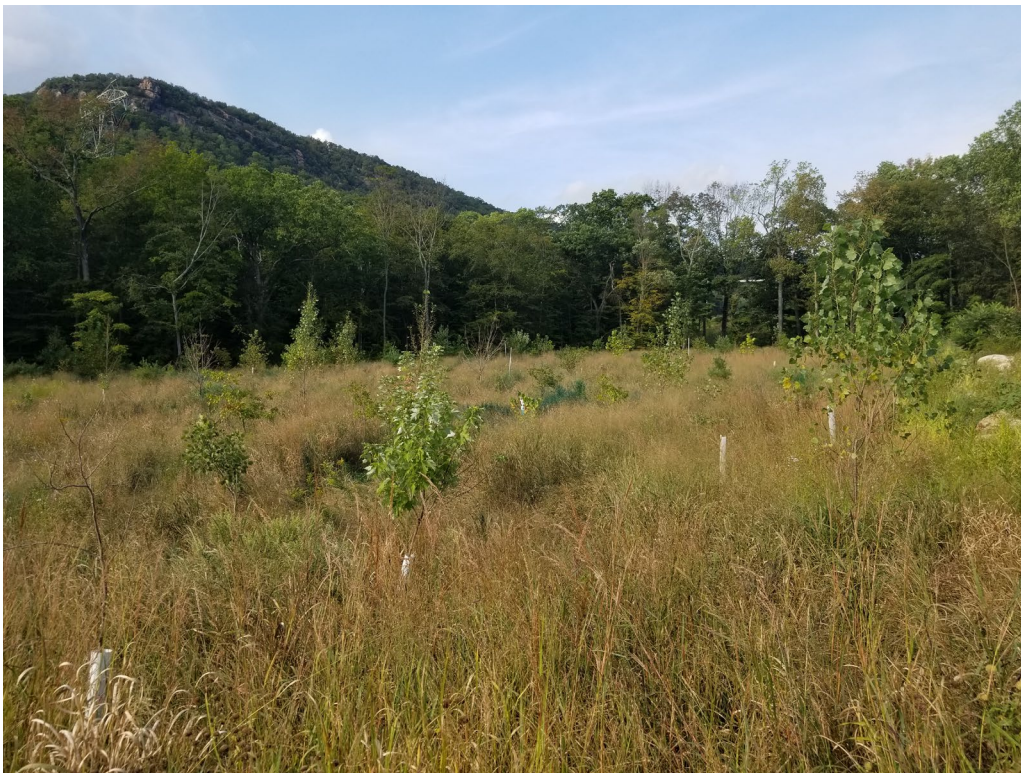
Photo 1: View of restoration, showing dense warm season grass coverage with large trees, in the southern portion of OU-2 (September 2019).

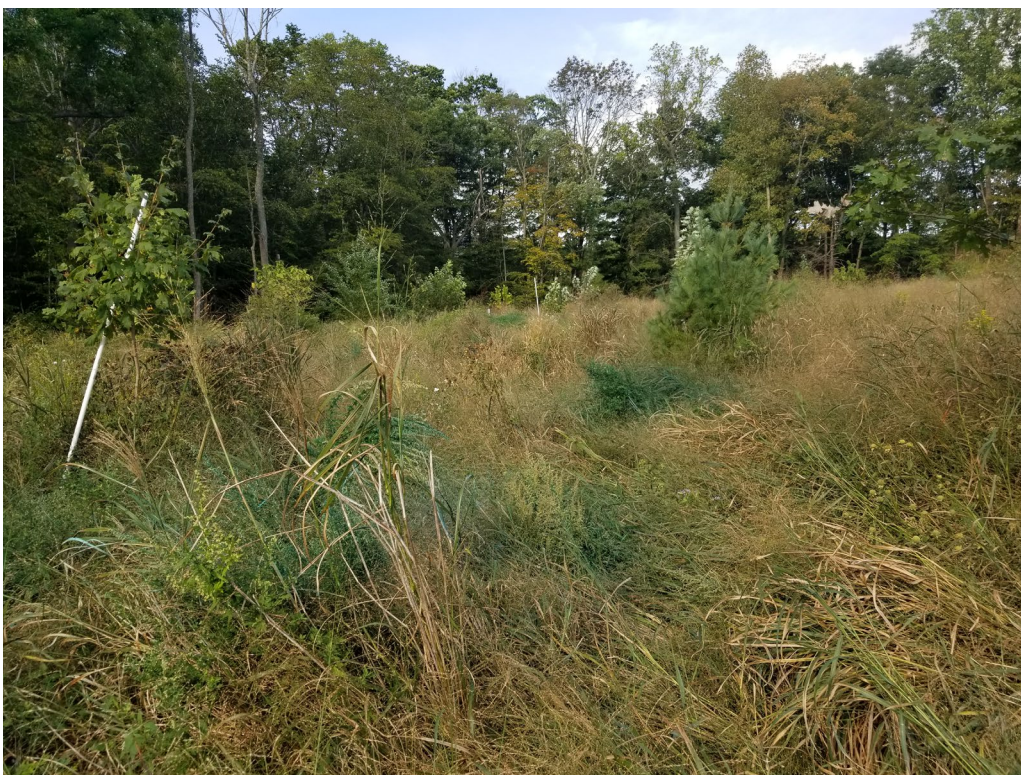
Photo 2: View, north of the southern portion of OU-2, showing dense cover within monitoring plot 2 (MP-2).

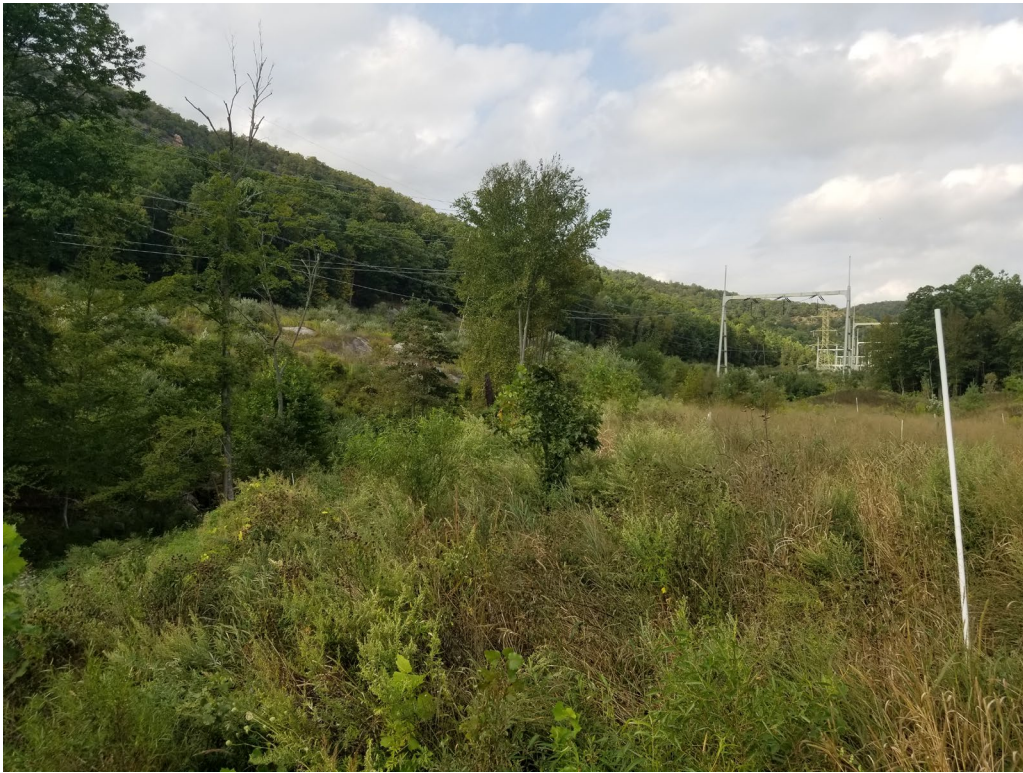
Photo 3: View, south of the northern portion of OU-2, overlooking the Site from near Plot MP-6.

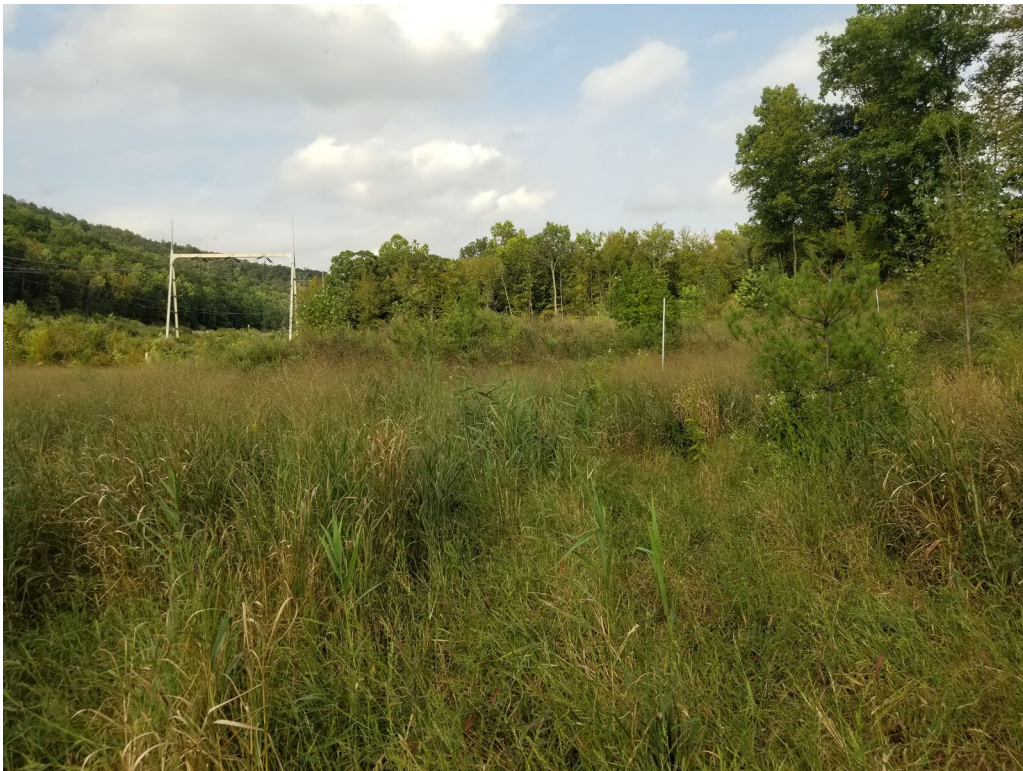
Photo 4: View, north of the northern portion of OU2, showing dense warm season grass coverage near Plot MP-4.

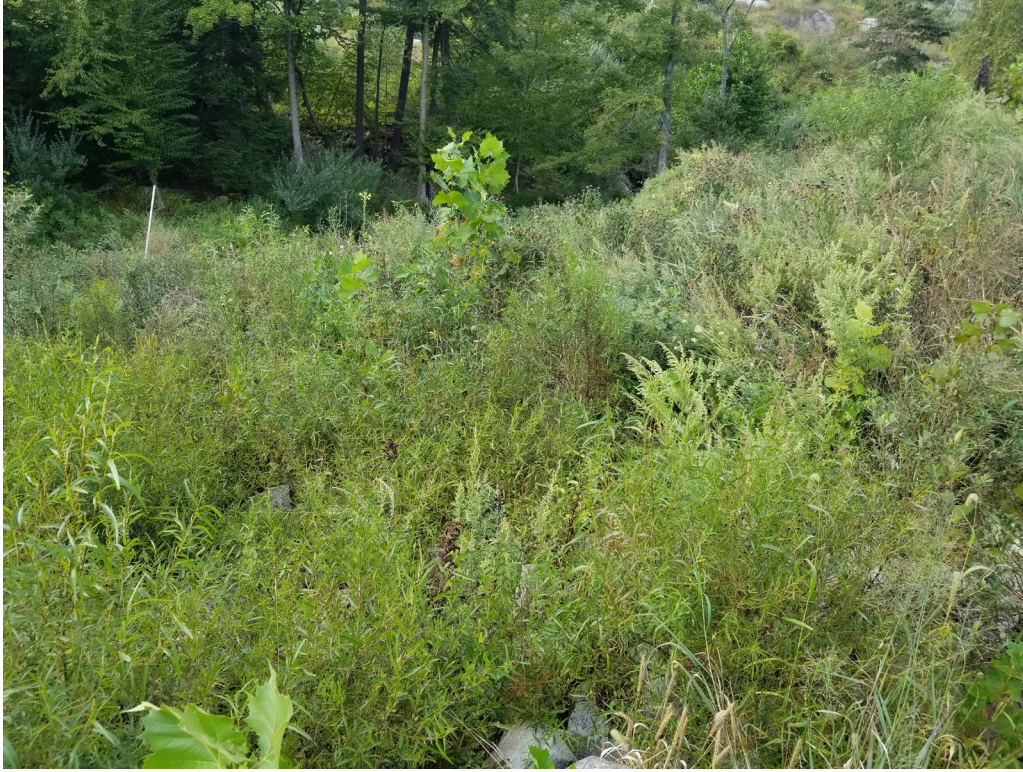
Photo 5: View, from near MP-3, showing the rip rap spillway that flows to Torne Brook and the establishment of black willow, pussy willow, and American sycamore live stakes.

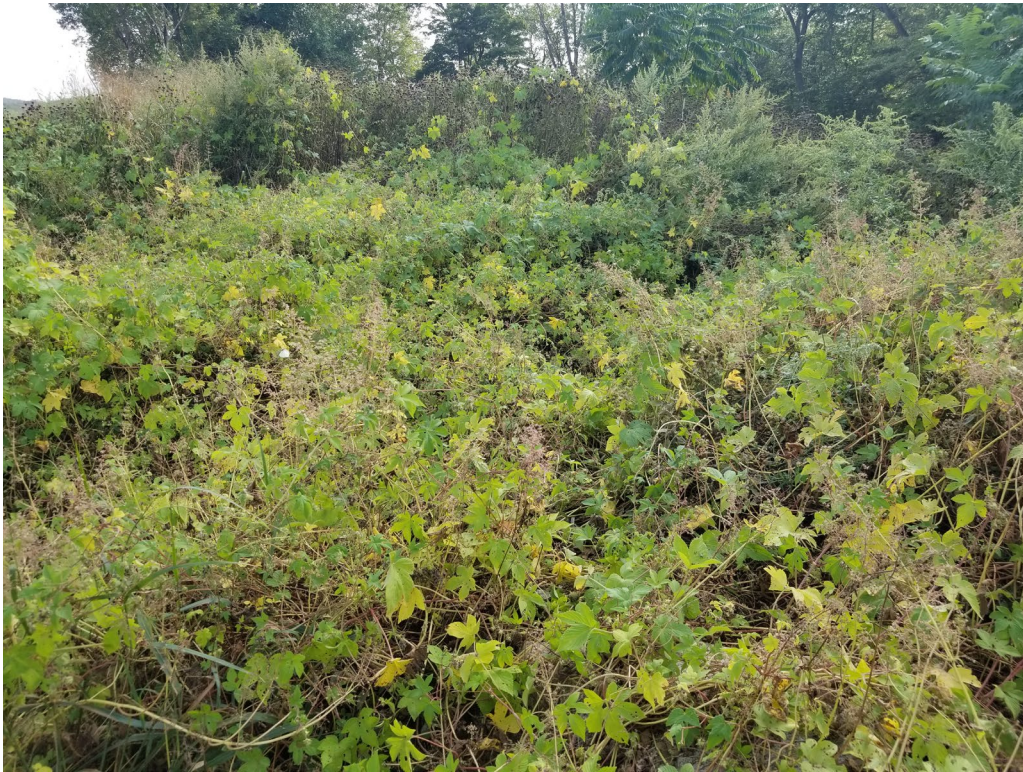
Volunteer species were identified within the sample plots and observed throughout the Site. Species including fireweed (*Erechtites hieraciifolius*), barnyard grass (*Echinochloa crus-galli*), fall panicum (*Panicum dichotomiflorum*), and calico aster (*Symphotrichum lateriflorum*) all were identified within many of the sampling plots. Invasive species including Japanese hops (*Humulus japonicus*), and mugwort (*Artemisia vulgaris*) were identified within the Site, mainly along areas sloping toward the stream. These species were targeted during the Fall 2019 herbicide treatment. Further information regarding invasive species control can be viewed in Section 5 of this report.

Photo 6: View along the Torne River embankment of the invasive species Japanese hops and common mugwort.

Furthermore, Davey implemented an herbicide treatment program to control the establishment of unwanted and invasive species. Davey contracted with Weeds, Inc., a NYSDEC Licensed Pesticide Applicator to treat invasive species including common reed (*Phragmites australis*), mugwort (*Artemisia vulgaris*), multiflora rose (*Rosa multiflora*), autumn olive (*Elaeagnus angustifolia*) and others. Weeds Inc. conducted a Site wide spot treatment of all invasive species in Spring and Fall 2019 in order to control mugwort and Japanese hops.
