2020 ANNUAL RESTORATION MONITORING REPORT

**Ford Motor Company Site: Operable Unit 2 Remediation Project
Ramapo, Rockland County, New York, Site No. 3-44-065**

February 7, 2022

Amy Greene Environmental, a Davey Company
4 Walter E. Foran Blvd., Suite 209
Flemington, NJ 08822

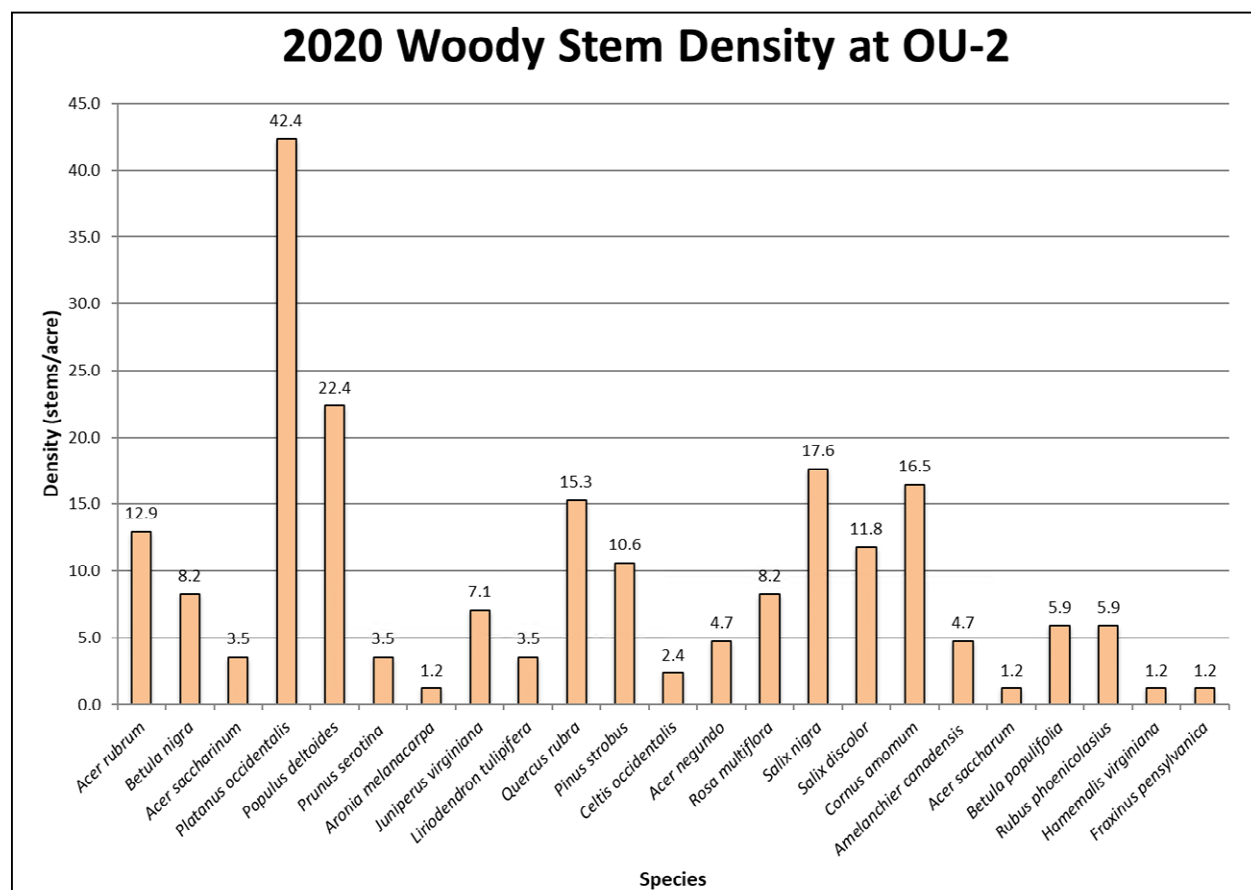
Planted tree and shrub density for individual species ranged from approximately 1 to 43 stems per acre (see Figure 3 below). Shrub establishment and growth improved throughout the 2020 growing season, especially where the stream embankment was planted with black willow (*Salix nigra*), pussy willow (*Salix discolor*), and silky dogwood (*Cornus amomum*) live stakes. In addition, naturally regenerating black willow and pussy willow were observed. Shrub establishment was likely hindered in past growing seasons by the presence of deers.

Figure 3: Average woody stem density for all species recorded within monitoring plots at the OU-2 Restoration Site following the 2020 growing season.

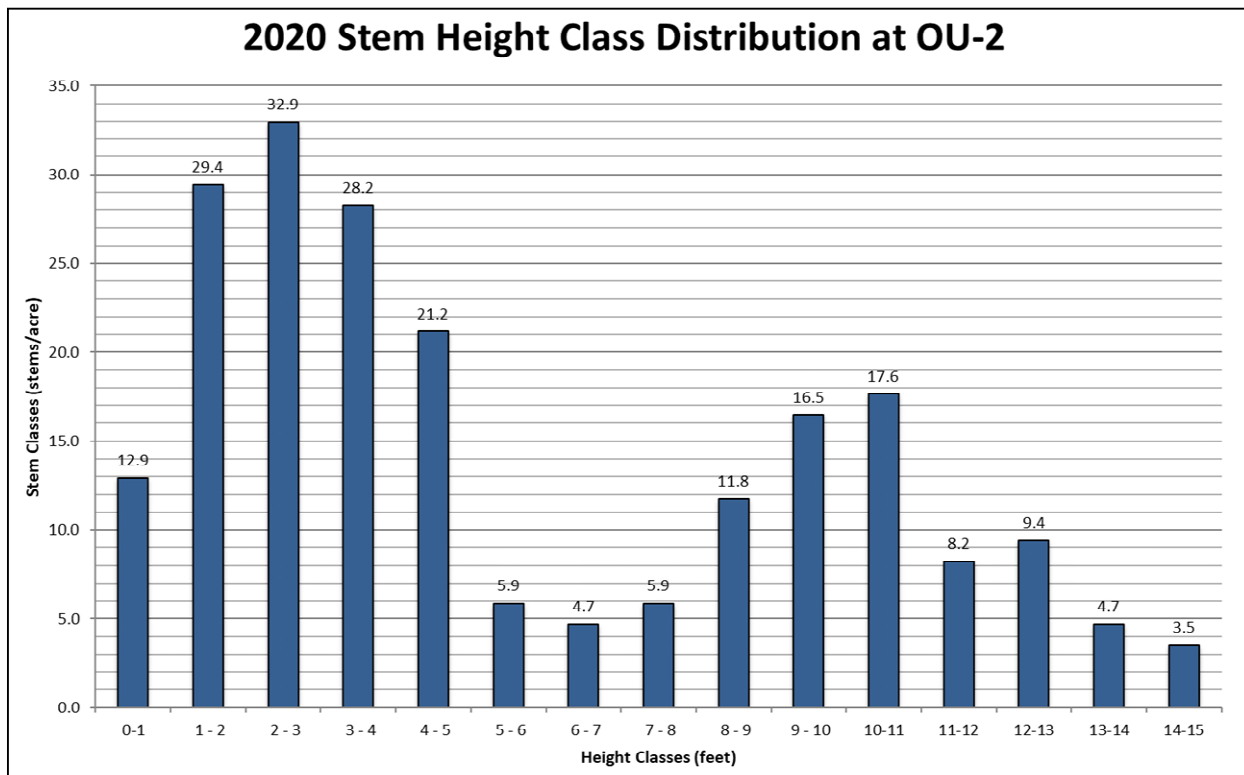
Average height of species sampled within the monitoring plots during 2020 was estimated at 6.5 feet, decreasing slightly from the previous monitoring year (see Table 1). This decrease is due to the number of naturally regenerating seedlings observed. Individual species ranged from 1-foot saplings to trees over 14 feet tall. The most abundant stem class was in the 2 to 3-foot range due to the presence of live stakes (see Figure 4 below). Not including live stakes, the highest number of stems fell within the 10 to 11-foot height class, an increase from the previous growing season. Comparing the 2020 monitoring data to previous growing seasons shows that planted trees and shrubs are successfully established and growing throughout the Site.

Figure 4: Woody stem height class distribution for planted species within the OU-2 Restoration Site following the 2020 growing season.

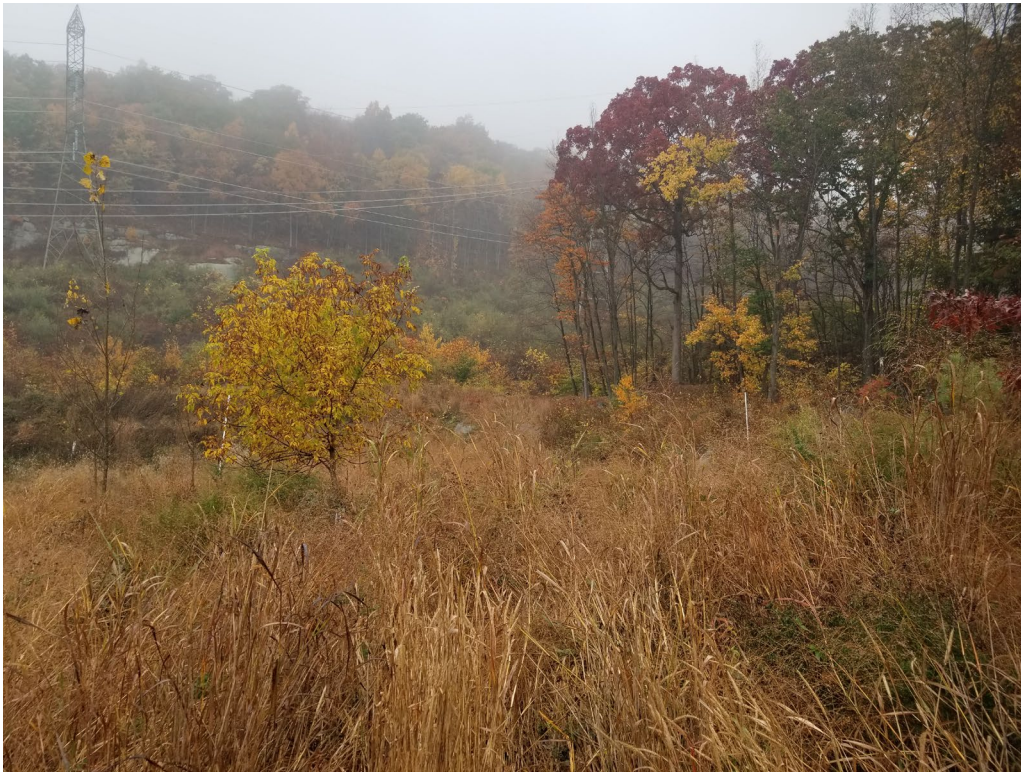
Photo 1: View of restoration area, showing dense warm season grass coverage with large trees, in the southern portion of OU-2 (October 2020).

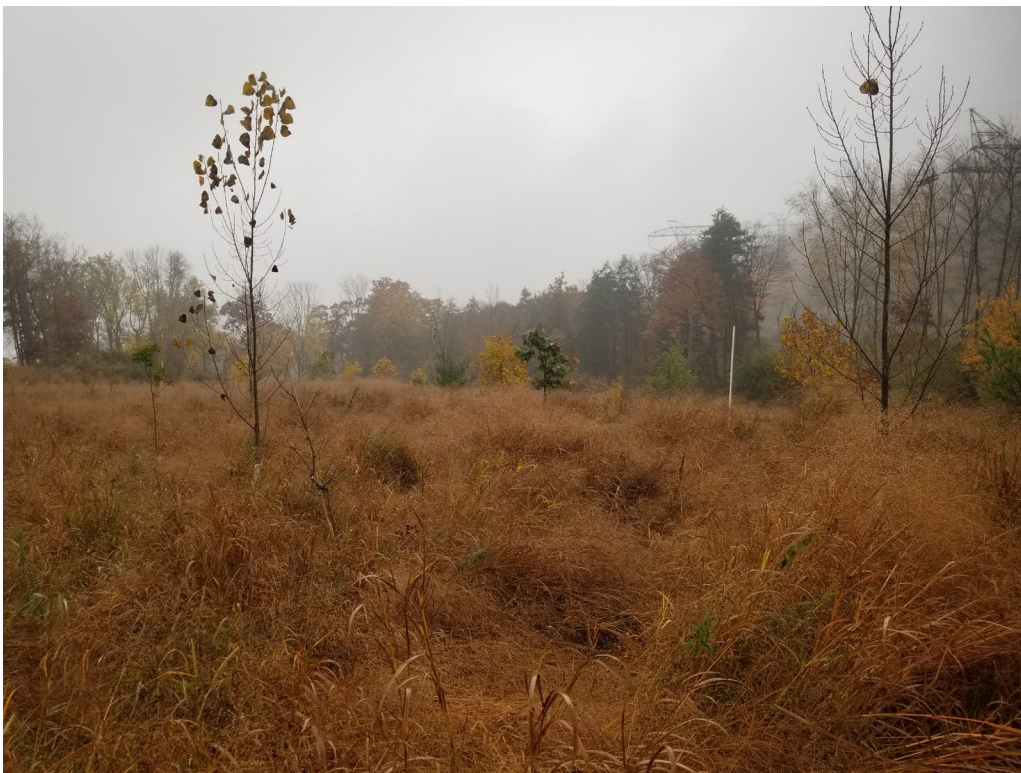
Photo 2: View, north of the southern portion of OU-2, overlooking the restoration area and showing dense herbaceous coverage within monitoring plot 2 (MP-2).

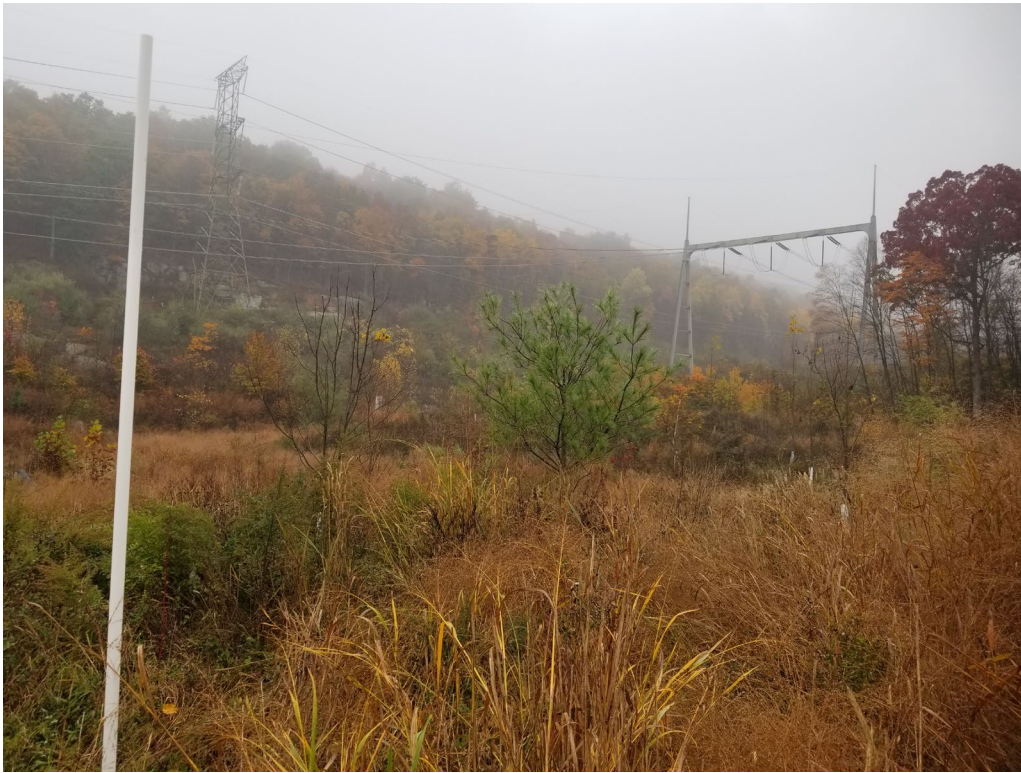
Photo 3: View, south of the northern portion of OU-2, overlooking the Site from near Plot MP-6.

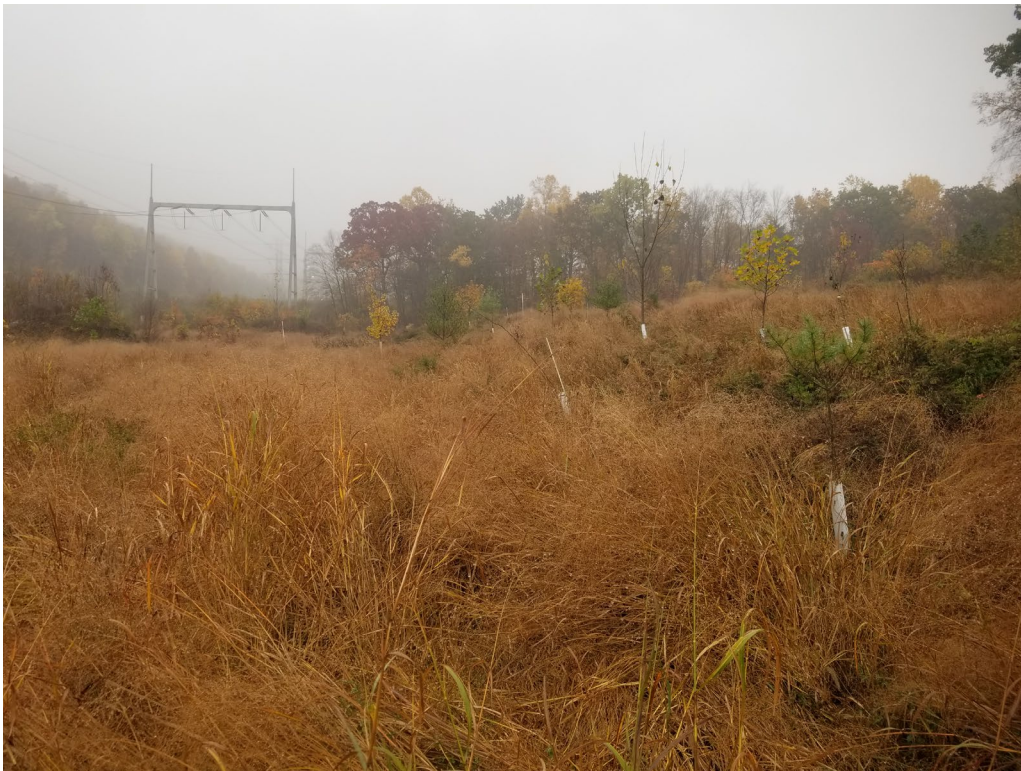
Photo 4: View, north of the northern portion of OU2, showing dense warm season grass coverage near Plot MP-4.

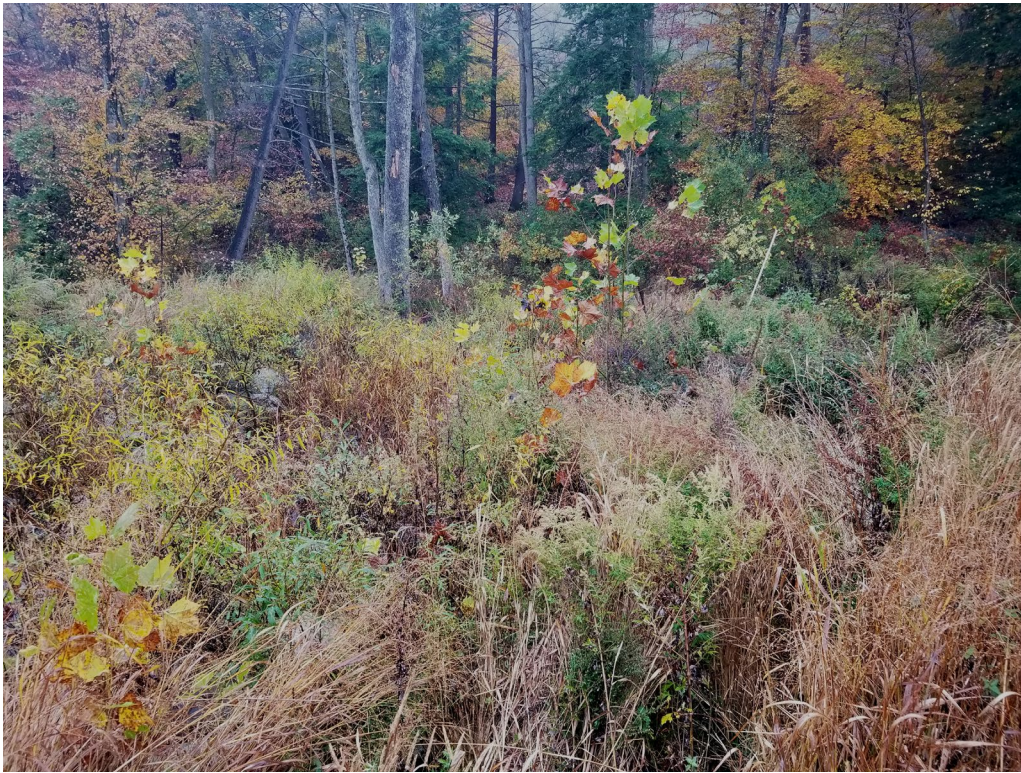
Photo 5: View, from near MP-3, showing the rip rap spillway that flows to Torne Brook and the establishment of black willow, pussy willow, and American sycamore live stakes.

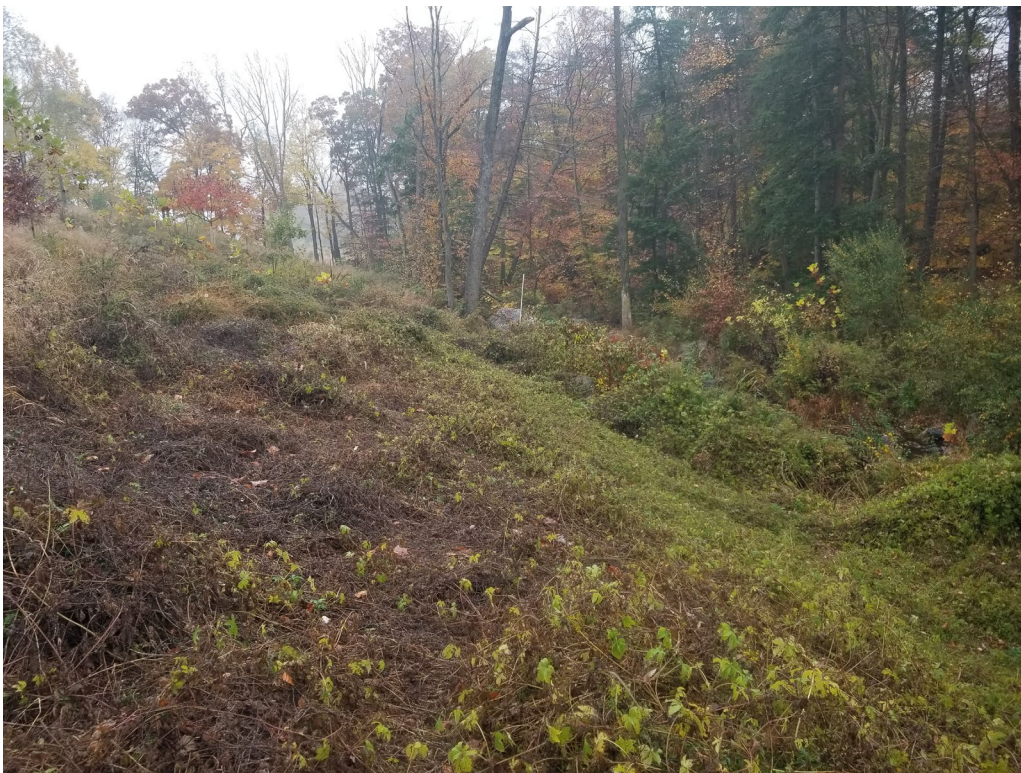
Photo 6: View along the Torne River embankment of the invasive species Japanese hops and common mugwort.
