RE: Sub-Slab Depressurization System (SSDS) – 2019 Annual Inspection

The three (3) SSDSs installed at 510 Furnace Dock Road (the site) located in Cortlandt Manor, New York have been operational since their installation in December of 2011. Each of the three (3) individual systems is comprised of two (2) sub-slab vapor extraction points. All three (3) systems are equipped with Radonaway HS-2000 fan units. Each system is also equipped with a pressure indicating alarm which illuminates a light in the event that the vacuum inside of the system falls below 0.25 inches of water column. All plumbing was completed using three-inch Schedule 40 PVC pipe and solvent-welded fittings. The three (3) fans were mounted securely to the roof and all piping was installed on a pitch to allow any condensation to flow back into the ground beneath the building's slab.

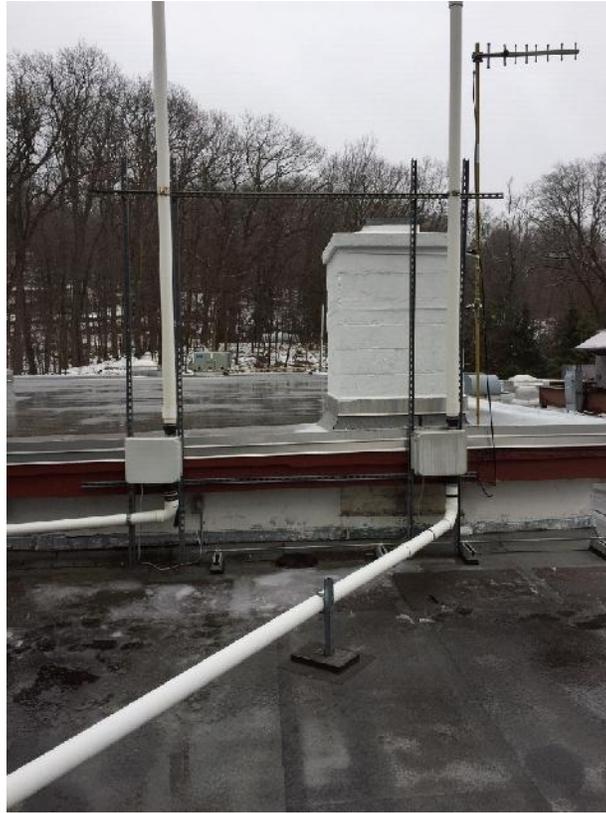
Seen here are the northern and central fans.

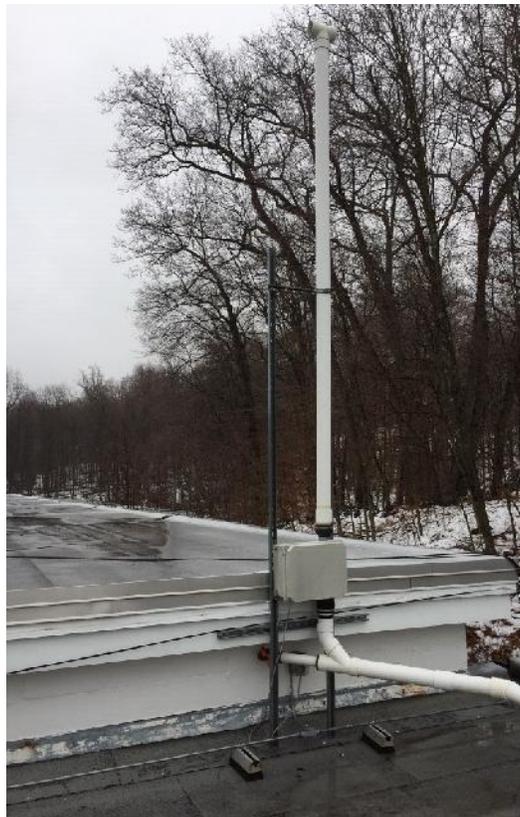
Seen here is the southern fan.
