May 4, 2021

**RE: Sub-Slab Depressurization System (SSDS)
2020 Annual Inspection
510 Furnace Dock Road
Cortlandt Manor, NY 10567**

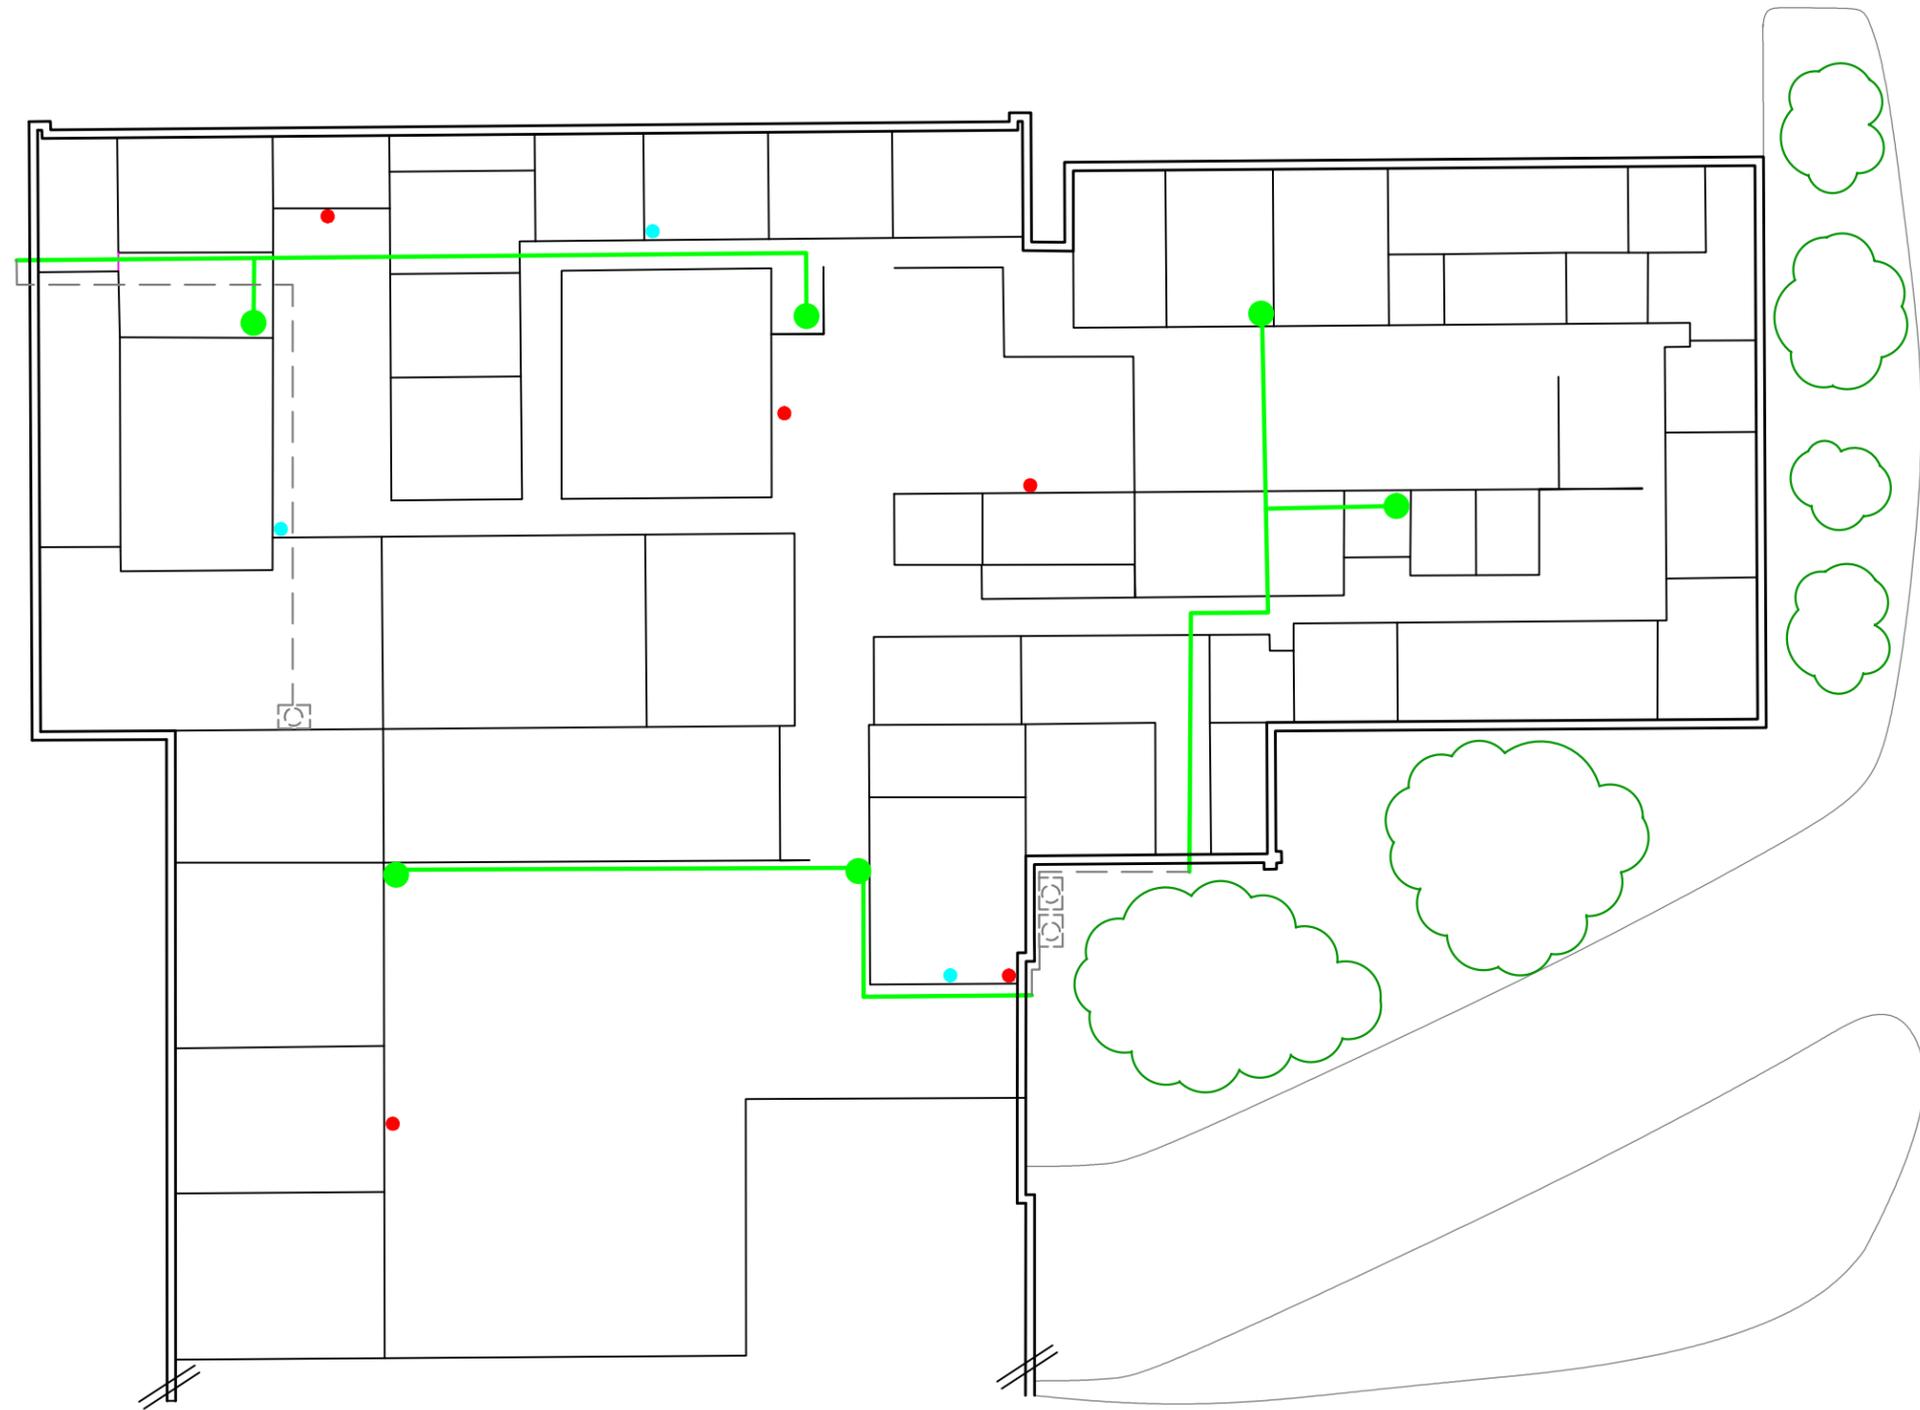
FIGURE 1

March 15, 2021 – SSDS Inspection Log
