OPERATIONS & MAINTENANCE STATUS REPORT
PERIOD: DECEMBER 31, 2005 THROUGH JULY 11, 2006

OPERABLE UNIT I
FORMER WASTEWATER TREATMENT AREA
METRO NORTH RAILROAD HARMON YARD
CROTON-ON-HUDSON, NEW YORK

Prepared by: Day Engineering, P.C.
40 Commercial Street
Rochester, New York 14614

Date: August 2006

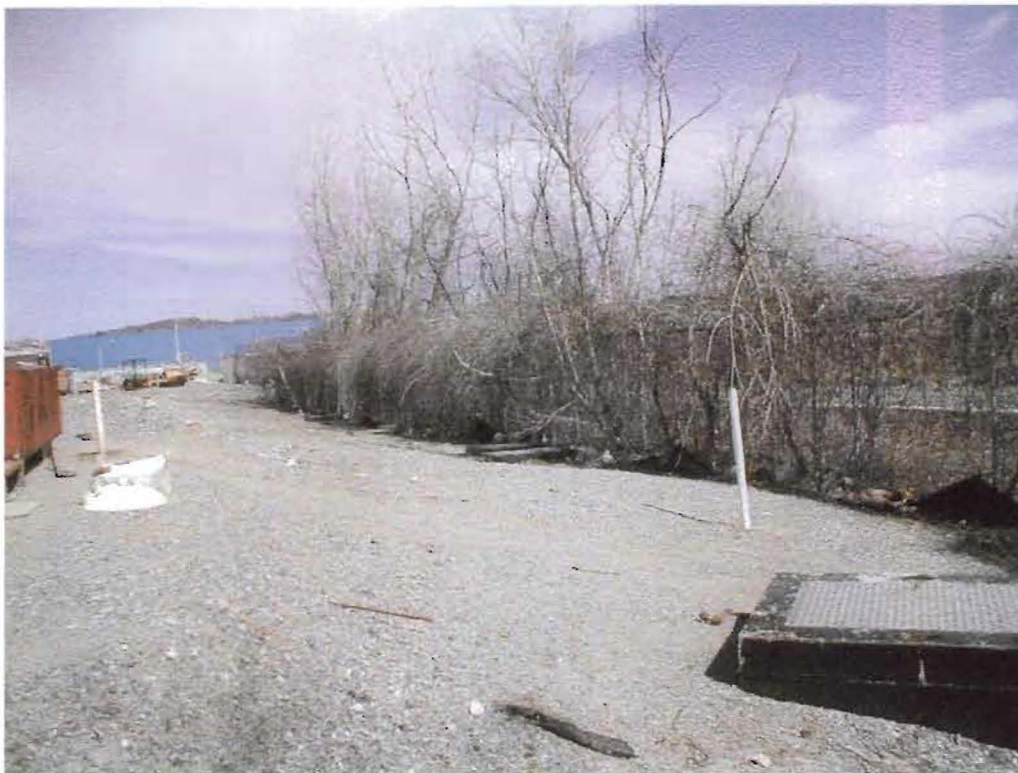
Location 1

scrub trees along various portions of fence (photos 1, 2, 3)

View of scrub trees along the perimeter fencing and minor erosion rivulets in the asphalt cover.

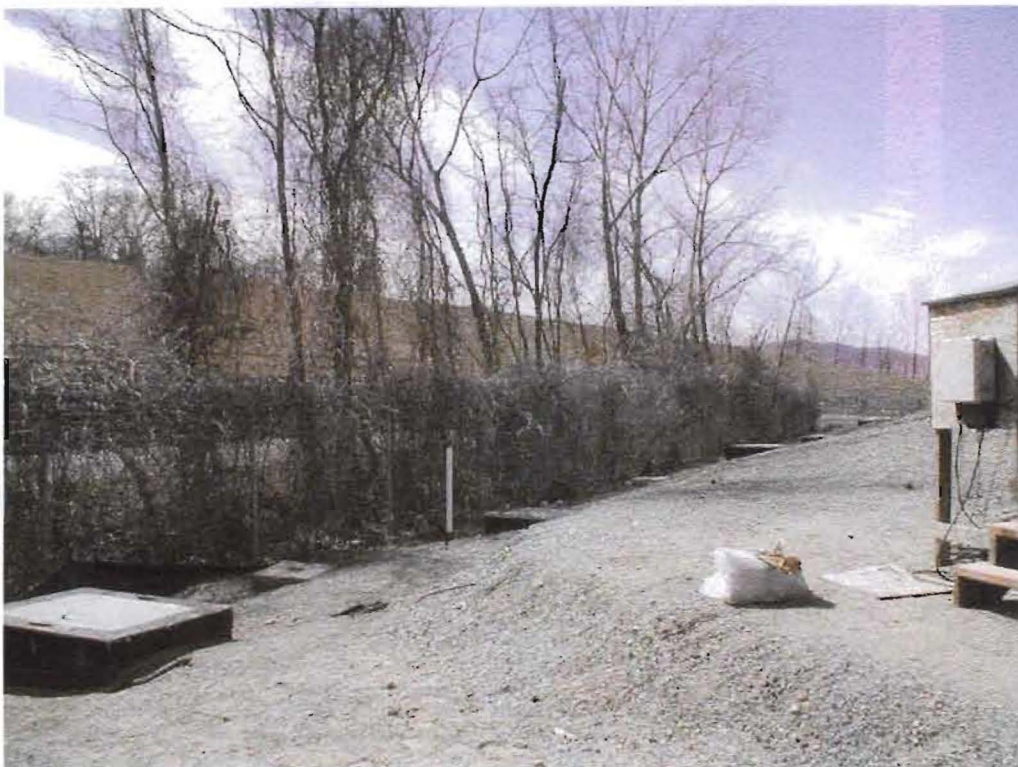
Location 2

Scrub trees along various portions of fence. (photos 2, 3)

View of scrub trees along the perimeter fencing.

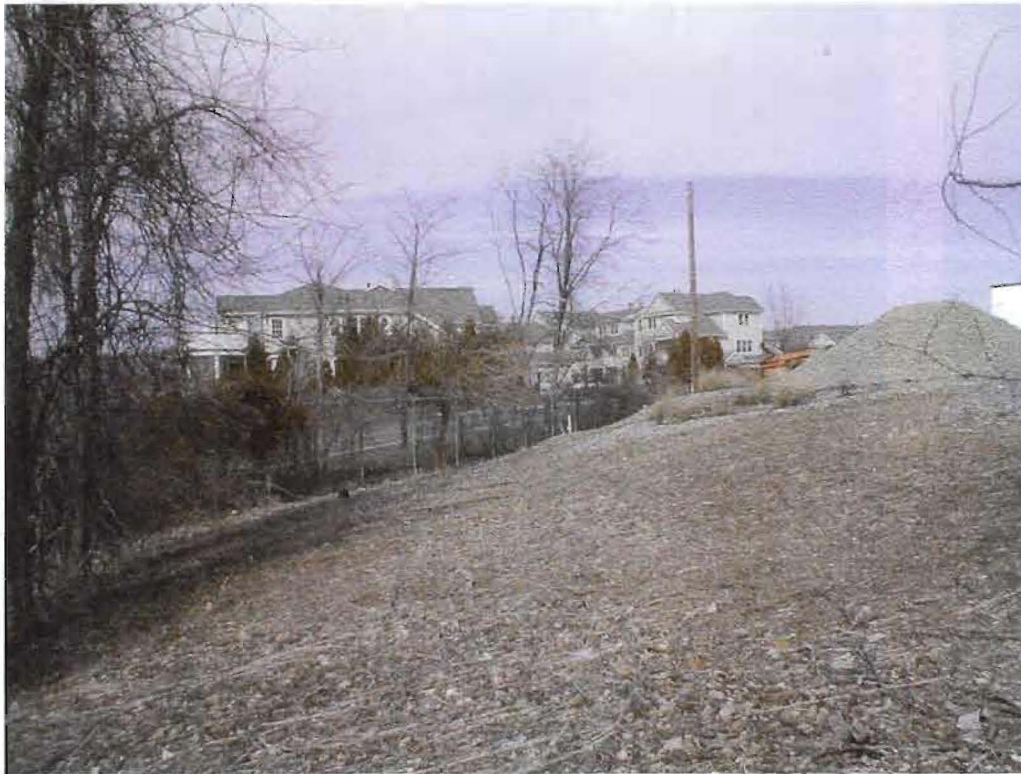
Location 3
View of the scrub trees along the perimeter fencing.

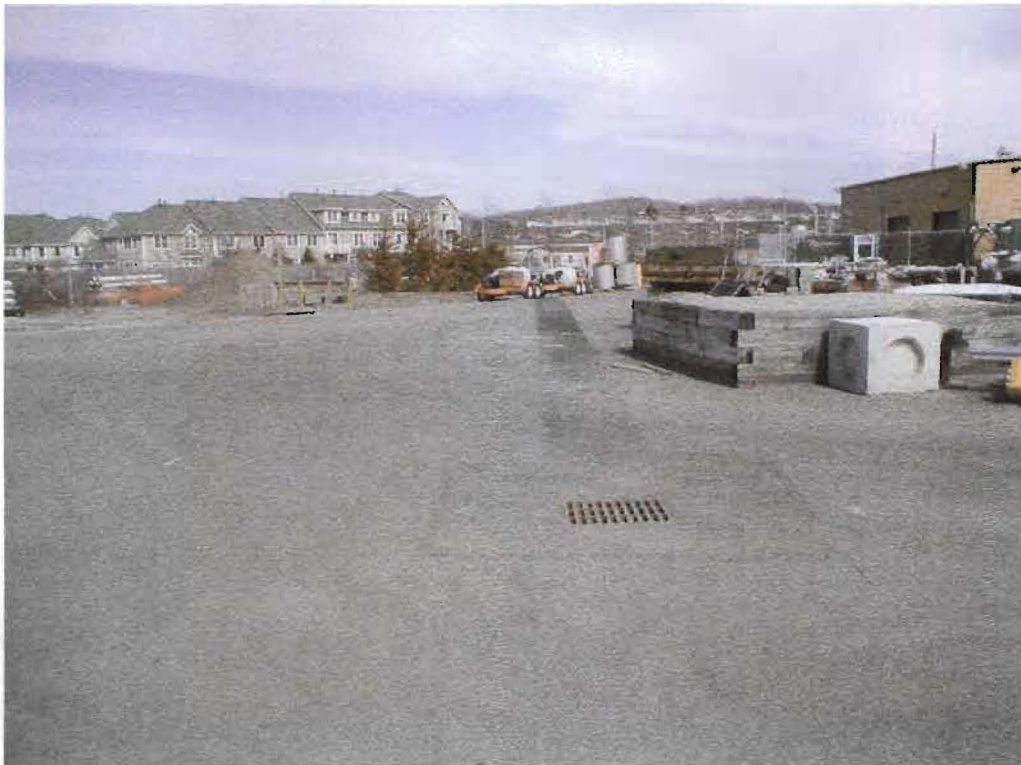
Location 4
View of the sump box installed during drainage modification system.

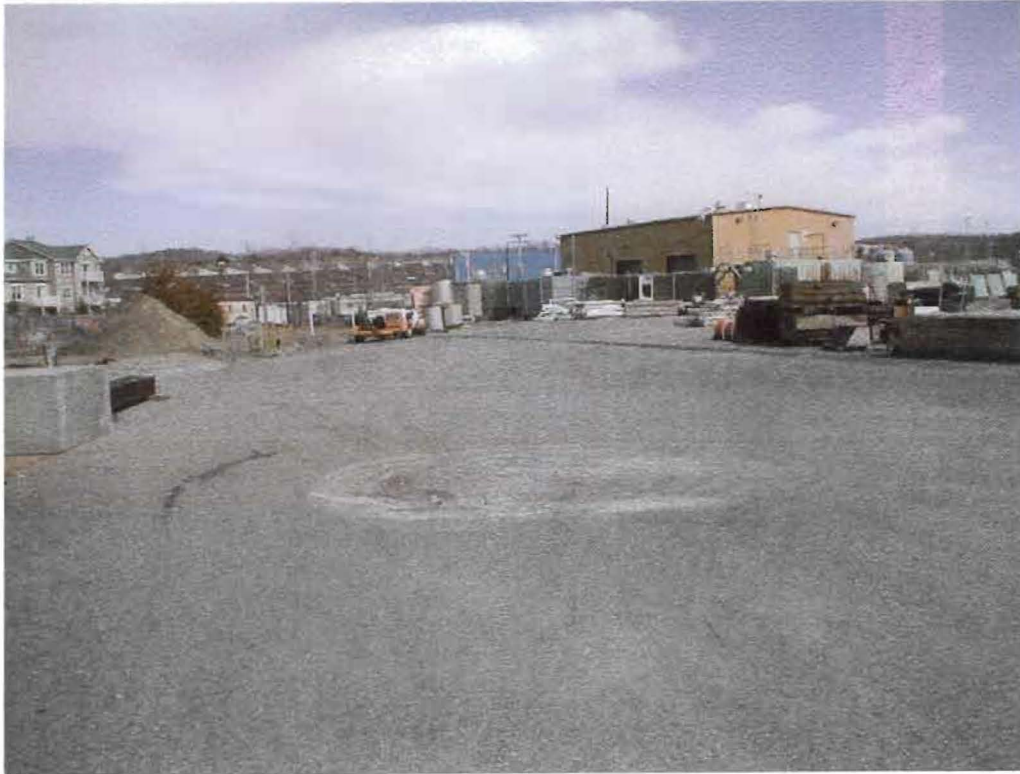
Location 5

Minor cracking (see photos 6 and 7) should be sealed, various locations on cover. catch basin and drain (photo 4) installed in low spot. Second low spot (photo 5) is self draining to catch basin.

View of the small depression in the asphalt cover 25 feet north of the sump box during the March 21, 2006 inspection.

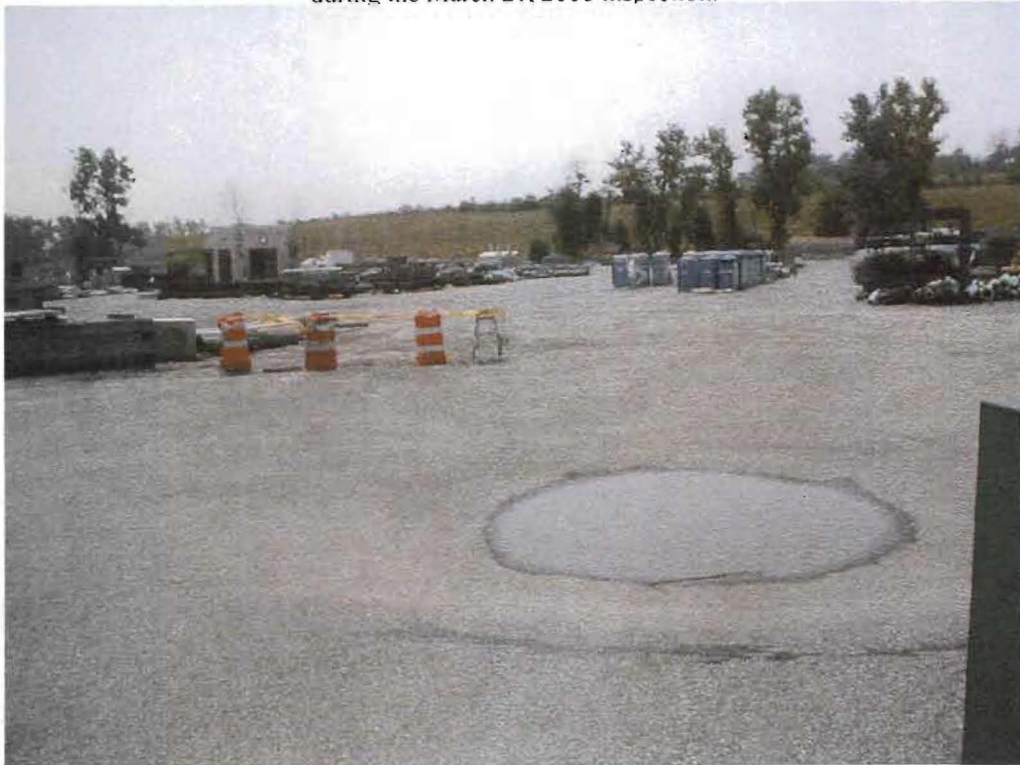
Location 5

Low spot ~ 25' North of catch basin holding ~ 8' circle of
water 2" deep. (photo 4-)
Minor cracking throughout.

View of the small depression in the asphalt cover 25 feet north of the sump box during the July 11, 2006 inspection.

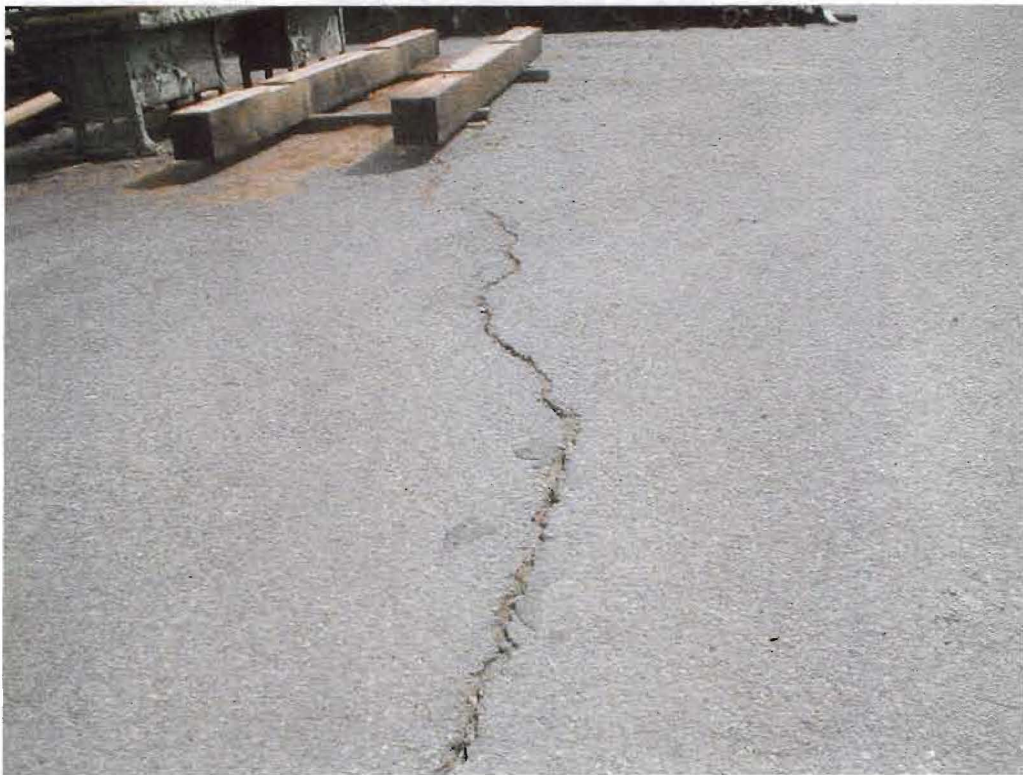
Location 6

View of minor cracking located throughout the asphalt cover.

Additionally, shallow surficial cracking radiating concentrically from the low spot in the center of the asphalt cover (i.e., in the area of the sump box) to various locations throughout the asphalt cap was noted during both inspections. It is recommended that the cracking on the asphalt cover be sealed on a routine basis to maintain the integrity of the asphalt cover.

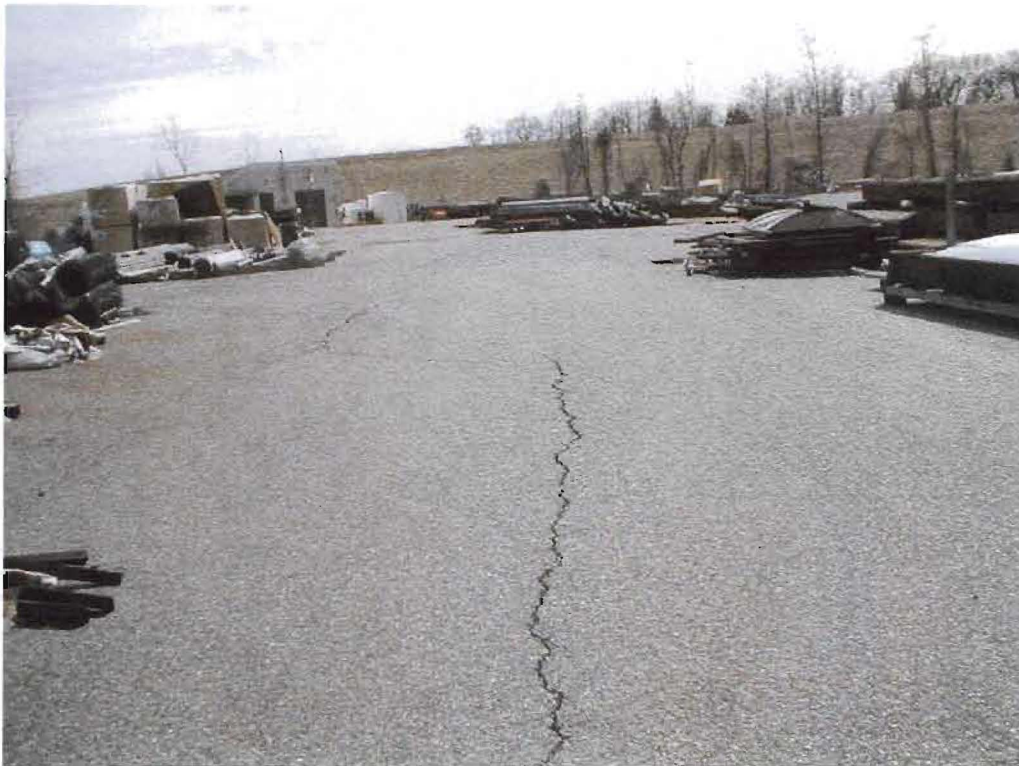
Location 7

View of minor cracking located throughout the asphalt cover.

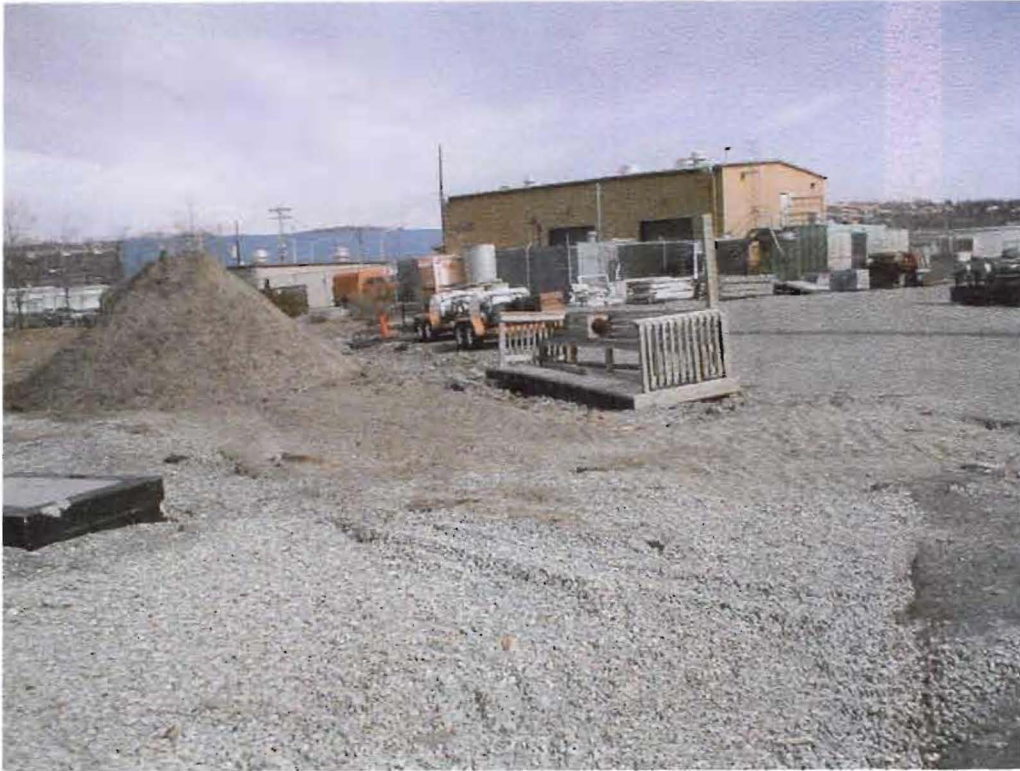
stockpiled sand next to drainage channel has gotten into drainage channel, however, drainage channel is not being used as originally intended, drainage being handled by new catch basin. (photo 8)

Location 8
Stockpiled sand next to the drainage channel of catch basin 1.
