CORRECTIVE ACTION PLAN

**METRO-NORTH RAILROAD
HARMON RAILROAD YARD
NYSDEC SITE # 3-60-010
OPERABLE UNITS OUI AND OUII**

Prepared By: Day Engineering, P. C.
1563 Lyell Avenue
Rochester, New York 14606

Date: March 2014

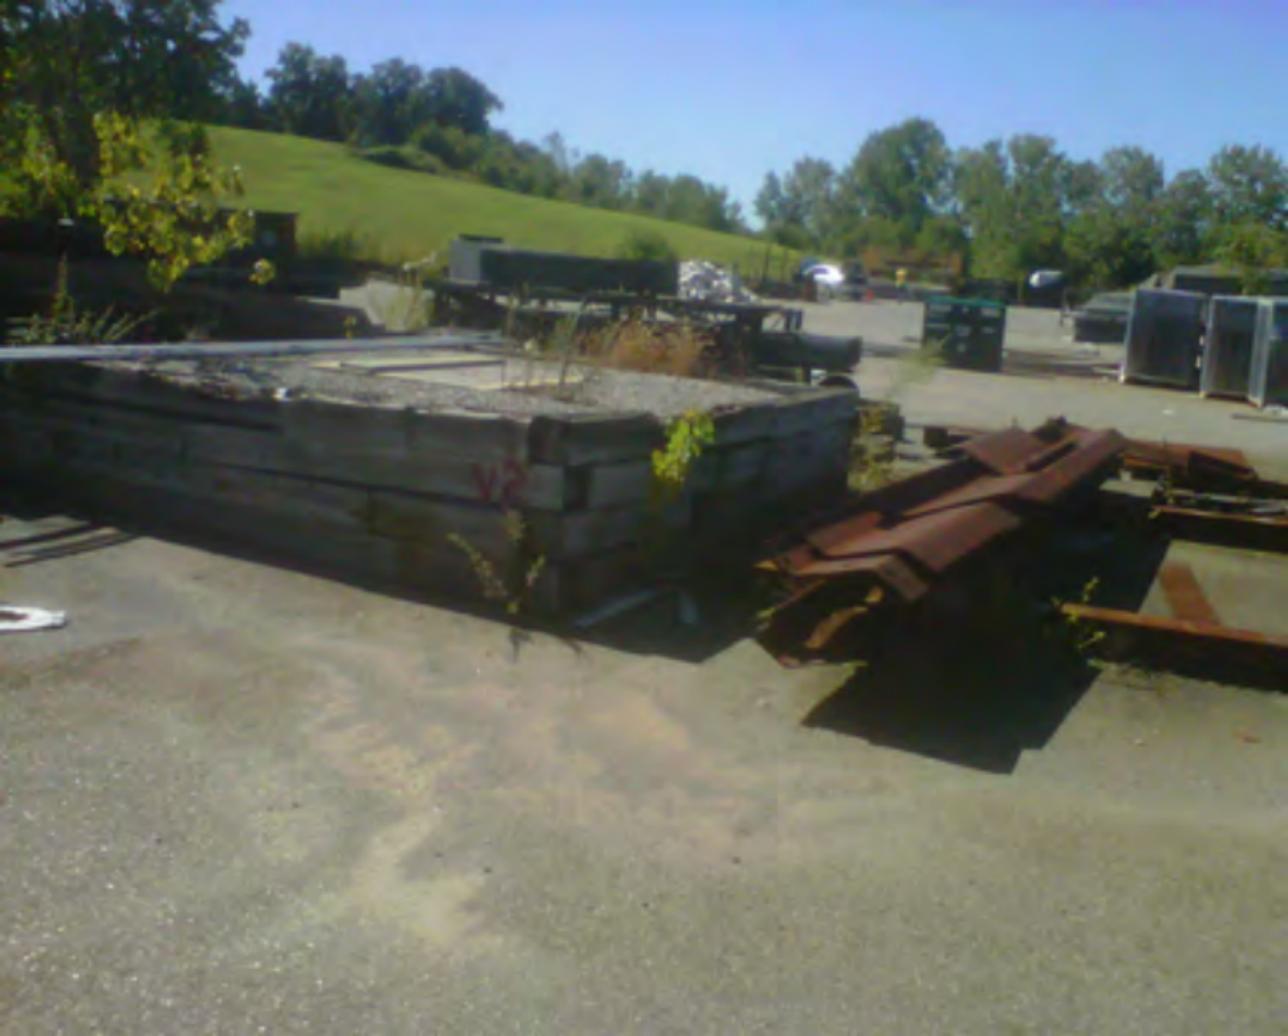
Attachment A: Photograph of a protective barrier taken during the September 24, 2013 SMP inspection

The well heads of the four groundwater pumping wells located within the OU I footprint are surrounded by, and covered with, pre-fabricated concrete vaults. The containment vaults were installed on top of the asphalt cap, and extend approximately three feet above grade. In order to protect the concrete vaults from damage by vehicle traffic and equipment storage, a barrier was constructed around each pre-fabricated concrete vault. These barriers consist of a perimeter wall constructed of railroad ties with gravel between the perimeter wall and the pre-fabricated concrete vault. During the September 24, 2013 SMP inspection, it was noted that the barriers surrounding each of the groundwater pumping well containment vaults were in disrepair. Specifically, the railroad tie perimeter walls were noted to be deteriorating and the gravel fill was beginning to leak out of these perimeter walls. A photograph taken of one of the protective barriers during the September 24, 2013 SMP inspection is included for reference as Attachment A.

It is proposed that the perimeter walls surrounding each of the four containment vaults be demolished and the concrete vaults observed to assess if the vaults are adequate or if the perimeter walls need to be rebuilt.
