DURACELL, INC.  
NORTH TARRYTOWN, NEW YORK

ENGINEERING REPORT EVALUATING  
ON-SITE RESIDUES

Report No. 7

PROJECT #425-1  
OCTOBER 1985

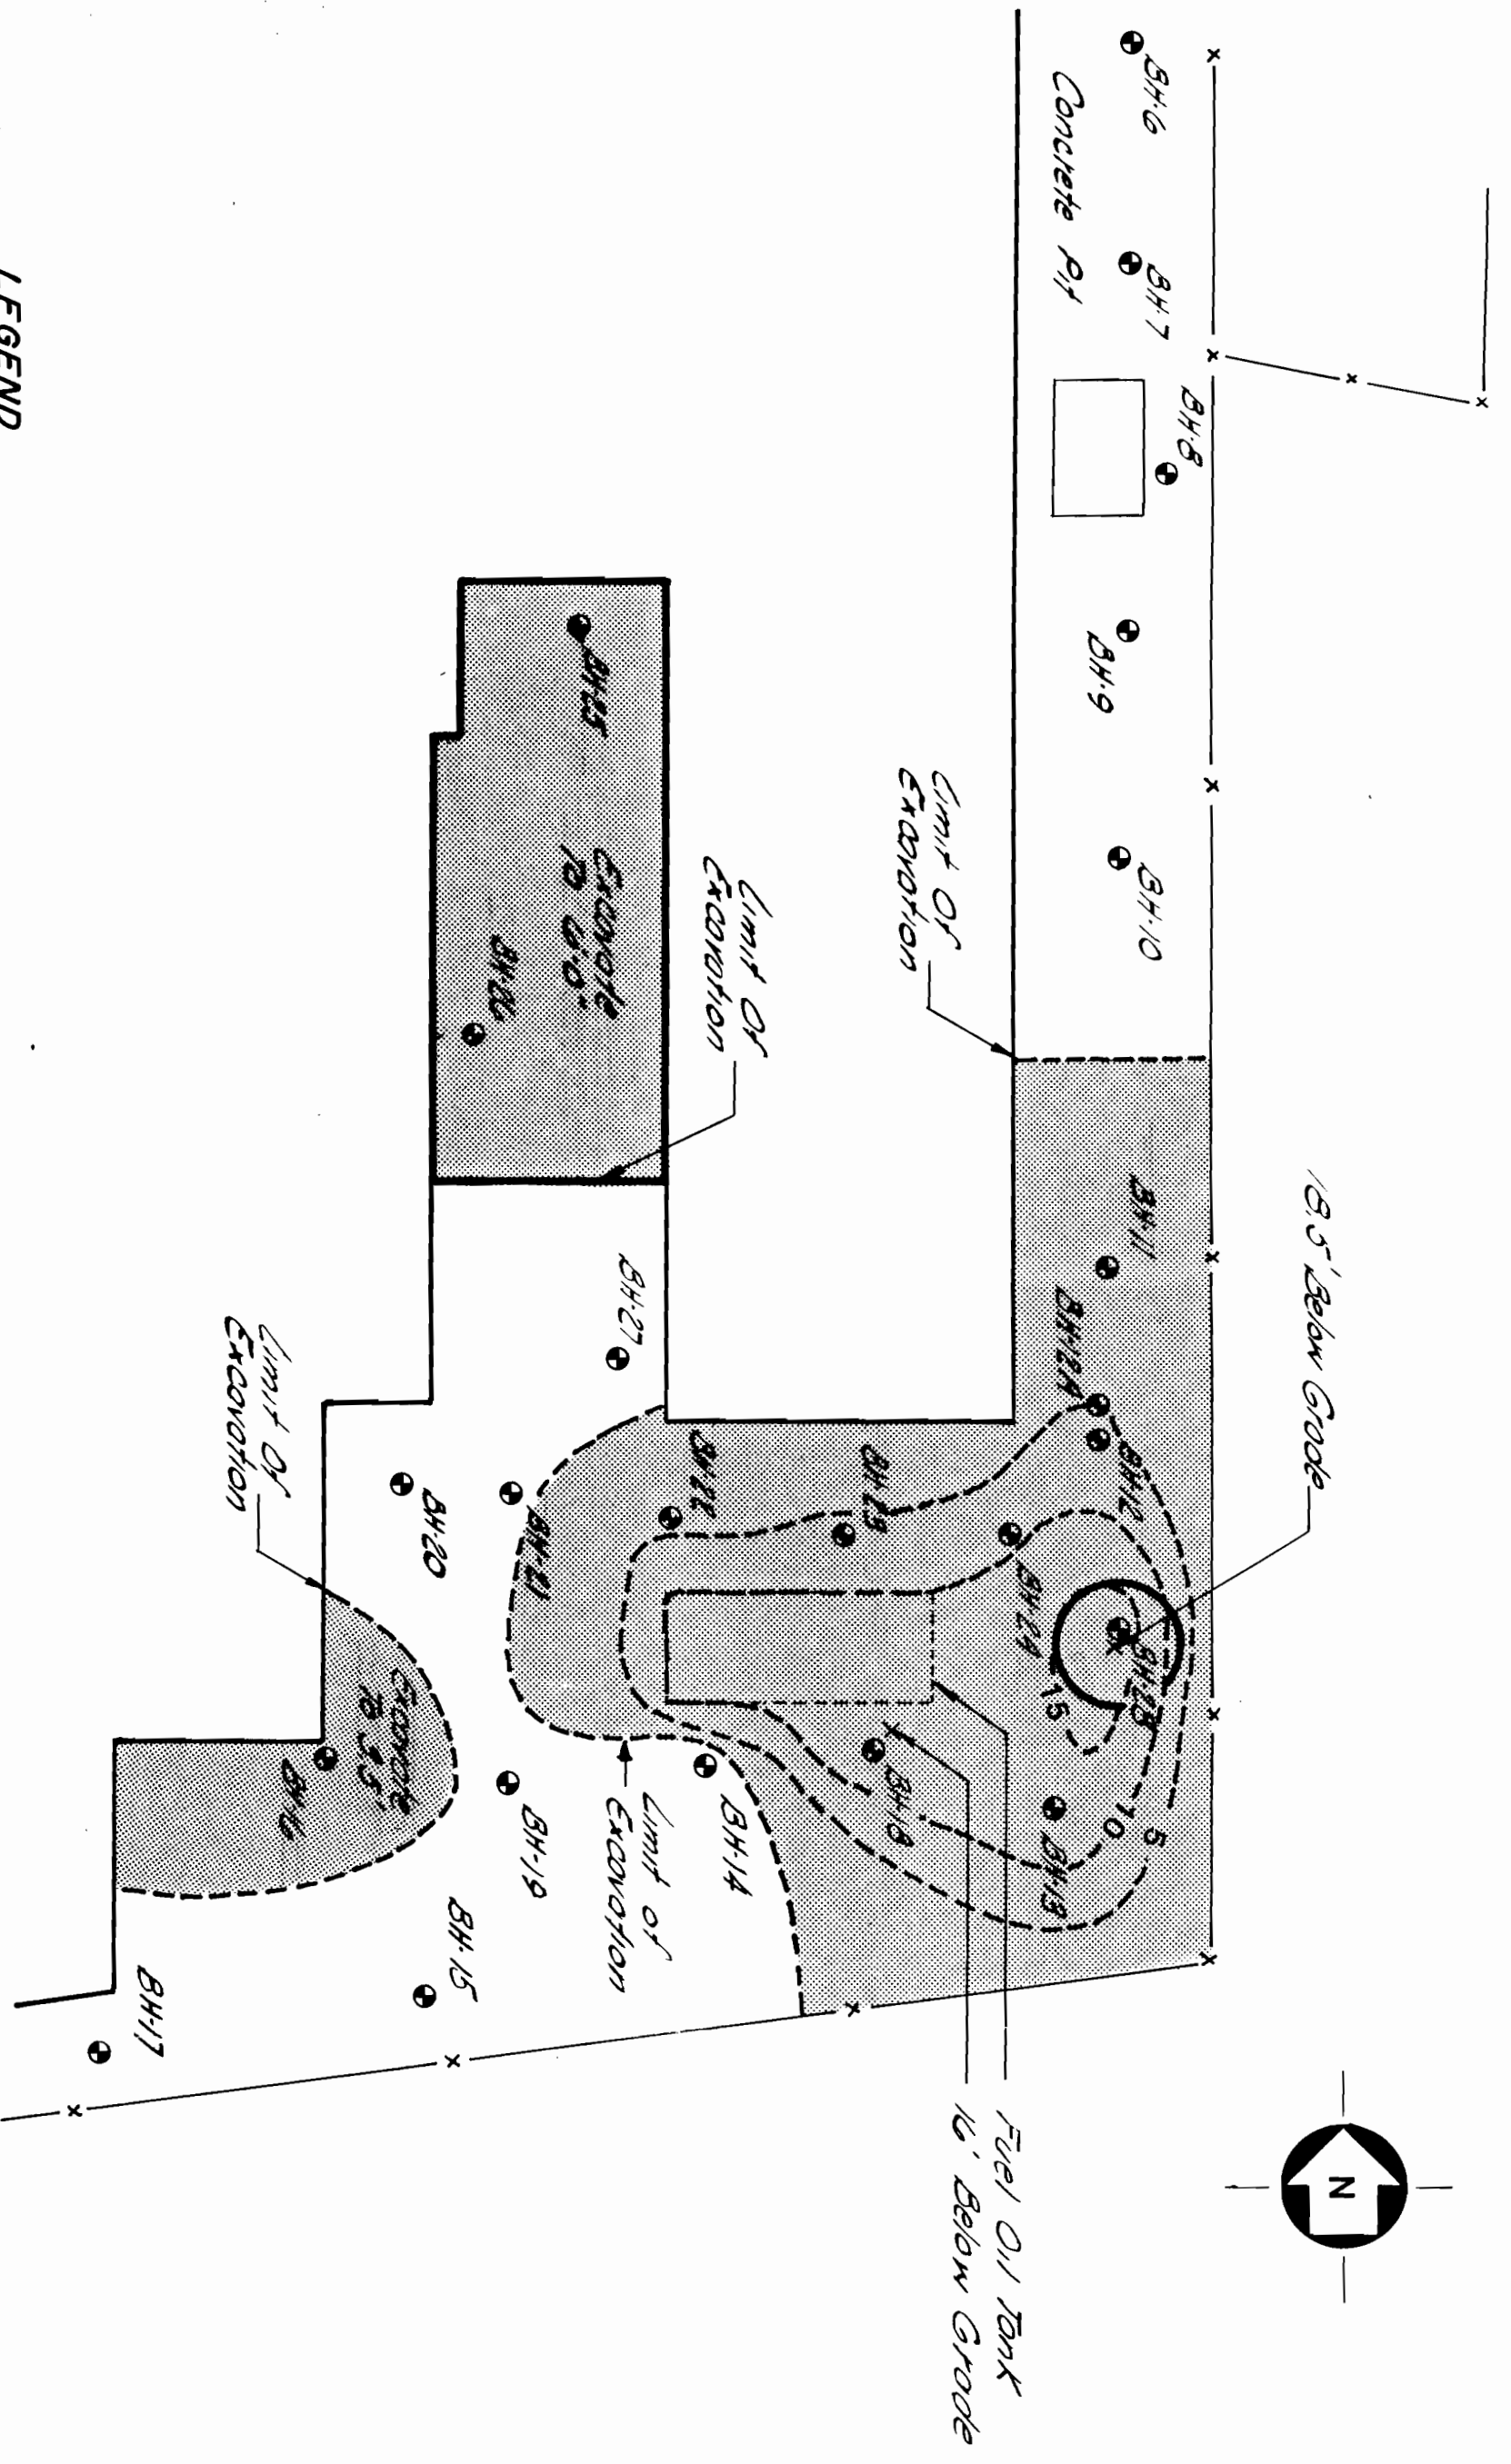
Some excavated soils may have to be handled and disposed of as hazardous wastes. Soil samples taken at Borehole 28, near the east boundary line, at Boreholes 25 and 26 in the areaway, and at Borehole 16, in the west area to be excavated, exhibit EP toxicity. Further investigation will be performed to confirm these results and verify the extent of soils exhibiting EP toxicity.

Soil samples taken in the vicinity of Borehole 28 did not exhibit EP toxicity. Some of these samples, from Boreholes 12, 23 and 24 show comparatively high concentrations of mercury. Further investigation in this area is required to verify the extent of soils with EP toxicity.

Soils excavated from the areaway, near Boreholes 25 and 26, and surface soils excavated in the vicinity of Borehole 28 to a depth of five feet, will probably be considered hazardous. These areas are shown in Figure 6. The estimated quantity of soils exhibiting hazardous waste characteristics is about 280 cubic yards weighing 380 tons.

Prior to implementing the removal program, a health and safety plan will be developed to ensure the protection of workers and minimize the release of resuspended soil. Implementation of the plan during the work will be documented. Following removal, soil sampling will be performed to verify that the remaining soils are within remediation values. After this demonstration, the excavated area will be backfilled with clean fill.
