Re: Westchester Colprovia; Site ID: 360018
April 29, 2010 Sub-Slab Depressurization System (SSDS) Installation and Testing Report

Soil Management Plan

**Seneca St
Schenectady, NY**

National Grid Seneca Street Site - Photolog

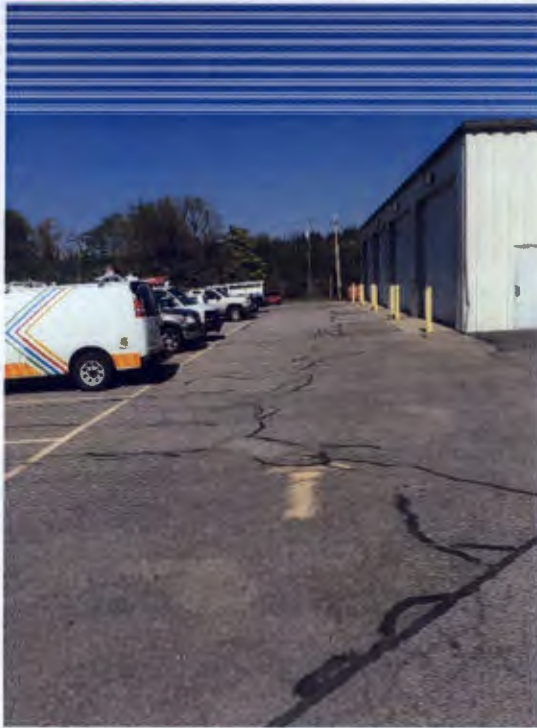
Asphalt condition - September 2016

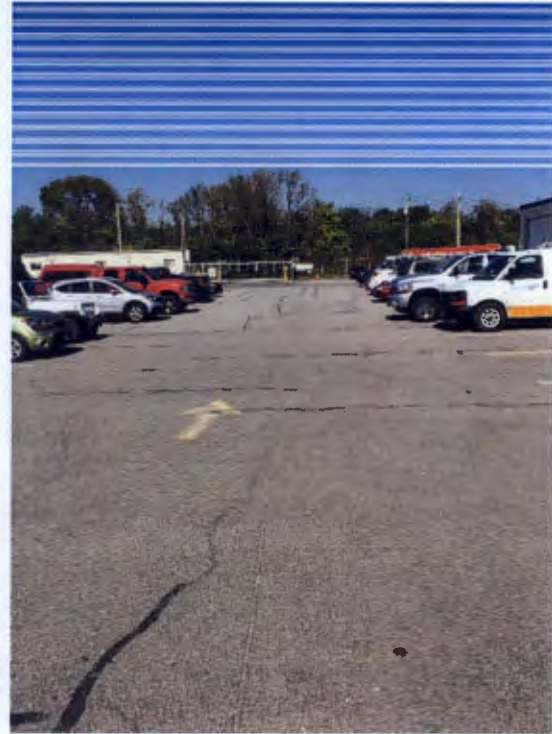
Asphalt Condition - September 2016

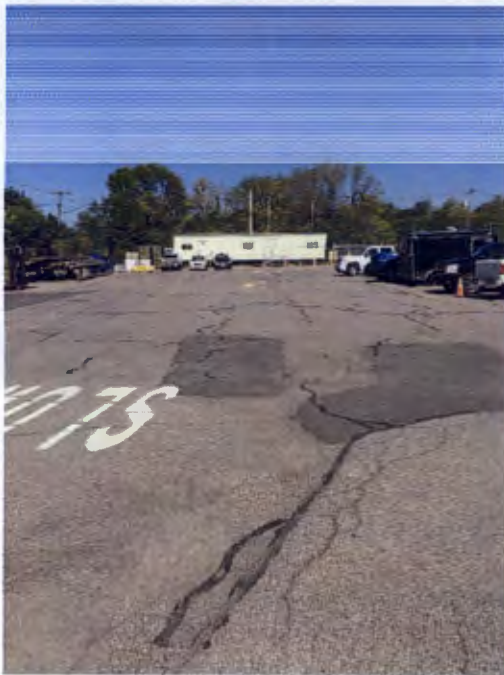
Asphalt Condition - September 2016

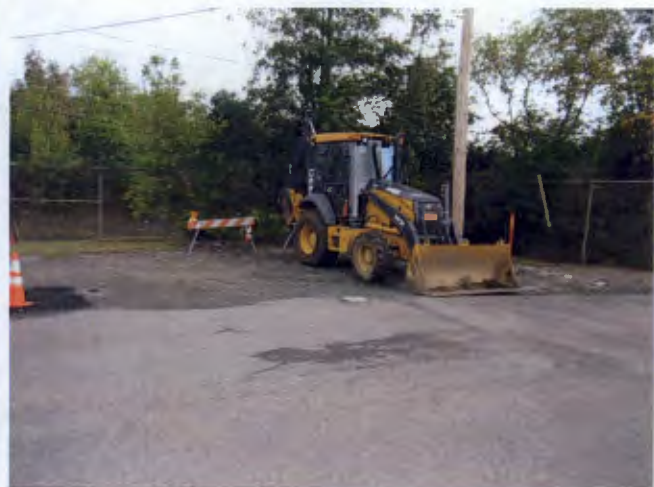
Monument #2 - September 2015

Monument - 1	PRESENT	MISSING	COMMENTS:
Condition of Monument - 1	GOOD	FAIR	
Monument - 2	PRESENT	MISSING	COMMENTS: Monument had been hit by snowplow. The concrete base is loose. But Secure.
Condition of Monument - 2	GOOD	FAIR	
Monument - 3	PRESENT	MISSING	COMMENTS:
Condition of Monument - 3	GOOD	FAIR	
Monument - 4	PRESENT	MISSING	COMMENTS:
Condition of Monument - 4	GOOD	FAIR

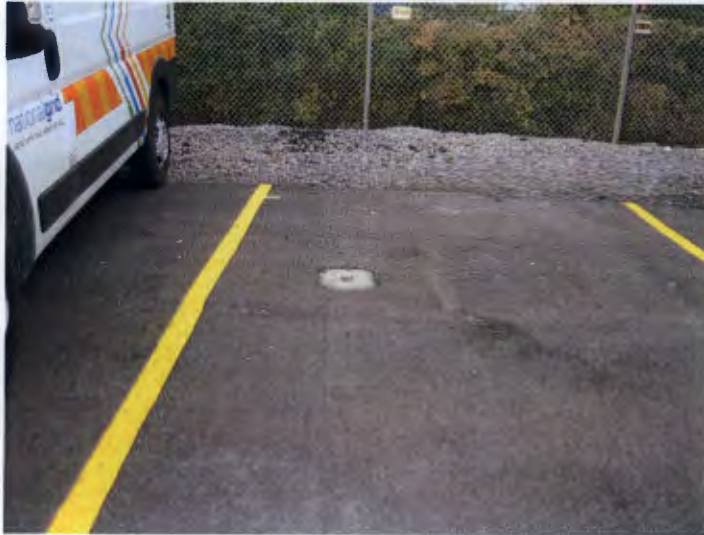
Monument #4 - September 2015

- In December 2013, it was discovered that Monument #4 was inadvertently covered by new asphalt. The monument was exposed and found to be intact on the September 2014 inspection date.

Monument 4 was covered with fresh asphalt upon arrival to site. Called Steve Plansker who contacted the contractor. Contractor called TJB who said the monument was not removed must have been covered. TJB located the monument under fresh asphalt. Contractor to come back in a few days and touch up the area. Contractor did not make any repairs-notified Steve Plansker.
