NEW YORK STATE DEPARTMENT OF ENVIRONMENTAL CONSERVATION
DIVISION OF HAZARDOUS WASTE REMEDIATION
INSPECTOR'S DAILY REPORT

Site Code No. <u>300021</u>	Date <u>11-1-86</u>	I.R. No. <u>27</u>
Site Name: <u>Hammerneck Taylor Lane</u>	Sheet <u>1</u> of <u>3</u>	AM
Location: <u>Hammerneck N.Y.</u>	Weather	PM
Engineer: <u>EnCon</u>	Temperature	
Contractor: <u>Breco</u>	Wind (Dir./Vel.)	
Job Phone: ()

ent to Report No. 27 Dated 11-1-96
Code No. 360021 Site Name Mamaroneck Taylor Lane

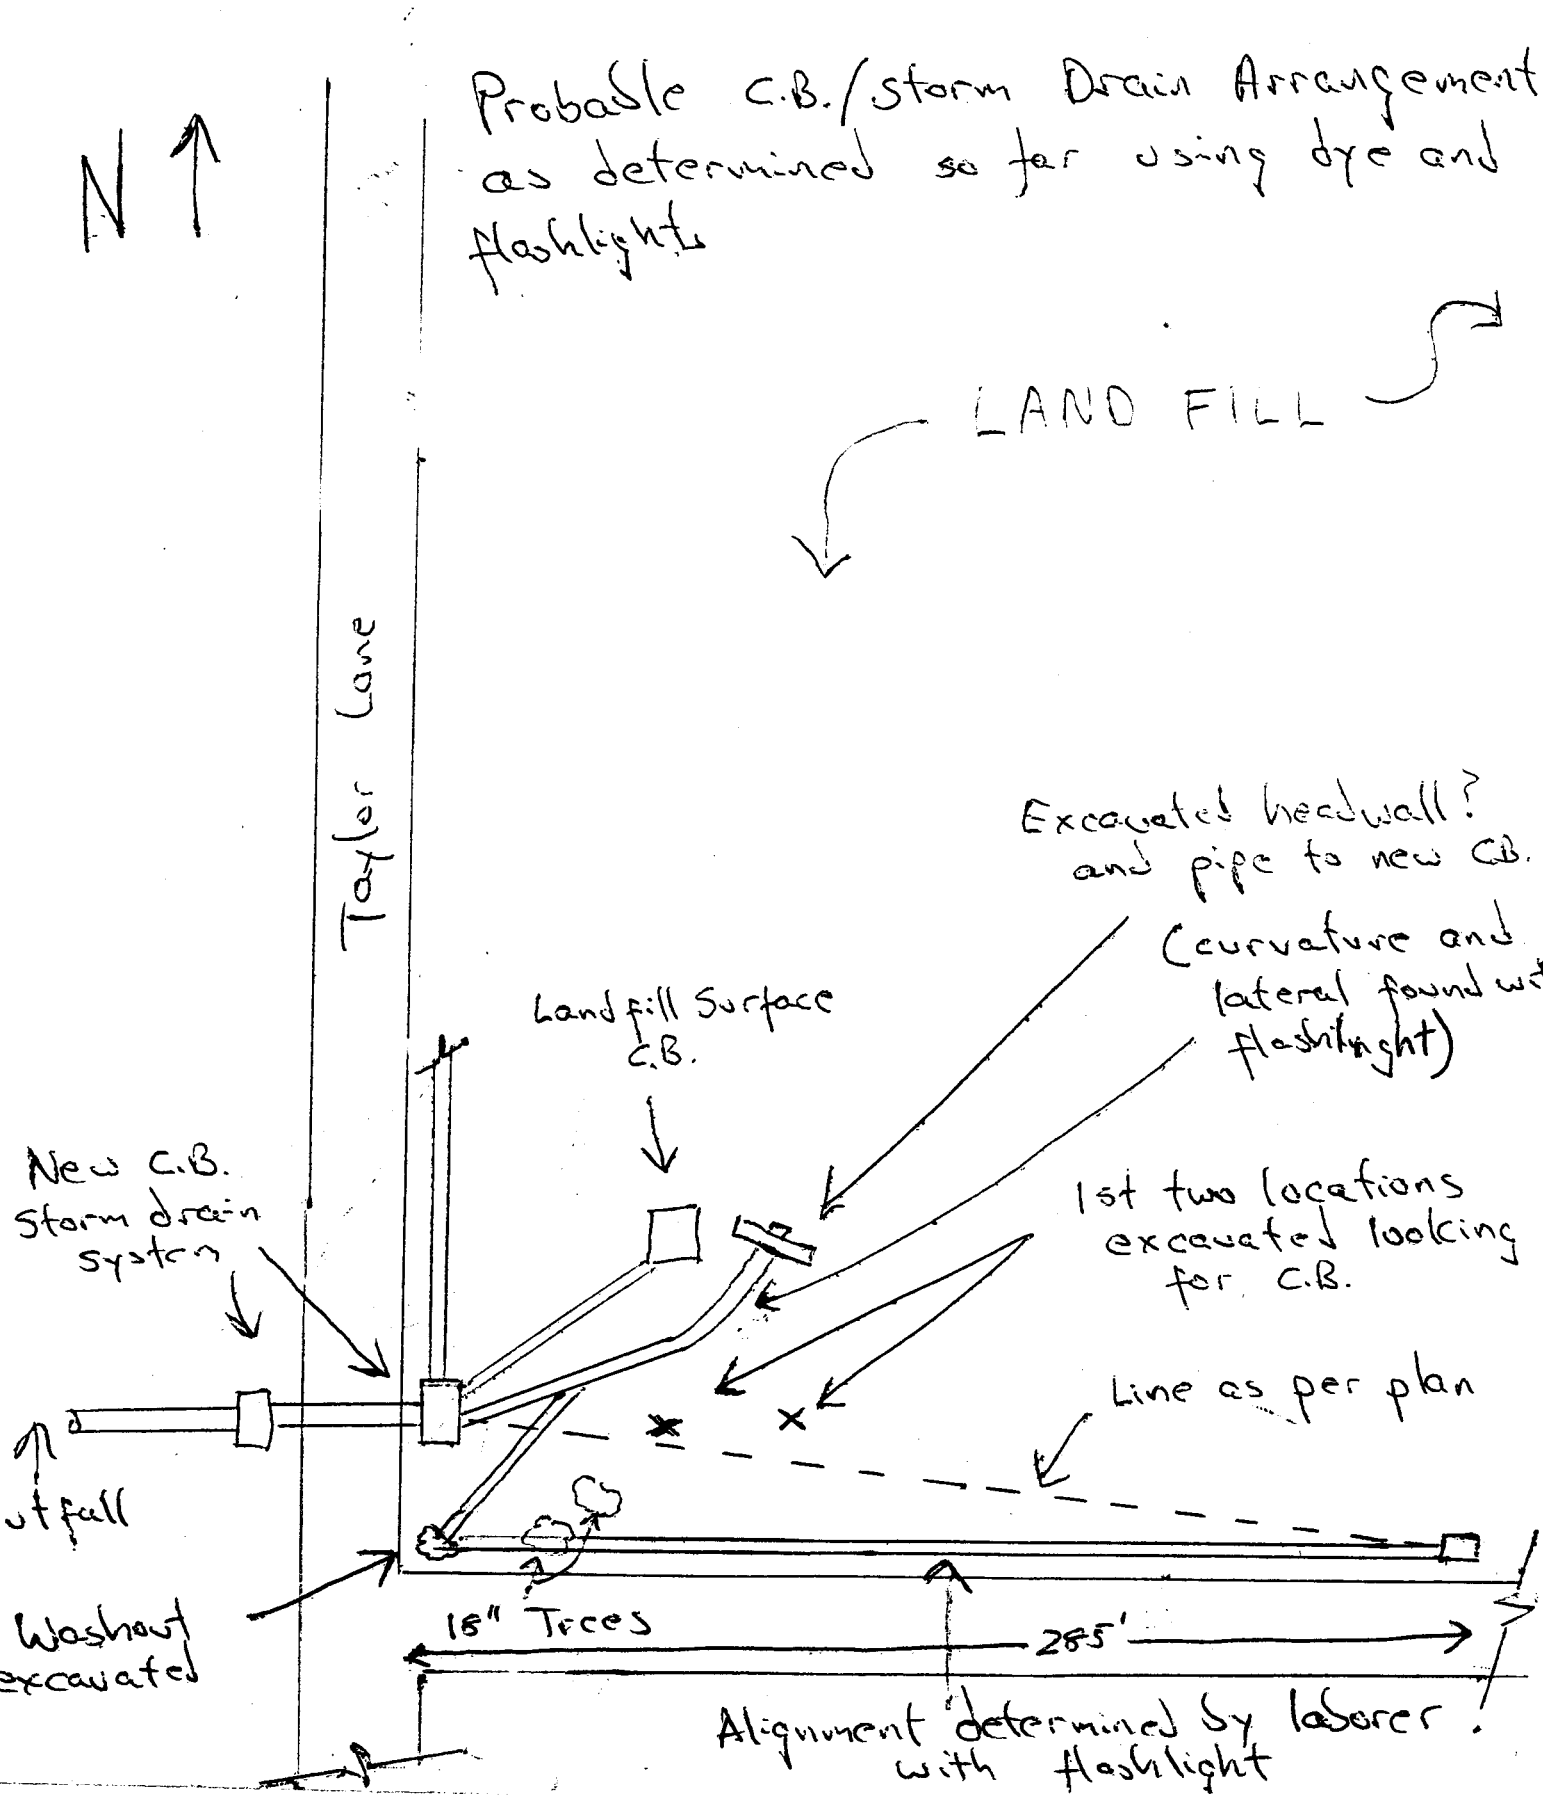
Probable C.B./storm Drain Arrangement
as determined so far using dye and
flashlights

Excavated headwall?
and pipe to new C.B.

(curvature and
lateral found with
flashlight)

1st two locations
excavated looking
for C.B.

Line as per plan

Washout
excavated

Alignment determined by laborer
with flashlight
