NEW YORK STATE DEPARTMENT OF ENVIRONMENTAL CONSERVATION  
DIVISION OF HAZARDOUS WASTE REMEDIATION  
INSPECTOR'S DAILY REPORT

| Site Code No. <u>360021</u> | Date <u>6-27-07</u> | I.R. No. <u>33</u> | |
| Site Name: <u>Maneroneck Taylors Lane</u> | Sheet <u>1</u> of <u>2</u> | AM | PM |

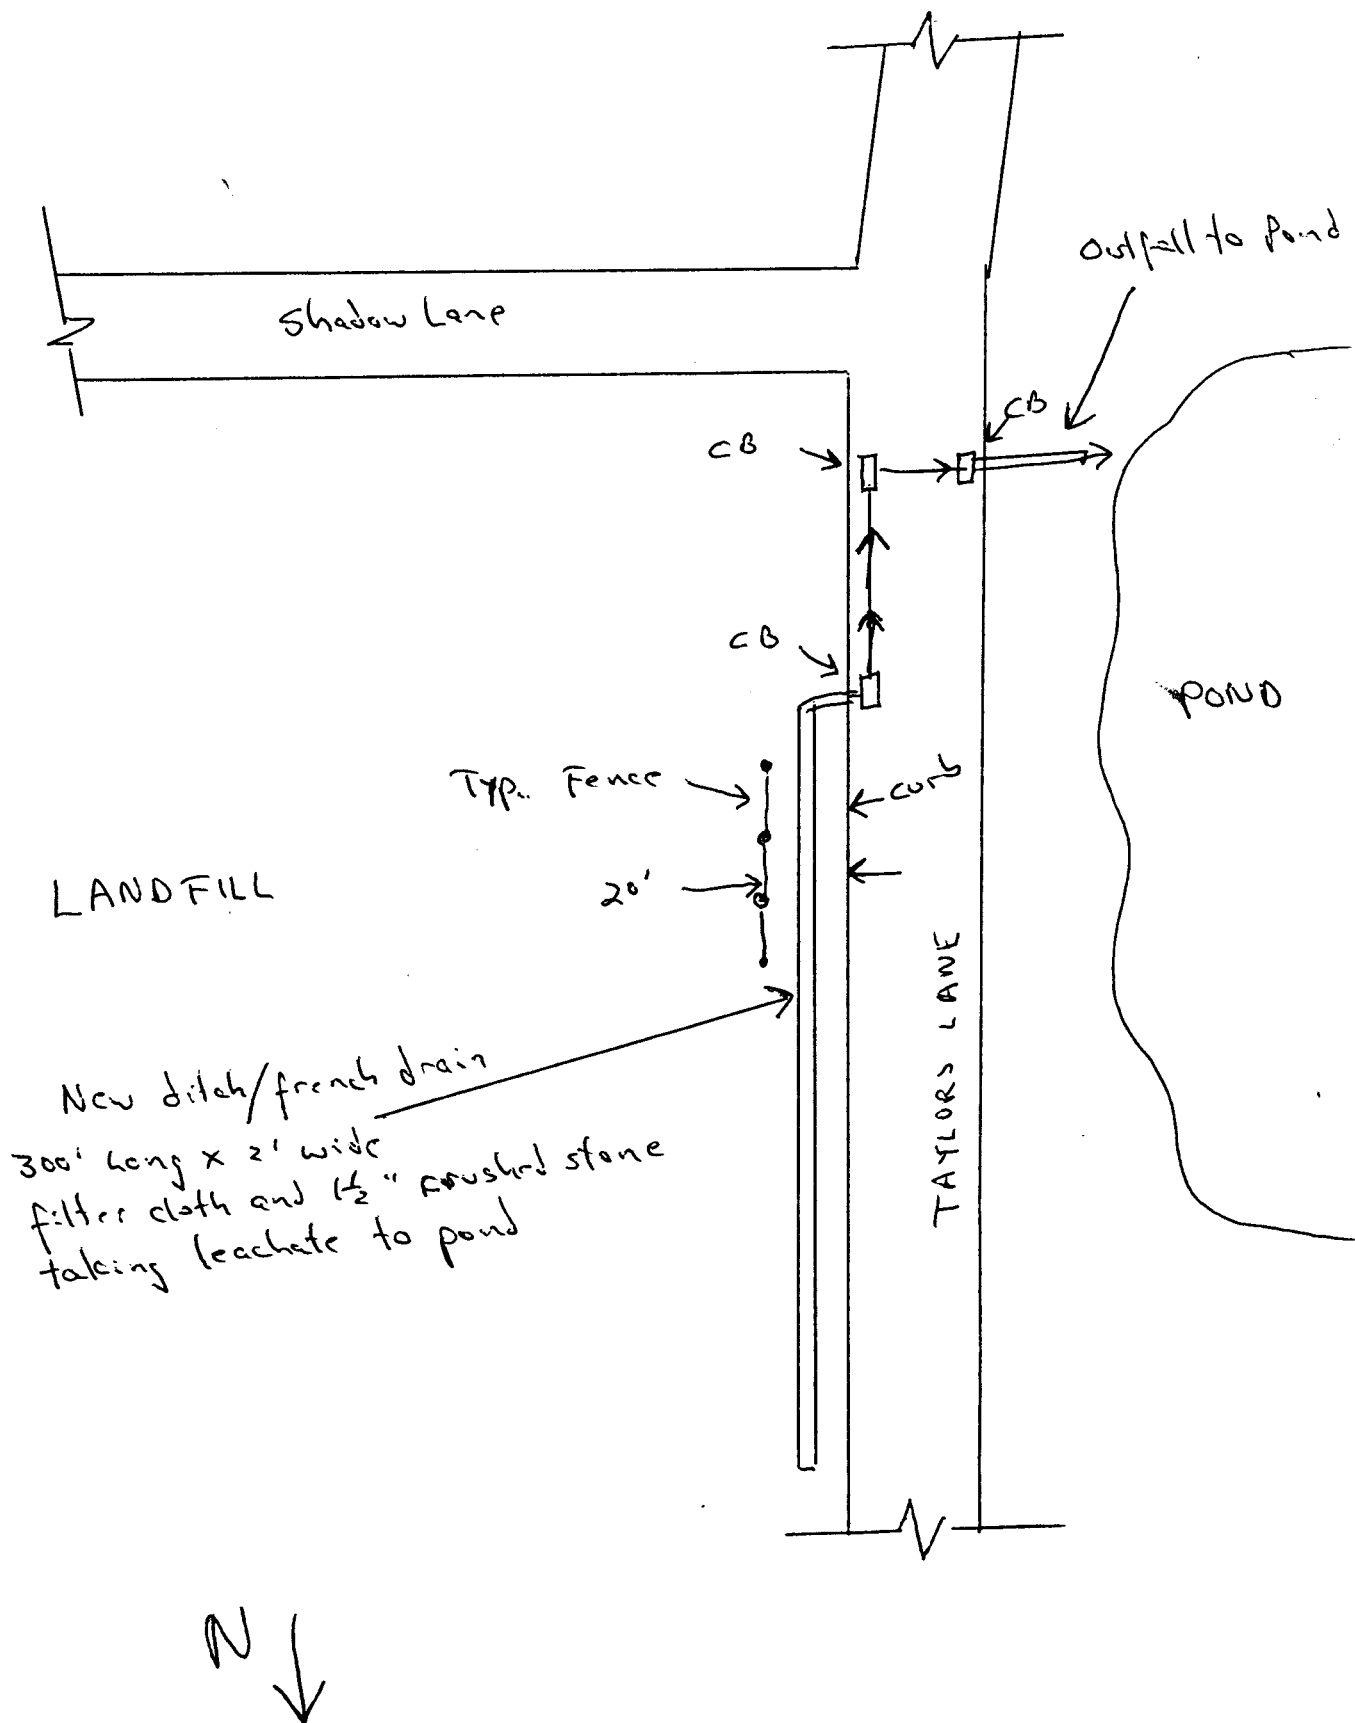
Sheet 3 of 3

(a) A ditch/french drain has been installed along the East side of Taylor's lane to control leachate. Leachate now drains directly to storm drain that drains to pond on West side of Taylor's lane. Heavy orange stains observed in catch basin and outfall to pond. Diagram skt 3 of 3

- ① Leachate from Taylors lane now directed into pond.  
Should be diverted to sanitary sewers for treatment  
or eliminated by lowering groundwater in LF.
