Re: Work Assignment #D004437-3
ISVWA- Marx Residence Vapor Mitigation System Installation
Mt. Kisco, Westchester County, New York
Site ID No. 3-60-024

Camp Dresser & McKee (CDM) is pleased to present this letter report, detailing the installation of a vapor mitigation system at the Marx Residence (the Site) located at 786 Armonk Road in the Town of New Castle, Village of Mount Kisco, Westchester County, New York. This project was part of the New York State Department of Environmental Conservation (NYSDEC) Work Assignment #D004437-3. The vapor mitigation system was installed at the Site on July 10, 2007. The vapor mitigation system installation was conducted in accordance with the New York State Department of Health (NYSDOH) *Final Guidance for Evaluating Soil Vapor Intrusion in the State of New York*, dated October 2006.

Attachment A
Photo Log

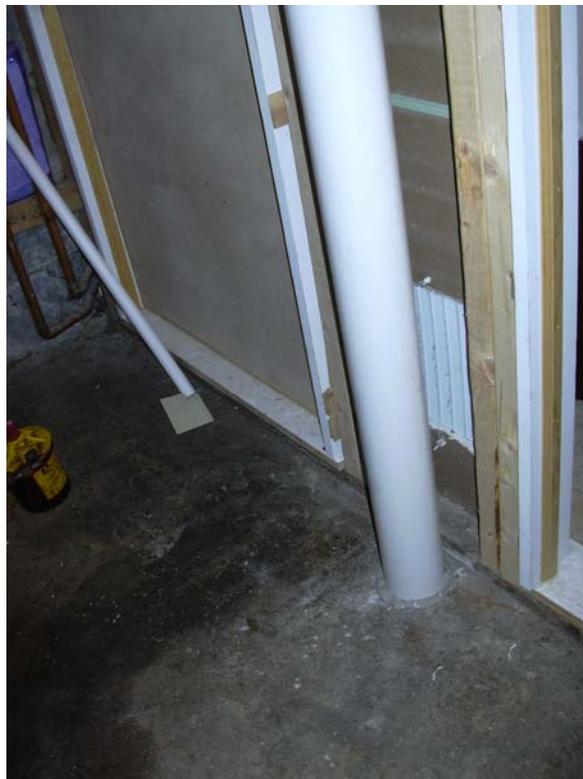
Description: View of the suction point located in the building's utility room.

To install the system, a 3 ½ -inch diameter hole was drilled through the basement slab of the building's utility room. Soil was then excavated below the slab at the drill-hole location to create an approximately 2-foot deep cavity beneath the slab. This cavity was designated as the suction point for the system. A 3-inch PVC pipe was inserted in the suction point and sealed in place. The pipe was routed up to the ceiling of the utility room, across the ceiling, and out of the building through a second hole that was drilled along the north (exterior) wall of the utility room. A high pressure suction fan was then connected to the piping on the exterior of the building (Figure 2). The fan was mounted to the north side of the building, adjacent to the building's chimney. To avoid entry of extracted subsurface vapors into the building, the fan's exhaust pipe was mounted above the eave of the roof, at least 10 feet above ground level, and at least 10 feet away from HVAC intakes and/or supply registers. On August 7, 2007, Radon Management Inc. returned to the site to install a shroud over the fan to hide it from sight. The shroud was placed over the fan at the owner's request.

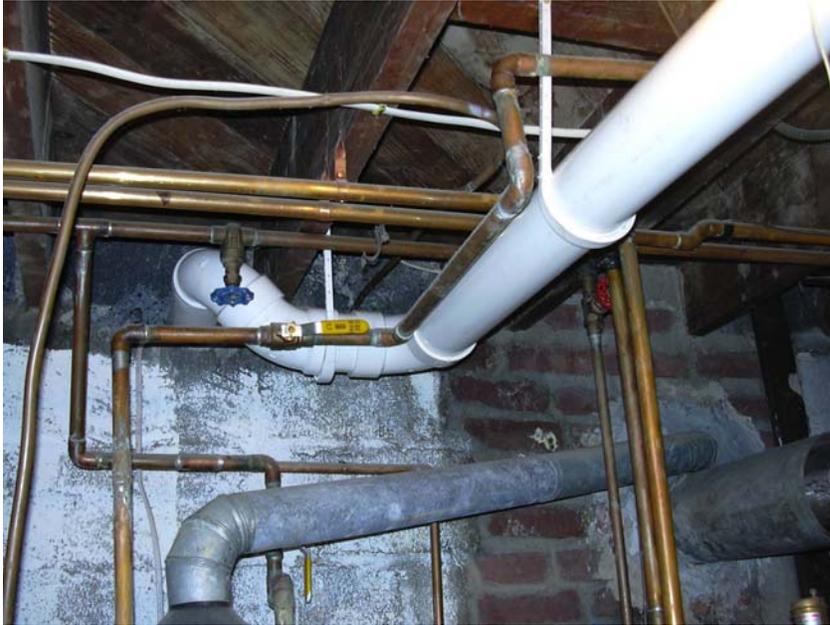
Description: View of the system piping (3-inch diameter white PVC pipe) exiting the building along the north wall.

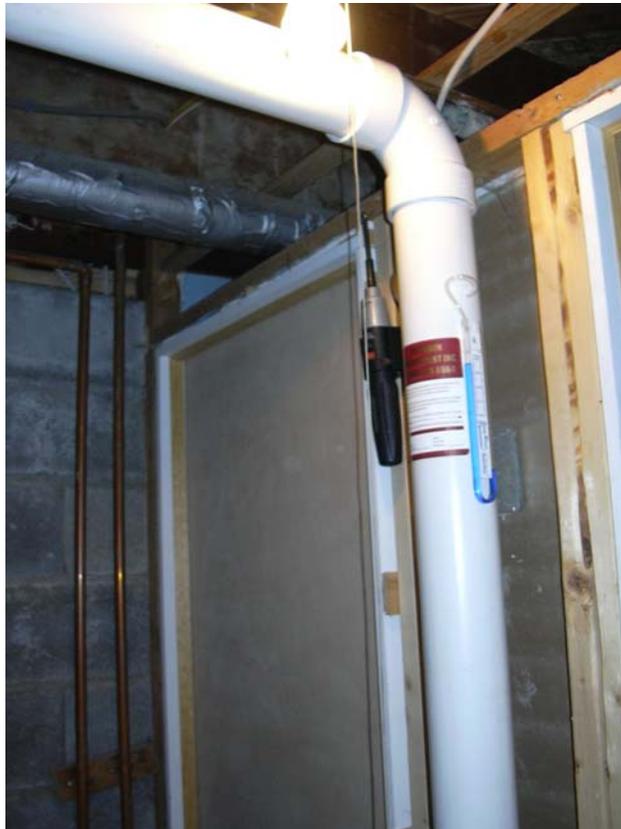
Description: View of the U-tube manometer and labeling on the vertical PVC suction piping in the utility room.

Once the installation of the system was completed, a U-tube manometer was installed along the west side of the suction pipe in the utility room, to measure suction. The manometer measured 7 inches of water (3.5 inches w.c/div) upon startup of the system. A label was affixed to the piping containing Radon Management's information as well instructions on reading the manometer. The property owner was also instructed by Radon Management Inc. on how to check that the system is operating properly and who to contact if there is a problem.

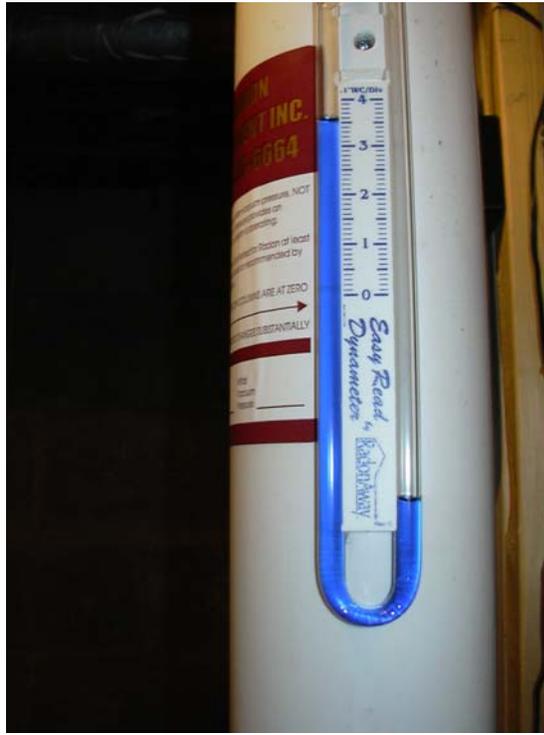
Description: View of the U-tube manometer after system upstart.

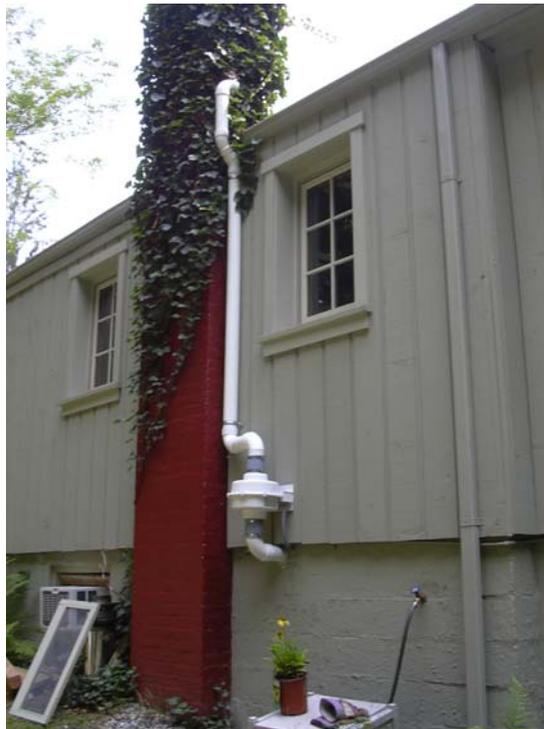
Description: View of the fan and exhaust piping along the north side of the building.
