Vapor Intrusion Mitigation System Former Sealectro Site NYSDEC Site No. 360027 Mamaroneck, New York

ITT Corporation

July 2014

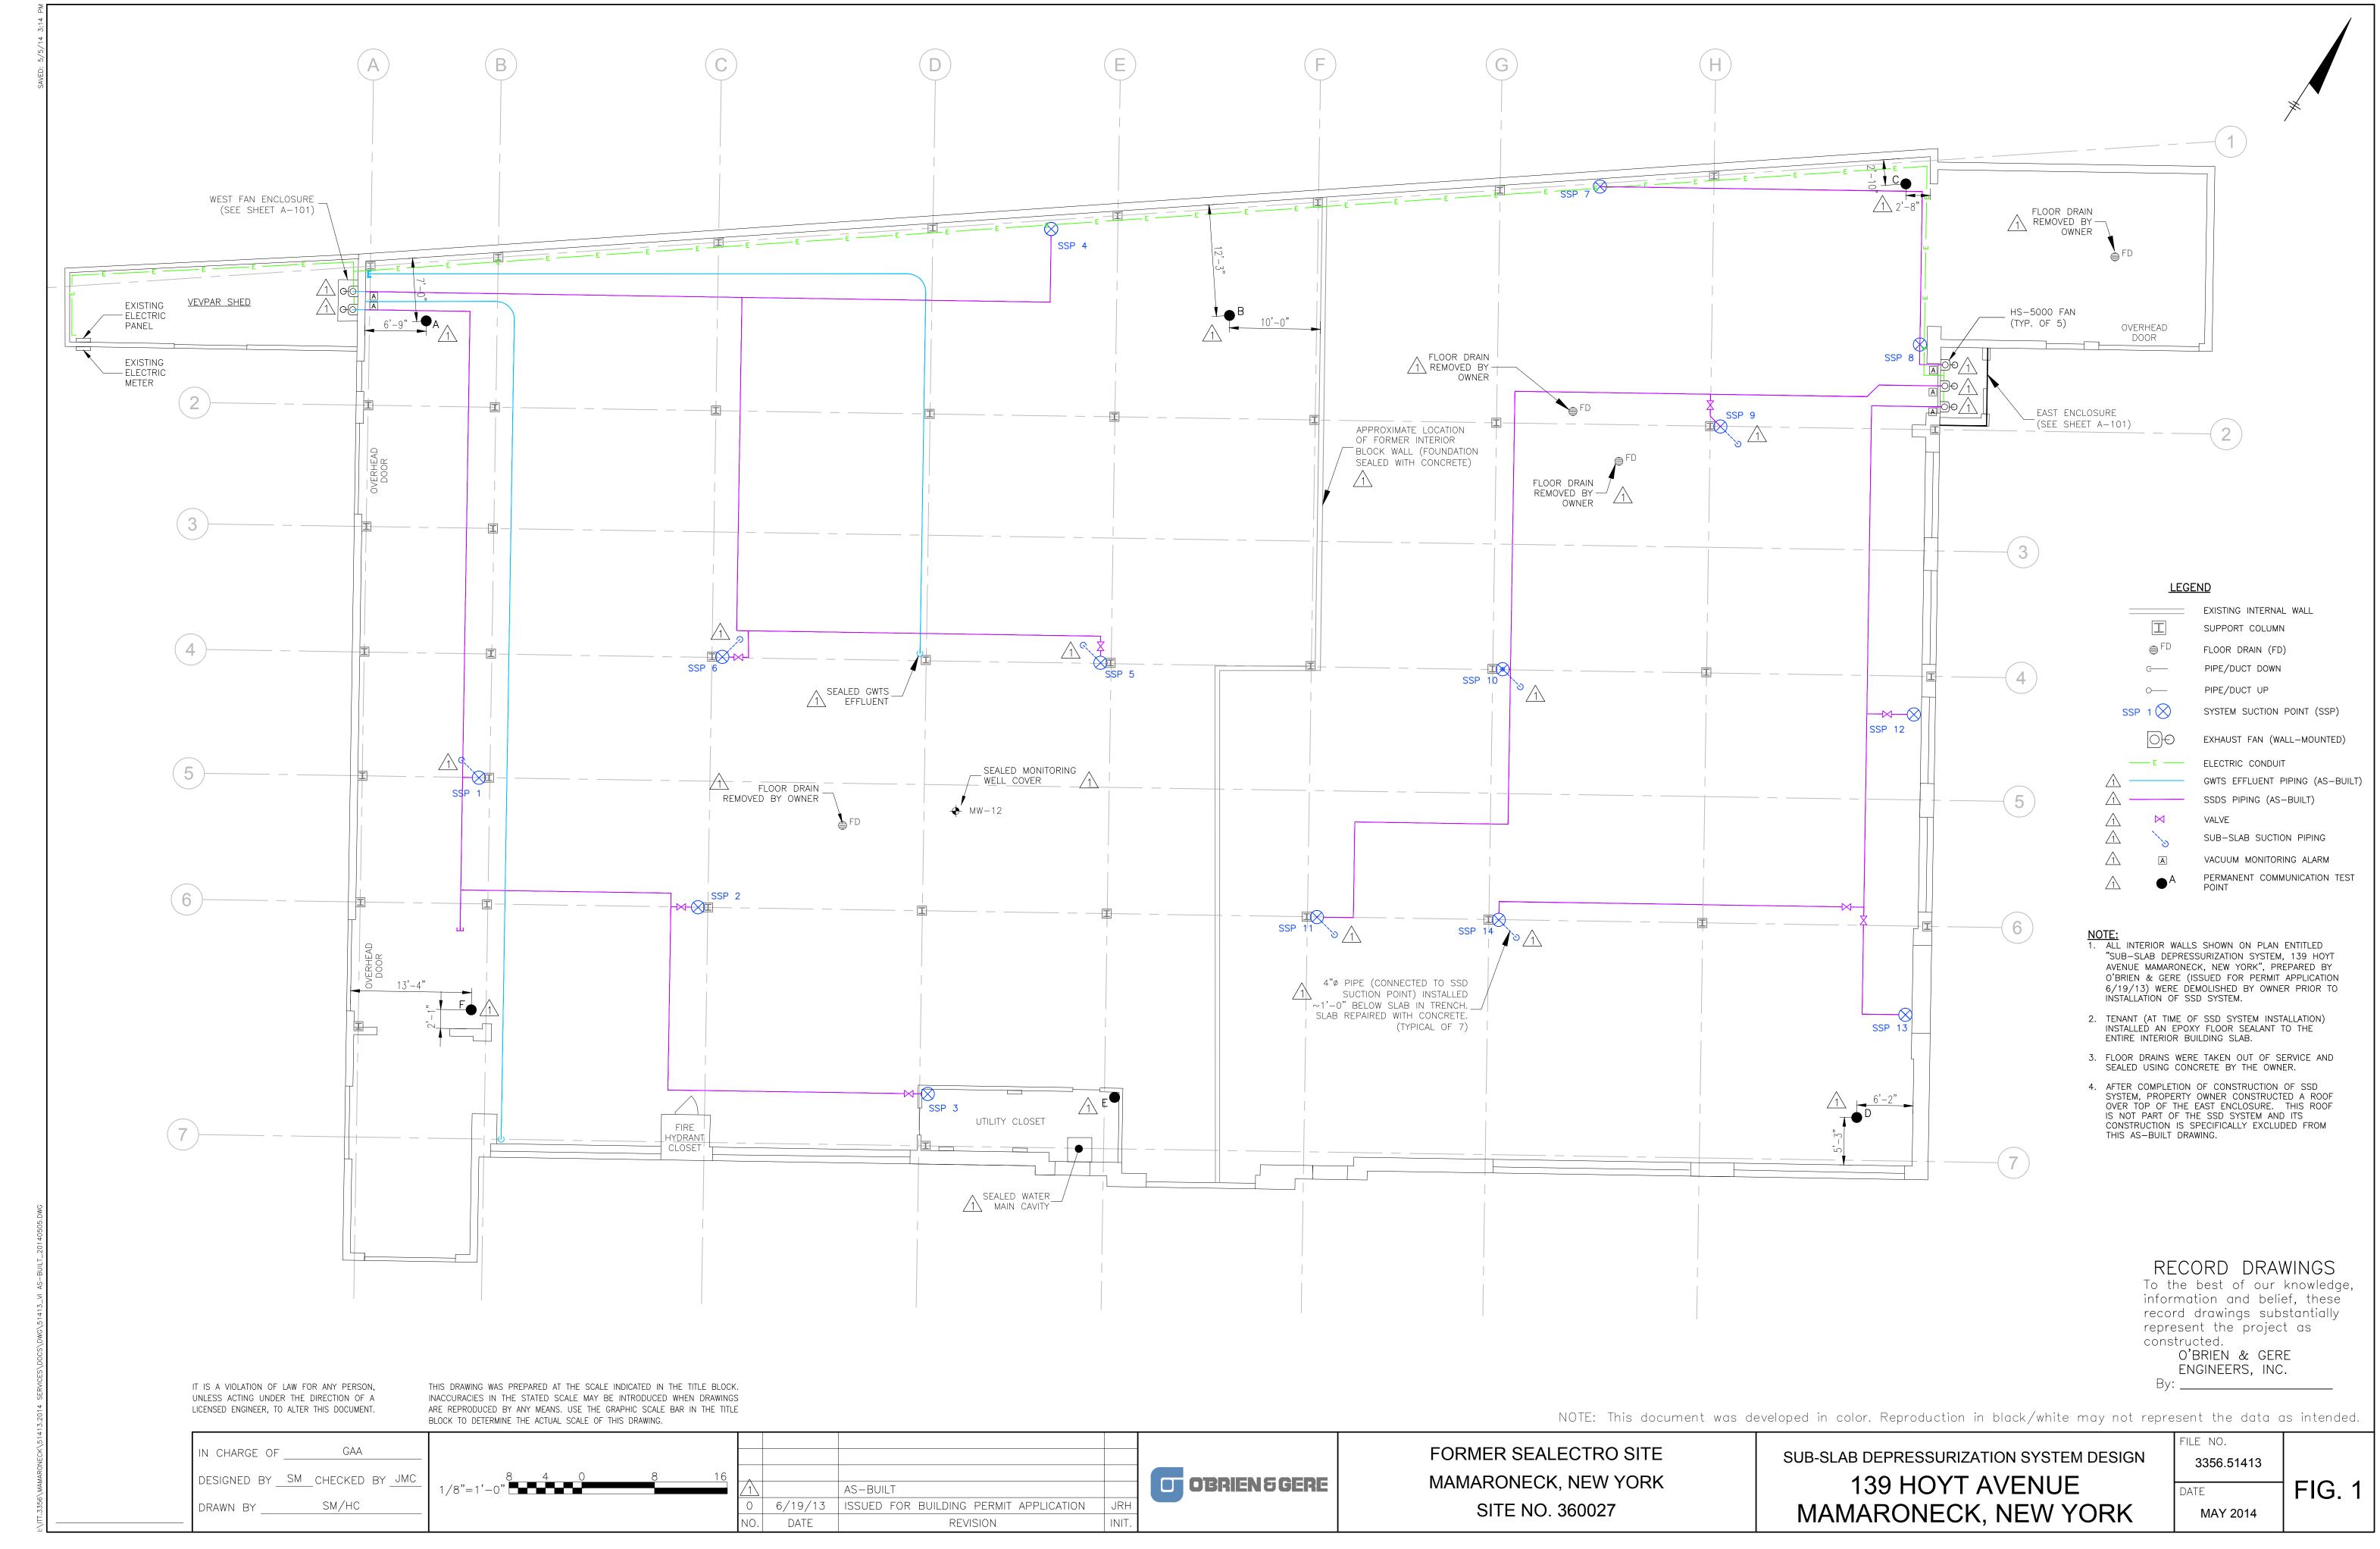
As-Built Sub-Slab Depressurization System: Building Floor Plan

As shown in the system design drawings and **Figure1**, the SSDS suction points were manifolded together so that no more than three SSPs would be connected to a single fan.

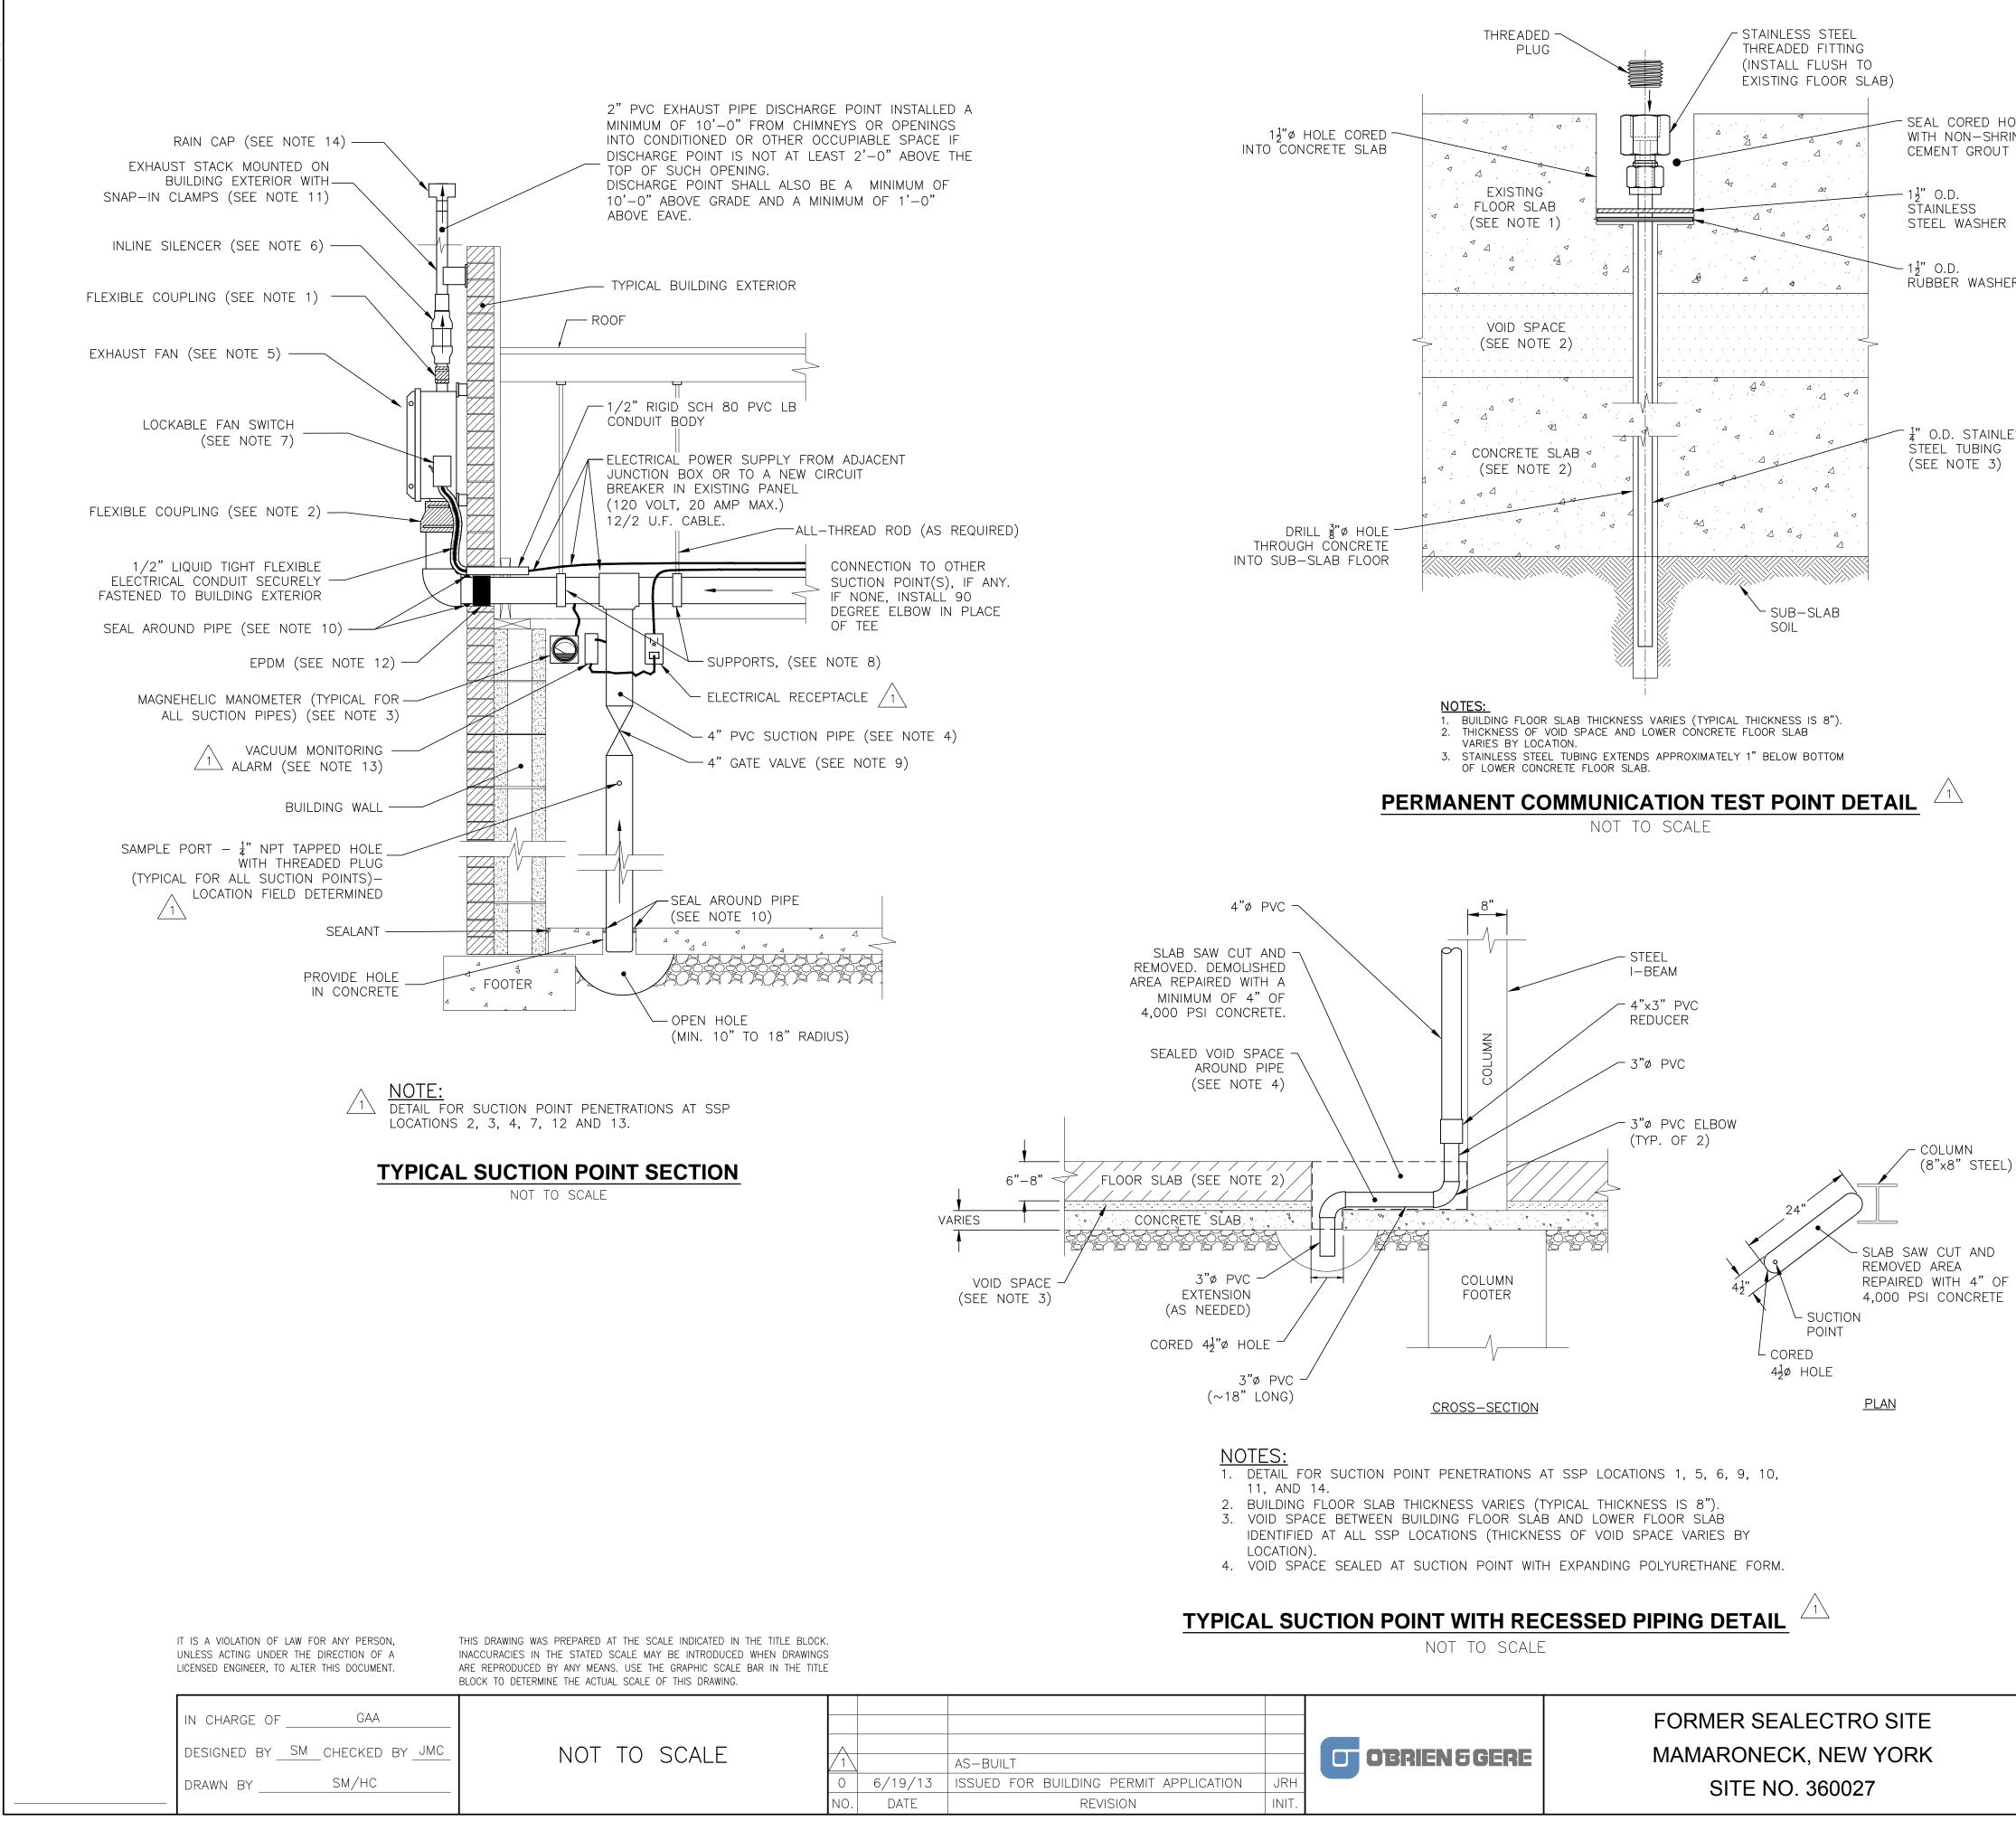
Figure 2 As-Built Sub-Slab Depressurization System: Section and Details

- 1. DIMENSIONS AND INSTALLATION LOCATIONS SHOWN ON FIGURE 1 ARE APPROXIMATE AND SHALL BE FIELD VERIFIED BY CONTRACTOR.
- 2. CONTRACTOR SHALL GROUT AND/OR CAULK ALL MAJOR CRACKS AND OPENINGS IN FLOOR OR WALLS THAT WOULD IMPAIR SYSTEM PERFORMANCE
- /1 3. All floor drains removed by owner. Sealed with concrete.
- 4. CONTRACTOR SHALL VERIFY ELECTRICAL TIE-IN LOCATION.
- 5. ALL WORK TO BE IN GENERAL CONFORMANCE WITH ESTABLISHED RADON MITIGATION STANDARDS AS ESTABLISHED BY THE U.S. ENVIRONMENTAL PROTECTION AGENCY AND THE ASTM STANDARD PRACTICE (E 2121-08) FOR INSTALLING RADON MITIGATION SYSTEMS IN EXISTING LOW-RISE RESIDENTIAL BUILDINGS.
- 6. PERMANENT COMMUNICATION TEST POINTS INSTALLED AT CTP LOCATIONS A, B, C, D, E, AND F AS SHOWN ON FIGURE 1.
- 1 7. EXPANSION JOINTS WERE SEALED BY OWNER AS PART OF NEW FLOOR SYSTEM.
