HARRISON SUB-RESIDENCY FIELD INSPECTION CHECKLIST for REGION 8 NYSDOT MAINTENANCE (OR REPRESENTATIVE) STAFF

Name of Inspectors: Val Basil, Mauricio Roma, Gretchen Teal

Date: March 28, 2006

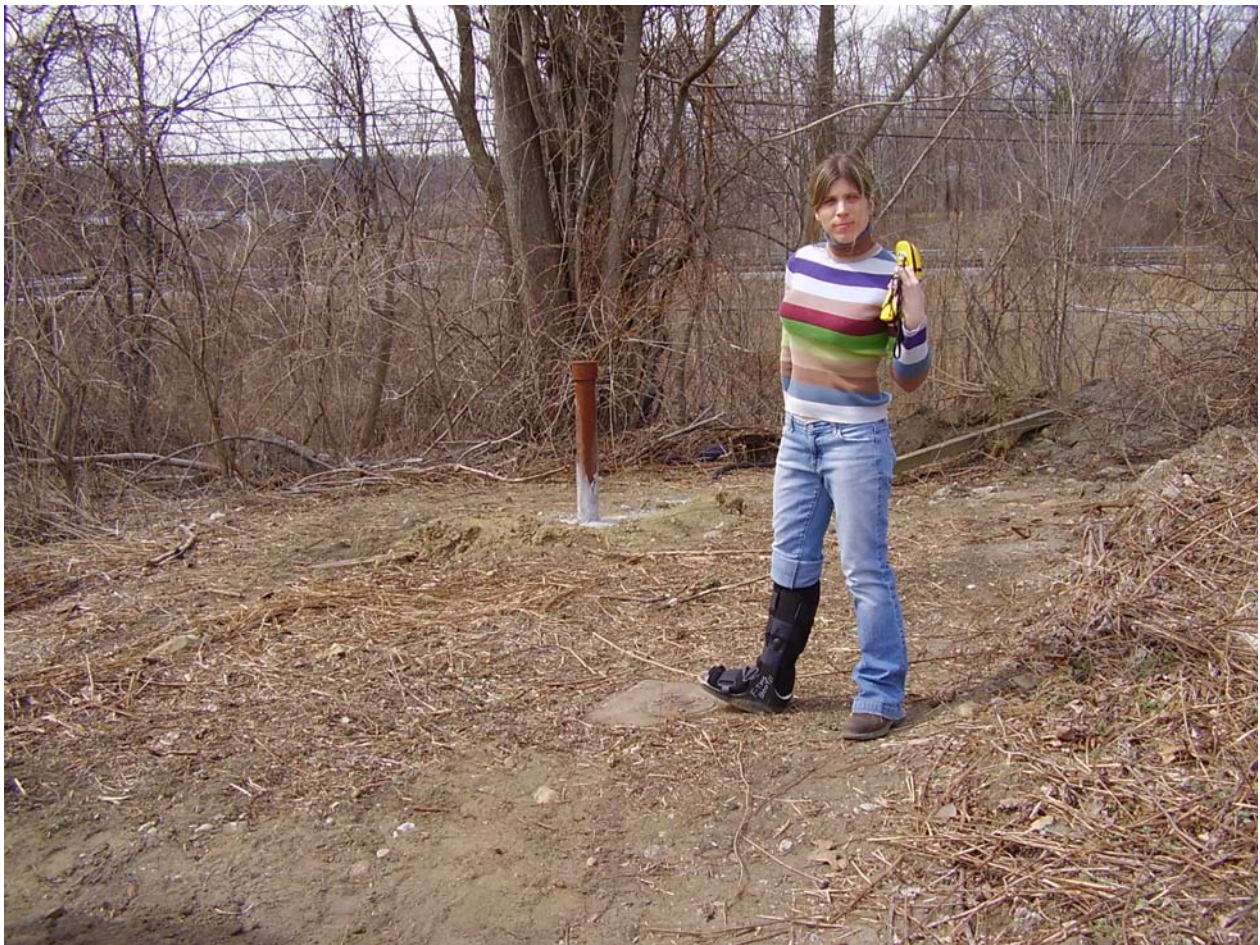
SP-2 is intact (in the foreground next to Gretchen)

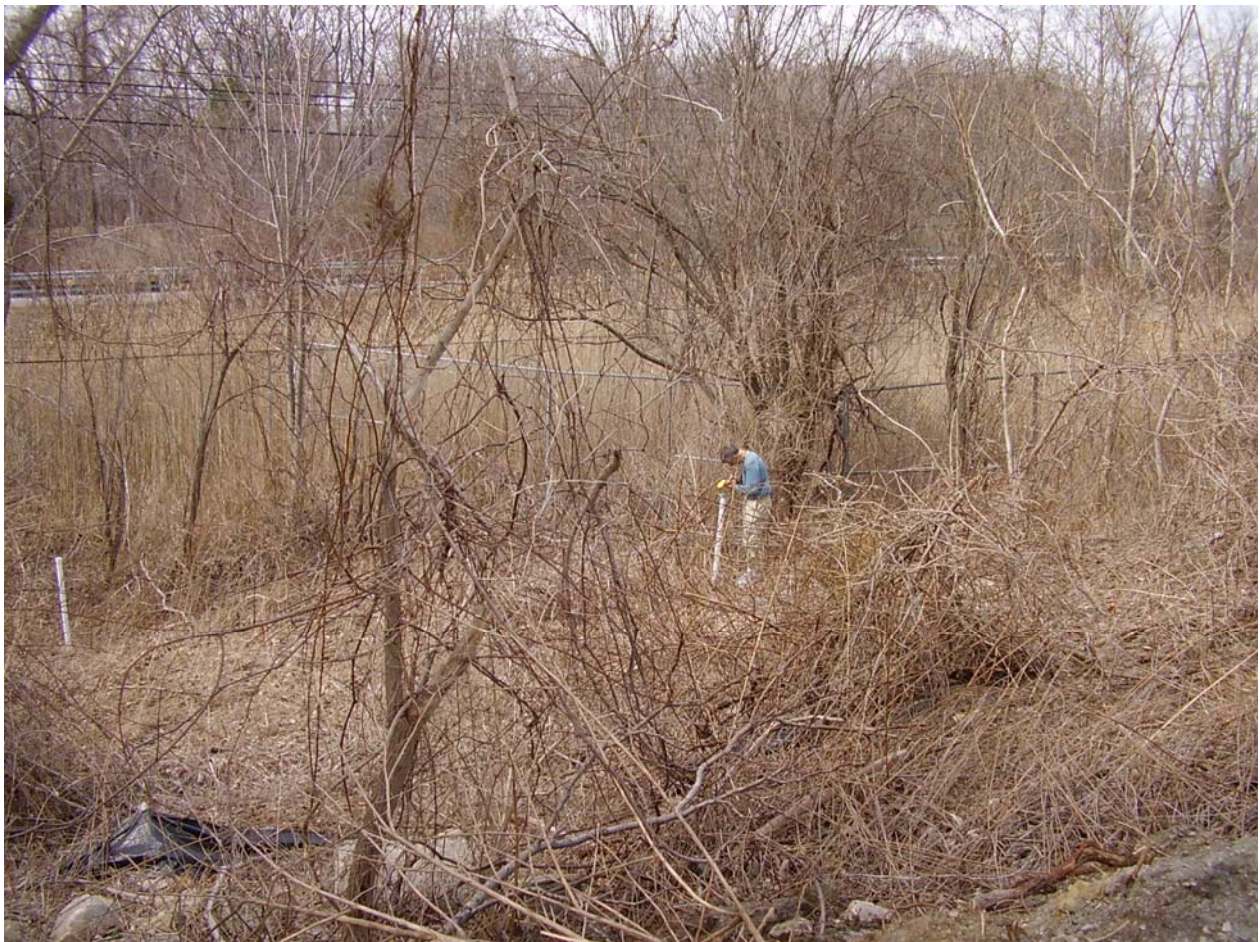
GP-1 and GP-2 are intact

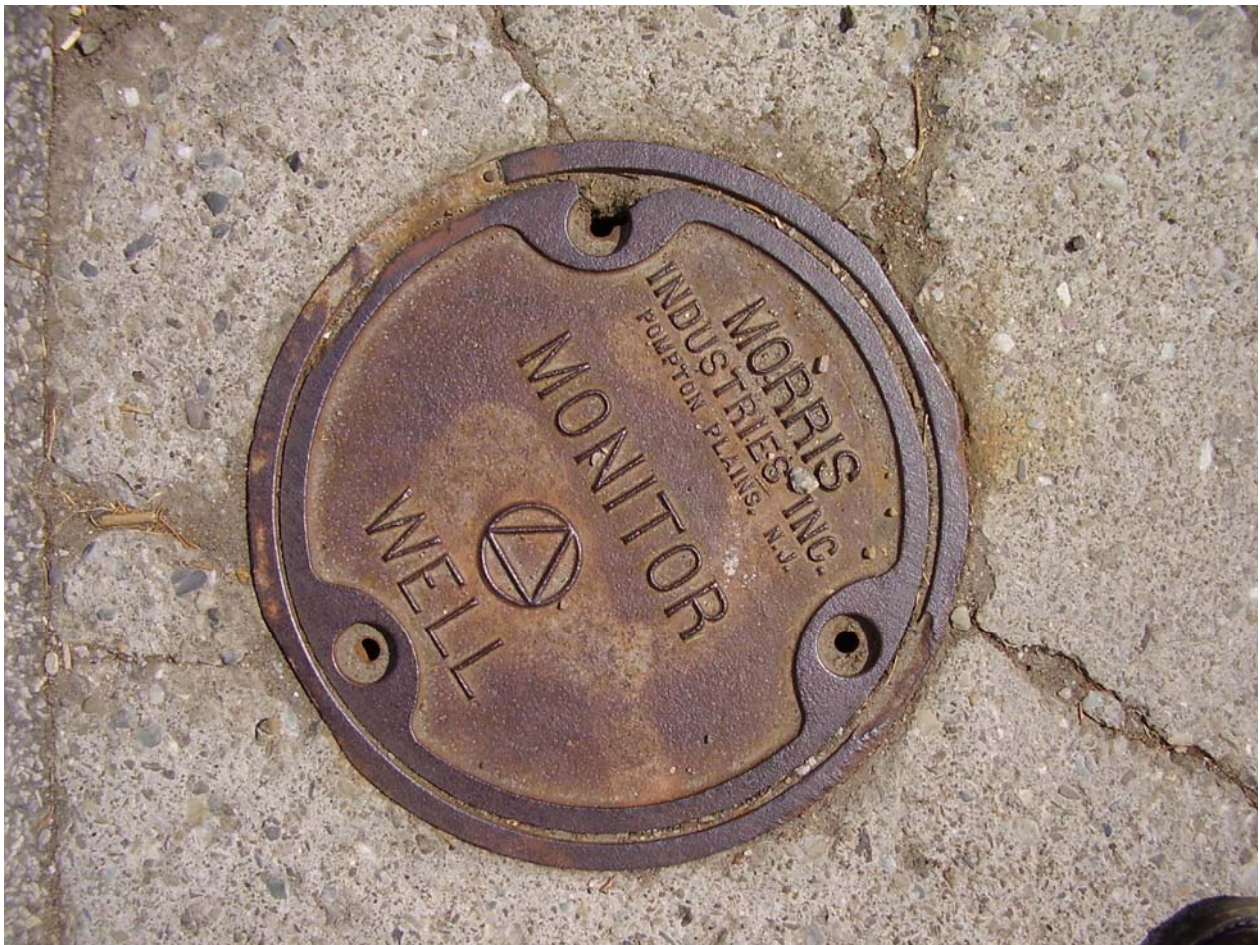
- SP-2 is intact.
- GP-2 is intact.
- Bolts are missing from some of the well caps. They need to be replaced.
- At PC-1, the PVC riser is slightly above the well casing. Therefore, it is unable to be locked.
- Lock on PC-2 needs to be replaced.
- Lock on LMW-2 needs to be replaced.
- Lock on LMW-4 needs to be replaced.

Replace missing bolts from well caps

- Replace the missing bolts on the well caps in the petroleum spill area.
- Replace the locks on PC-2, LMW-2, and LMW-4.
- Place seeded topsoil along the western edge of the landfill near gas vent V-3 where minor erosion has occurred.
- Contact the Town of Harrison; request they move their yard waste pile away from the landfill fence.
- Fix the electrical panel on the remediation trailer.

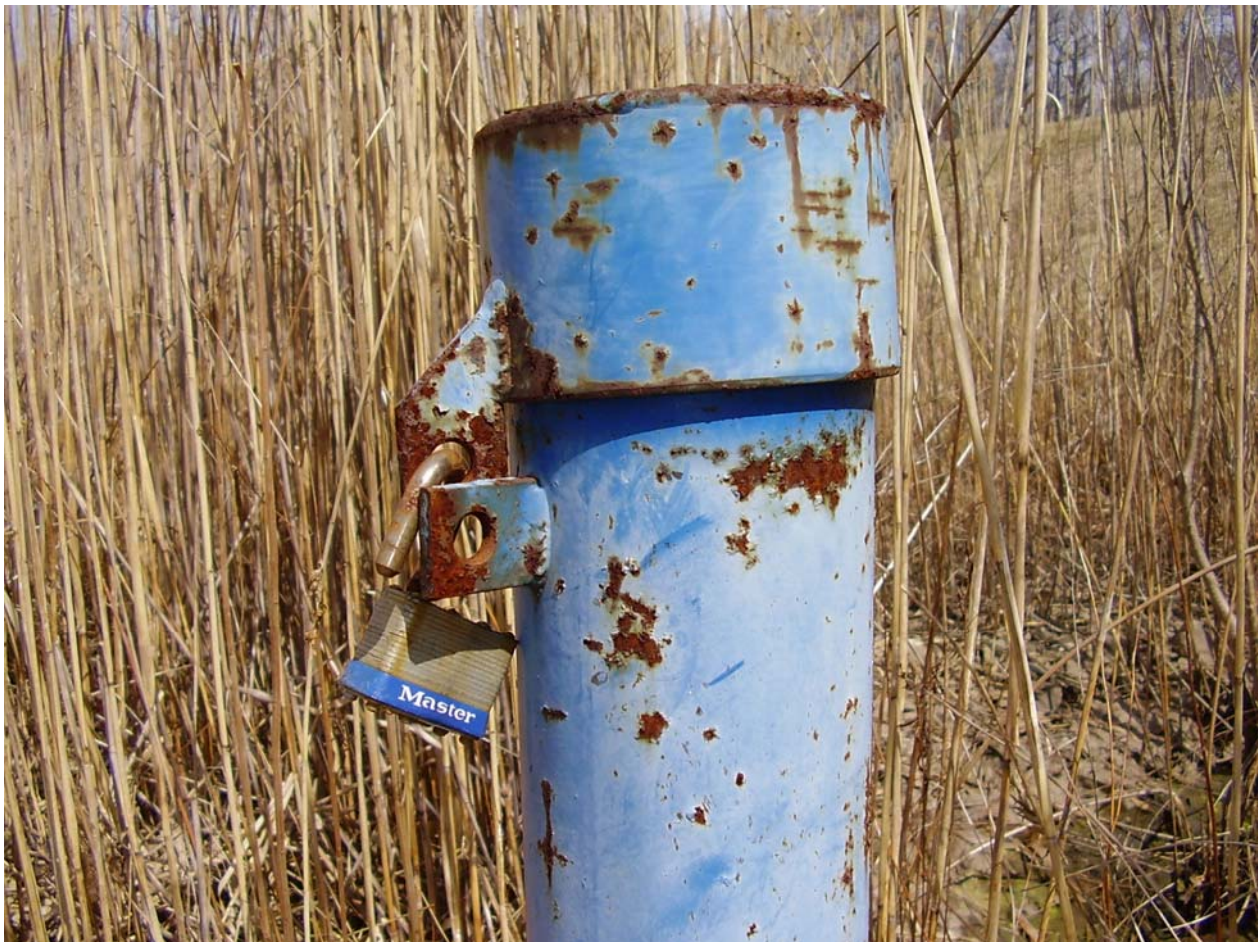
PC-1 – replace lock

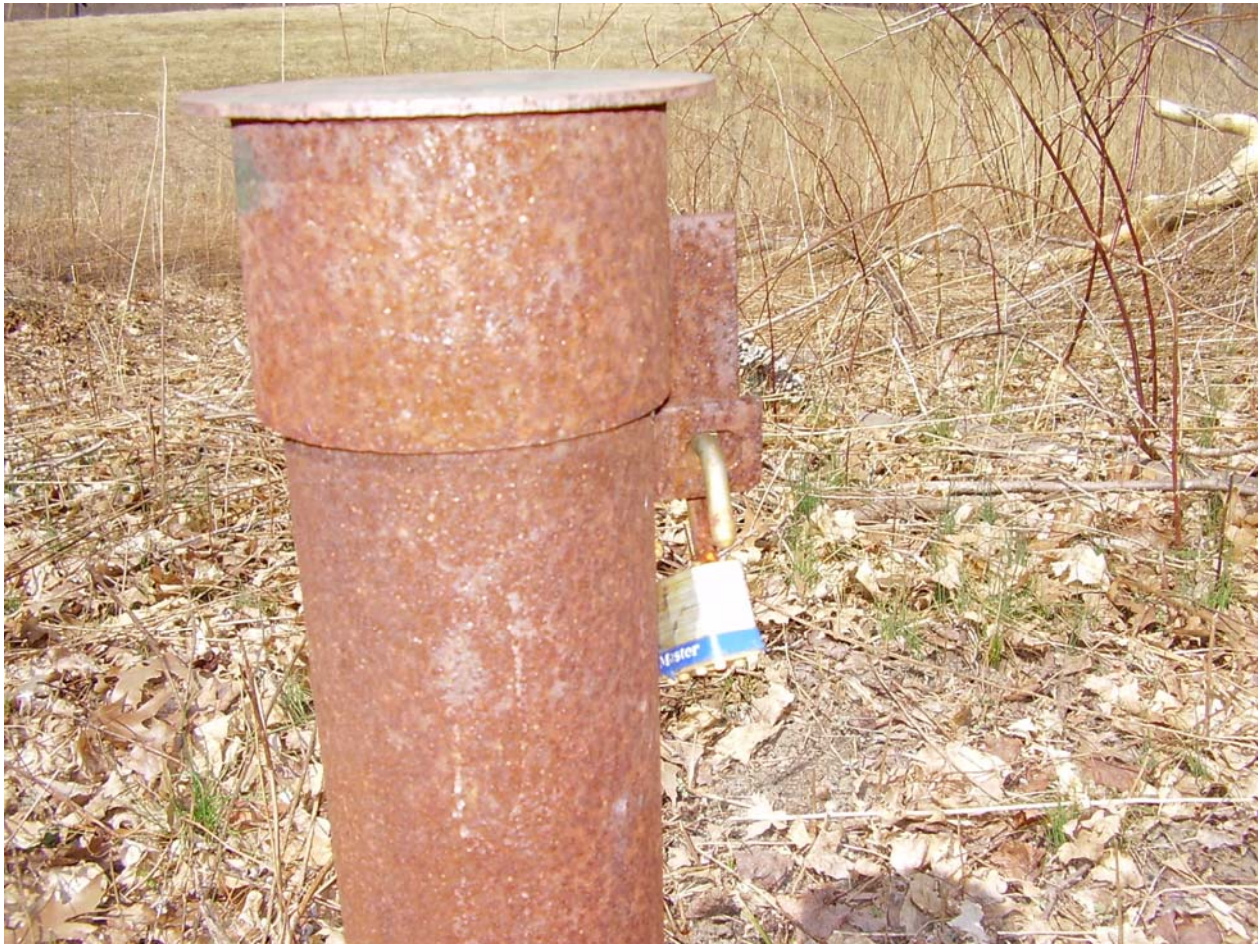
PC-2 – replace lock

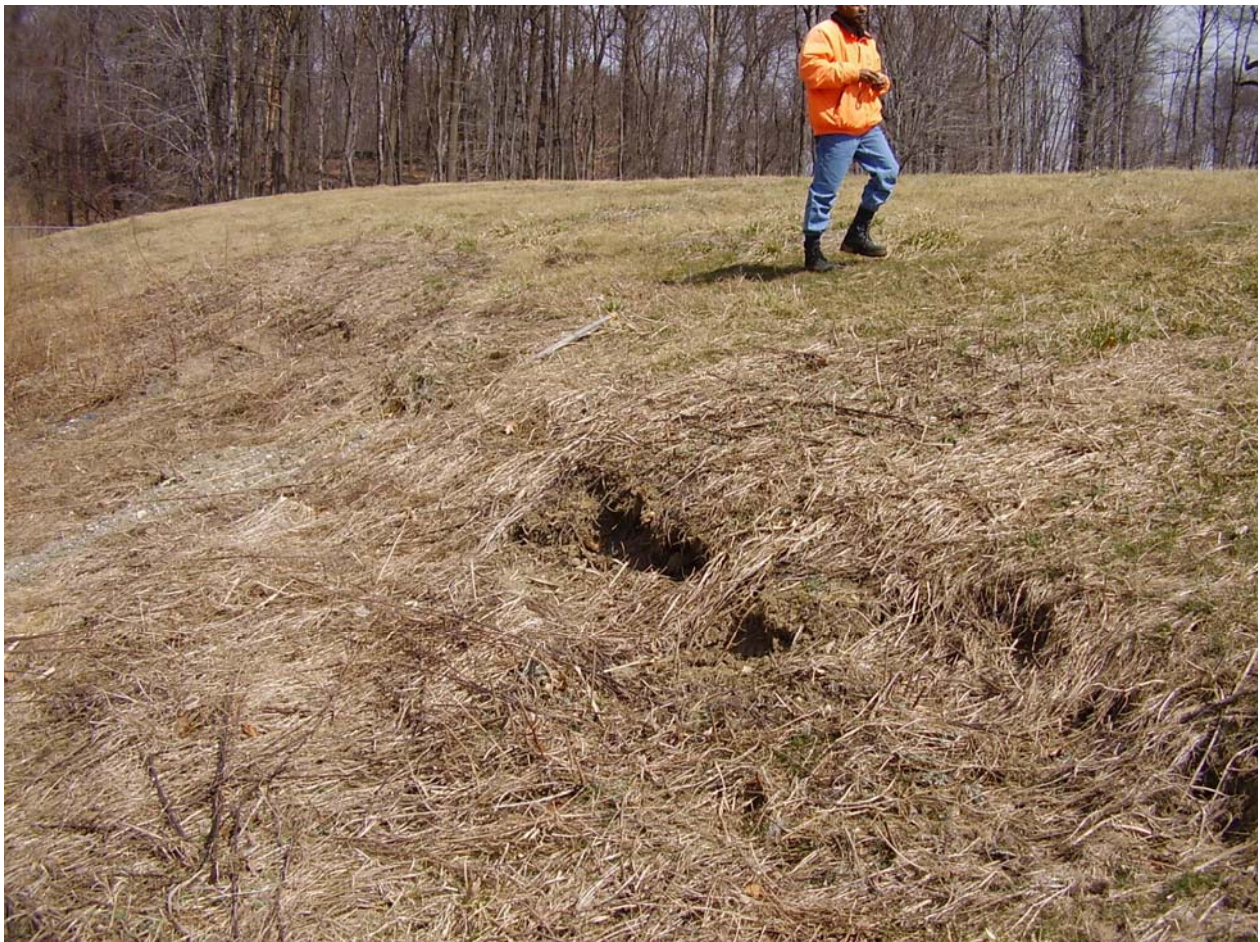
- Minor erosion on the western edge of the landfill near gas vent V-3. Seeded topsoil is needed.
- Netting is showing through in two small areas of the landfill. This is not a concern.

Place seeded topsoil on the eroded area on the western side of the landfill

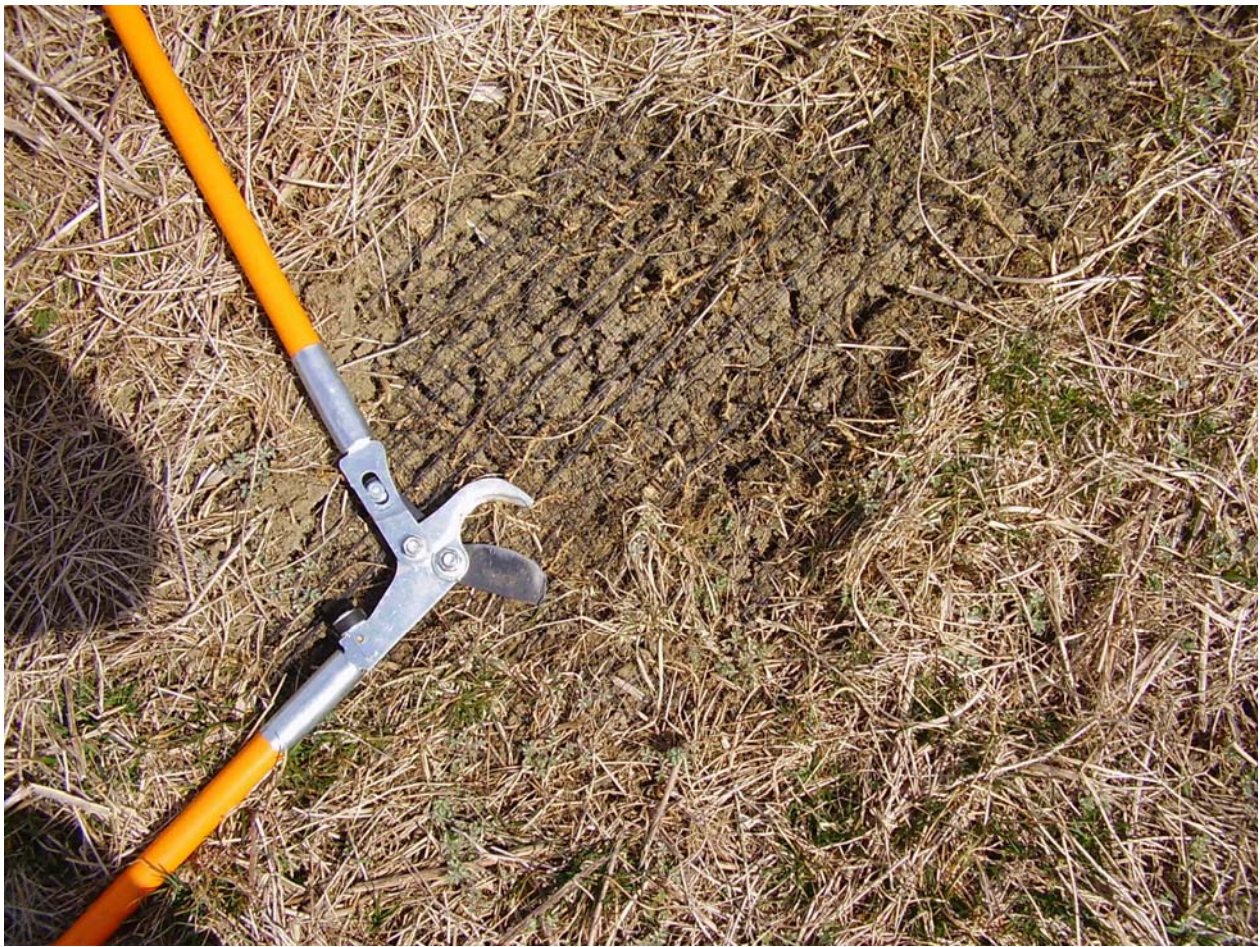
Netting showing through the groundcover – this is not a concern

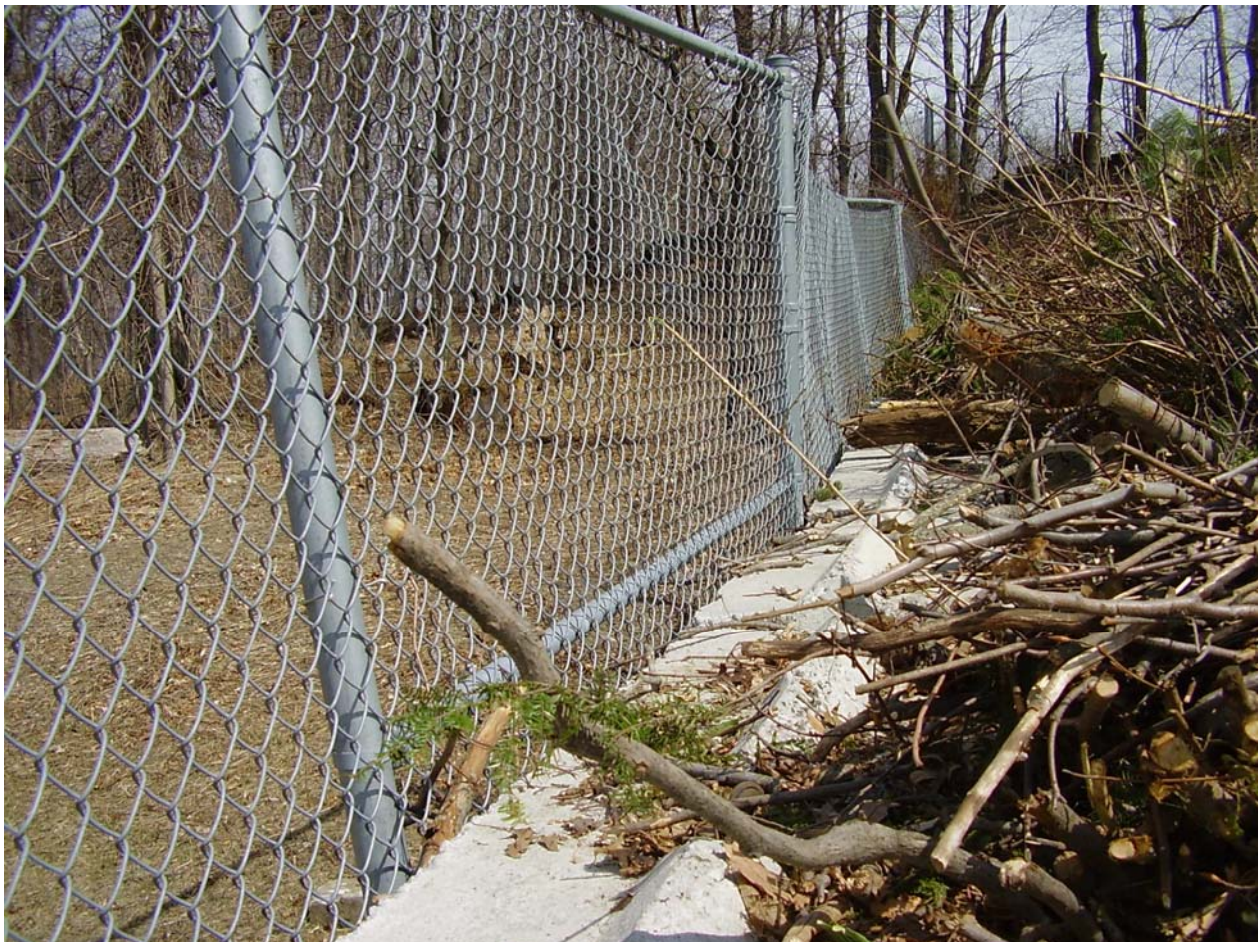
- The Town of Harrison's yard waste pile is leaning against the southeastern section of the landfill fence, causing slight damage.

Request the Town of Harrison move their yard waste pile away from landfill fence

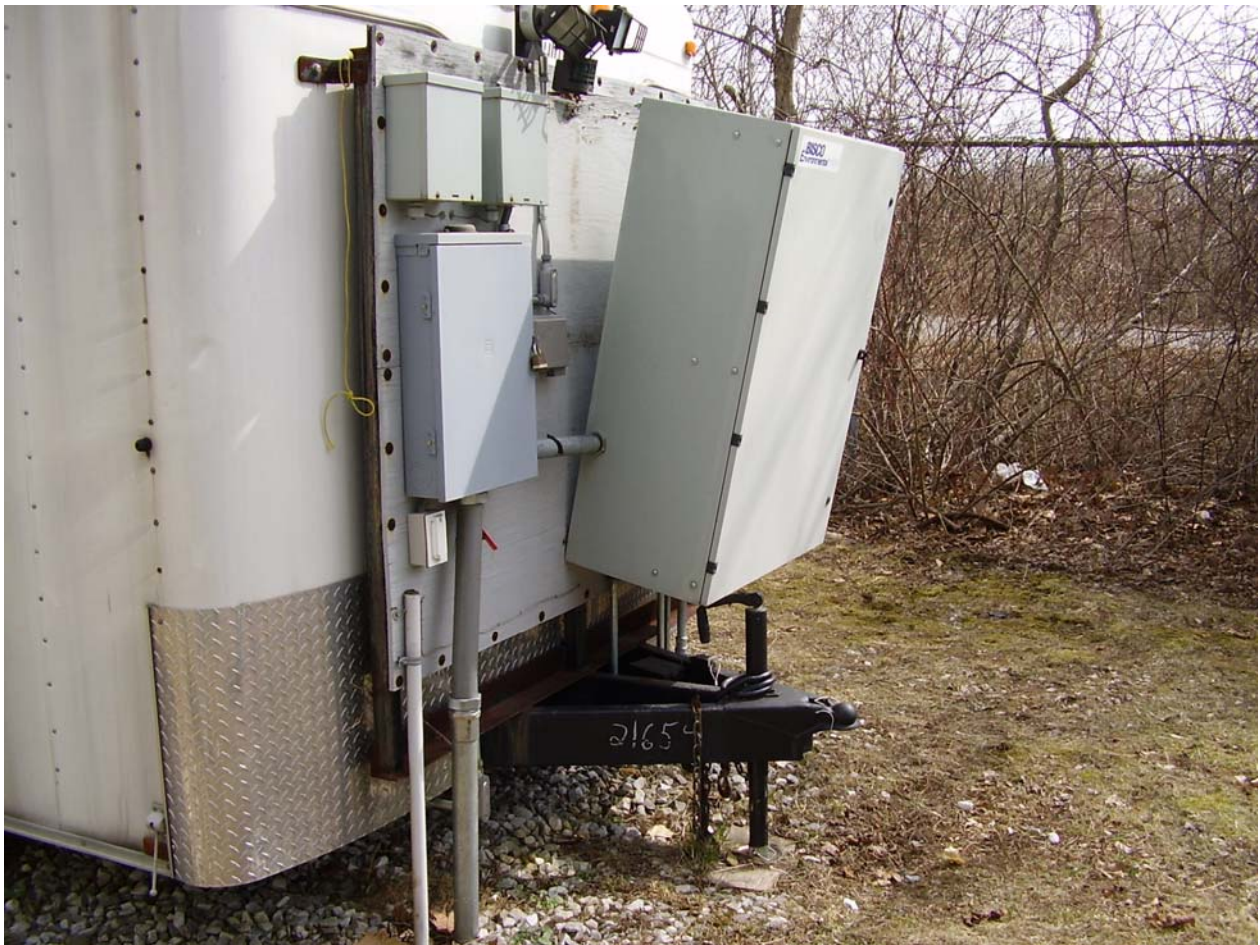
- PC-3 was inadvertently not inspected.
- The electrical panel on the remediation trailer is falling off and needs to be reattached.
- Animal (possibly deer) tracks were observed in the wetland area just north of LMW-2; animals may be entering though the space underneath the northeastern section of the fence by the stream; no correction is needed.

Reattach electrical panel on the remediation trailer

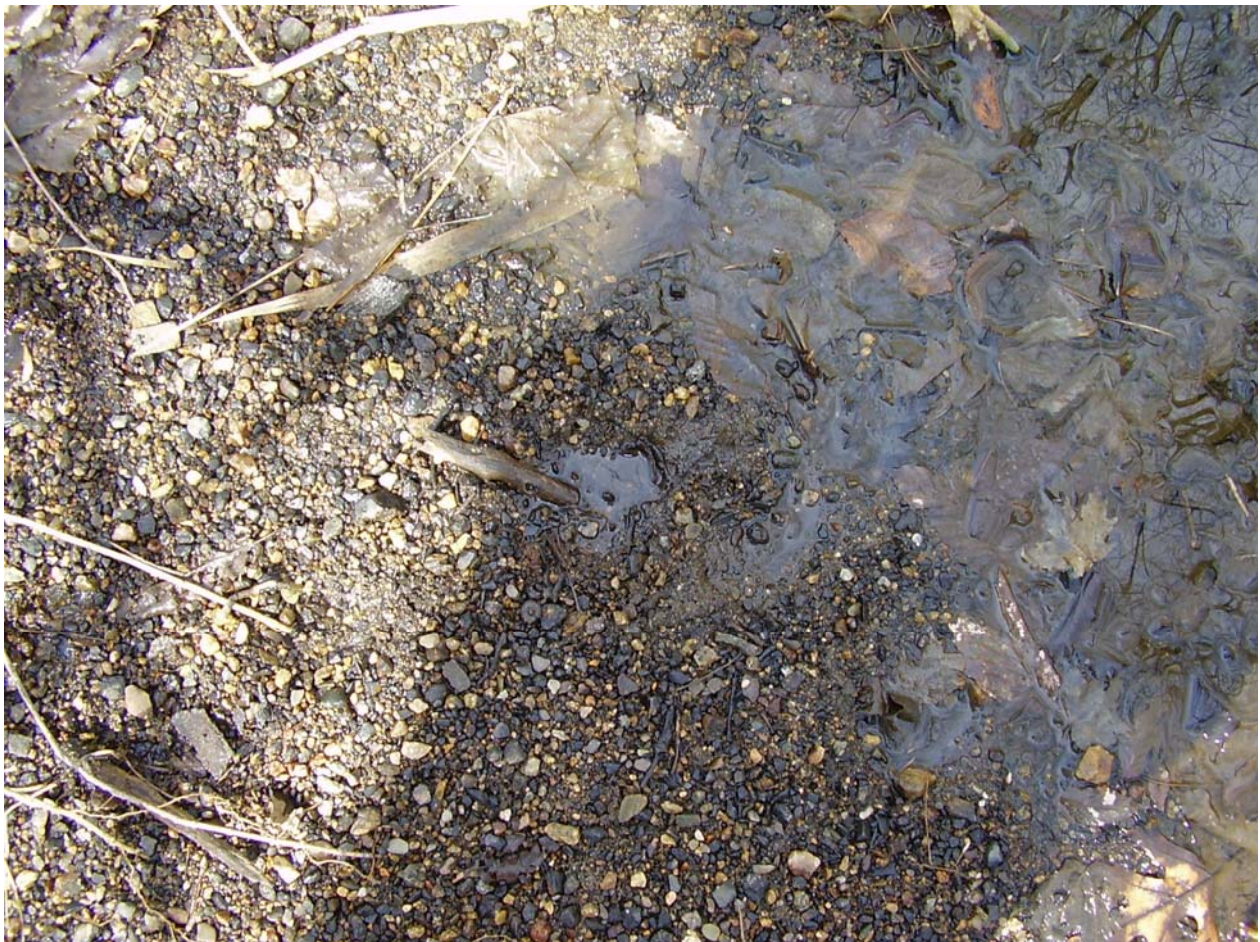
Animal tracks within landfill area...

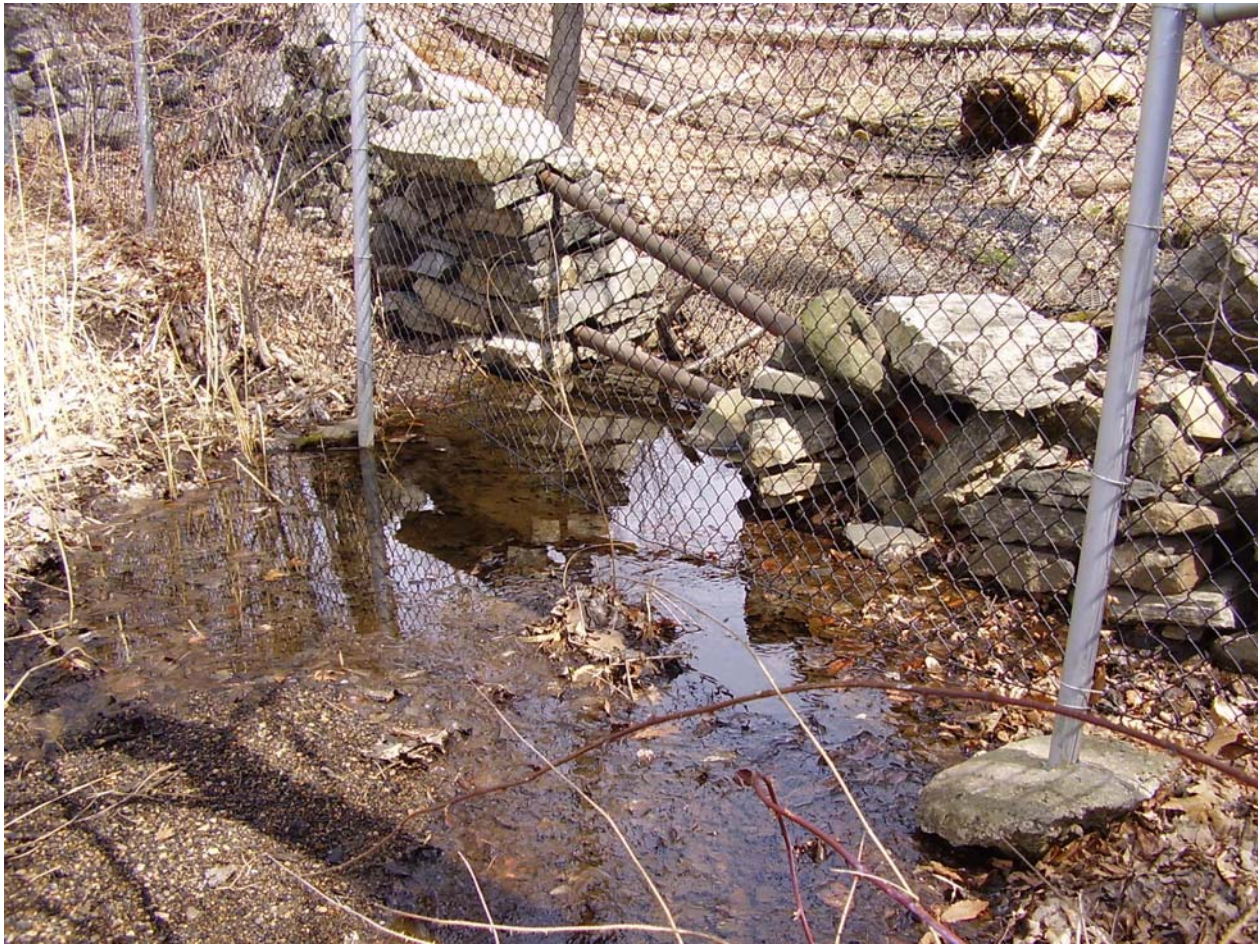
...space underneath fence where animals could be entering landfill. This space is necessary to prevent blockage of the stream. Therefore, no correction is needed.
