HARRISON SUB-RESIDENCY FIELD INSPECTION

Name of Inspector: Chris Kappeller and Val Basil

Date: 1/29/07

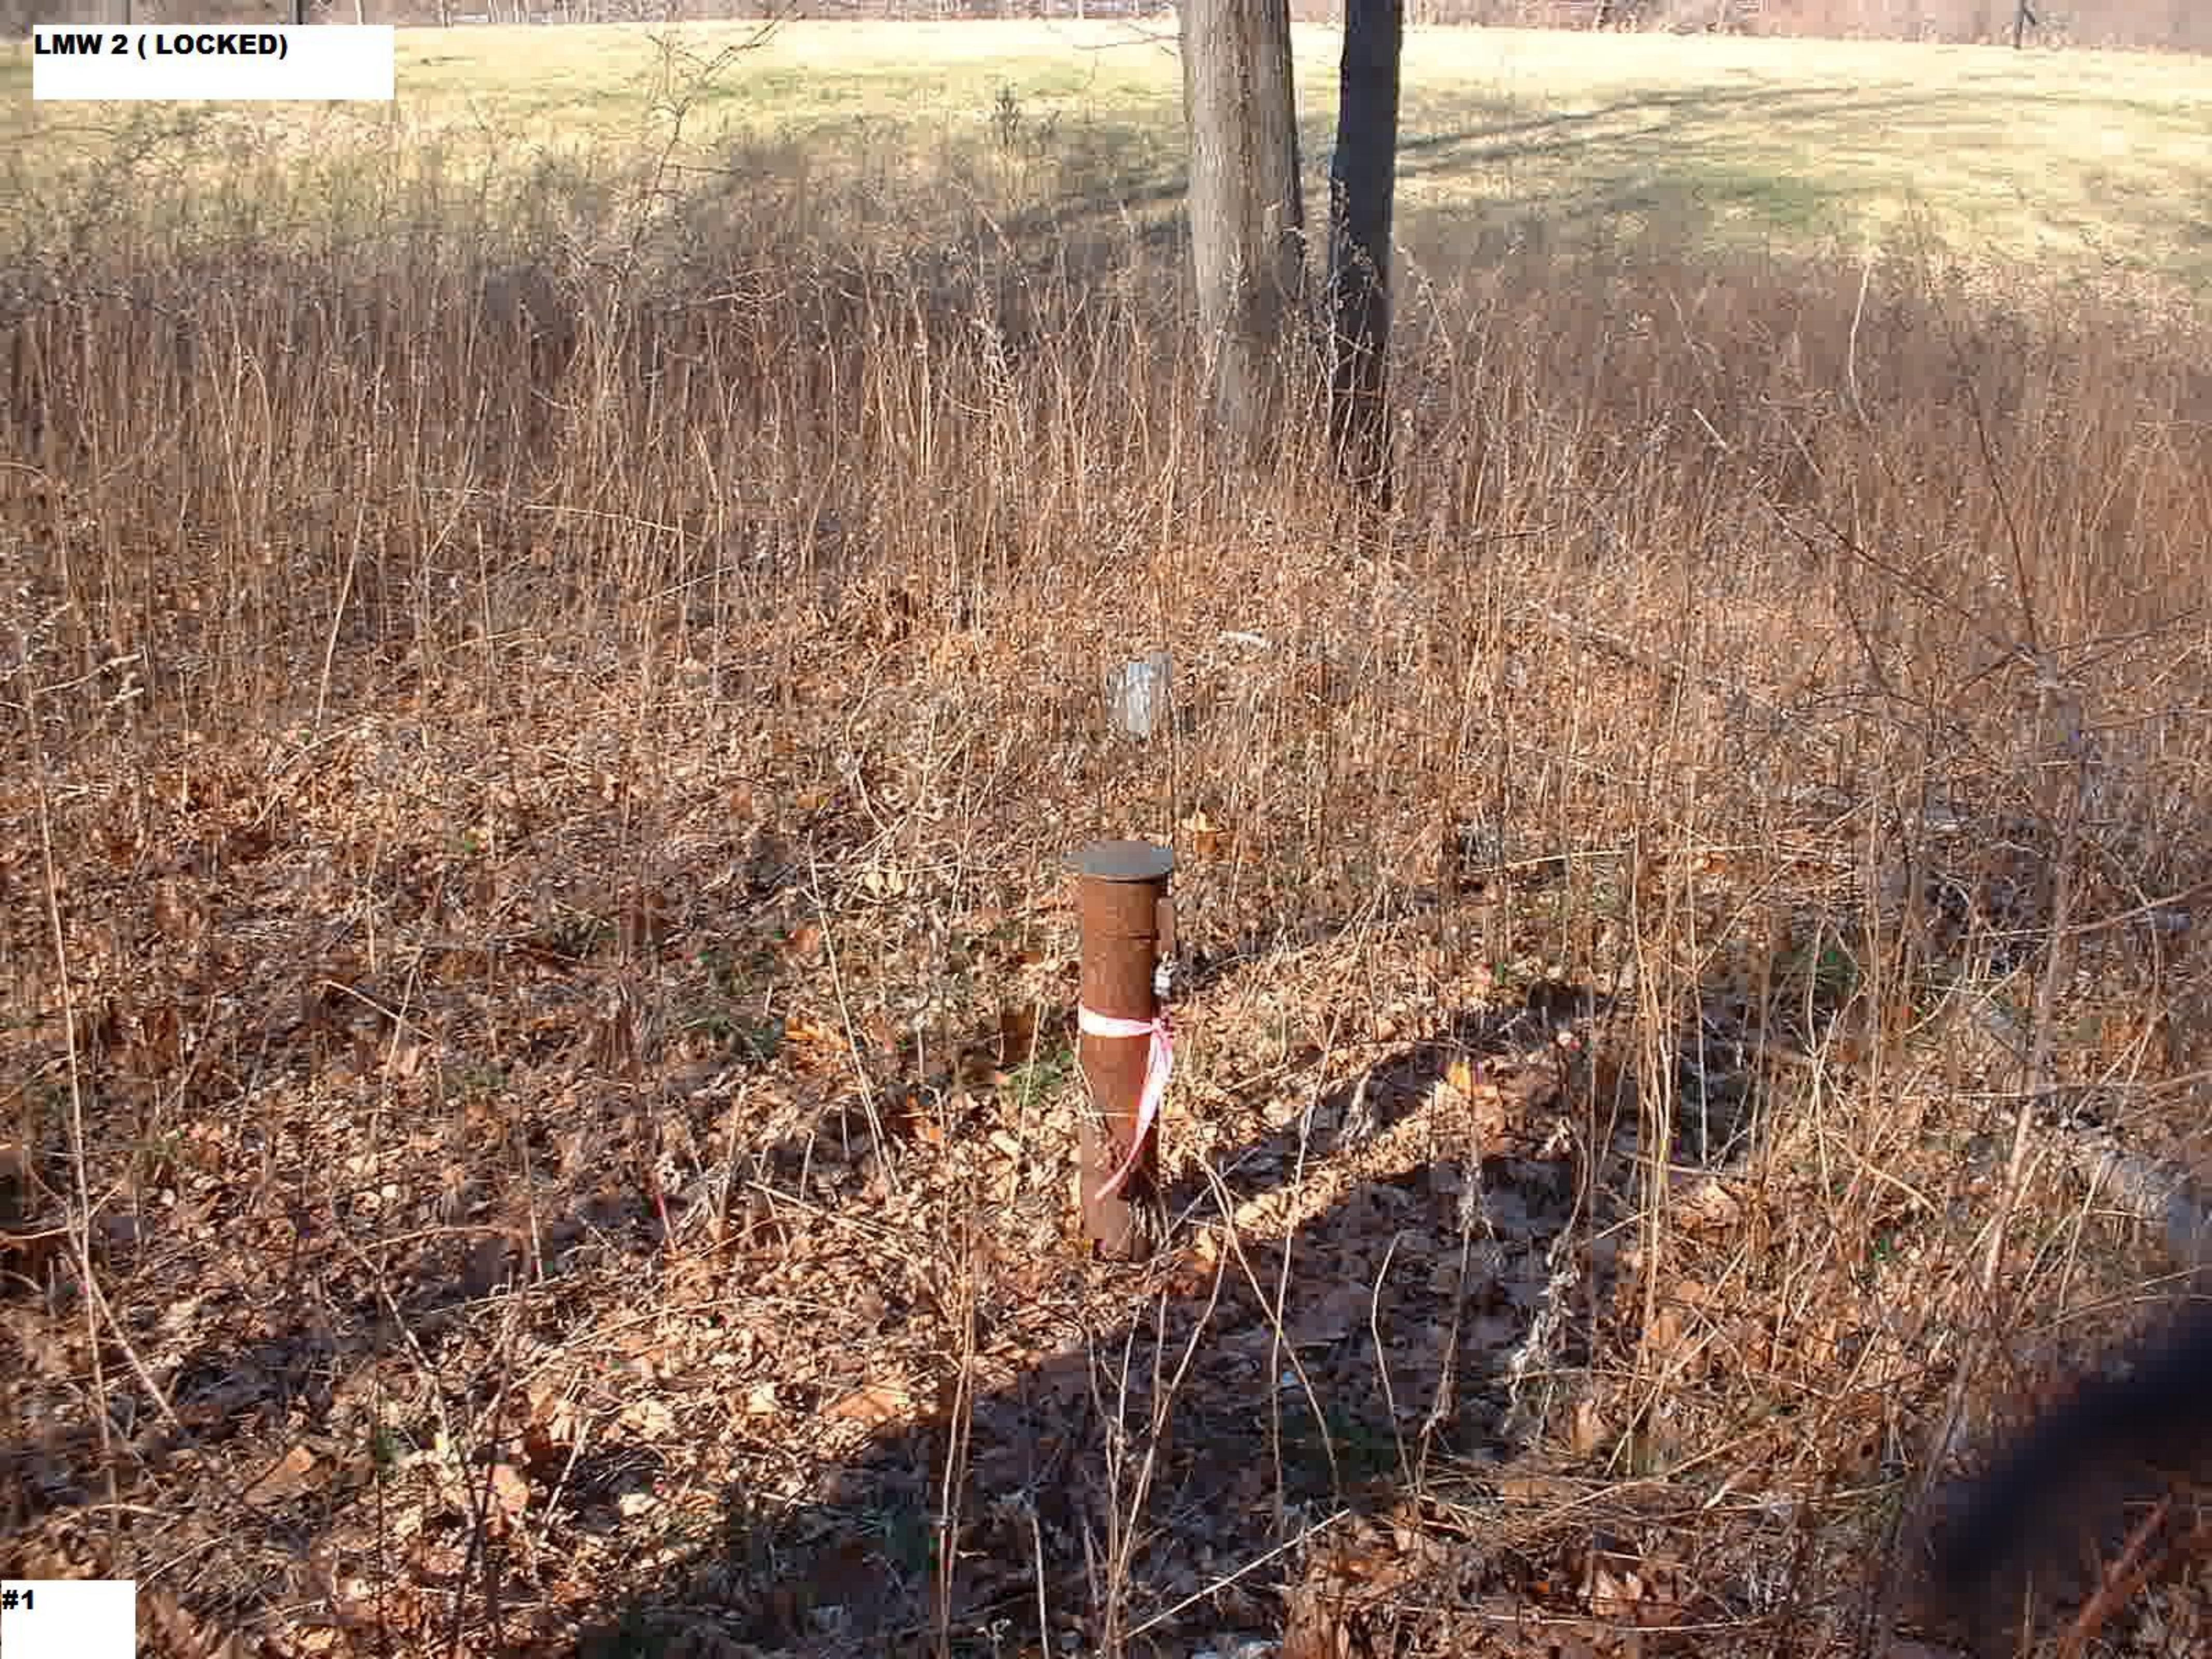
#1

All wells inspected and found to be in good condition. See Pictures # 1 - 8.

LMW 2 (LOCKED)

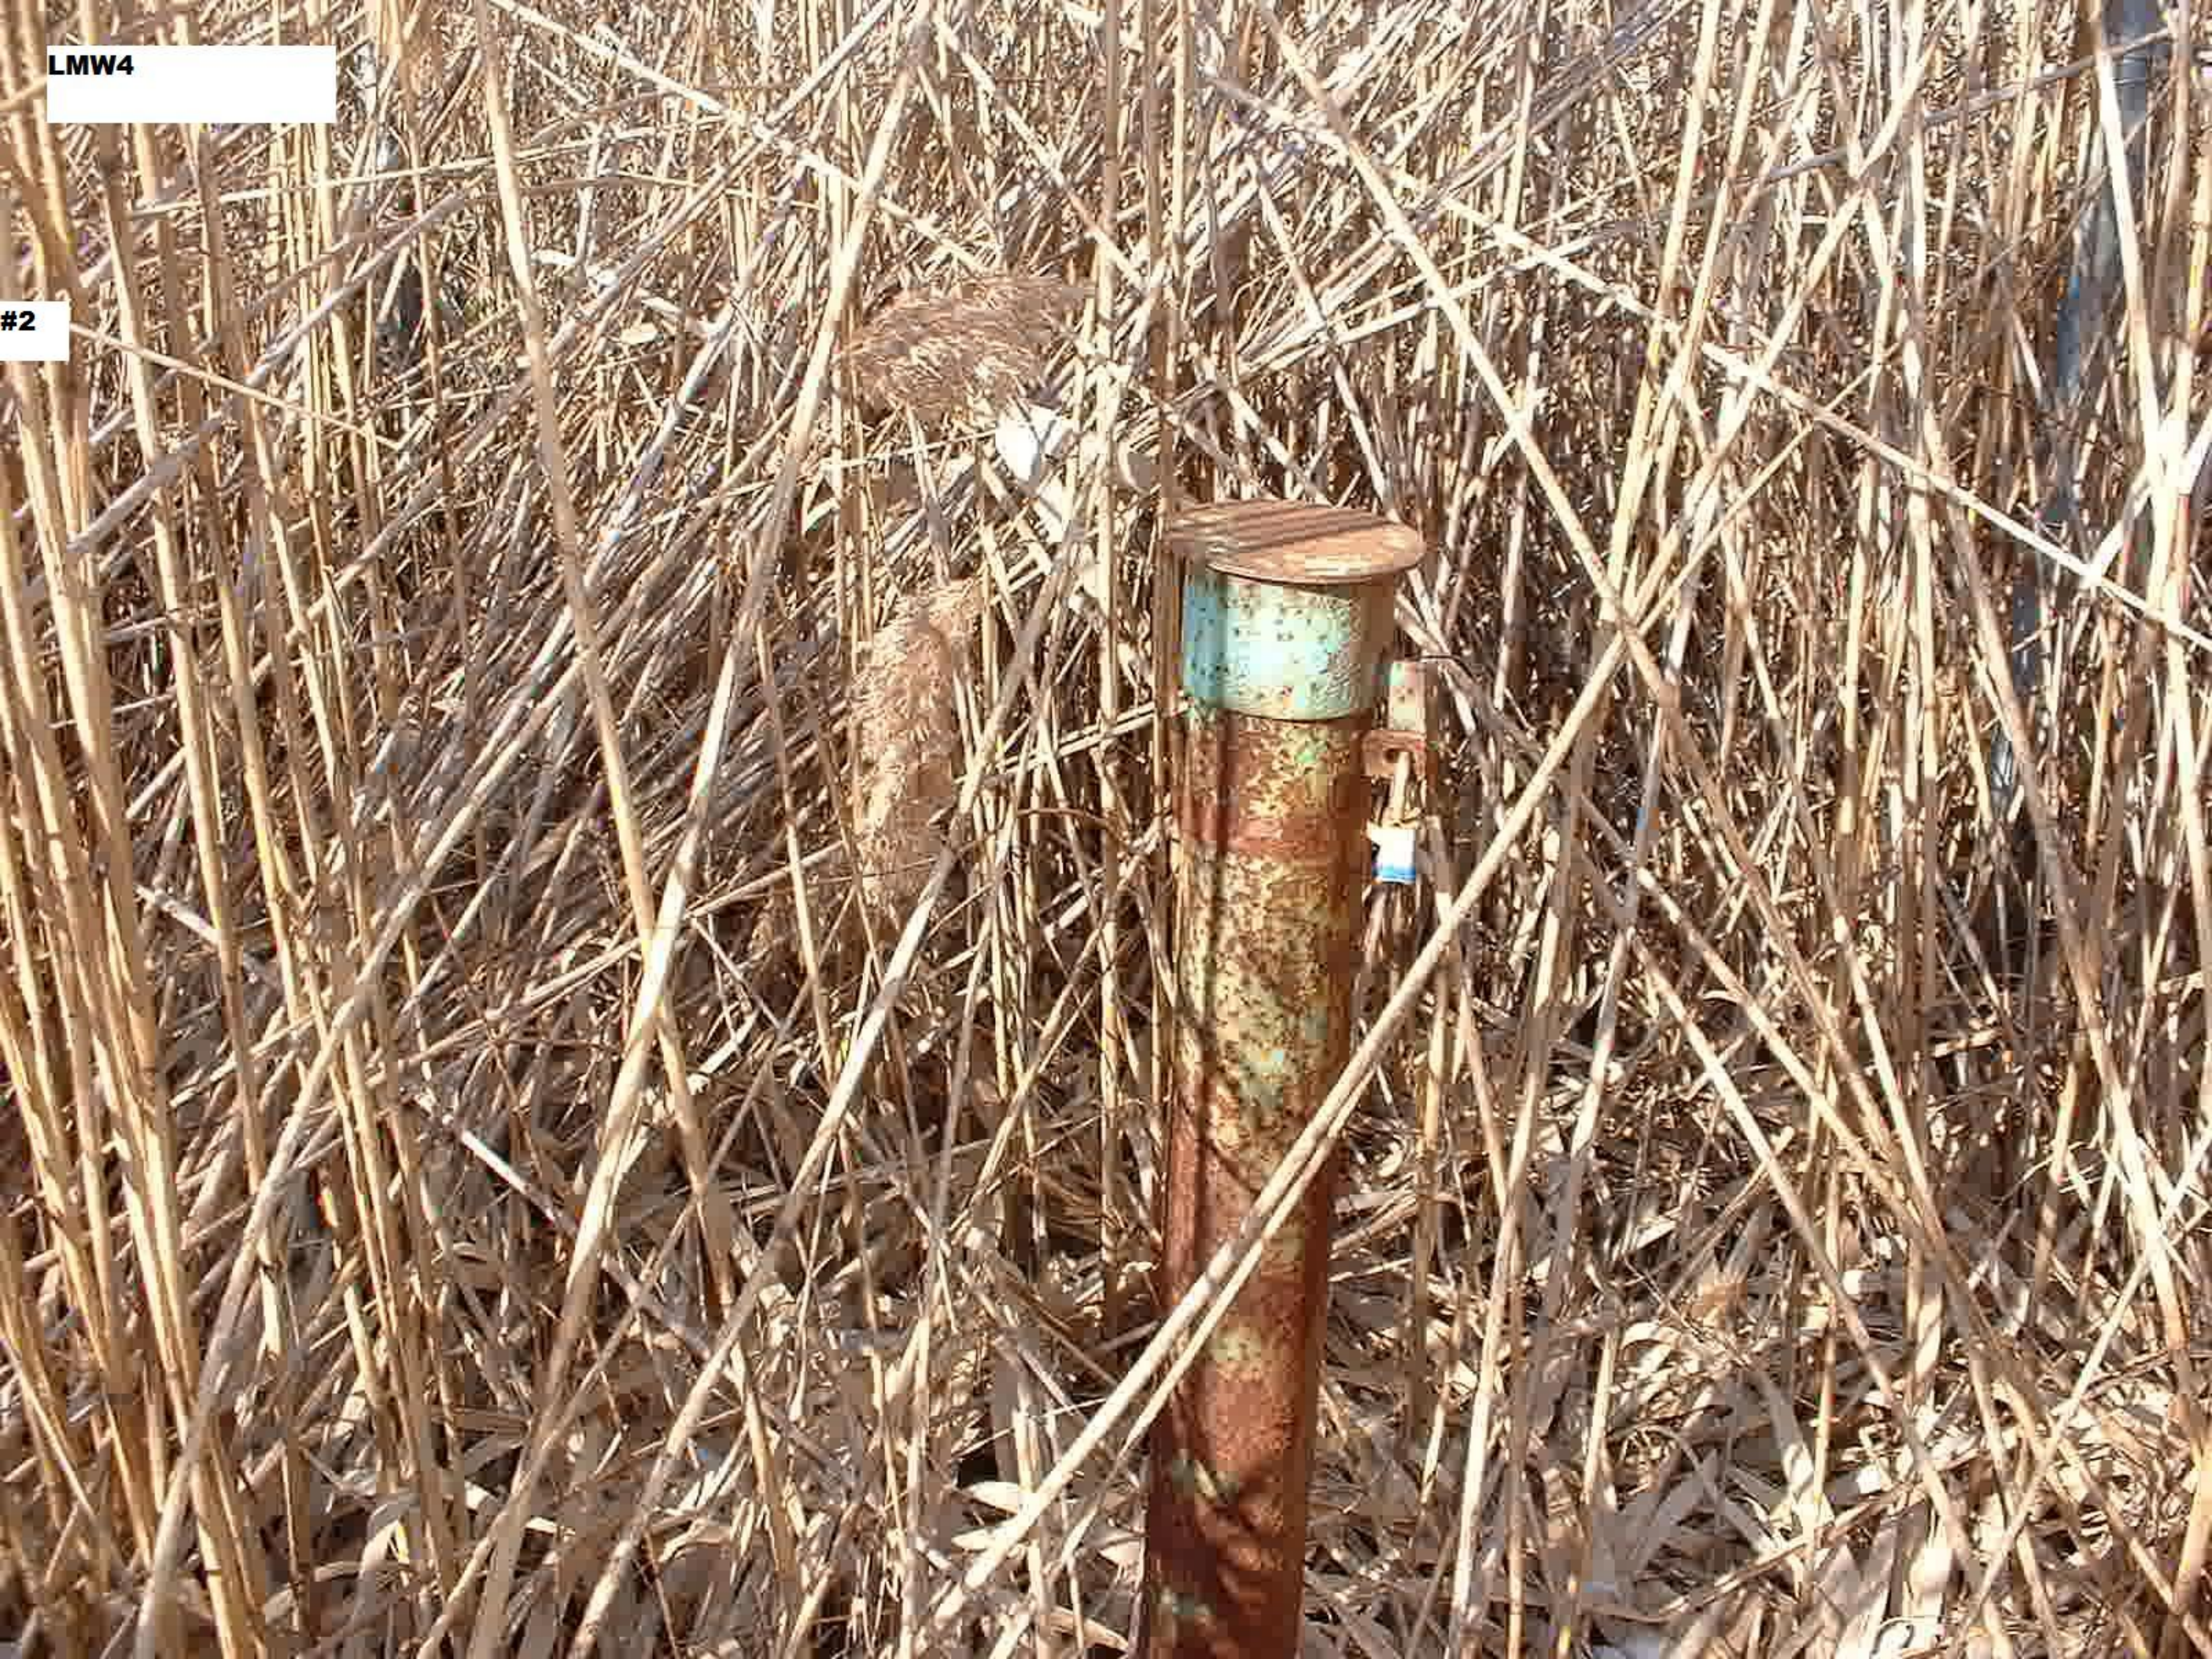
#2

LMW4

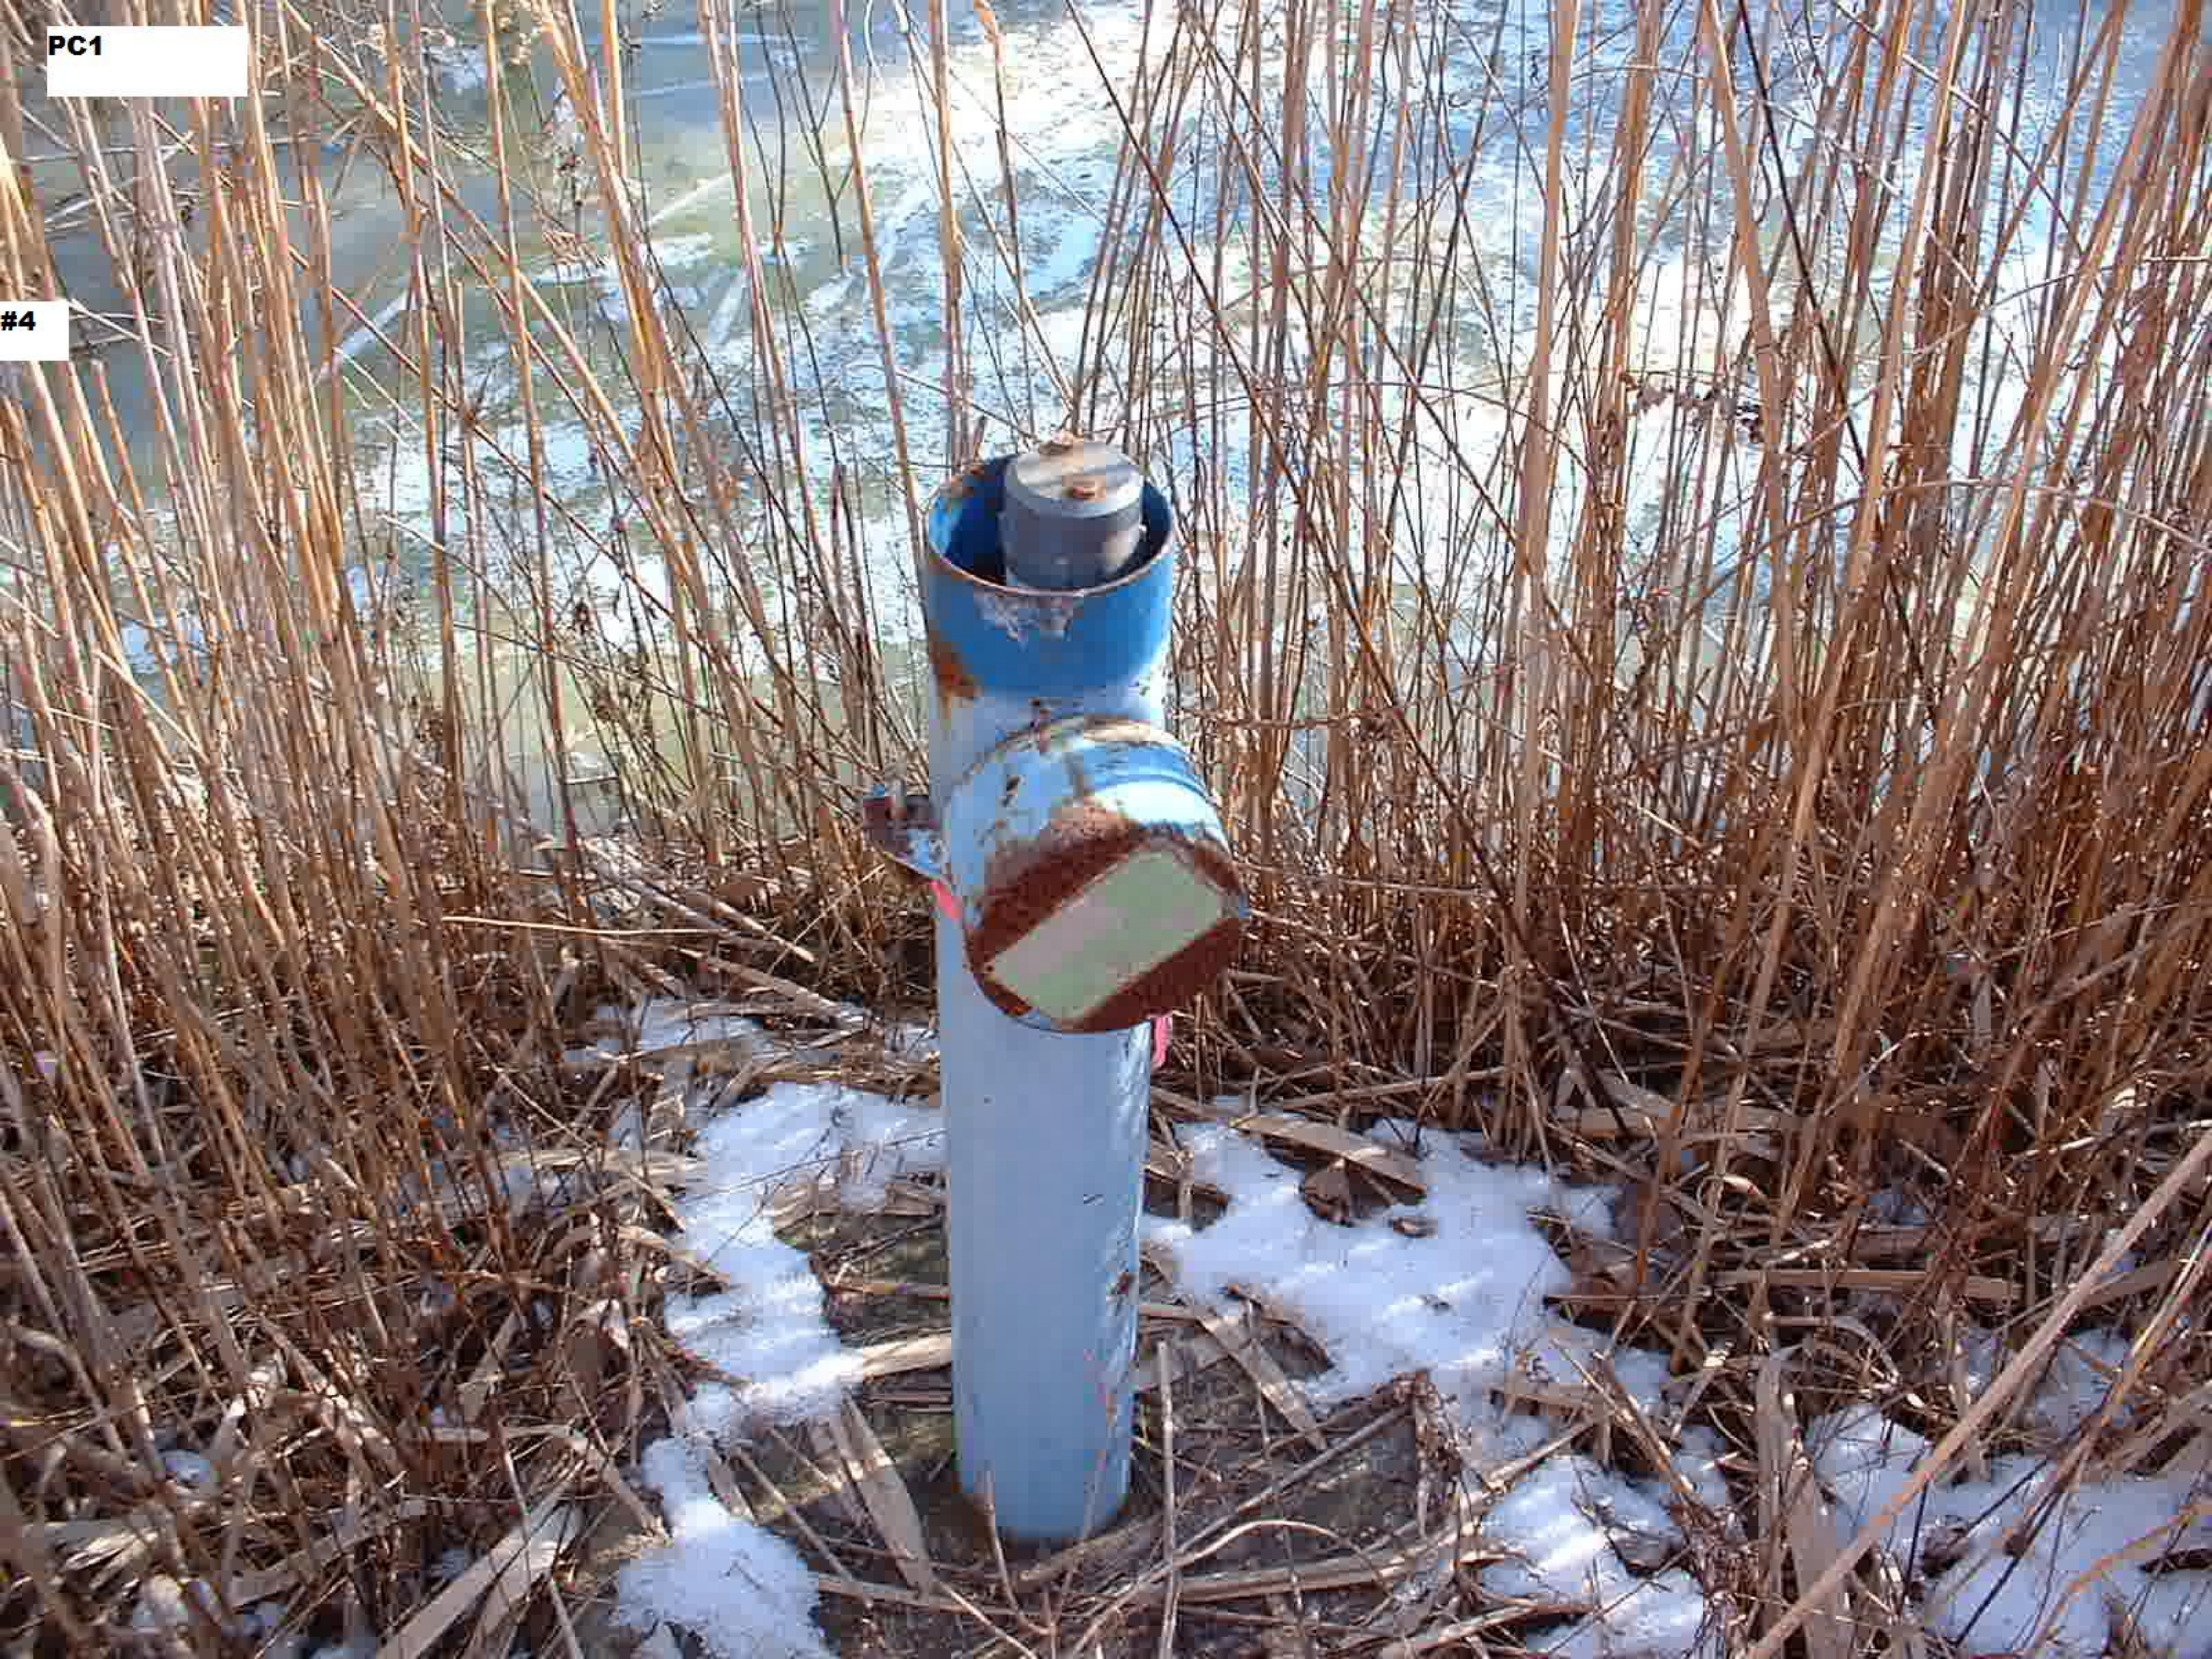
#4

PC1

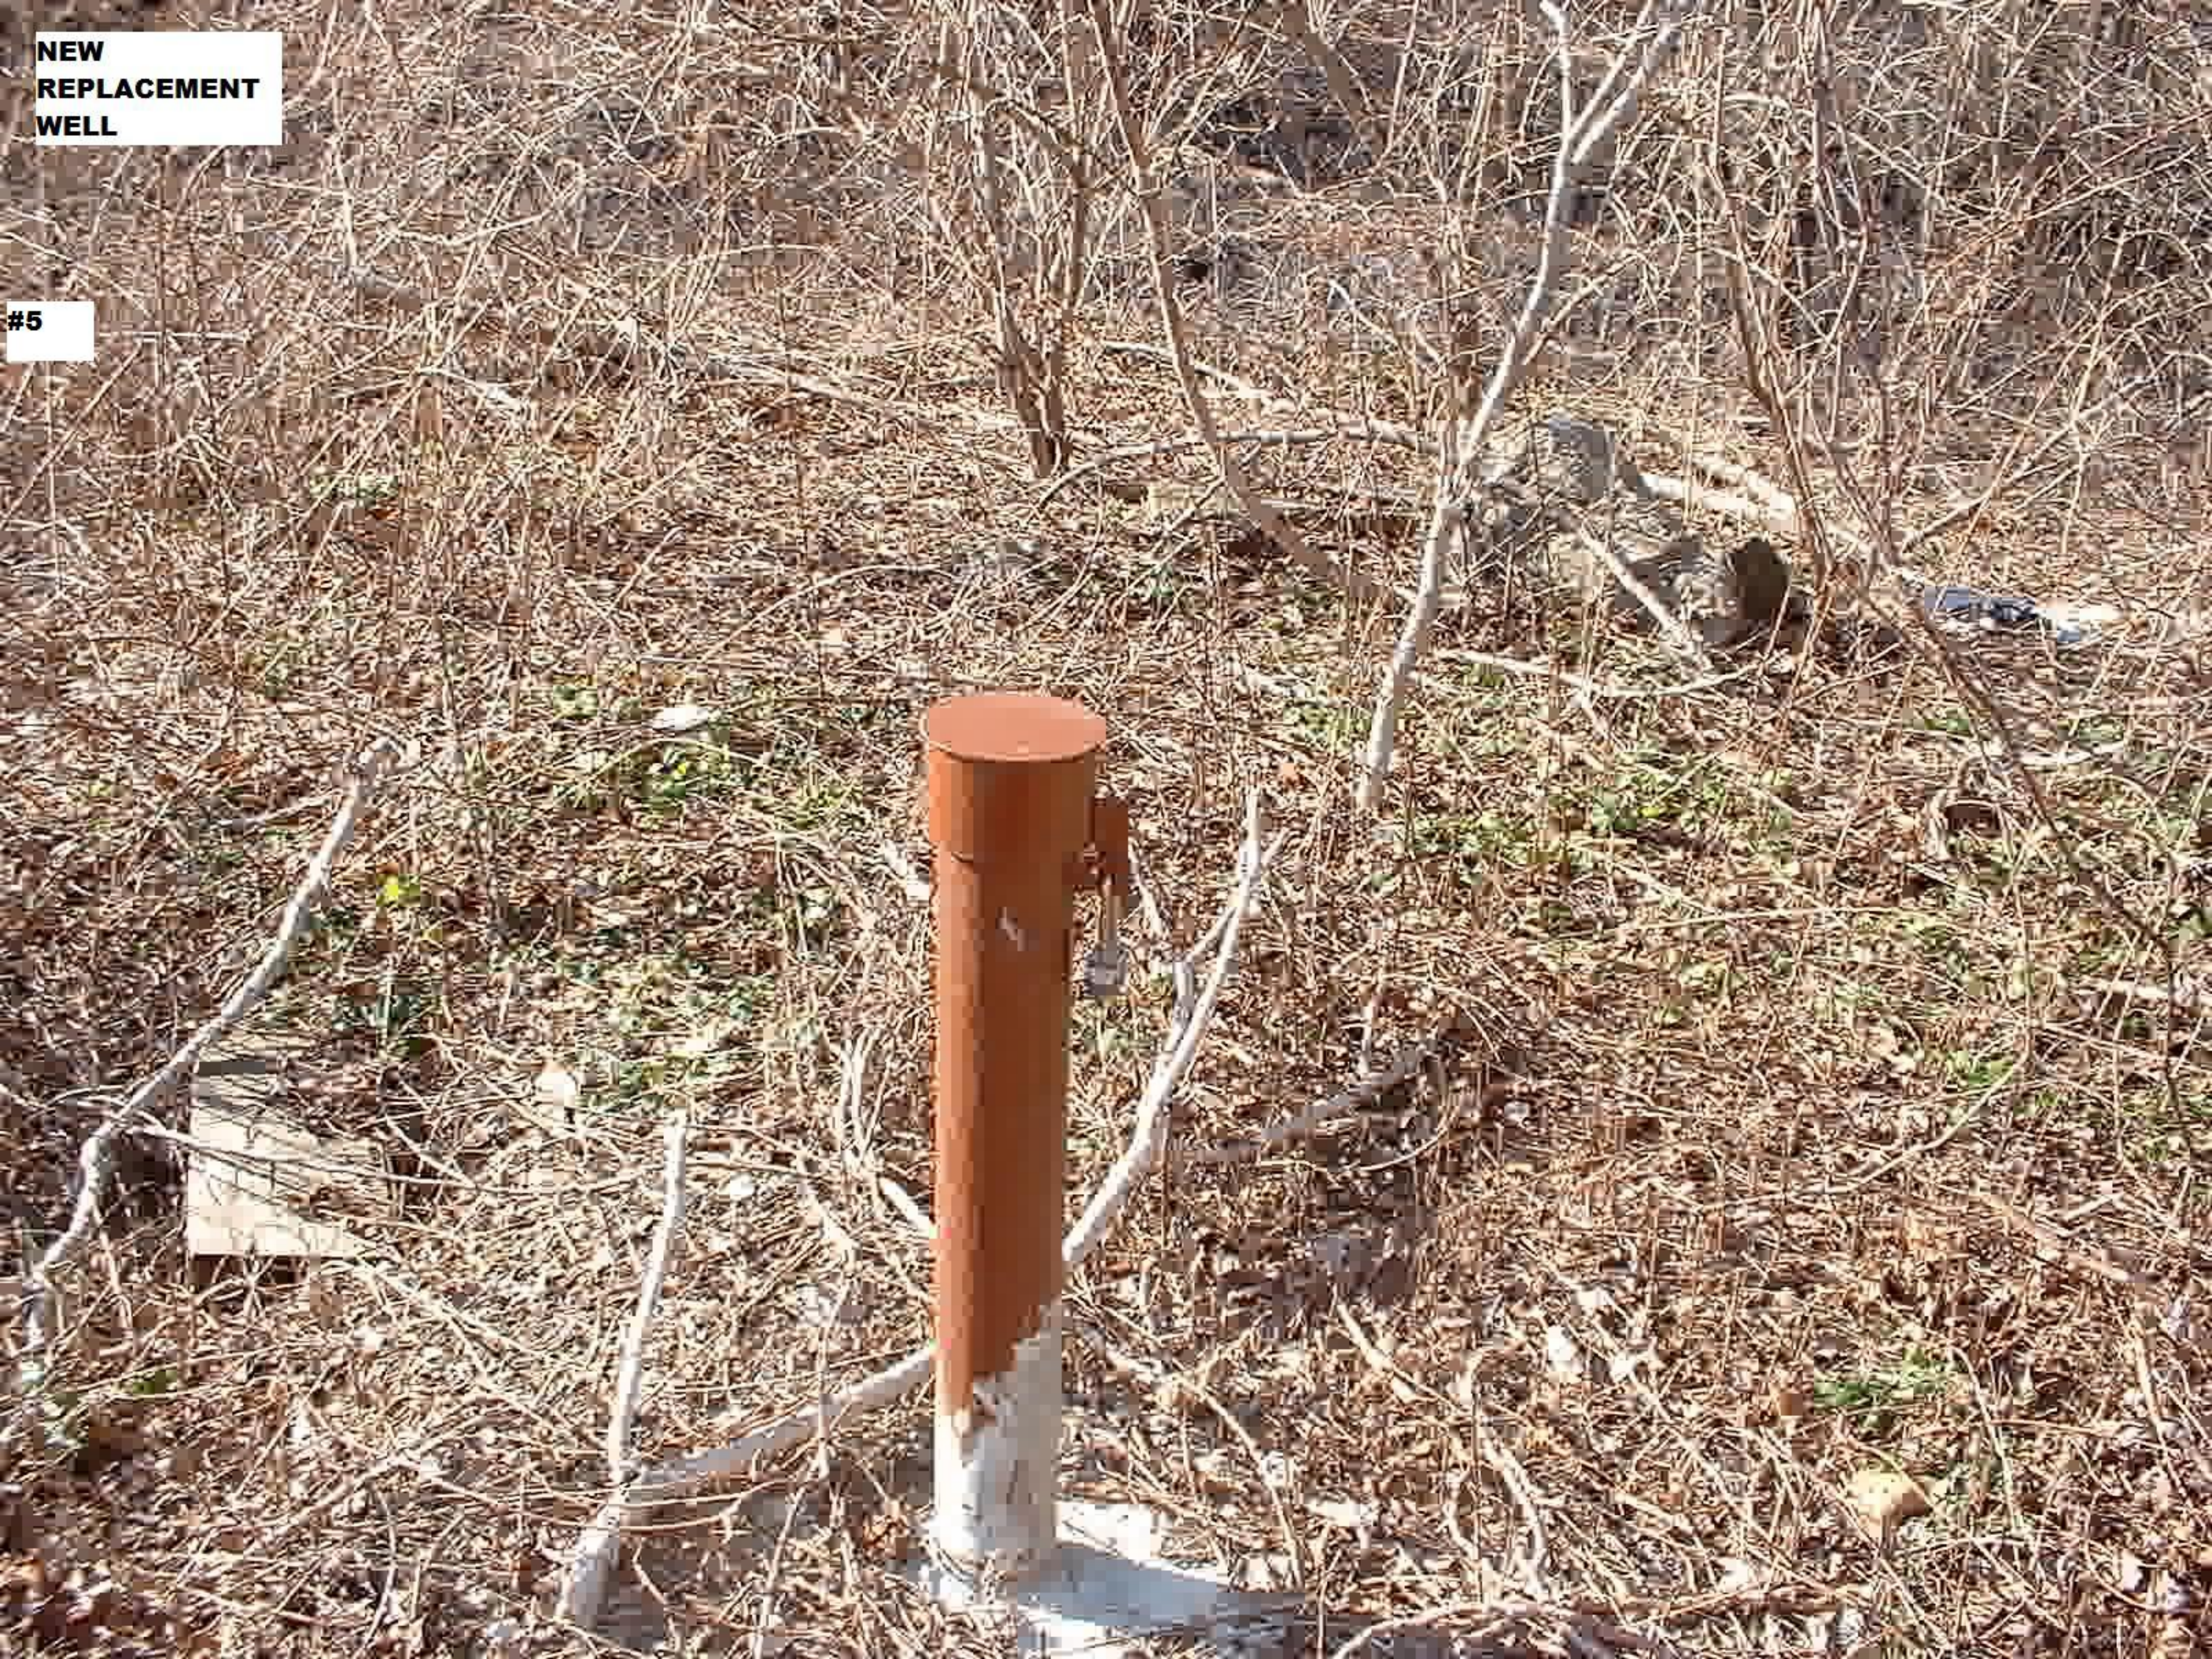
#5

**NEW
REPLACEMENT
WELL**

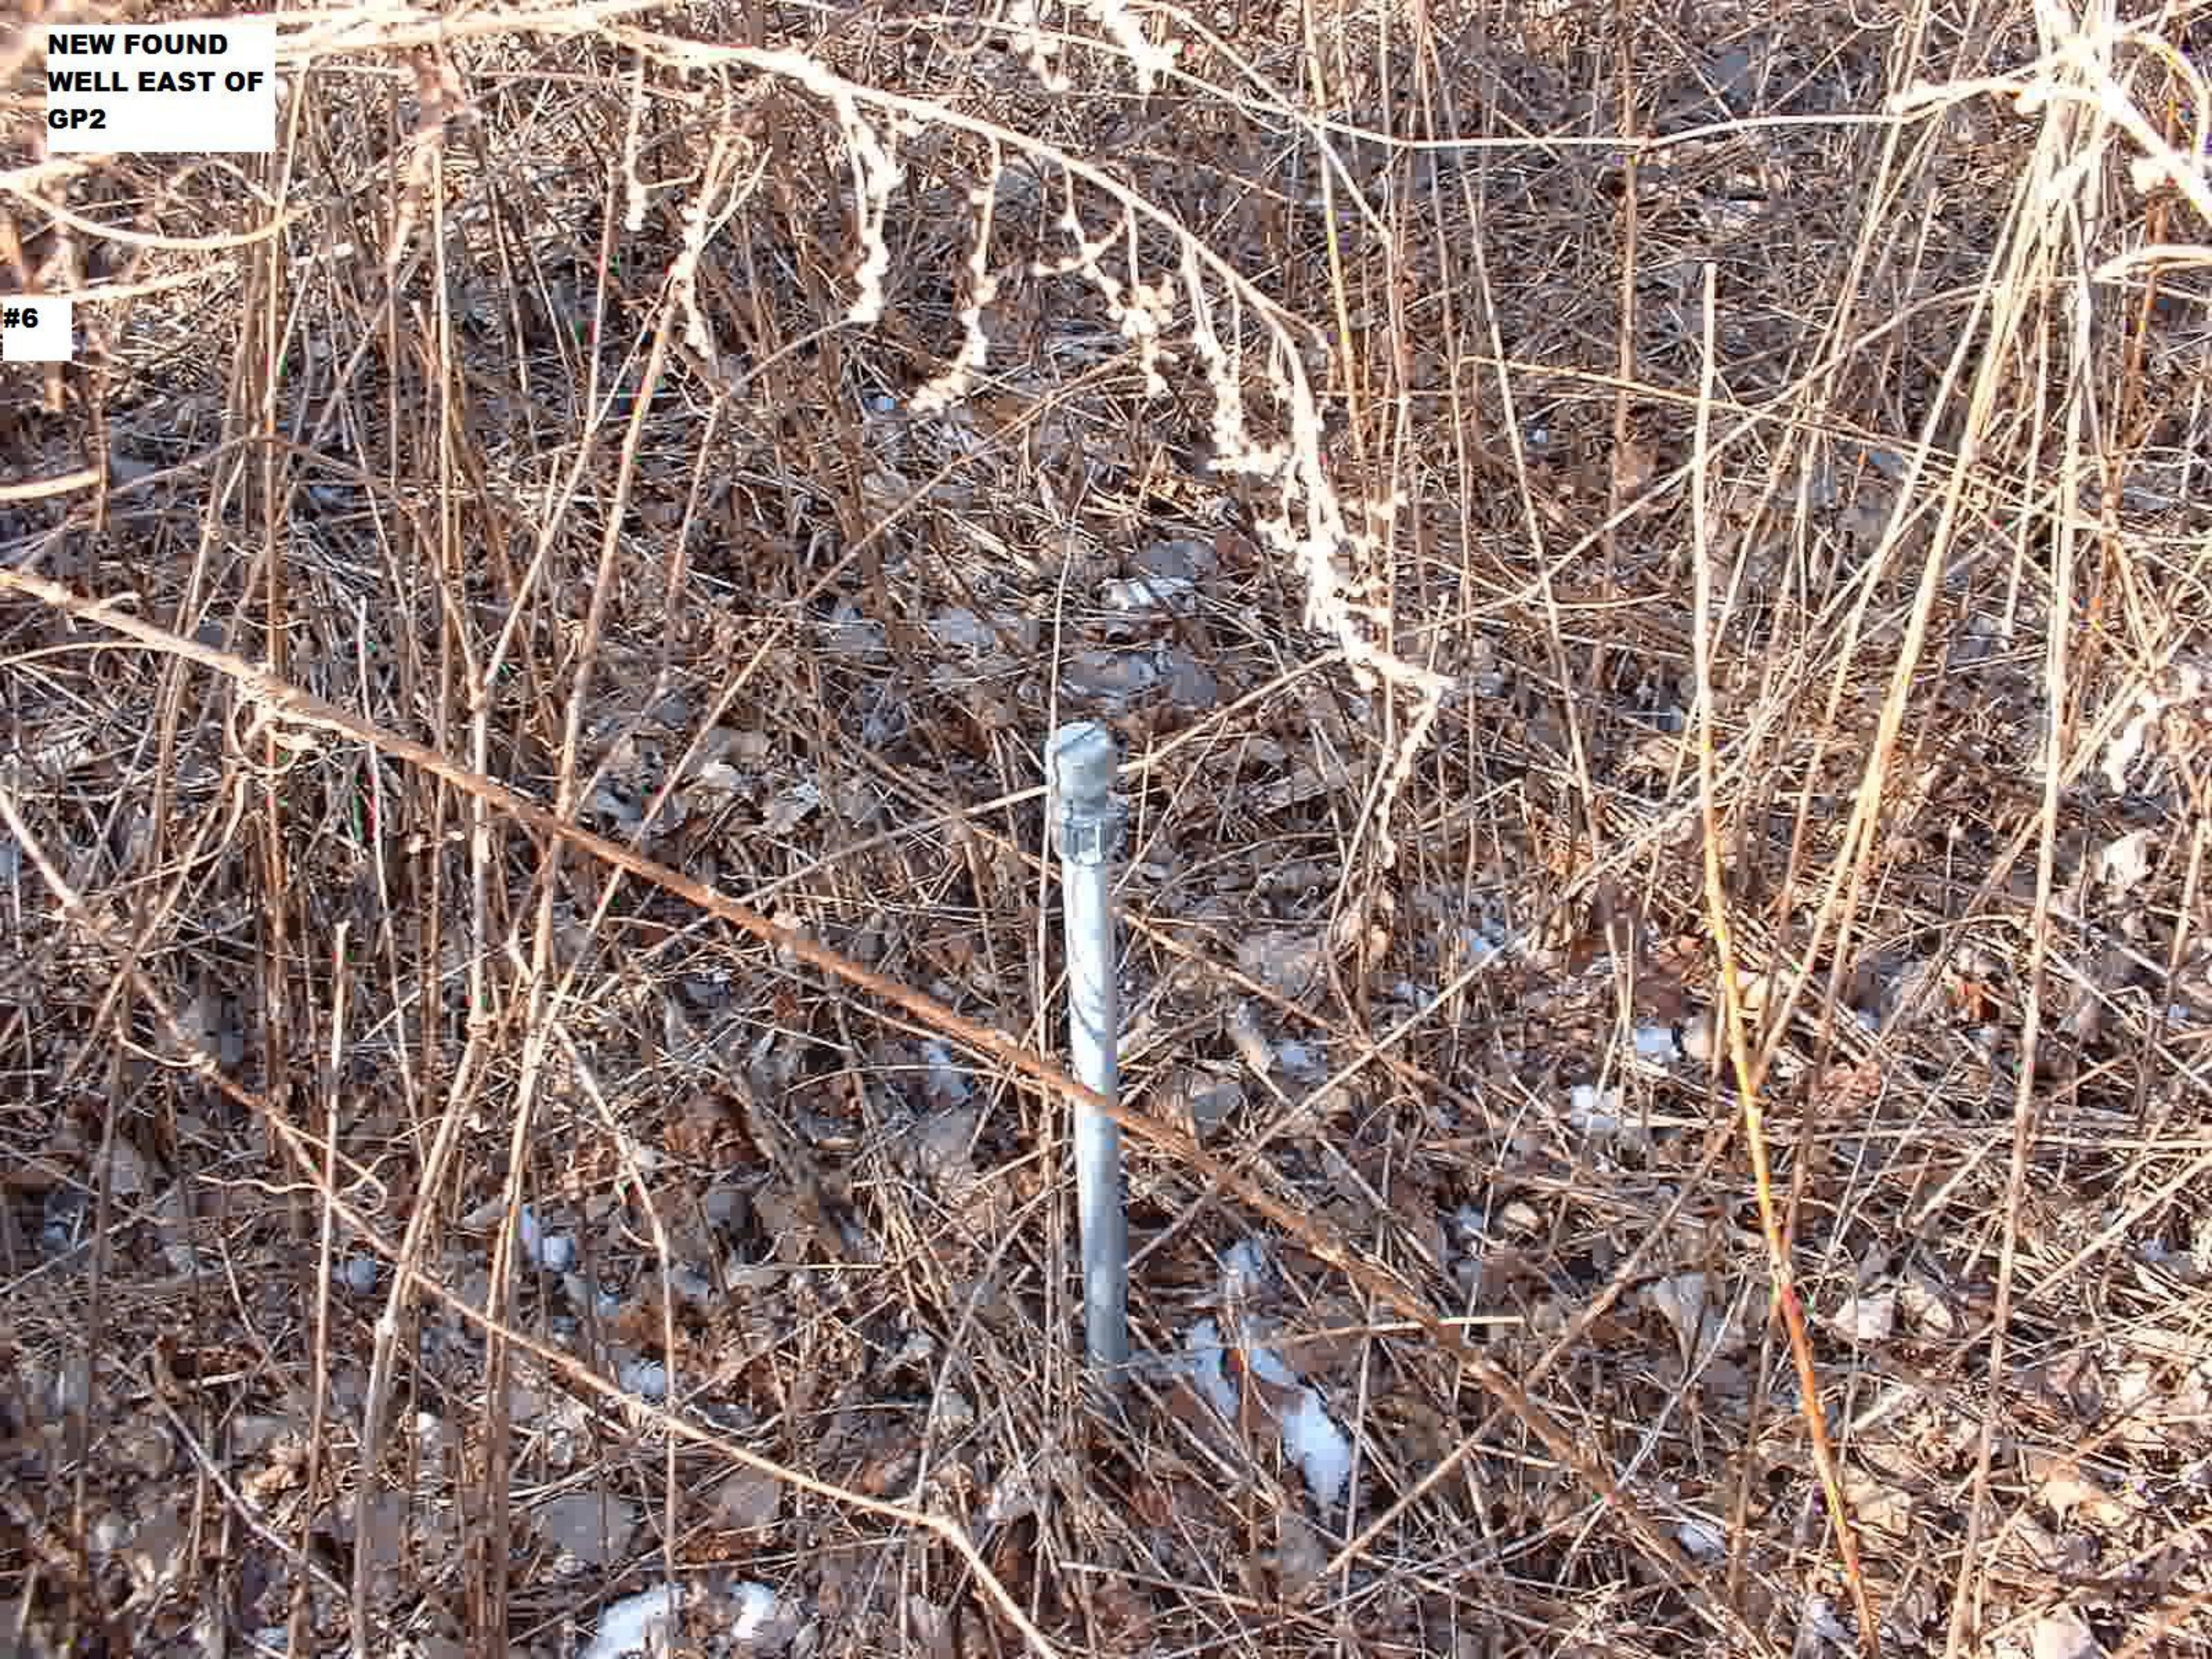
#6

**NEW FOUND
WELL EAST OF
GP2**

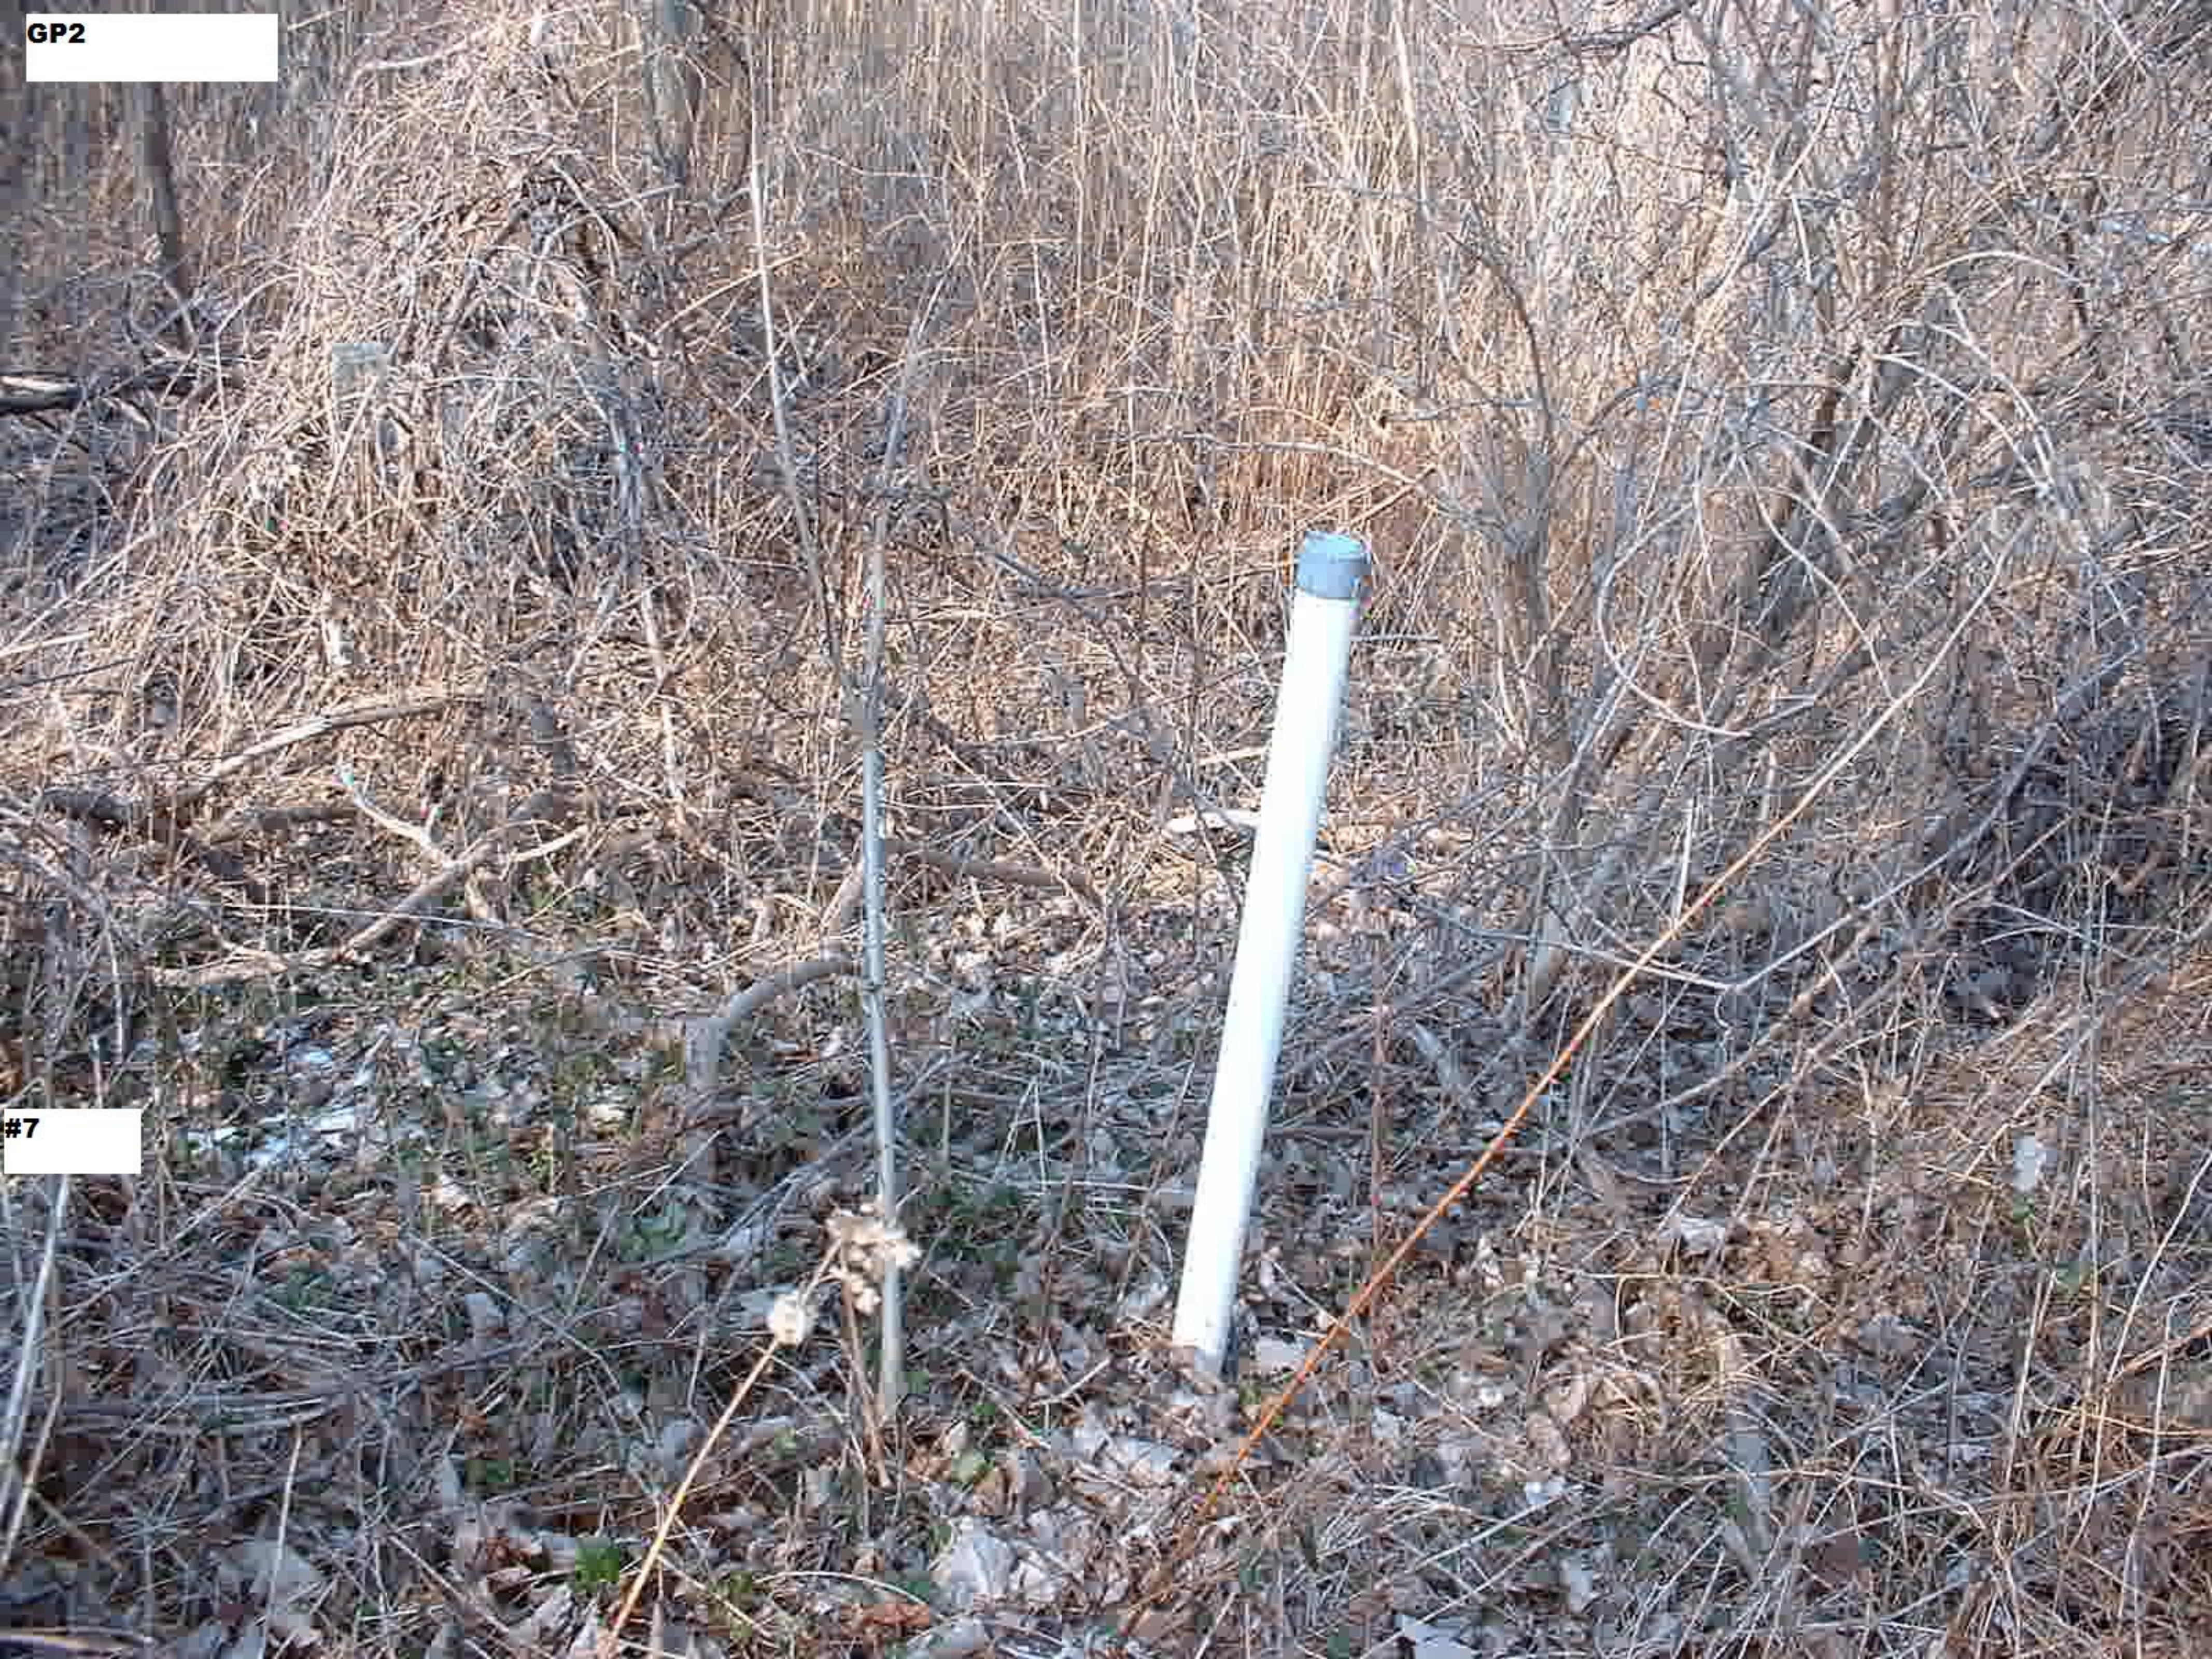
#7

GP2
