HARRISON SUB-RESIDENCY FIELD INSPECTION

Name of Inspector: Chris Kappeller and Val Basil

Date: 1/29/07

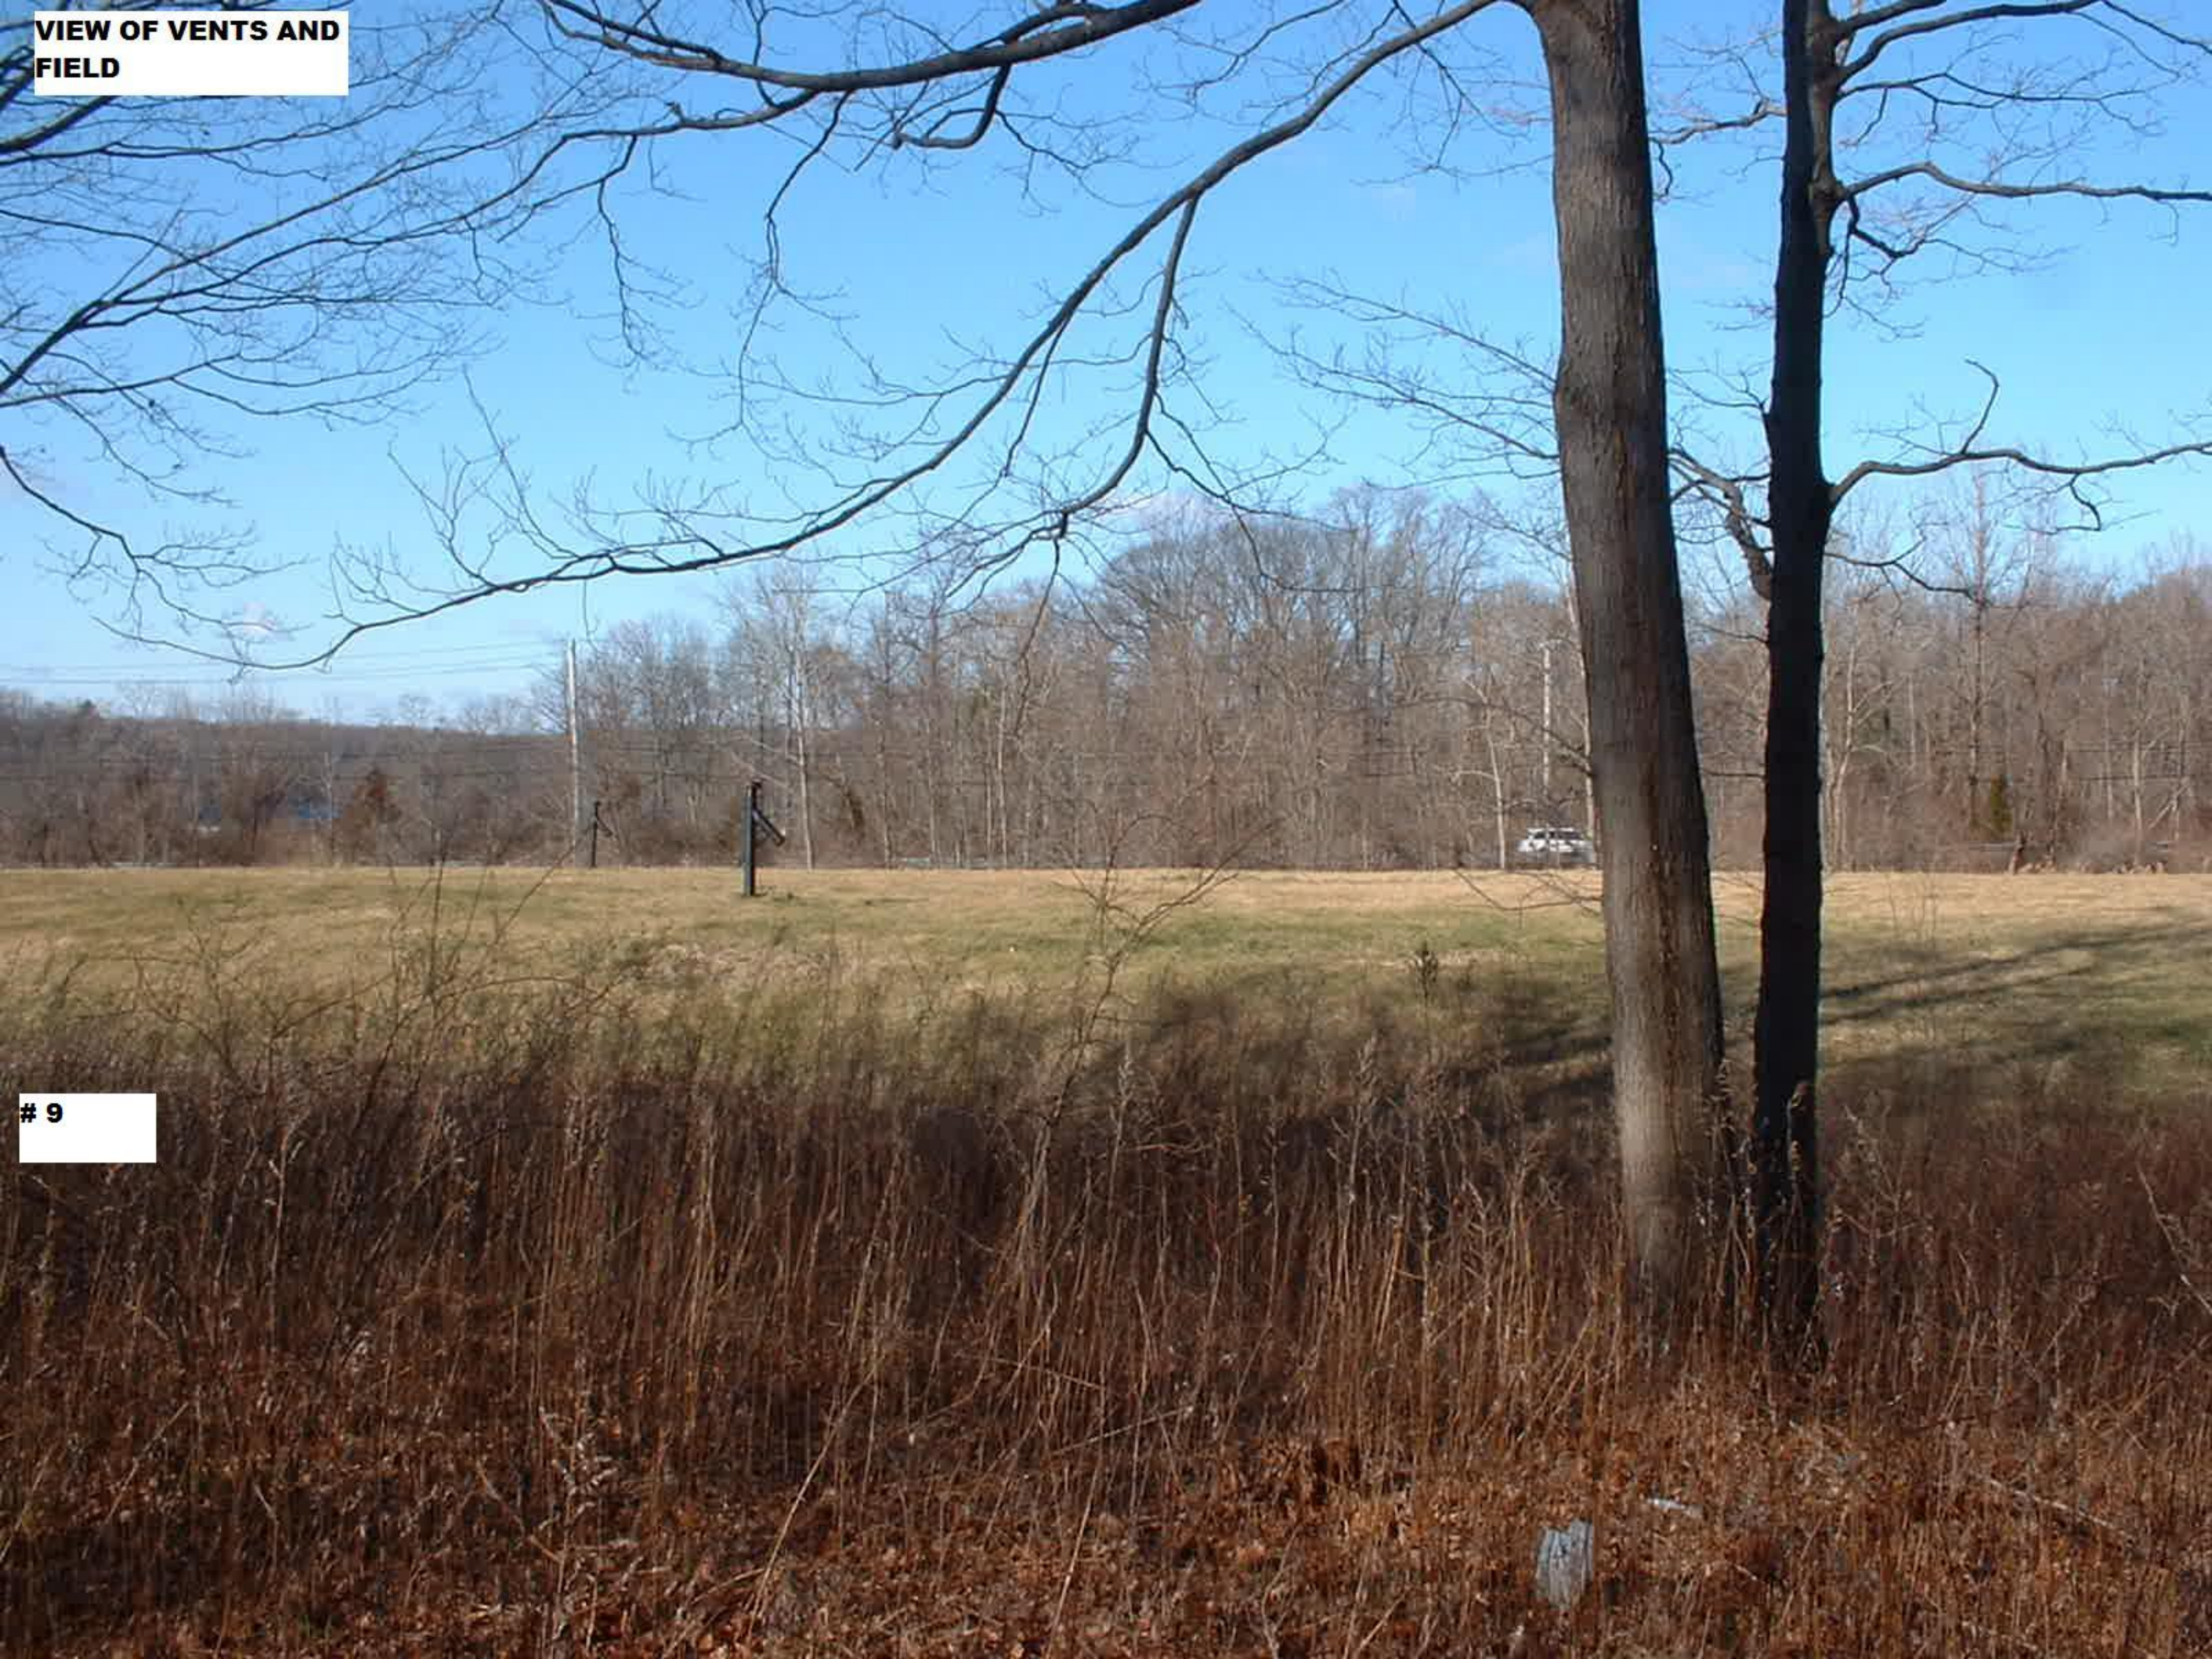
1. Vegetation is short. See Picture # 9

Four vents, (V1 – V4) were inspected. Found OK. See Picture # 9.

**VIEW OF VENTS AND
FIELD**

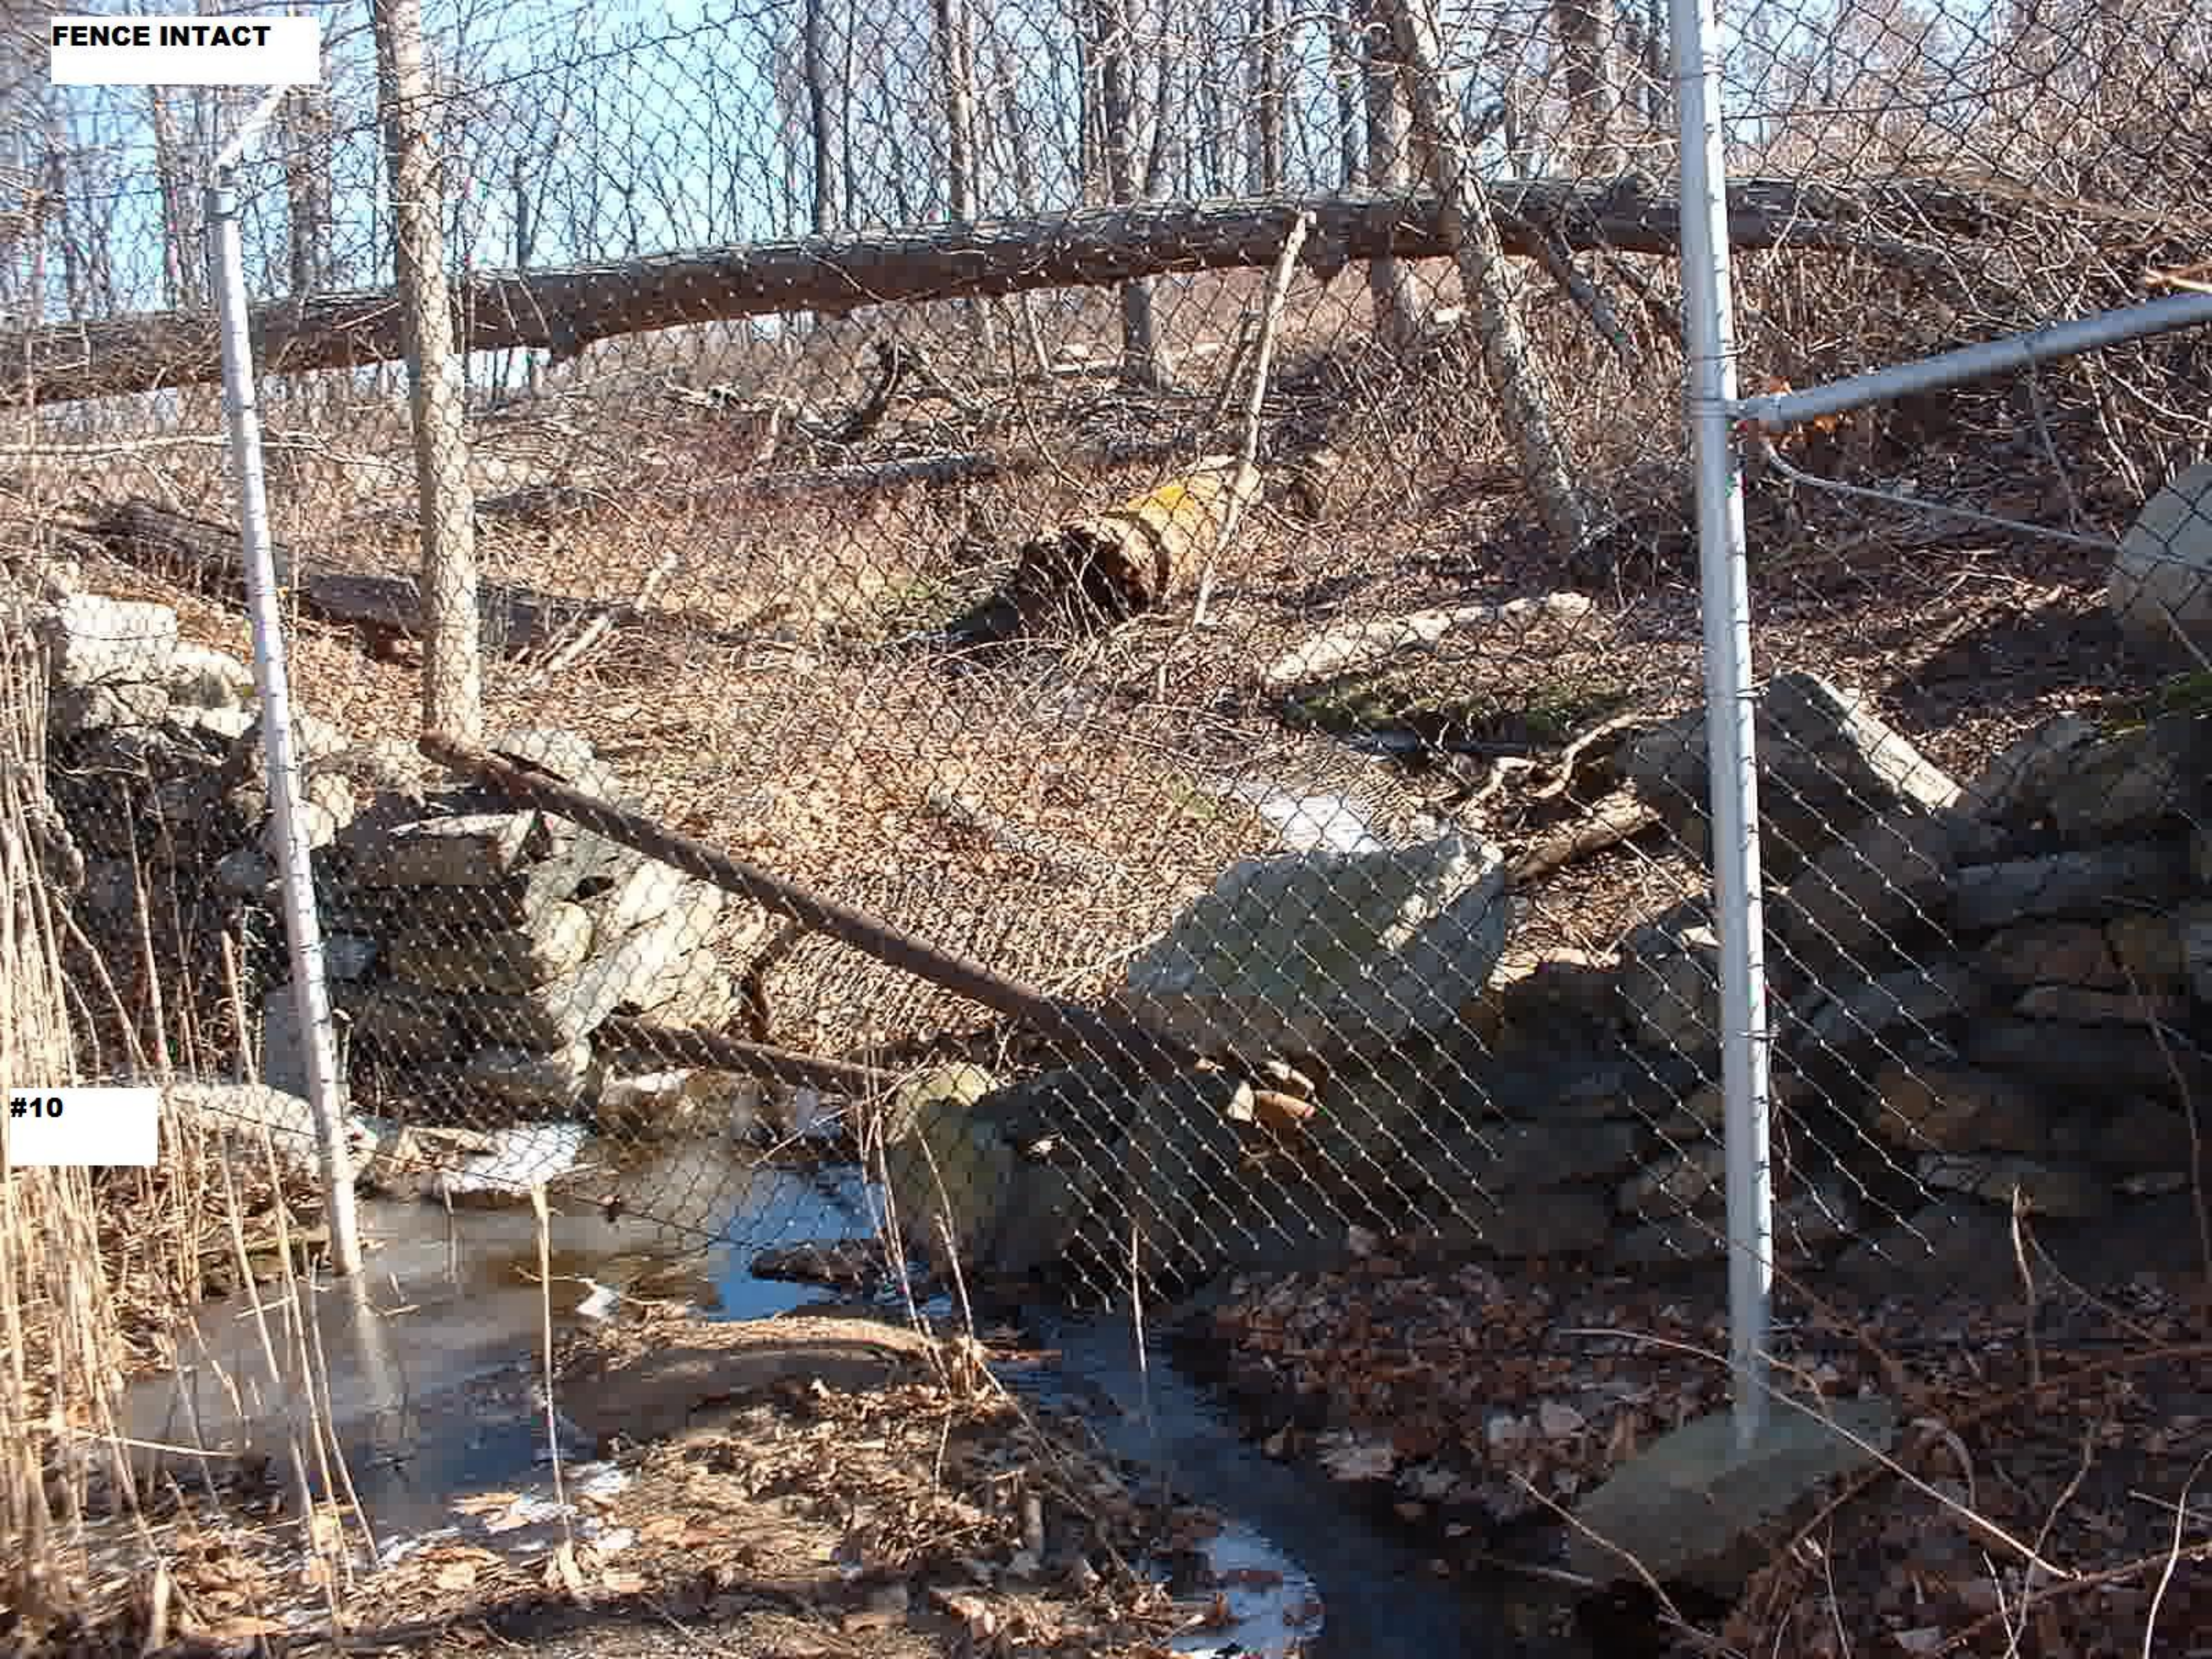
#10

FENCE INTACT

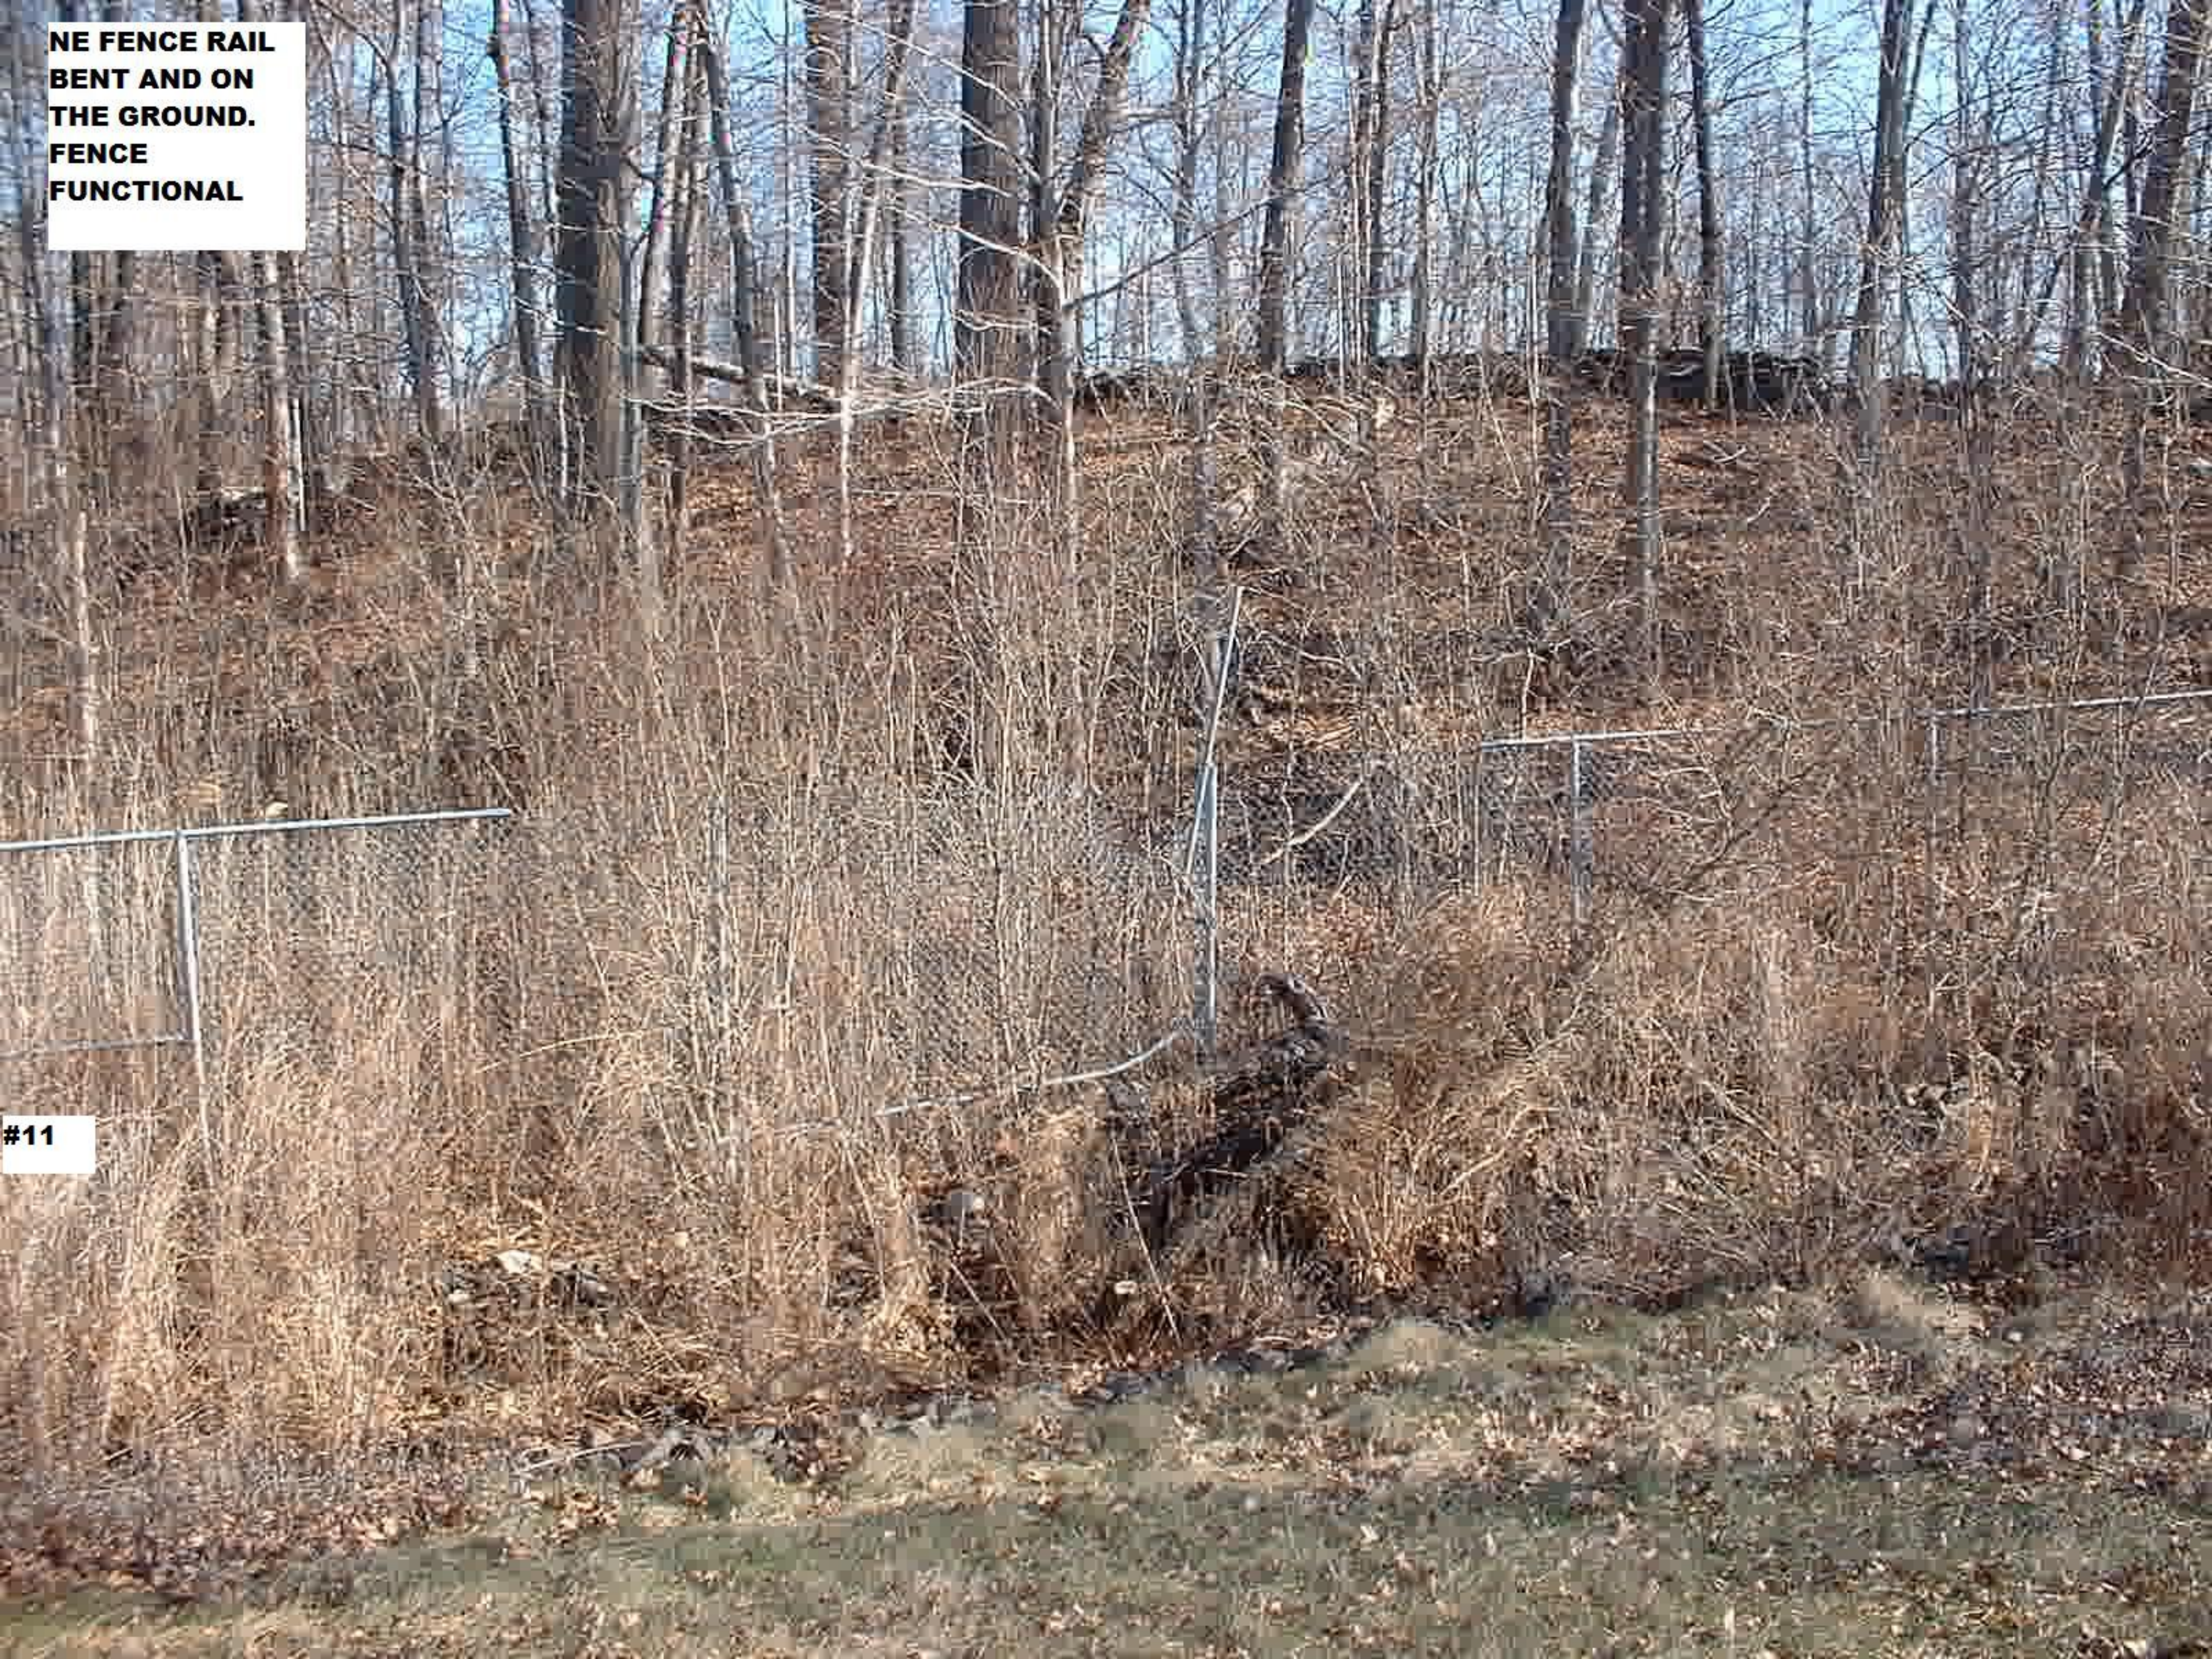
#11

The fence has a section of its top rail bent and dislodged by a fallen branch on the N/E side of the landfill, and two (2) sections of the top rail missing on the S/E side. Also, there is a hole in the fence on the south side near the main gate to the landfill. See Pictures # 10- 13.

NE FENCE RAIL
BENT AND ON
THE GROUND.
FENCE
FUNCTIONAL

1. The fence needs to be repaired at three (3) areas referenced above. Three months ago, the Town of Harrison was asked to fix the fence at the two areas on the south/southeast side. NYSDOT Real Estate will send a letter to the Town of Harrison requesting that they repair the damage or else NYSDOT will cancel their Use and Occupancy permit.
2. The soil slump at the western area will need some topsoil, seed and mulch. A vegetated mat or equivalent should be placed to secure this area from future failures and to prevent any further erosion. NYSDOT Residency 8-9 was asked to perform this work three months ago. It has been decided that this task will be performed by NYSDOT Region 8's hazardous waste term agreement consultant, HDR/LMS.

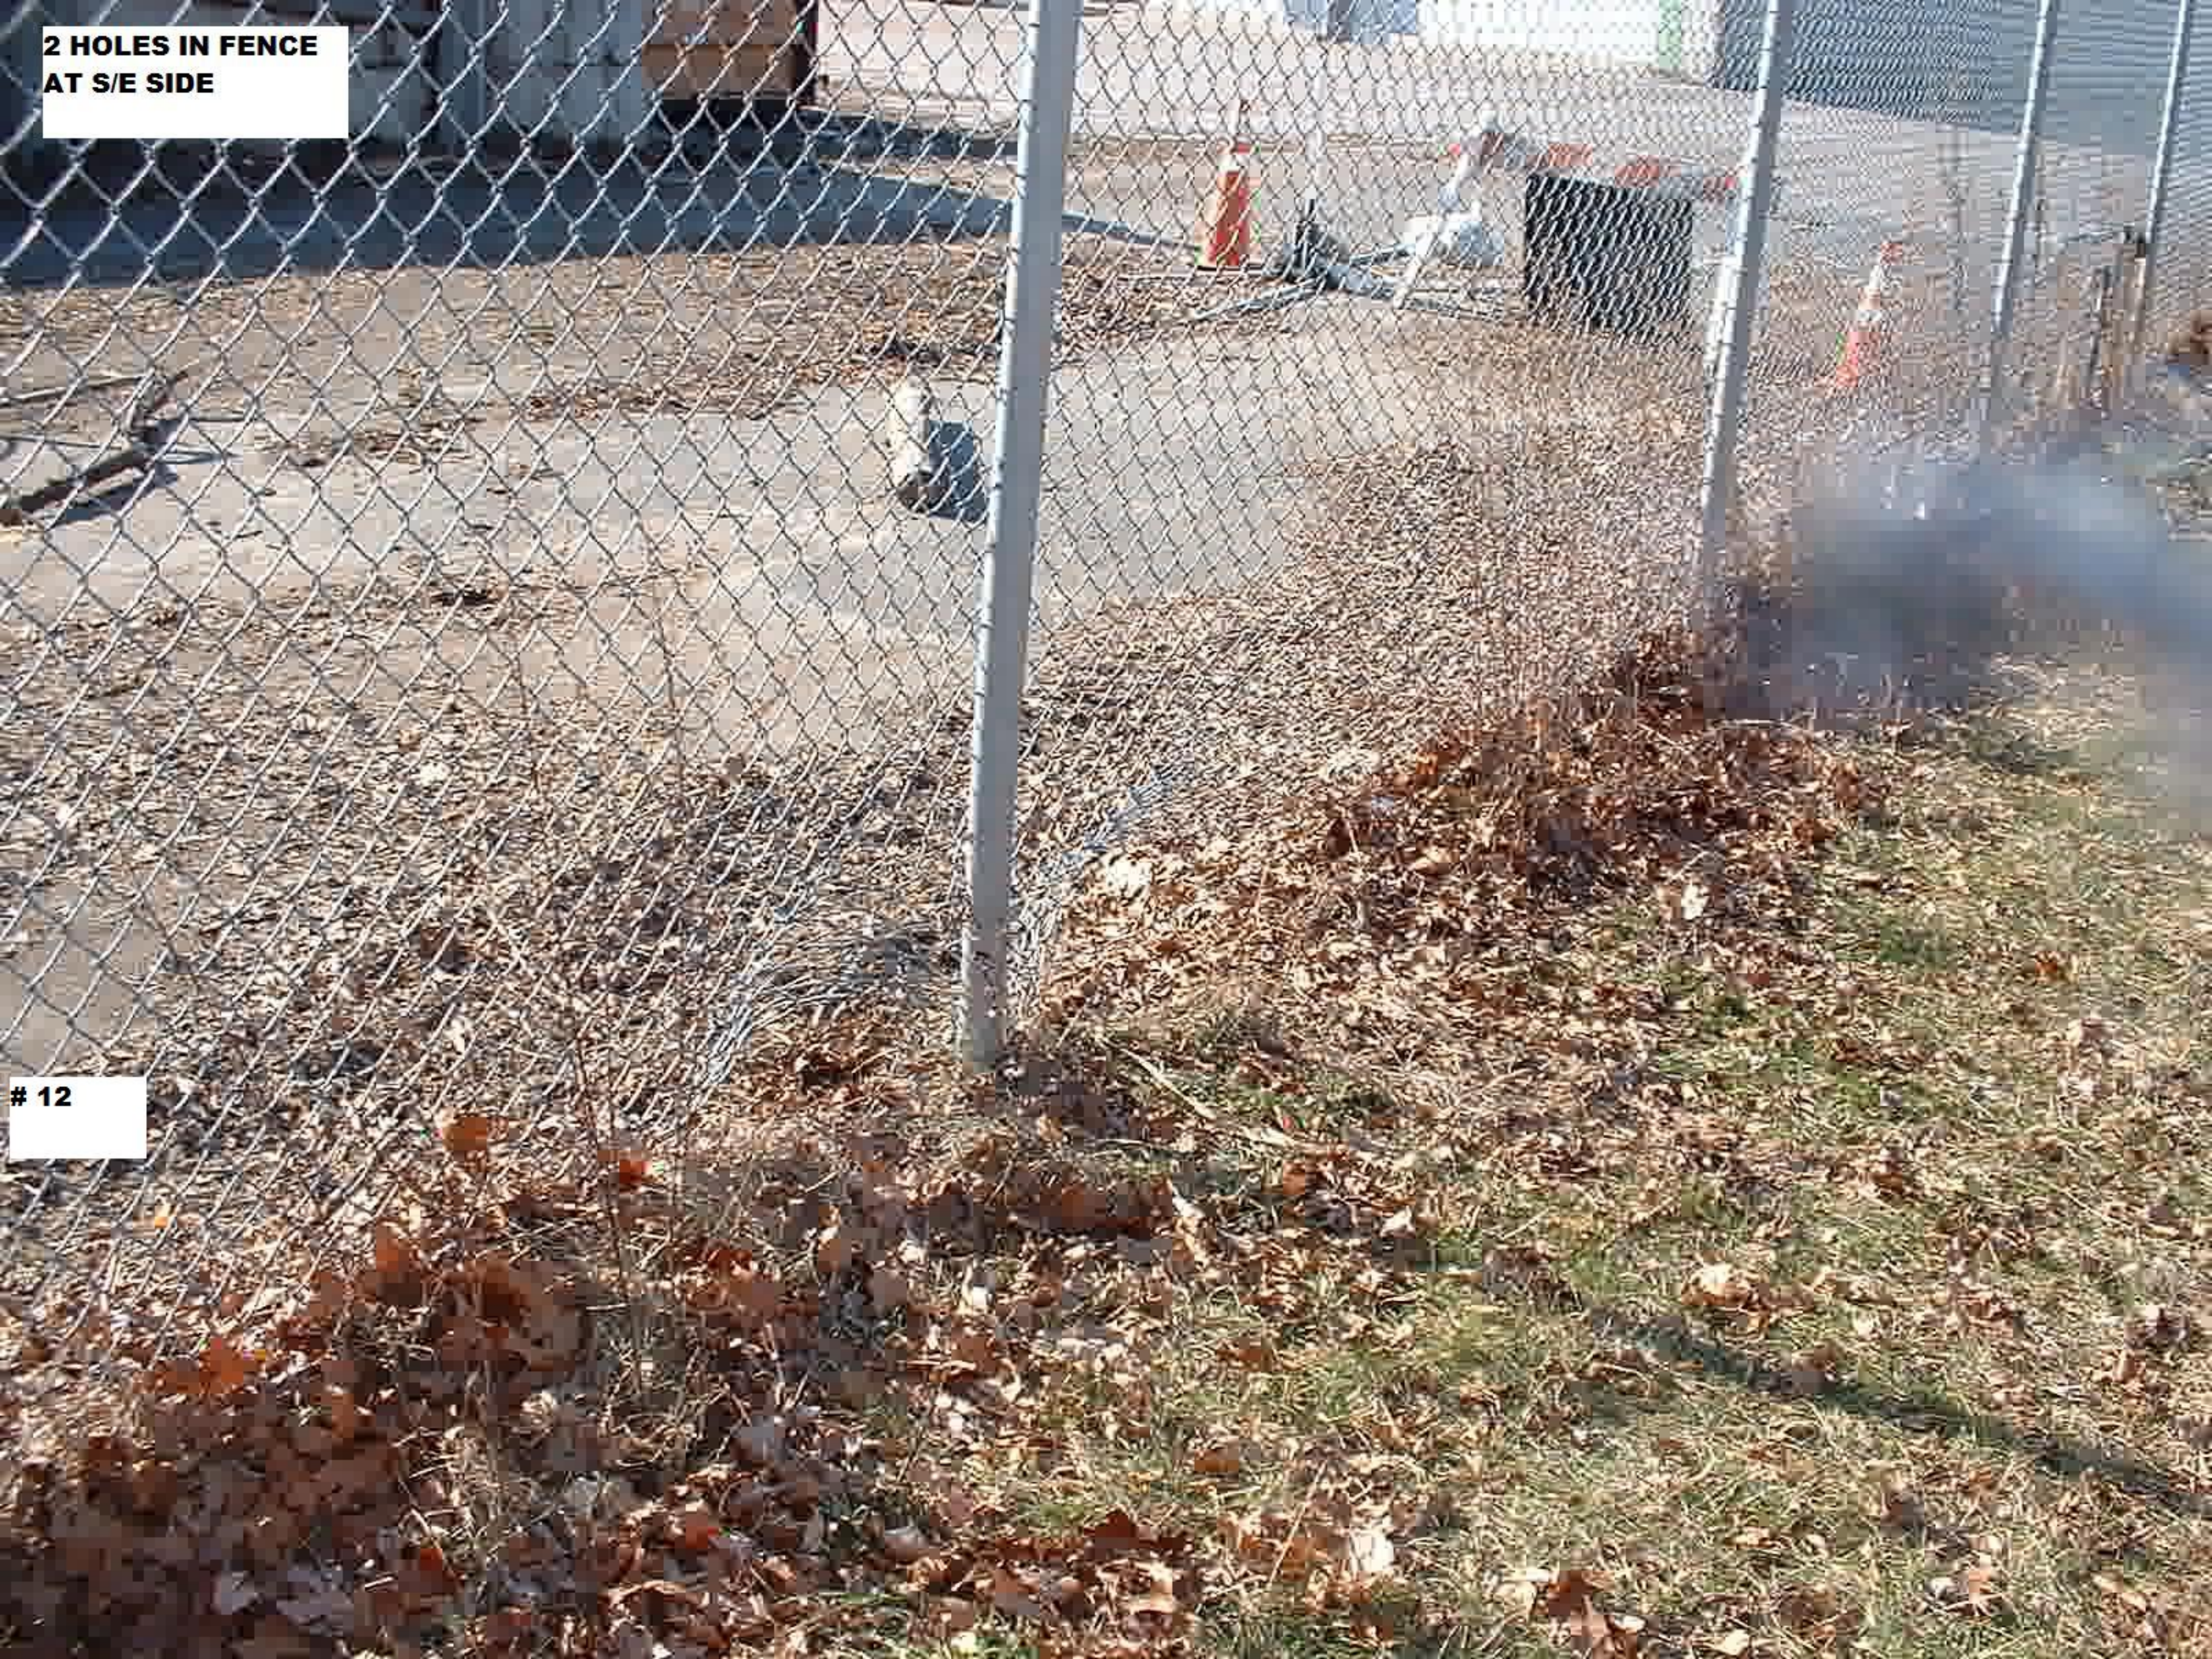
12

**2 HOLES IN FENCE
AT S/E SIDE**

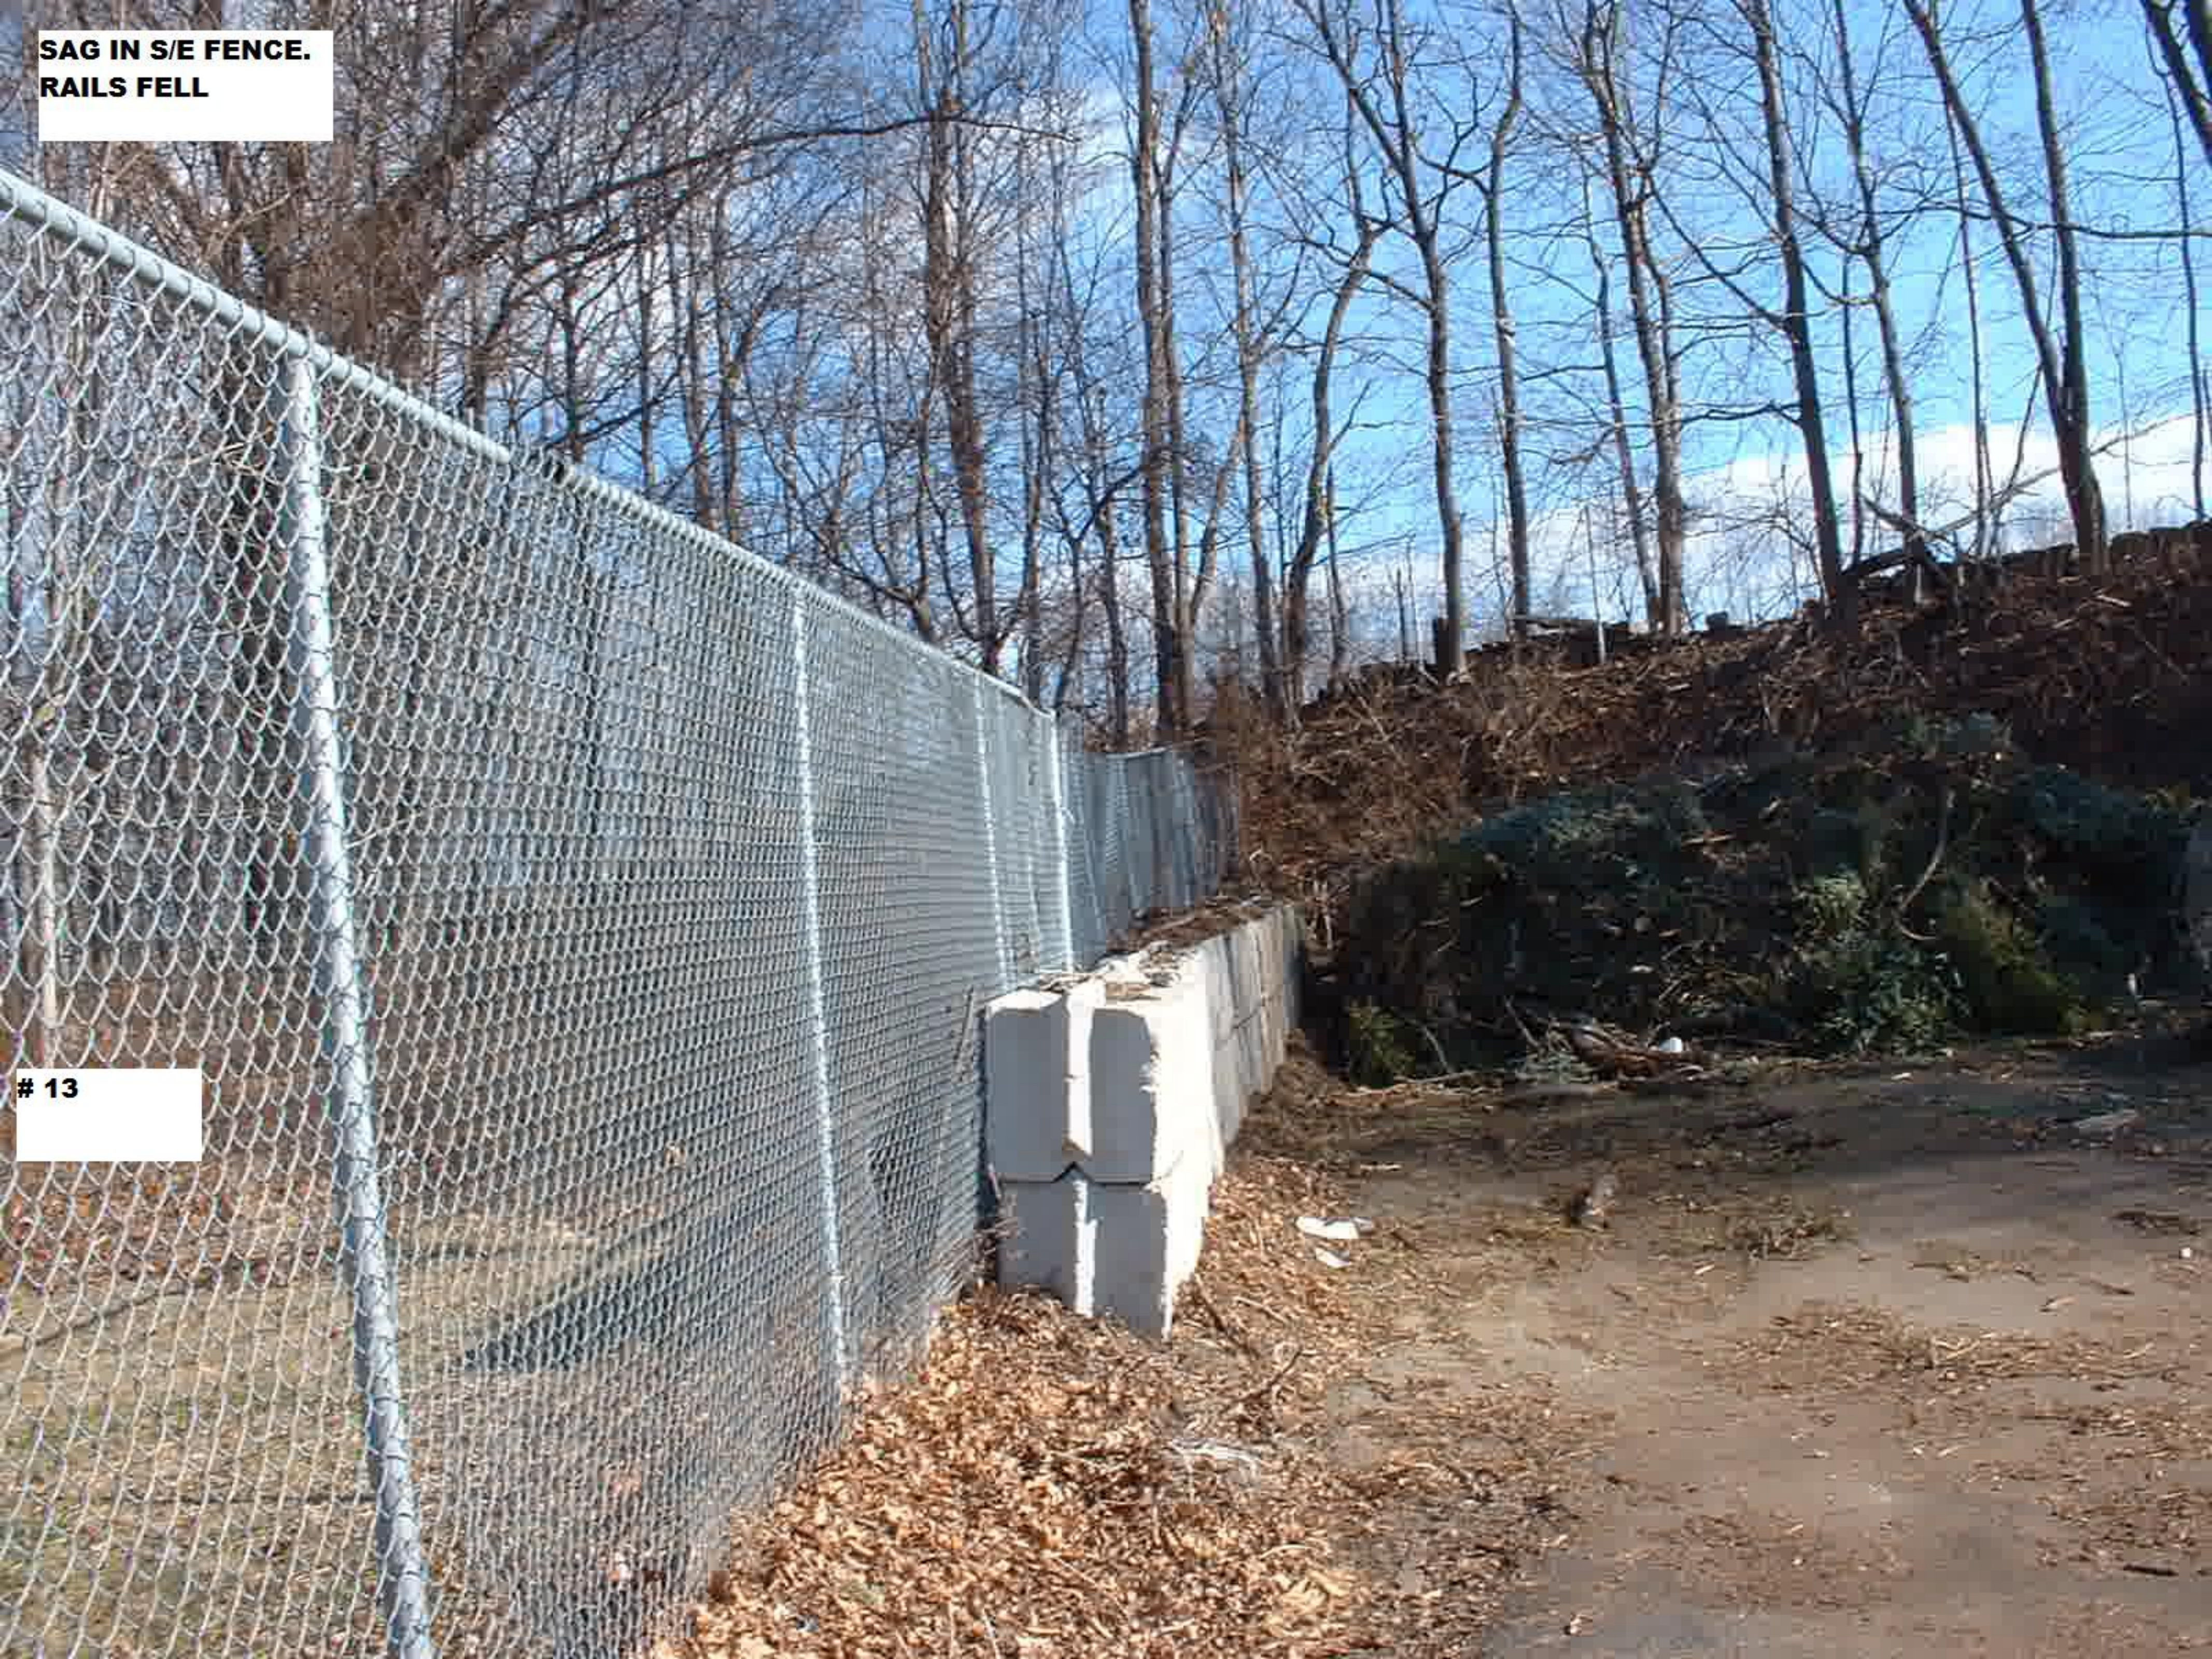
13

**SAG IN S/E FENCE.
RAILS FELL**

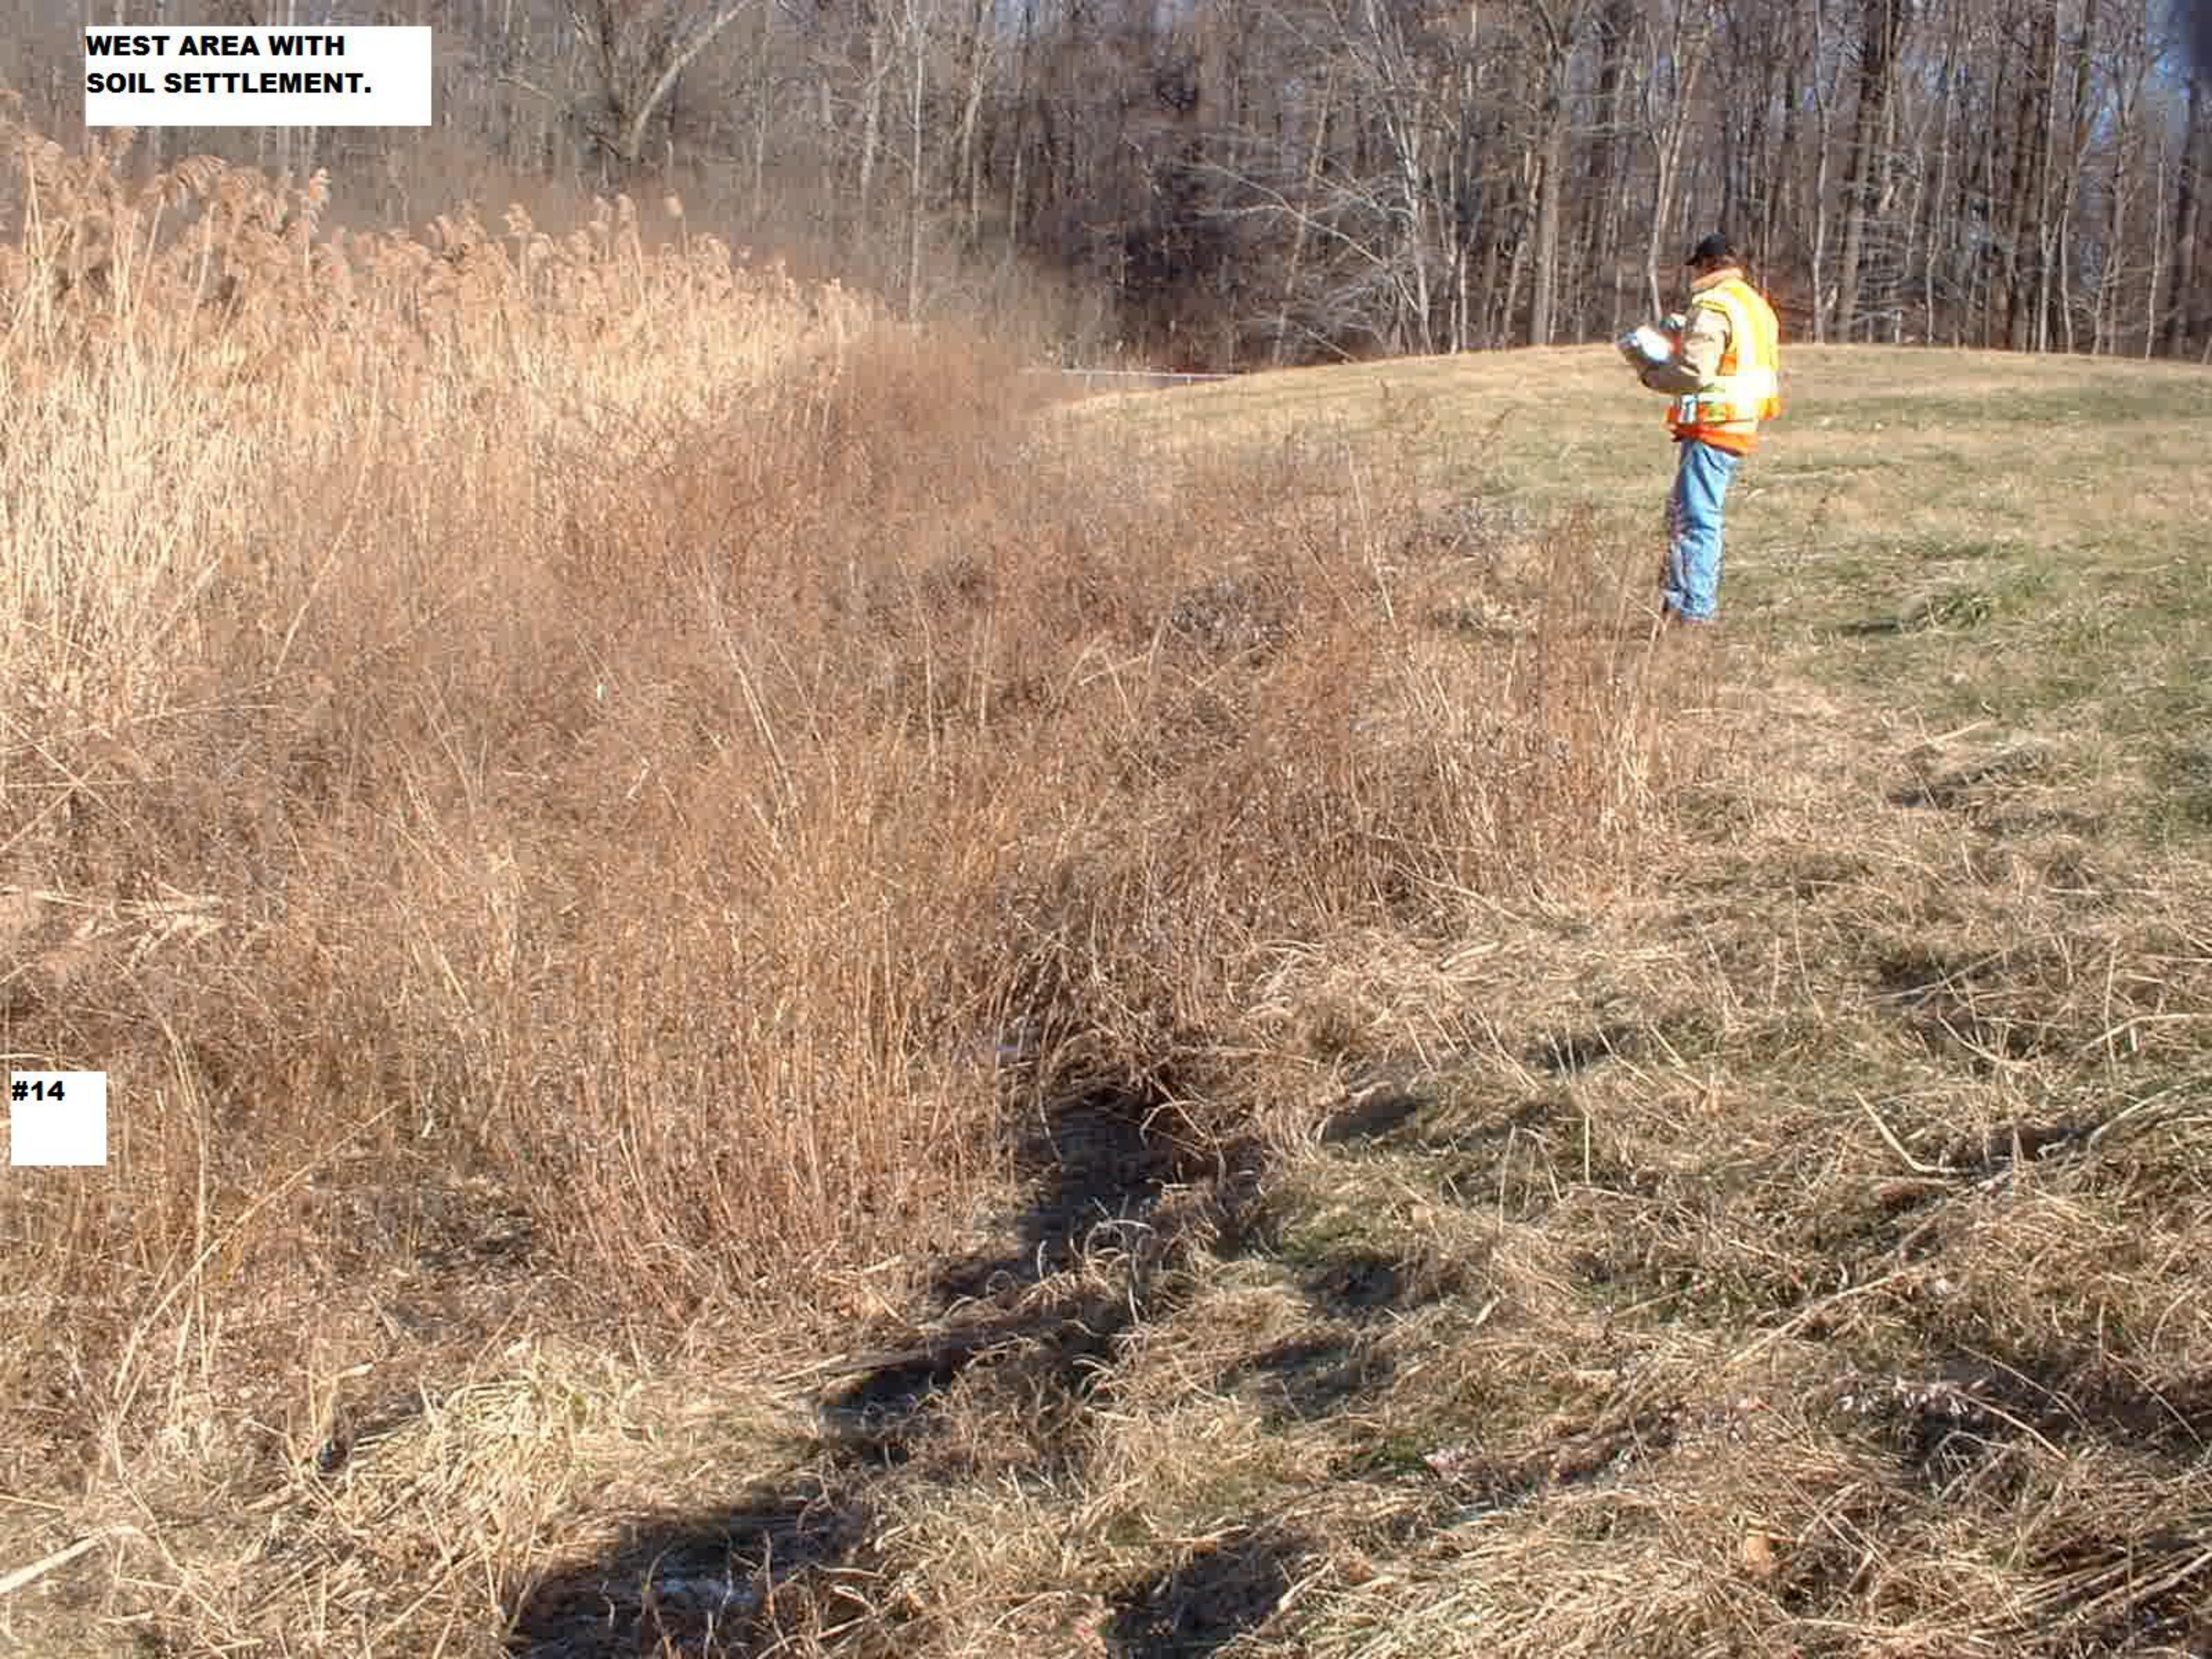
#14

2. Soil slump on west side. See Picture # 14

**WEST AREA WITH
SOIL SETTLEMENT.**
