HARRISON SUB-RESIDENCY FIELD INSPECTION

Name of Inspector: Chris Kappeller and Val Basil

Date: 10/30/07

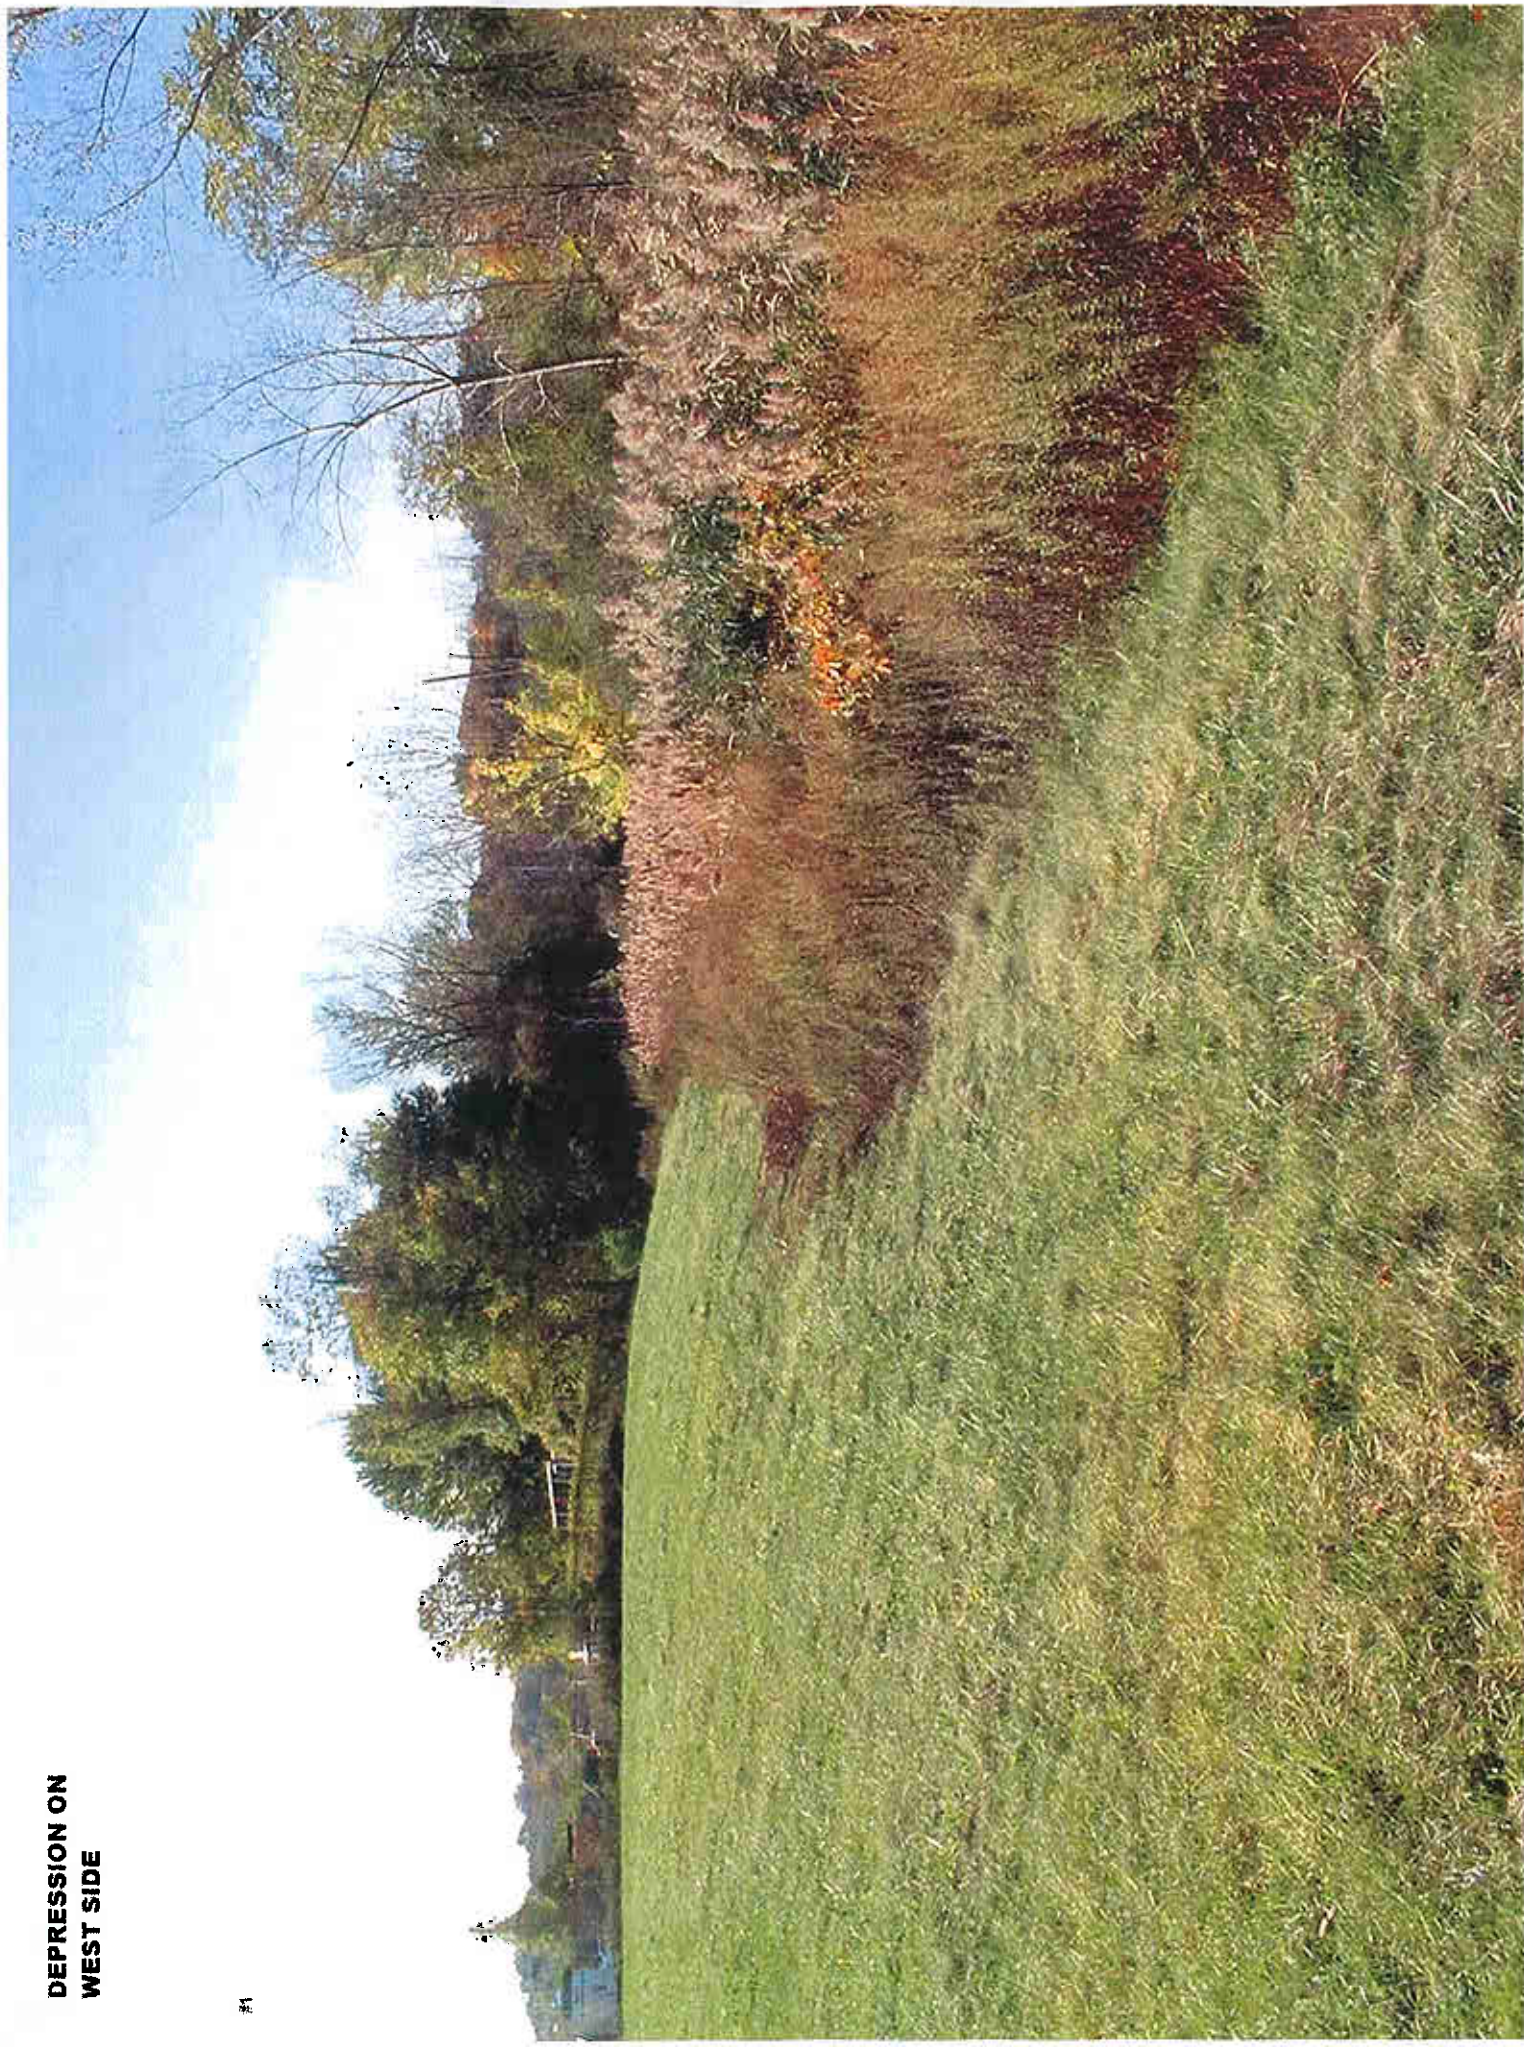
#1

1. Vegetation short. See Pictures # 13-15
2. Soil slump on west side. See Pictures # 1&2

DEPRESSION ON
WEST SIDE

1. Fence needs to be repaired at the NE section. This should be done by HDR/LMS or their contractor.
2. Soil slump area on the west side of the landfill will need some soil and a vegetated mat to prevent any further erosion. This may be repaired in-house by Region 8's Geotechnical Group. If not, then the contractor hired by HDR/LMS will be asked to do this.
3. The fence on the southeast side was repaired by NYSDOT and Town of Harrison. The concrete blocks were moved away from the fence and no longer place pressure on it (Picture #4).
4. Well risers in the land fill area were marked with their ID with a paint marker for easier identification.

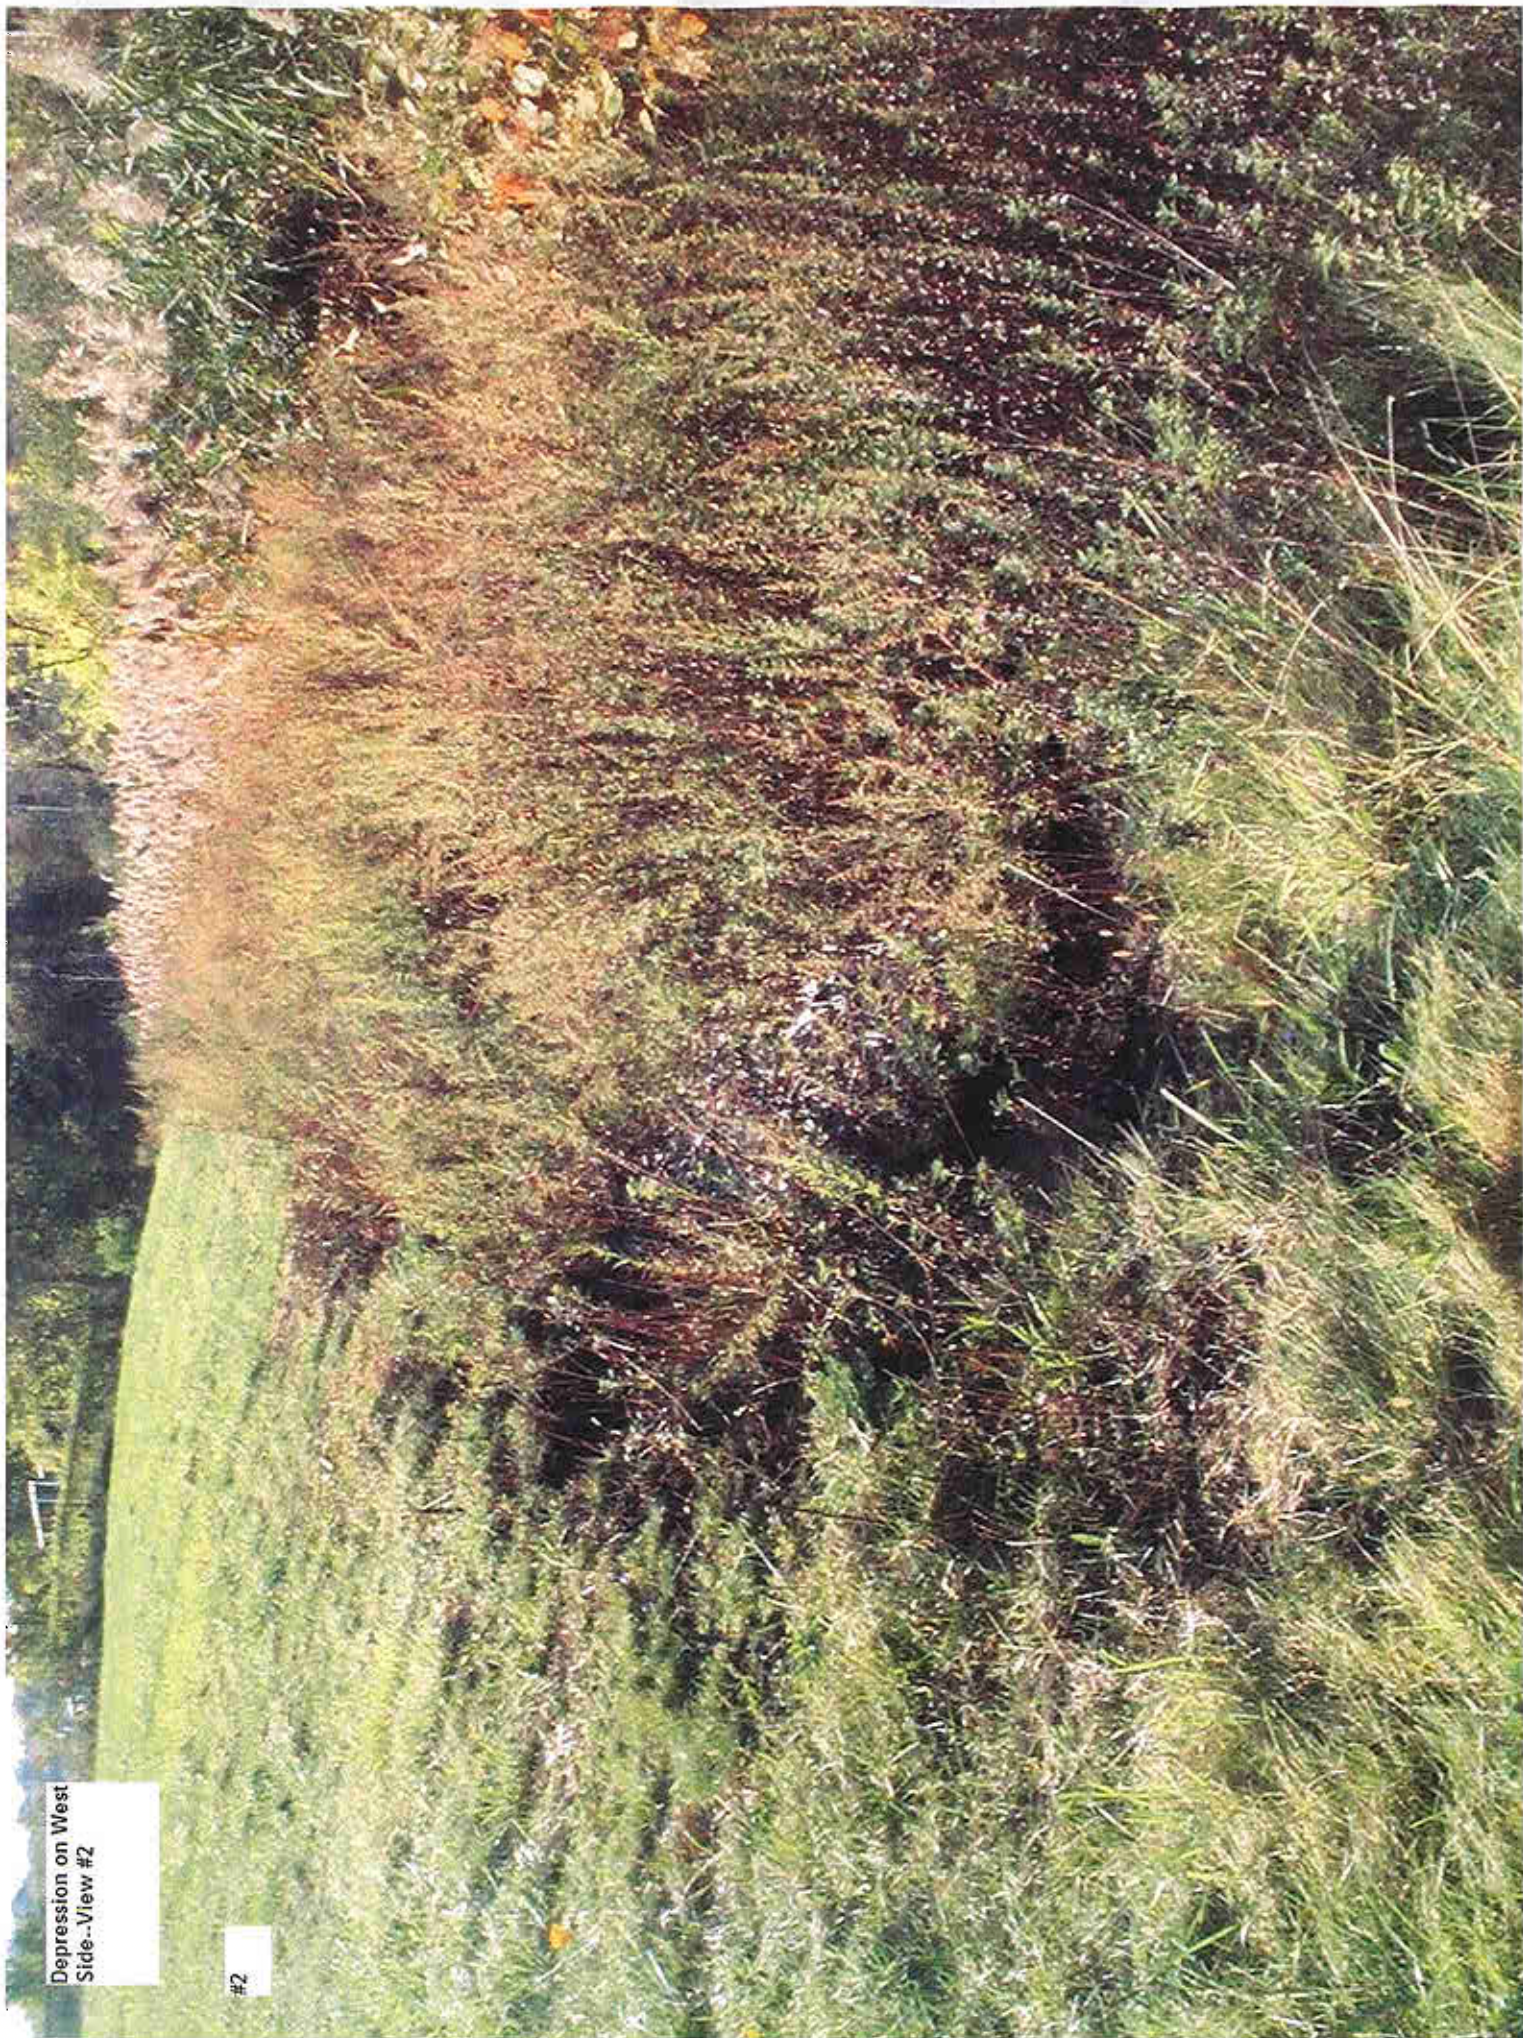
Depression on West
Side--View #2

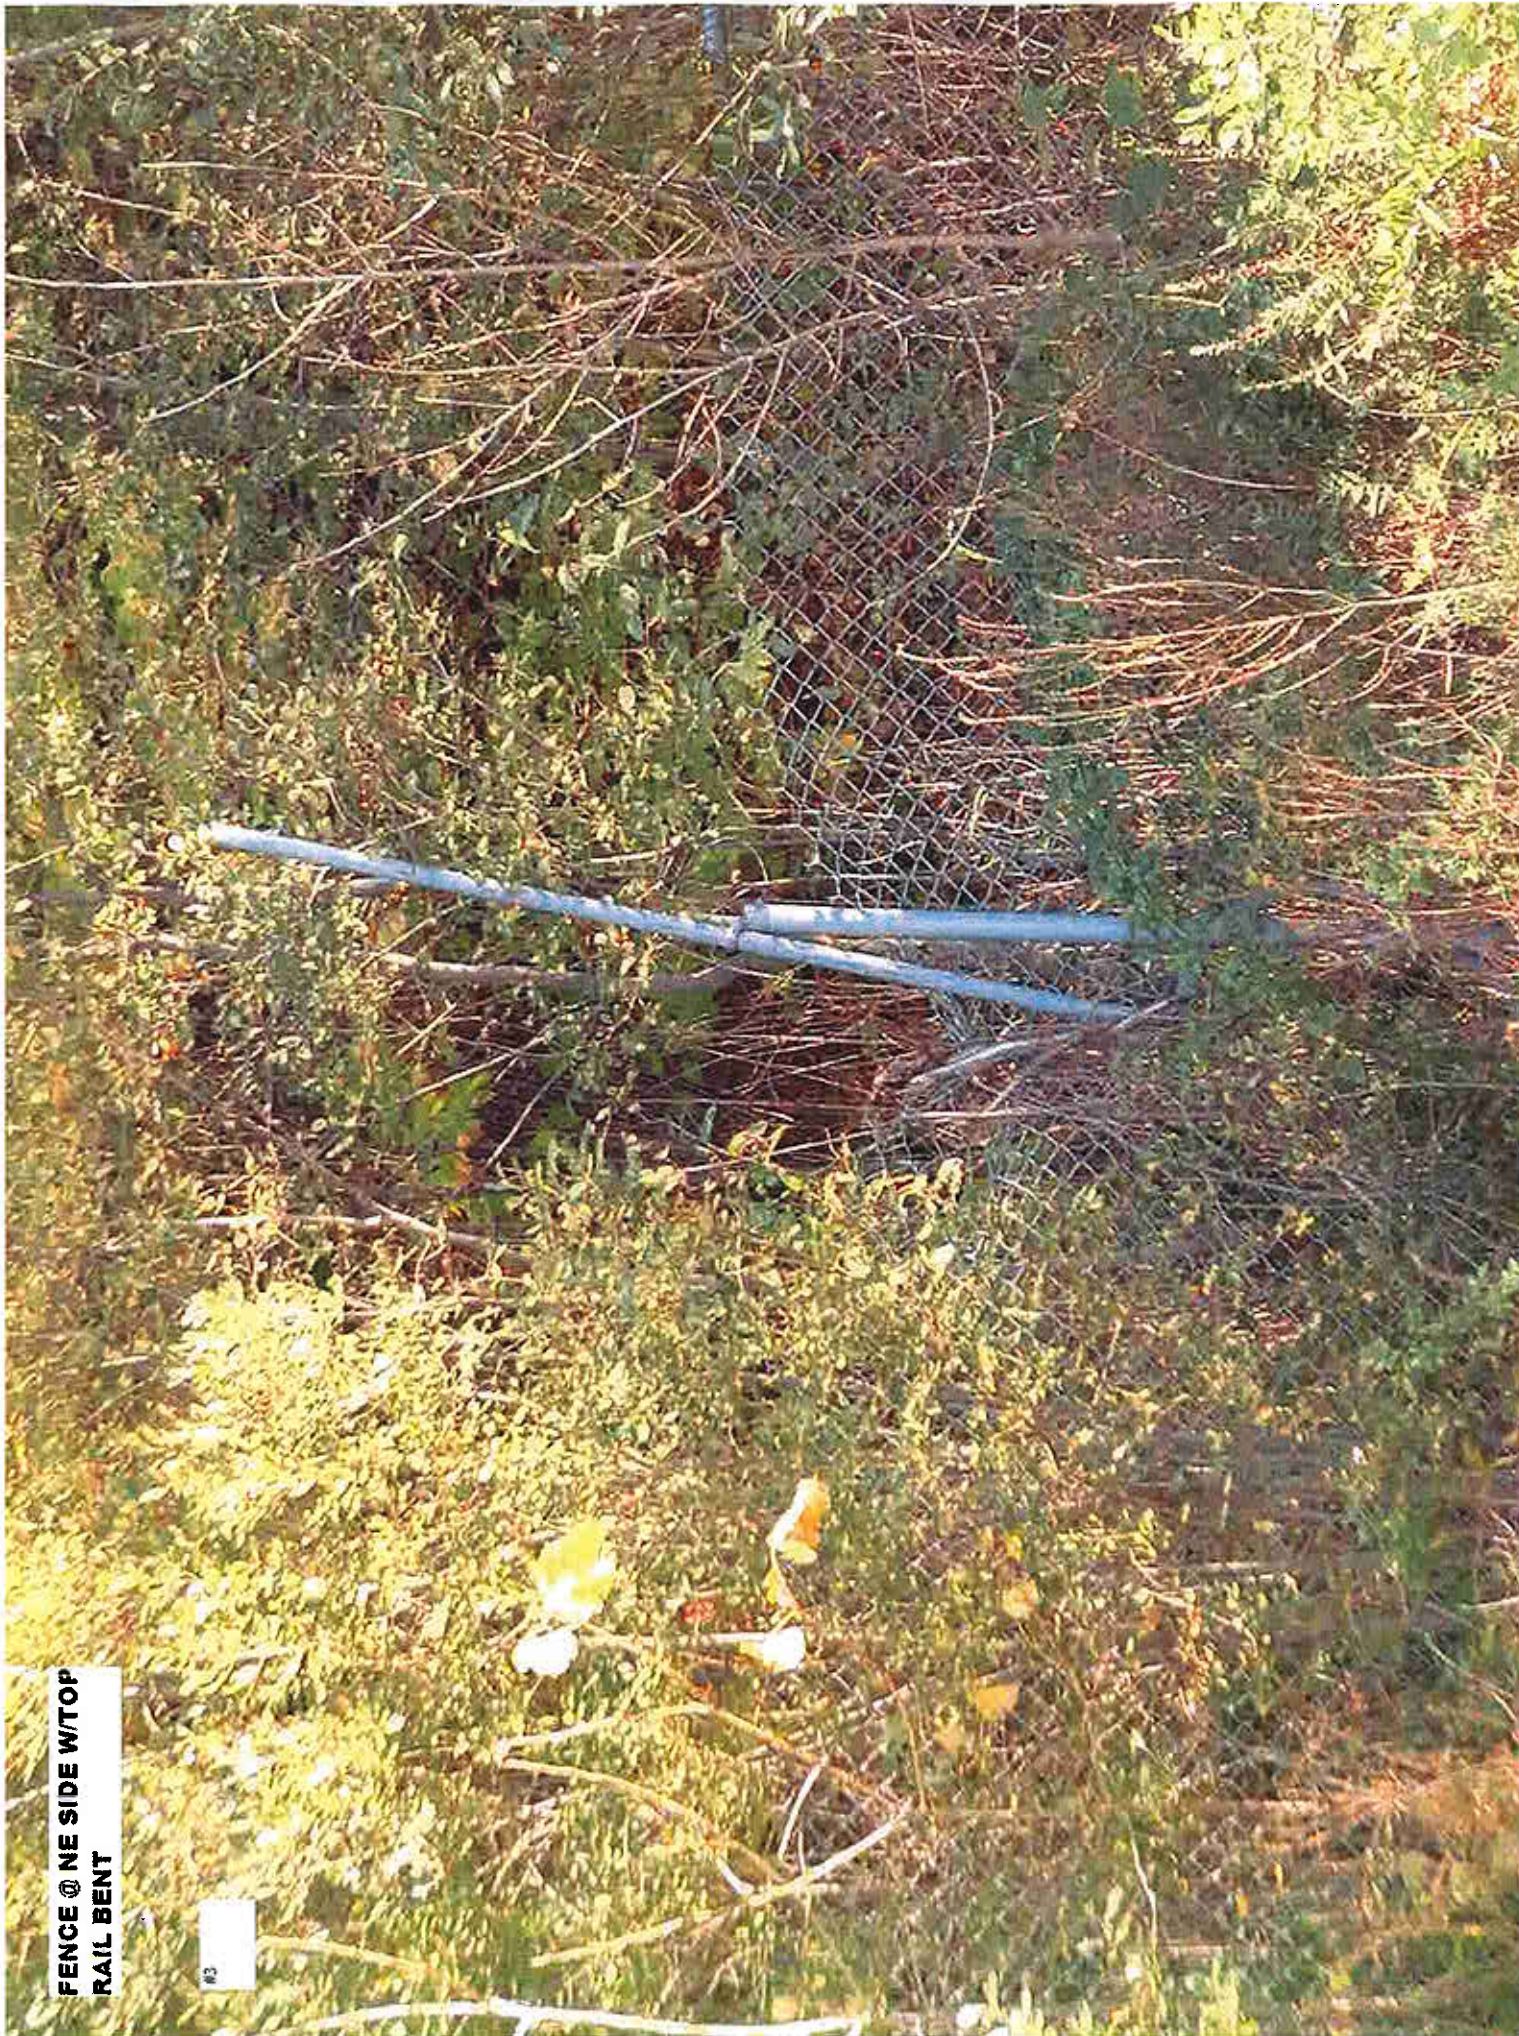
#3

Fence has a section of its top rail bent and dislodged on the N/E side by a fallen branch. See Picture # 3 attached. The fence at the northeast side of the landfill near the stream inlet to the site is also missing the top bar but the fence is still functional. At this location, a 10"-12" gap exists between the bottom of the fence and the base of the stream which allows unrestricted flow of the stream around the border of the landfill (see Picture #12).

FENCE @ NE SIDE W/TOP
RAIL BENT

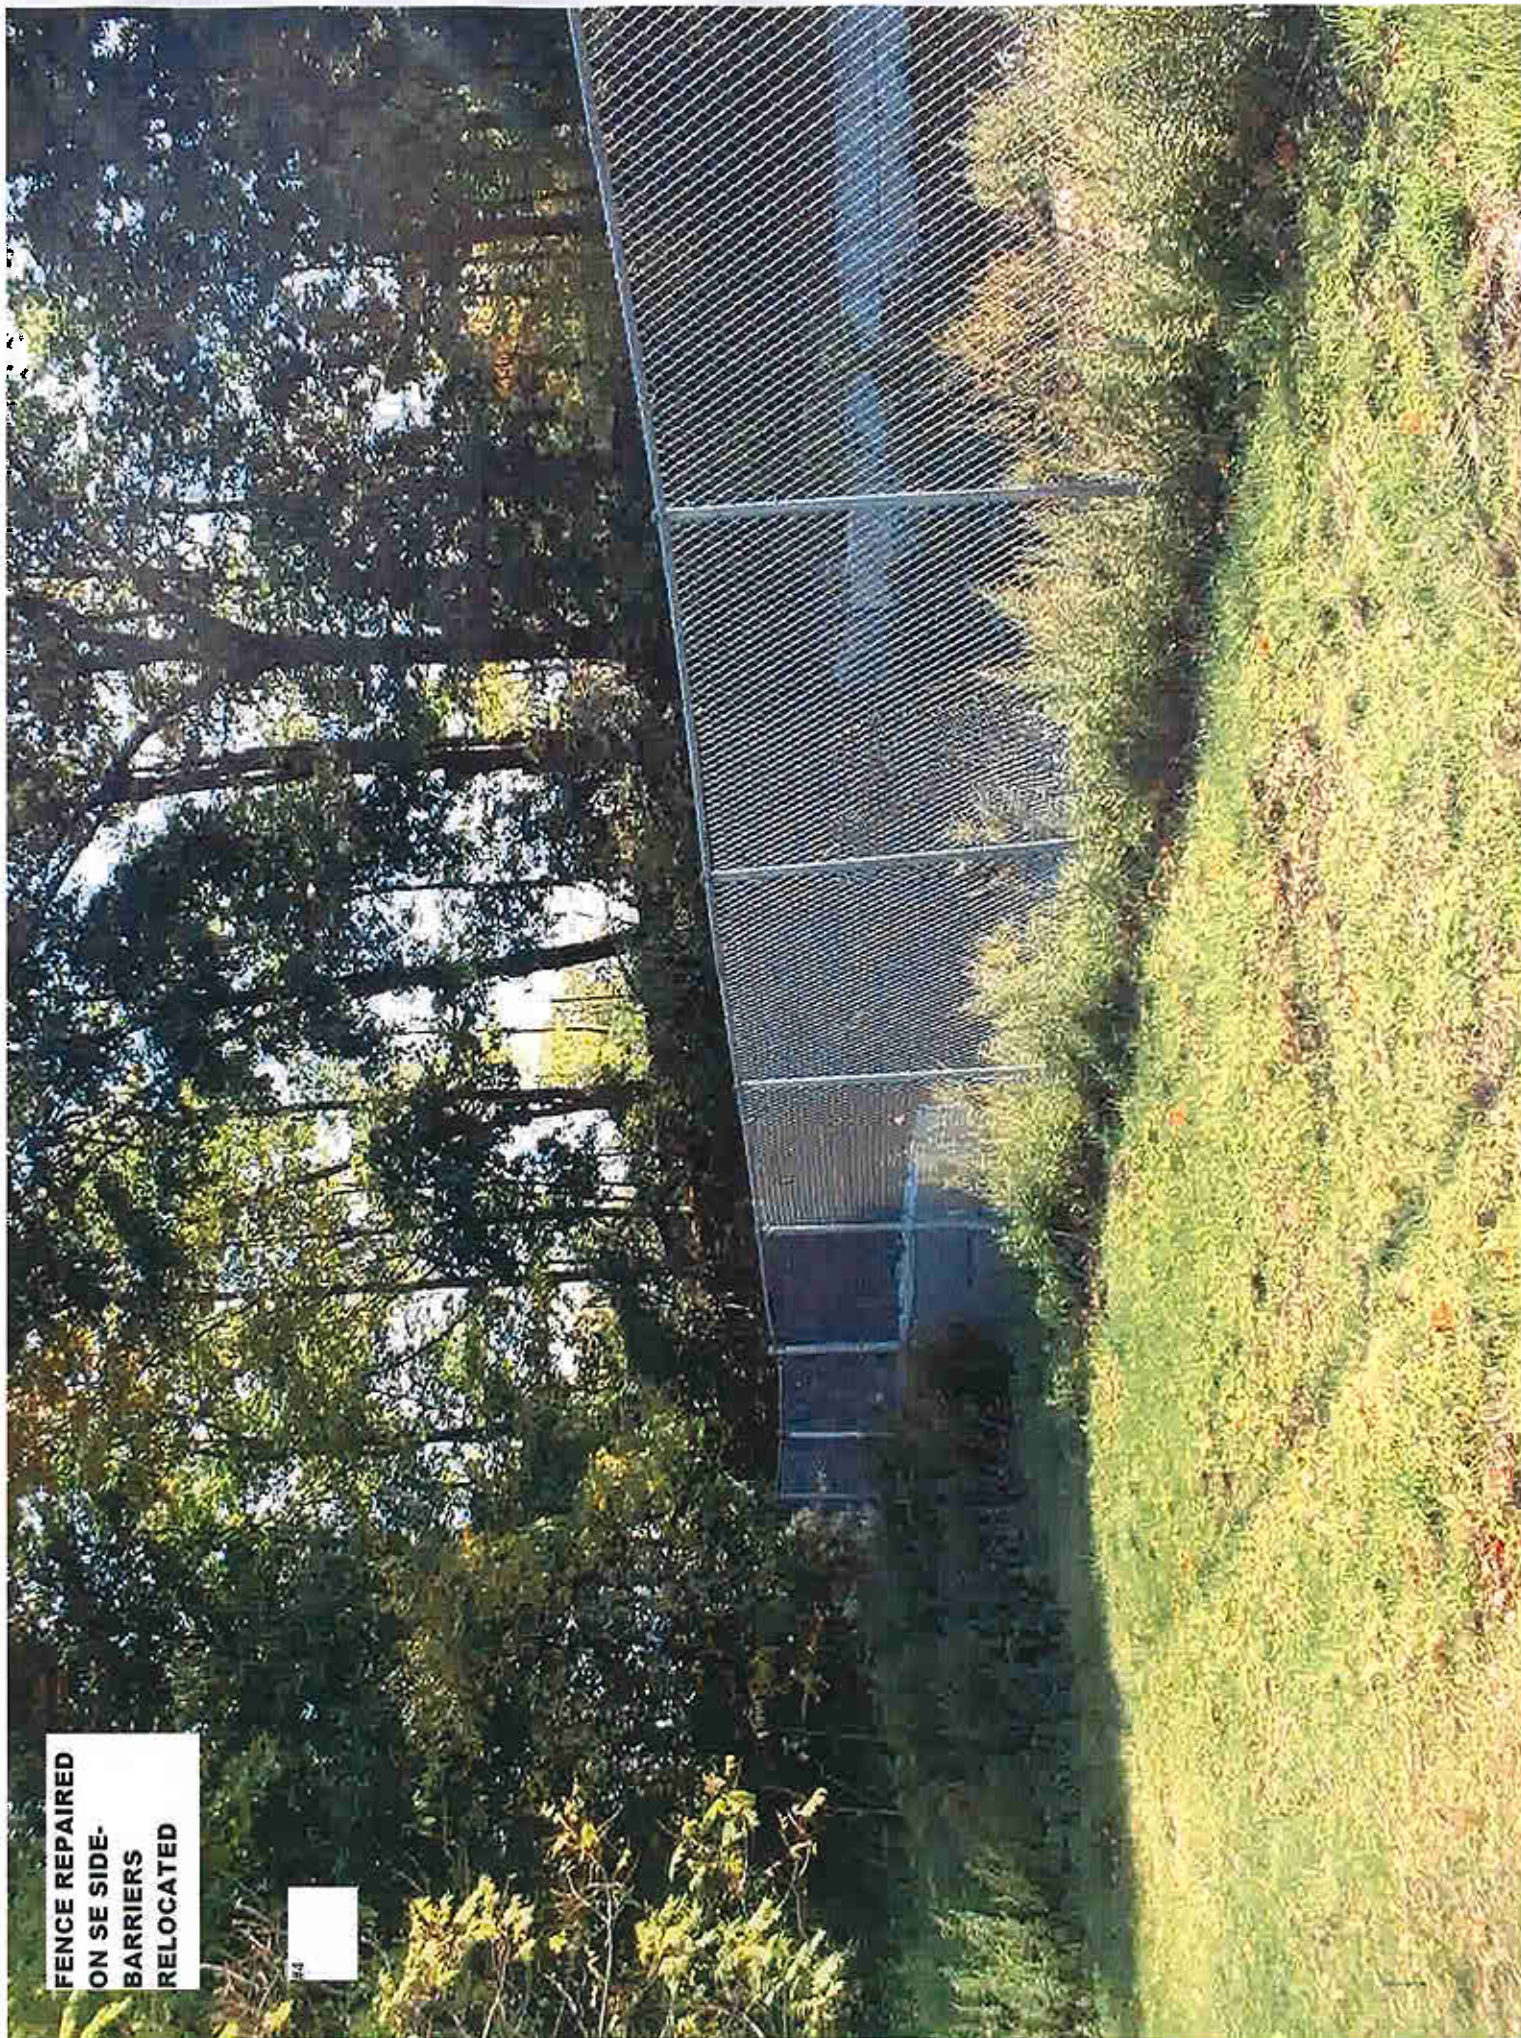
FENCE REPAIRED
ON SE SIDE-
BARRIERS
RELOCATED

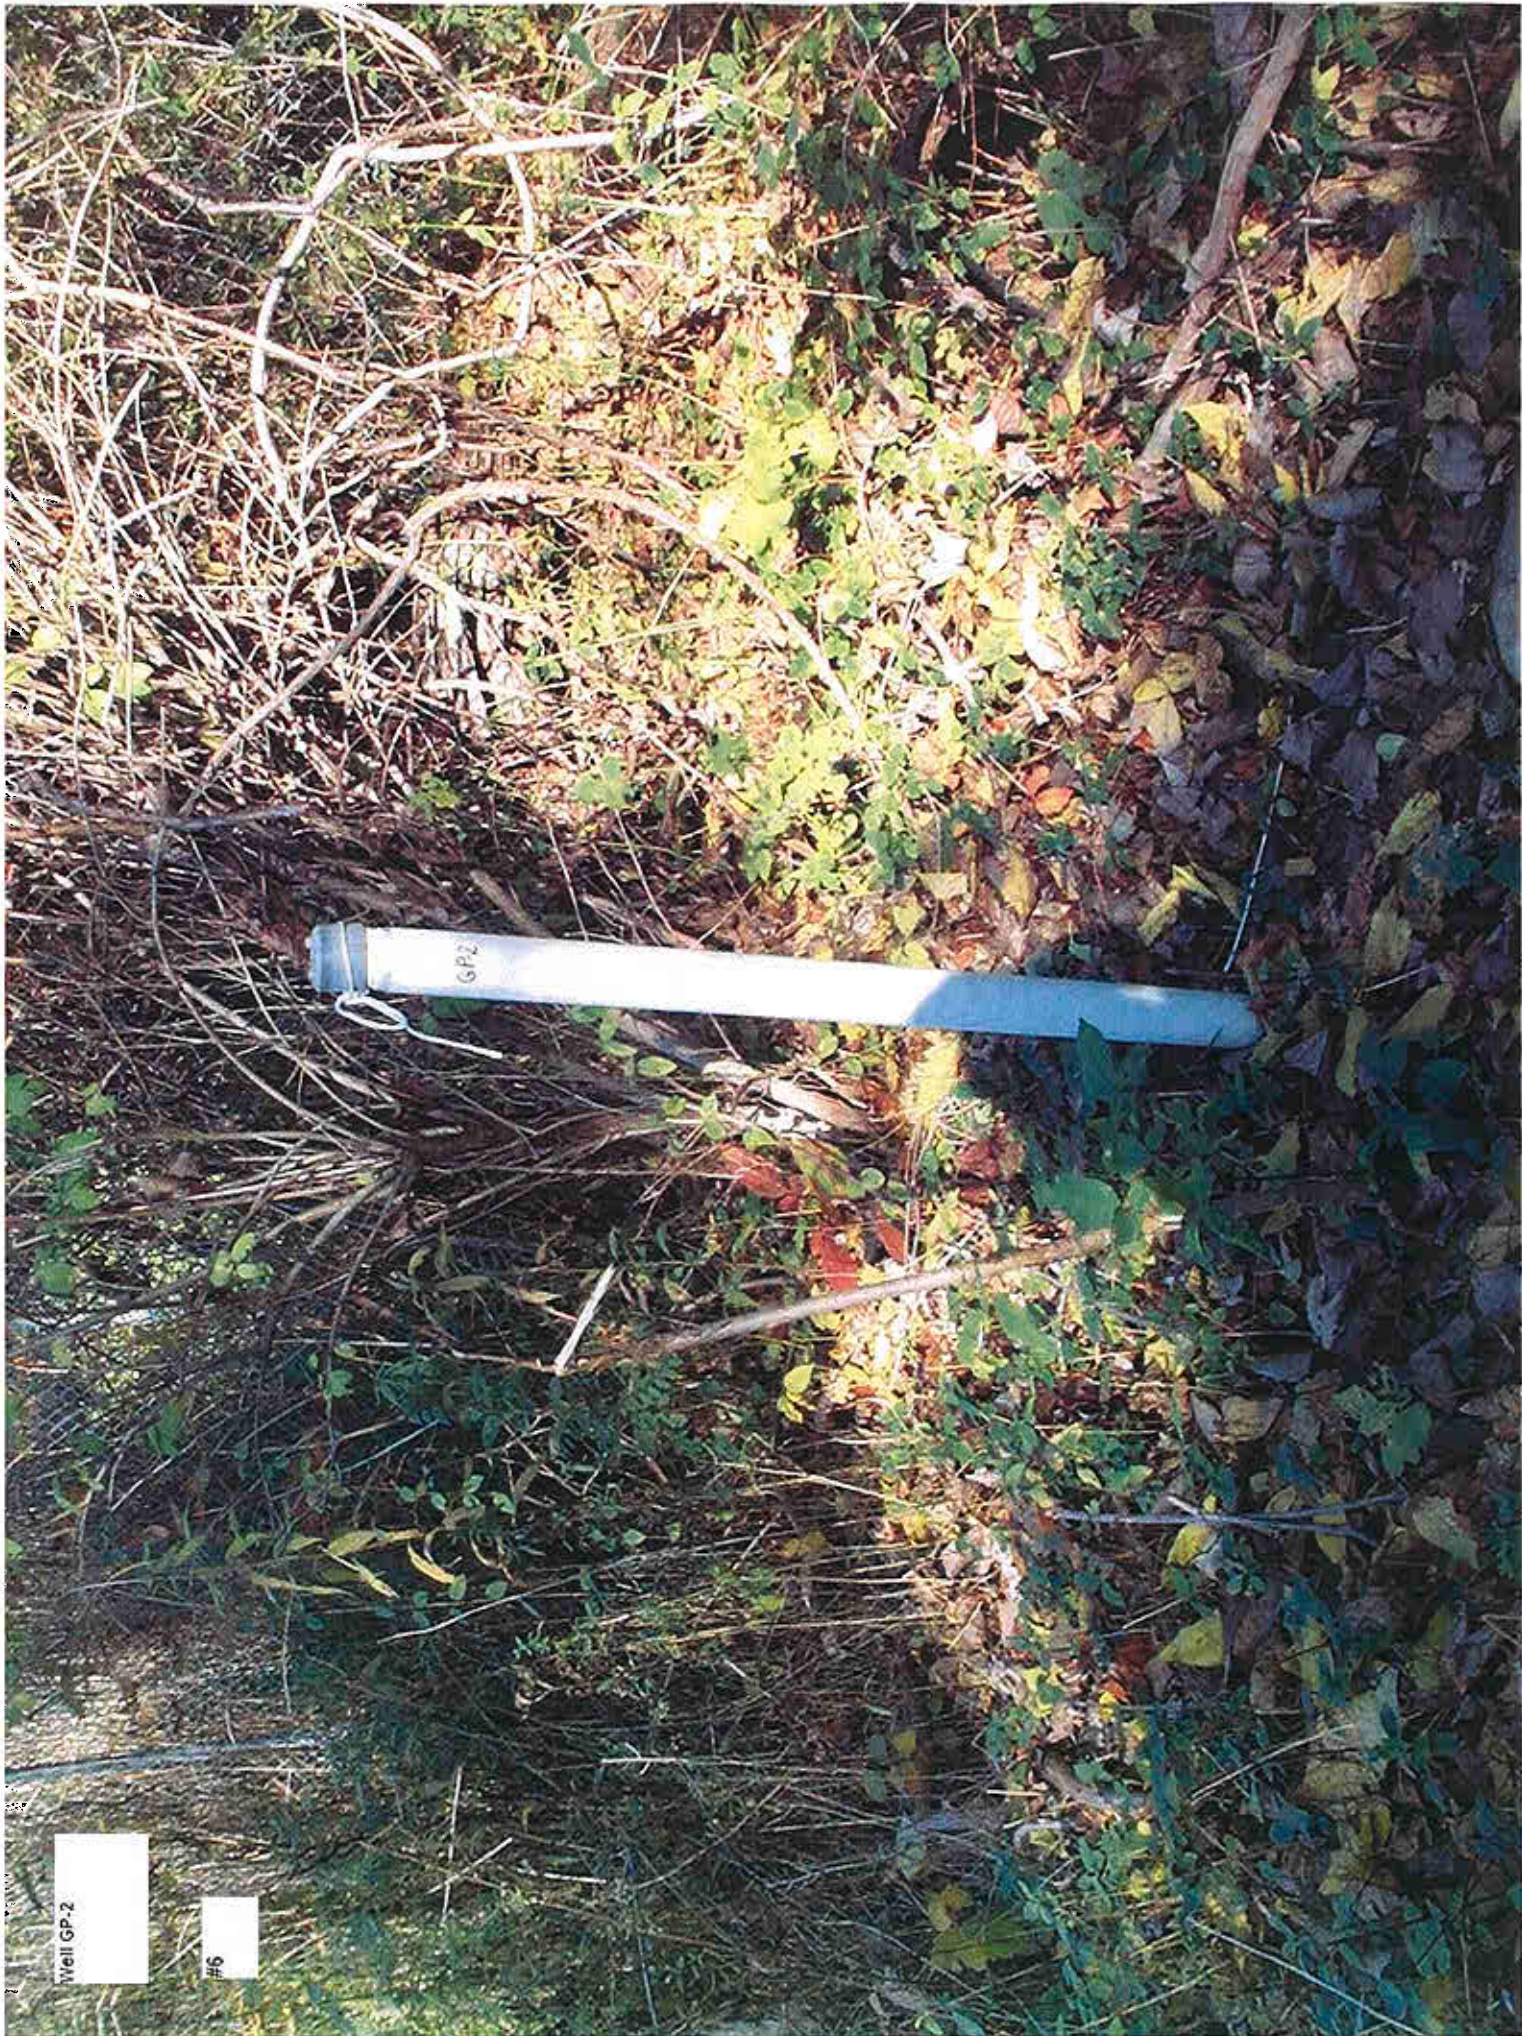
#5

All wells inspected and found to be in good condition. See Pictures # 5-11 and # 13-15 attached.

Well GP-1

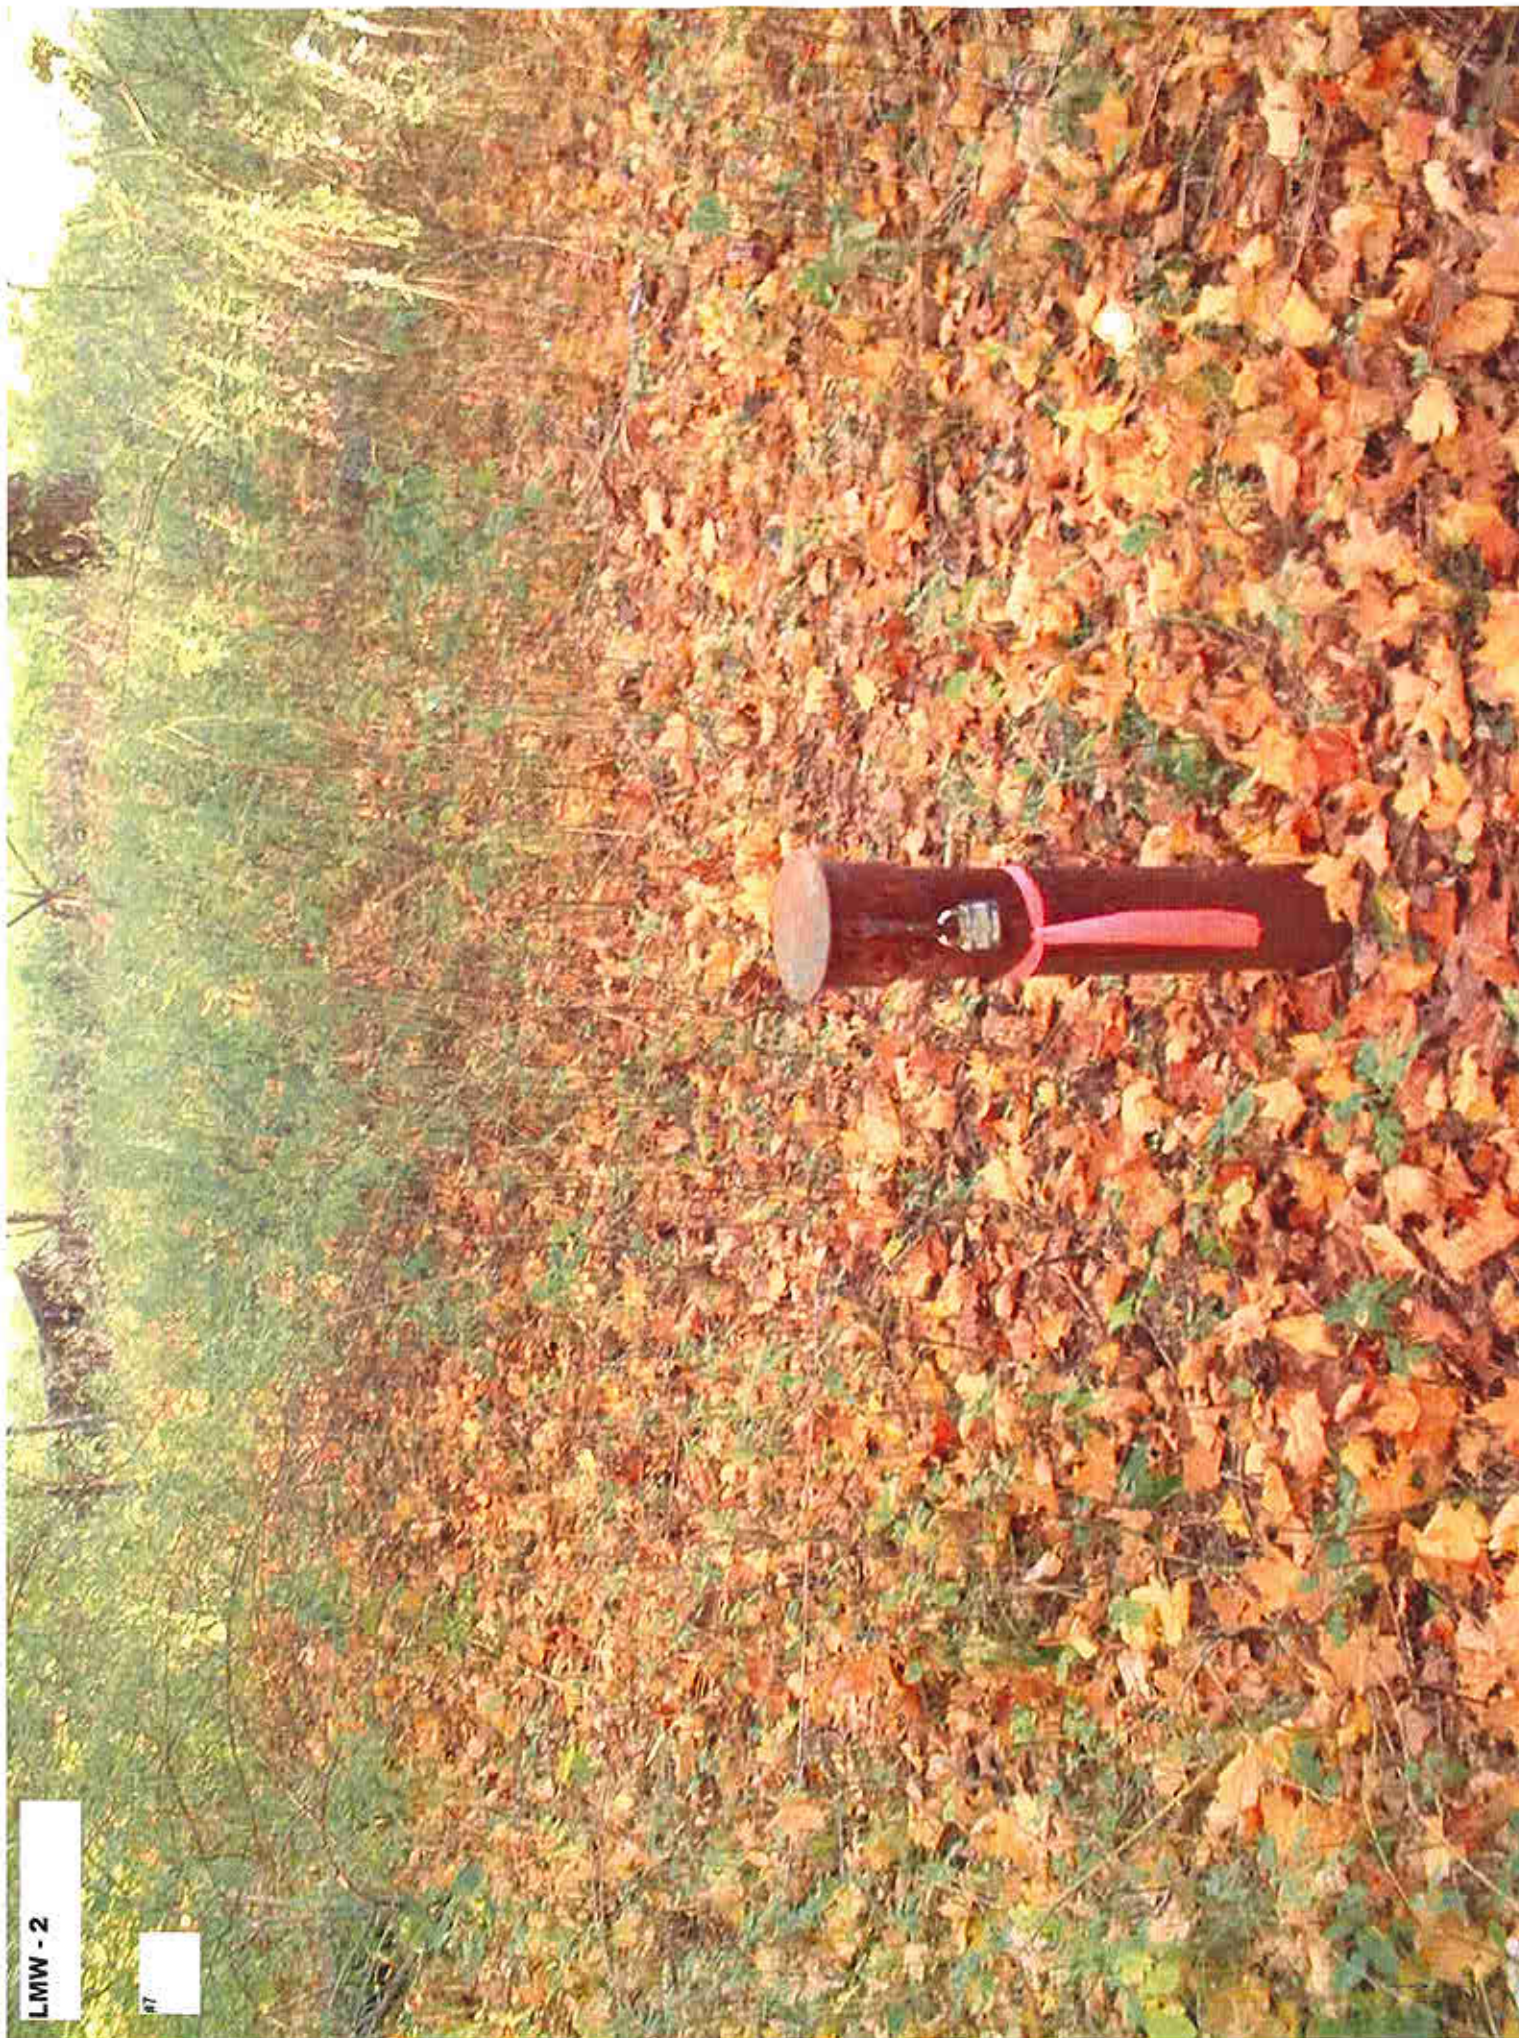
#6

Well GP-2

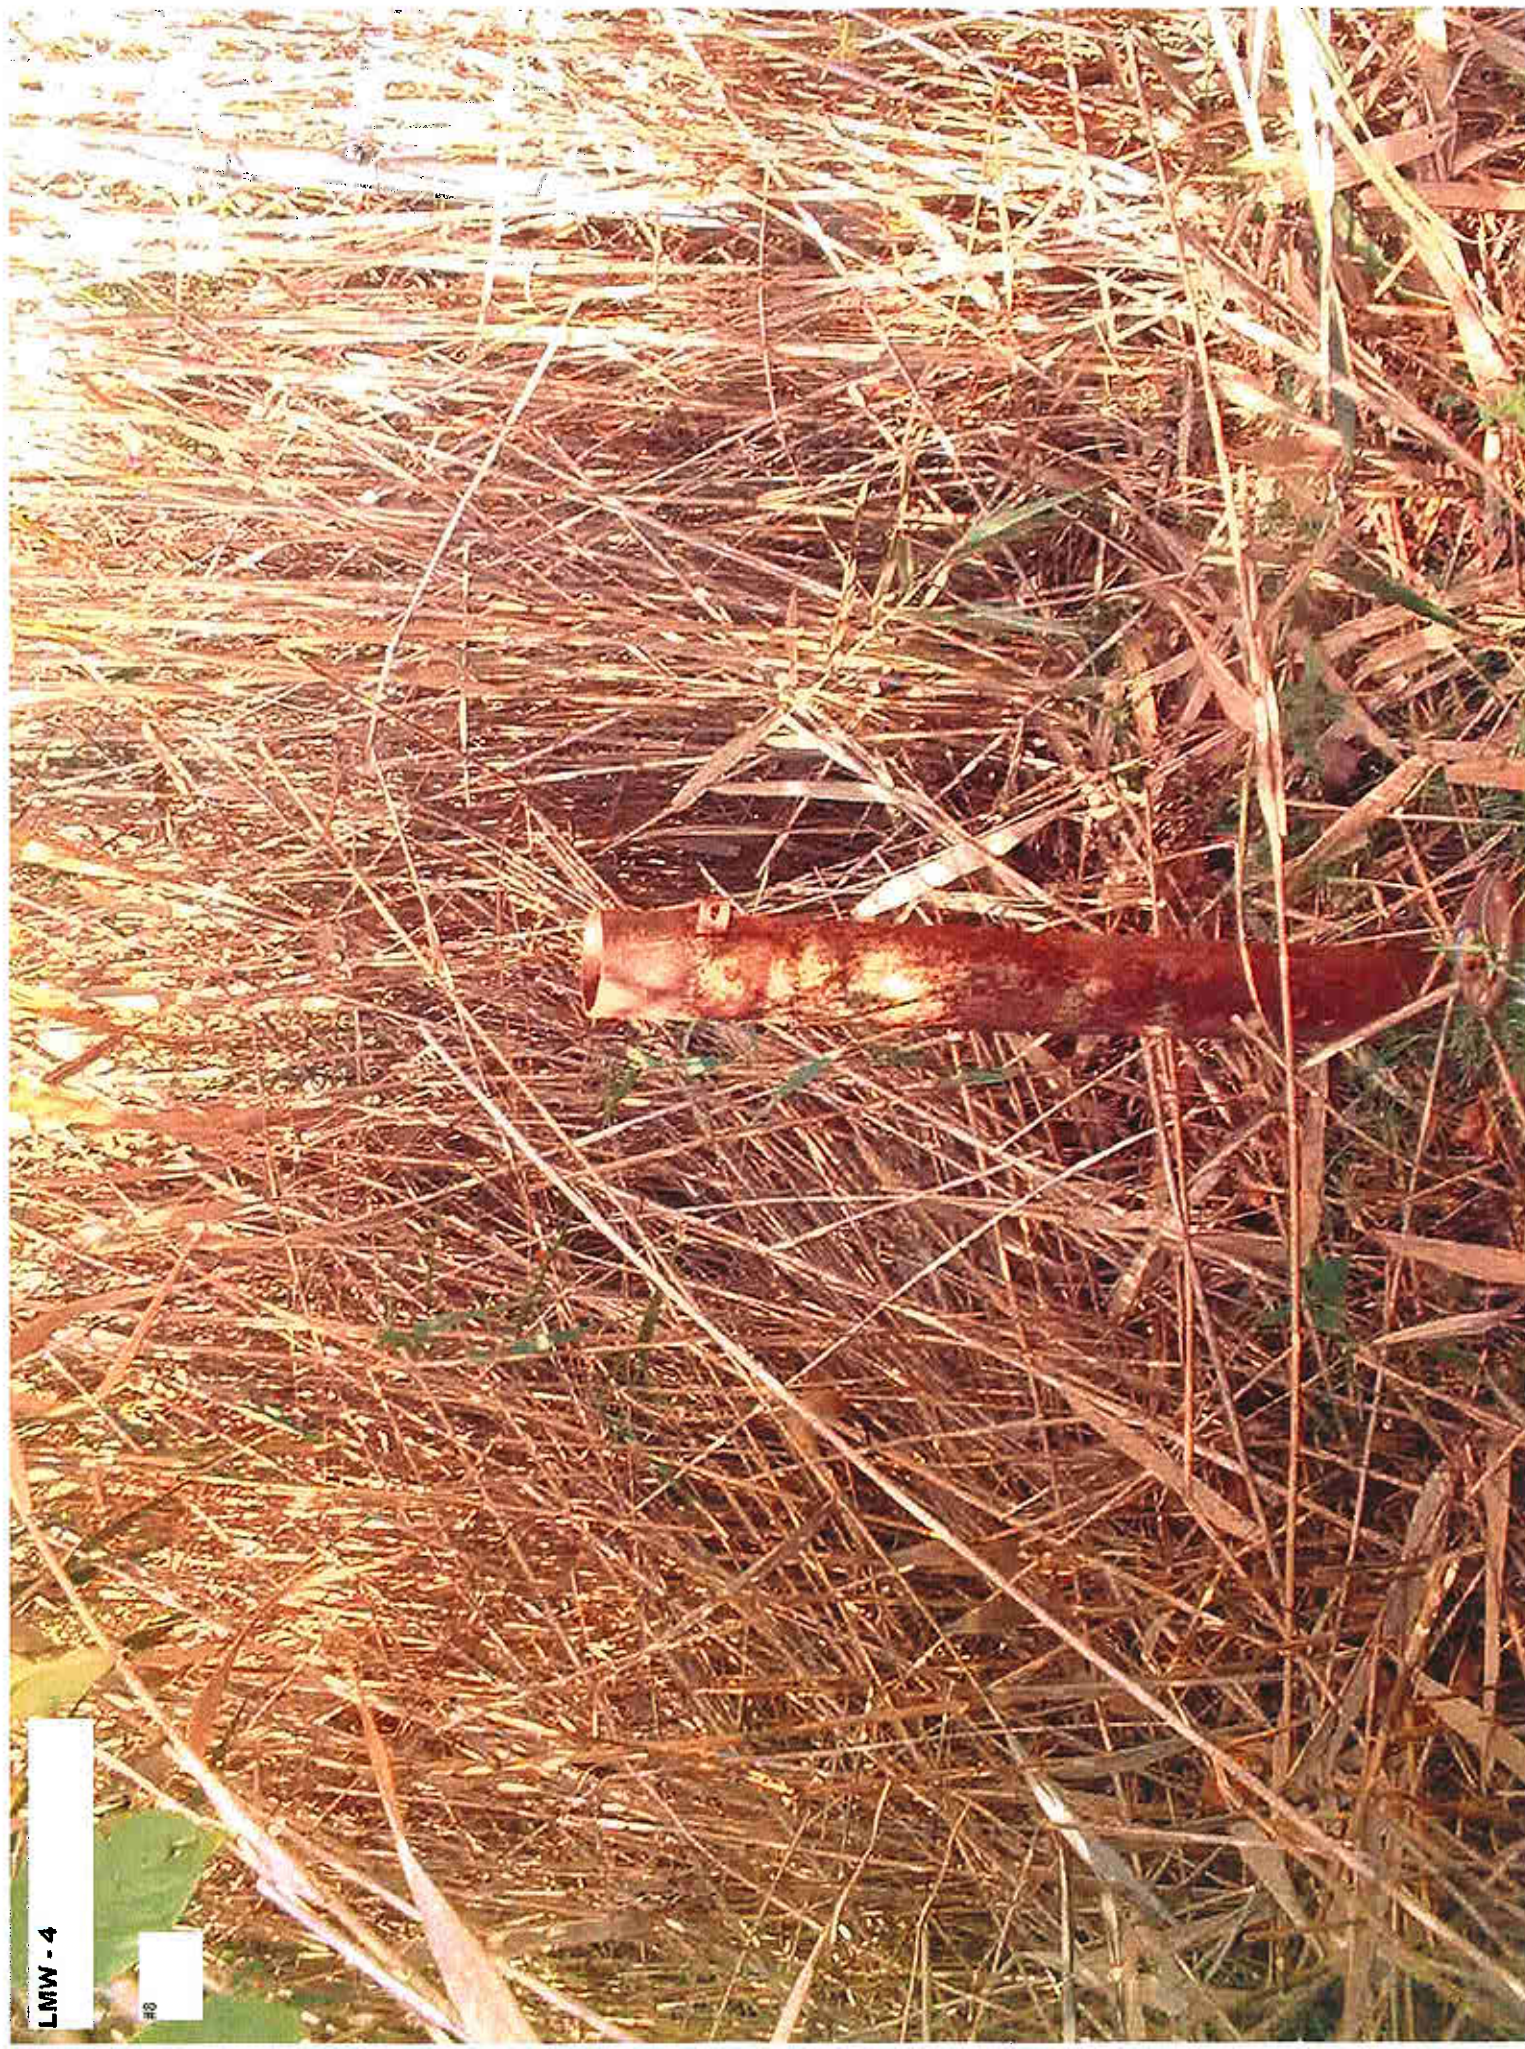
87

LMW - 2
