HARRISON SUB-RESIDENCY FIELD INSPECTION

Name of Inspector: Chris Kappeller and Val Basil

Date: 10/30/07

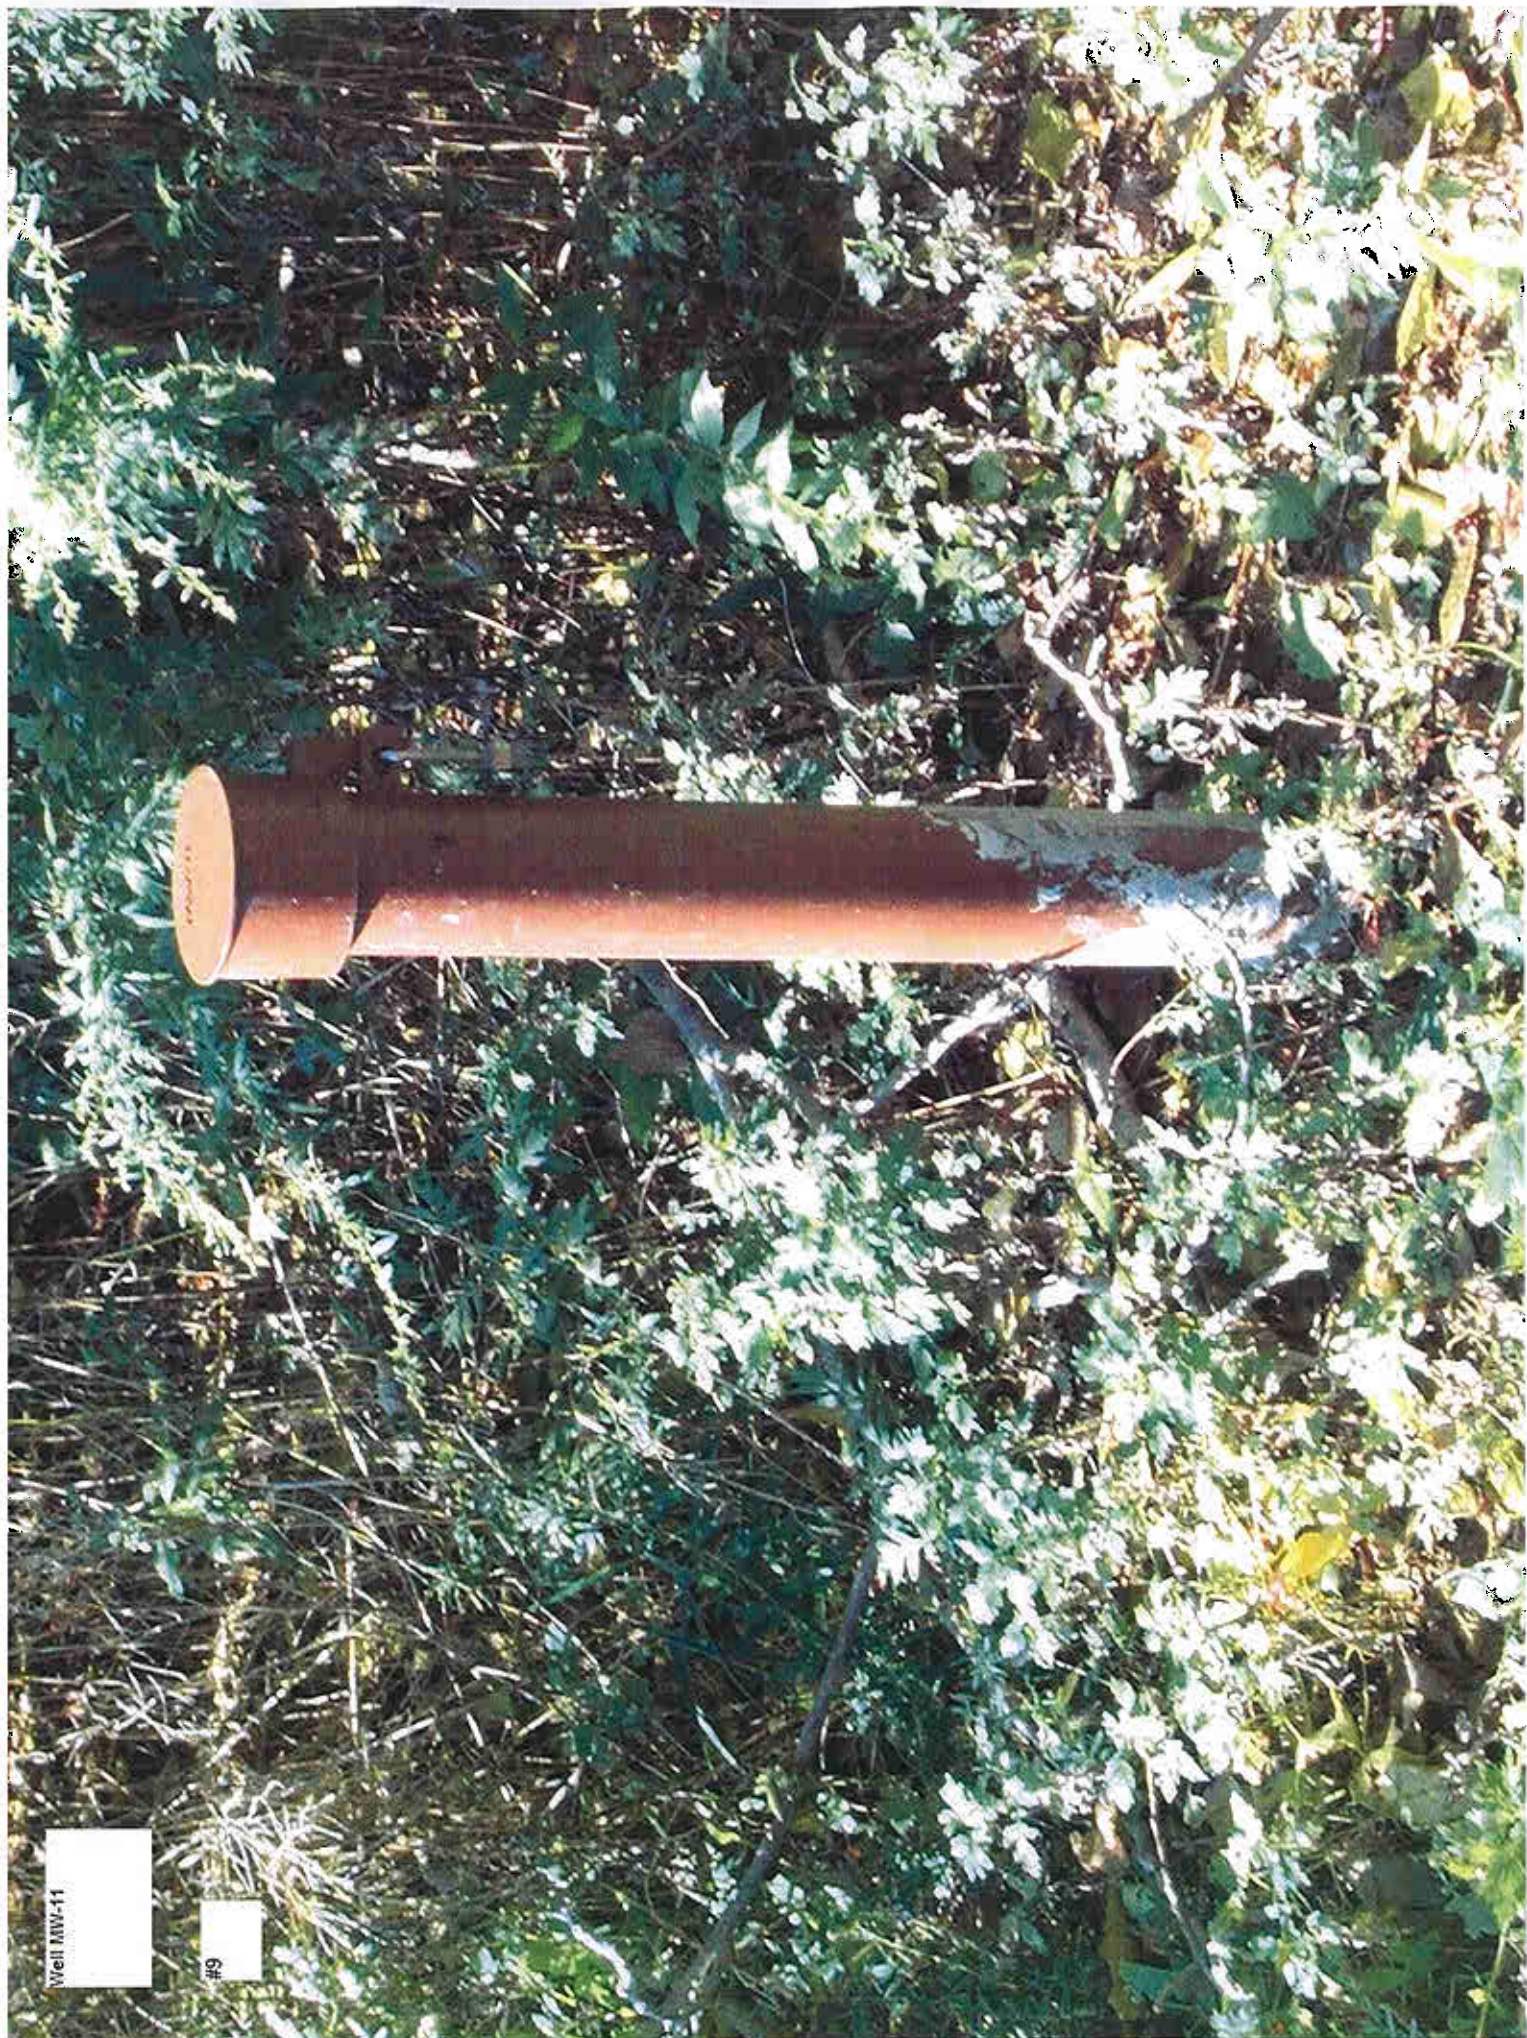
#8

All wells inspected and found to be in good condition. See Pictures # 5-11 and # 13-15 attached.

LMW - 4

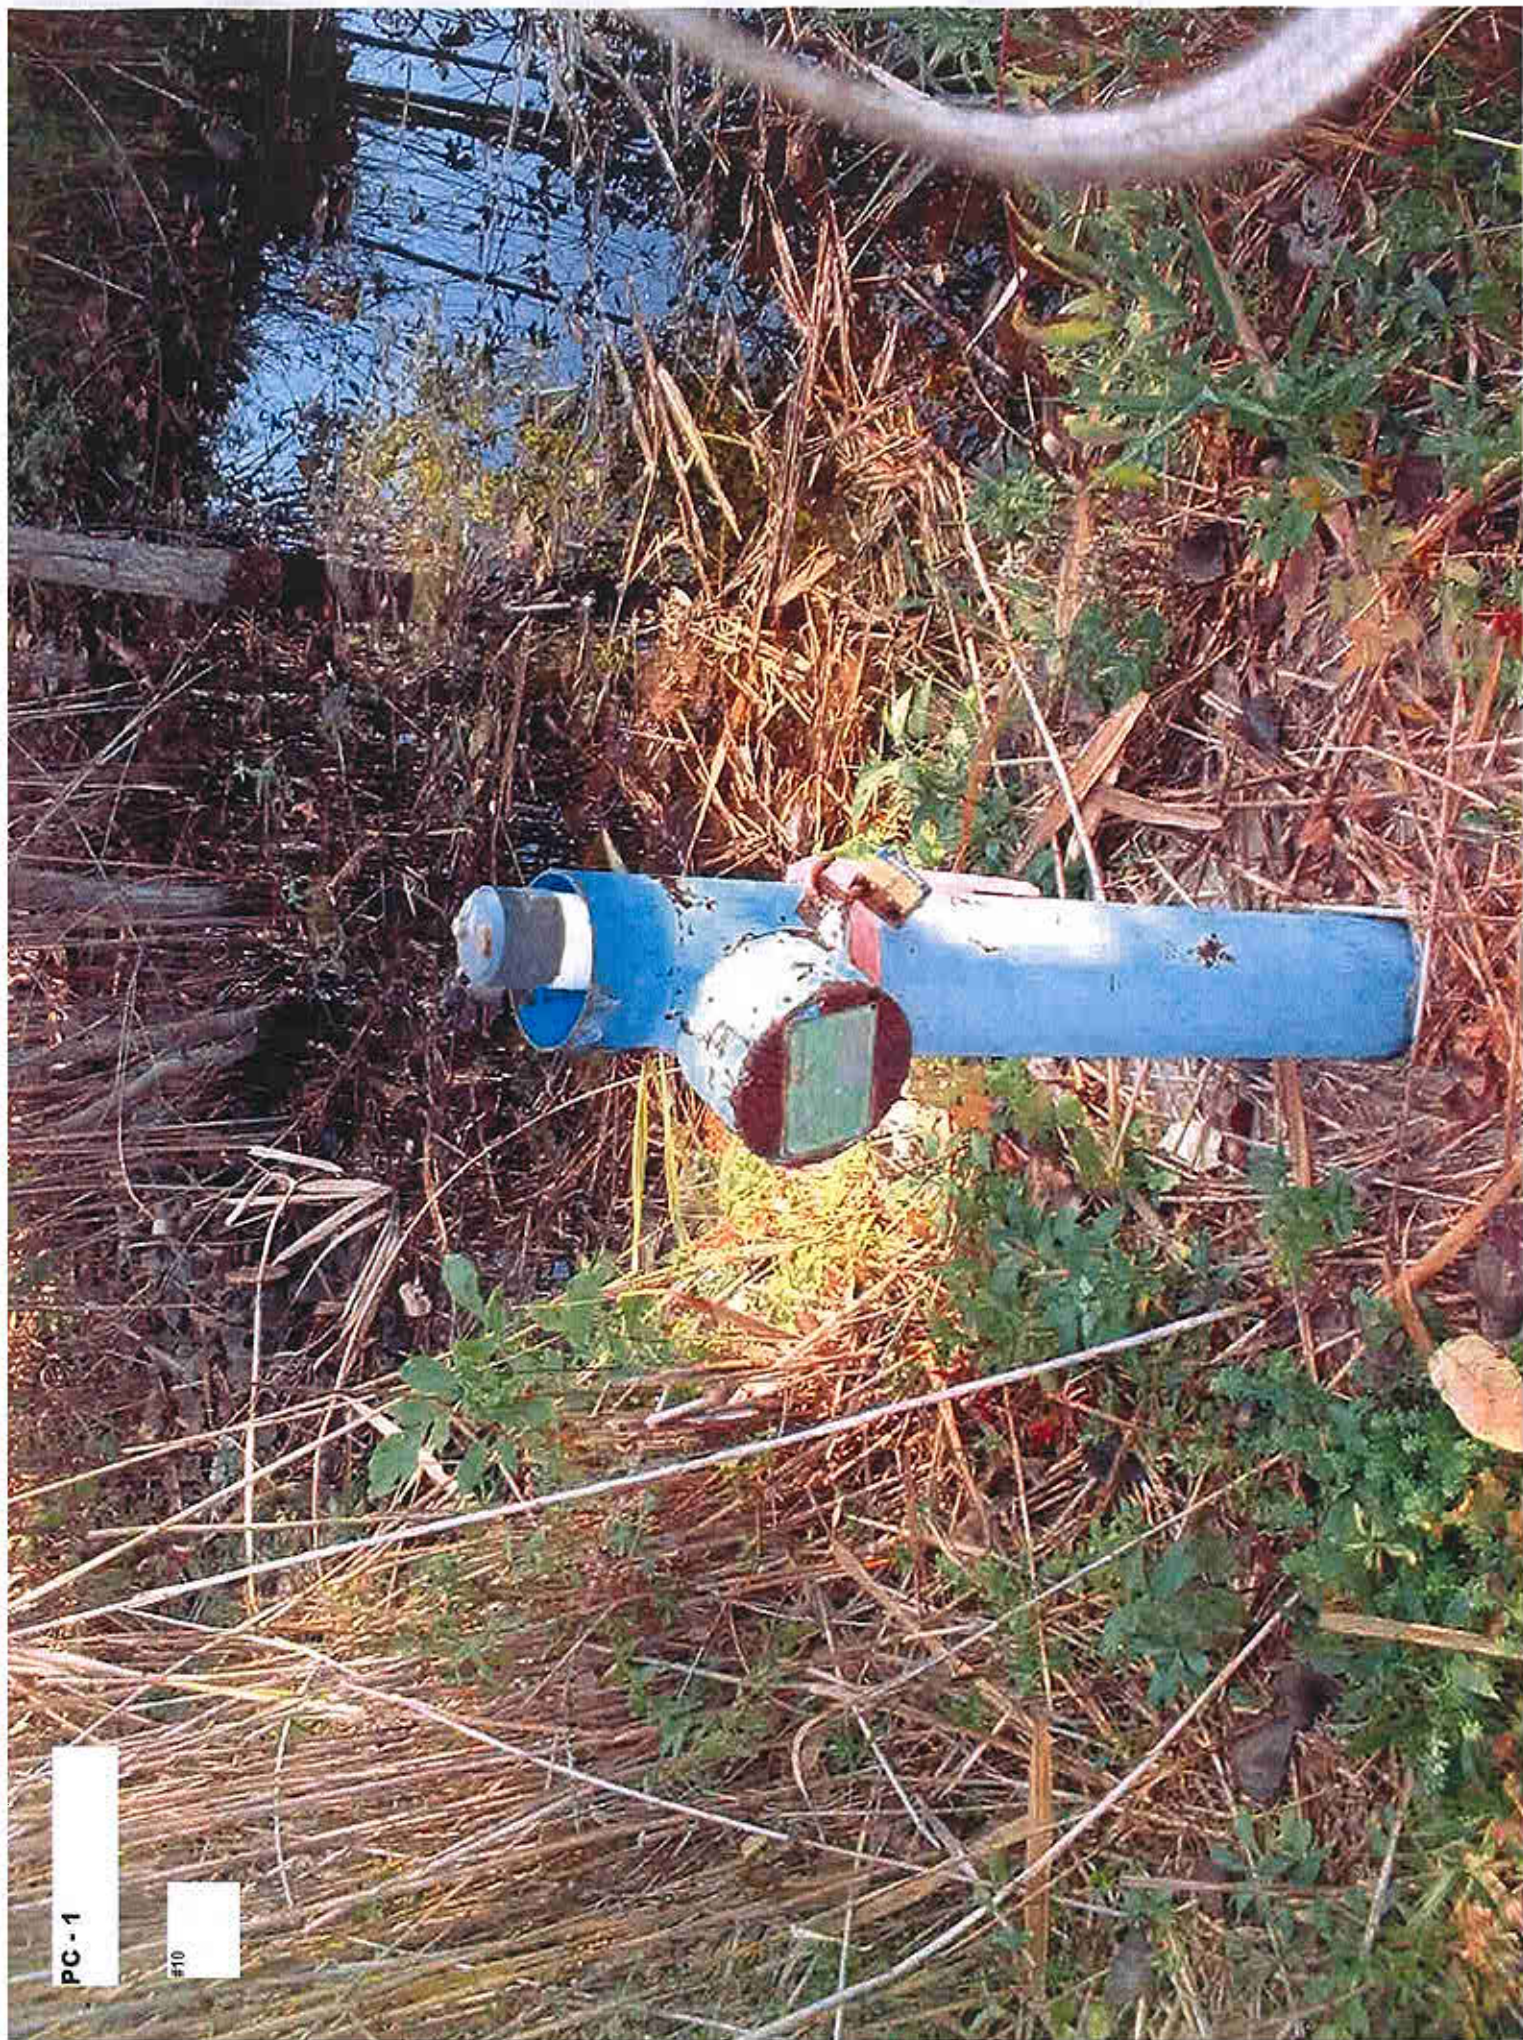
#9

Well MW-11

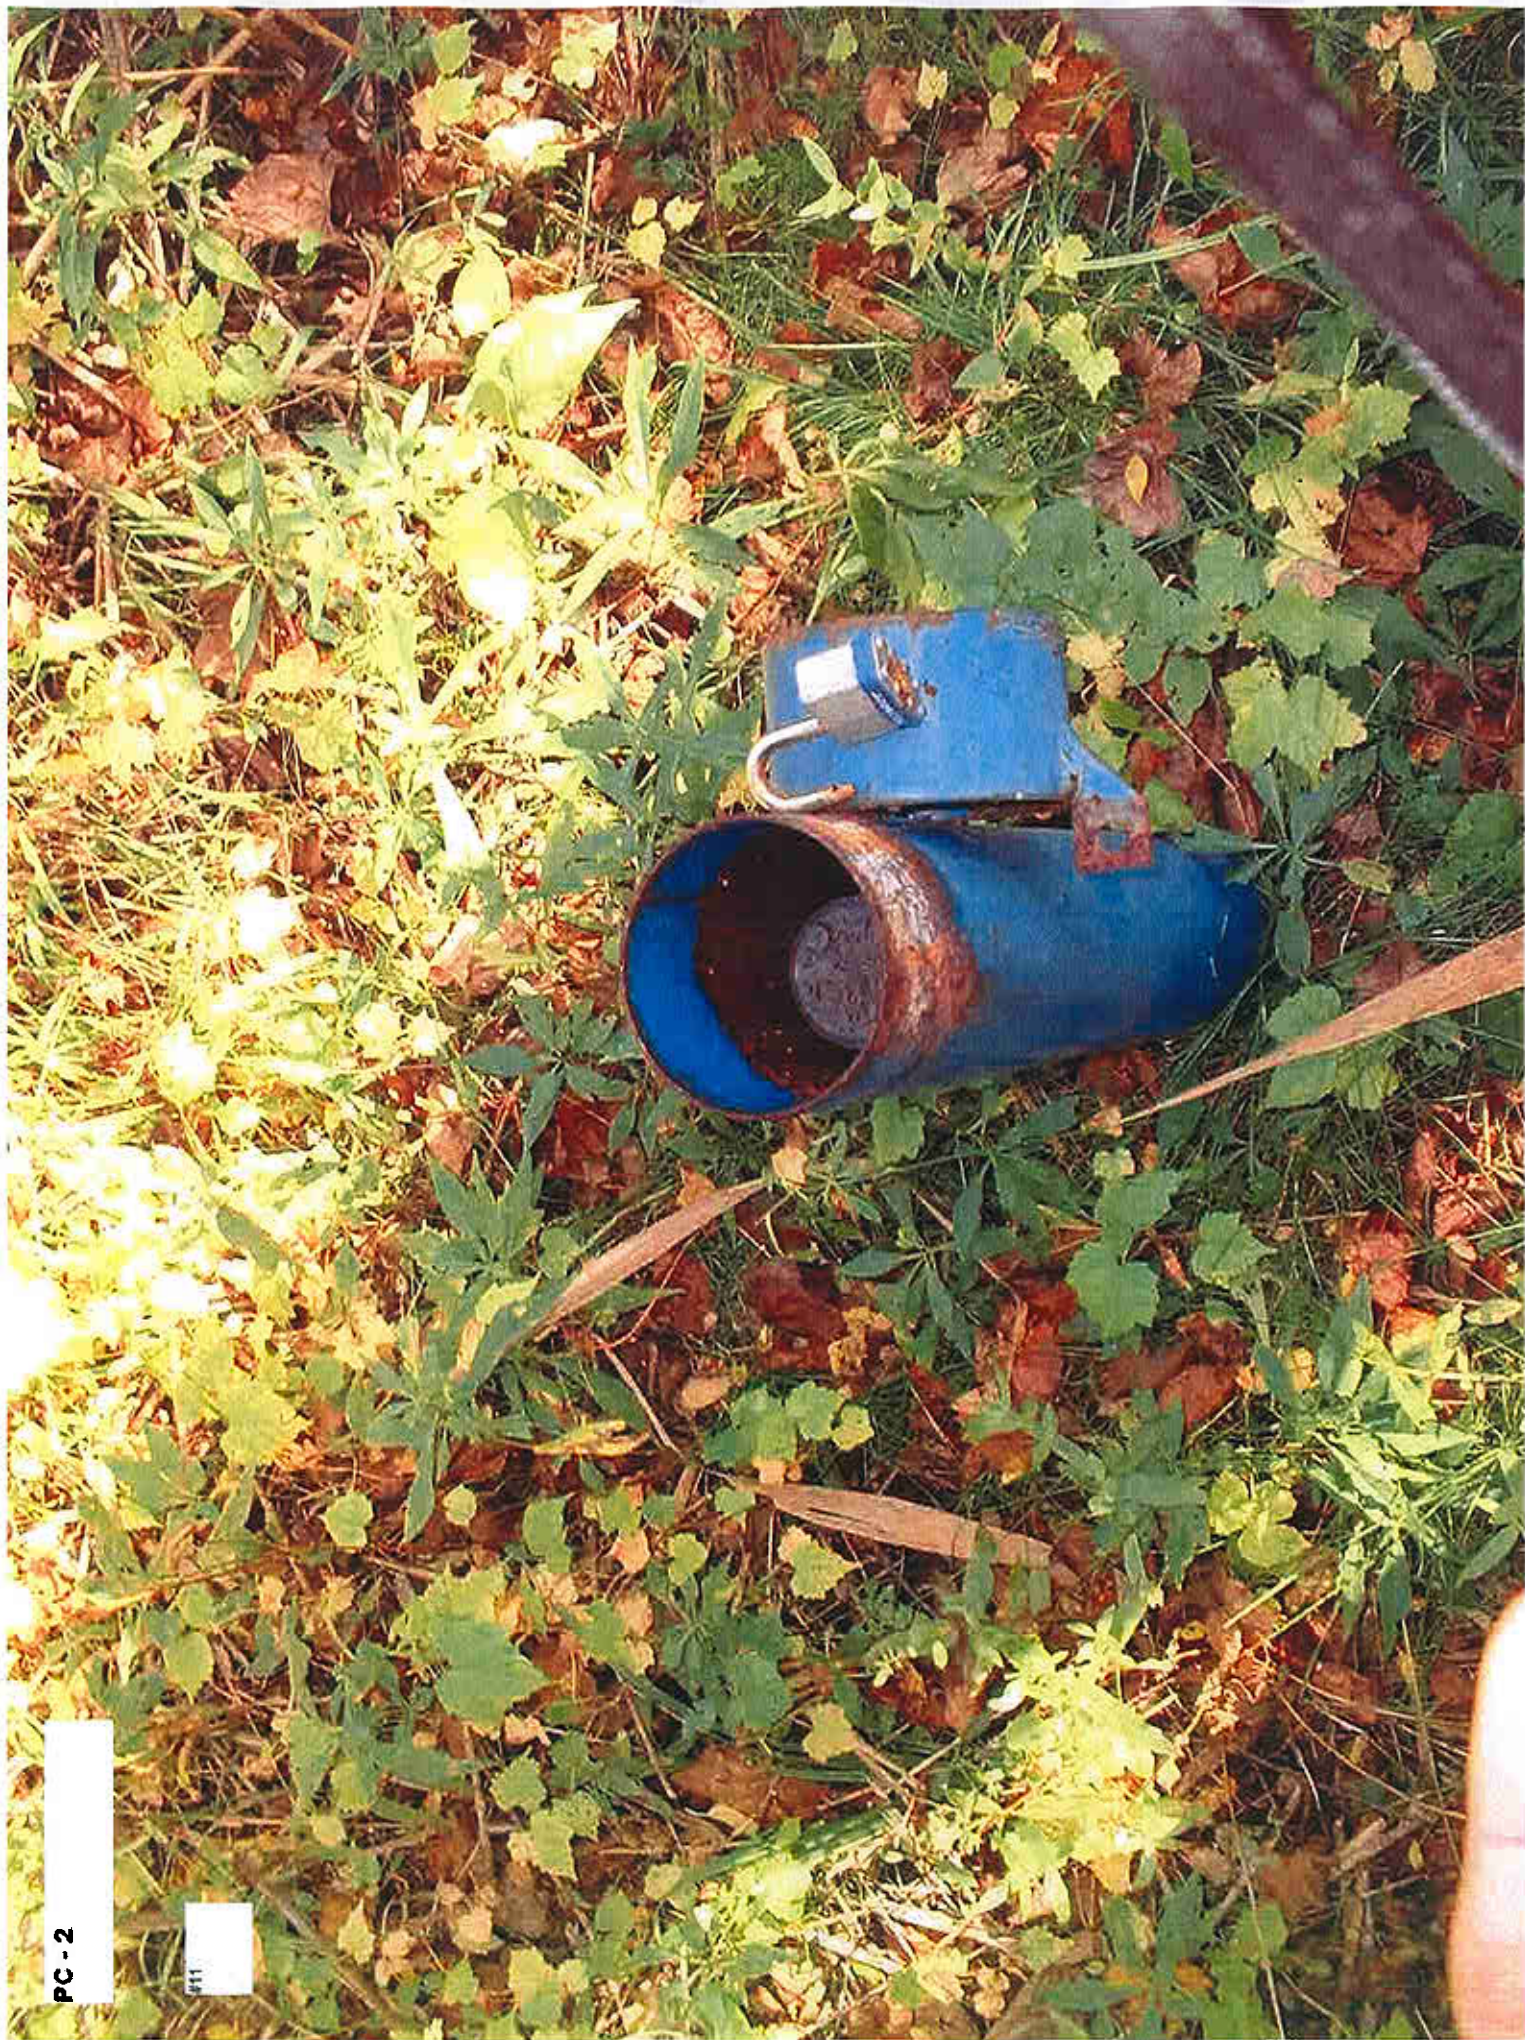
#10

PC-1

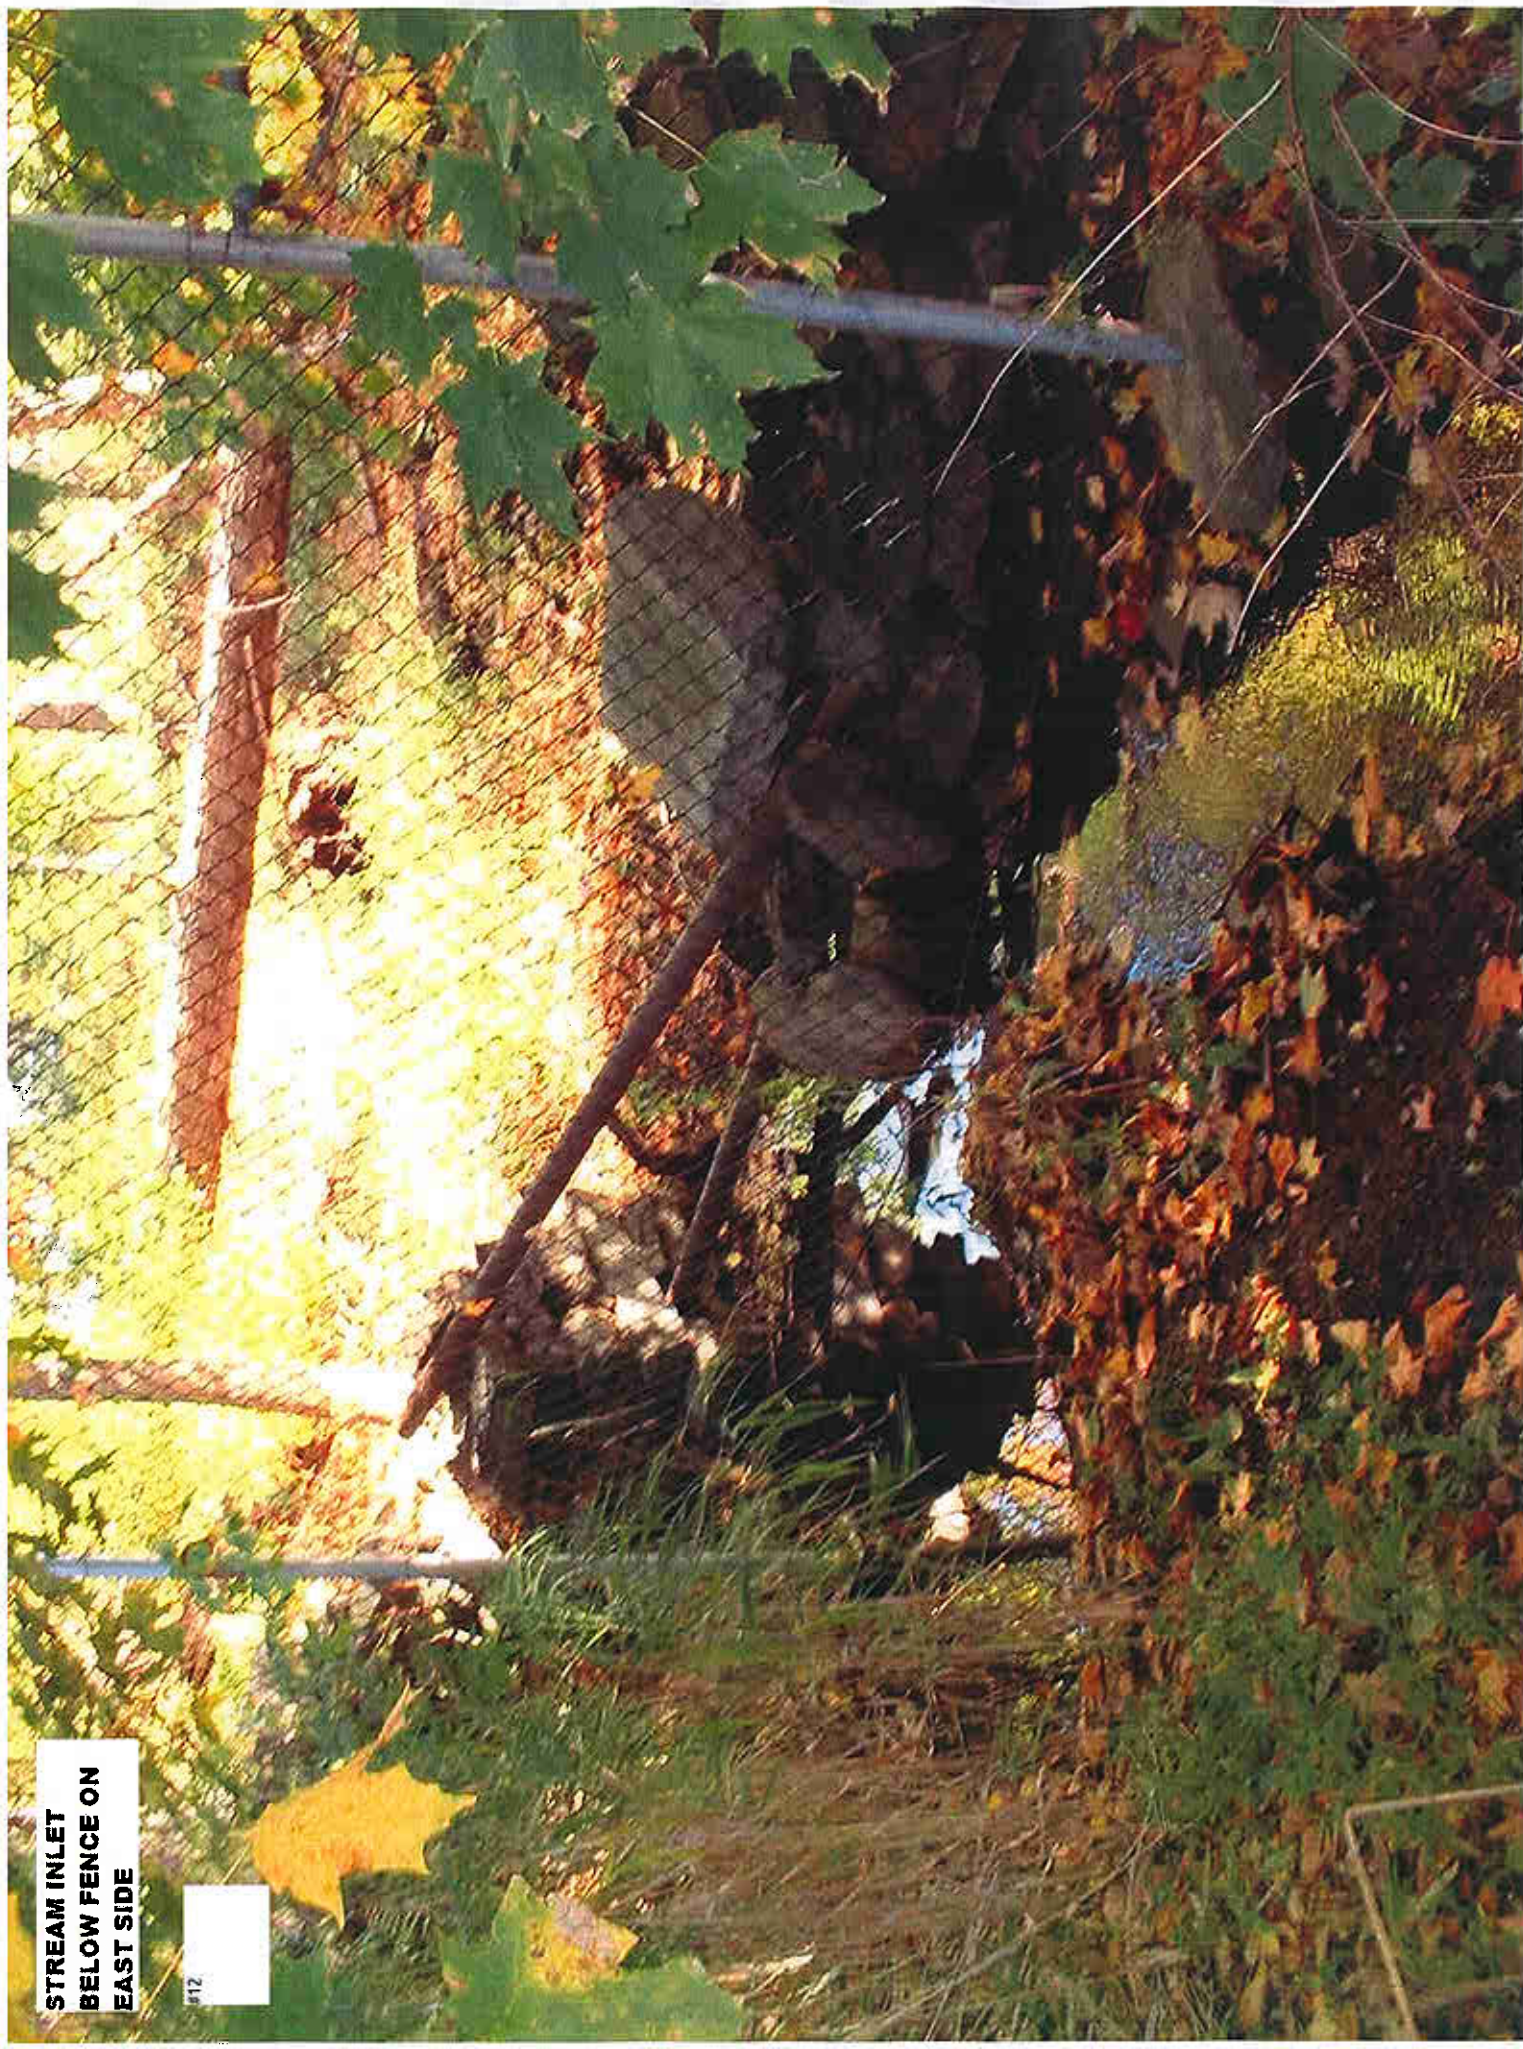
012

Fence has a section of its top rail bent and dislodged on the N/E side by a fallen branch. See Picture # 3 attached. The fence at the northeast side of the landfill near the stream inlet to the site is also missing the top bar but the fence is still functional. At this location, a 10"-12" gap exists between the bottom of the fence and the base of the stream which allows unrestricted flow of the stream around the border of the landfill (see Picture #12).

**STREAM INLET
BELOW FENCE ON
EAST SIDE**

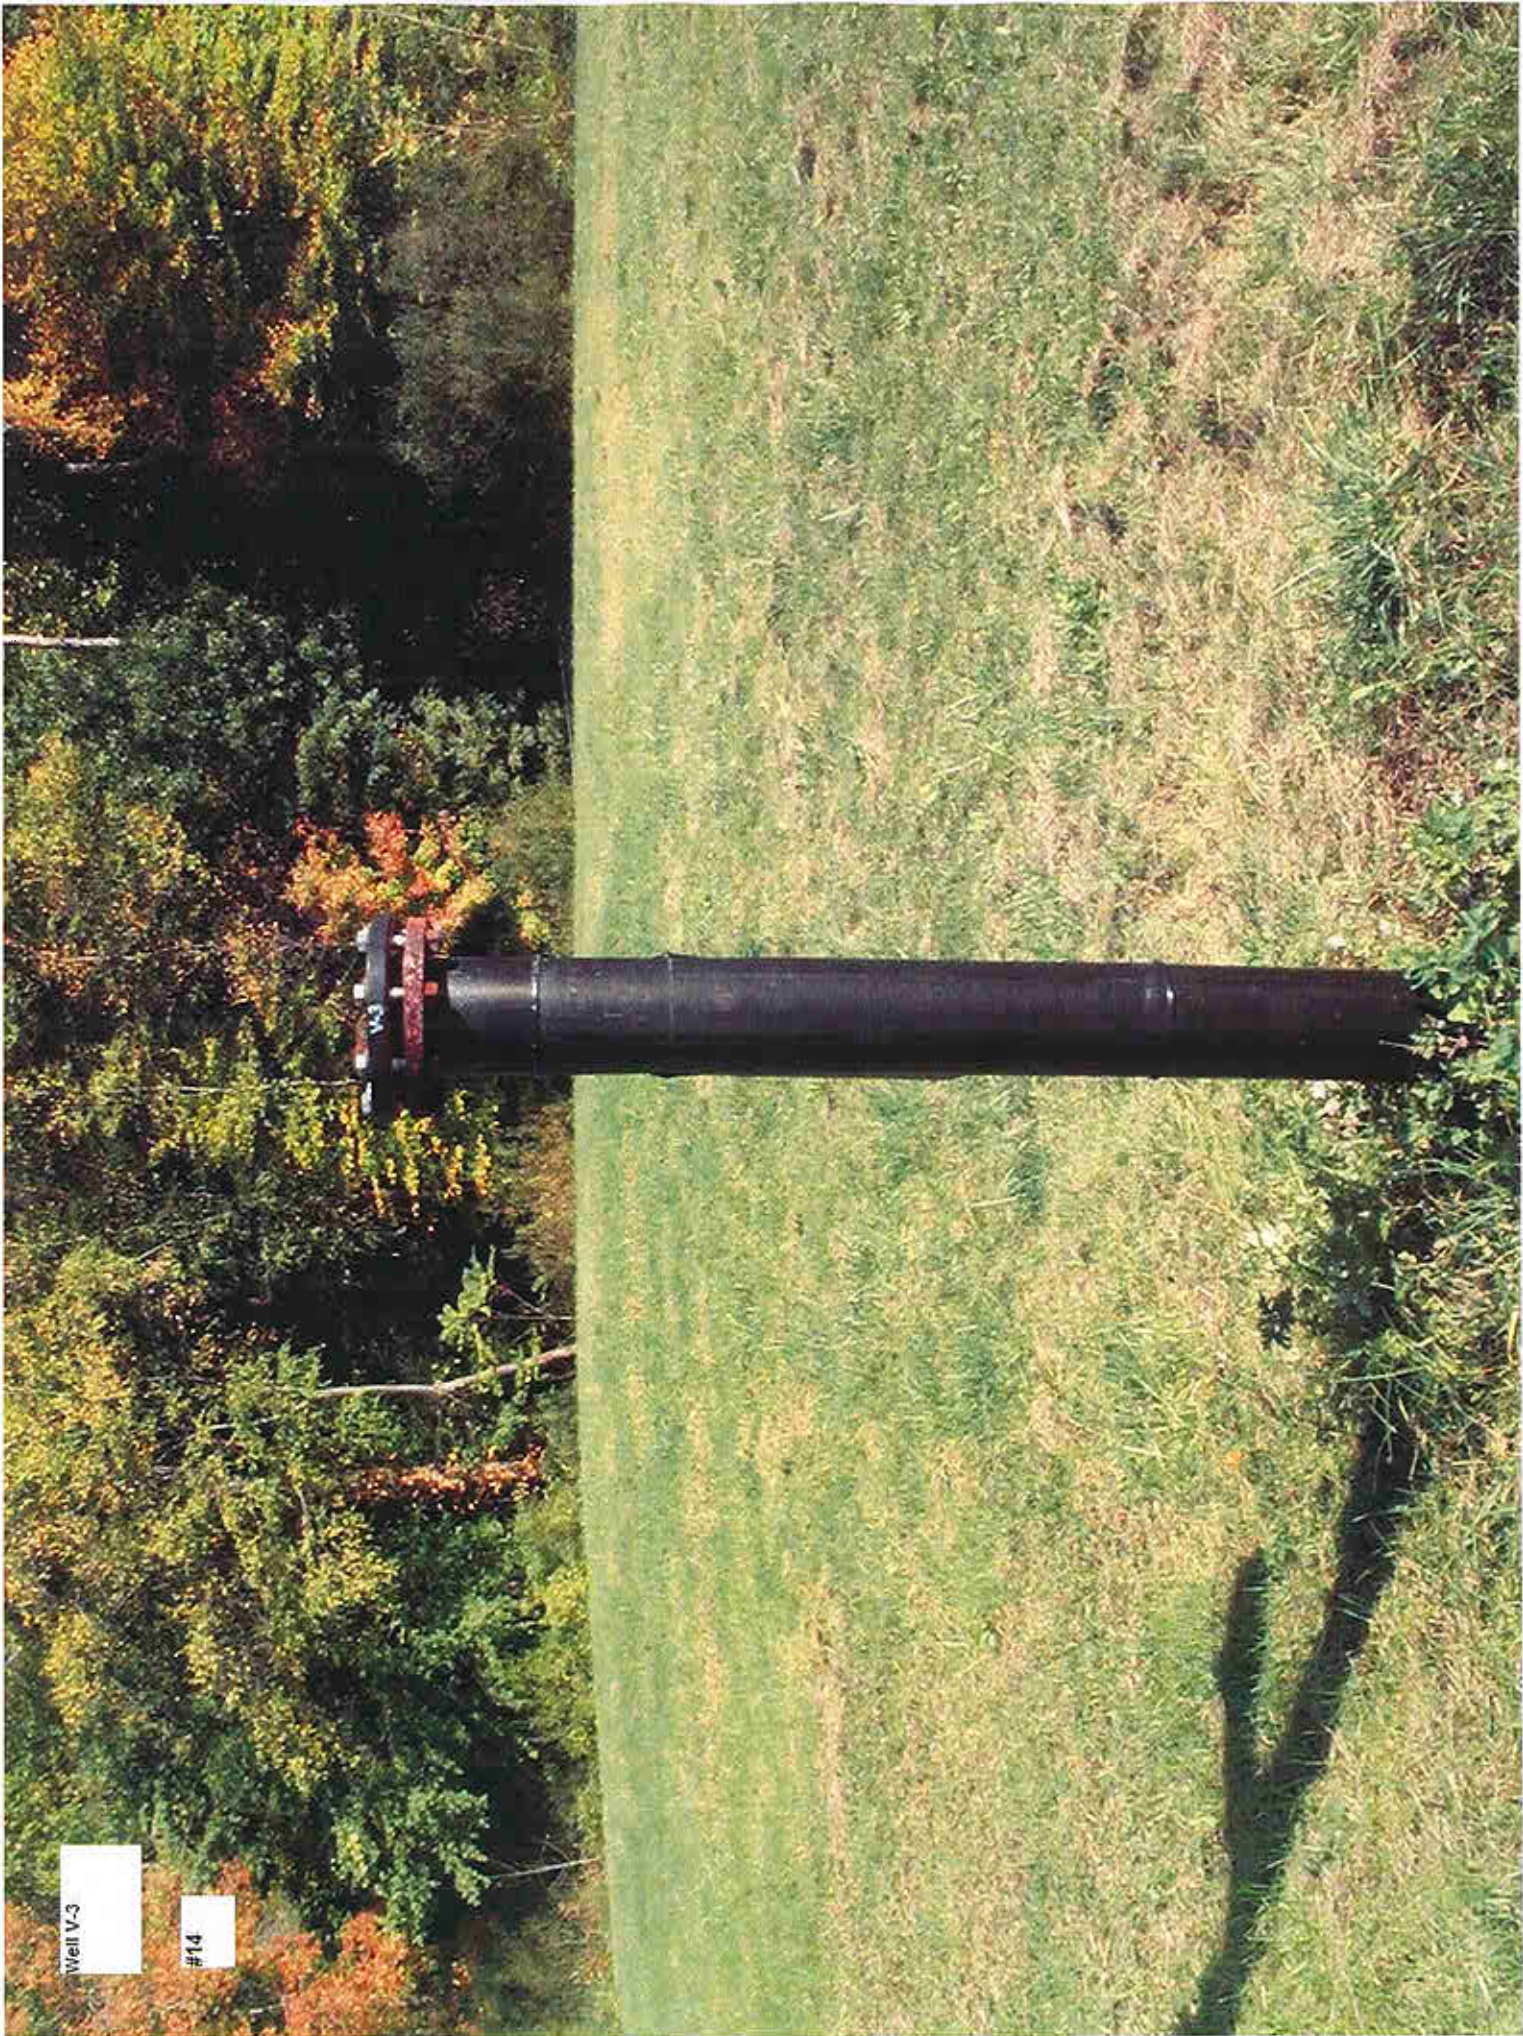
#13

Four vents, (V1 – V4) were inspected. Found OK. See Pictures # 13-15

V-1

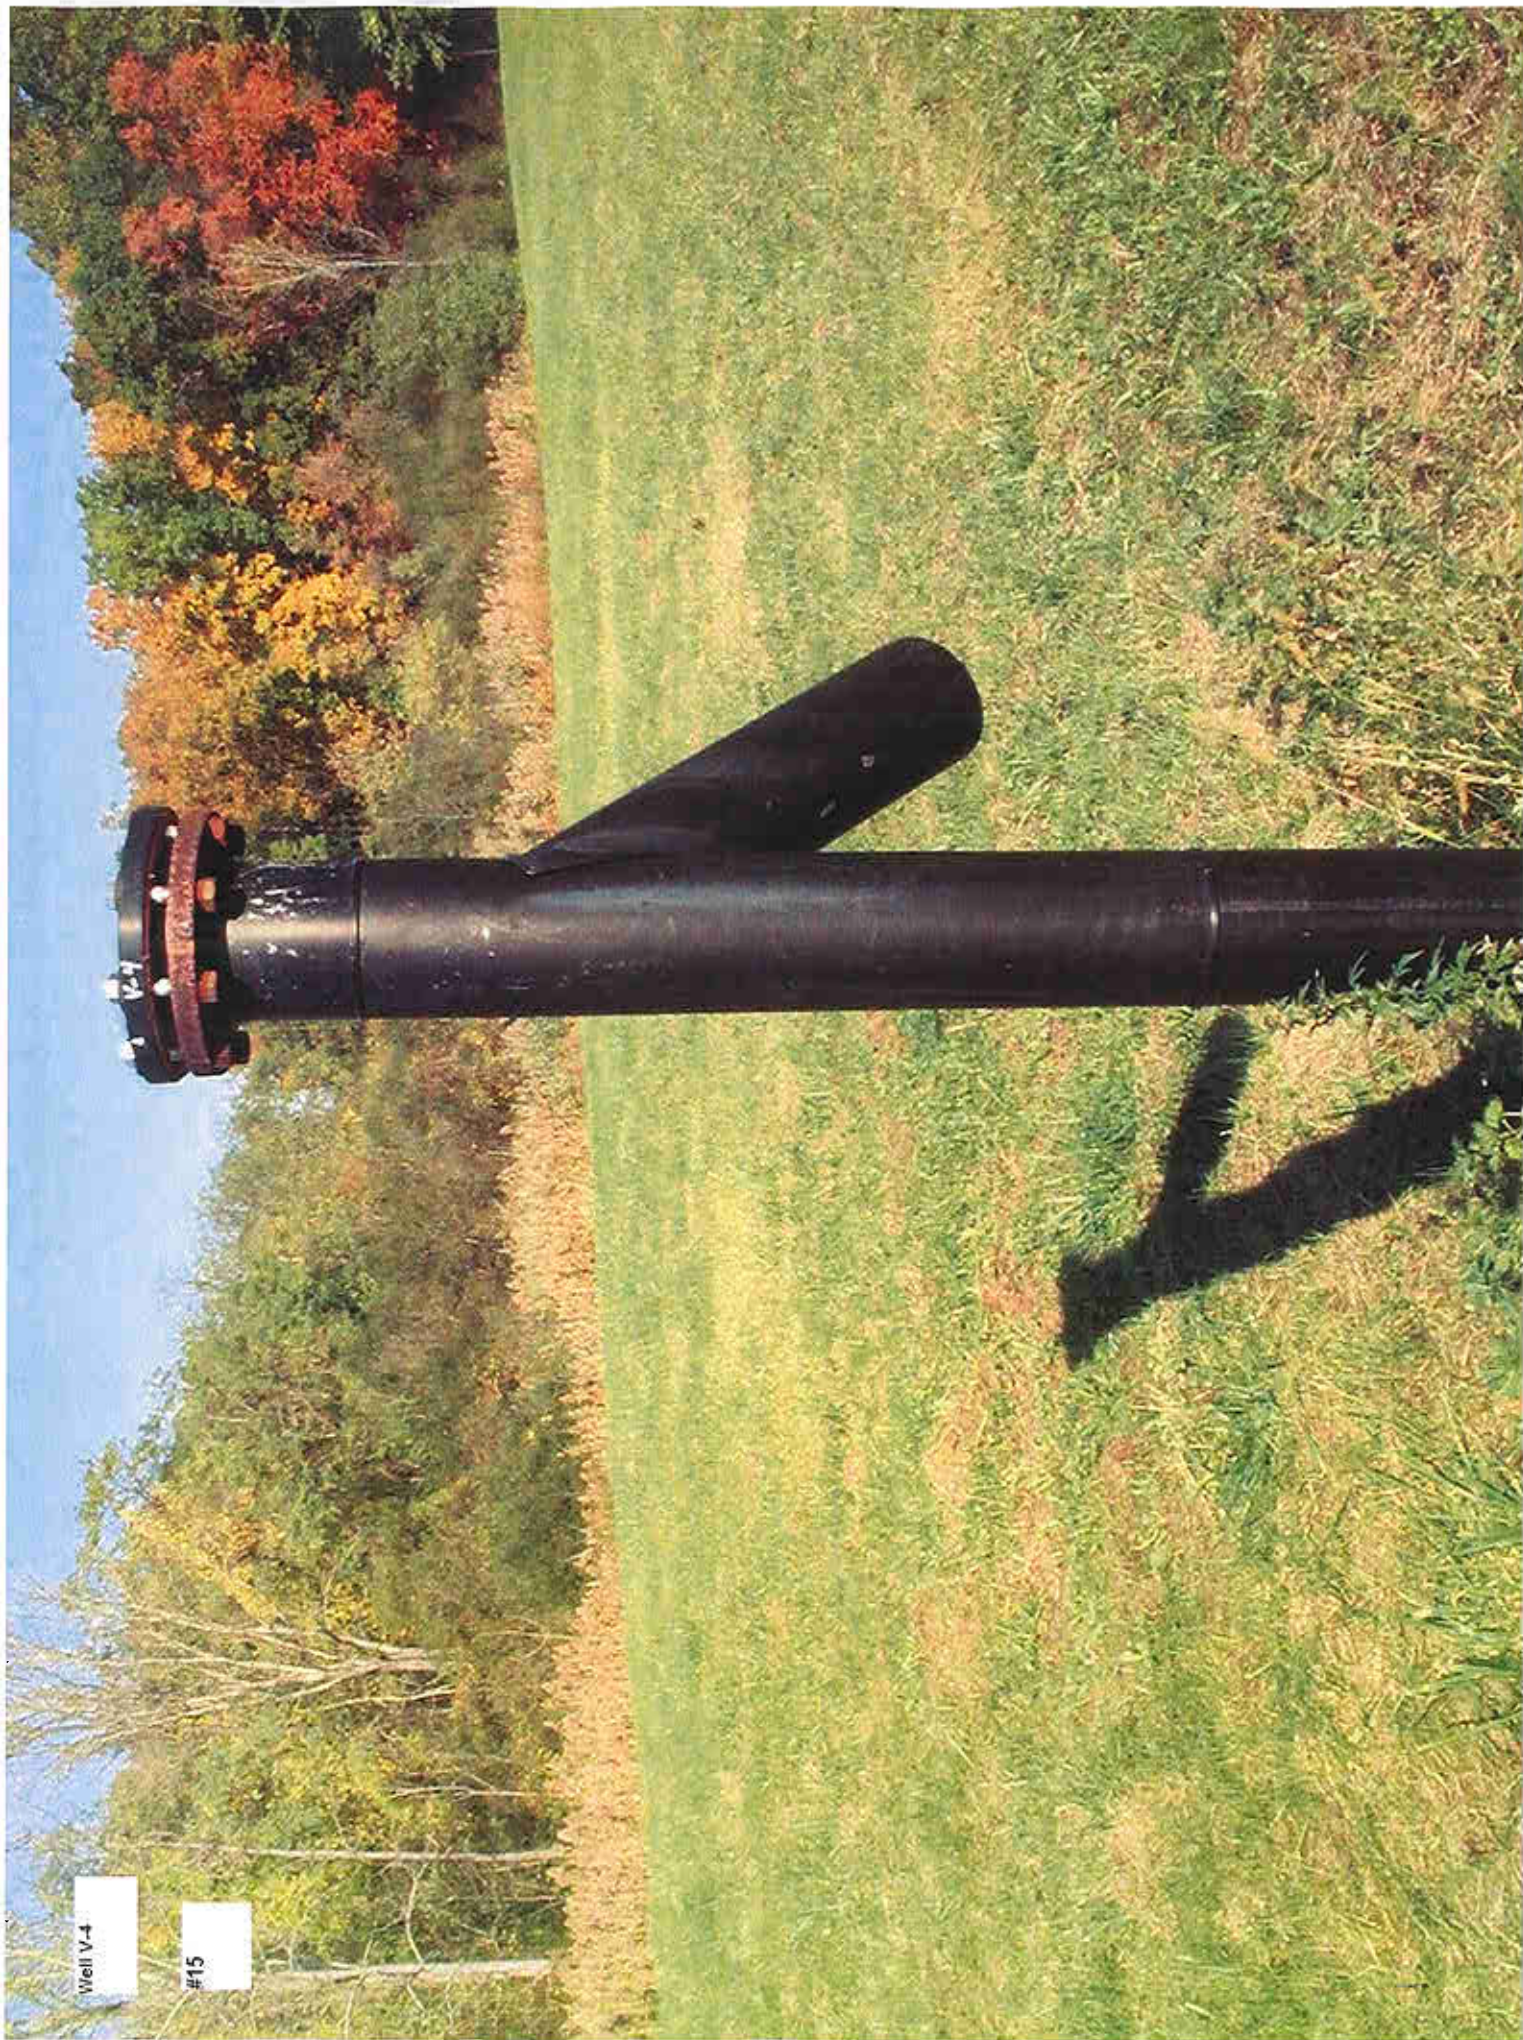
#14

Well V-3

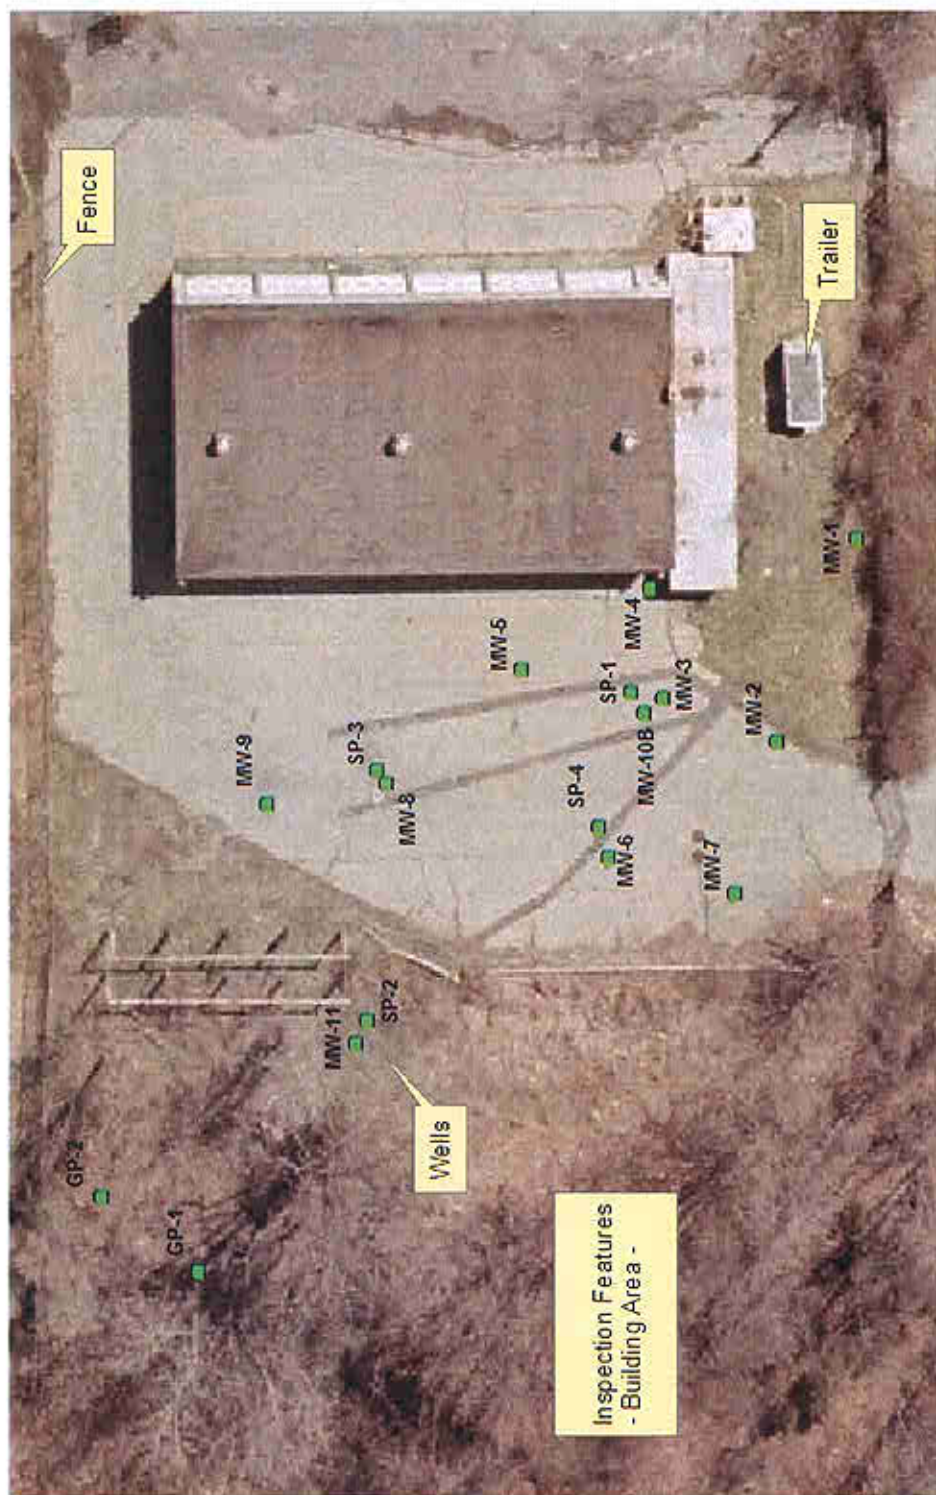
#15

Well V-4
