HARRISON SUB-RESIDENCY FIELD INSPECTION

Name of Inspector: Chris Kappeller

Date: 2/29/08

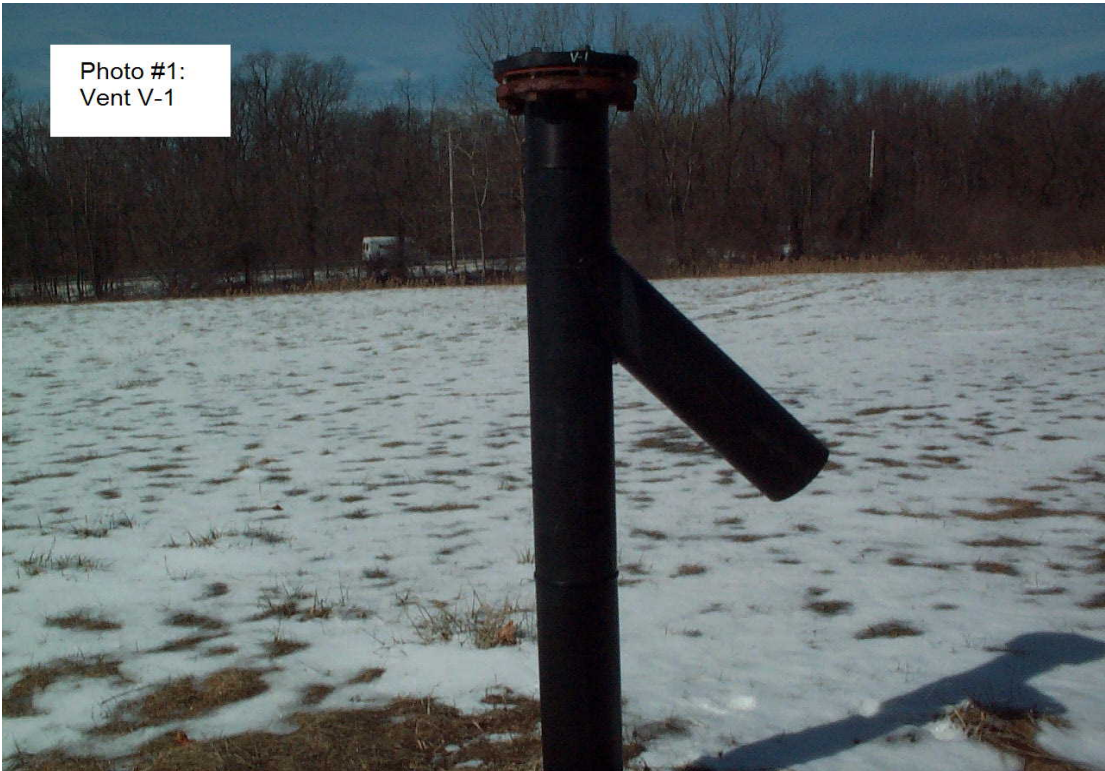
Photo #1:
Vent V-1

Four vents, (V1 – V4) were inspected and found OK (visually unblocked, neither cracks nor movement were observed). V-2 shows a slight lean to north (See Pictures # 1-4).

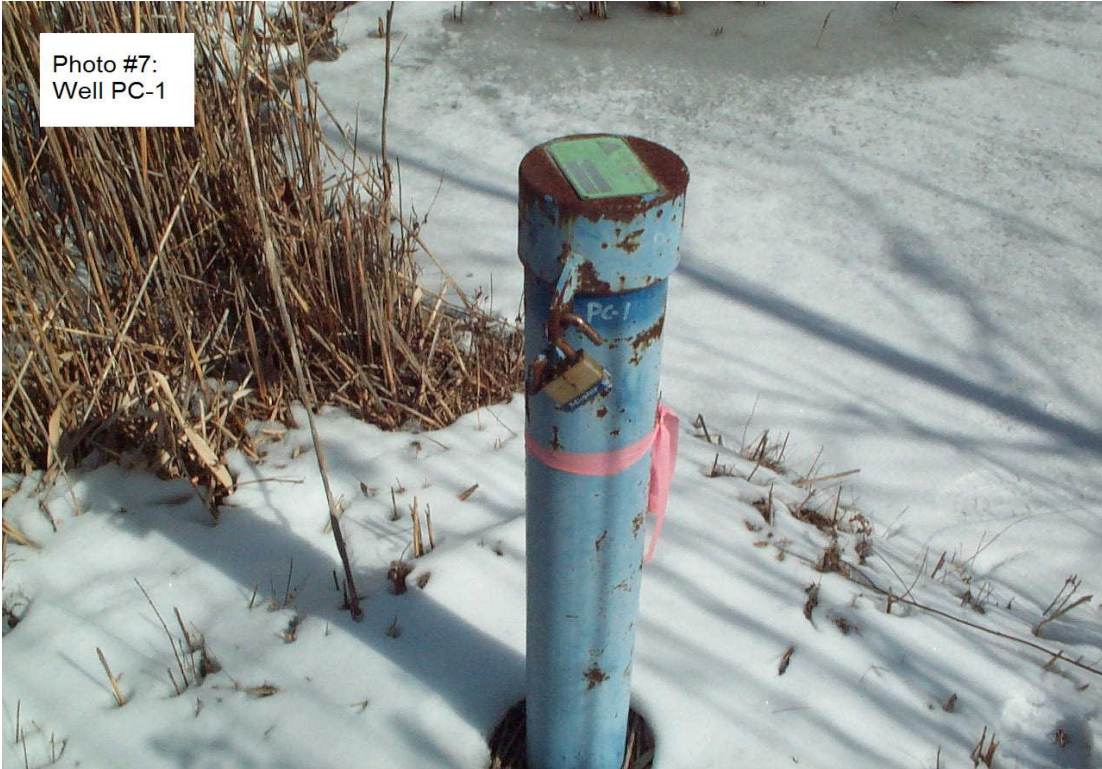
Photo #8:
PC-1 with
casing cap off.
PVC riser above
steel casing.
Steel cap can
not be locked.

All wells inspected and found to be in good condition (See Pictures # 5-12). The PVC riser of well PC-1 (Picture #8) should be cut about 4" so that the steel cap can fit back onto the external steel protective casing. This can be done during the next site inspection by NYSDOT in a couple of months (or sooner if DOT is in the area with the equipment needed). The length of PVC casing cut would be recorded and the measurement given to HDR/LMS so they may use it to update the "top of casing" elevation for their site file.

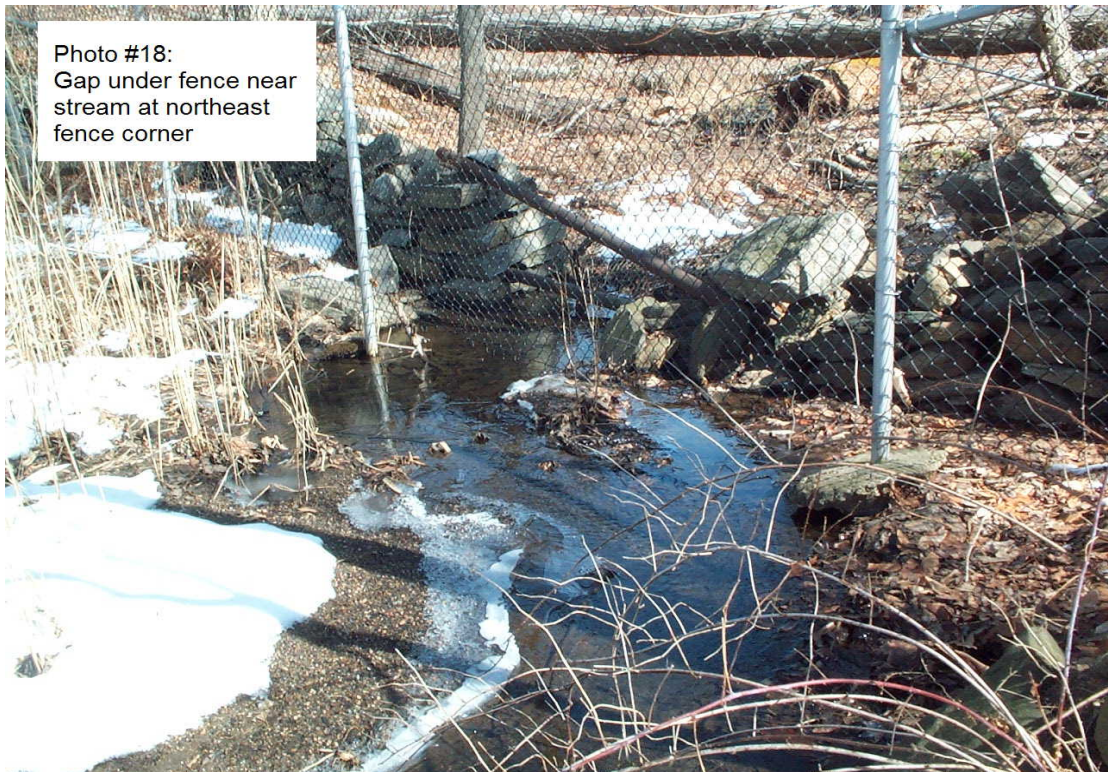
Photo #18:
Gap under fence near
stream at northeast
fence corner

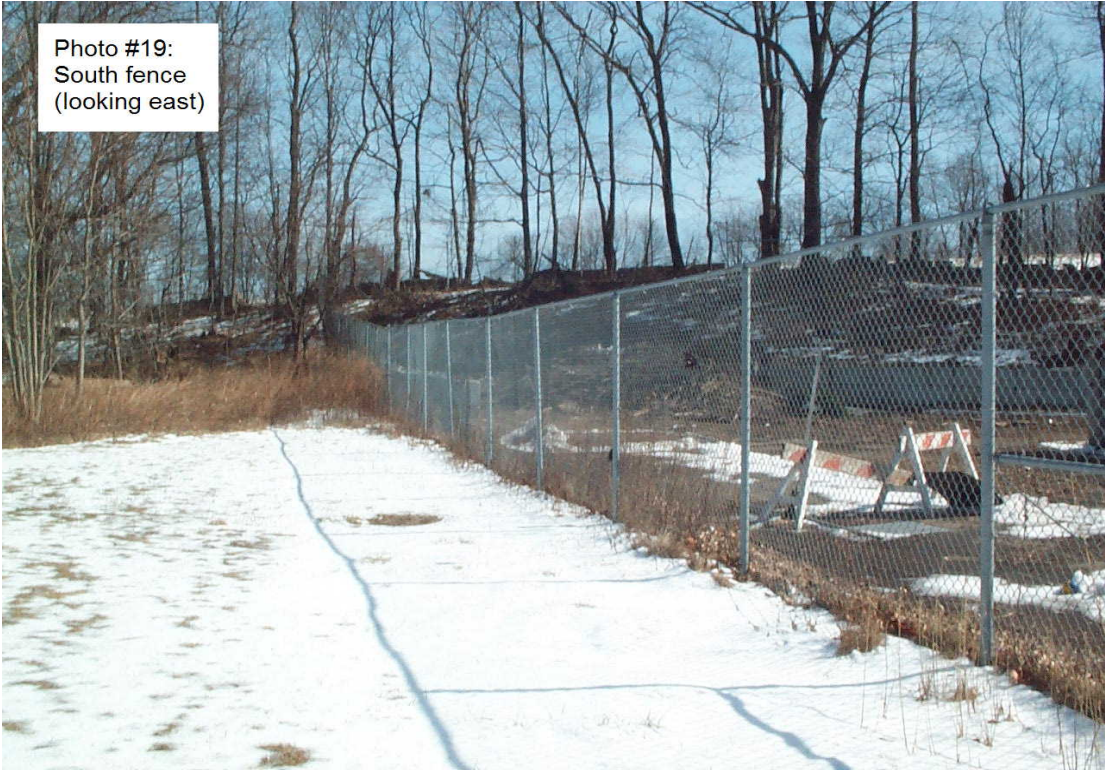
Photo #19:
South fence
(looking east)

3. The fence on the southeast side was repaired by NYSDOT and Town of Harrison in mid 2007. The concrete blocks were moved away from the fence and no longer place pressure on it (Picture #19).
