HARRISON SUB-RESIDENCY FIELD INSPECTION

Name of Inspector: Chris Kappeller

Date: 2/27/09

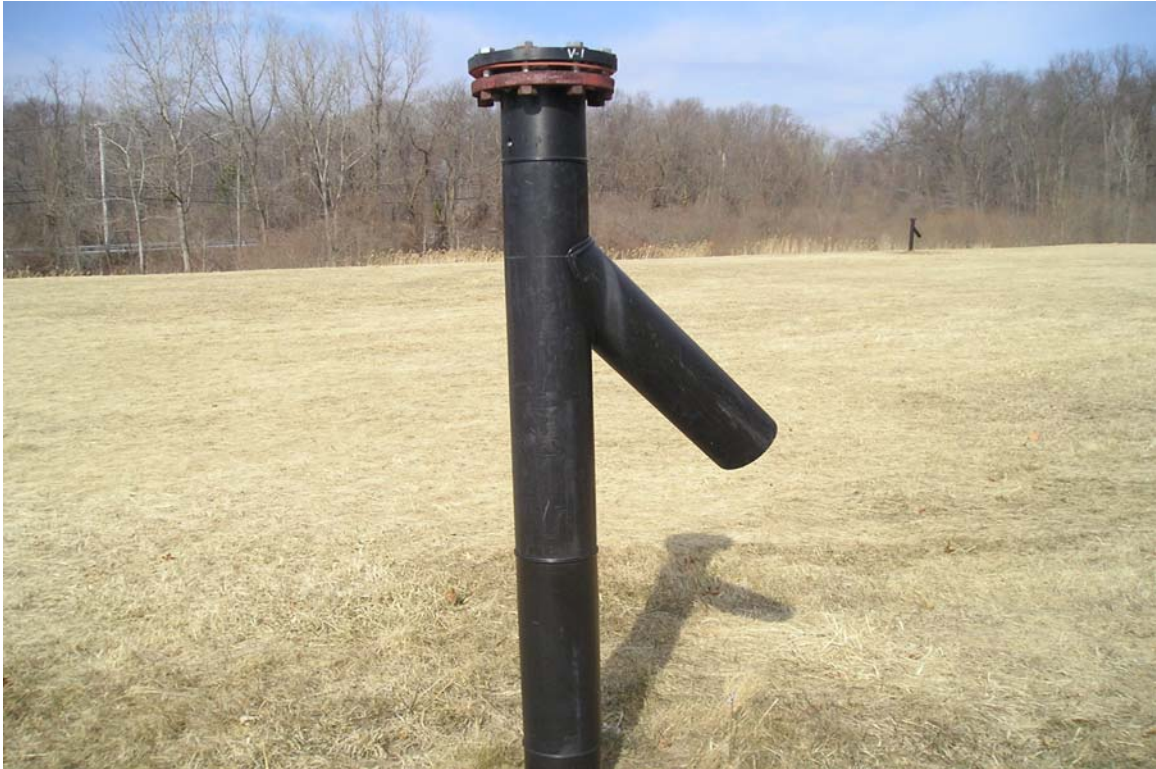
Four vents (V1 – V4) were inspected and found in good condition (visually unblocked, neither cracks nor movement were observed) (Photos # 1-4). V-2 shows a slight lean to north.

Photo 1: Vent V-1

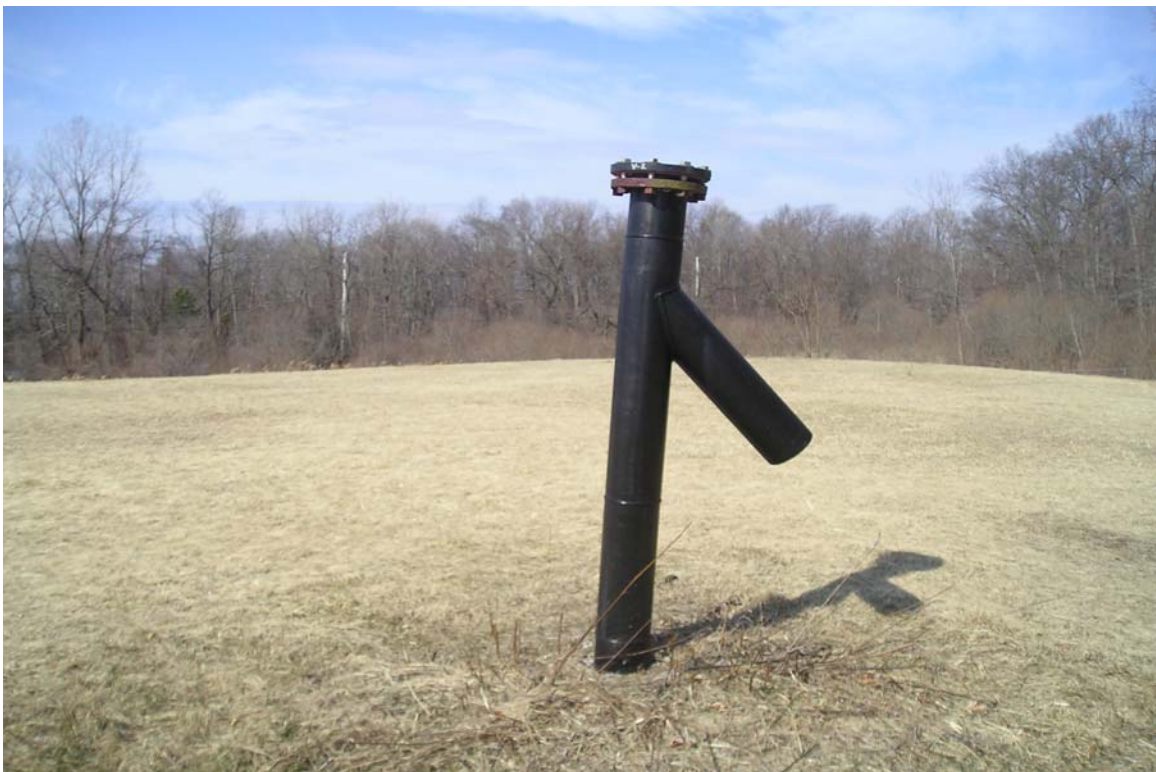
Photo 2: Vent V-2

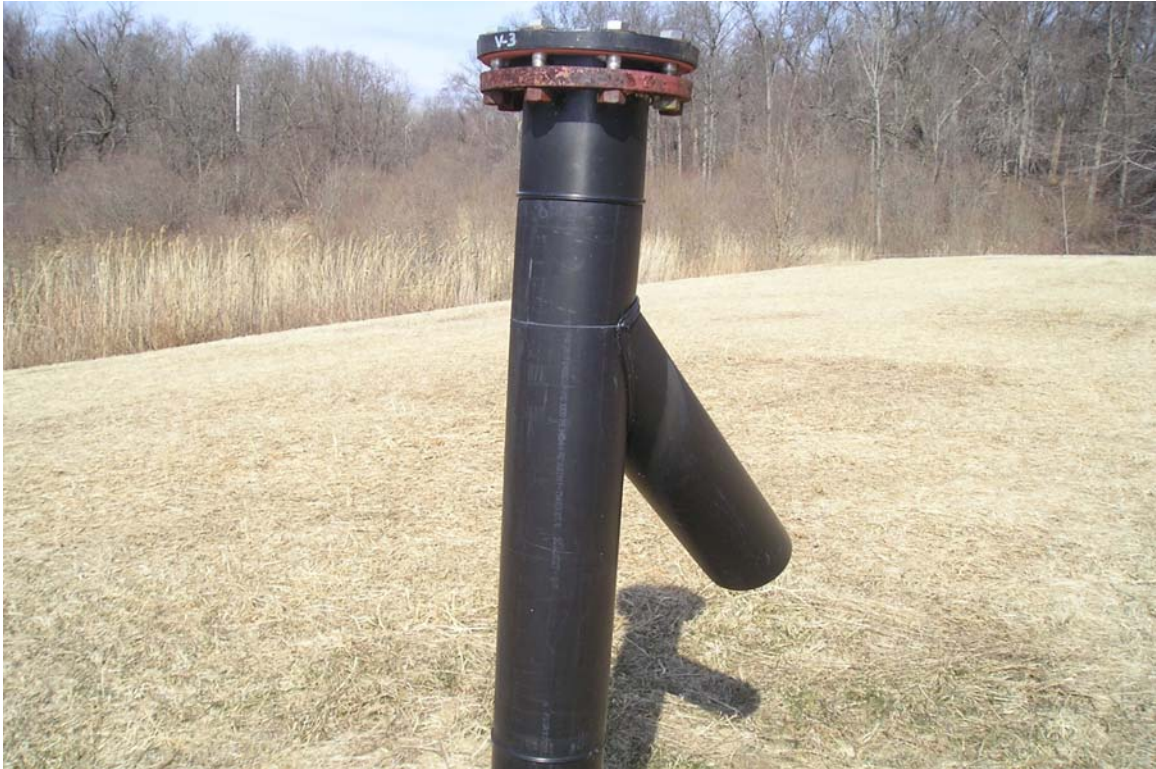
Photo 3: Vent V-3

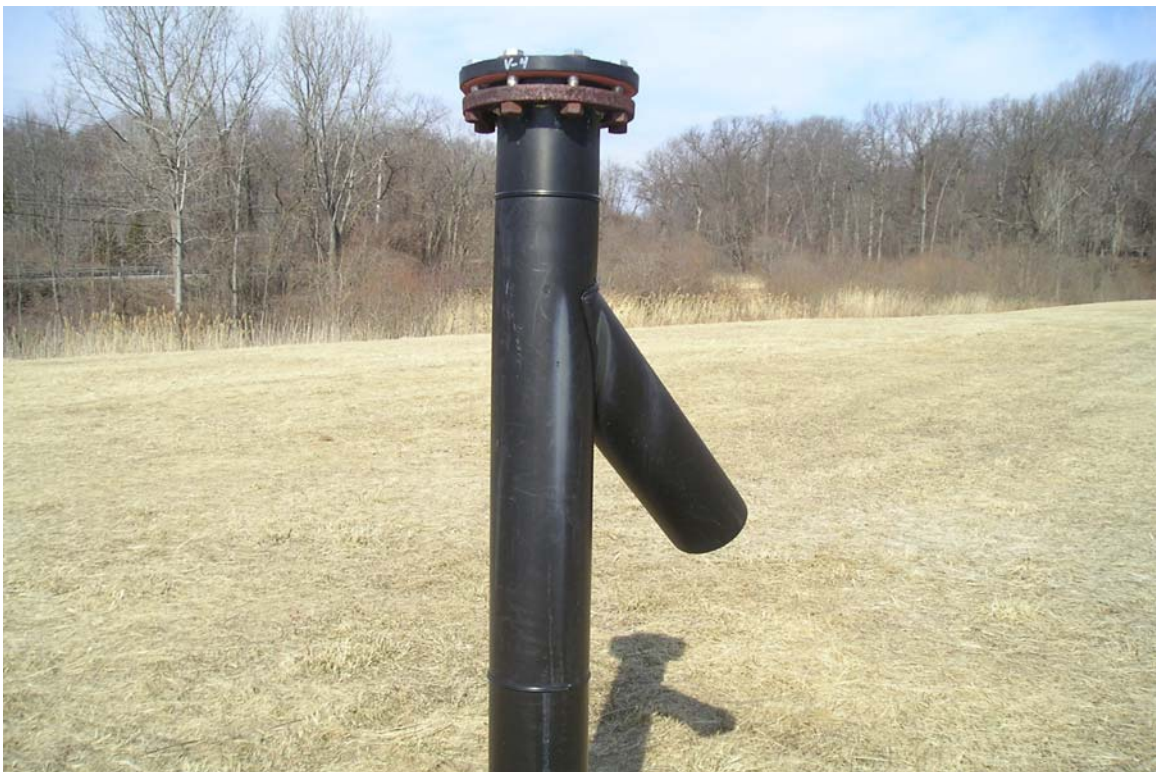
Photo 4: Vent V-4

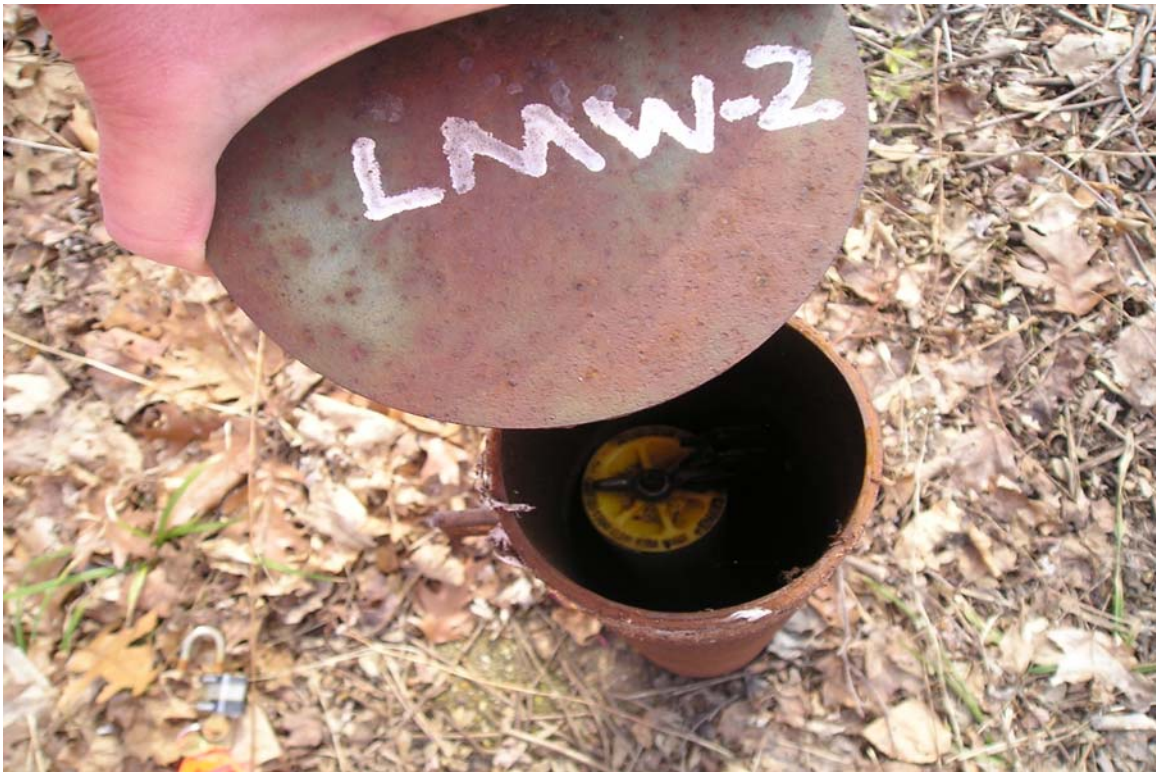
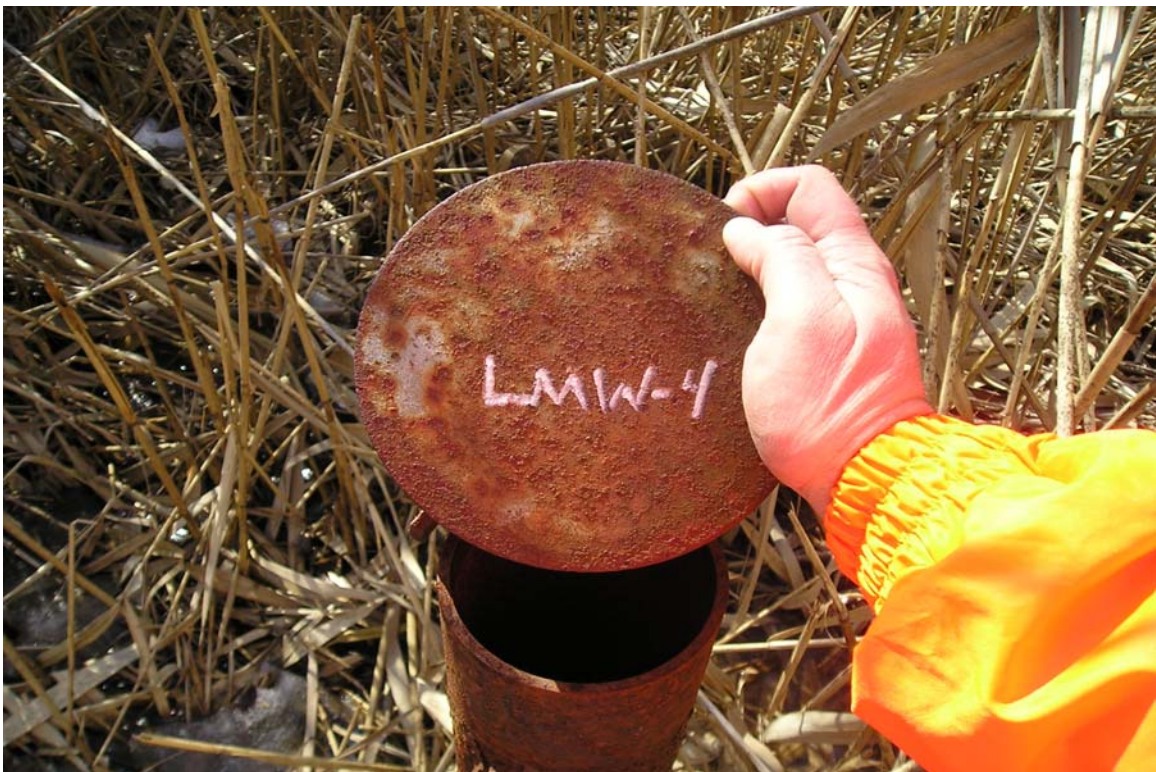
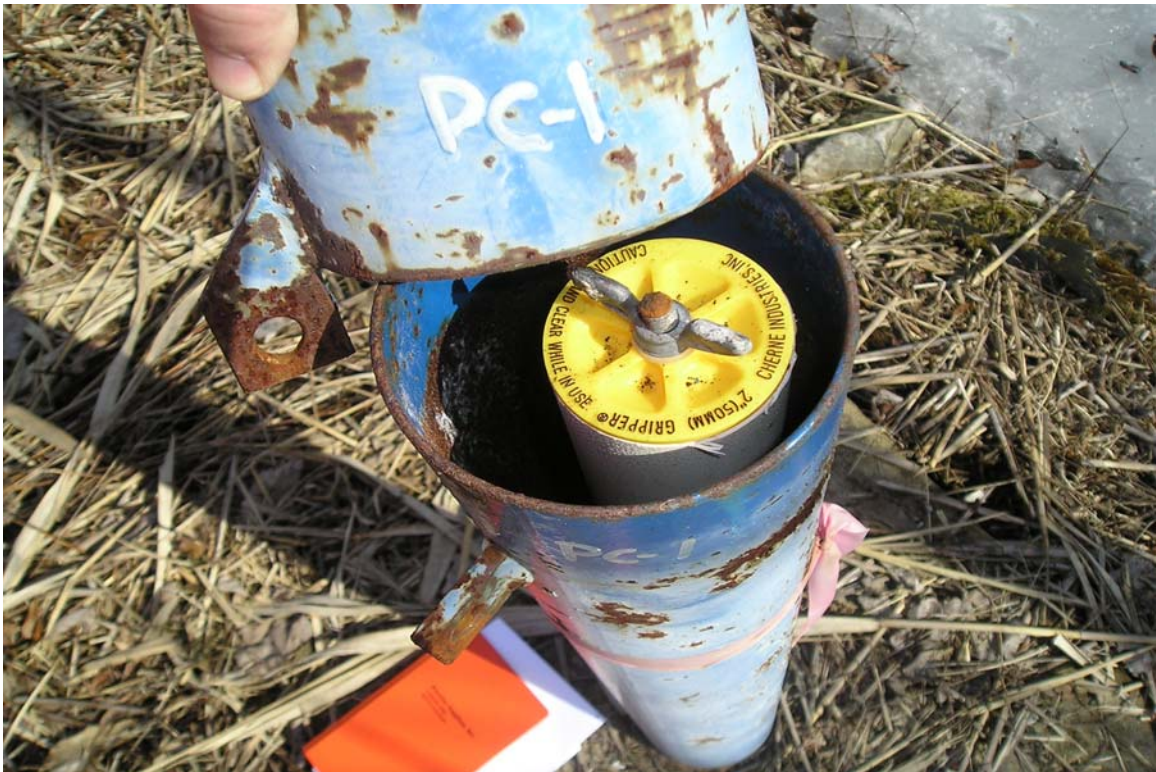
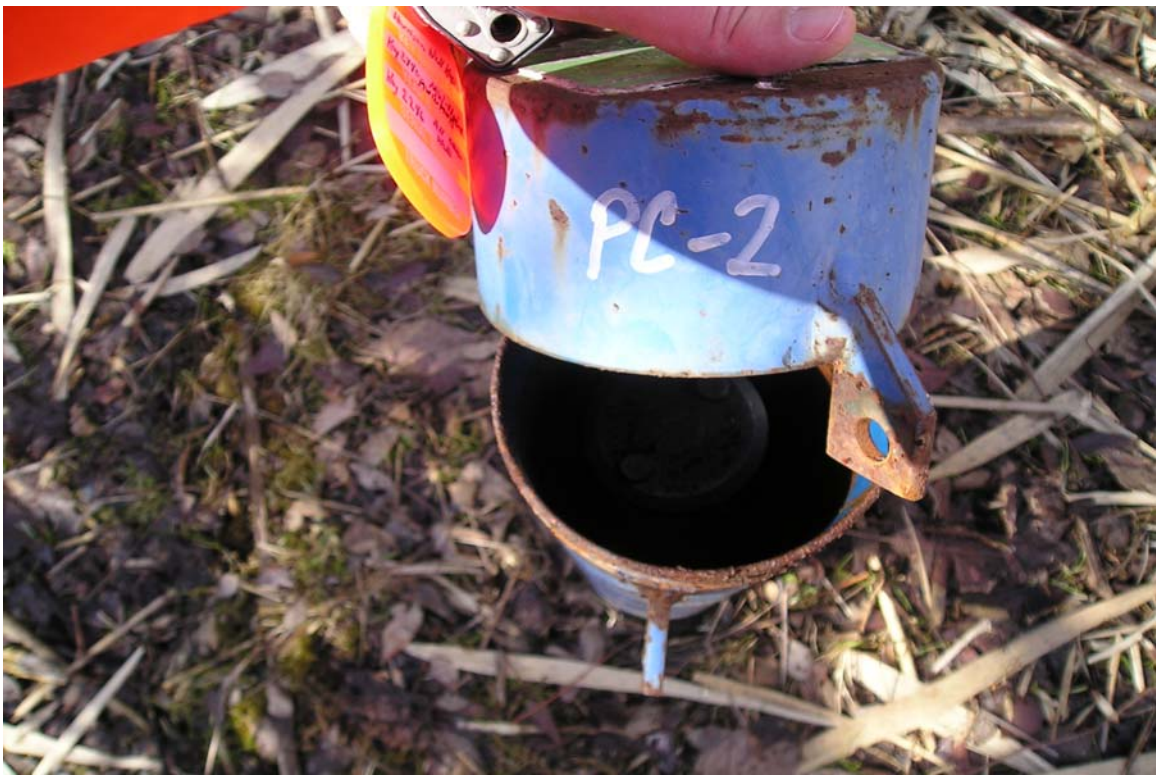
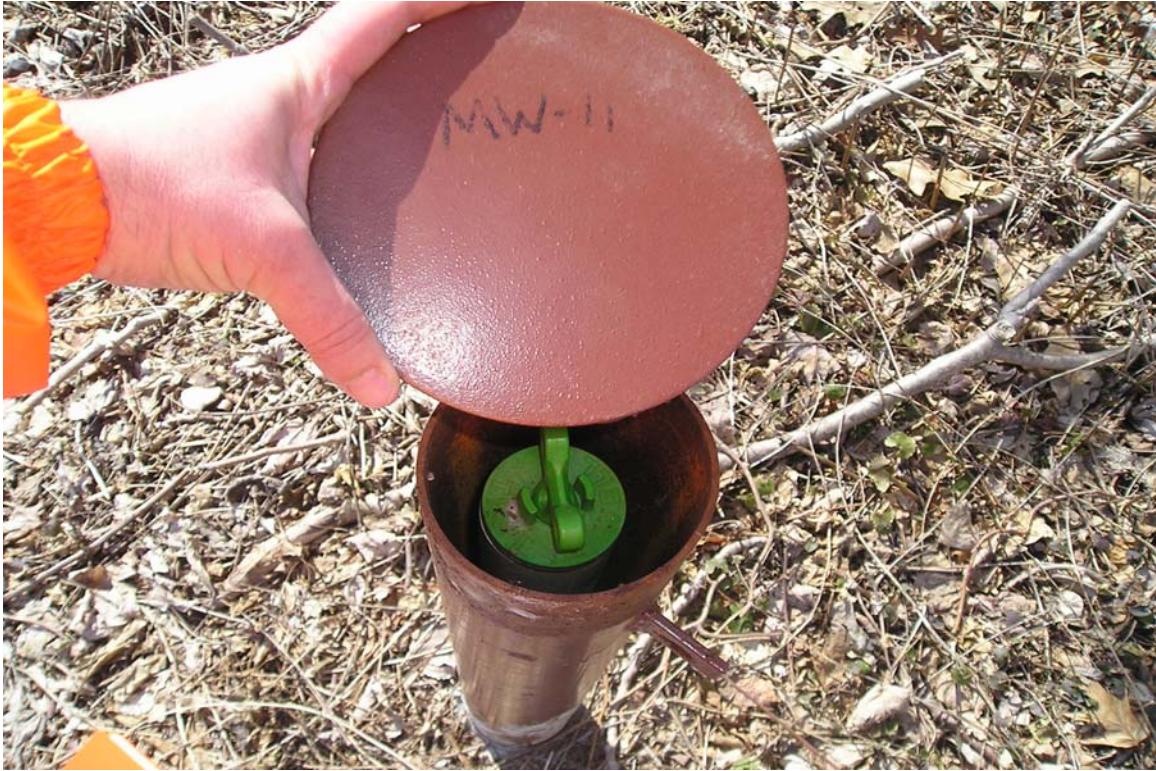
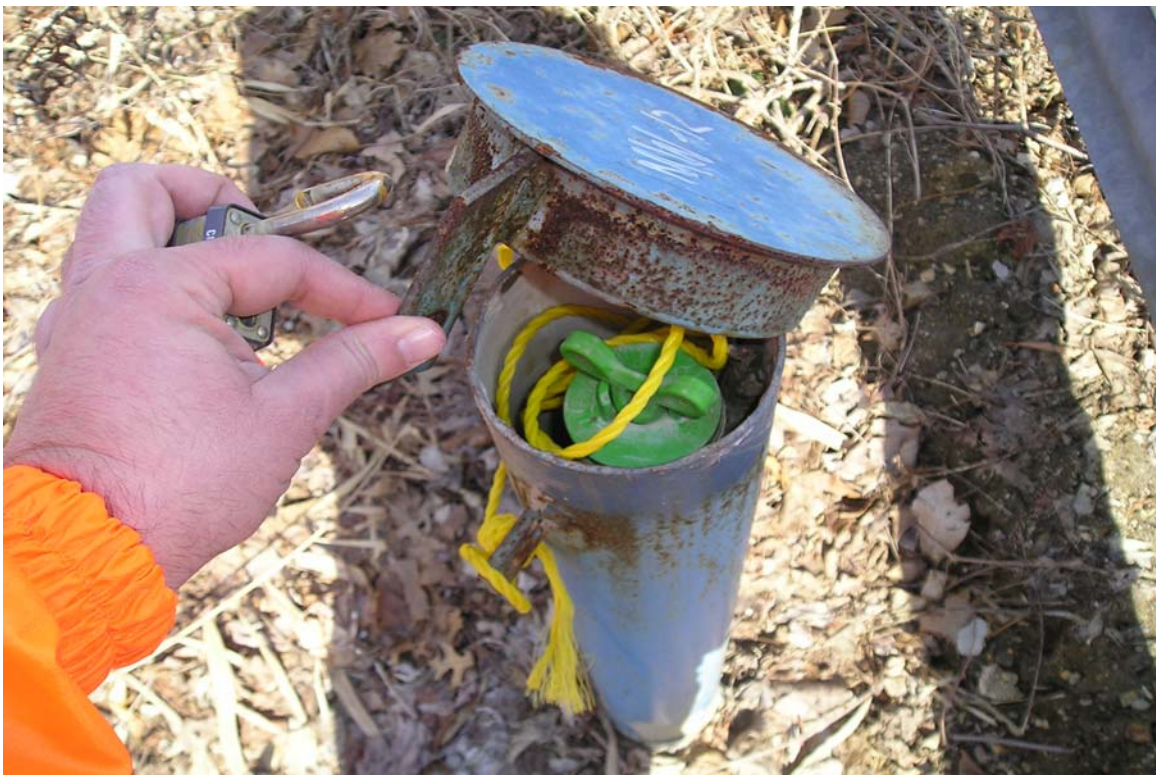
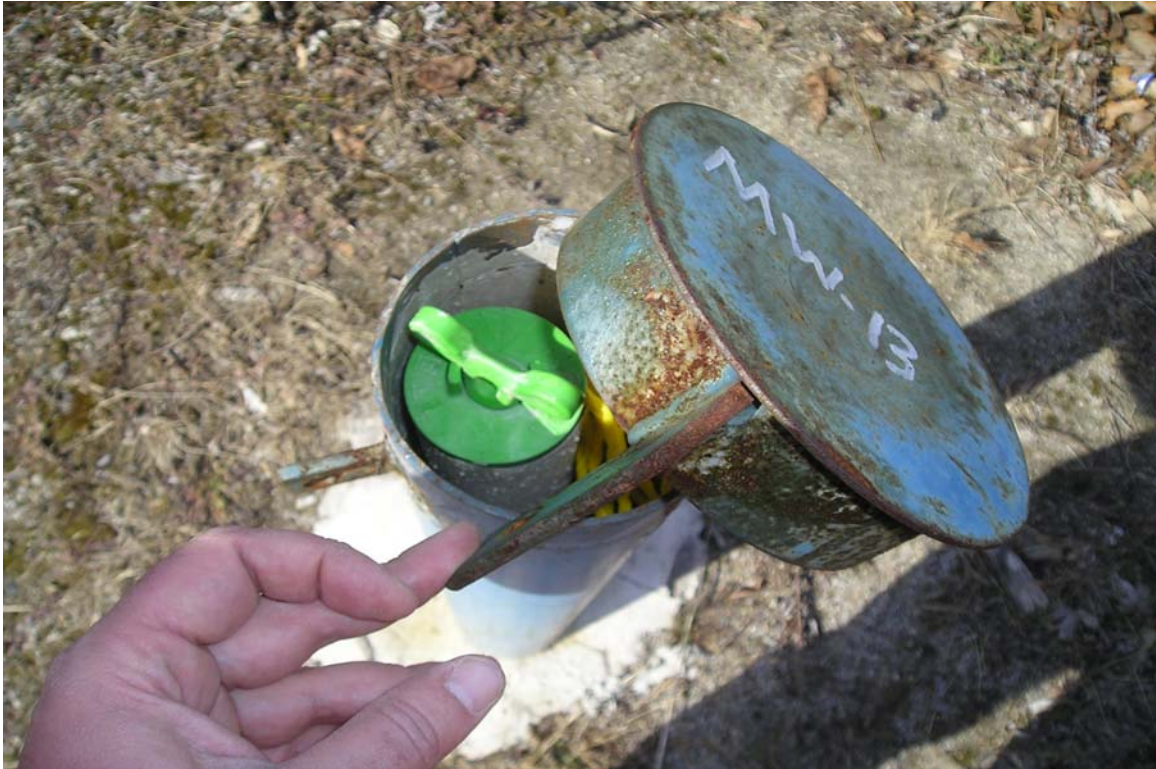
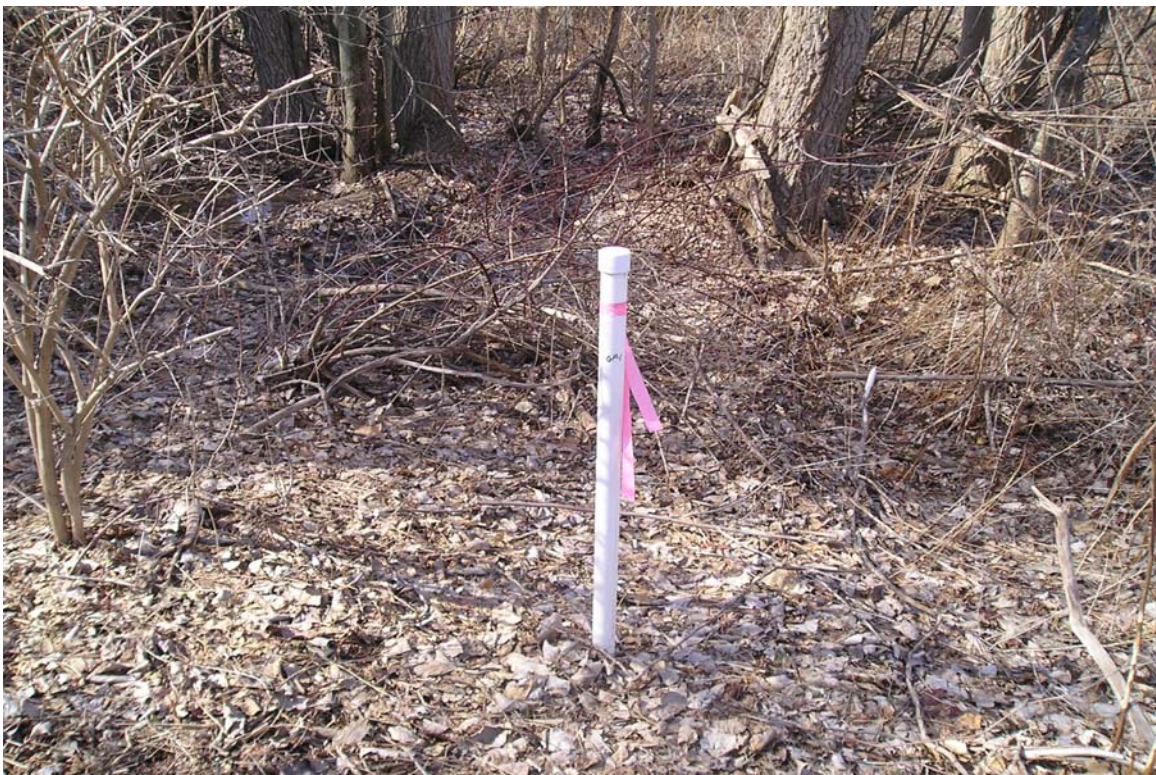
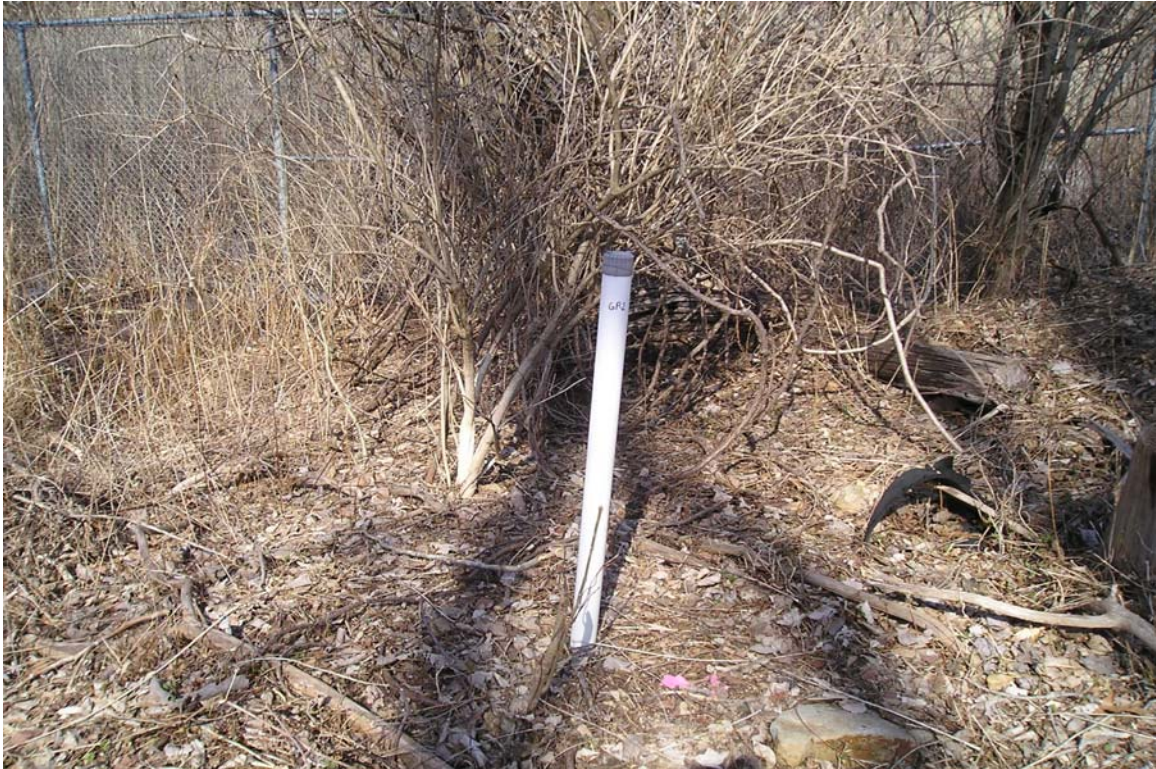
All wells inspected and found to be in good condition (Photos # 5-13). New locks were placed on wells LMW-2, LMW-4, and PC-2 since the last inspection.

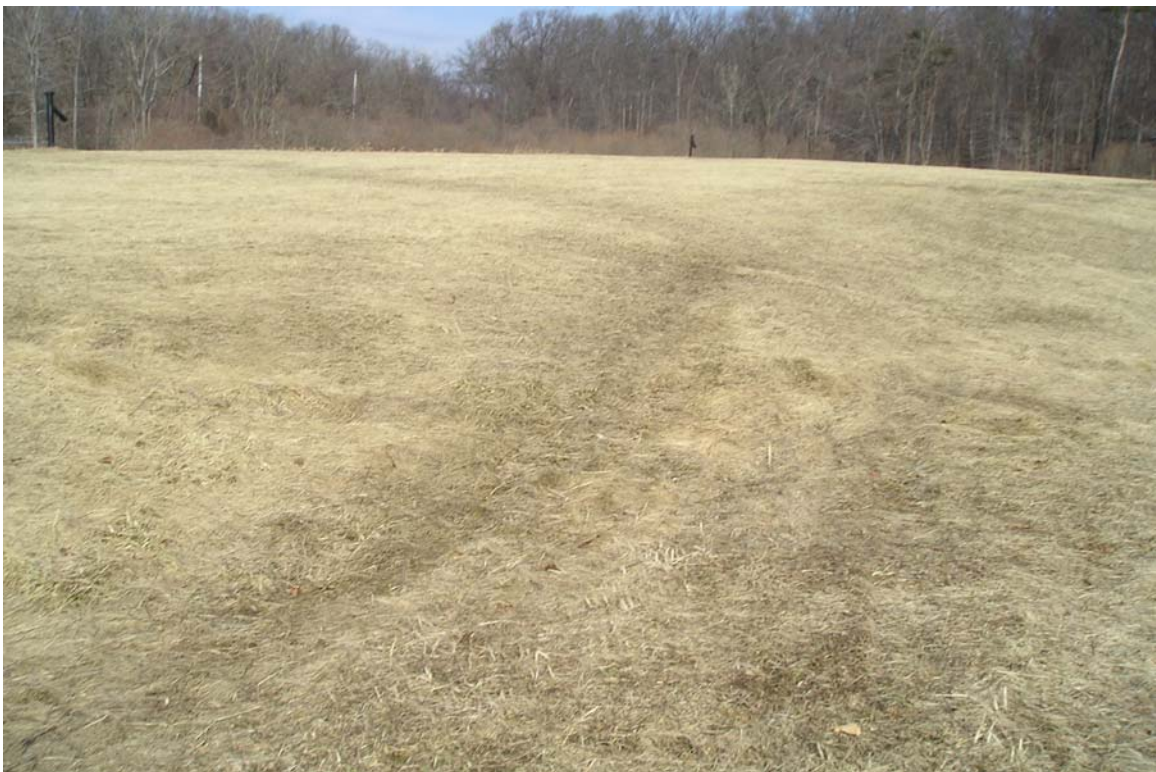
Grass on the entire landfill cover was mowed since the last visit (Photo #14).

Photo 14: Grass on landfill cap

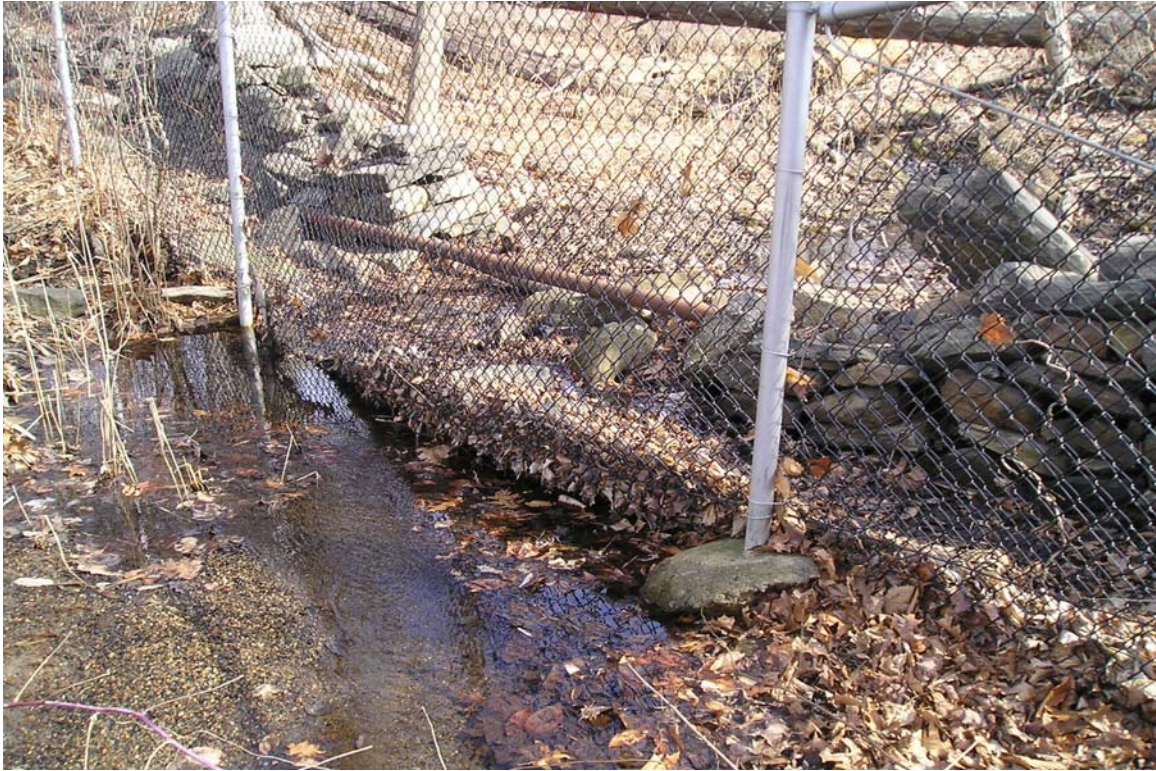
The large gap between the bottom of the fence and the stream surface was narrowed using additional fence material and rock to prevent burrowing animals from entering the landfill area (Photo #15).

Photo 15: Stream inlet

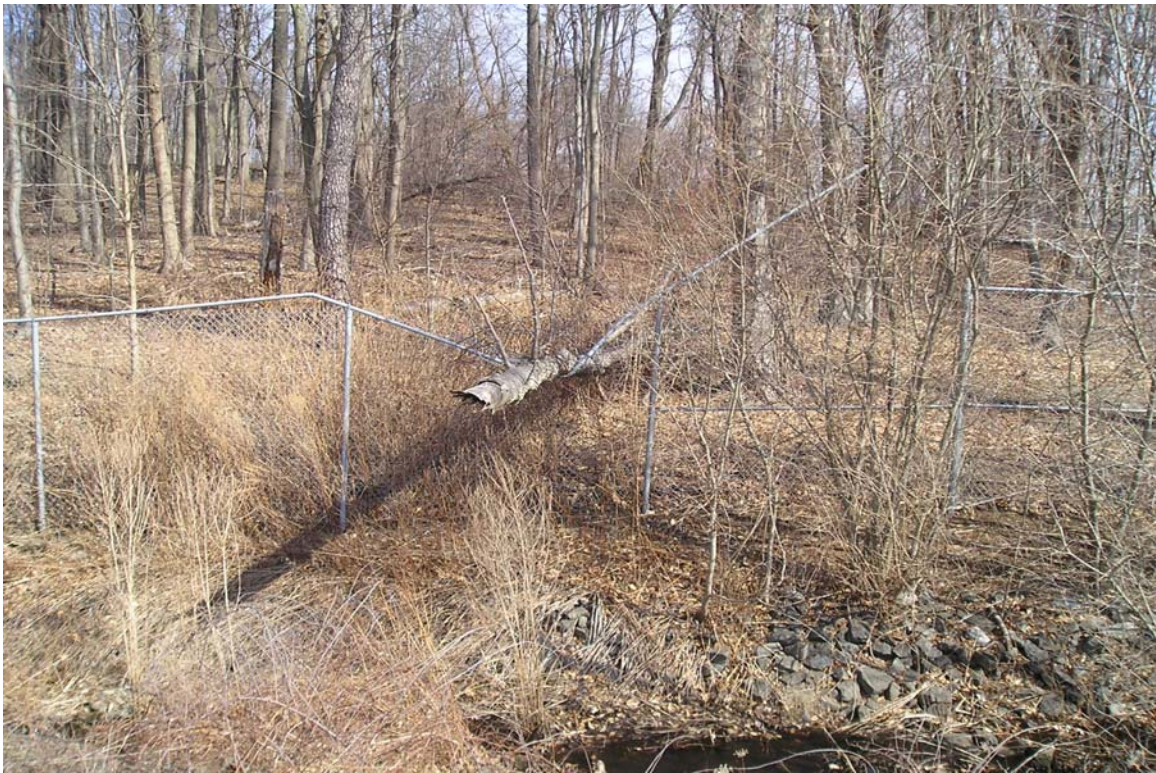
The north fence (towards the east) has a section of its top rail bent and dislodged by a fallen branch (Photo #20) and at the midpoint of the north fence by a fallen tree (Photo #16).

Photo 16: Fallen tree on north fence

1. The northern fence needs to be repaired at the NE section and near the midpoint of the north fence length. Any tree limbs resting on the fence in these areas need to be removed. This should be done by the NYSDOT 8-9 Residency in Valhalla.

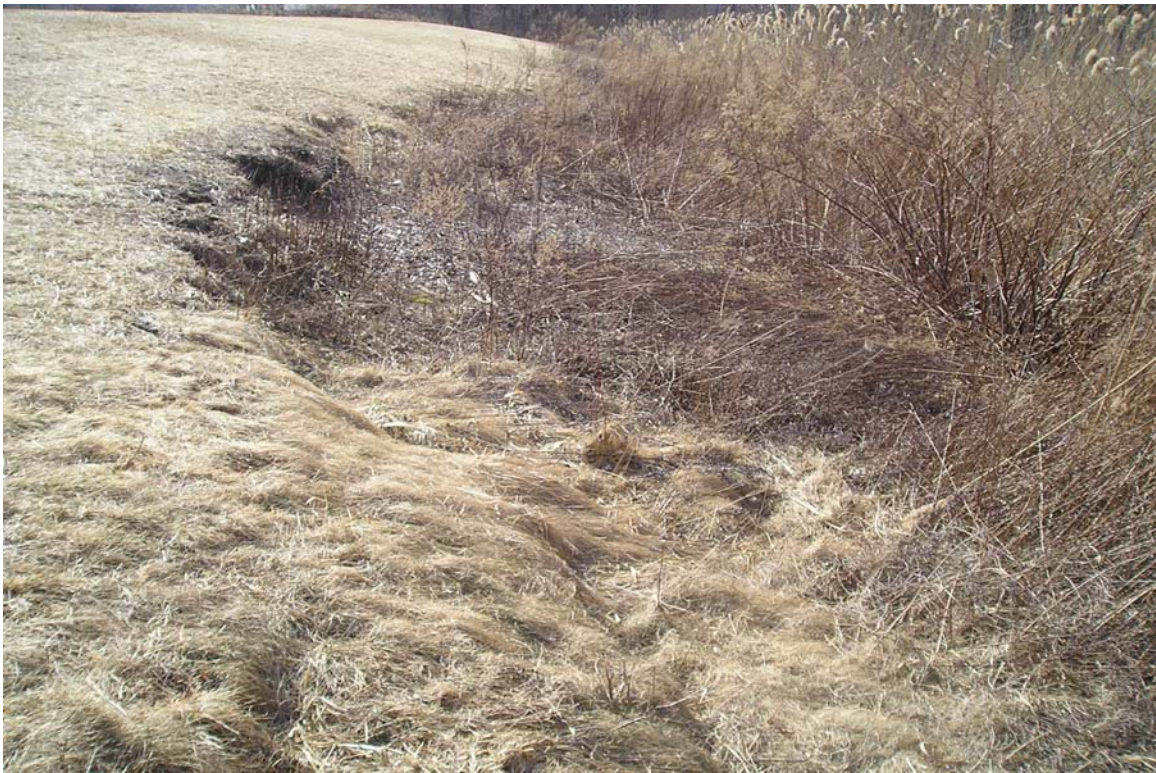
The soil slump on west slope of landfill (Photo #18) still needs to be repaired.

Photo 18: West slope erosion area

2. The soil slump area on the west side of the landfill needs some stone, top soil, and a vegetated mat to prevent any further erosion. Work repair specifications were prepared by NYSDOT Geotechnical Services. Repair work will be done by NYSDOT Residency 8-9 in Valhalla. An on-site preconstruction meeting was held on December 16, 2008.

3. GPS information was obtained from MW-12 and MW-13 and will be used to position the wells on an updated site map..
4. An onsite meeting for the planned landfill slope repair work was held on December 16, 12008. The residency has purchased the materials to repair the slope and plans to perform the repairs the week of March 30, barring any extremely wet weather.

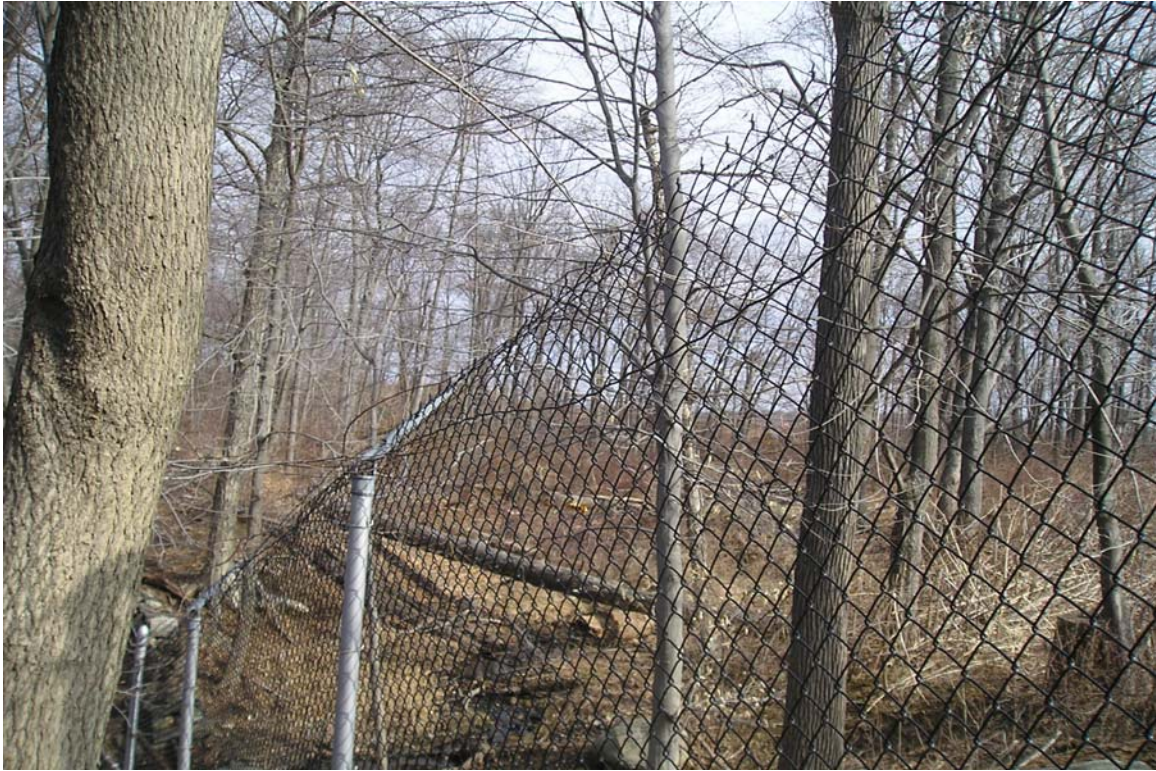
The dangling barbed wire off of the east side of the landfill boundary fence (just south of the stream) was clipped and tucked in during the inspection to reduce the potential for bodily injury near that area (Photo# 19).

Photo 19: East fence near stream inlet (hanging barb wire fixed)

1. The dangling barbed wire off of east side of the landfill boundary fence (just south of the stream) was clipped and tucked in for safety..
2. The faded well labels were repainted and are now more visible.

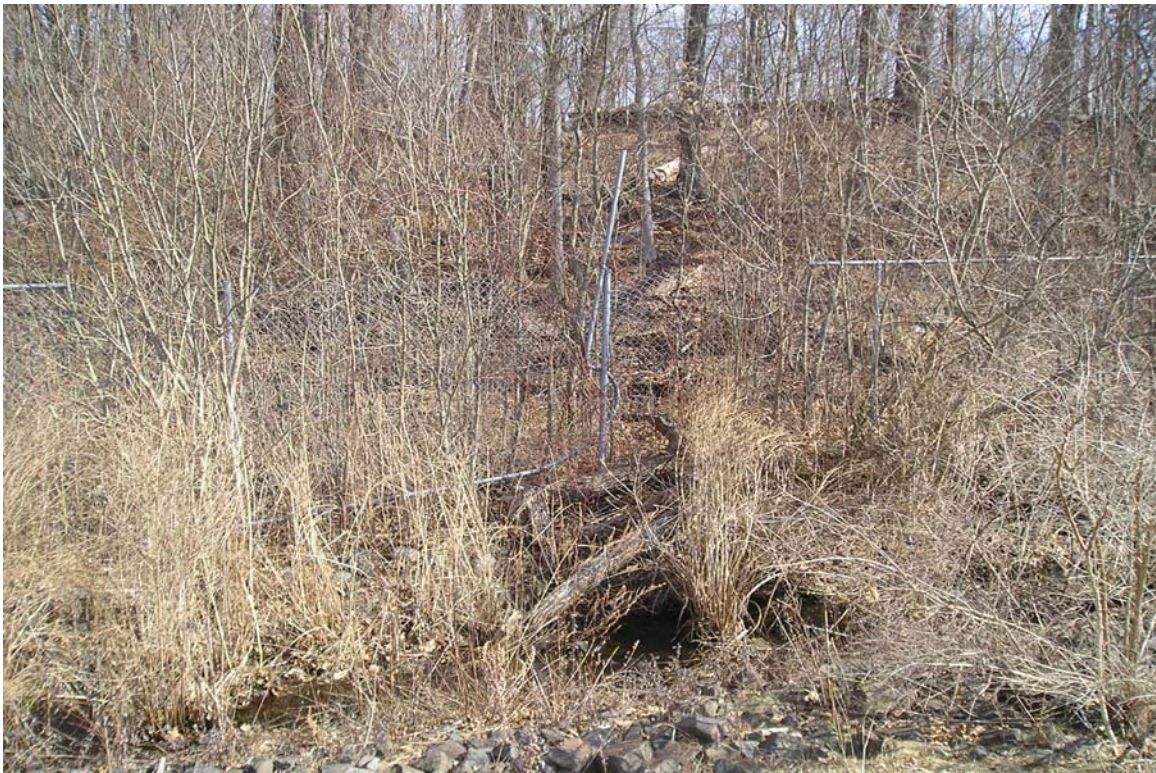
Photo 20: North fence (towards the east) top rail damage
