# HARRISON SUB-RESIDENCY FIELD INSPECTION

**Name of Inspectors:** Chris Kappeller

**Date:** 5/29/09

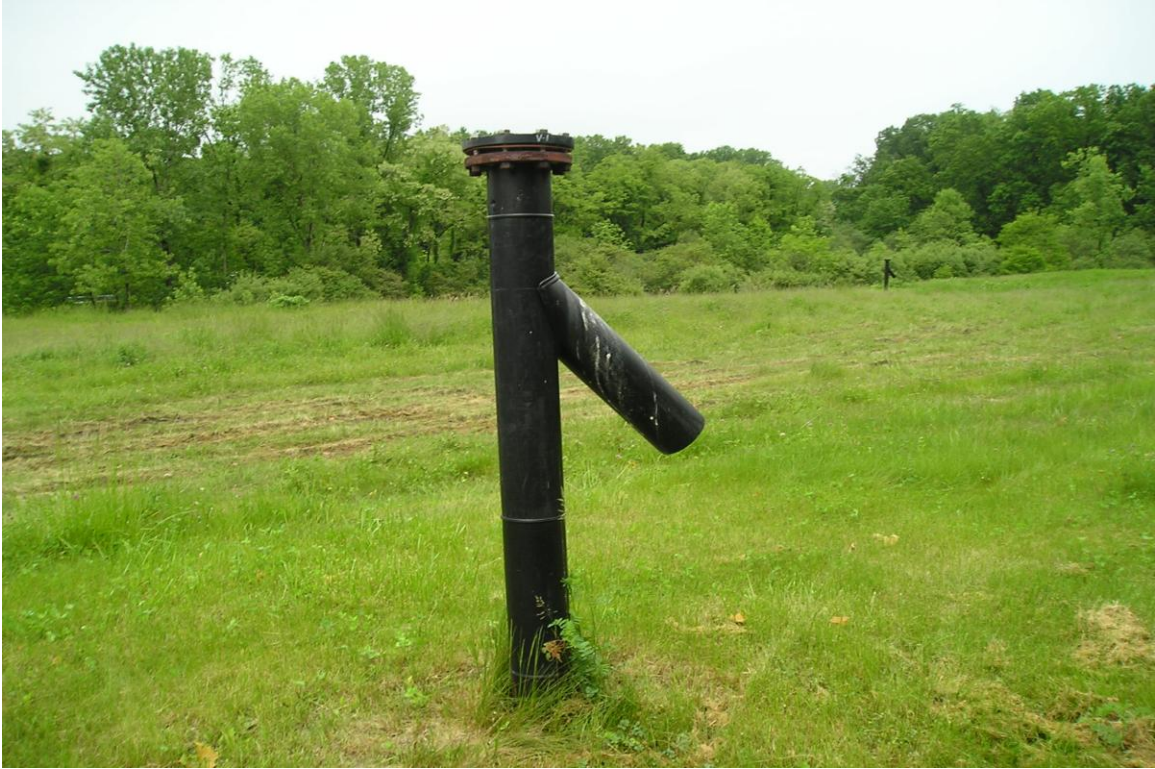
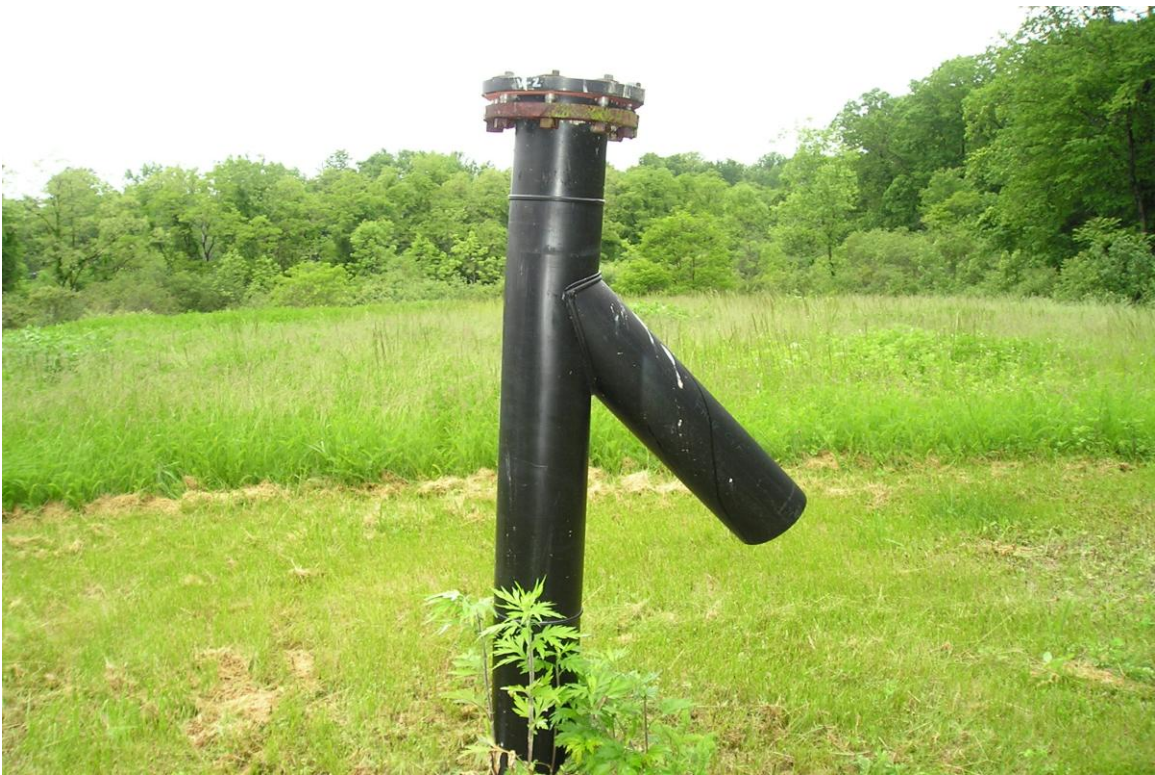
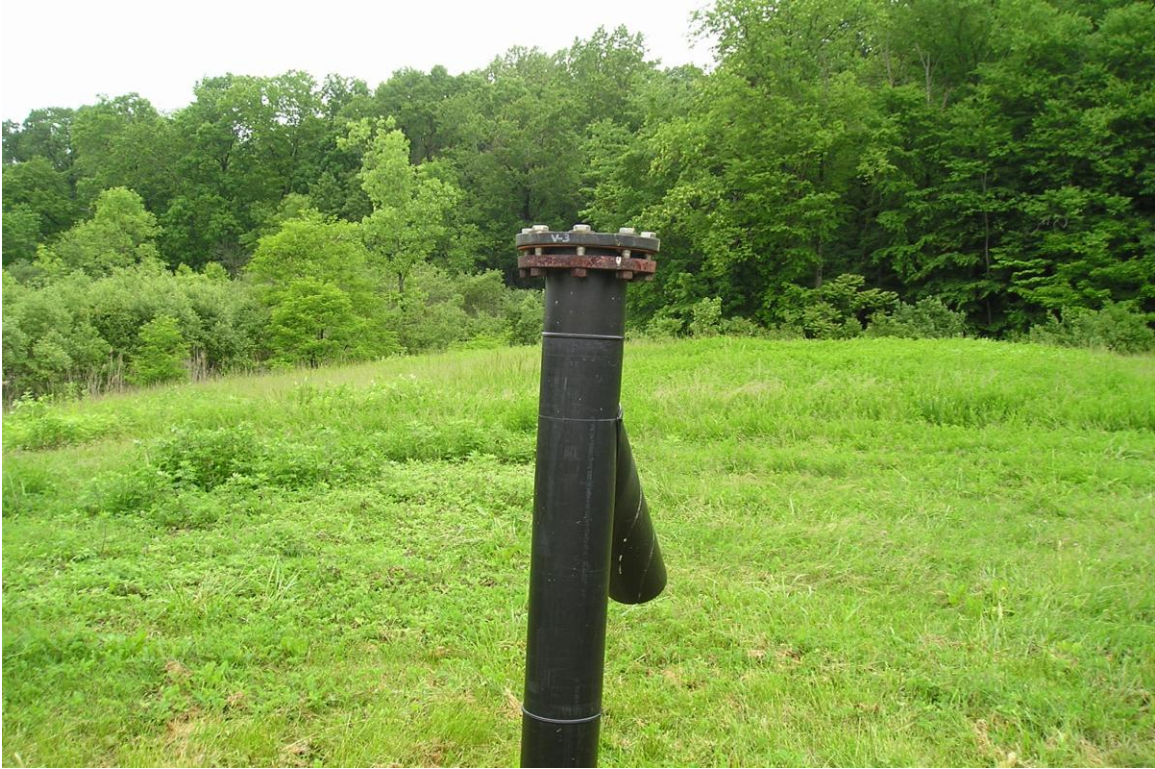
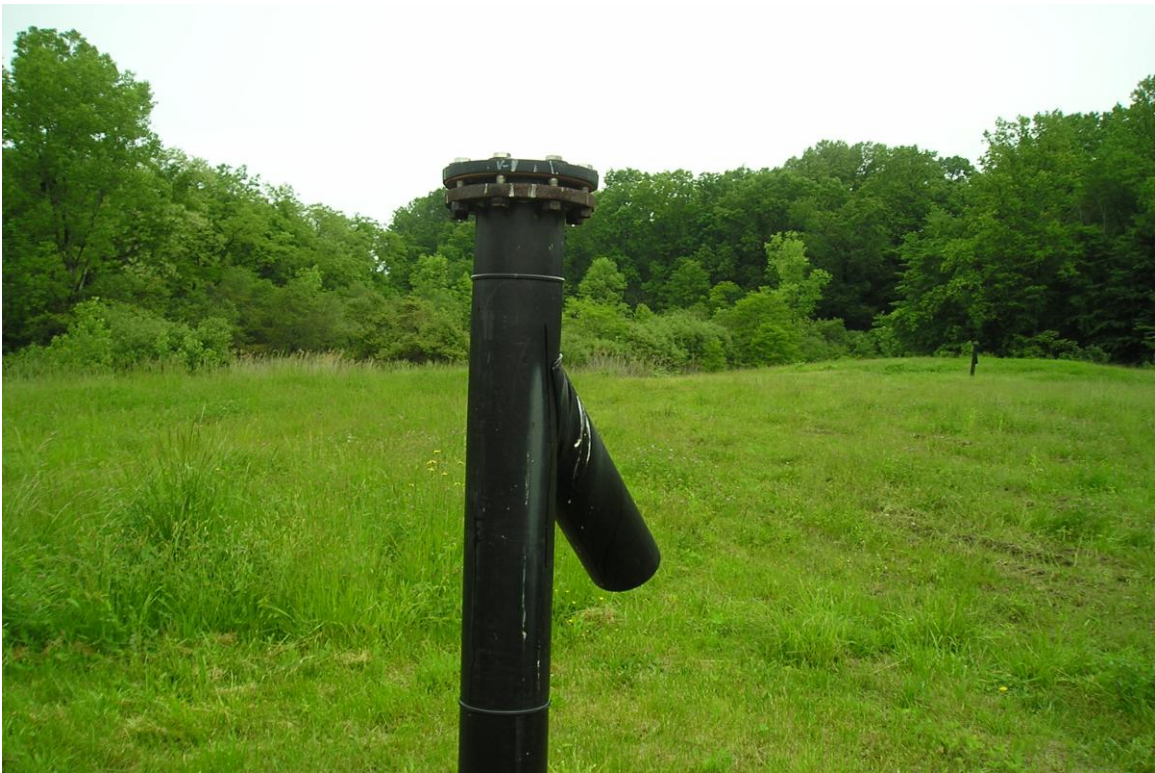
Four vents (V1 – V4) were inspected and found in good condition (visually unblocked, neither cracks nor movement was observed) (Photos # 1-4). V-2 shows a slight lean to north.

Photo 1: Vent V-1

Photo 2: Vent V-2

Photo 3: Vent V-3

Photo 4: Vent V-4

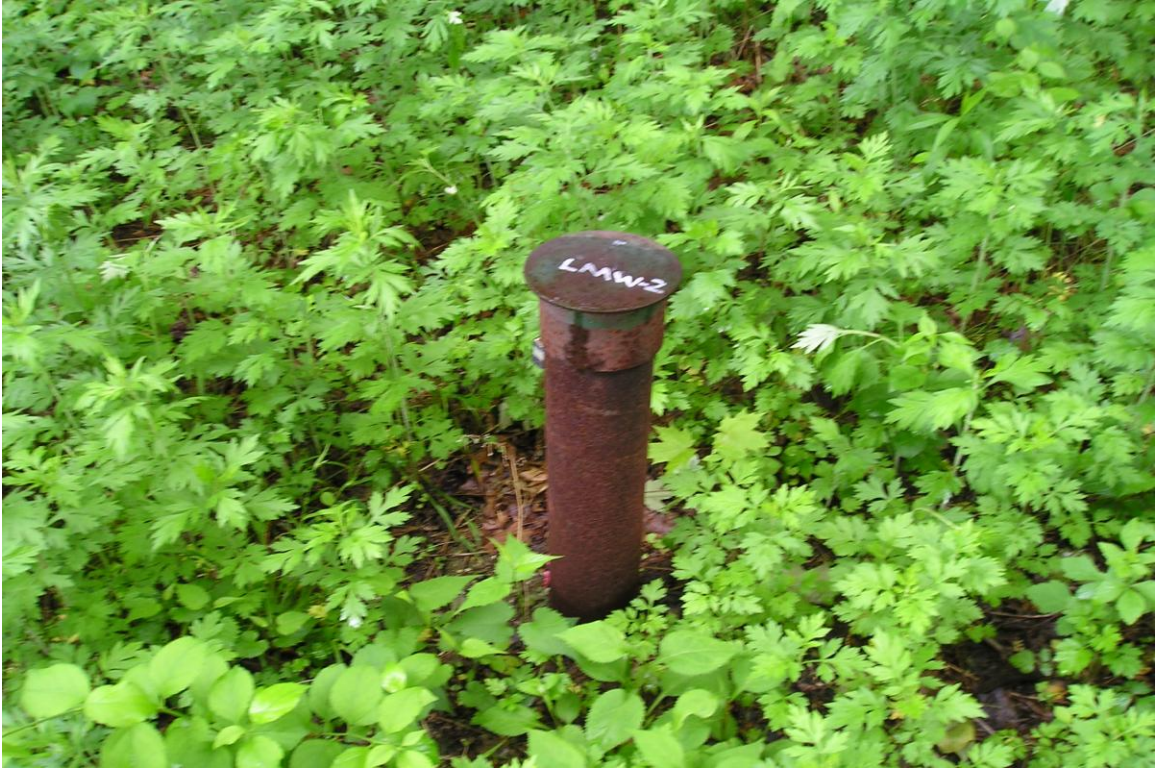
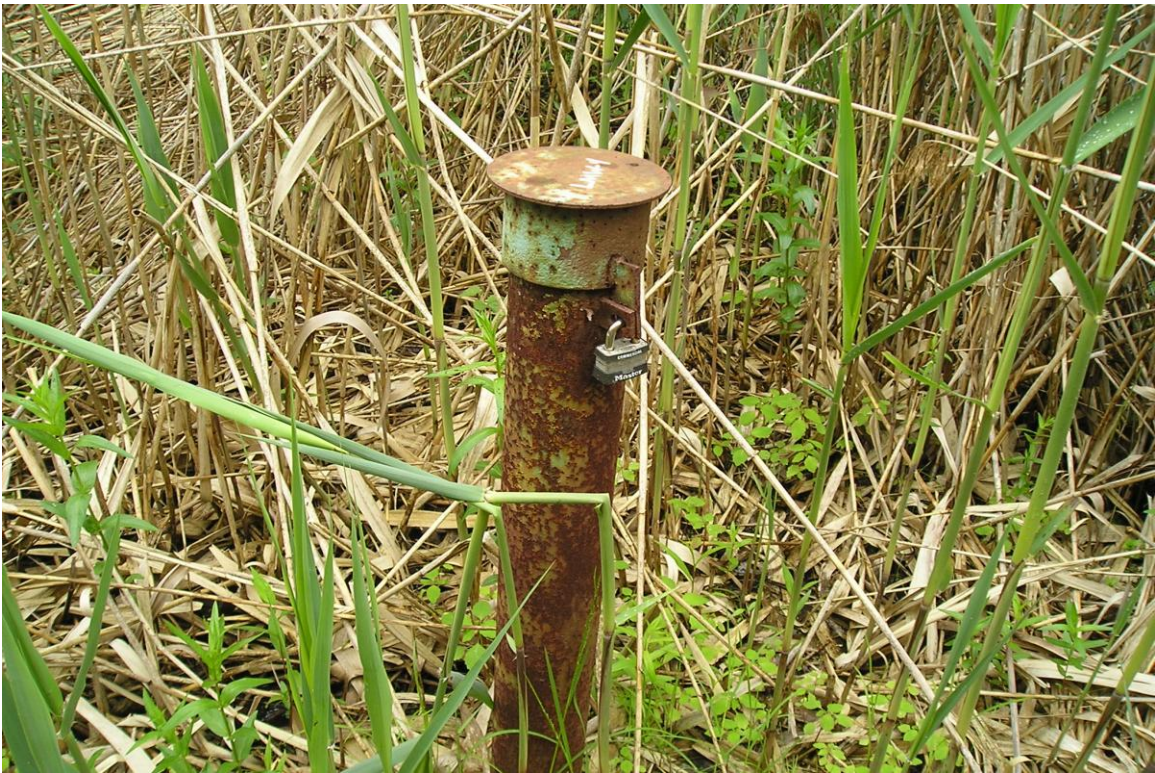
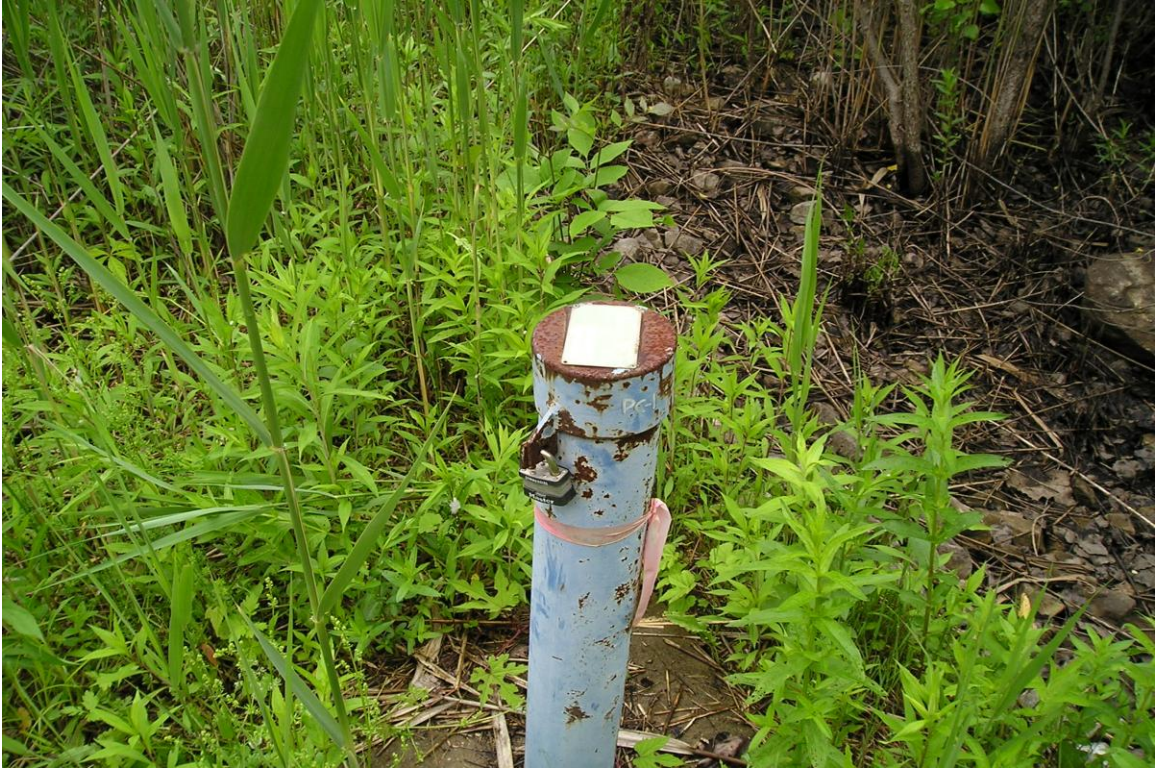
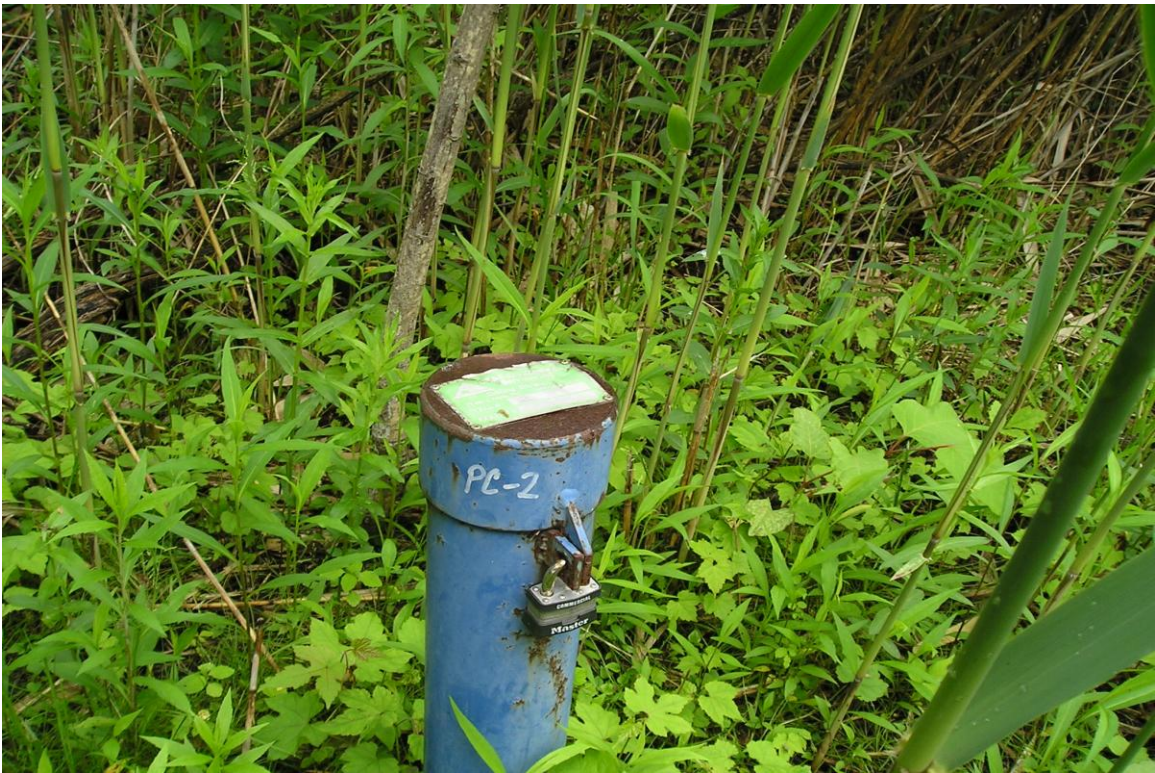
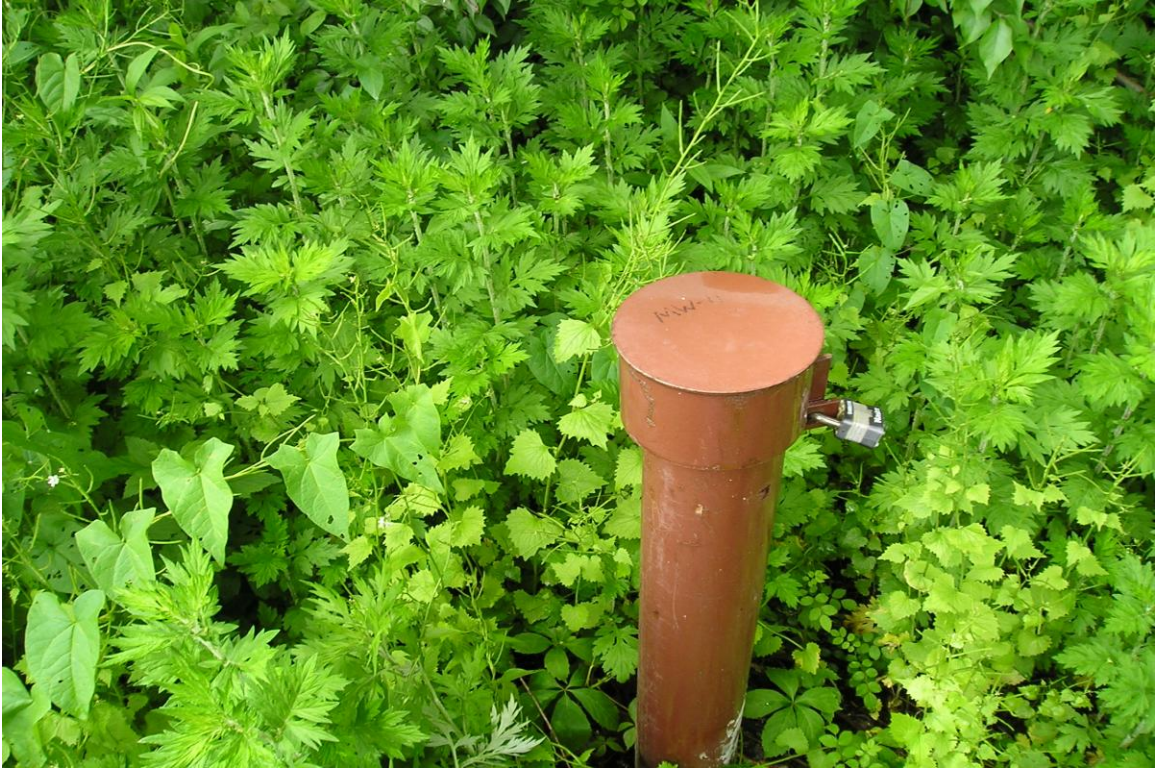
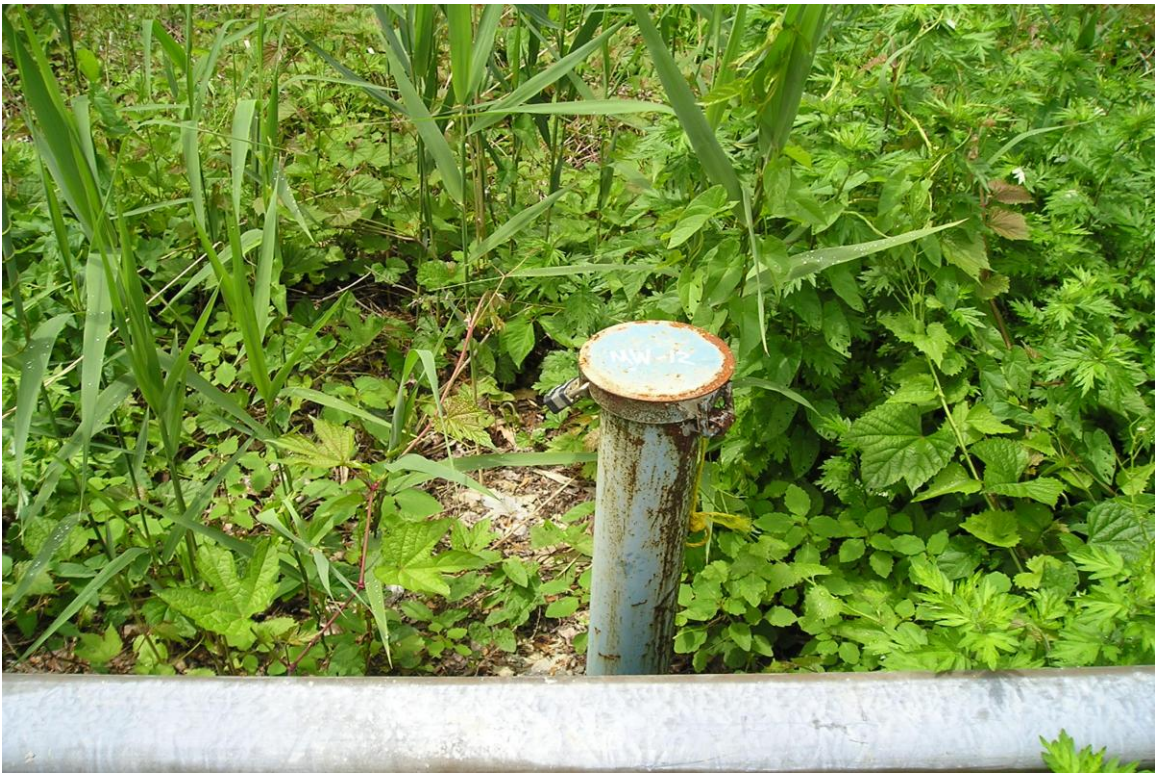
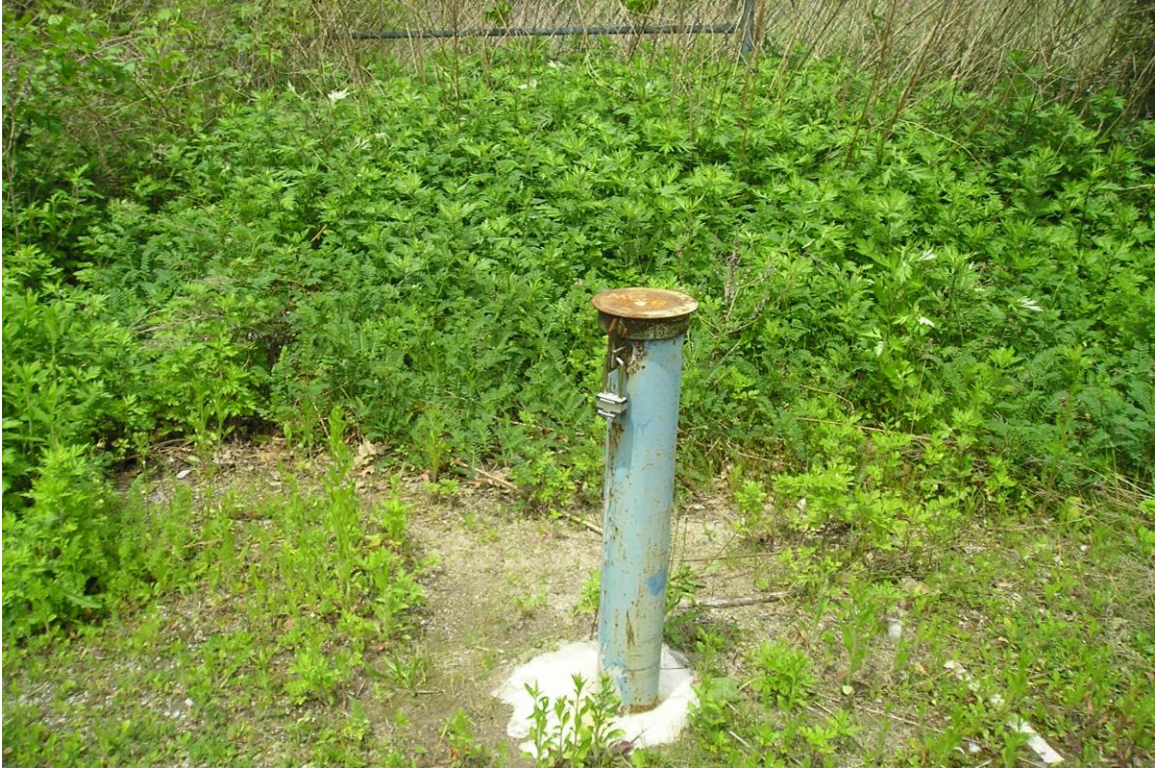
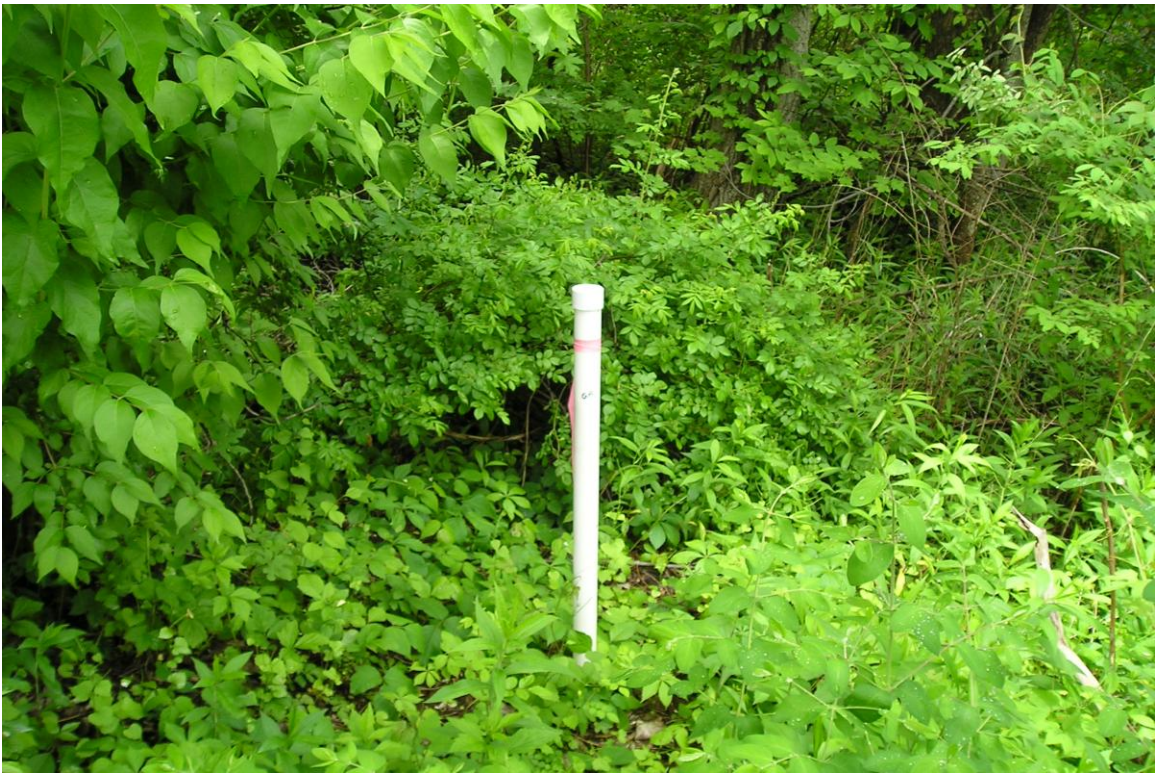
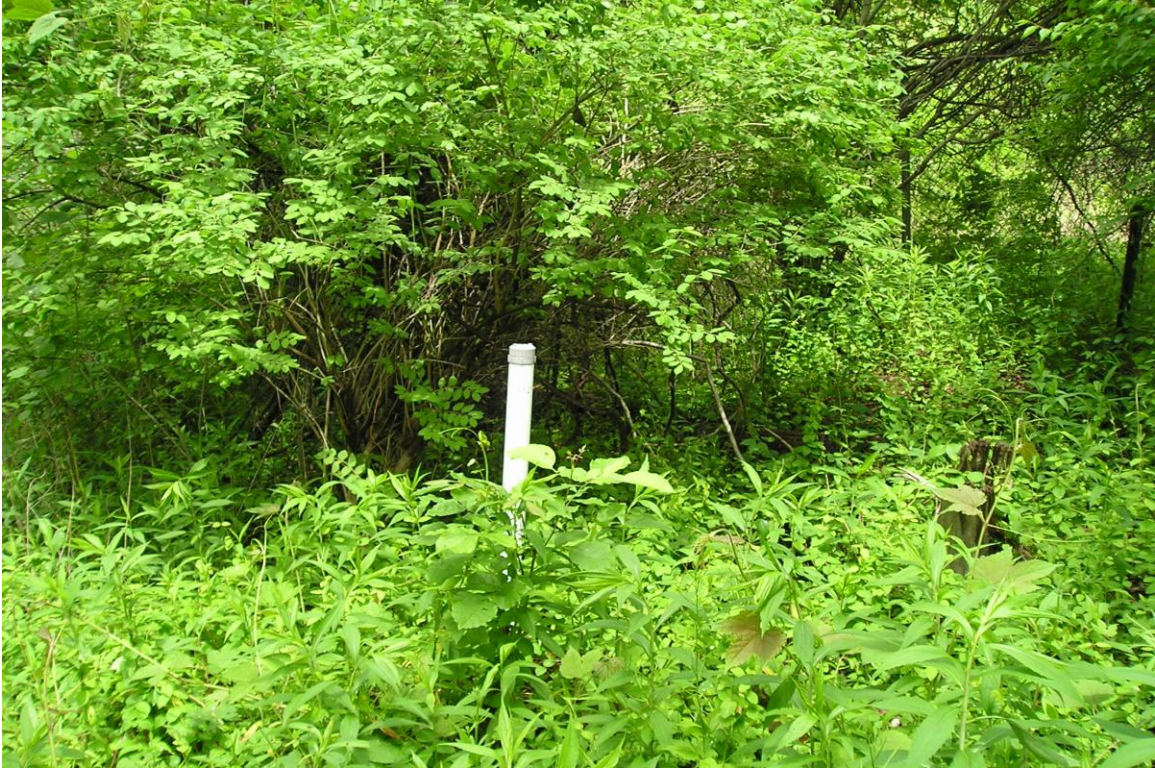
All wells inspected and found to be in good condition (Photos # 5-15). Several monitoring wells onsite were decommissioned in May and June of 2008 due to low or non-detect petroleum related compounds in water samples obtained from each during the course of the groundwater monitoring program that is still in progress. NYSDEC approved the decommissioning of these wells. The remaining wells left active in the petroleum remediated area for periodic sampling include MW-1, MW-11, GP-1, GP-2 and PC-1.

Photo 5: Well LMW-2

Photo 6: Well LMW-4

Photo 7: Well PC-1

Photo 8: Well PC-2

Photo 9: Well MW-11

Photo 10: Well MW-12

Photo 11: Well MW-13

Photo 14: Well GP-1

Photo 15: Well GP-2

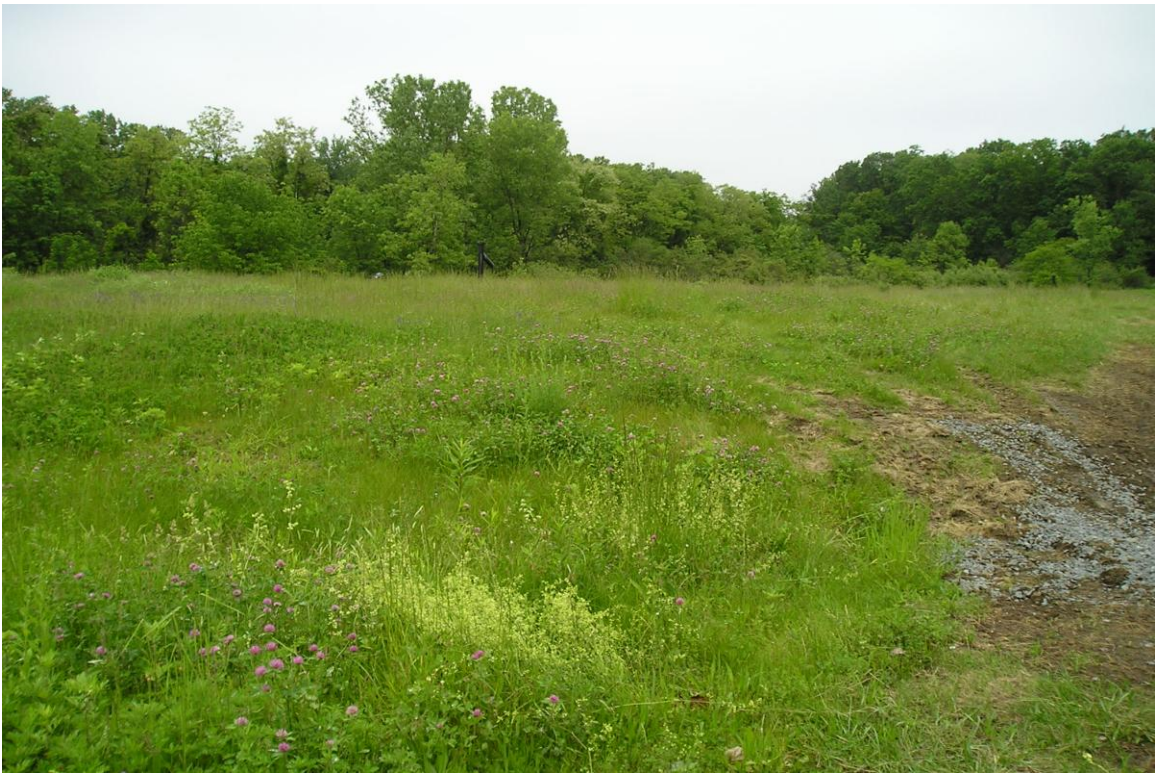
Grass on the entire landfill cover needs to be mowed (Photo #16).

Entire grass cover of the landfill needs to be mowed.

Photo 16: Grass on landfill cap

1. Along with landfill mowing, the areas around the landfill vents and some of the paths leading to the monitoring wells that have become overgrown during the spring and summer months need to be weed whacked.
2. Well cap keys are located in the left drawer of the facility office desk.
3. During the next 5<sup>th</sup> quarter sampling round, a soil and/or water sample from the area of orange iron bacterial staining should be collected and analyzed.

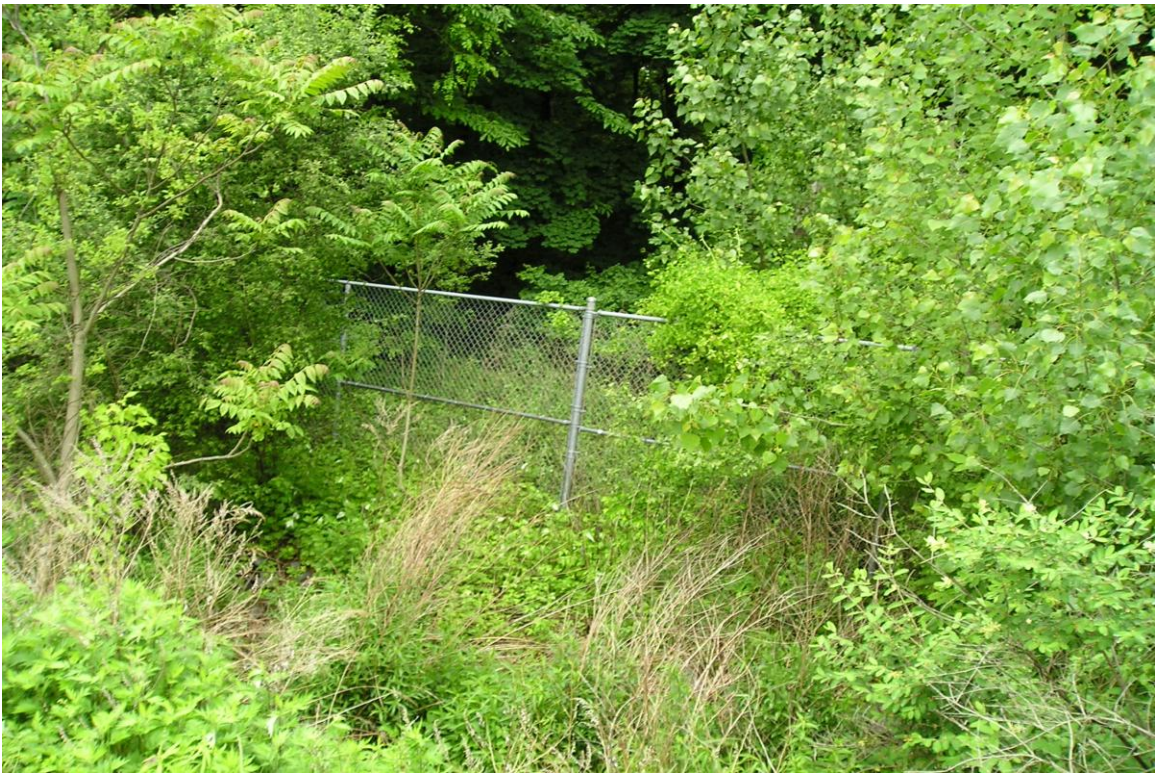
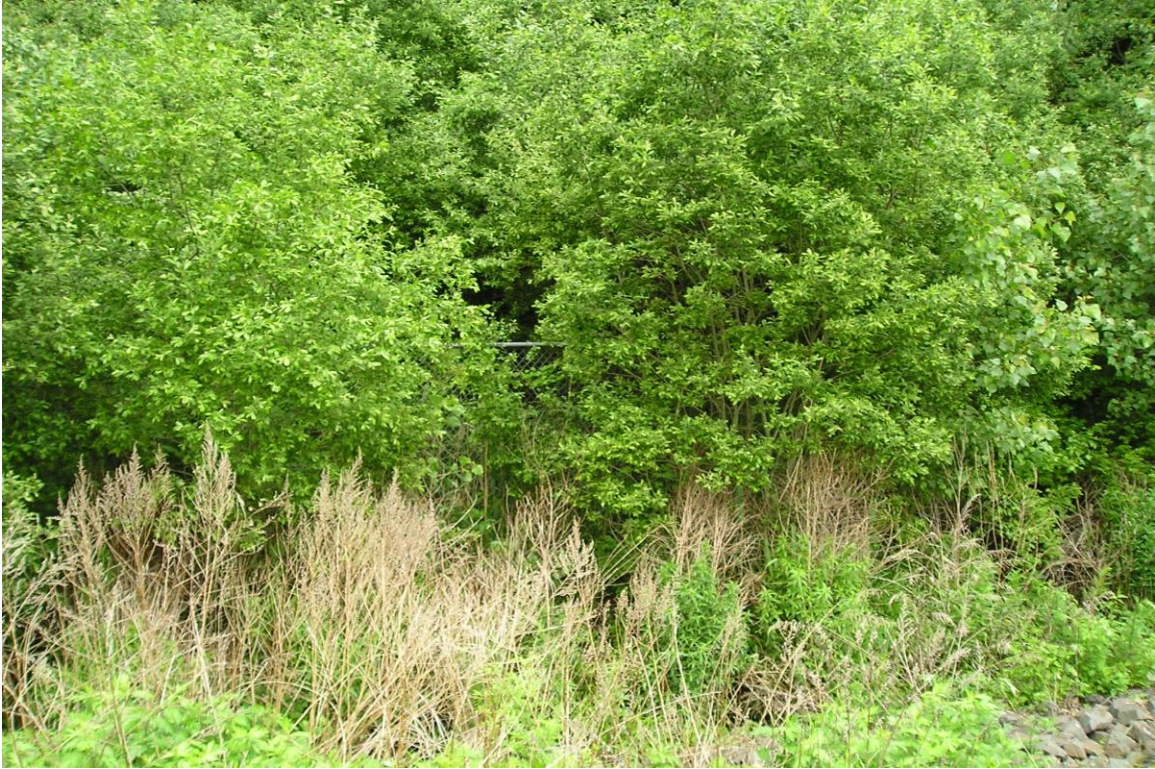
Tree limbs lying on sections of the north fence were removed and damage to the fence was repaired by NYSDOT Residency 8-9 personnel (Photo 18 & 19).

Photo 18: Fallen tree repair on north fence (mid section)

Photo 19: North fence (towards the east) top rail repaired

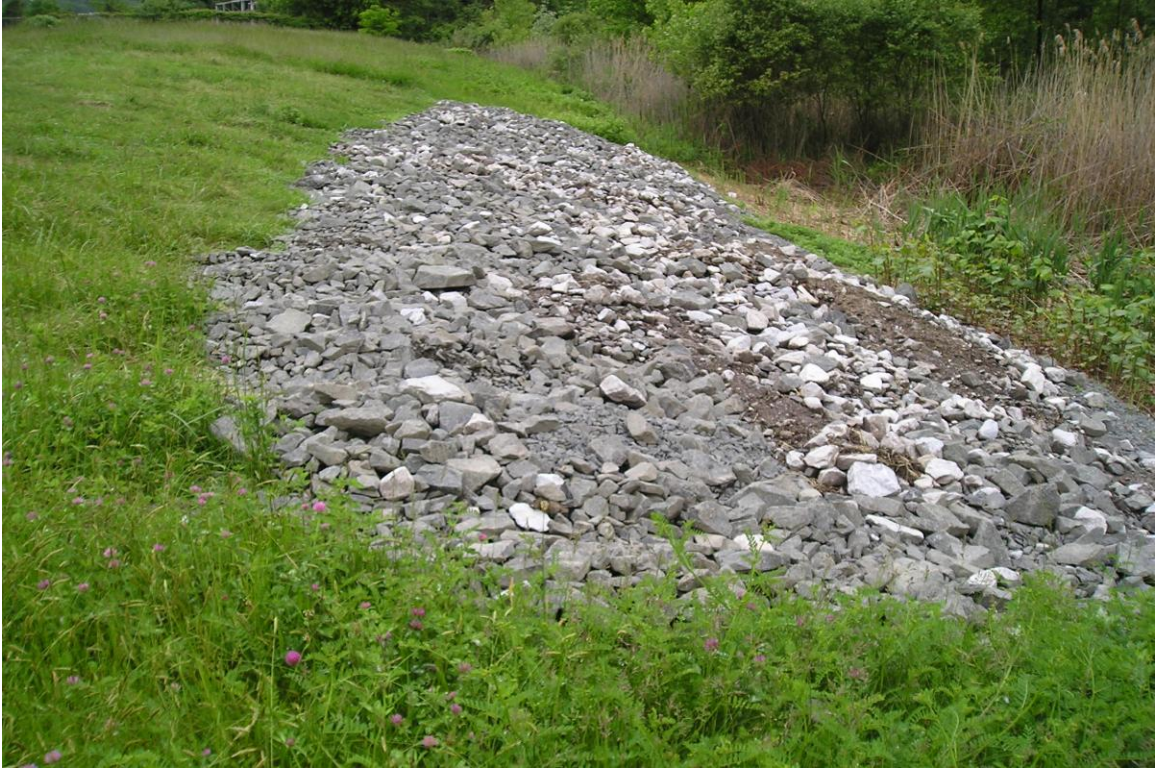
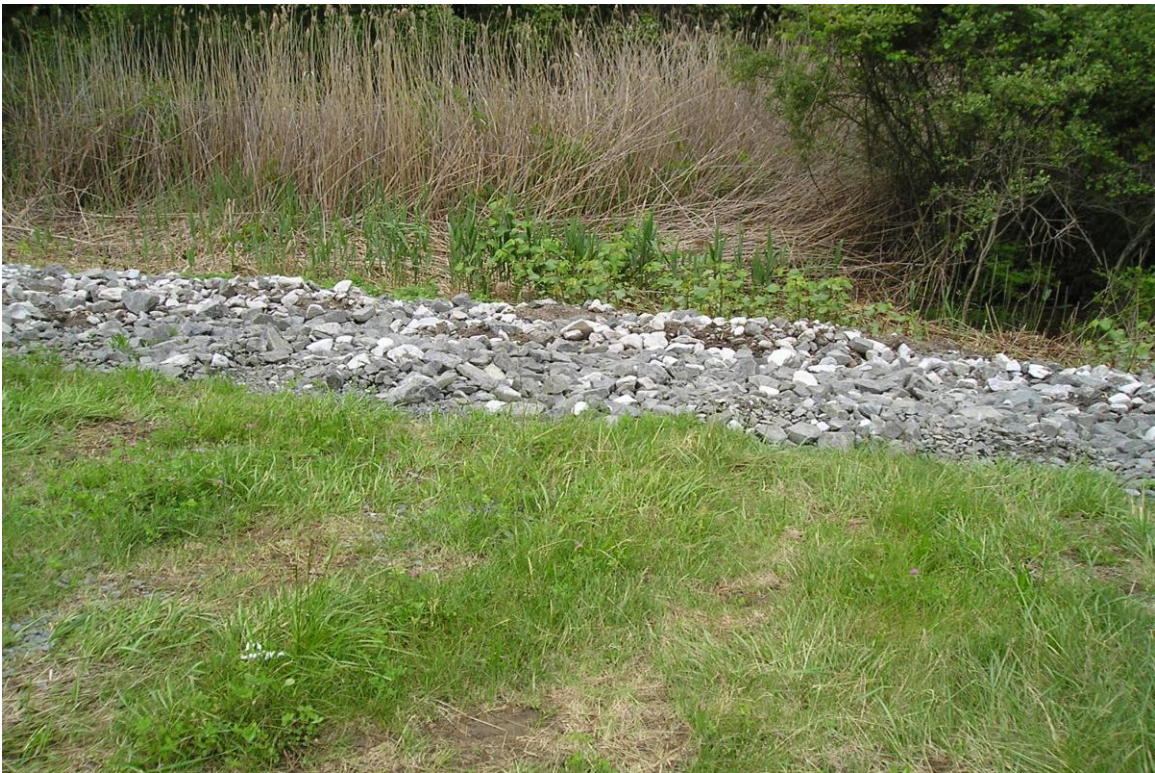
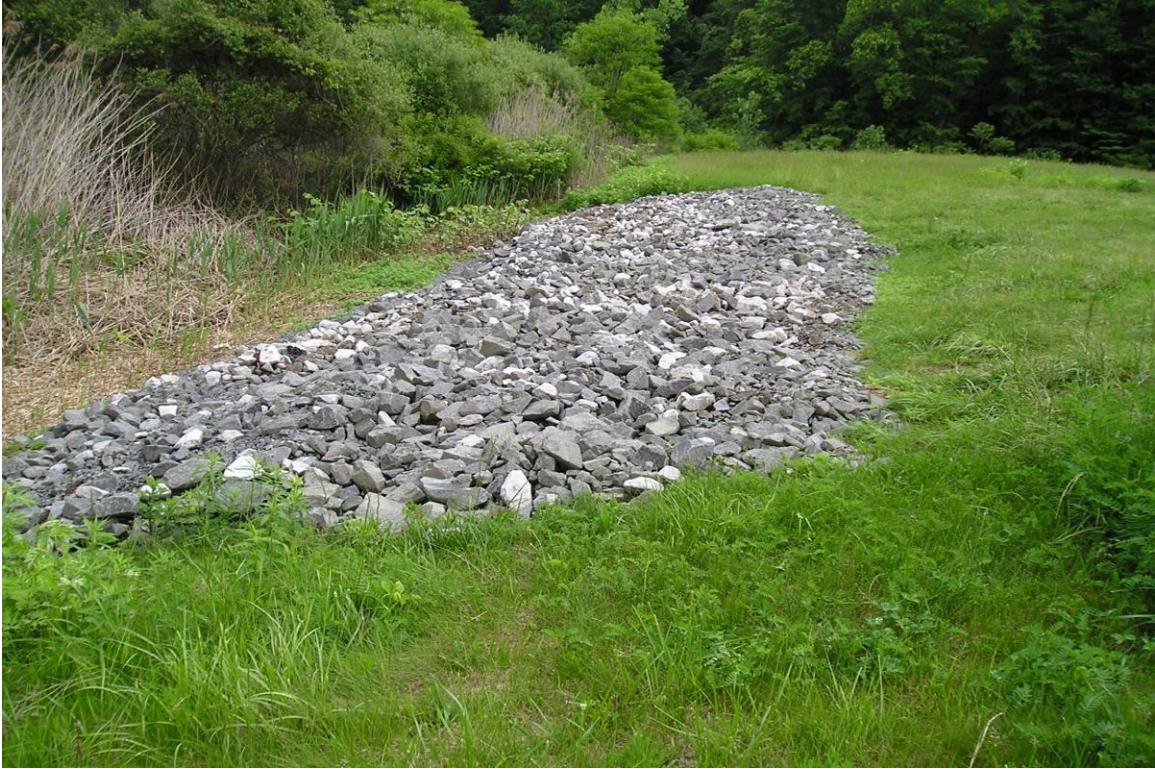
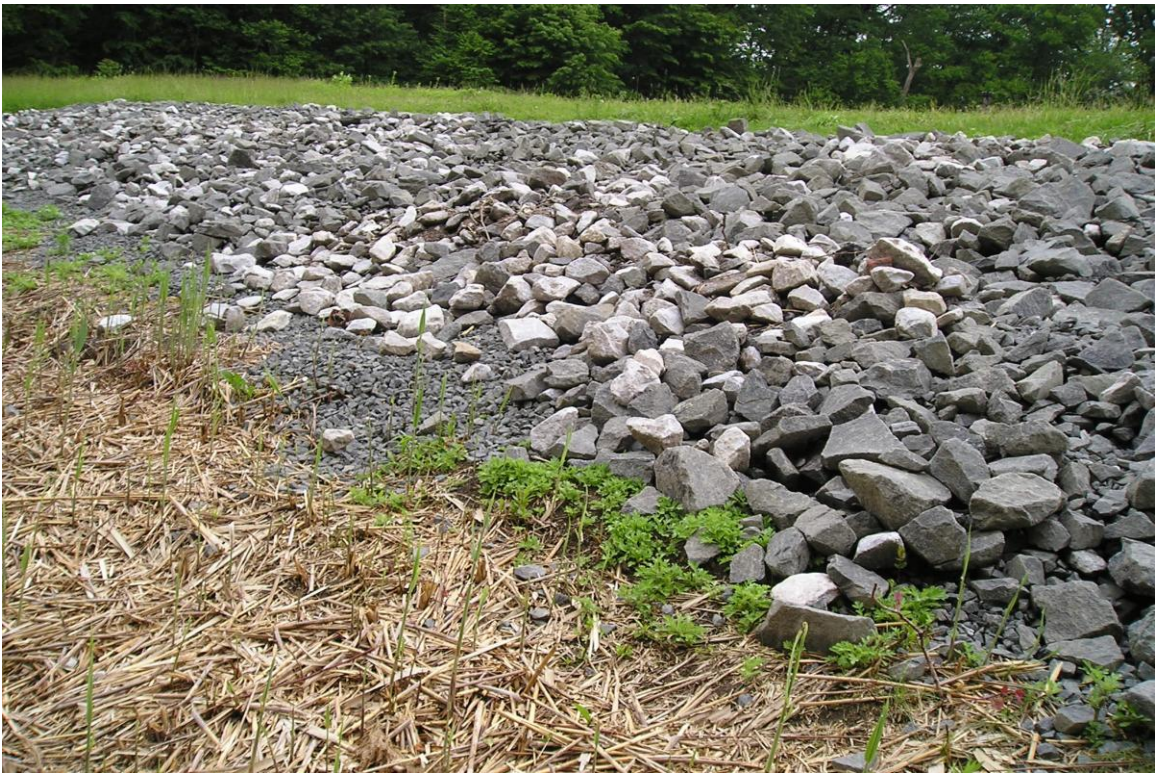
The soil slump on west slope of landfill (Photos 21-24) was repaired in May 2009 by NYSDOT Residency 8-9 personnel. Approximately 6" thick mat of #2 crushed stone (NYSDOT Standard Spec. 623.12) was placed on the slump then covered with approximately 12" of fine stone fill (NYSDOT Standard Spec. 620.02). Repair suggestions were provided by the NYSDOT geotechnical department.

Photo 21: West slope erosion area repair (looking south)

Photo 22: West slope erosion area repair (looking west)

Photo 23: West slope erosion area repair (looking north)

Photo 24: West slope erosion area repair (looking east)

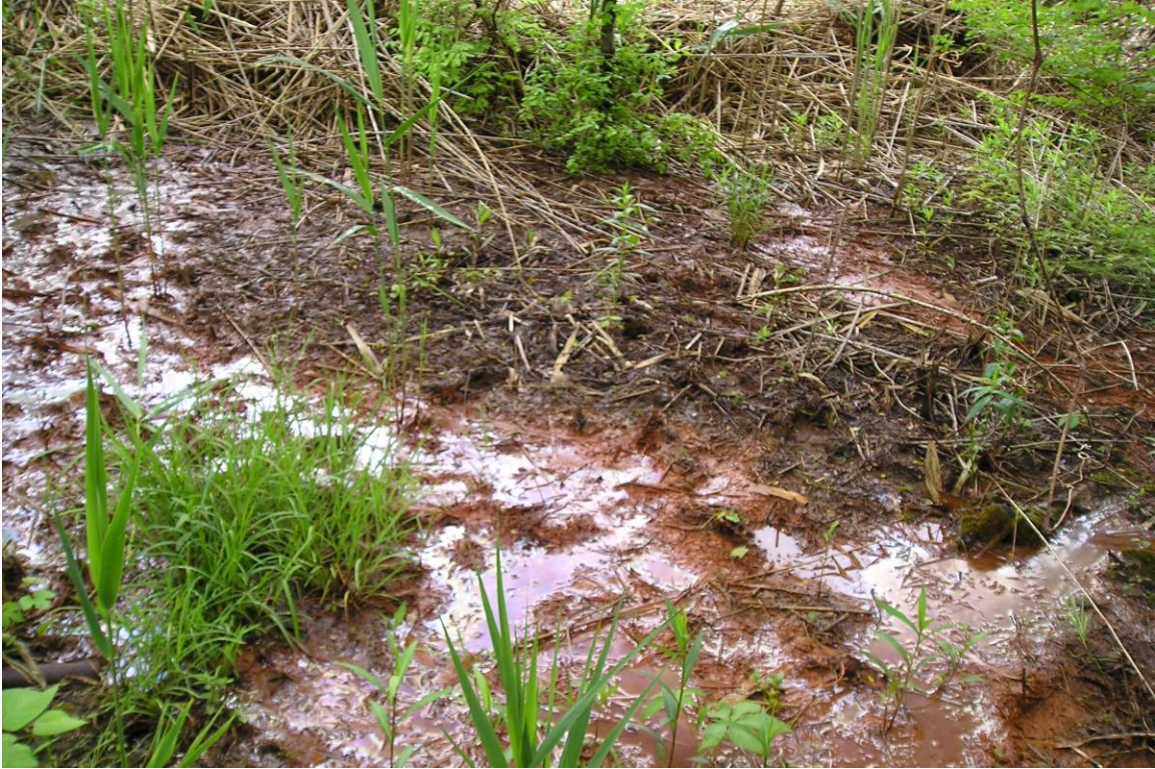
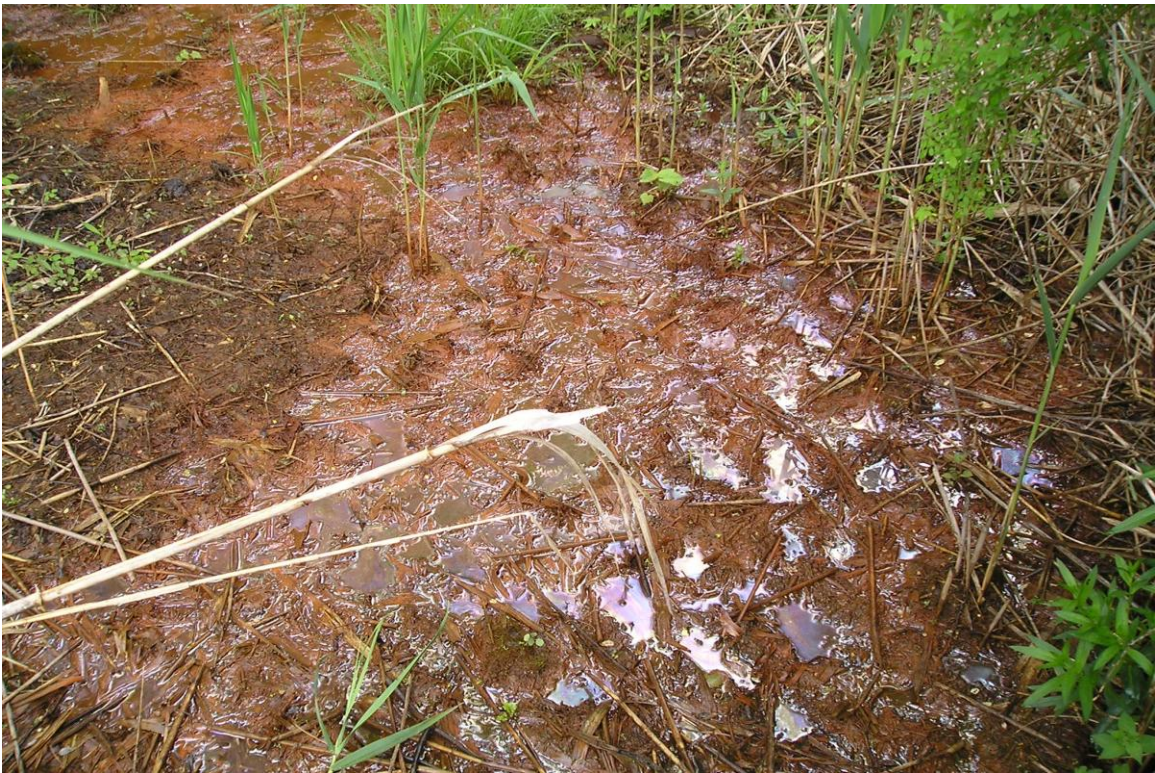
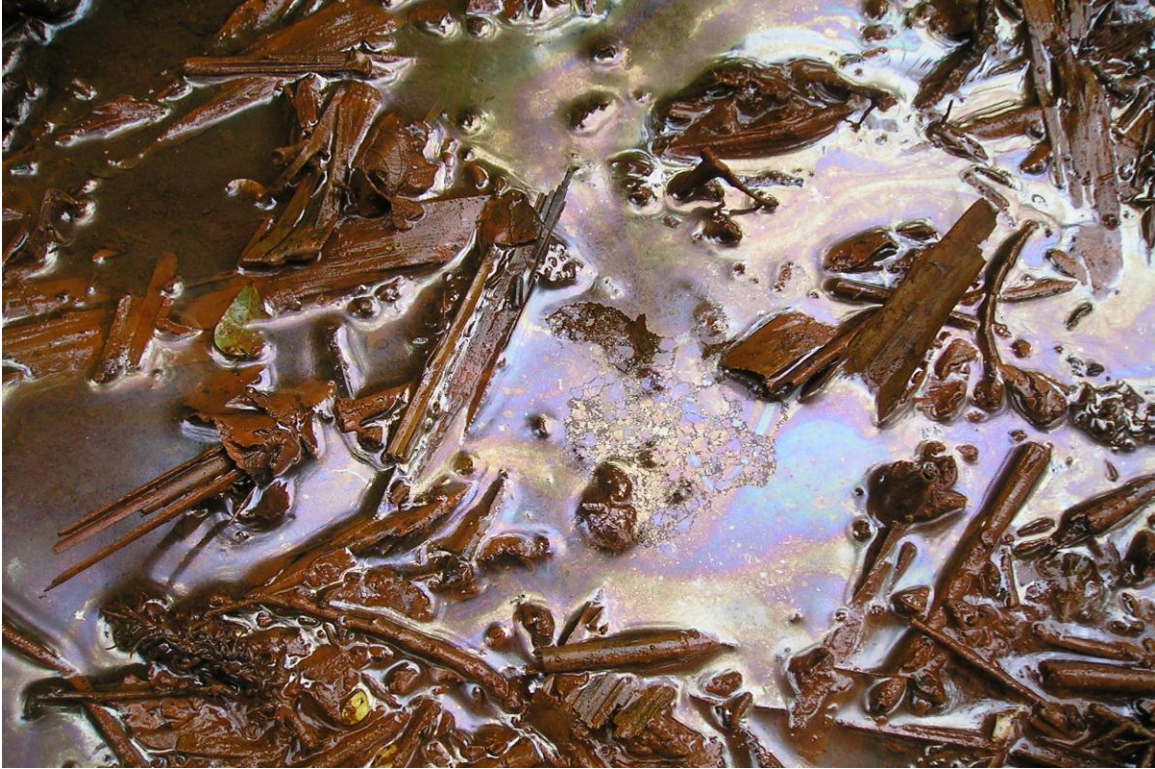
Area of orange iron bacteria staining exists near the area just east of PC-2 and down slope of the slump repair. An iridescent film was noted on the standing water of the orange staining, which broke into jagged pieces when disturbed (Photos 25 - 27). No questionable odors were noted on the stained soil or the standing water (marsh-like odor). Area of staining tends to fluctuate with the change in season (less pronounced in winter) and more pronounced when increased disturbance from deer foot traffic through this area is observed and during the spring and summer months.

Photo 25: Orange staining near PC-2 (view 1)

Photo 26: Orange staining near PC-2 (view 2)

Photo 27: Iridescent film on water where orange staining is located
