HARRISON SUB-RESIDENCY FIELD INSPECTION

Name of Inspector: Chris Kappeller

Date: 4/22/10

Semi-Annual

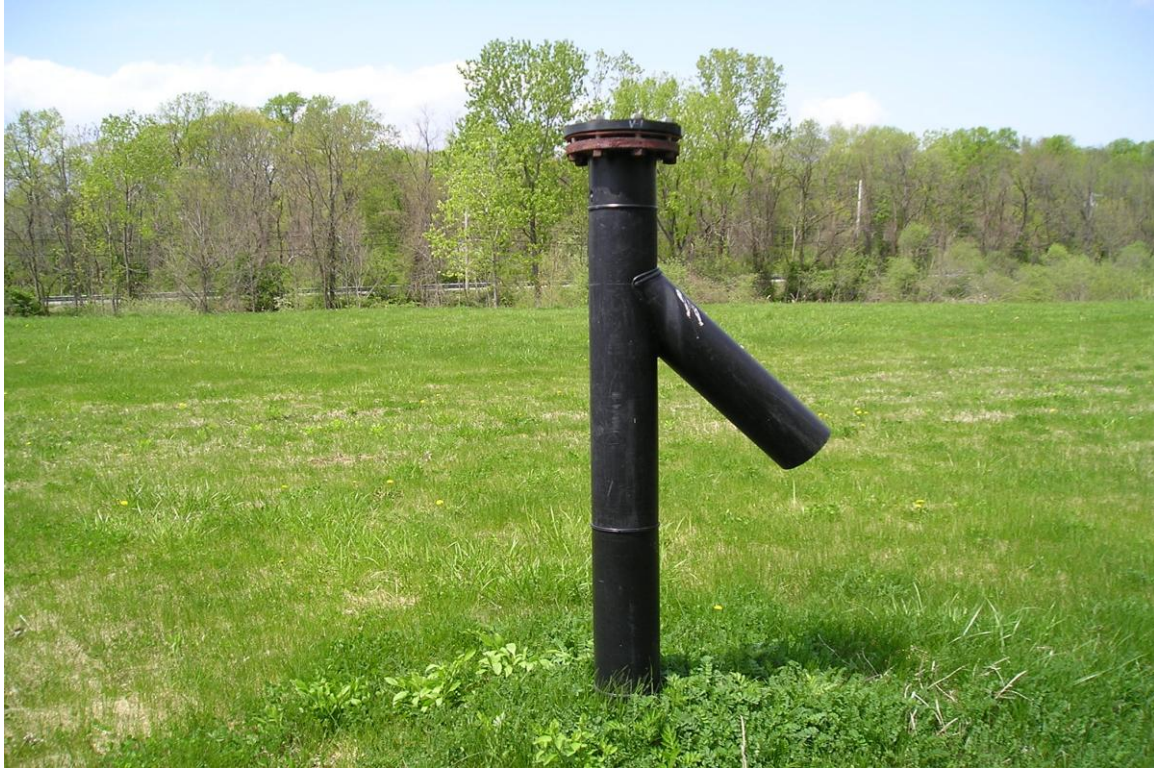
Four vents (V1 – V4) were inspected and generally found in good condition (visually unblocked, neither cracks nor movement was observed) (Photos 1-4). V-2 shows a slight lean to the north. V-1 revealed a BB sized hole through the side of the vent. This appears to be insect damage based on other markings on the vent. The hole needs to be patched (with epoxy putty). NYSDOT Maintenance will repair this in June 2010.

Photo 1: Vent V-1

1. Well cap keys and the new gate key are located in the left drawer of the facility office desk.
2. Fence gate chain install and V-1 repair will be performed in June 2010 by NYSDOT Maintenance.
3. New locks have to be installed on wells LMW-2, MW-11, and MW-12.
4. Inspections have been changed from quarterly to semi-annually with permission from DEC (letter dated February 2010).

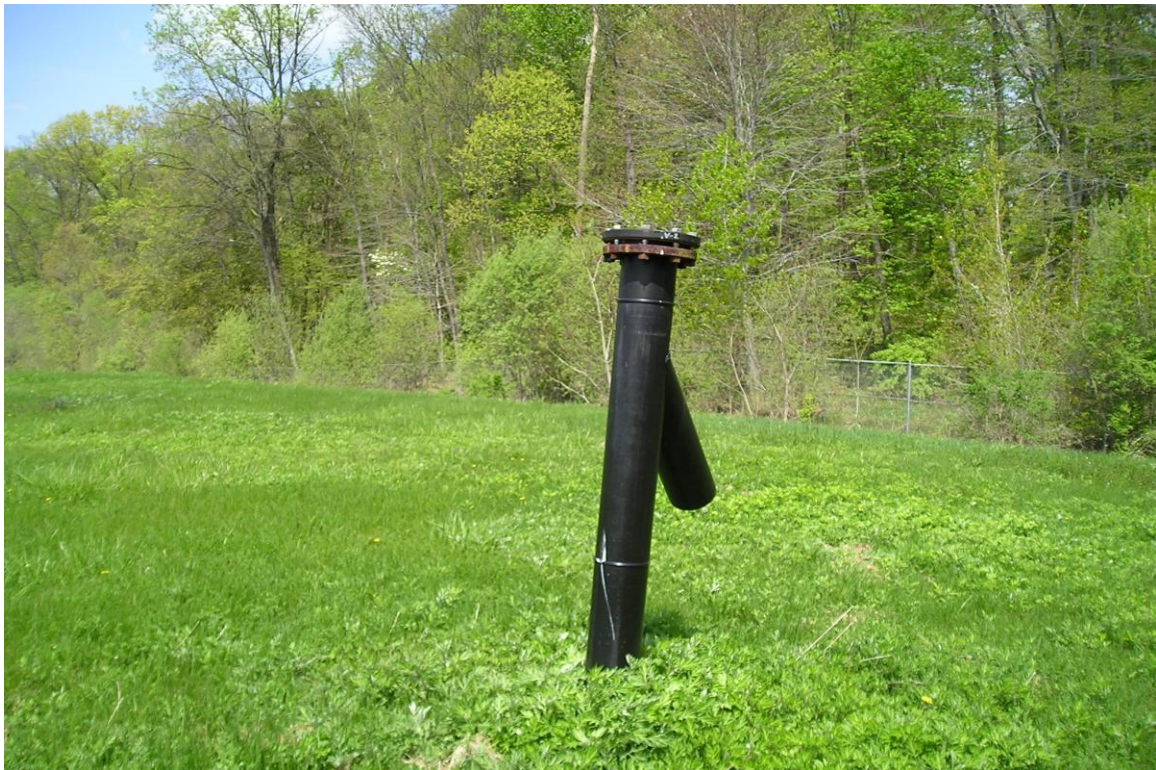
Photo 2: Vent V-2

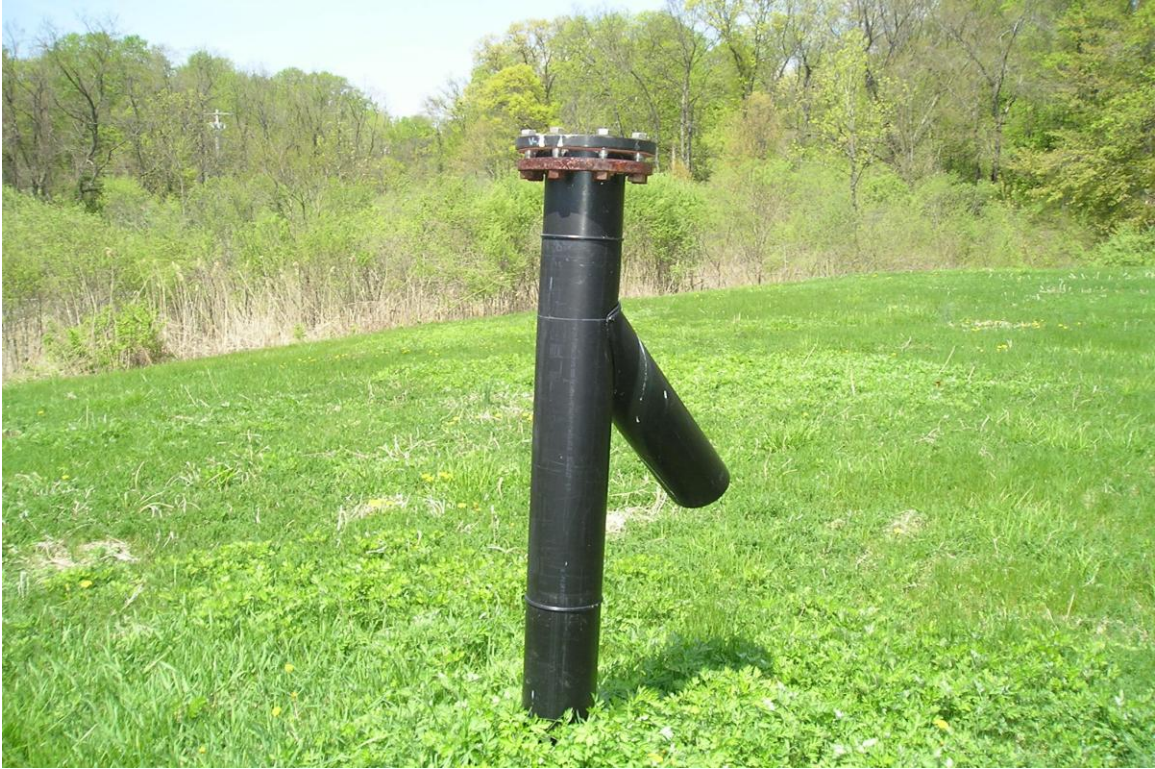
Photo 3: Vent V-3

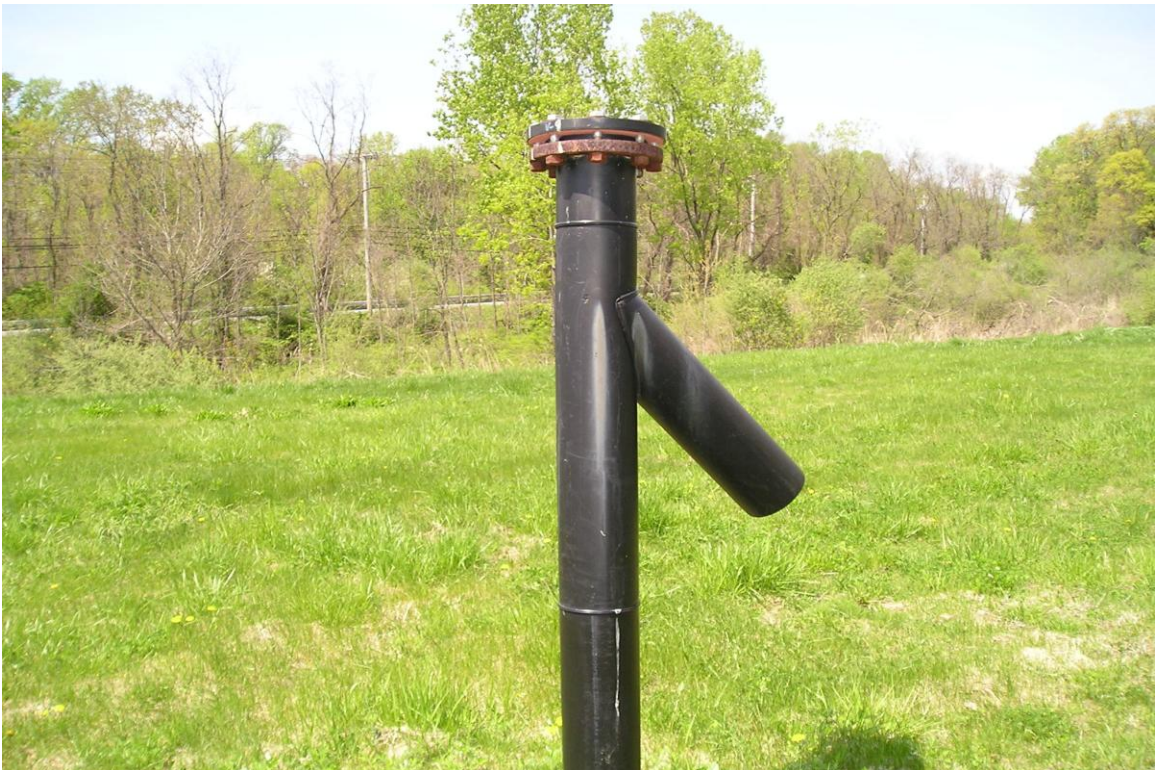
Photo 4: Vent V-4

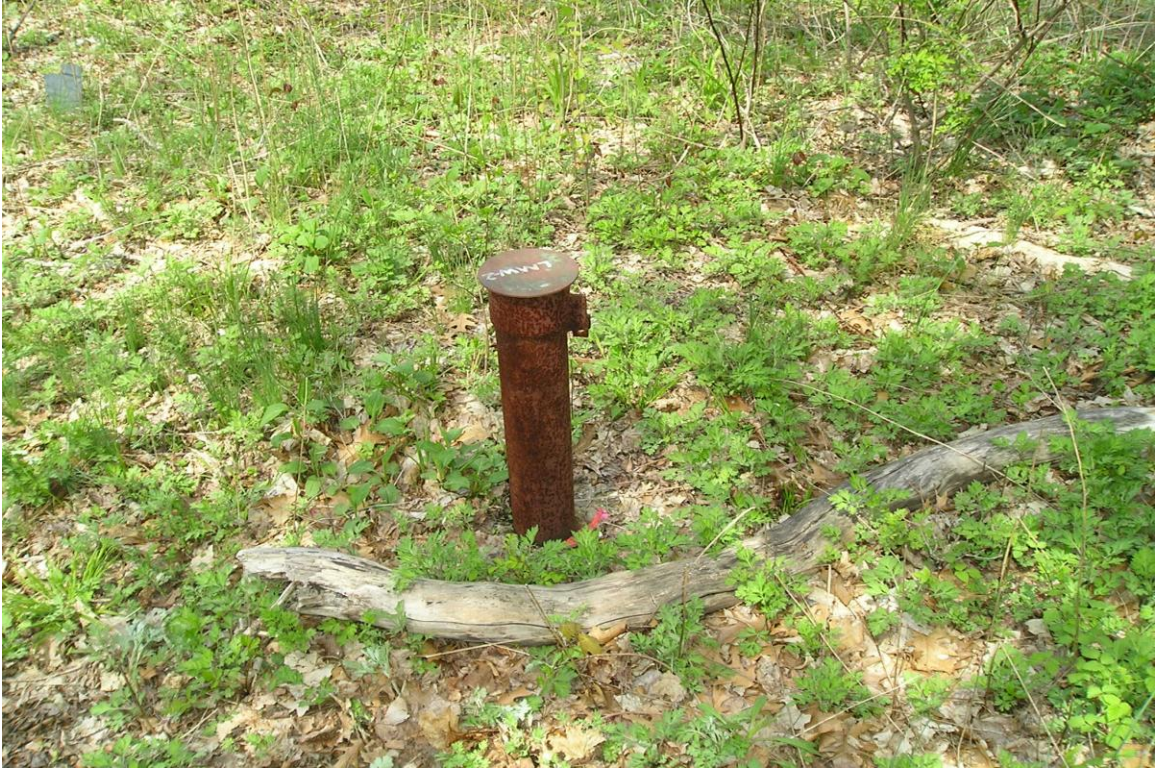
All the wells were inspected. Locks were missing on wells LMW-2, MW-11, and MW-12 (possibly resulting from the monitoring well water sampling that took place in January 2010 by a NYSDOT consultant) (Photos 5, 9 & 10).

Photo 5: Well LMW-2 (lock missing)

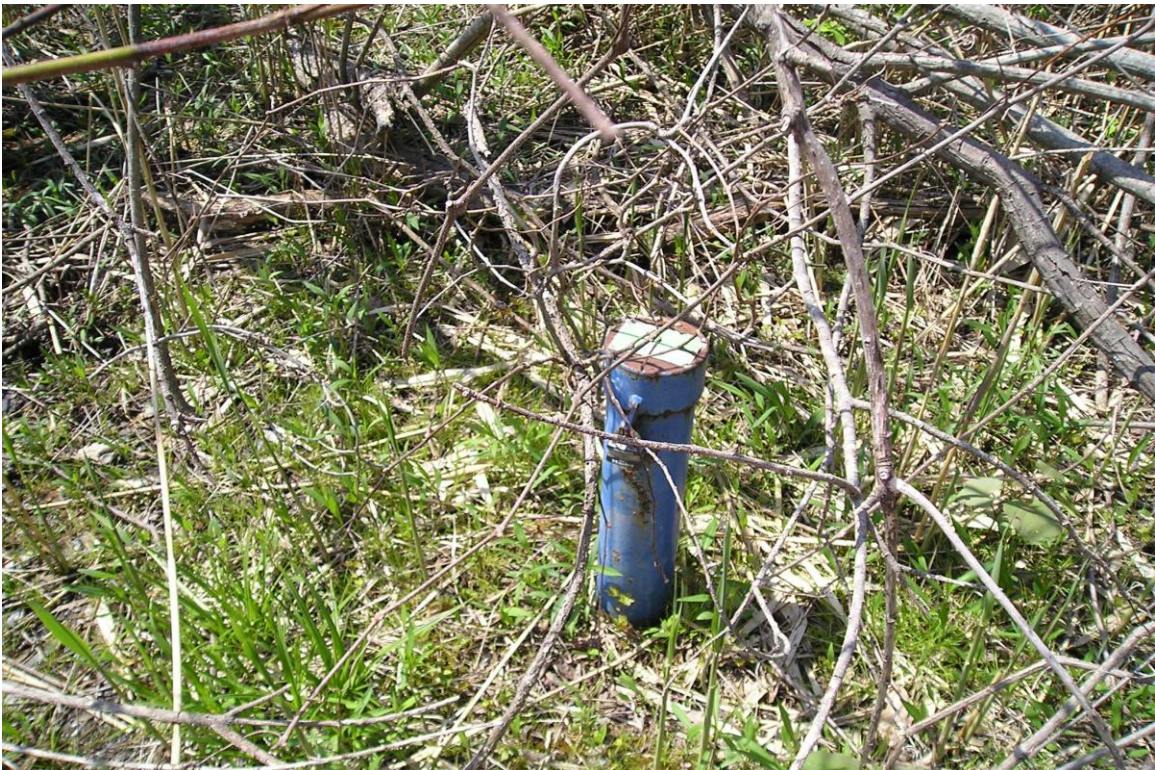
A downed tree blocks the path to access PC-2 (Photos 8 & 23). The tree should be cut up and cast to the side of the path.

Photo 8: Well PC-2 (covered with downed tree limbs)

2. Along with landfill mowing, the areas around the landfill vents and some of the paths leading to the monitoring wells that become overgrown during the spring and summer months need to be weed whacked. The tree blocking the access path to PC-2 needs to be cut up and removed.

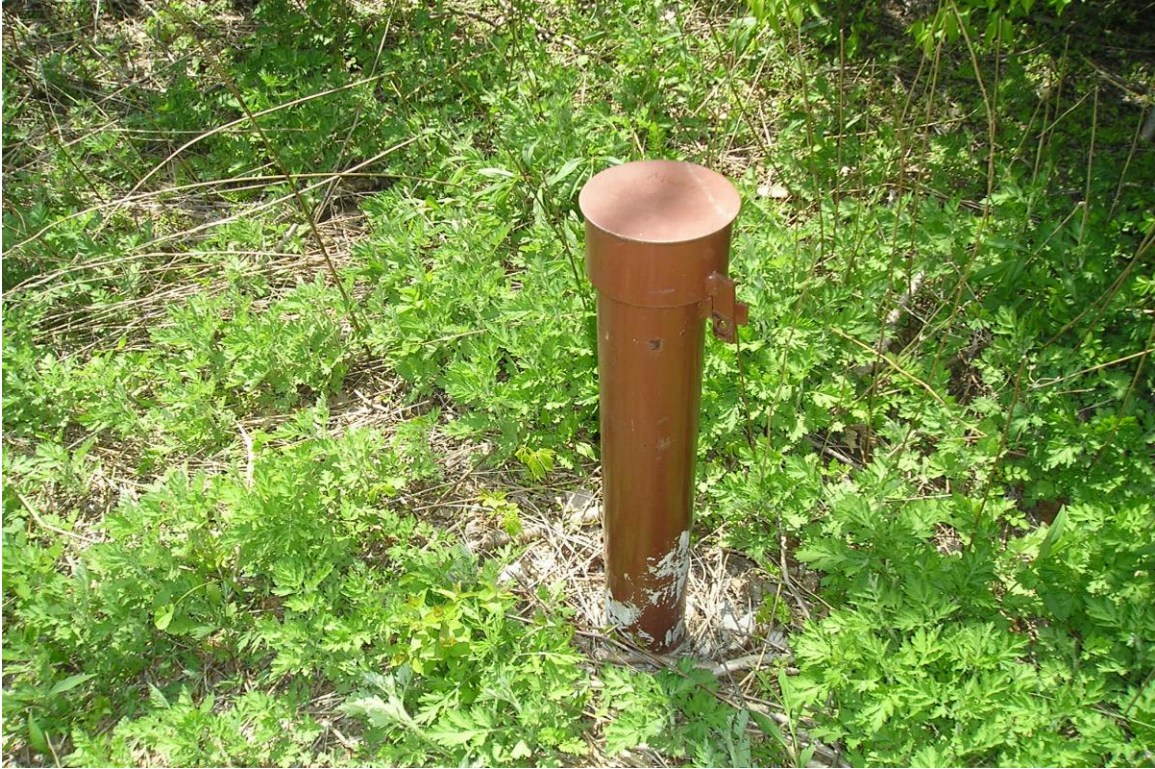
Photo 9: Well MW-11 (lock missing)

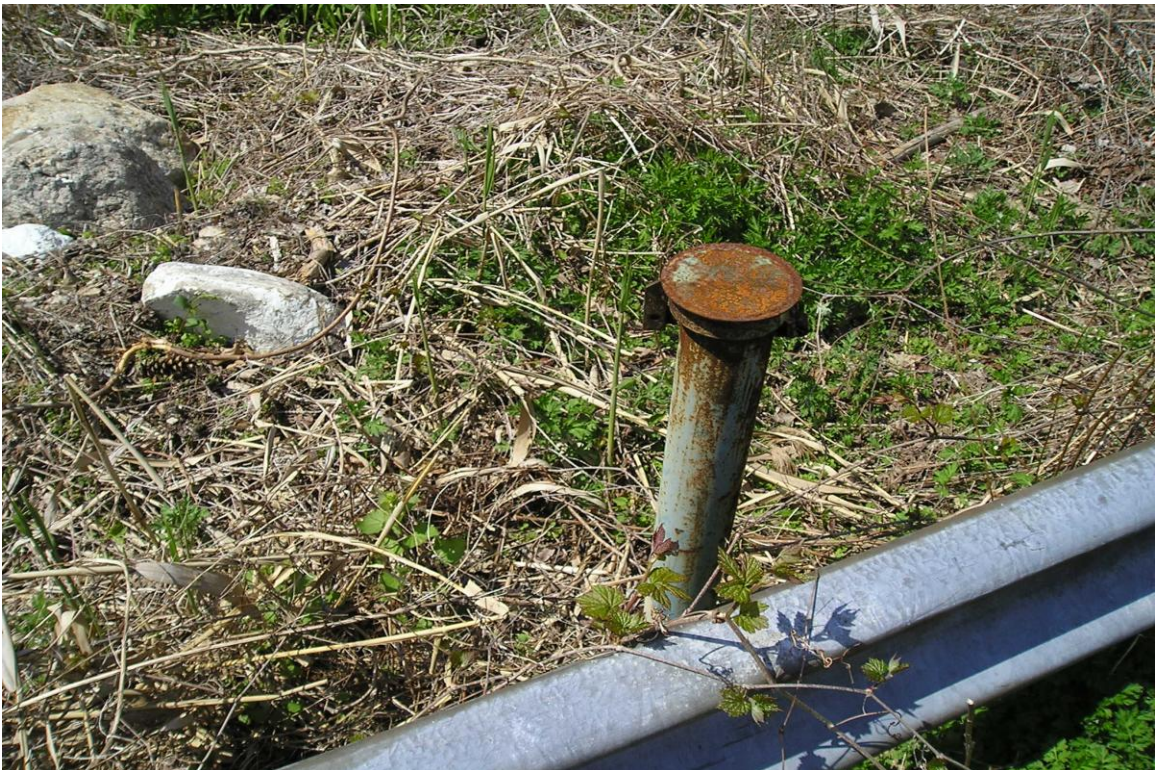
Photo 10: Well MW-12 (lock missing)

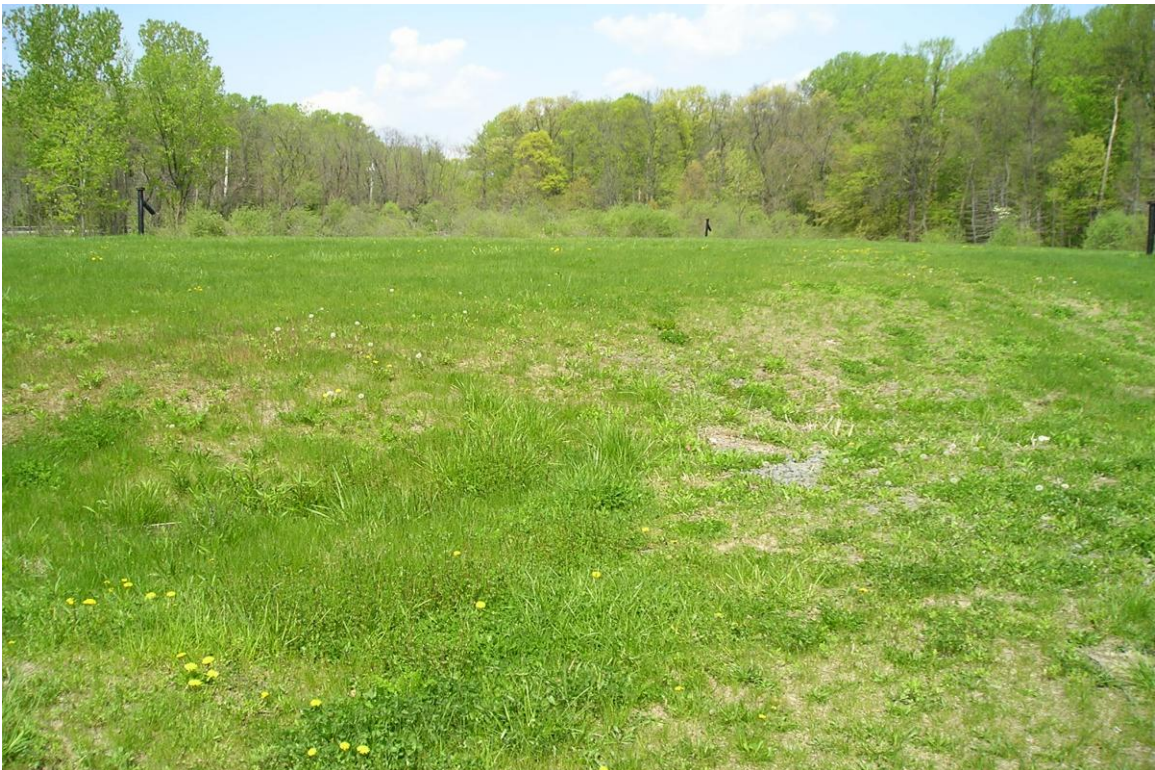
The grass height was good at the time of inspection. It may have to be mowed in June or July (Photo 14).

Photo 14: Grass on landfill cap

Entire grass cover of the landfill should be mowed in June or July.

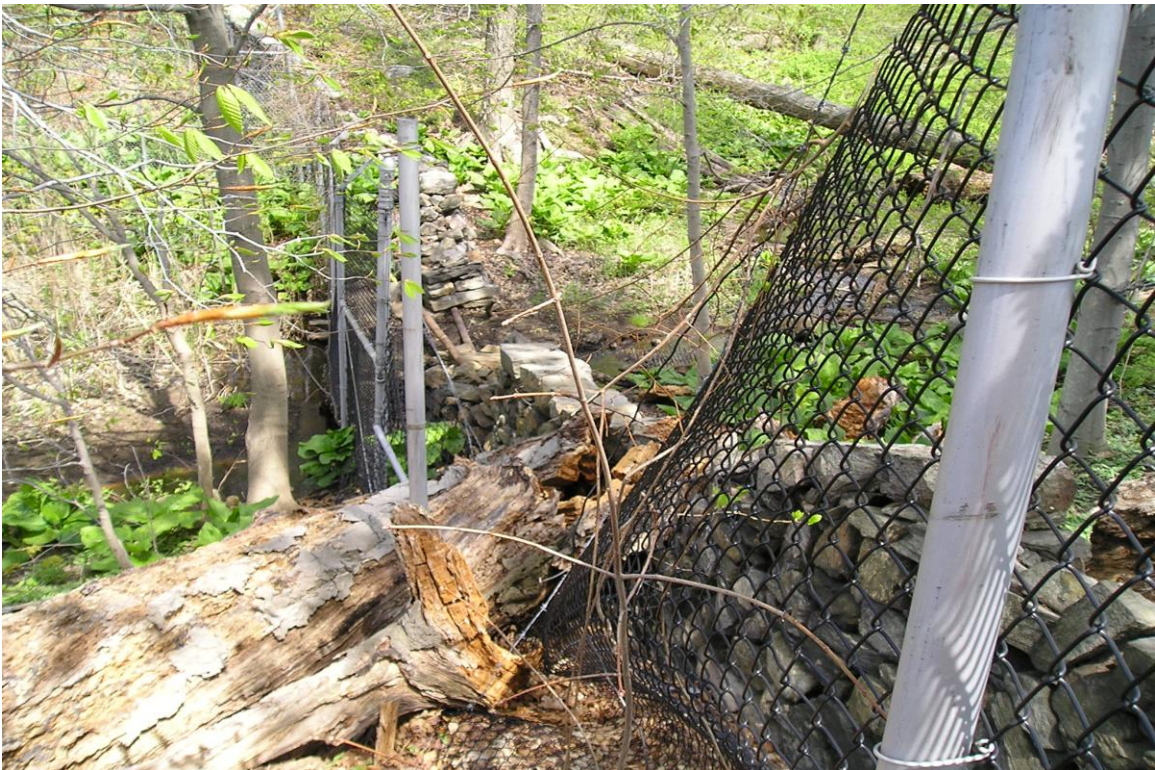
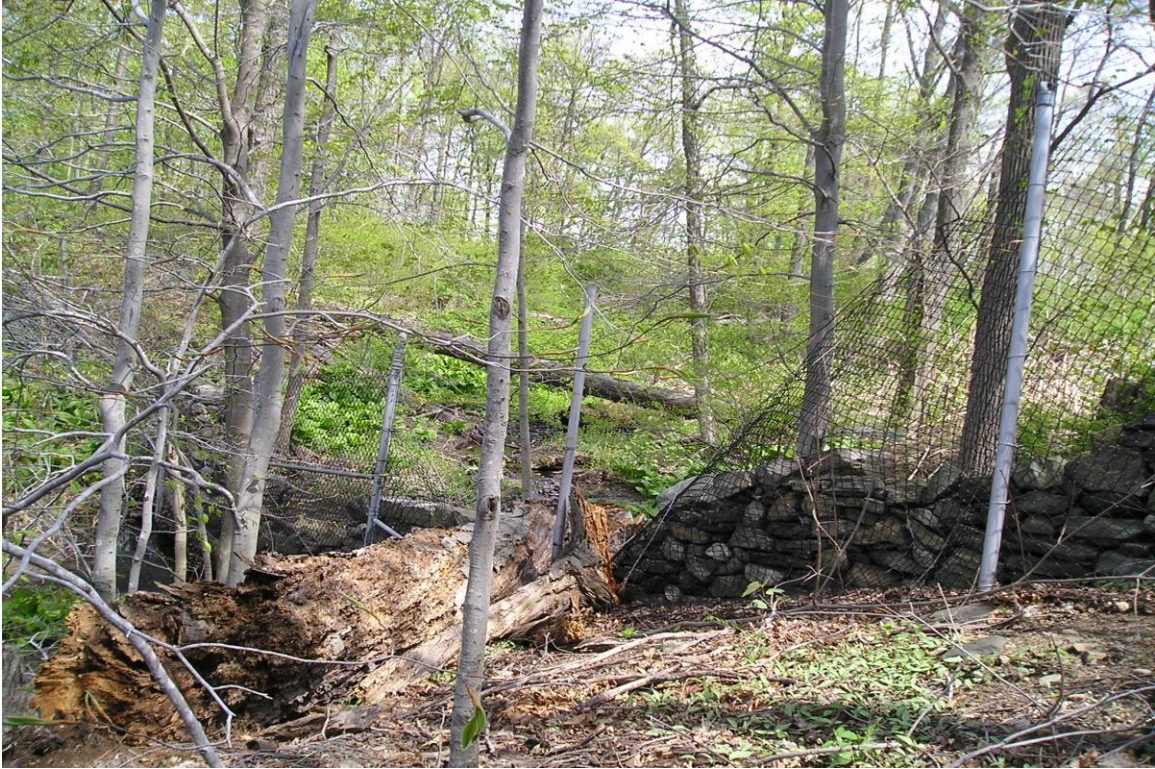
The fence was damaged by a fallen tree (near stream inlet – northeast of landfill cap). The rotten tree needs to be removed and the fence needs to be repaired.

Photo 16: Fence damage by fallen tree (near stream inlet – northeast of landfill cap)

Photo 17: Another view of fence damage by large, rotten tree near stream inlet

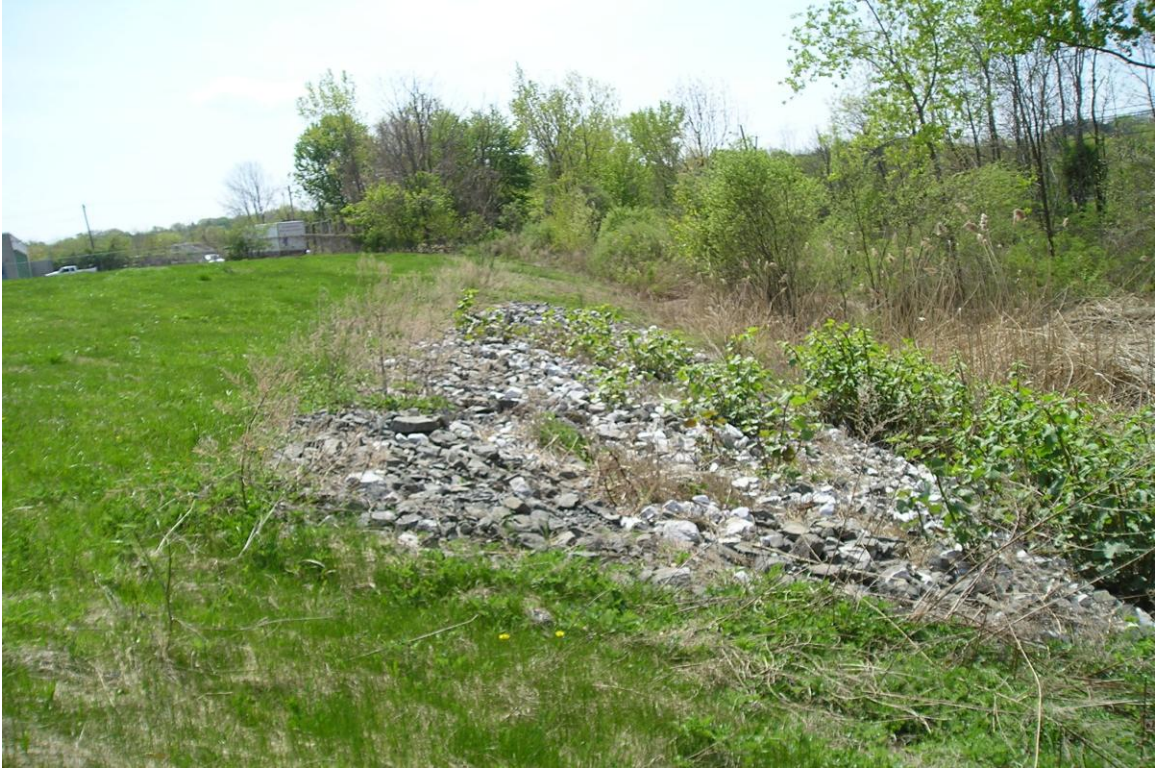
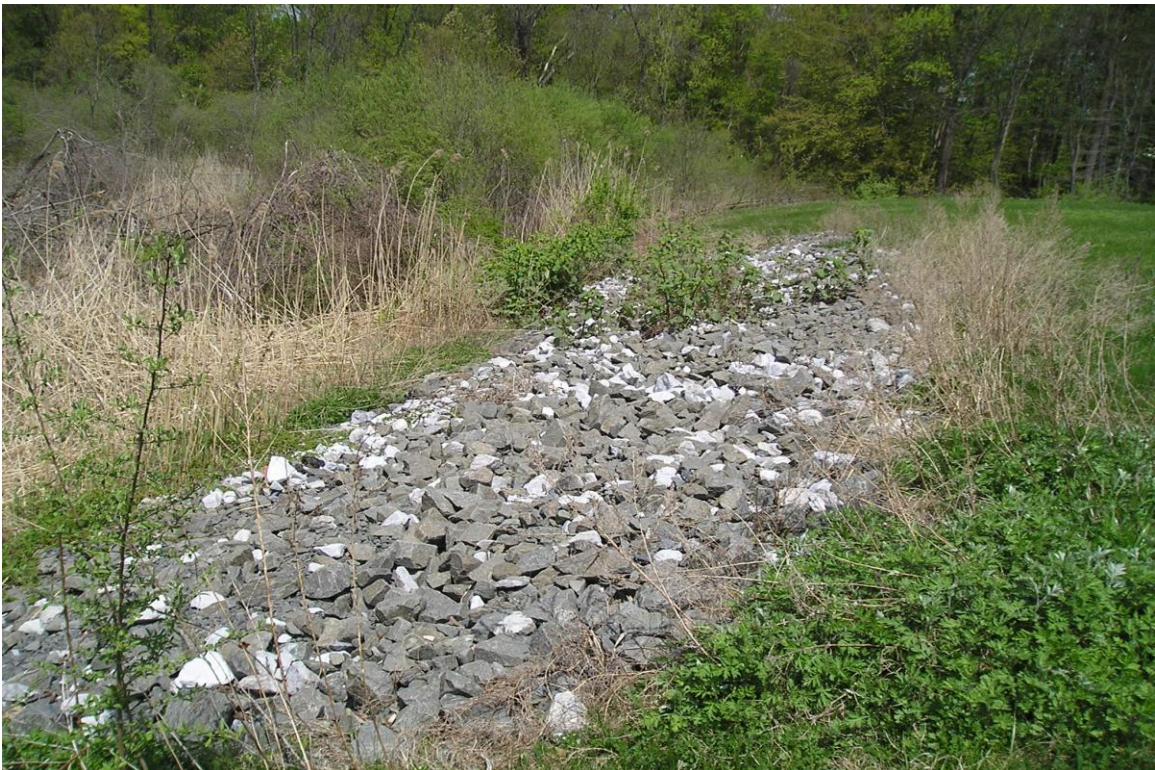
The soil slump on west slope of landfill (Photos 21-22) was repaired in May 2009 by NYSDOT Residency 8-9 (Valhalla) personnel. The area of the repair is still in good condition (Photos 19 & 20).

Photo 19: West slope erosion area repair (looking south)

Photo 20: West slope erosion area repair (looking north)

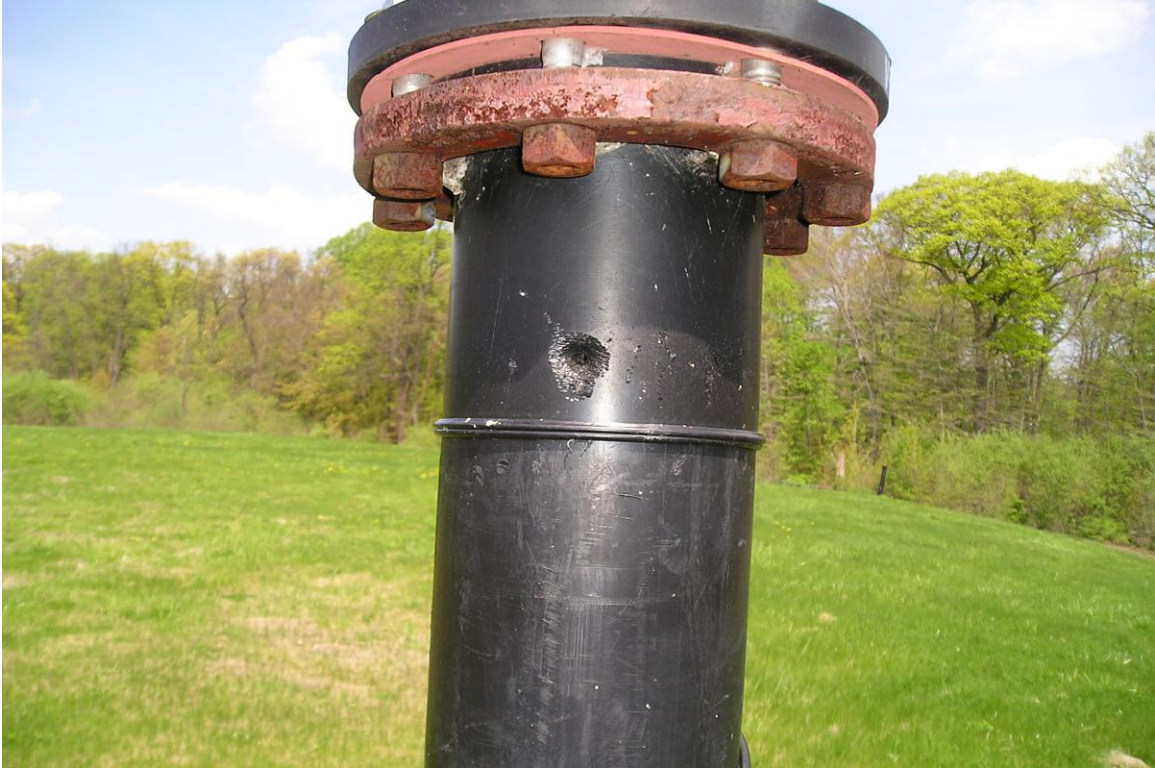
Photo 21: Pinhole in V-1 from suspected insect boring

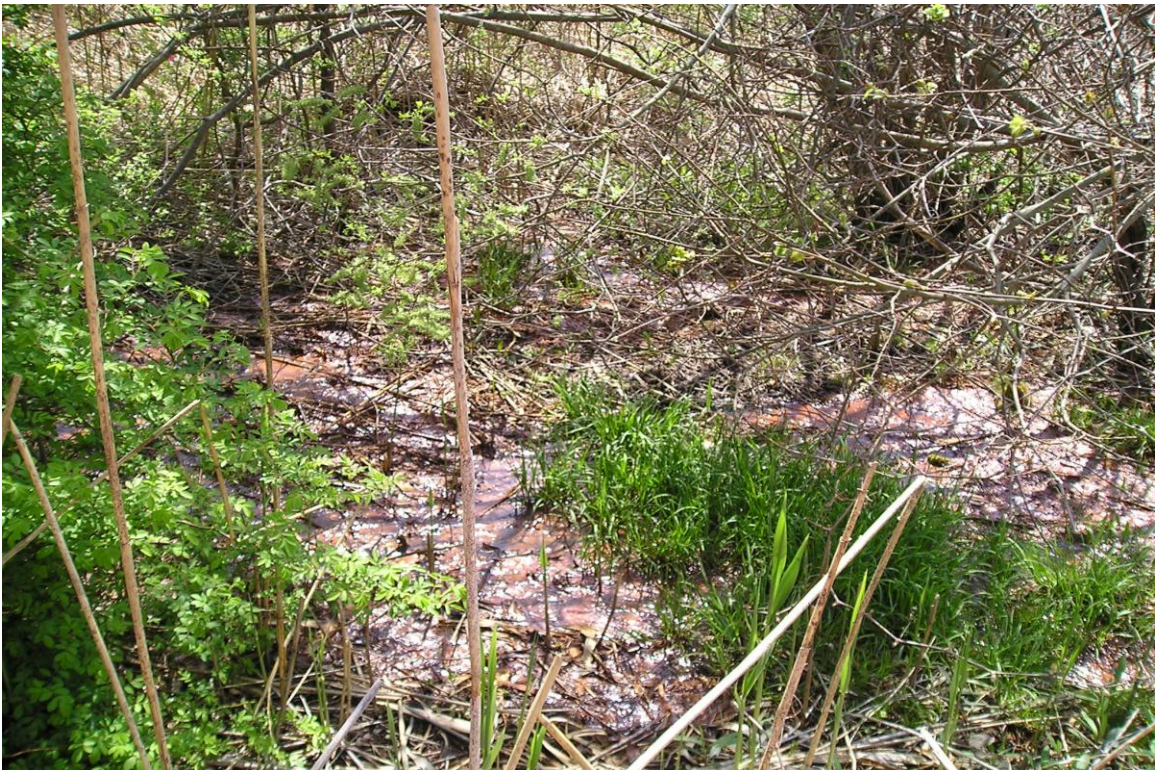
There is some naturally-occurring orange iron bacteria staining near the area just east of PC-2 and downslope of the slump repair (Photo 22). No questionable odors were noted on the stained soil (marsh-like odor). The area of staining tends to fluctuate with the change in seasons; it is less pronounced in winter and is more pronounced during the spring and summer months and when increased disturbance from deer foot traffic through this area is observed.

Photo 22: Orange staining near PC-2

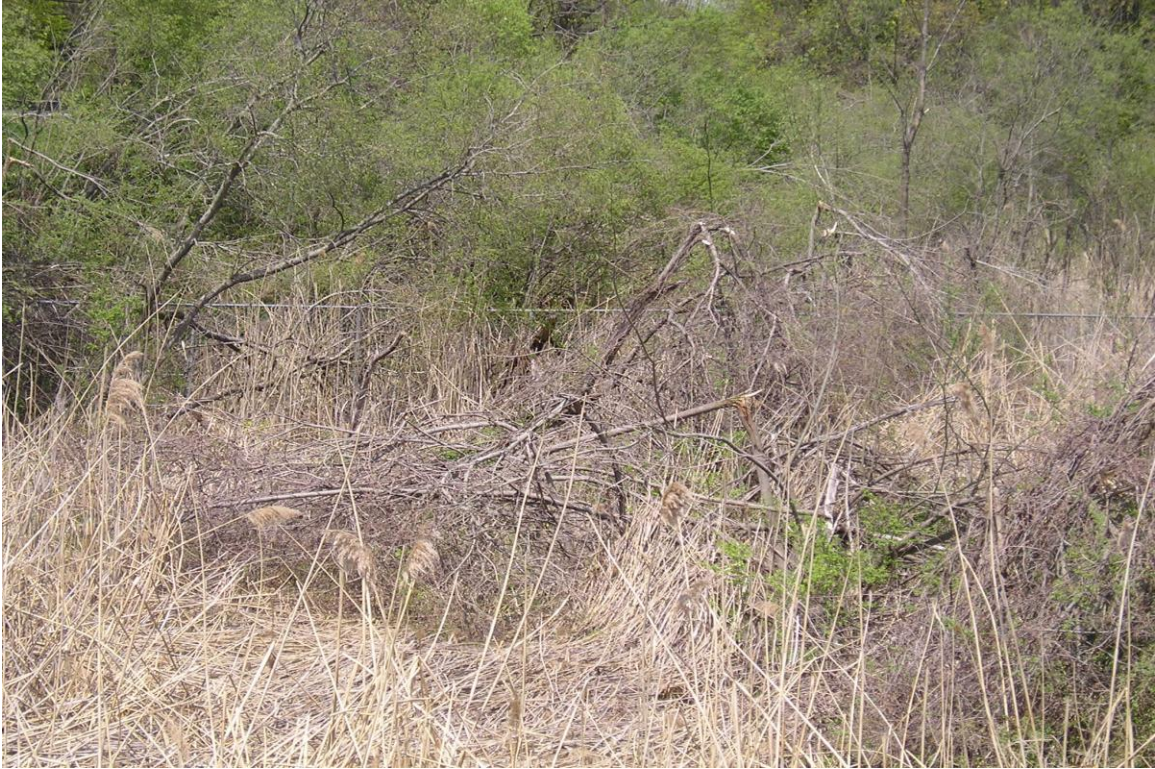
Photo 23: Downed tree from March 2010 storm over PC-2

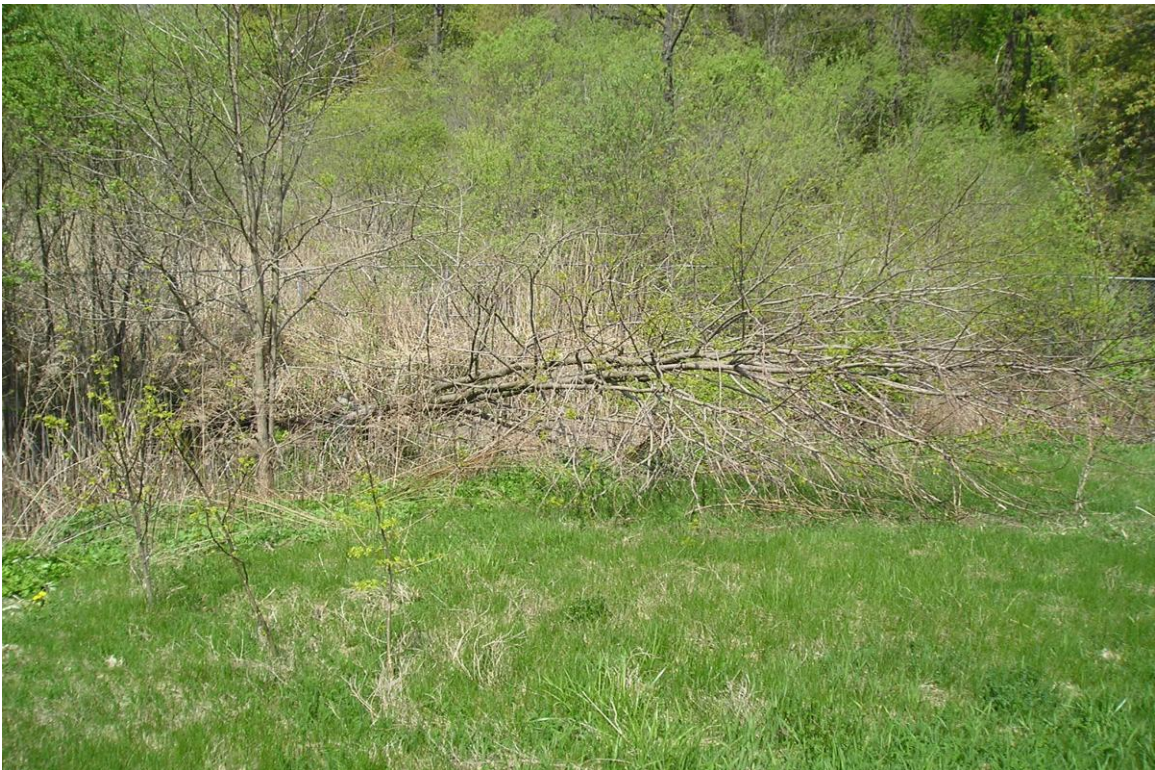
A downed tree on the northwestern portion of landfill cap from the March 2010 storm needs to be removed. (Photo 24)

Photo 24: Downed tree from March 2010 storm on northwestern portion of landfill cap
