HARRISON SUB-RESIDENCY FIELD INSPECTION

Name of Inspector(s): Chris Kappeller

Date: 11/12/10

Semi-Annual

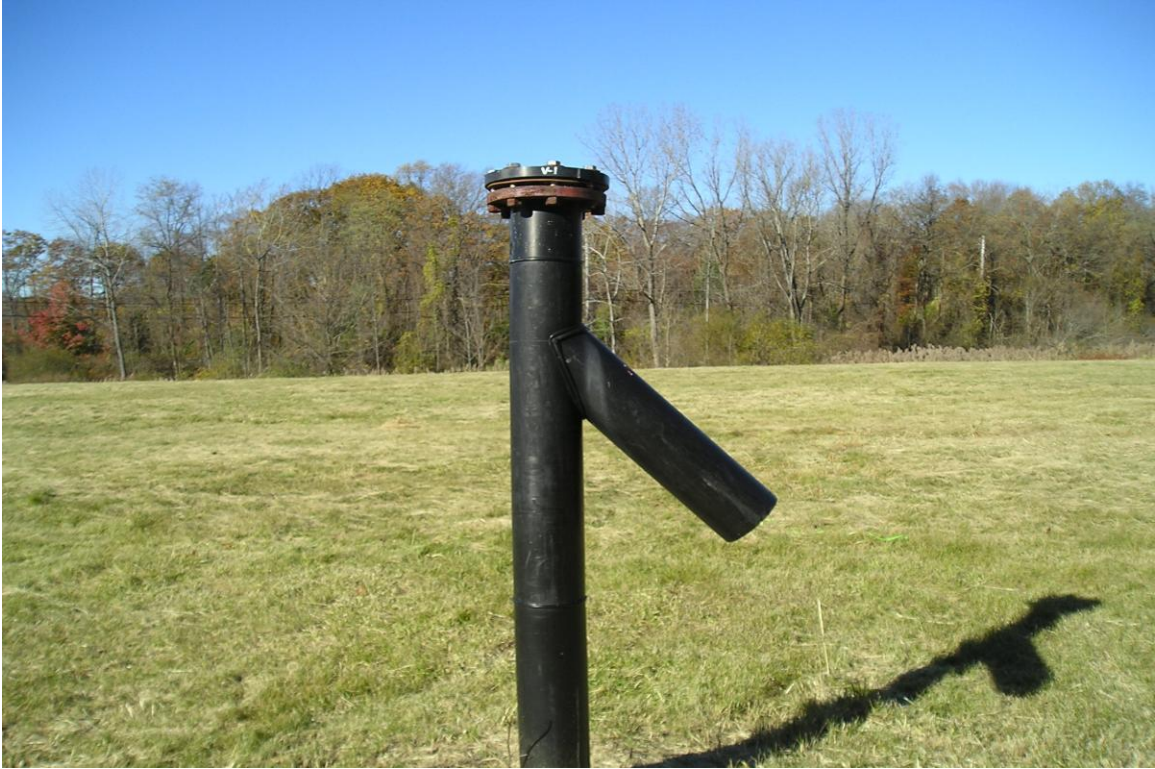
Four vents (V1 – V4) were inspected and generally found in good condition (visually unblocked, neither cracks nor movement was observed) (Photos # 1-4). V-2 shows a slight lean to the north. The BB-sized hole in vent V-1 was filled in with epoxy. This appeared to be insect damage based on other markings on the vent.

Photo 1: Vent V-1

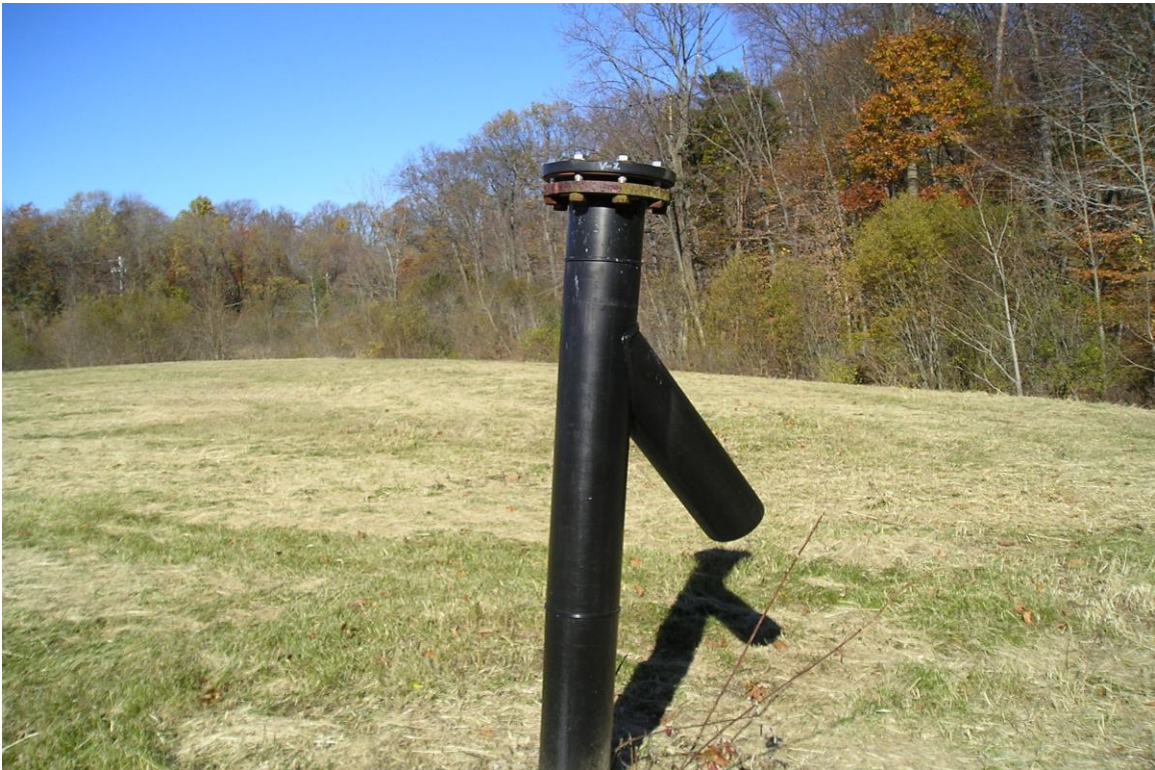
Photo 2: Vent V-2

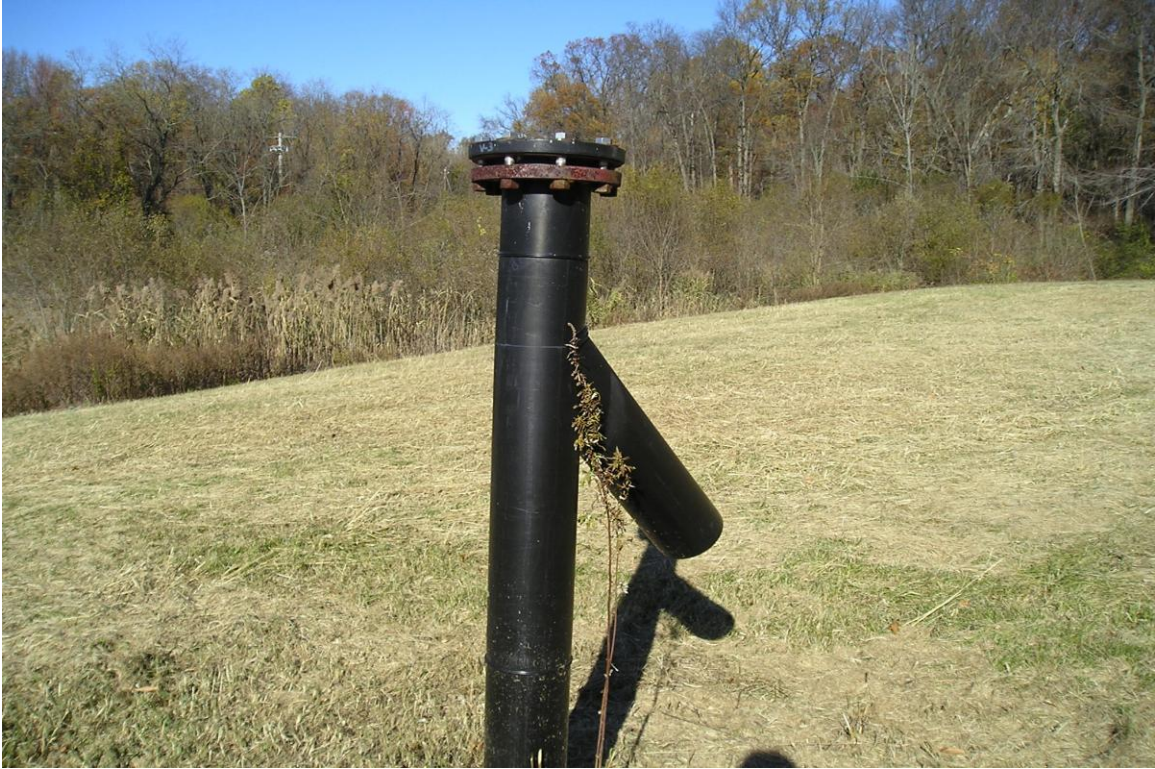
Photo 3: Vent V-3

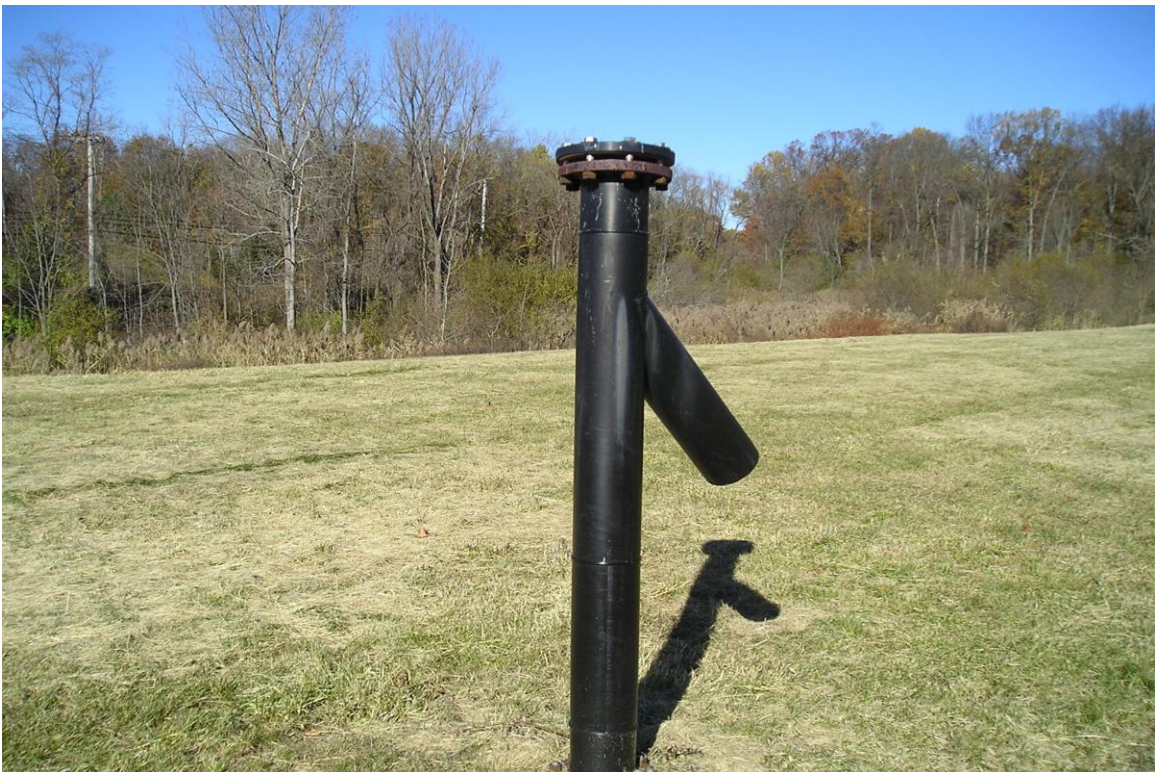
Photo 4: Vent V-4

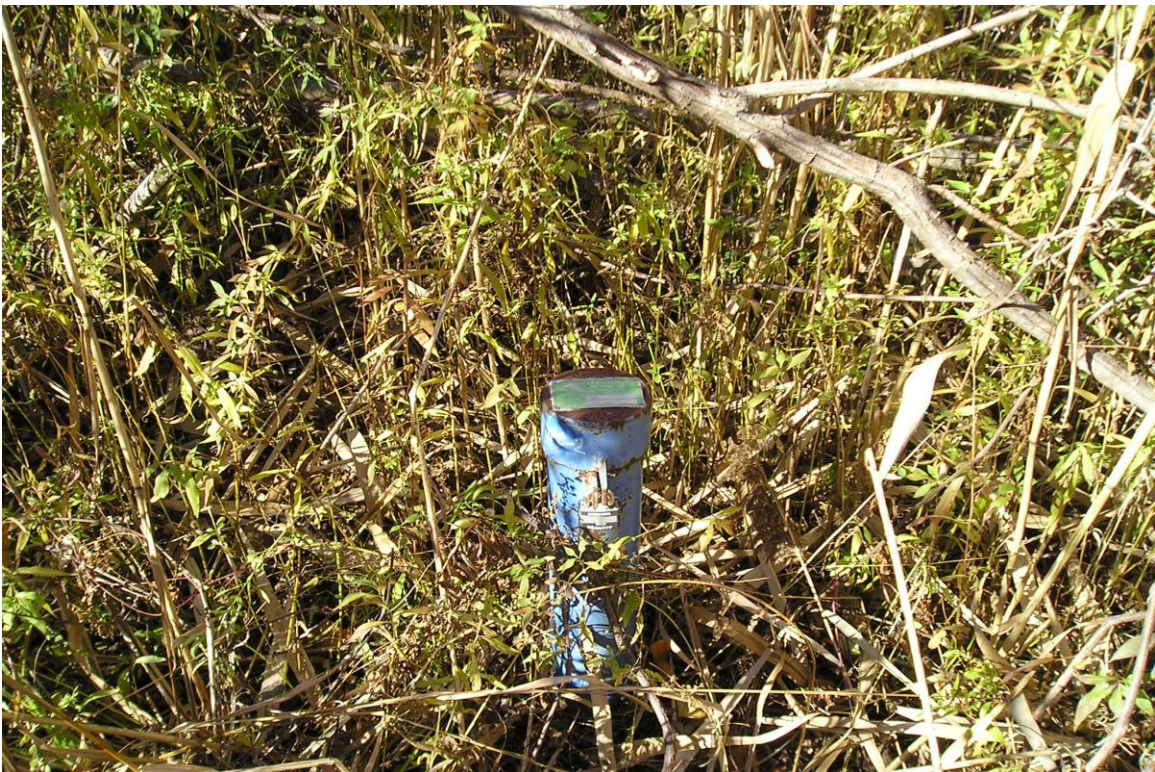
A downed tree blocks the path to access PC-2. Tree needs to be cut up and cast to the side of the path.

Photo 8: Well PC-2 (covered with downed tree limbs)

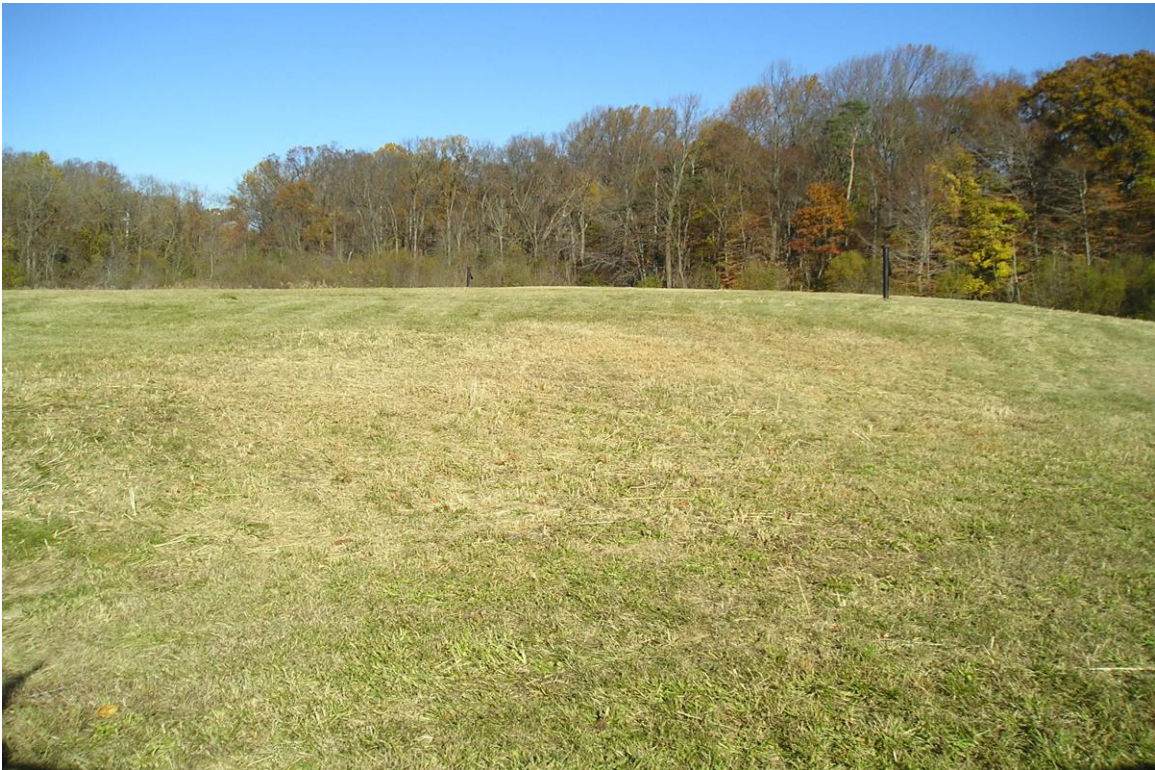
Grass height was good at the time of inspection (Photo #14).

Photo 14: Grass on landfill cap

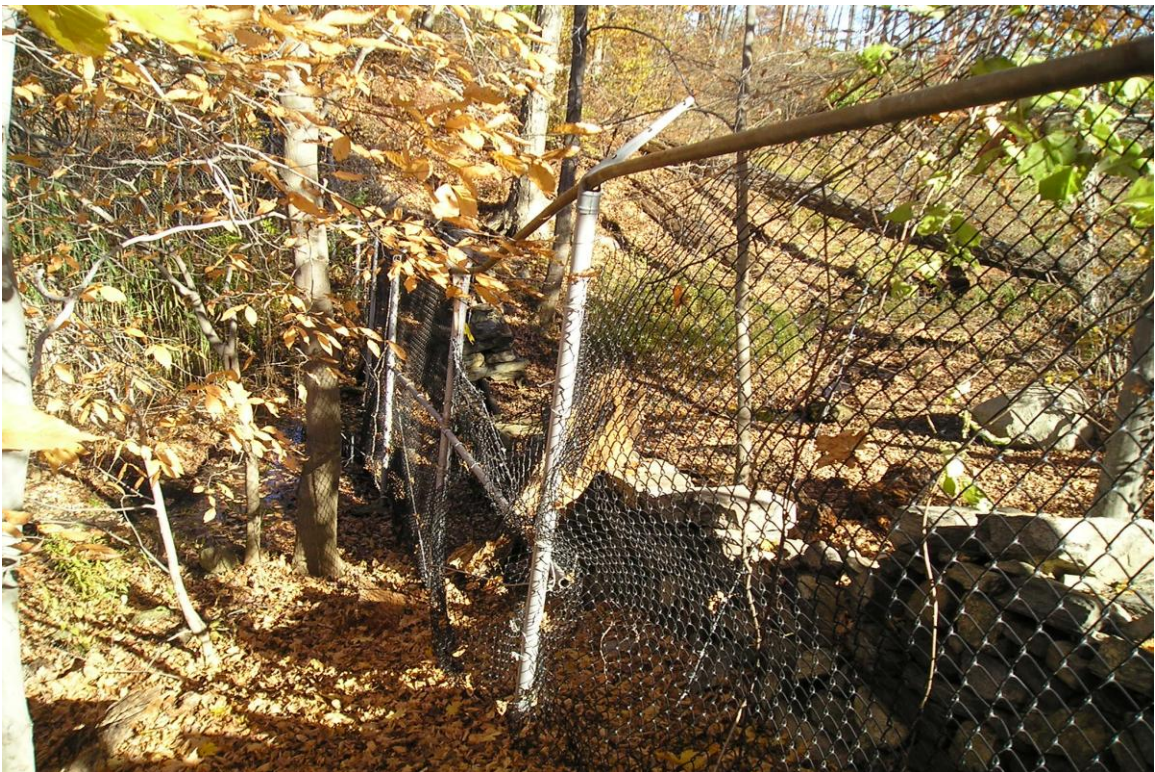
Photo 16: Fallen tree removed off fence (near stream inlet – northeast of landfill cap)

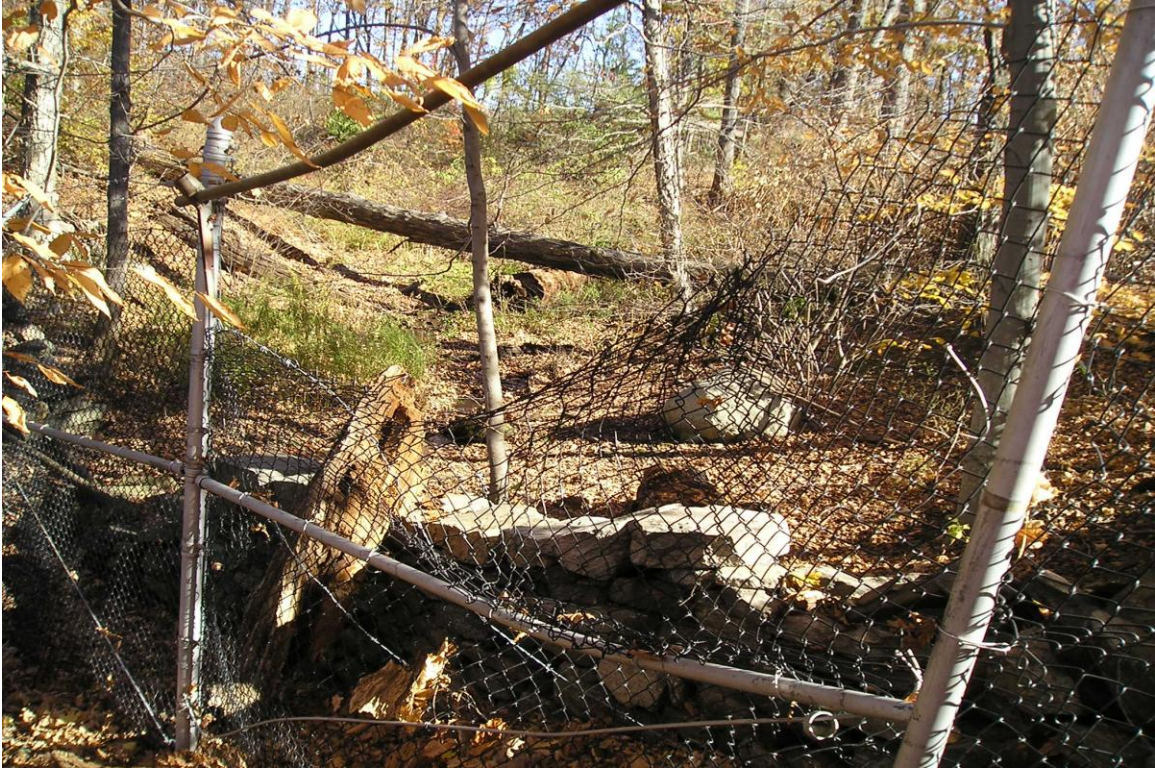
Fence damage by fallen tree (near stream inlet – northeast of landfill cap) was partially repaired (Photo #17)

Photo 17: Fence partially repaired (near stream inlet)

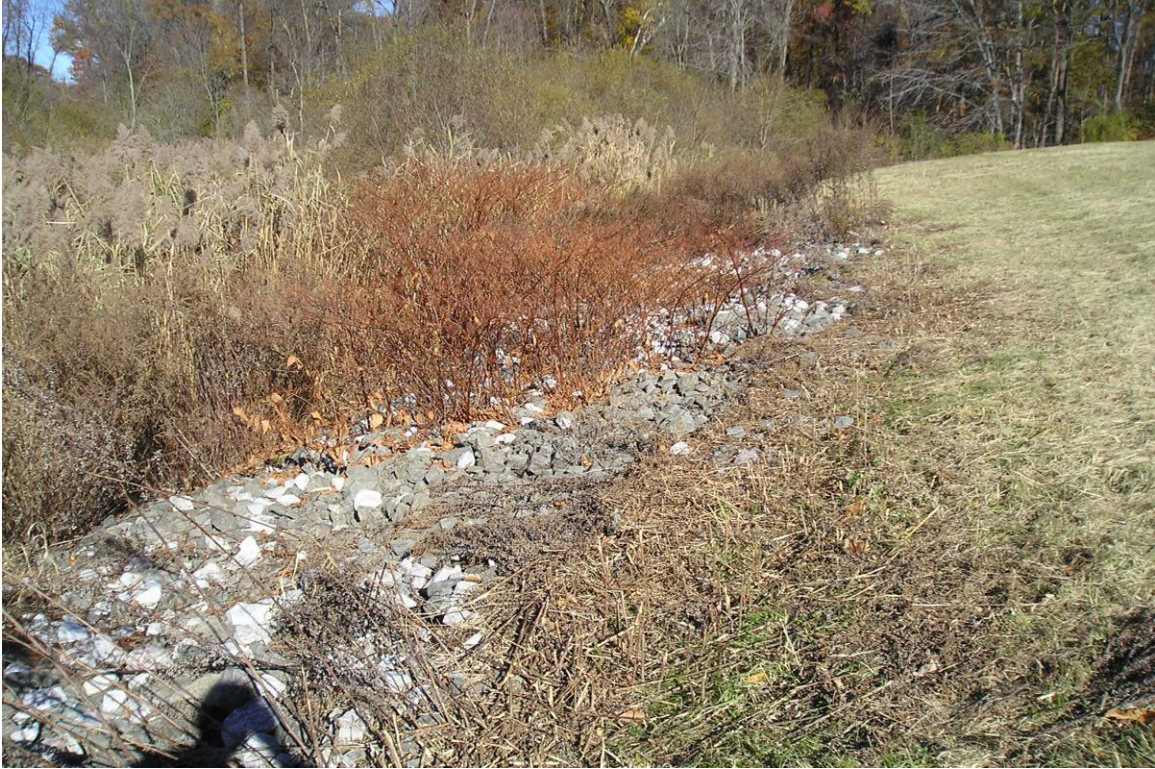
The soil slump on west slope of landfill was repaired in May 2009 by NYSDOT Residency 8-9 personnel. Repaired area is still in good condition (Photo #19).

Photo 19: West slope erosion area repair (looking north)

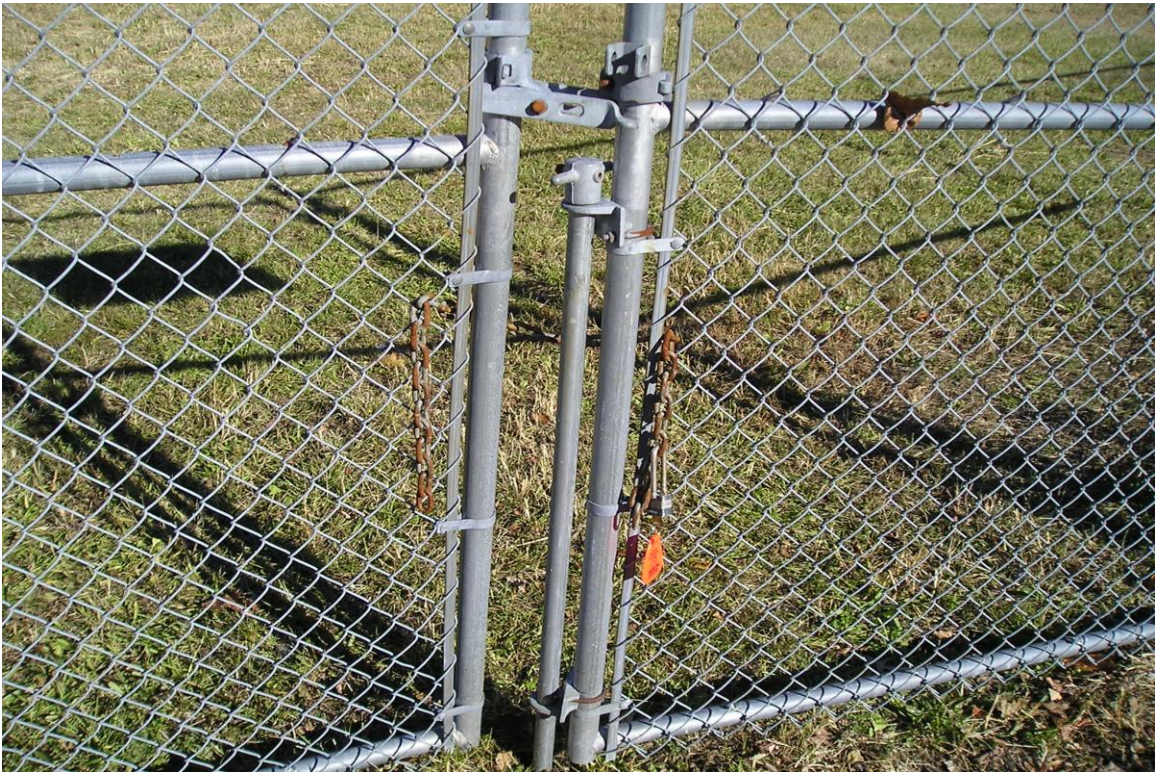
A longer chain and lock added to the gate to the landfill to secure it better (Photo #20)

Photo 20: Landfill gate with locking chain

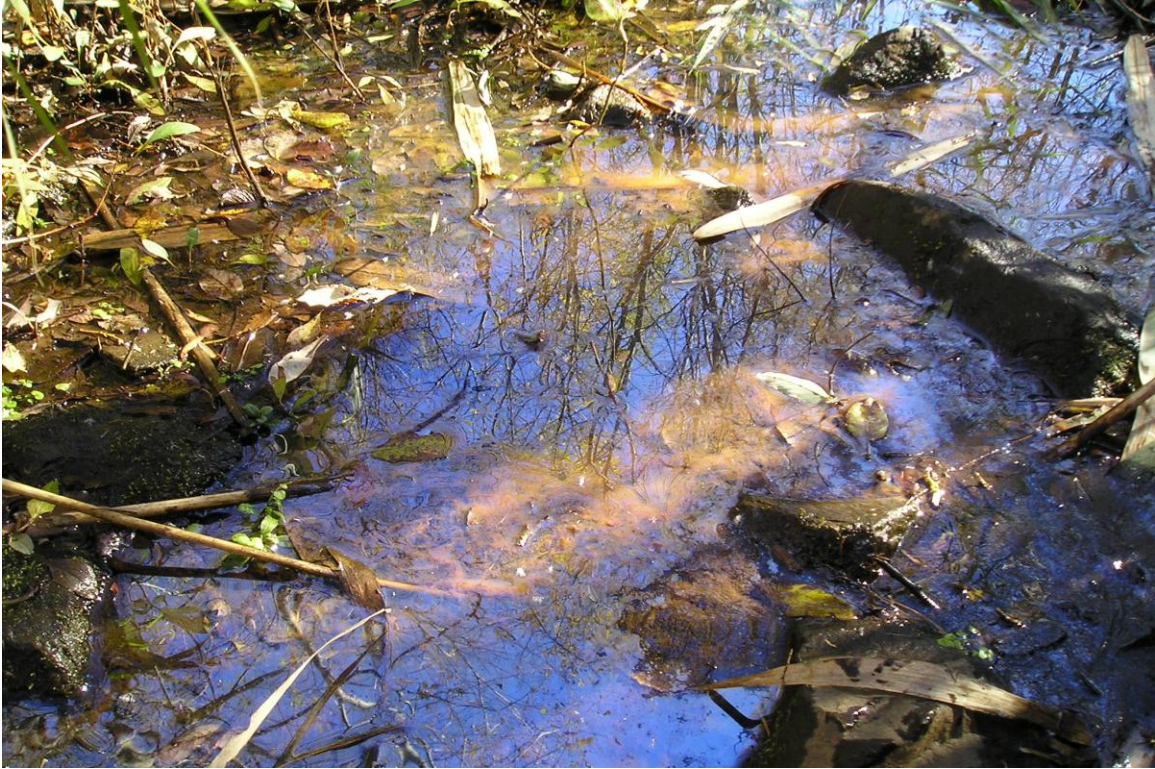
Photo 21: Orange staining near PC-2

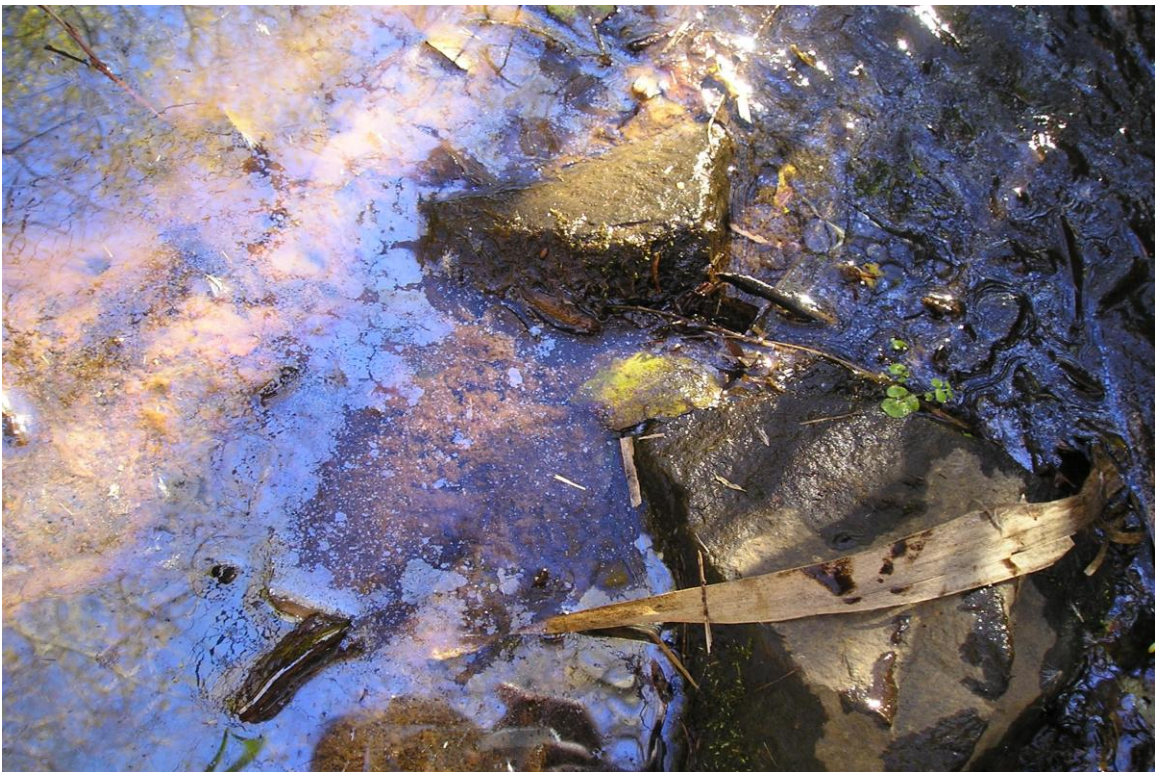
Area of orange iron bacteria staining and floating organic film on water exists near the area just east of PC-2 repair (Photo #22). No questionable odors were noted.

Photo 22: Orange staining and organic film near PC-2

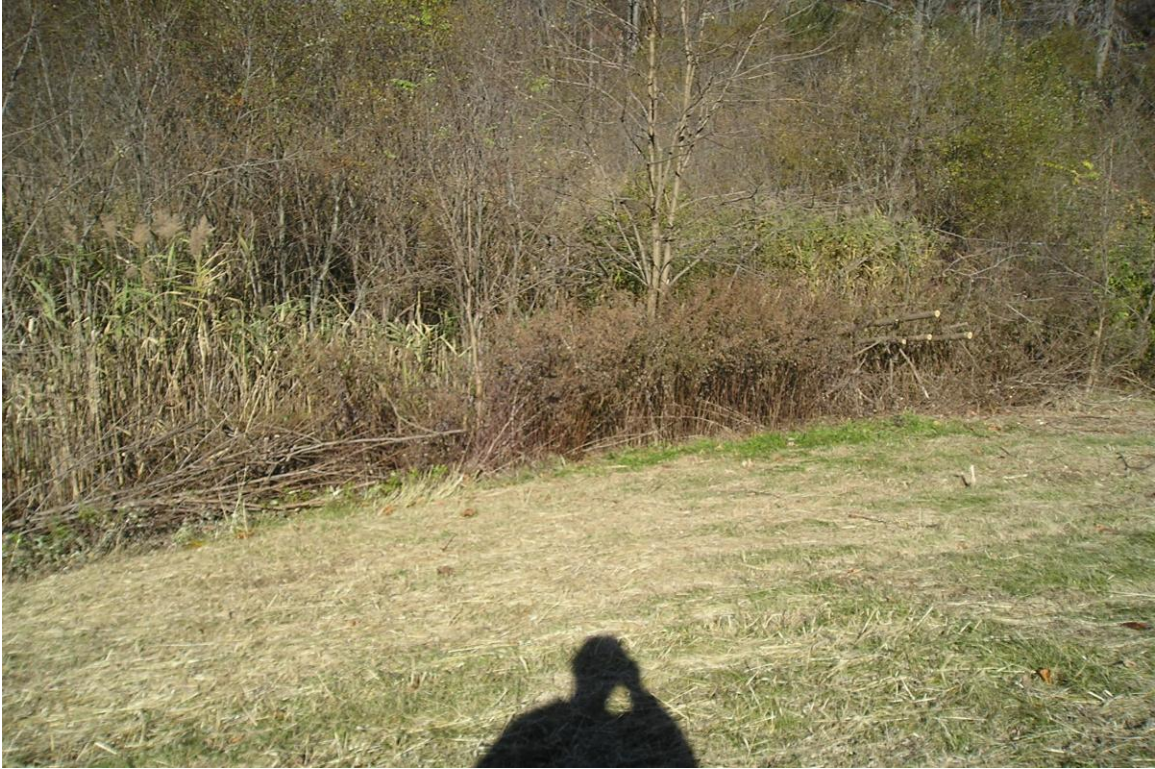
Downed tree over on northwestern portion of landfill cap from March 2010 storm was removed (Photo #16)

Photo 23: Downed tree removed from northwestern portion of landfill cap.
