HARRISON SUB-RESIDENCY FIELD INSPECTION

Date: 4/29/11

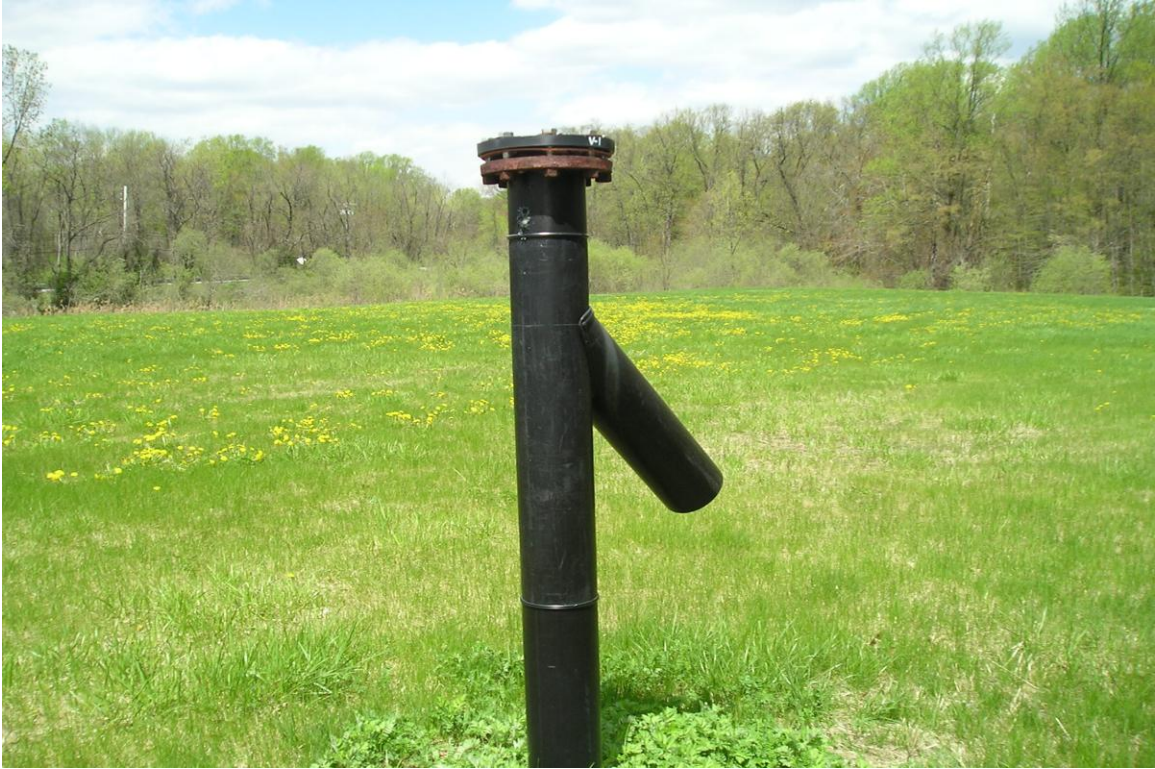
Photo 1: Vent V-1

Four vents (V1 – V4) were inspected and generally found in good condition (visually unlocked, neither cracks nor movement was observed) (Photos #1-4). V-2 shows a slight lean to north.

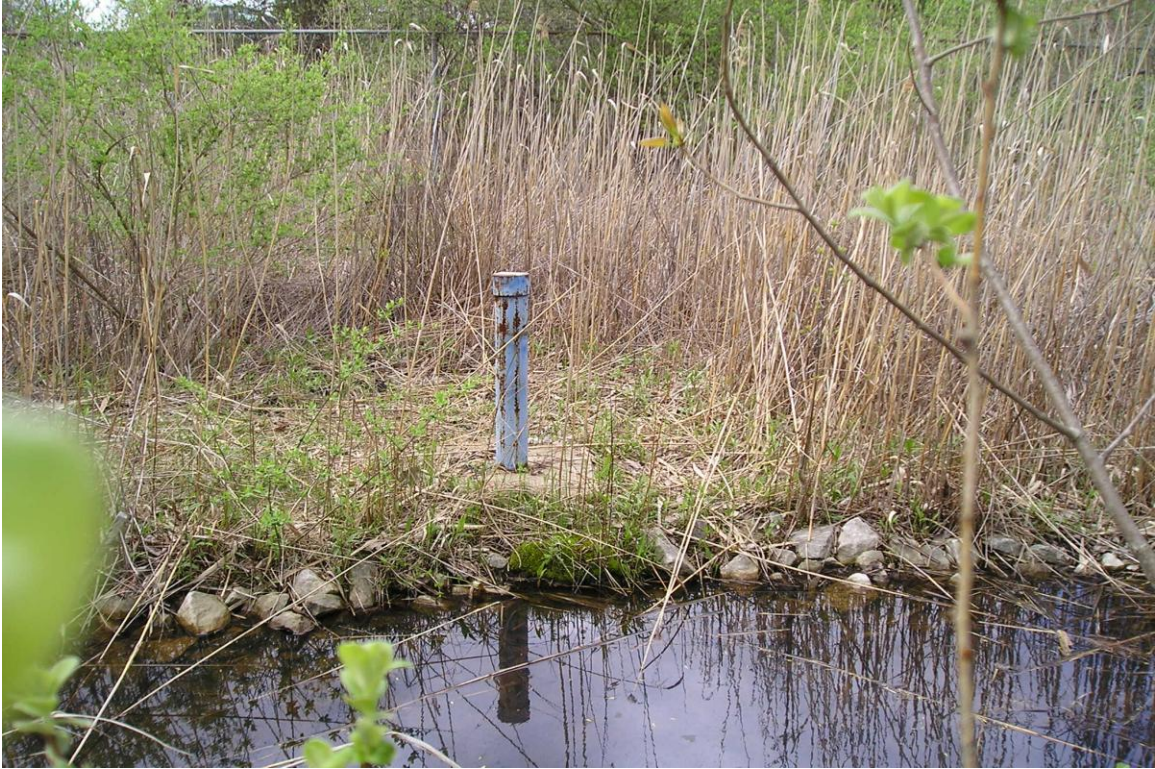
Photo 7: Well PC-1

All wells were inspected. During DOT's 5th quarter sampling event in April 2011, the key broke off in the lock for PC-1; the casing was cut with a hacksaw and the cap was replaced. There is currently no lock on this well (Photo #7).

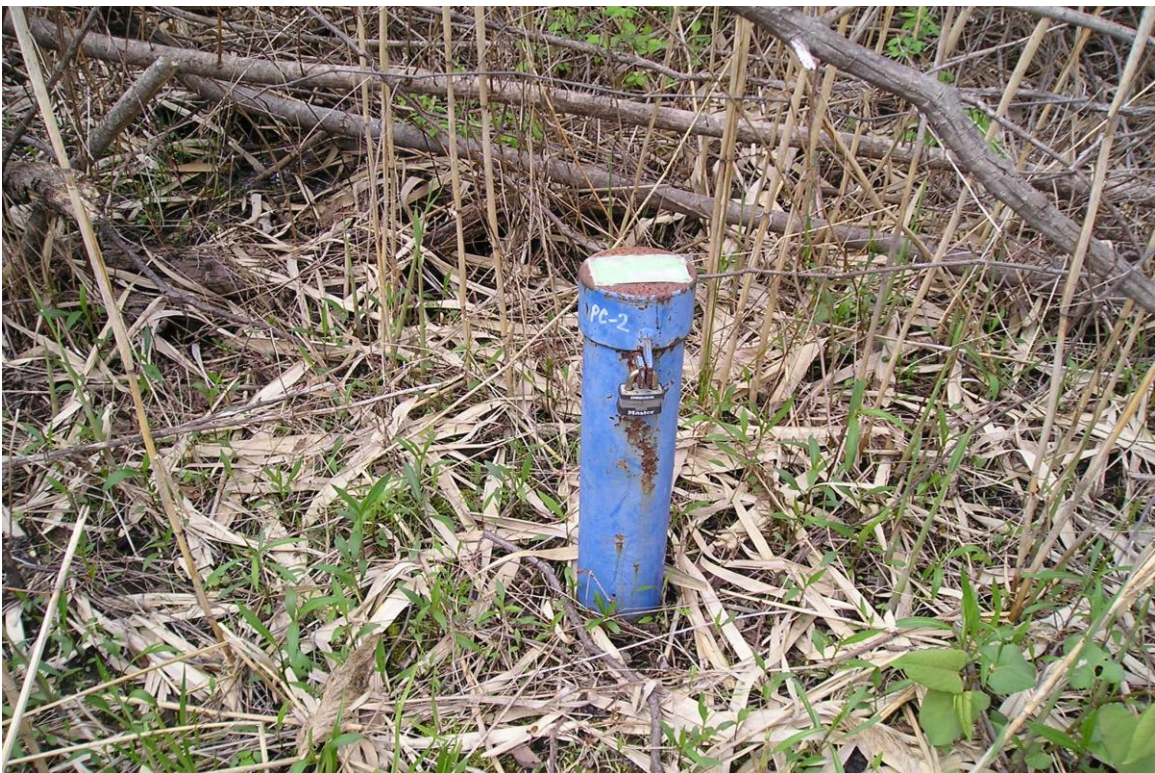
A downed tree blocked the path to access PC-2. Made a new path to access this well.

Photo 8: Well PC-2 (covered with downed tree limbs)

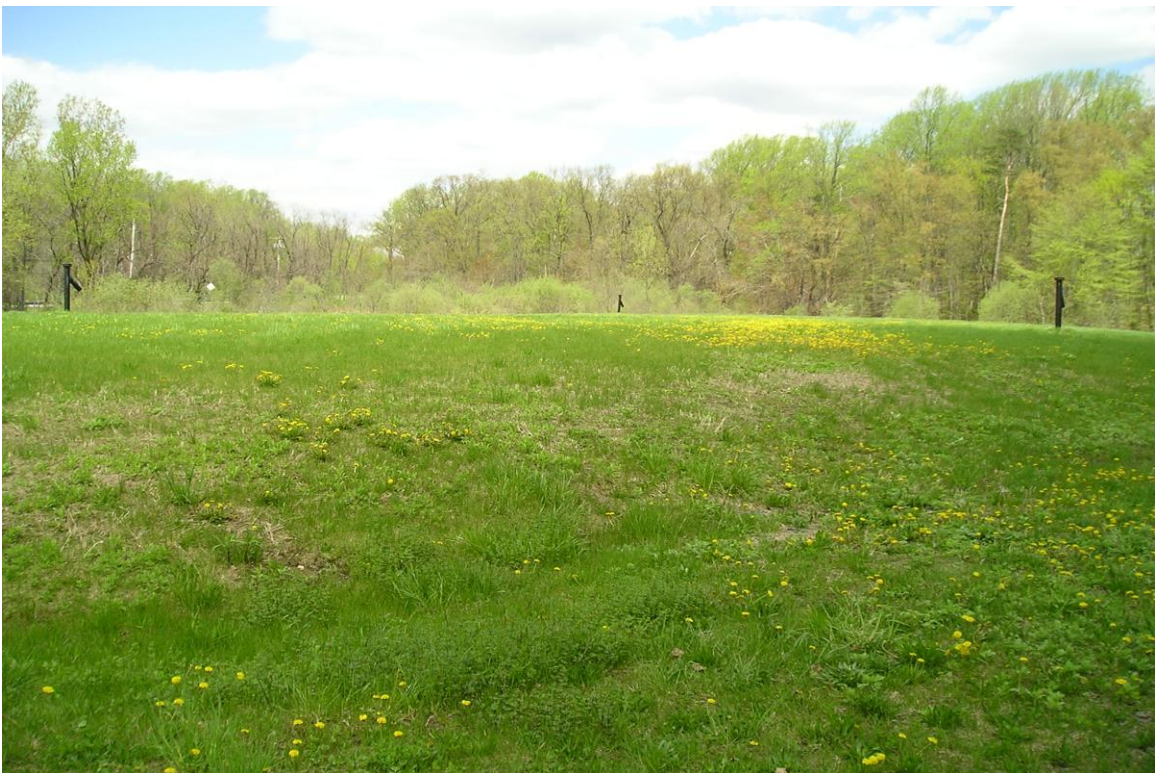
Grass height was good at the time of inspection (Photo #14). Mow cap in June and October.

Photo 14: Grass on landfill cap

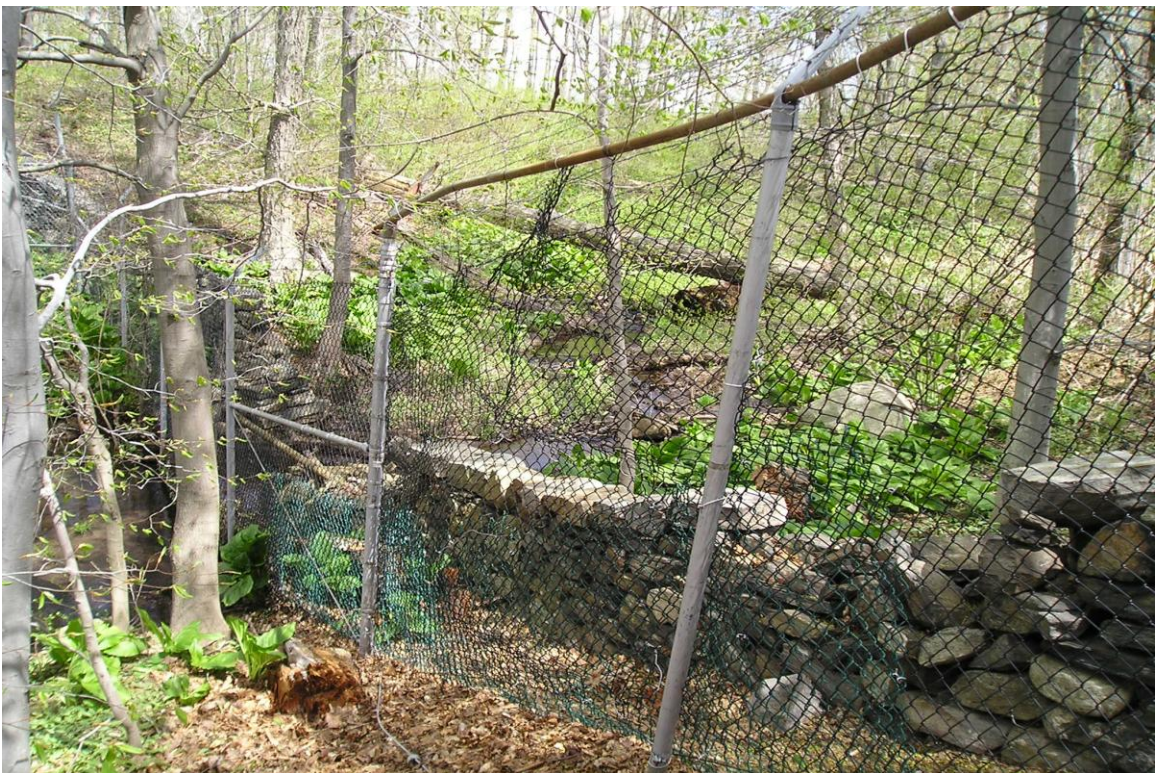
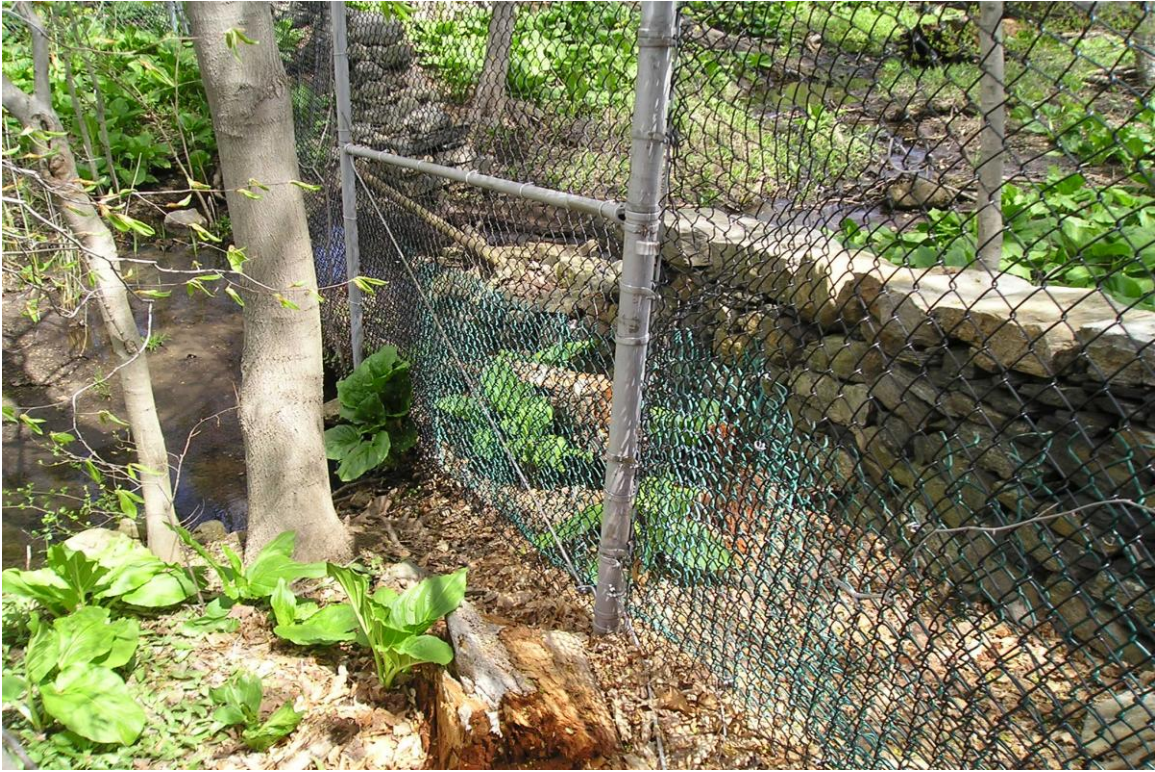
Fence damage by fallen tree was repaired (near stream inlet – northeast of landfill cap) (Photos #16 & 17)

Photo 16: Fallen tree removed off fence and repairs were made
(near stream inlet – northeast of landfill cap)

Photo 17: Fence repaired (near stream inlet)

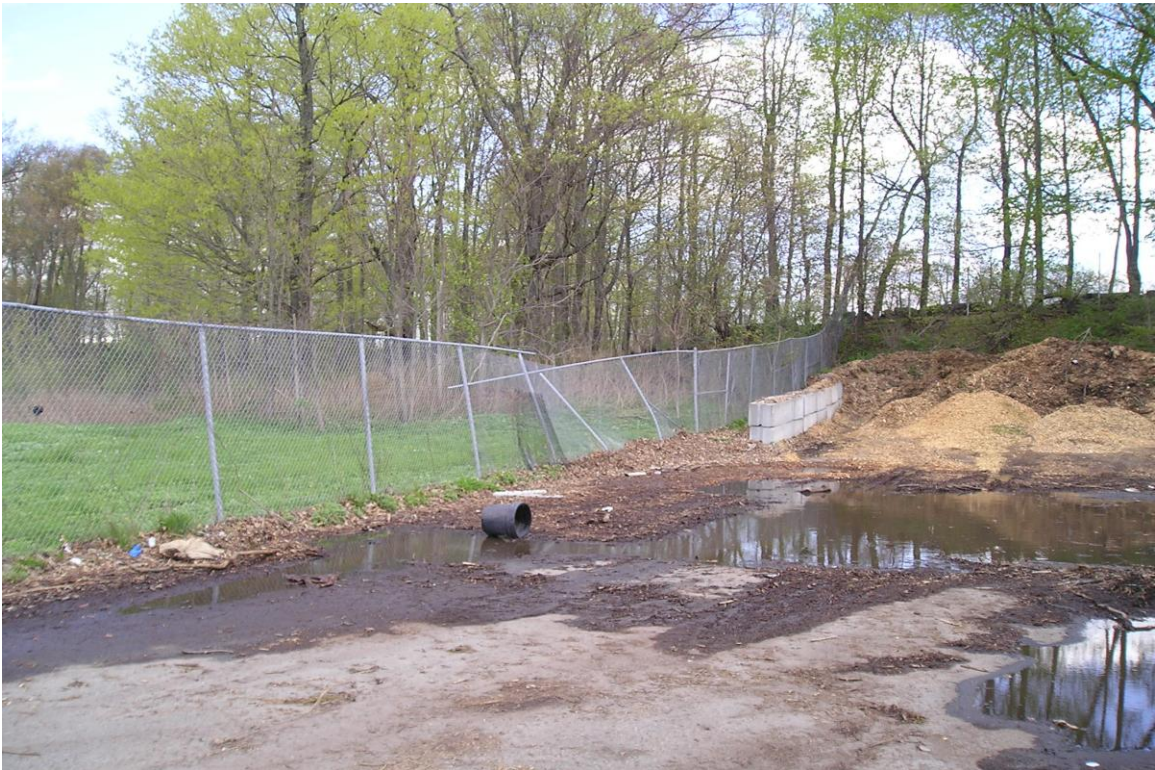
There is damage to the south fence near the landfill gate. The Harrison DPW will be contacted, since they caused the damage from the on-site activities they are involved with. (Photo #18)

Photo 18: South fence damage (looking east)

1. The landfill gate key and the keys to the well locks are in the facility office desk. The main gate to the facility is currently locked by on-site personnel at the end of the day.
2. Contact Harrison DPW regarding the damage to the south fence.

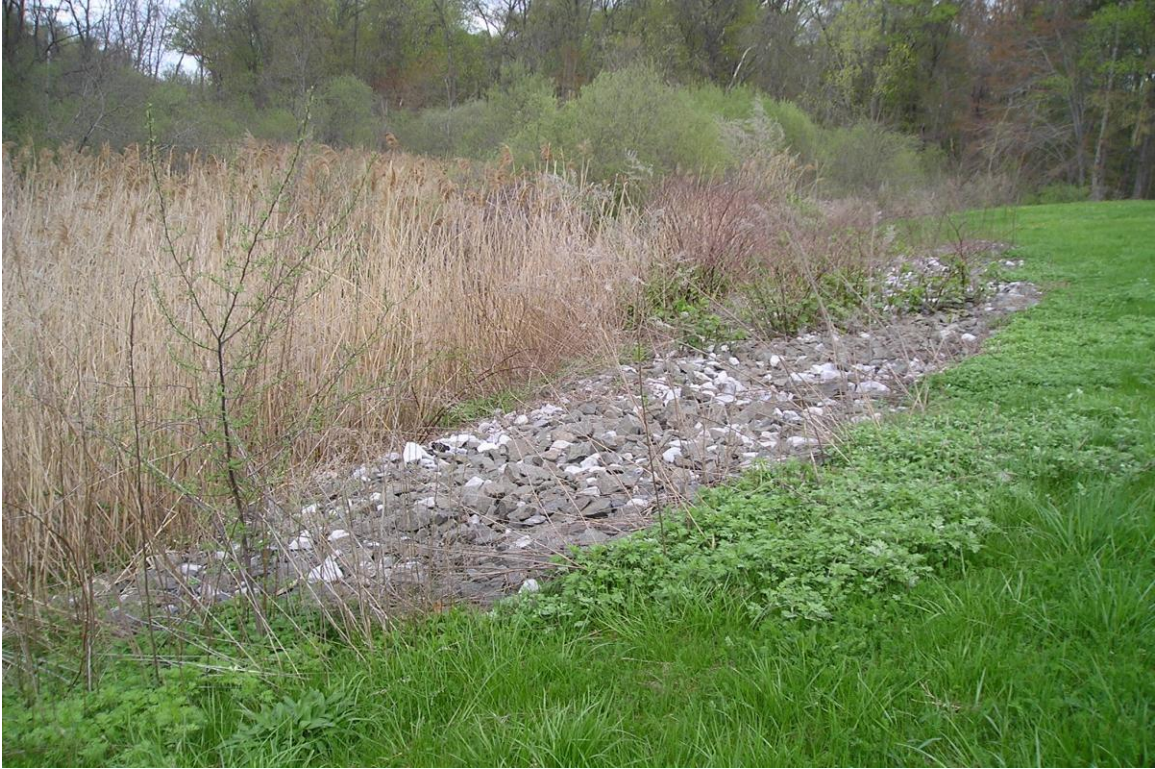
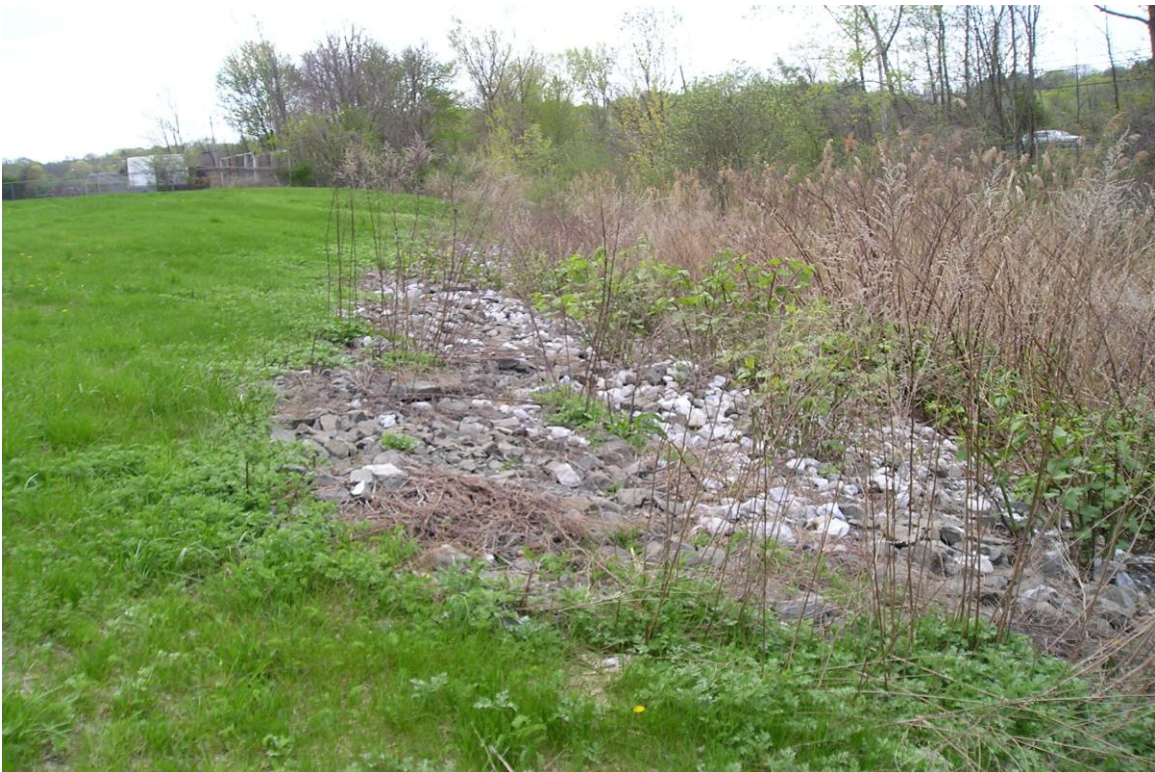
The soil slump on west slope of landfill was repaired in May 2009 by NYSDOT Residency 8-9 personnel. Repaired area is still in good condition (Photos #19 & 20).

Photo 19: West slope erosion area repair (looking north)

Photo 20: West slope erosion area repair (looking south)

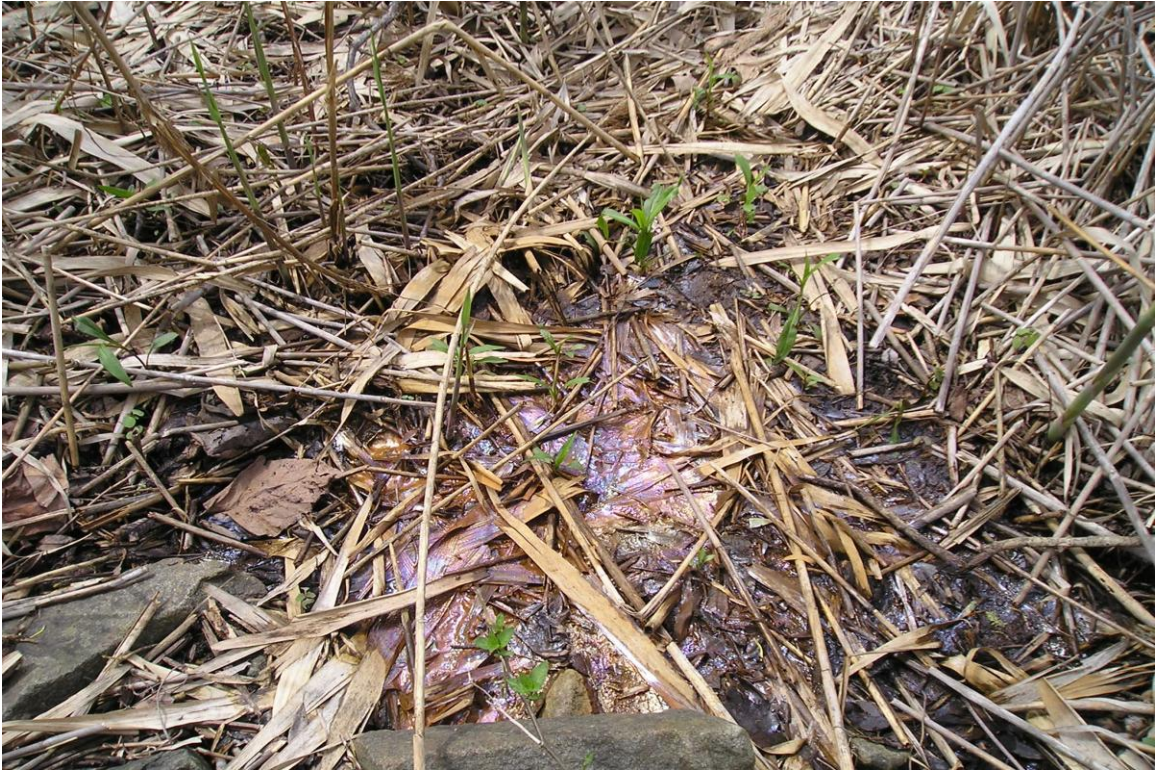
Area of orange iron bacteria staining and floating organic film on water exists near the area just east of PC-2 repair (Photo #21). No questionable odors were noted.

Photo 21: Orange staining near PC-2
