## HARRISON SUB-RESIDENCY FIELD INSPECTION

**Name of Inspector(s):** Christopher Kappeller

**Date:** 11/8/11

### Semi-Annual

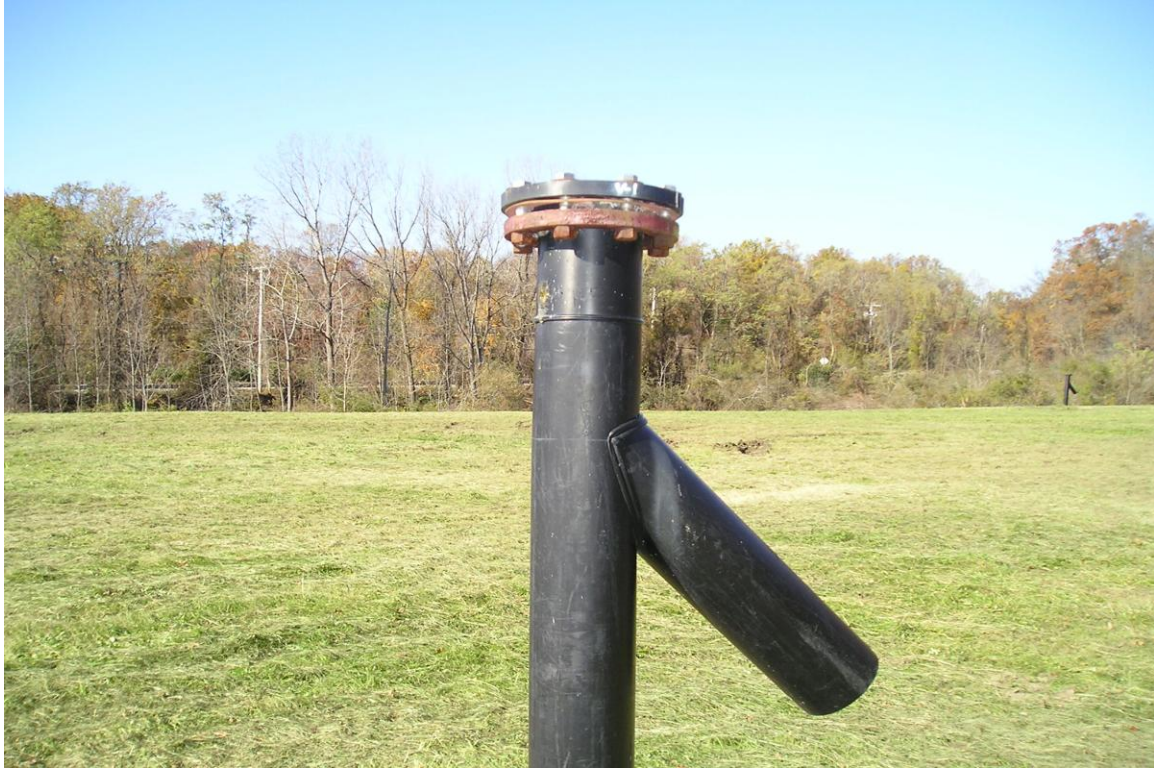
Photo 1: Vent V-1

Four vents (V1 – V4) were inspected and generally found in good condition (visually unlocked, neither cracks nor movement was observed) (Photos # 1-4). V-2 shows a slight lean to north.

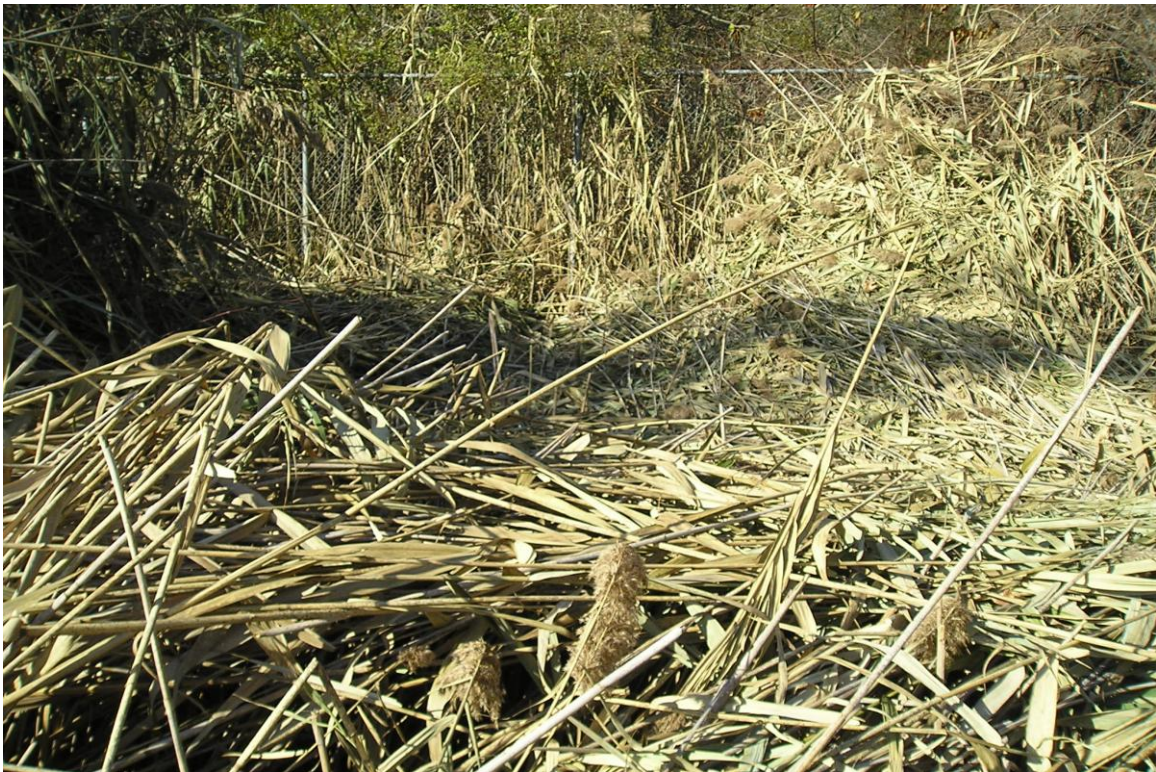
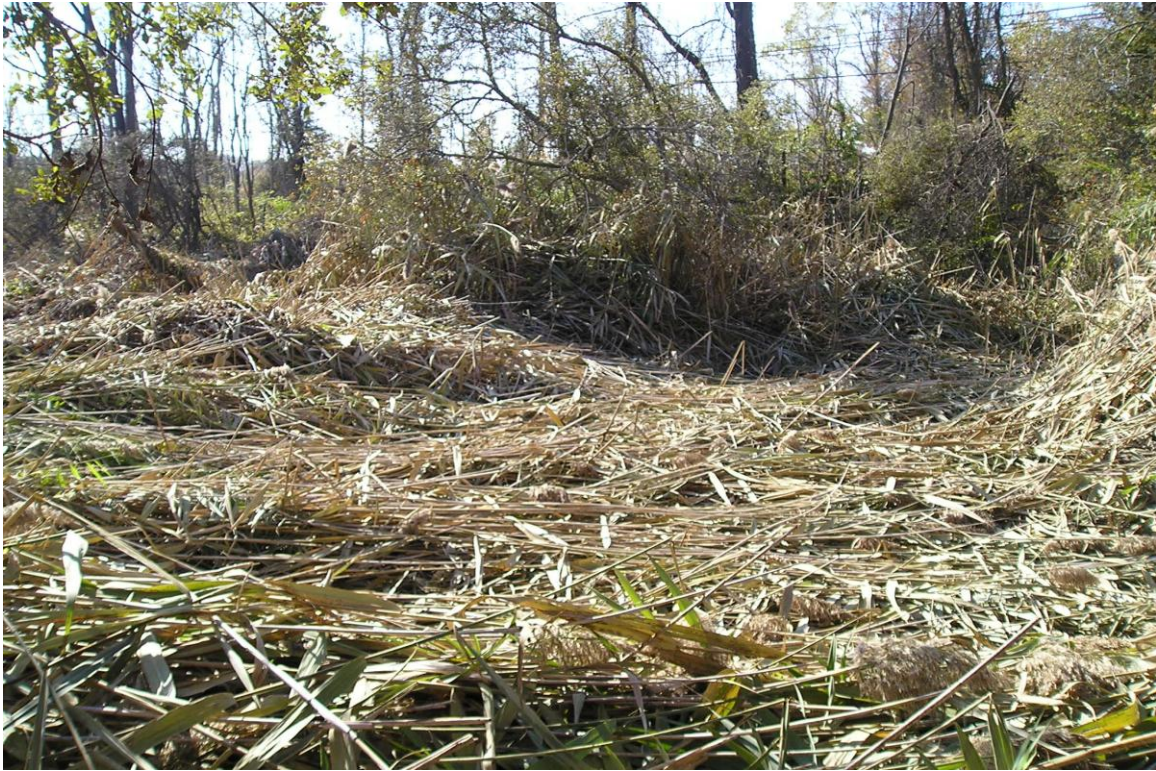
LMS-4 could not be located at the time of the inspection. Heavy snow and wind from an October 2011 snowstorm flattened the dense phragmites over the area of the well. An attempt to clear debris from over the well will be made during the winter when the water and mud freezes up in that area (Photo # 6 & 7).

Photo 6: Well LMW-4 area (looking northwest)

Photo 7: Well LMW-4 area (looking southwest)

1. The well keys are in the office desk. The main gate to the facility is currently locked by on-site personnel at the end of the day. Debris will have to be removed from the top of MW-Well LMS-4 in the winter to expose the well. Old vegetation should be removed in the area of the west slope repair.

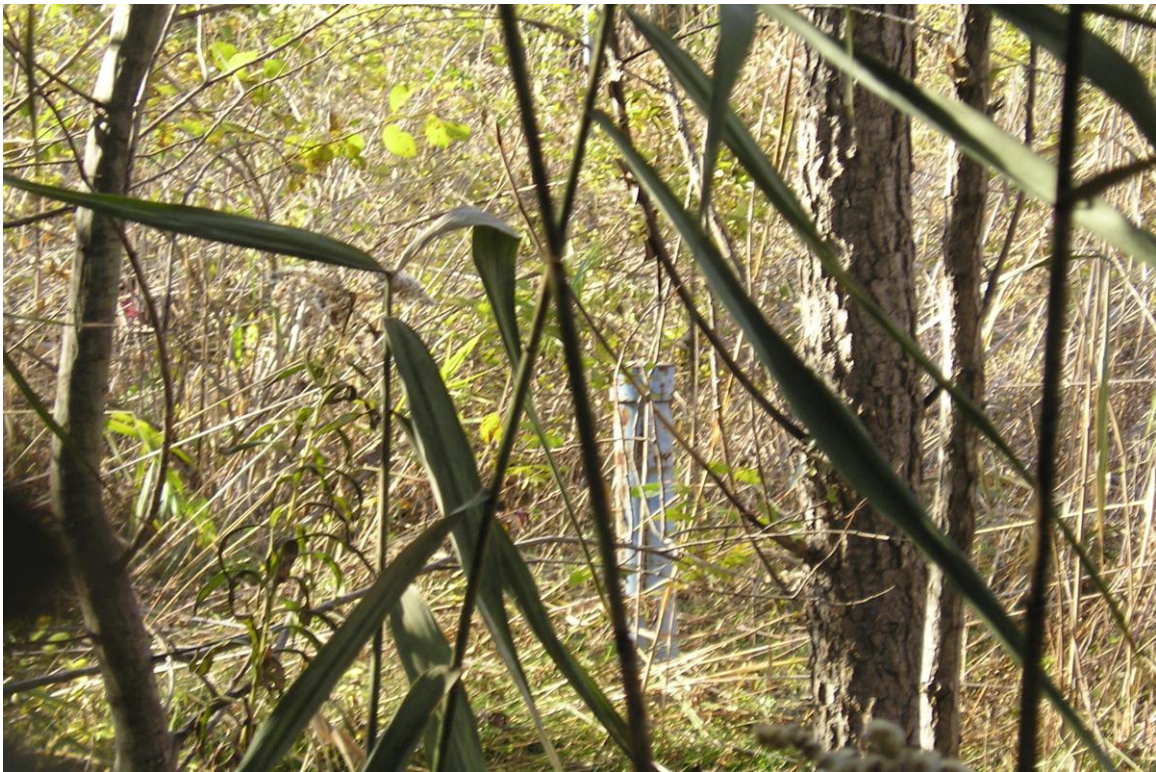
Photo 8: Well PC-1 appears in good condition (couldn't get close to well due to debris and high water).

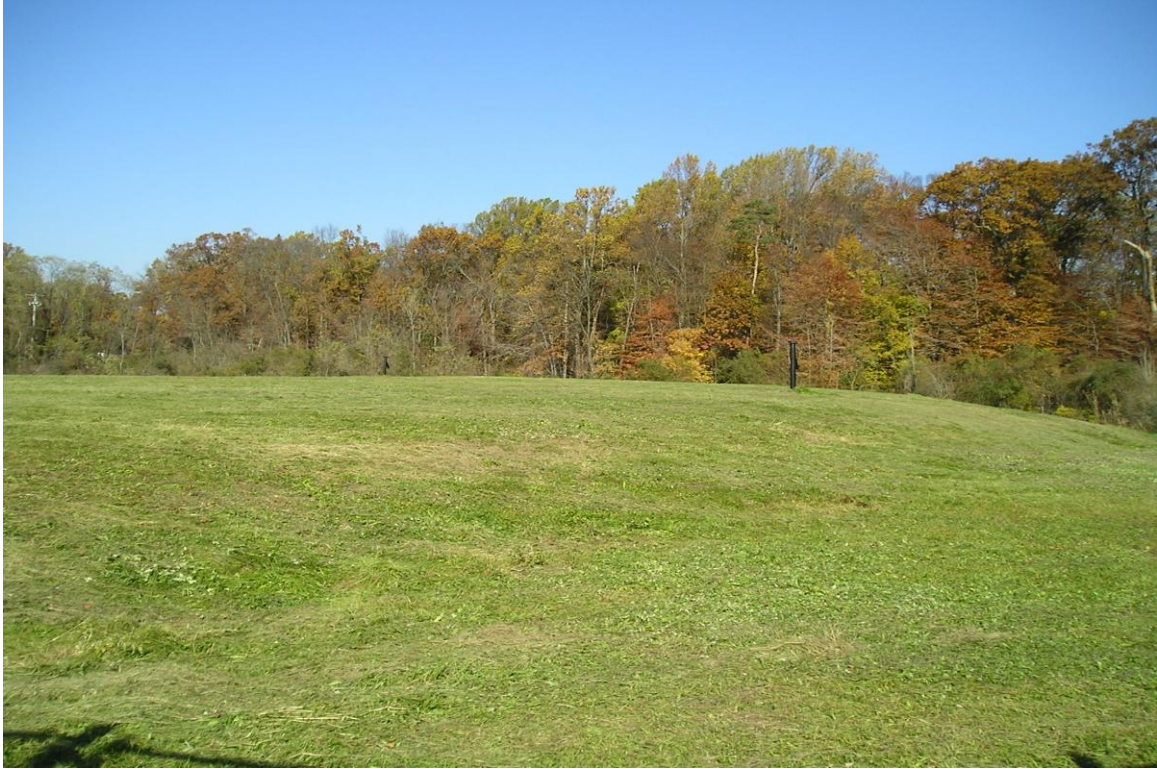
Grass height was good at the time of inspection. The cap was mowed on 11/7/2011 (Photo #15). Continue to mow cap in June and October to control grass height.

Photo 15: Grass on landfill cap

Entire grass cover of the landfill was last mowed the day before the inspection on November 7, 2011. The cap should be mowed in June and in October.

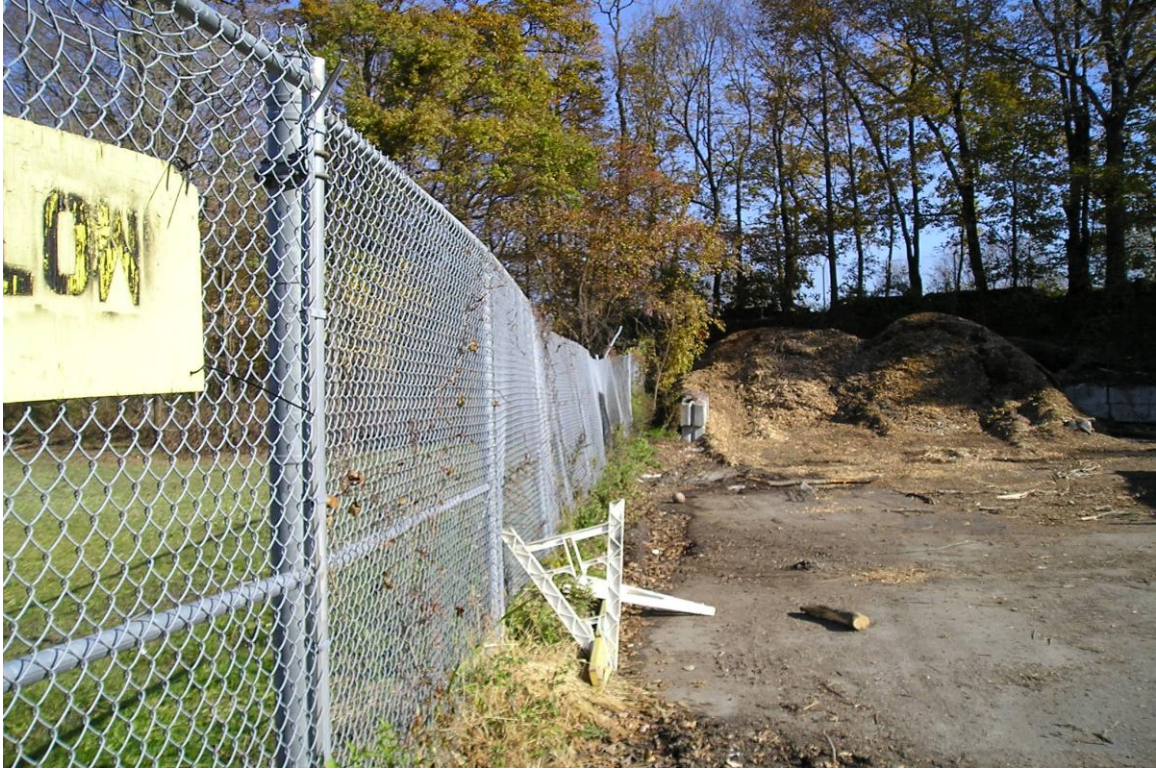
Damage to the south fence present near the landfill gate during the last inspection, was patched by Town of Harrison DPW. (Photo #17)

Photo 17: South fence damage repaired (looking east)

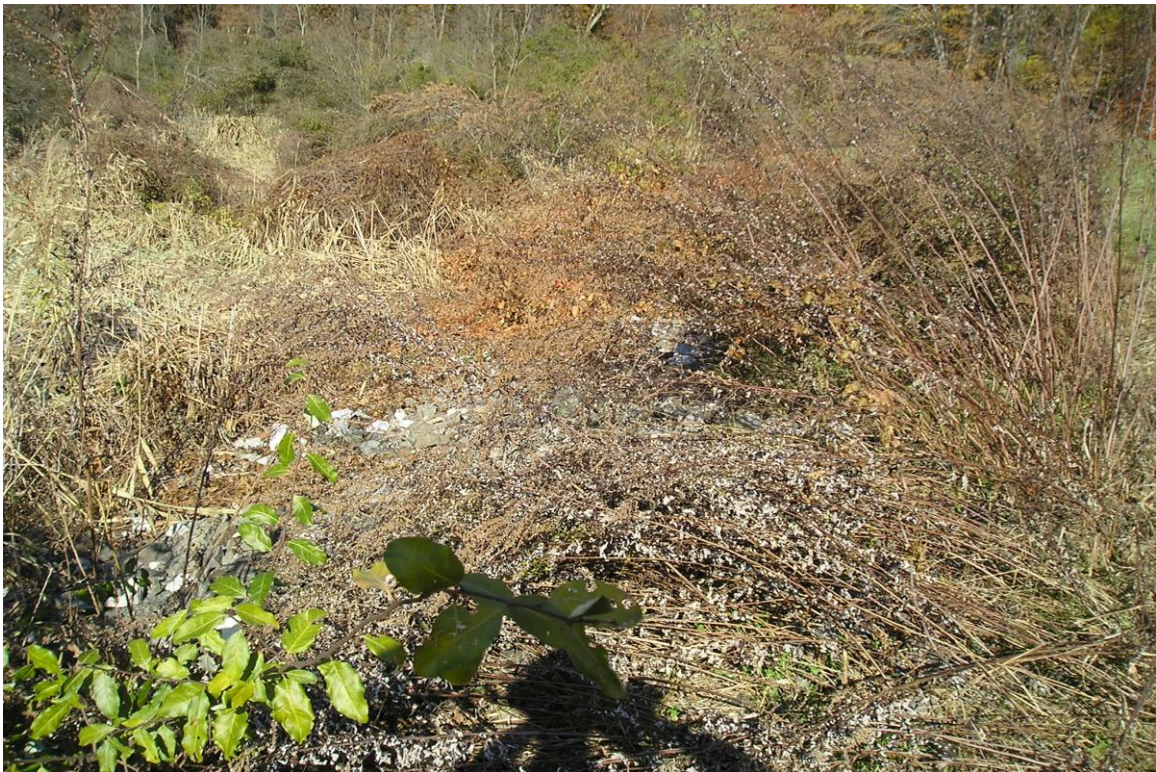
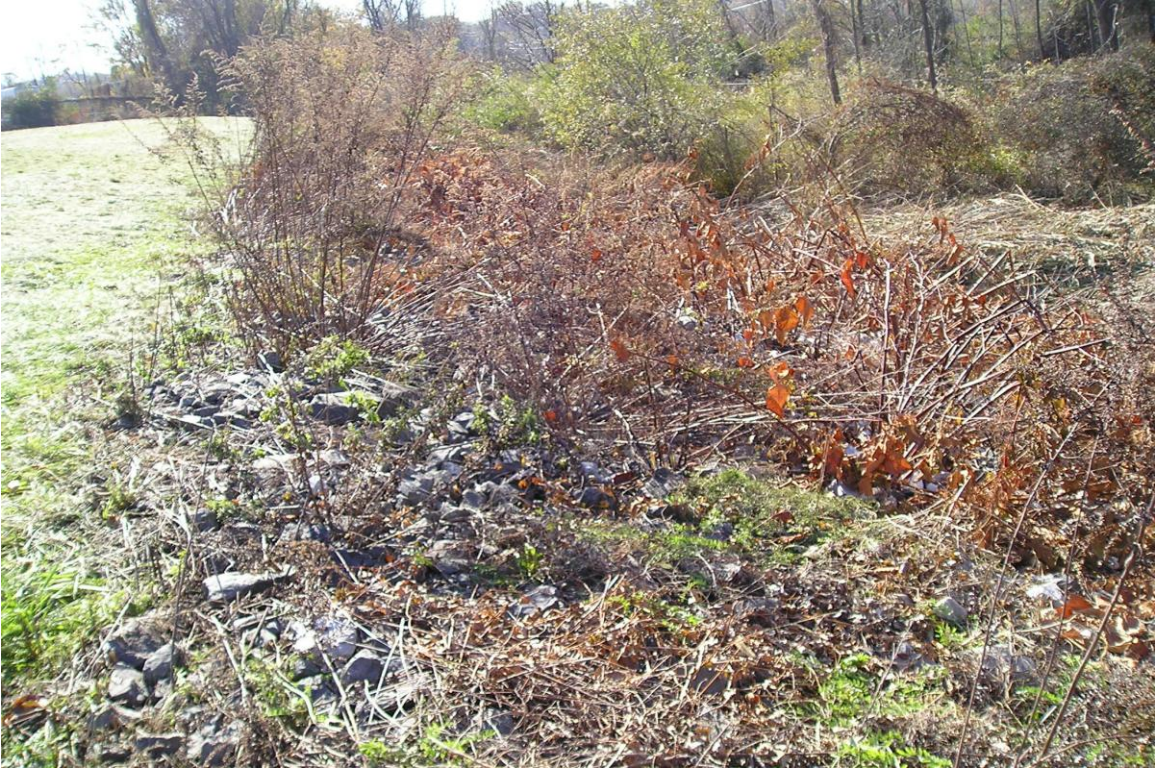
The soil slump on west slope of landfill was repaired in May 2009 by NYSDOT Residency 8-9 personnel. Area repair is still in good condition (Photo #18 & 19) but old vegetation should be weeded in the spring..

Photo 18: West slope erosion area repair (looking north)

Photo 19: West slope erosion area repair (looking south)

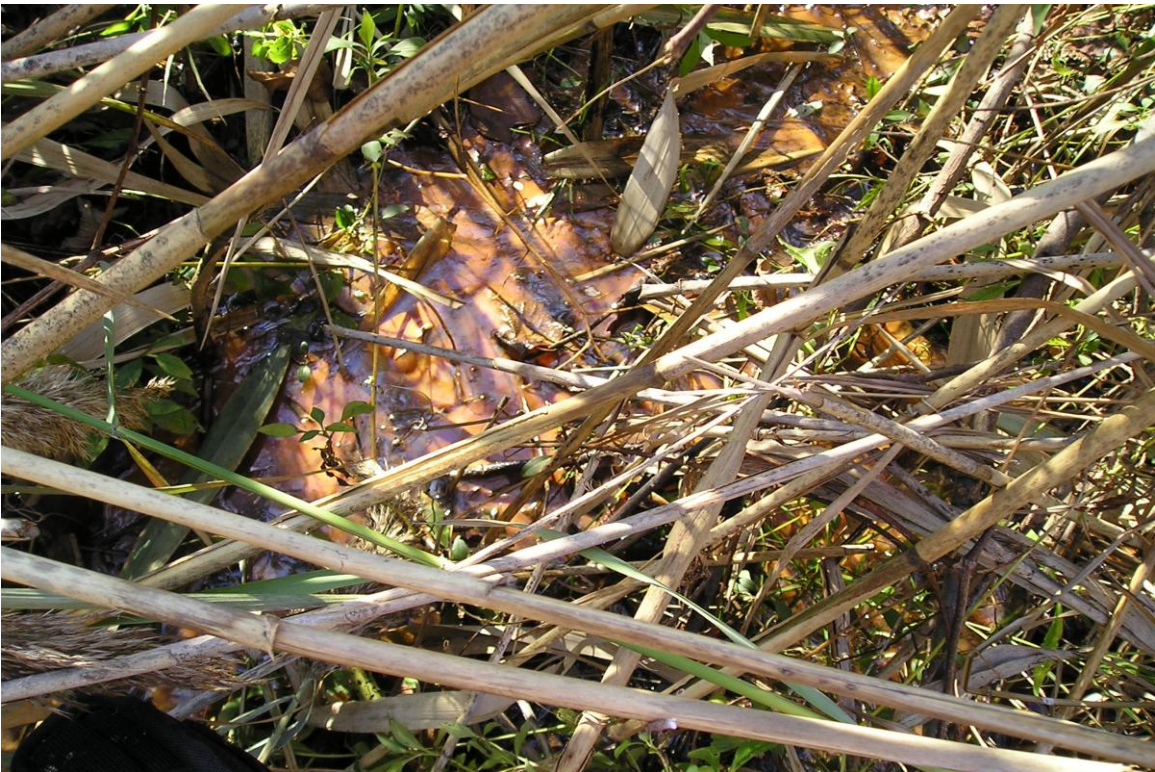
Area of orange iron bacteria staining and floating organic film on water exists near the area just east of PC-2 repair (Photo #20). No questionable odors were noted.

Photo 20: Orange staining near PC-2
