HARRISON SUB-RESIDENCY FIELD INSPECTION

Date: 4/18/12

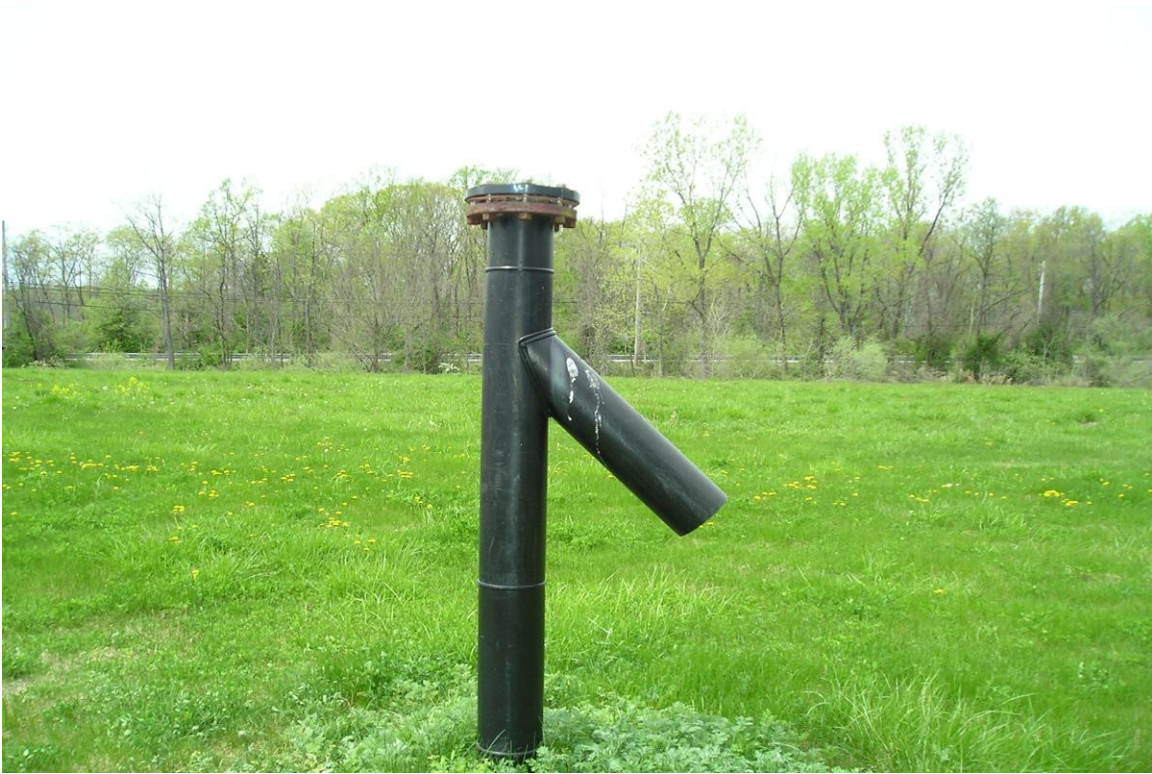
Photo 1: Vent V-1

Four vents (V1 – V4) were inspected and generally found in good condition (visually unlocked, neither cracks nor movement was observed) (Photos # 1-4). V-2 leans slightly to the north.

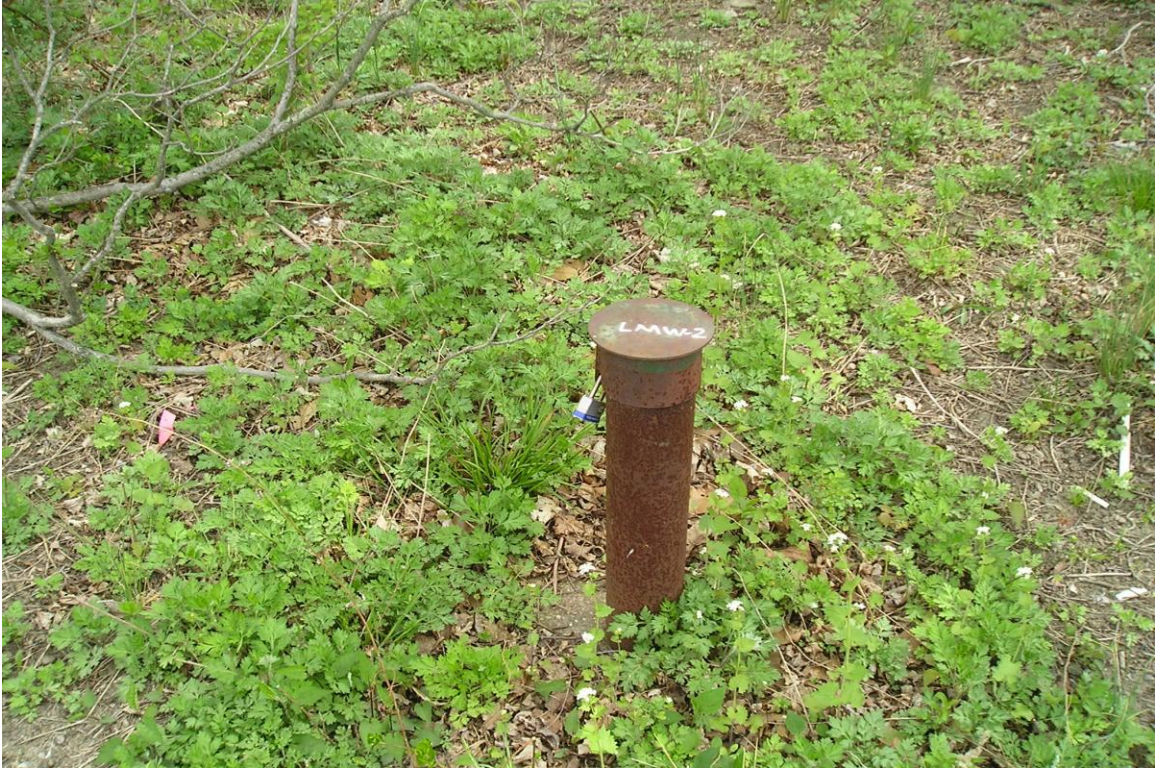
Photo 5: Well LMW-2

The lock on LMW-2 was rusted shut and could not be opened.

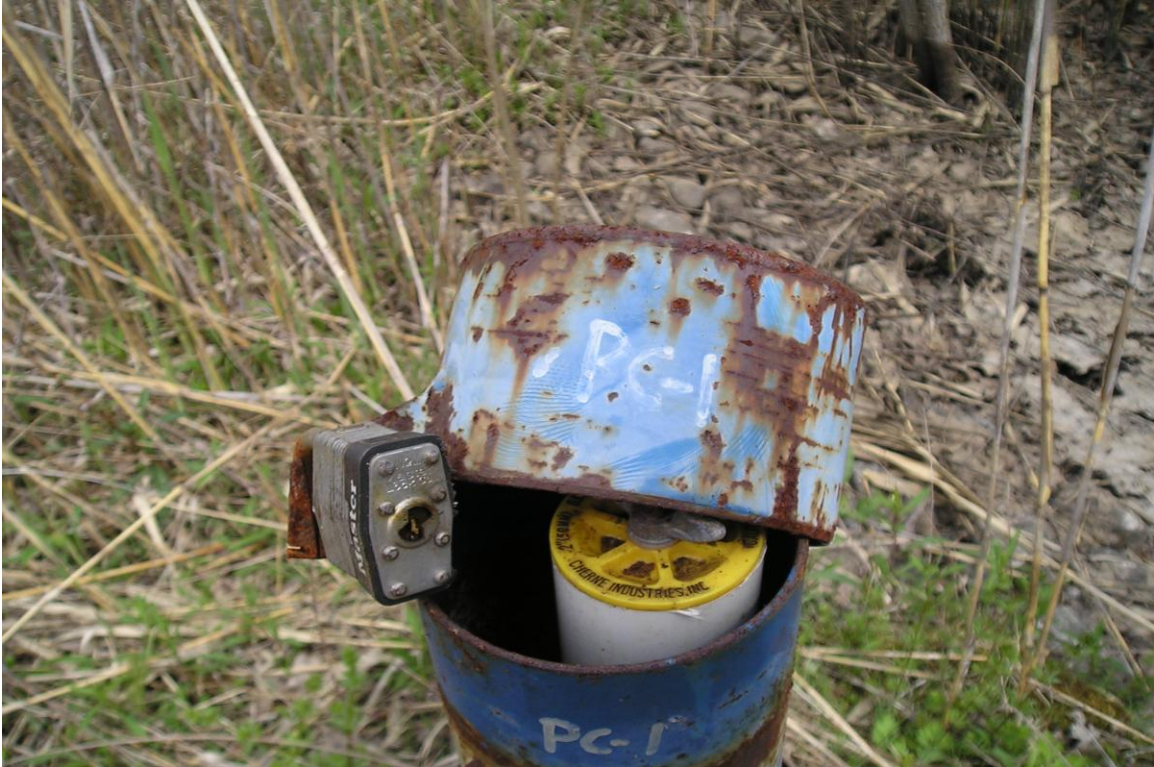
The wells are in satisfactory condition. The steel well casings are secured with locks, with one exception: the key in the lock on PC-1 is broken off inside and the tab on the casing cap that the lock went through has been cut through. NYSDOT's hazardous waste consultant did this to remove the rust-frozen lock so they could obtain a water sample during the last periodic 15-month sampling cycle in April 2011.

Photo 7: Well PC-1 with broken key in lock)

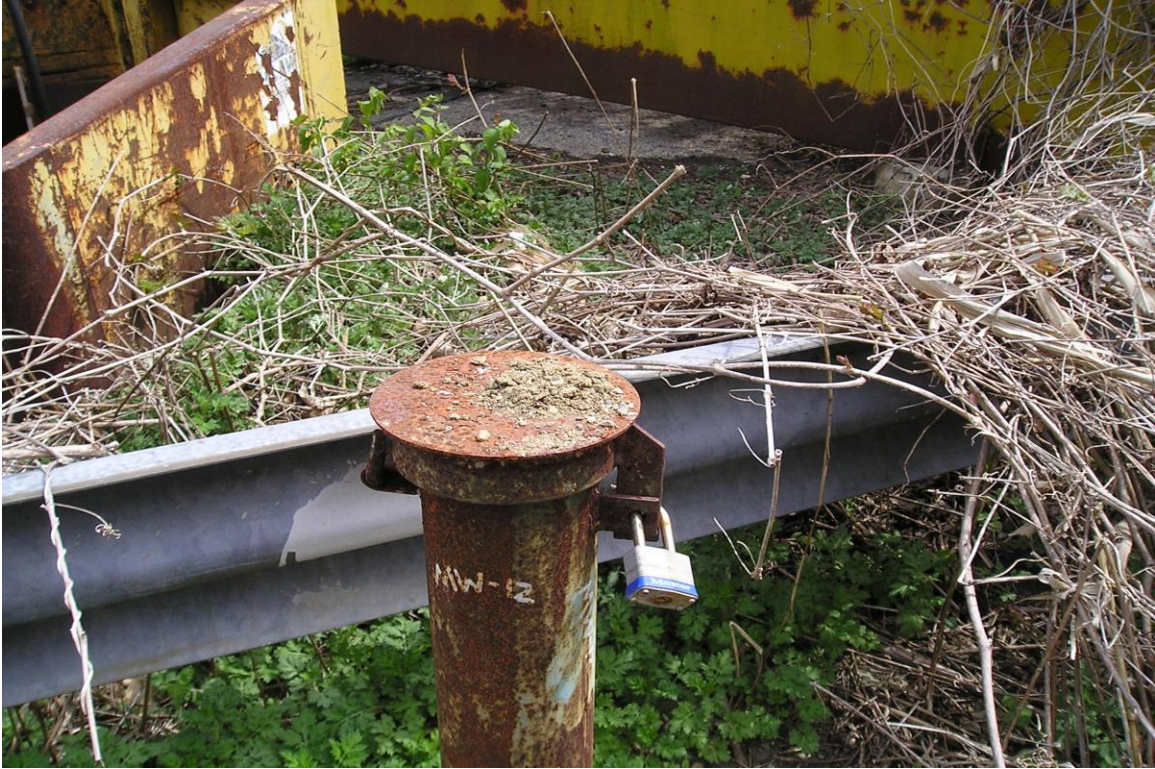
Photo 11: Well MW-12 later removed on 5/2/12.

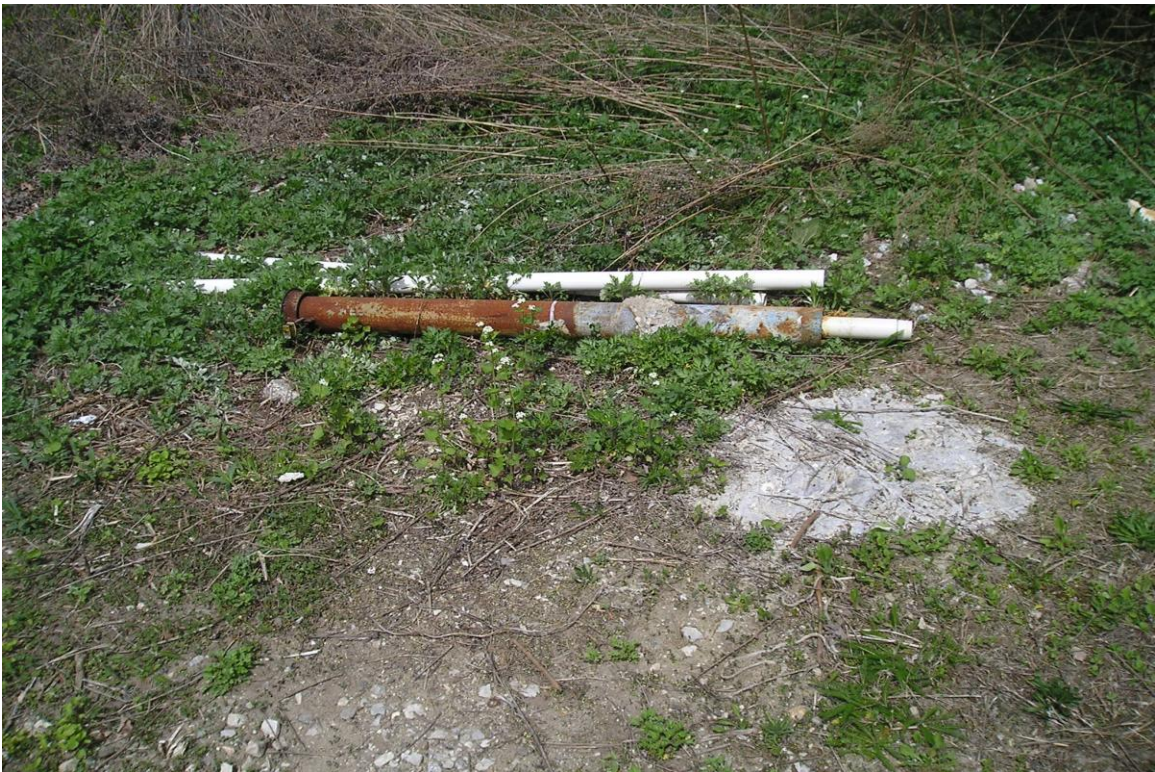
Photo 12: Well MW-13 casing removed from ground on 11/29/11.

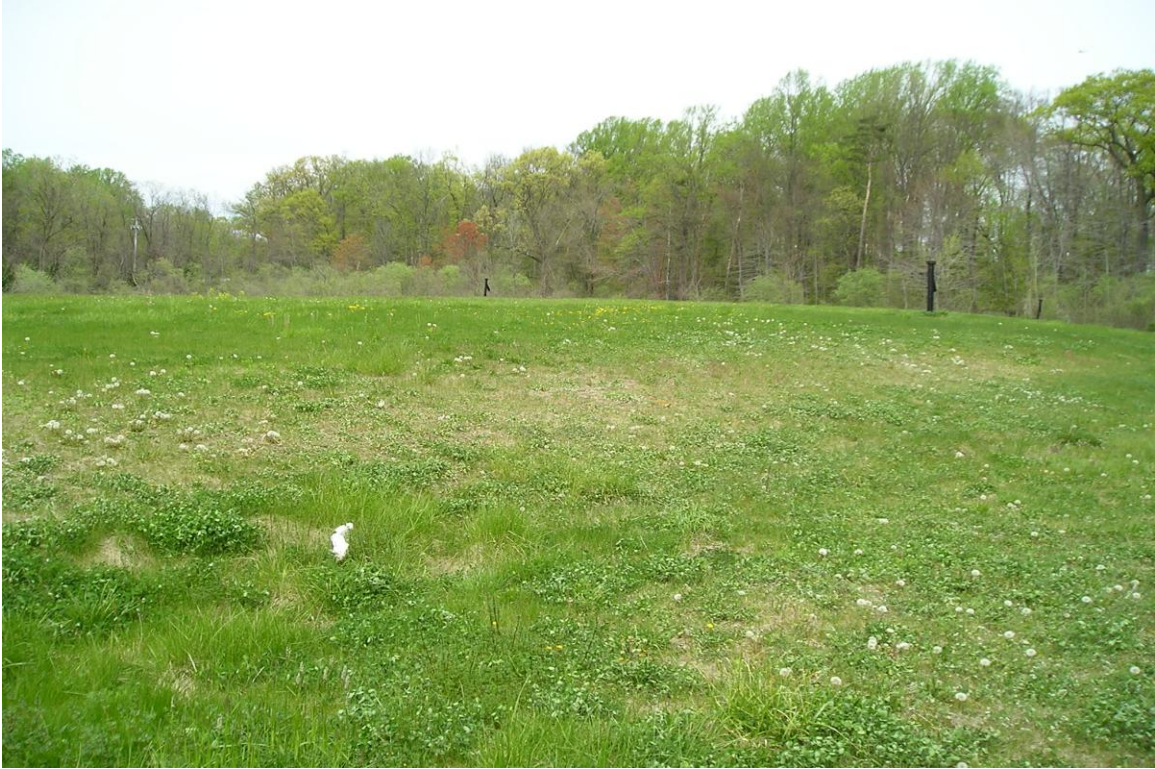
Photo 13: Grass on landfill cap

Grass height was good at the time of inspection. The cap was mowed on 11/7/2011 (Photo #13).

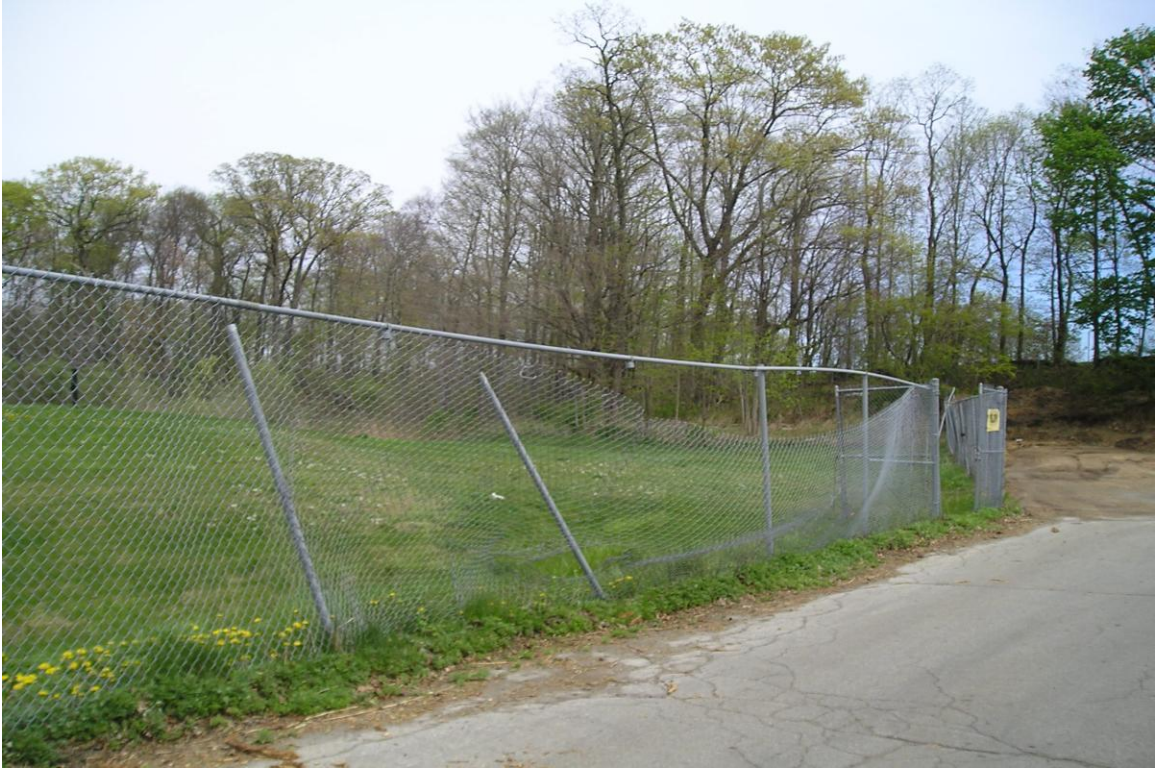
Damage was present to the south fence near the landfill gate during this inspection and needs to be repaired. (Photo #15)

Photo 15: South fence damage (looking east)

1. The cap should continue to be mowed every June and October to control grass height.
2. Overgrown vegetation on the west slope of the landfill should be removed/weed-wacked during the next cap mowing. NYSDOT Maintenance is aware of this.
3. The damage to the south fence near the landfill gate needs to be repaired. Harrison DPW will be contacted to fix this.

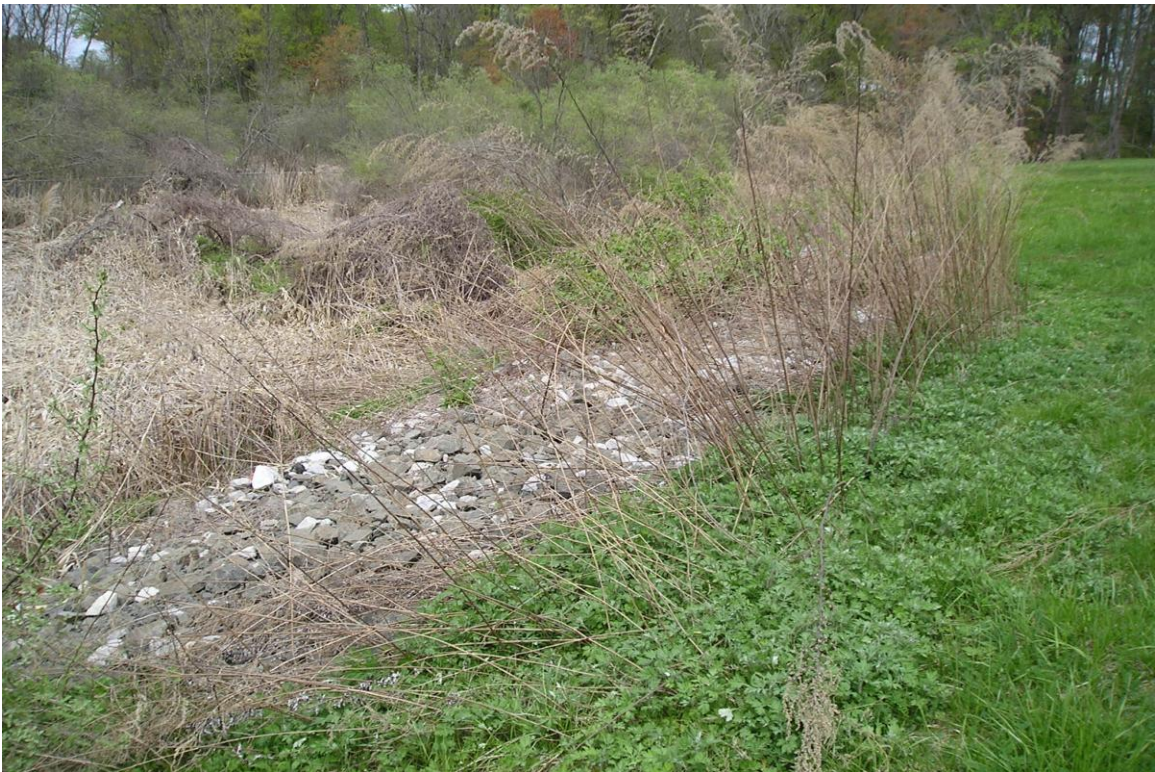
The soil slump on west slope of landfill was repaired in May 2009 by NYSDOT Residency 8-9 personnel. The repaired area is still in good condition (Photos #16 & 17), but overgrown vegetation should be weed-wacked this Spring (soon!).

Photo 16: West slope erosion area repair (looking north)

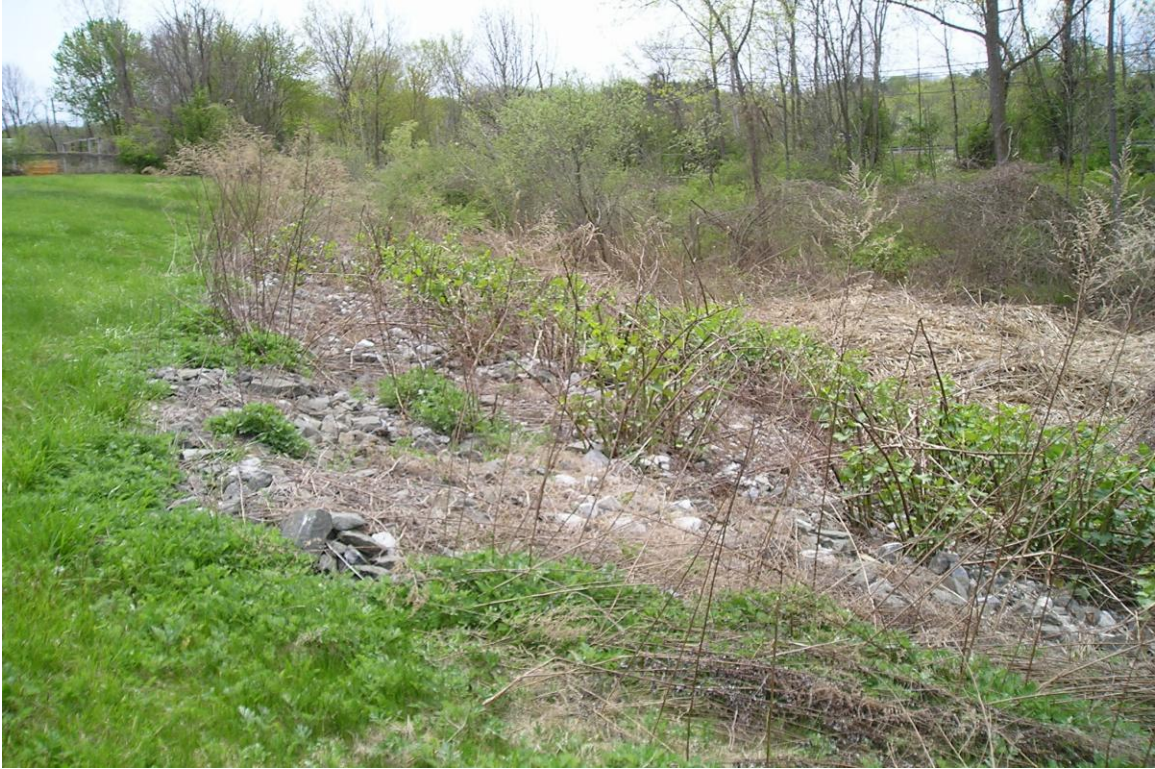
Photo 17: West slope erosion area repair (looking south)

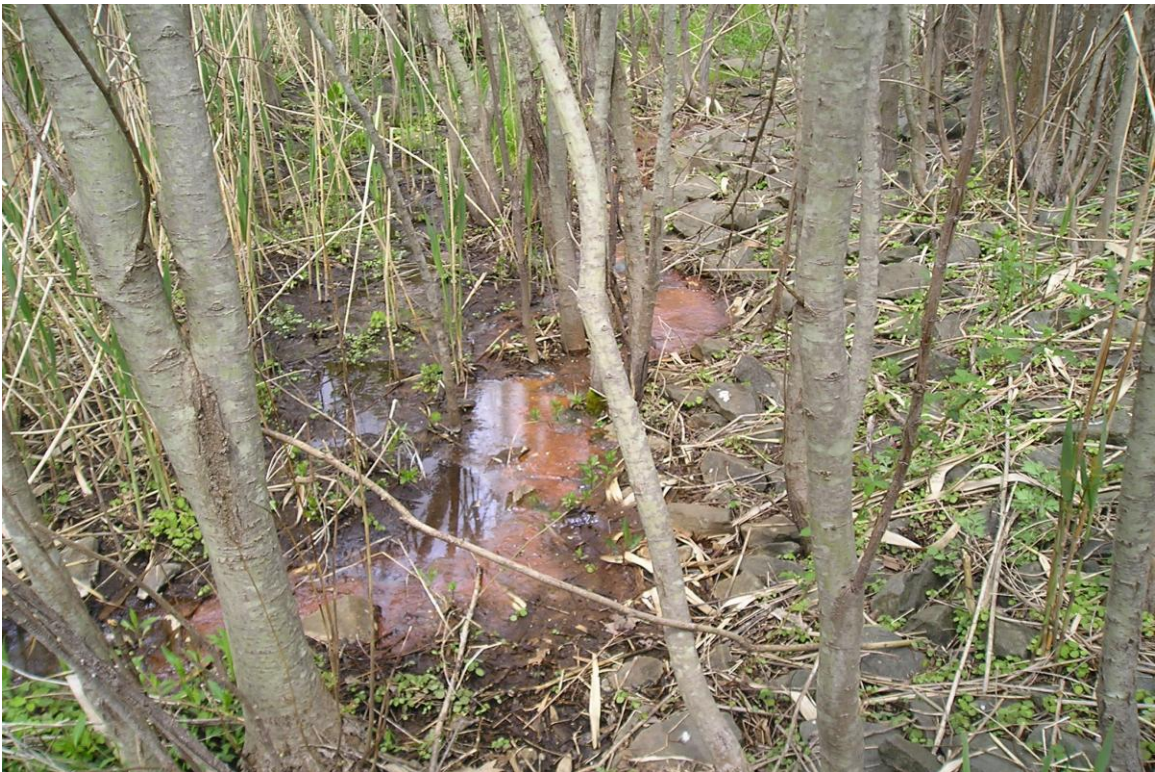
There is an area of orange iron bacteria staining and floating organic film on the water just east of PC-2 (Photo #18). No questionable odors were noted.

Photo 18: Orange staining near PC-2
