## HARRISON SUB-RESIDENCY FIELD INSPECTION

**Date:** 10/25/12

### Semi-Annual

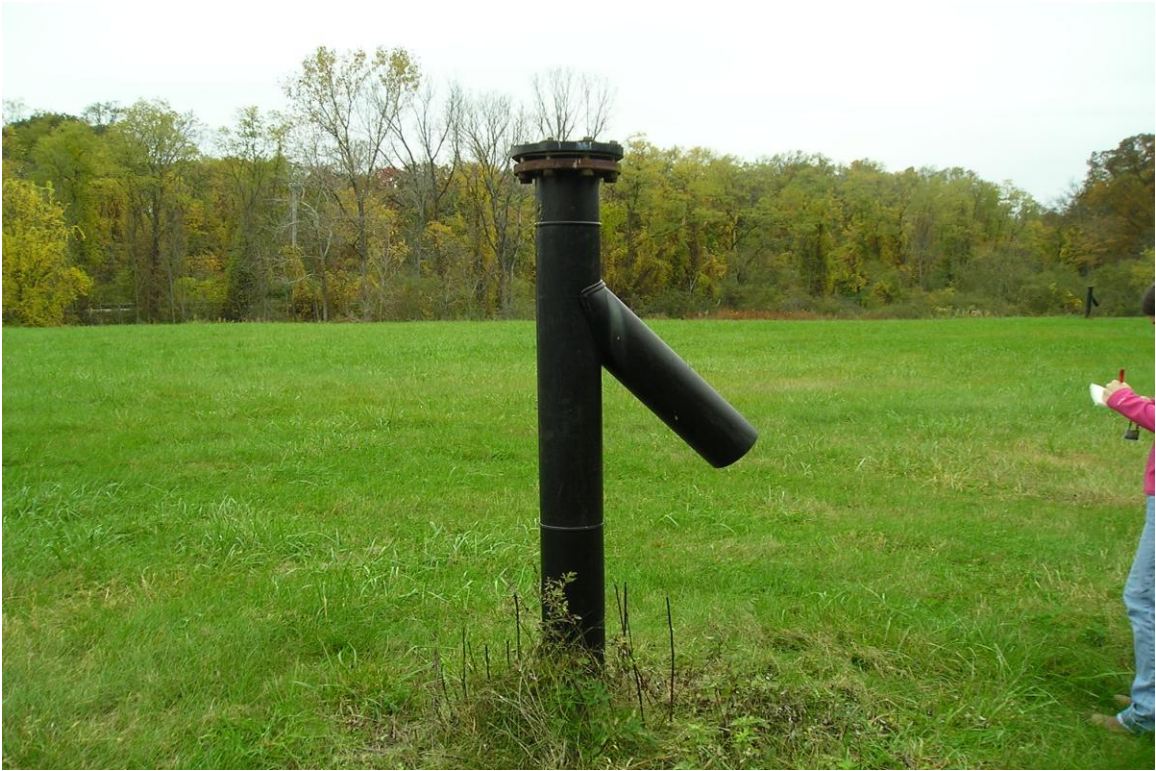
Four vents (V1 – V4) were inspected and generally found in good condition (neither cracks nor movement was observed) (Photos # 1-4). V-2 leans slightly to the north.

Photo 1: Vent V-1

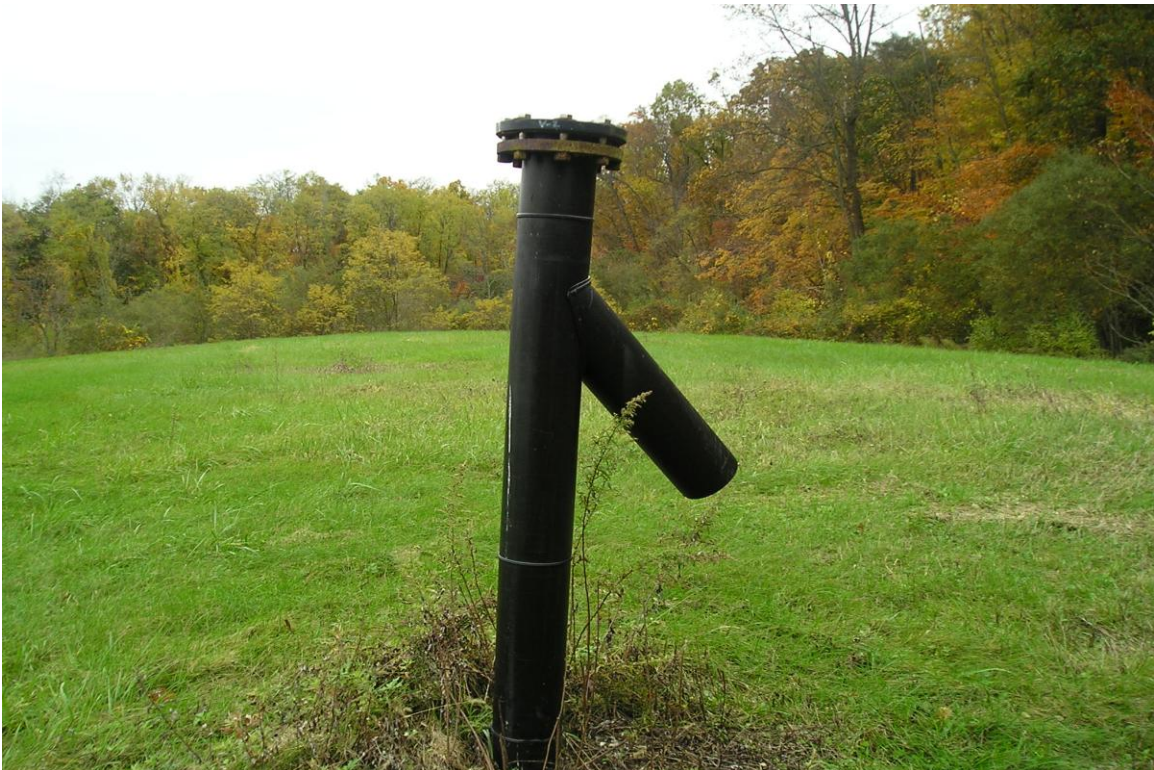
Photo 2: Vent V-2

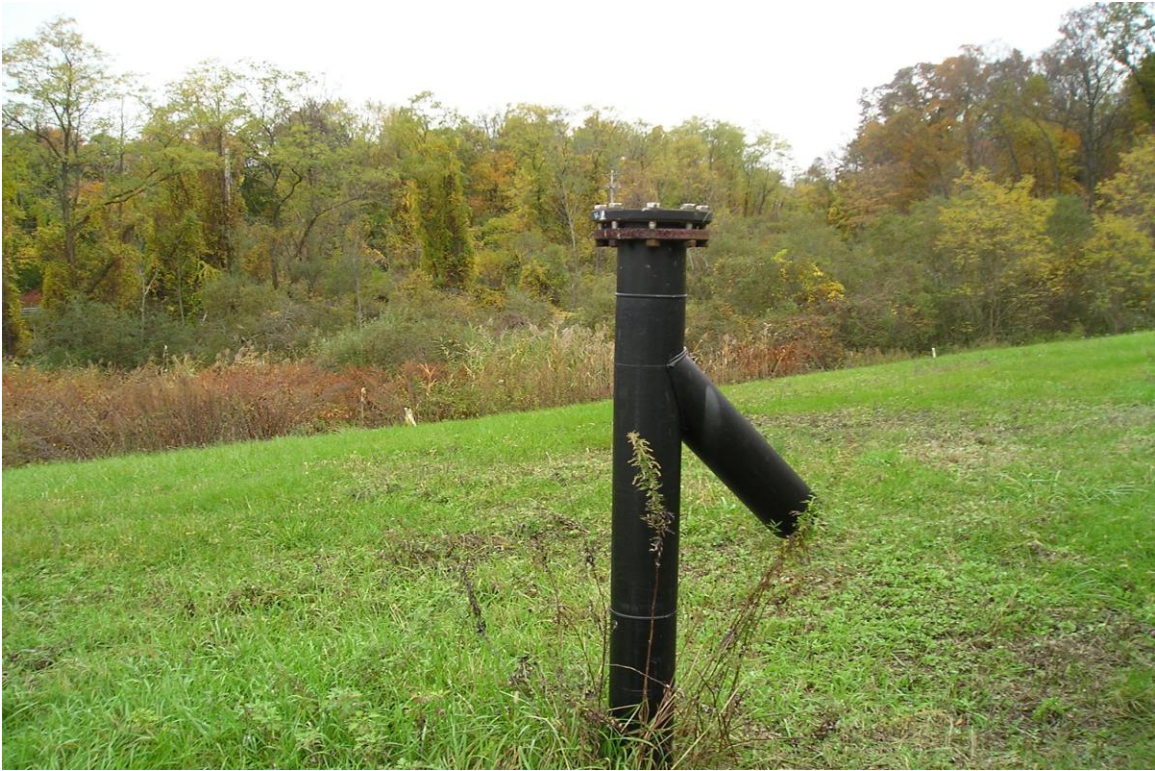
Photo 3: Vent V-3

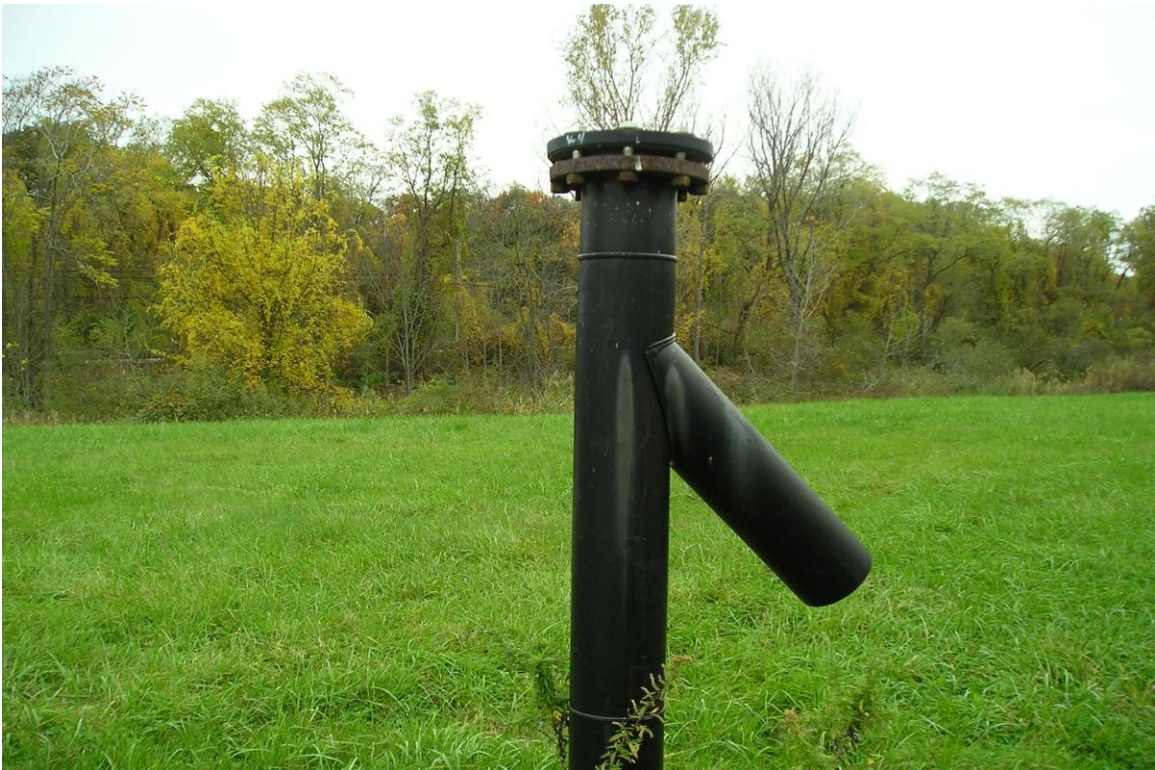
Photo 4: Vent V-4

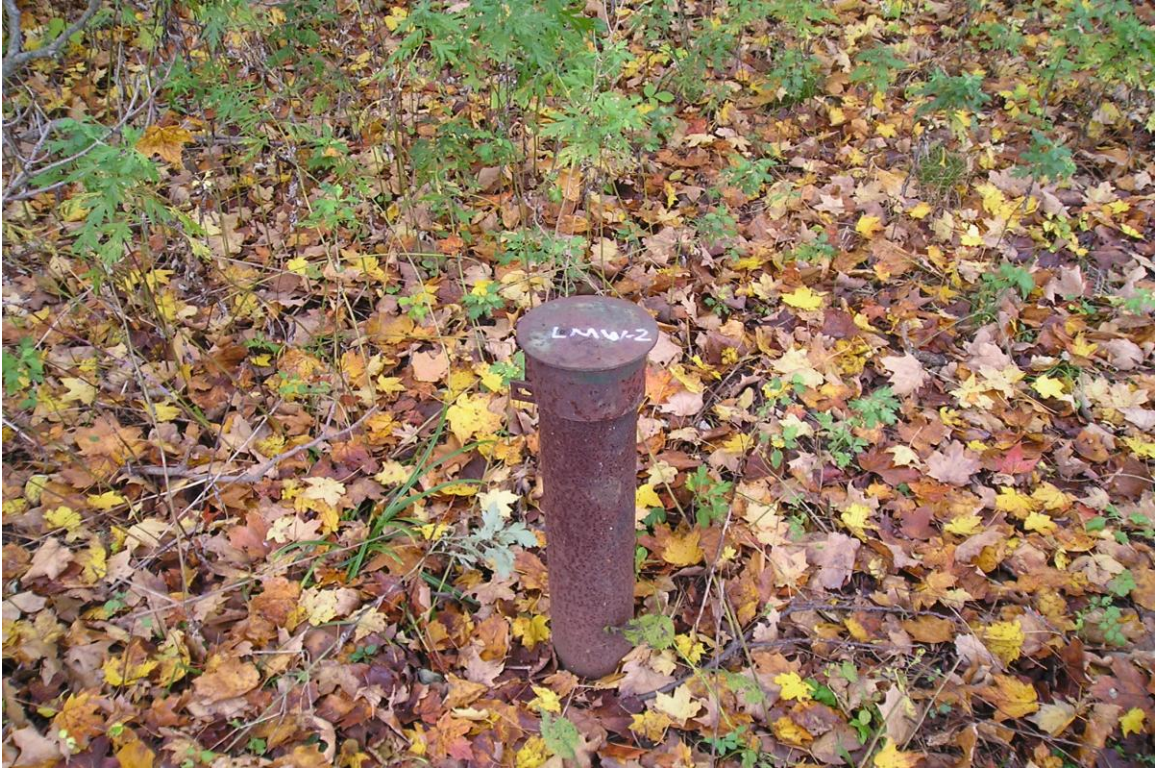
Photo 5: Well LMW-2

All wells were inspected and found to be in good condition. Locks were removed from the well casings of wells PC-1, PC-2, LMW-2, and LMW-4. It was decided that the locks will remain off, because the site is secured with perimeter fencing and the locks continually rust closed, requiring them to be cut to gain access to the well casing for inspection and water sampling.

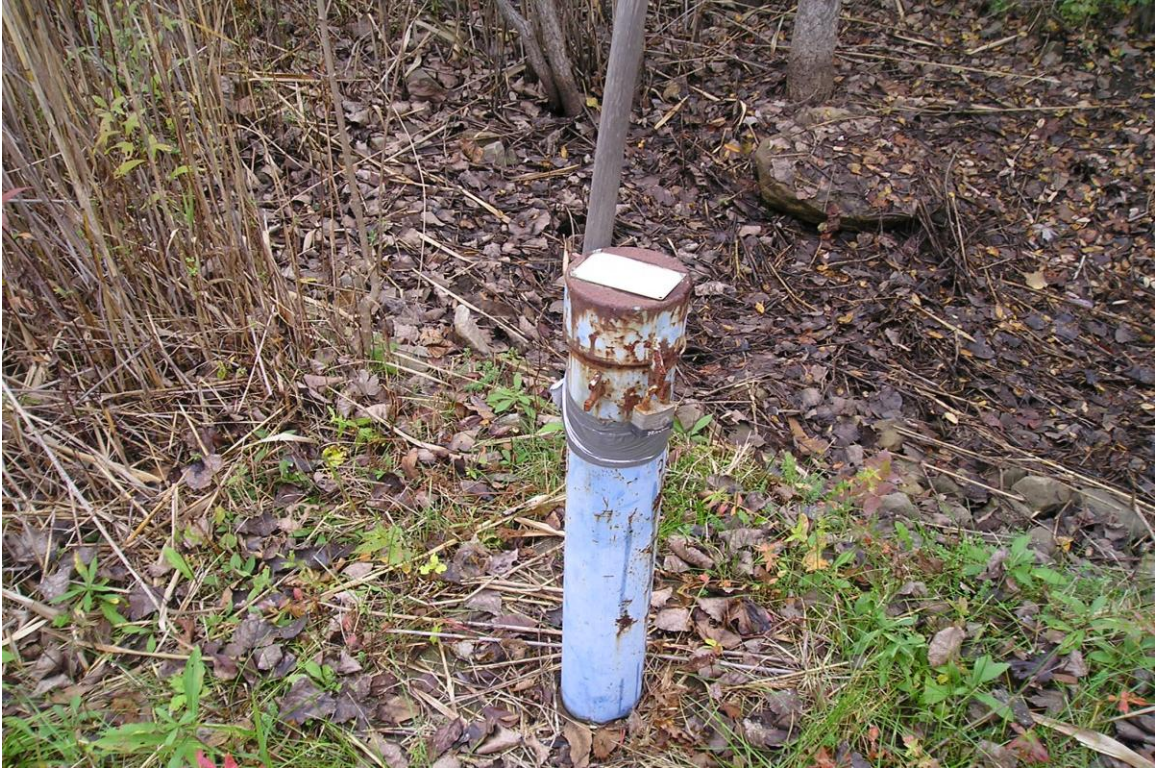
Photo 7: Well PC-1 (with broken key in lock)

1. The well keys are in the office desk. The main gate to the facility is currently locked by on-site personnel at the end of the day. The gate to the landfill is kept closed and locked.
2. The locks on wells PC-1, PC-2, LMW-2, and LMW-4 were removed and will not be replaced.

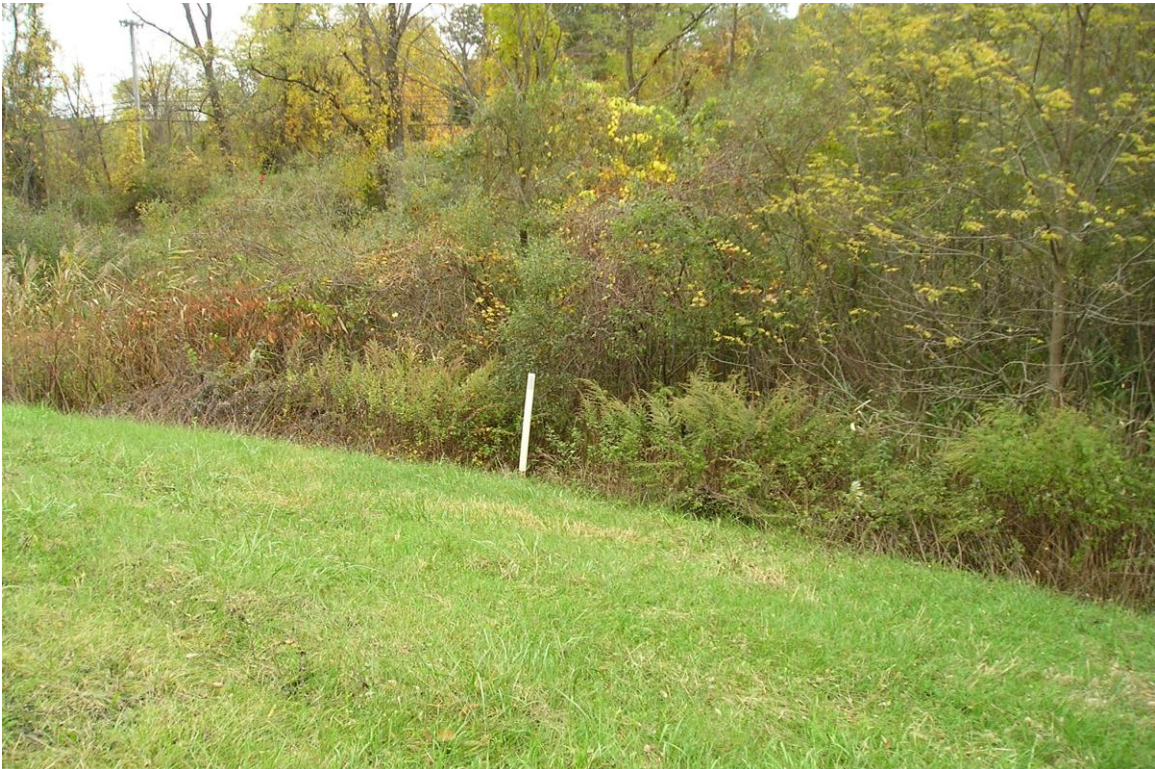
Grass height was good at the time of inspection (Photo #10).

Photo 10: Grass on landfill cap

The entire grass cover of the landfill was last mowed in September 2012. The cap should be mowed every June and October.

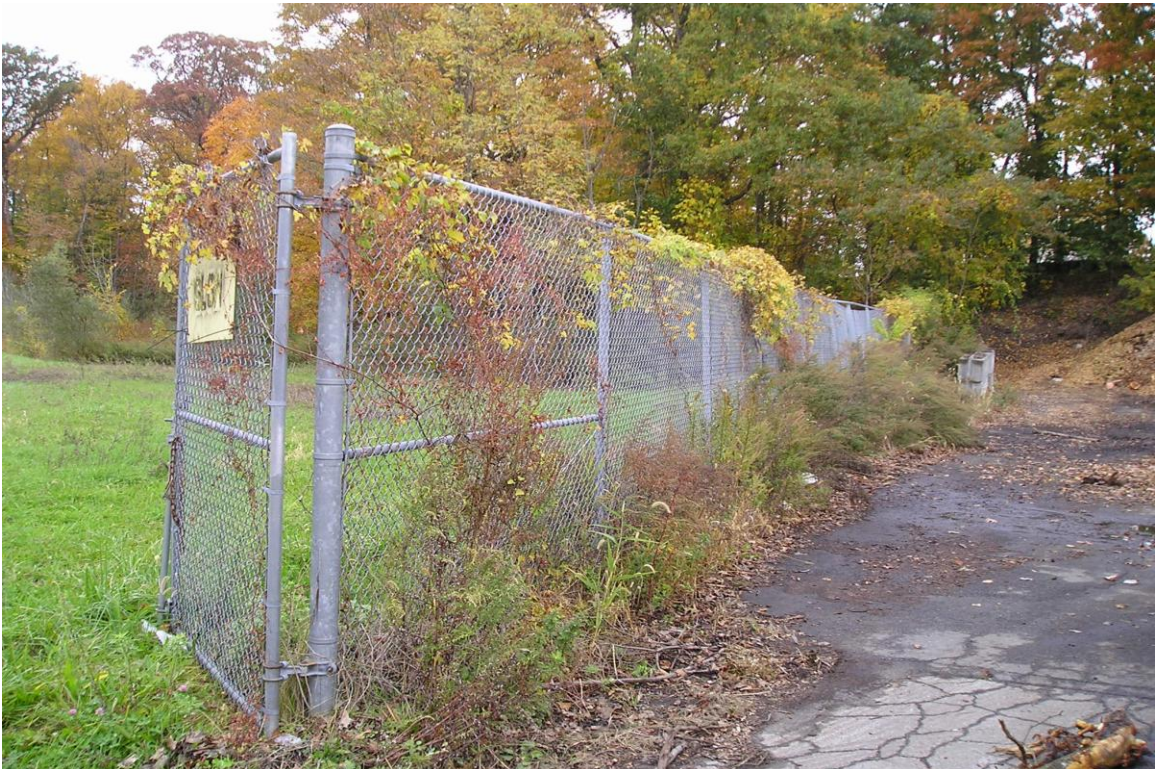
The damage to the south fence near the landfill gate was repaired since the last inspection in April 2012. (Photo #12)

Photo 12: South fence damage (looking east)

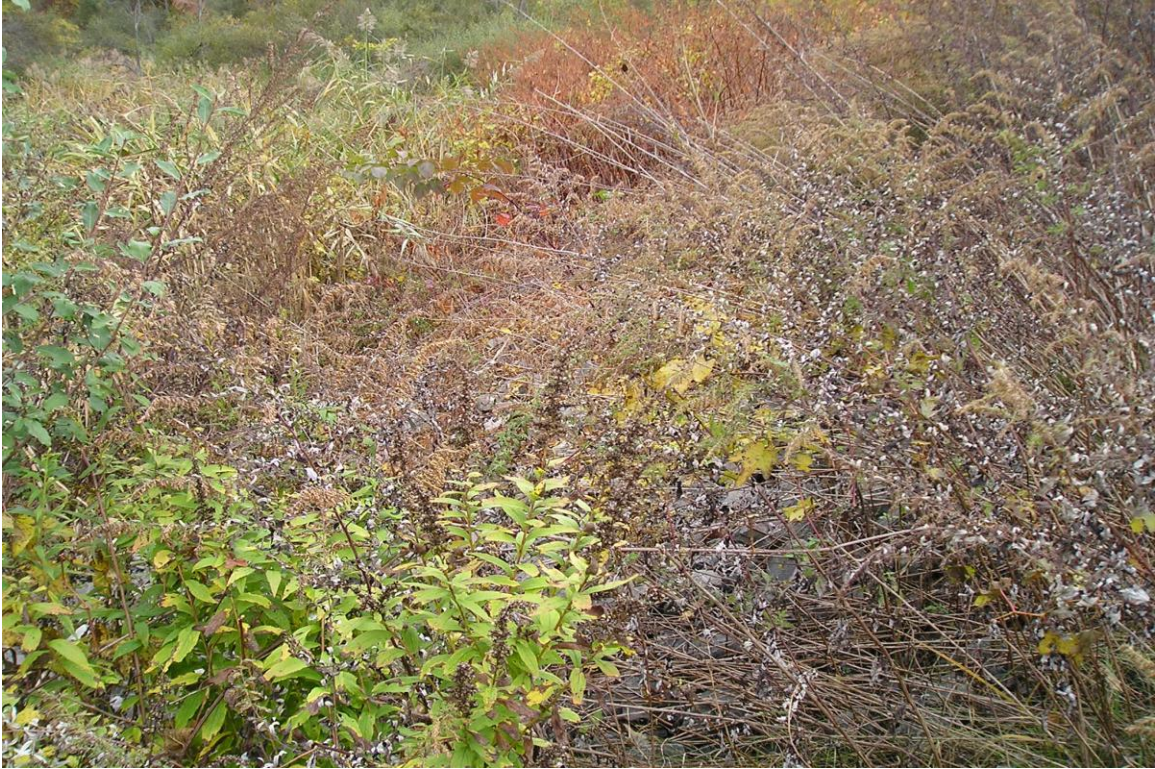
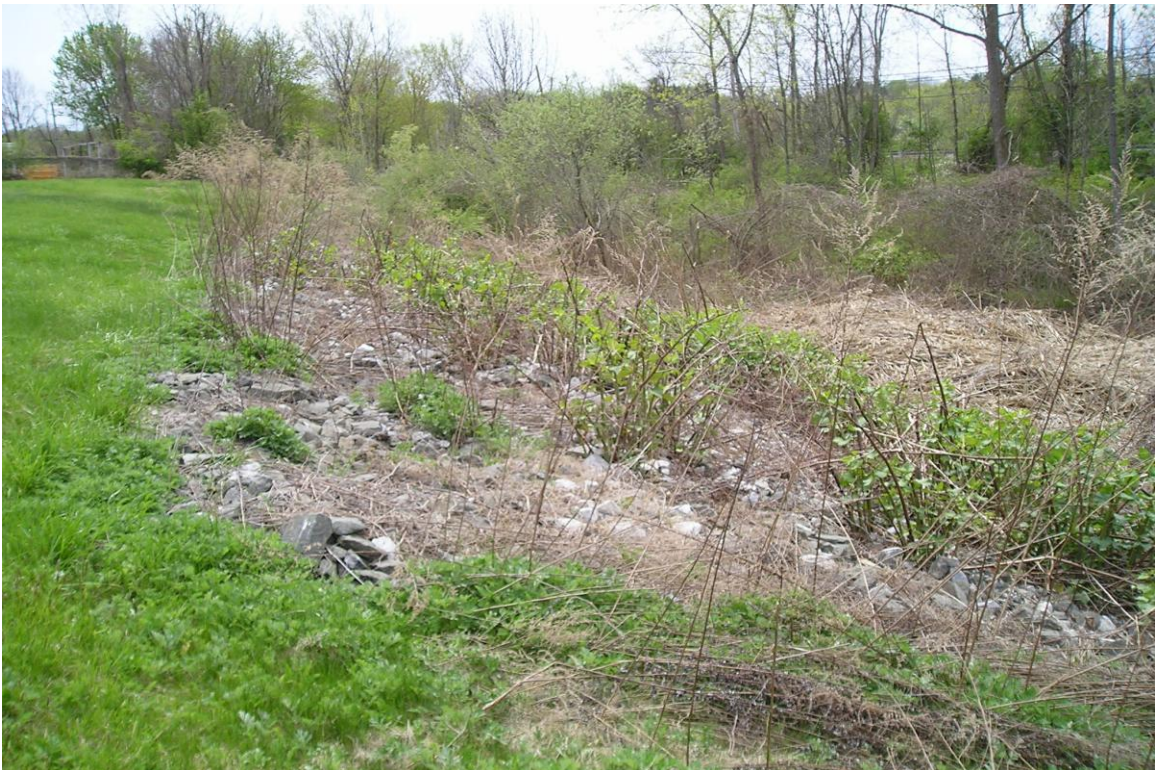
The soil slump on west slope of landfill was repaired in May 2009 by NYSDOT Residency 8-9 personnel. The repaired area is still in good condition (Photos #13 & 14), but old vegetation should be weed-wacked in the spring.

Photo 13: West slope erosion area repair (looking north)

Photo 14: West slope erosion area repair (looking south)

1. The cap should continue to be mowed every June and October to control grass height.
2. Old vegetation in the area of the west slope repair should be removed during the next cap mowing.
